Ridinger Lake Watershed Diagnostic Study

KOSCIUSKO AND WHITLEY COUNTIES, INDIANA

November 1, 2004

RIDINGER LAKE WATERSHED DIAGNOSTIC STUDY EXECUTIVE SUMMARY

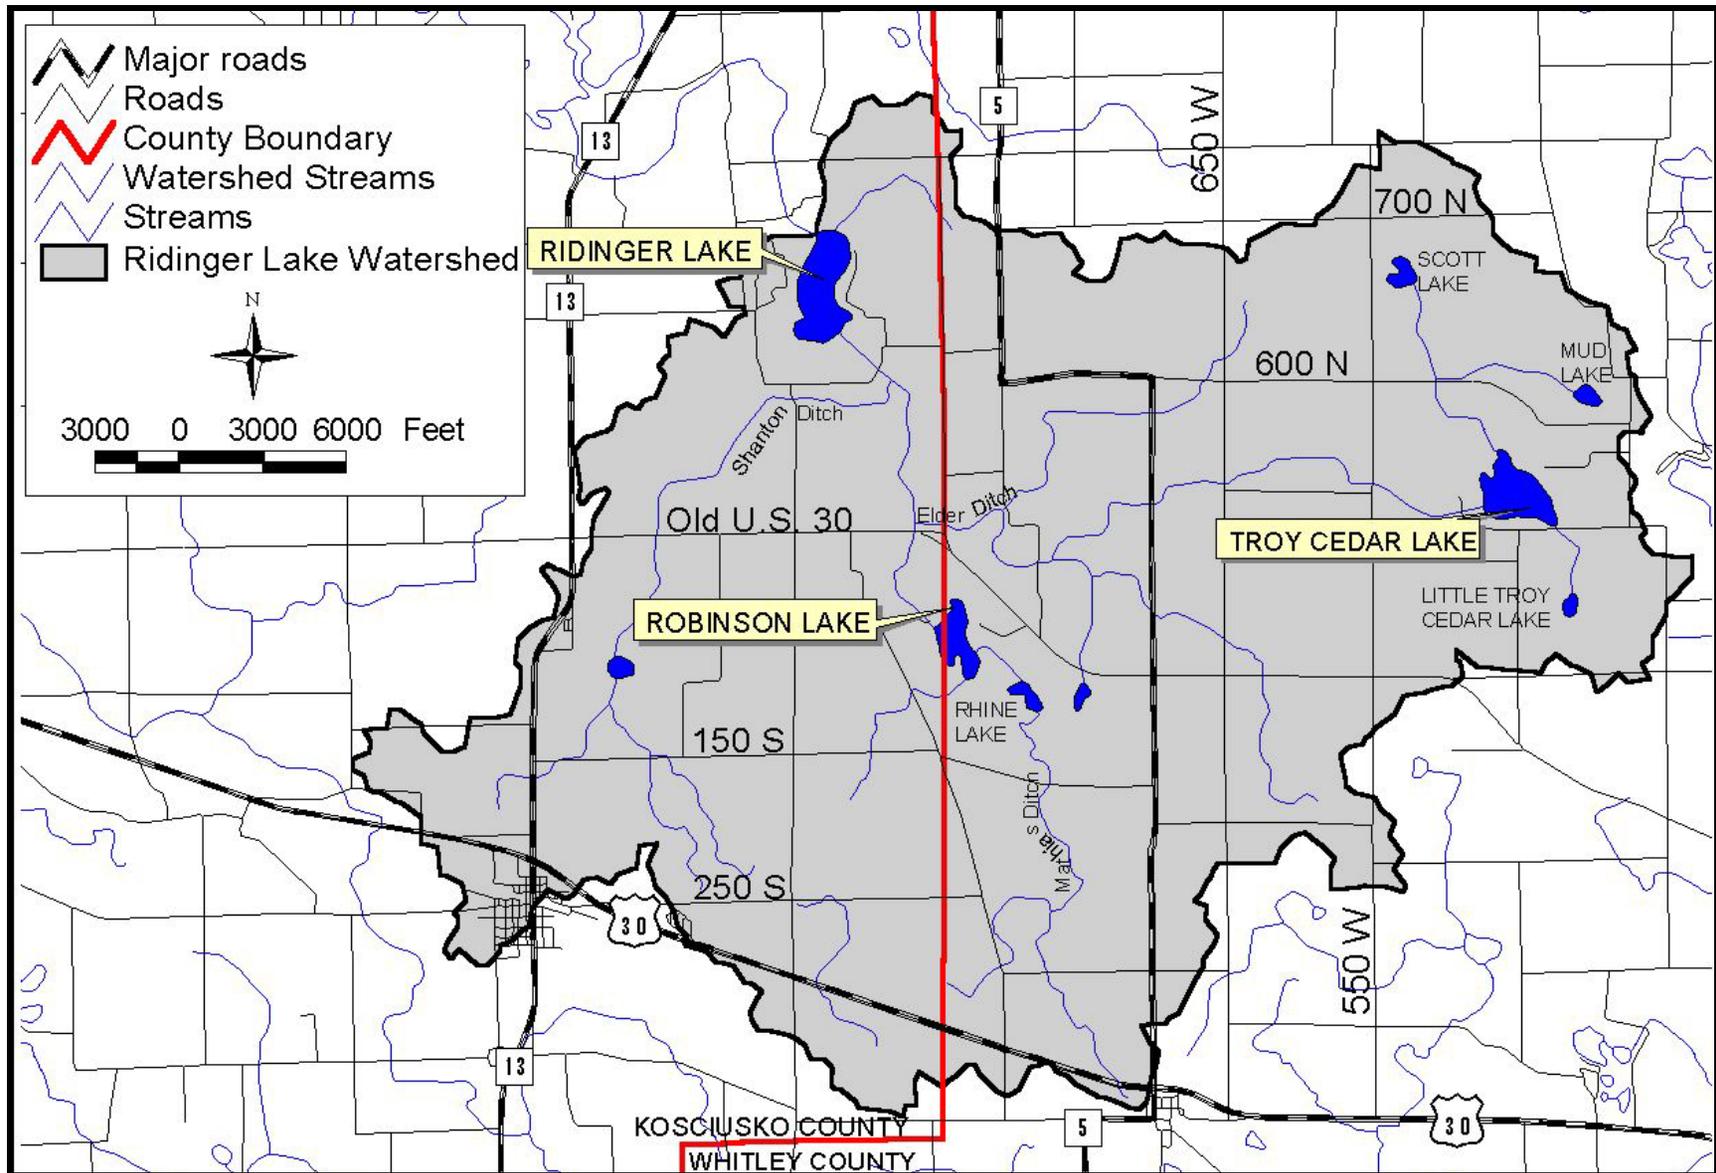
Figure 2. The Ridinger Lake watershed.

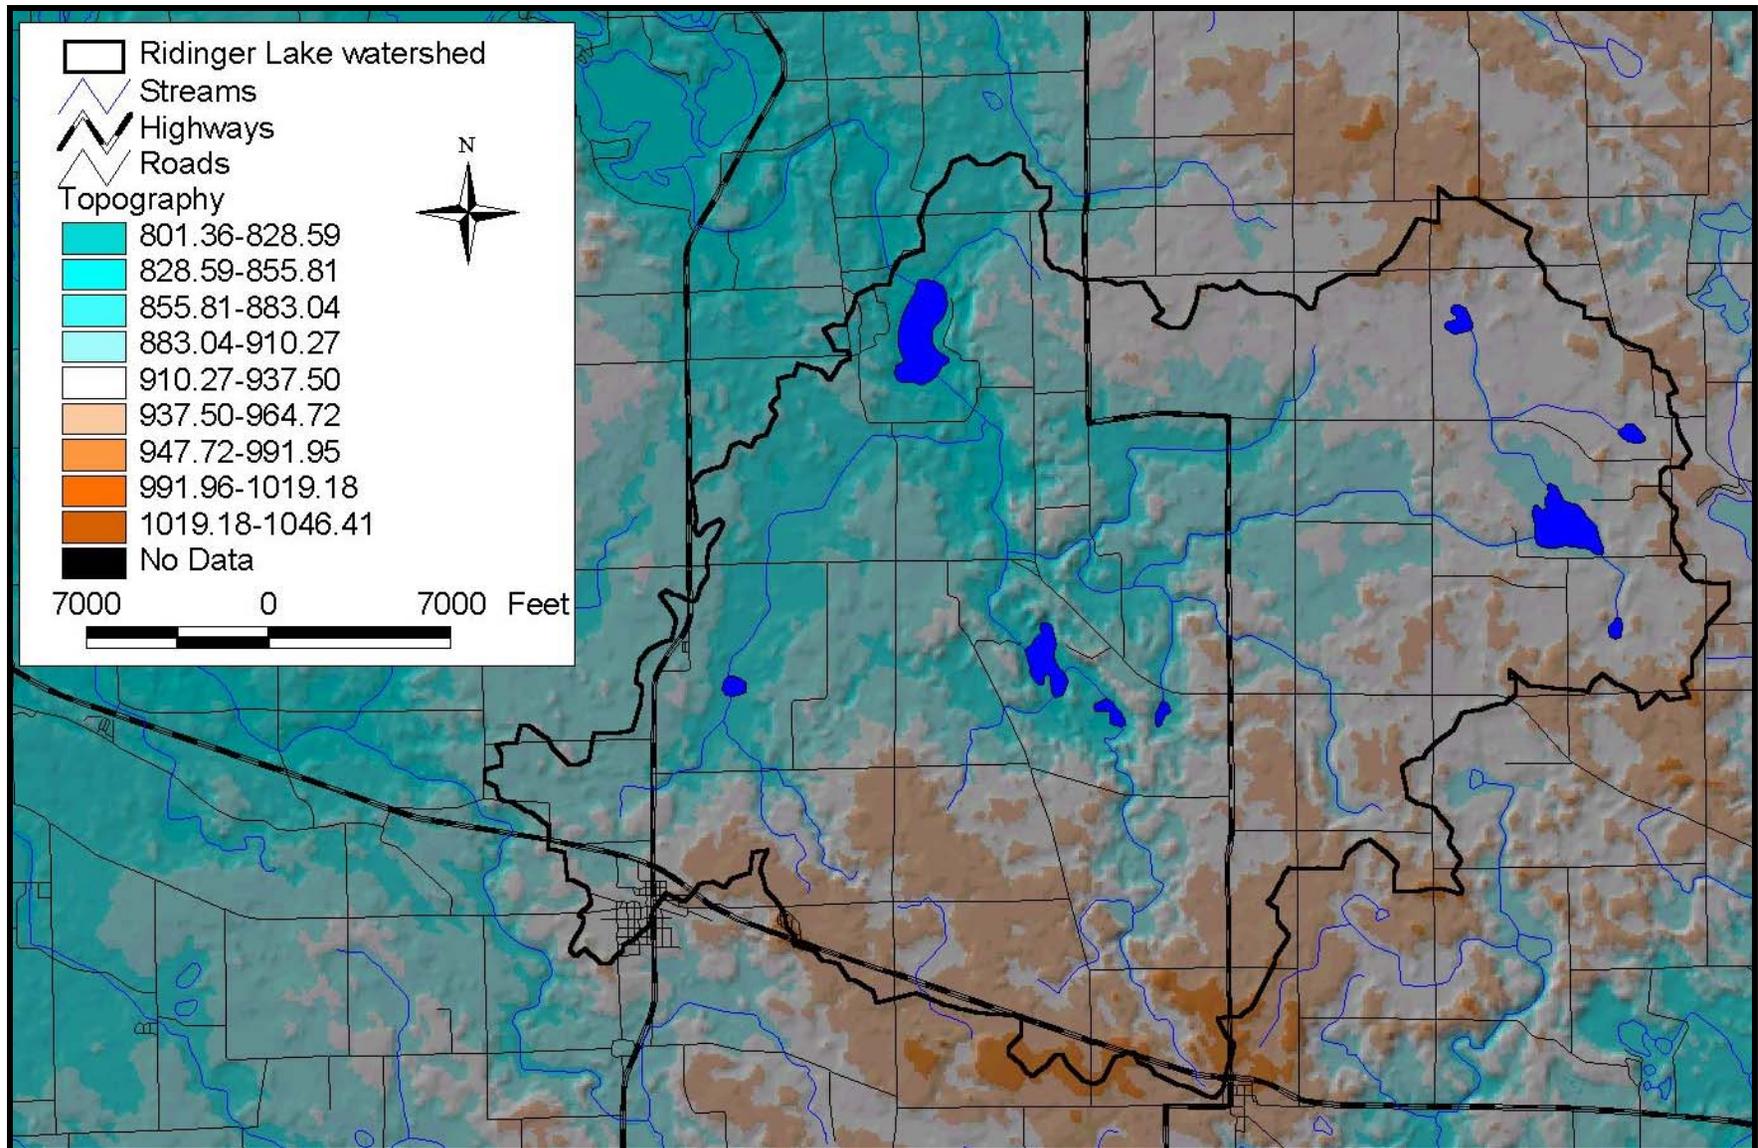
Figure 3. Topographical map of the Ridinger Lake watershed.

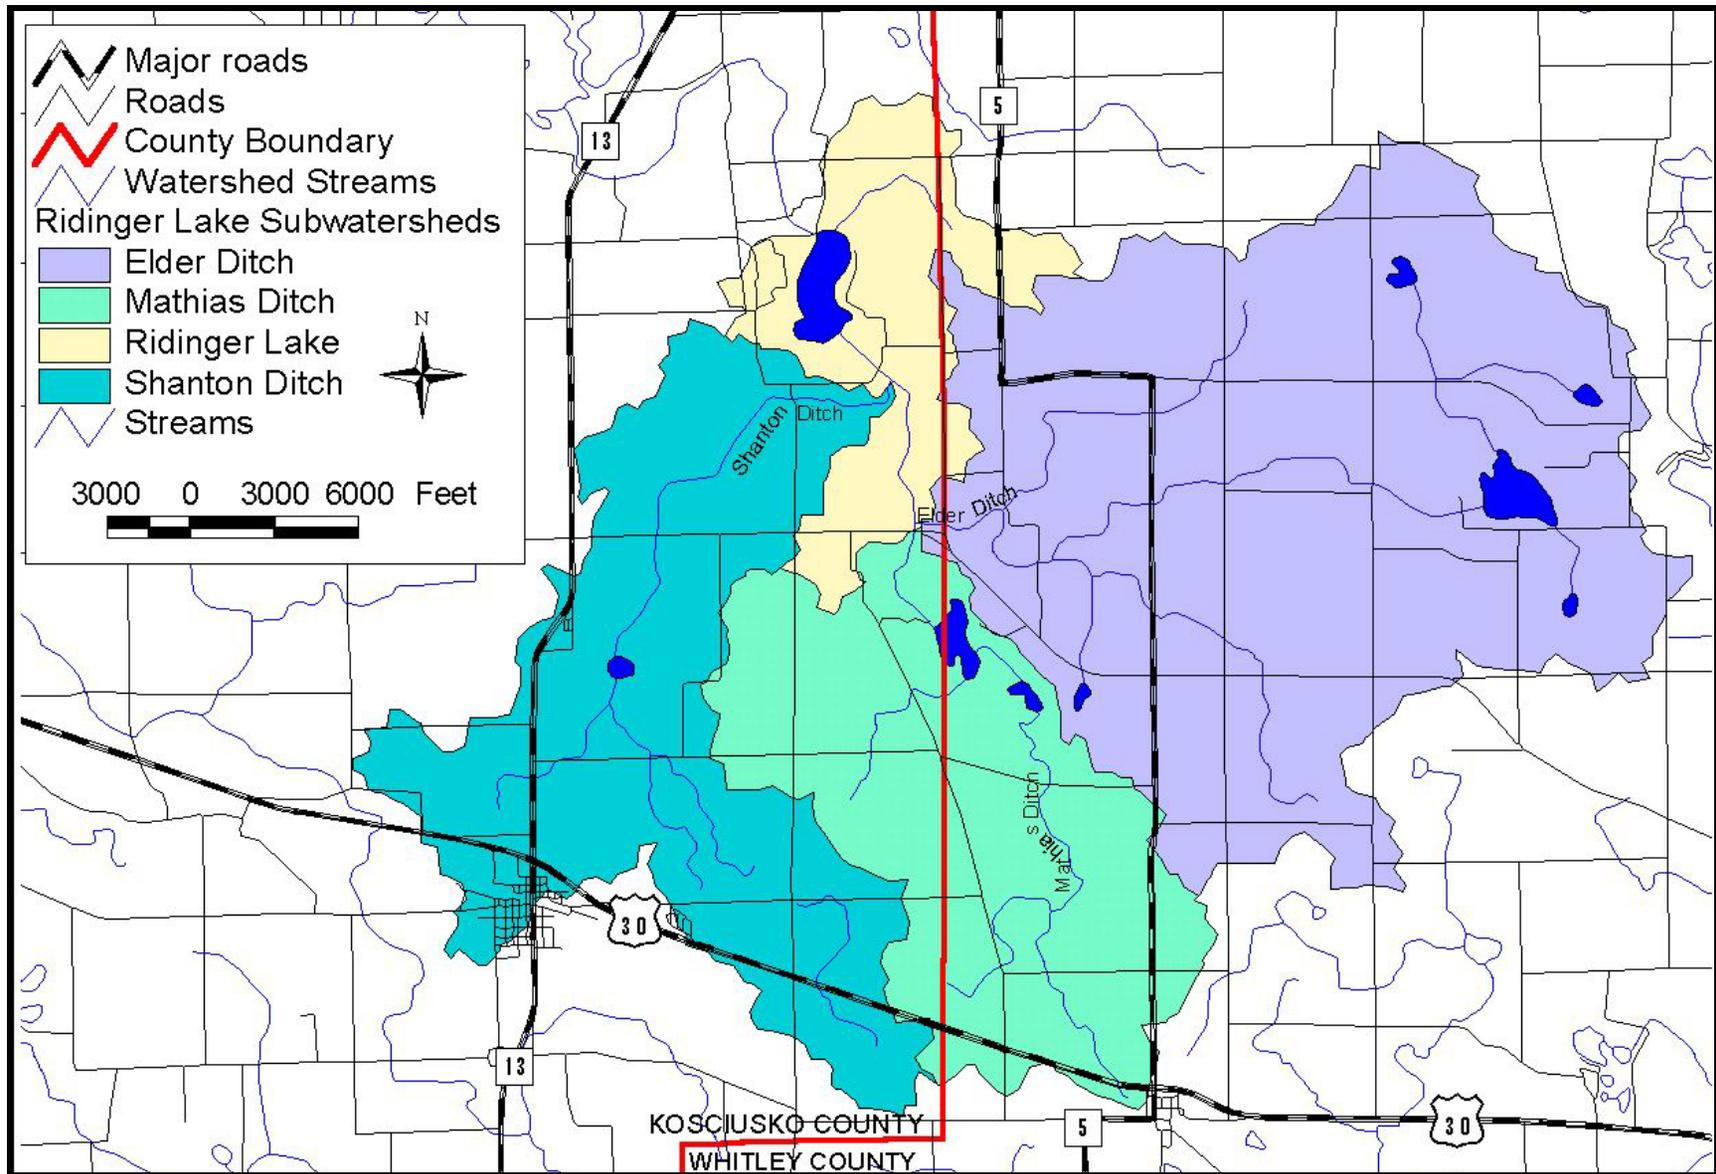
Figure 4. Ridinger Lake subwatersheds.

Table 1 presents the approximate sizes of each of the three major subwatersheds as well as the size of the subwatershed that drains directly to Ridinger Lake or is below the confluence of the major drainages. Elder Ditch is the largest subwatershed, draining 10,202 acres (4,129 ha) and covering nearly 50% of the Ridinger Lake watershed. Shanton Ditch and Mathias Ditch drain similar sized areas, 5,261 acres (2,129 ha) and 4,584 acres (1,855 ha), respectively. Approximately 2,134 acres (863 ha) of land drain to Elder Ditch below its confluence with Mathias and Shanton Ditches or directly into Ridinger Lake. Combined, Ridinger Lake possesses a watershed area of 22,181 acres (8,976 ha).

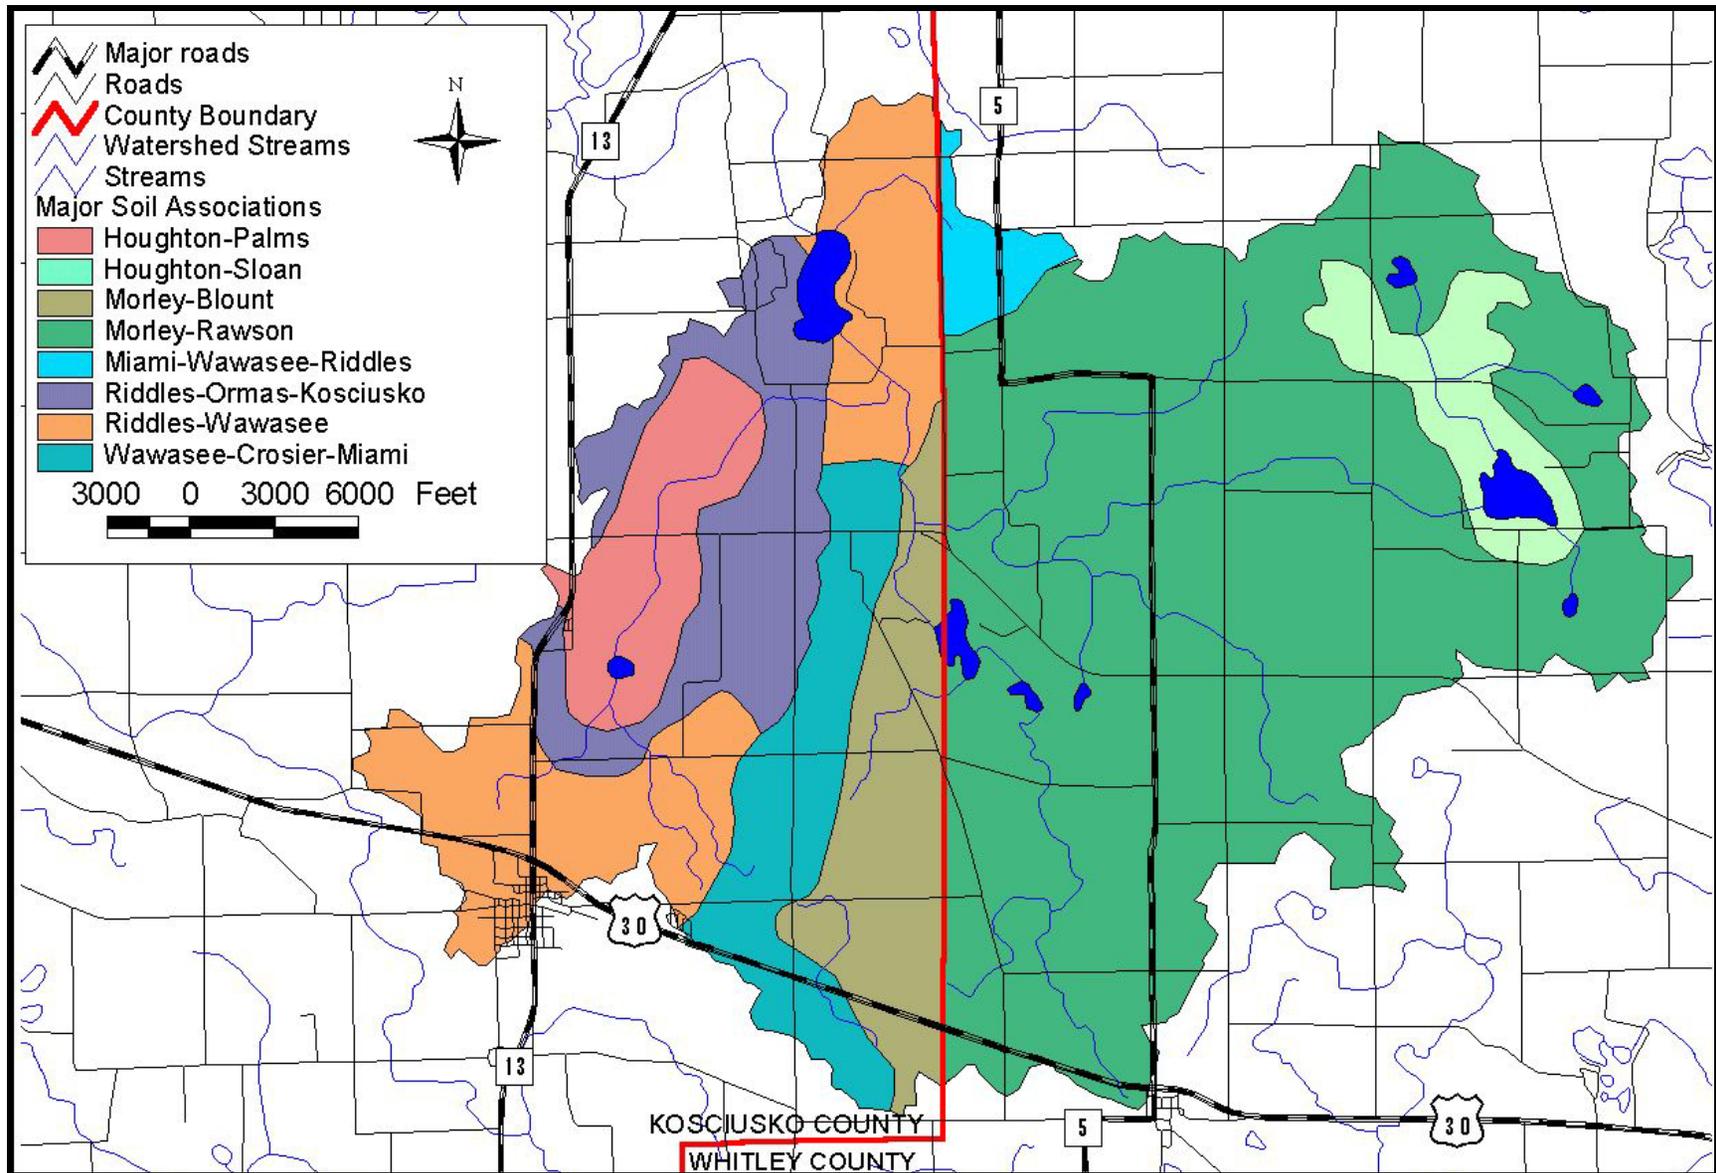
Figure 7. The major soil associations covering the Ridinger Lake watershed.

The Ridinger Lake watershed’s geological history described in the previous section determined the soil types found in the watershed and is reflected in the eight major soil associations that cover the Ridinger Lake watershed (Figure 7). The watershed’s soils show the influence of both the Erie Lobe and the Saginaw Lobe of the last Wisconsin period. Because the Erie Lobe originated from the east and scoured historical Lake Maumee, the Erie Lobe left glacial till with a high clay content. In contrast, the Saginaw Lobe moved from the north toward the south, leaving sandier till material that is more characteristic of Canadian bedrock. The Erie Lobe left the Mississinewa and Salamonie Moraines, the remains of which border the western edge of the Ridinger Lake watershed. Consequently, soils with relatively high clay content, such as Morley soils, are common in western portion of the Ridinger Lake watershed. The Packerton Moraine, left by the Saginaw Lobe, forms the southern edge of the watershed. Sandier soils, such as Riddles, Wawasee, and Miami, cover the southeastern and eastern portion of the watershed.

Eight major soil associations cover the Ridinger Lake watershed (Figure 7). Five of these associations, Morley-Blount, Riddles-Ormas-Kosciusko, Riddles-Wawasee, Wawasee-Crosier-Miami, and Houghton-Palms, lie within the Kosciusko County portion of the Ridinger Lake watershed. The Riddles-Wawasee soil association covers the largest portion of the Ridinger Lake watershed within Kosciusko County. This association is the second most common soil association found in Kosciusko County covering approximately 10% of the county landscape. Generally, all of the remaining soil associations are equally proportioned throughout Kosciusko County portion of the watershed. The Wawasee-Miami-Crosier association is the most common soil association found in Kosciusko County covering approximately 28% of the county landscape. The other three associations are less common in Kosciusko County. Morley-Blount, Riddles-Ormas-Kosciusko, and Houghton-Palms soil associations cover approximately 4%, 6%, and 9%, respectively (Staley, 1989). The following discussion on soil associations in the Kosciusko County portion of the Ridinger Lake watershed relies heavily on the *Soil Survey of Kosciusko County* (Staley, 1989). Readers should refer to this source for a more detailed discussion of soil associations covering Kosciusko County.

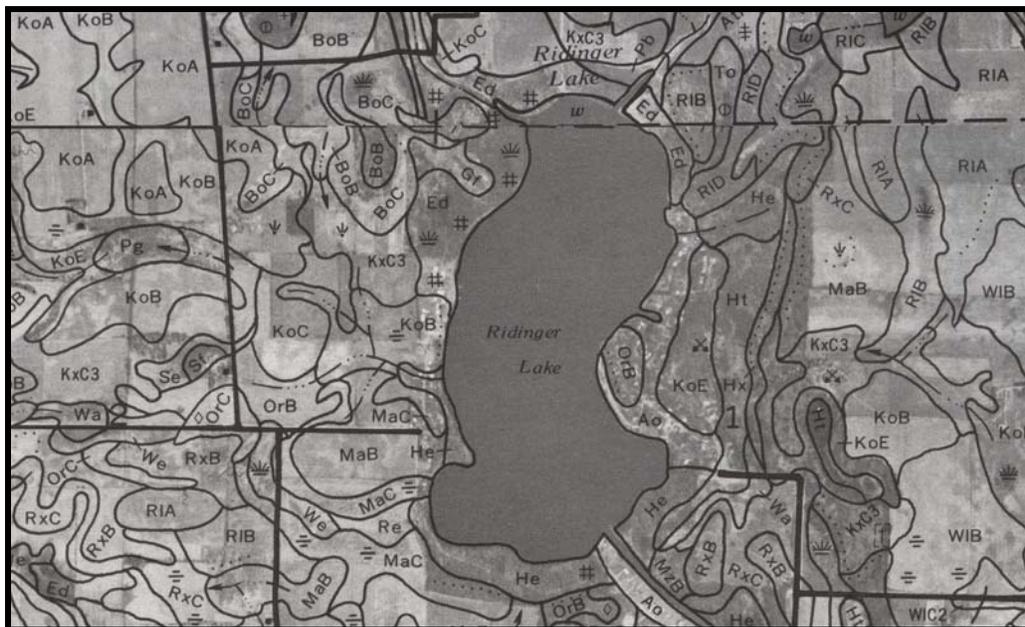
Figure 8. Soil series bordering Ridinger Lake.

Figure 8 shows the soil units surrounding Ridinger Lake, while Table 6 summarizes the soils' suitability for use as septic tank absorption fields. Following Table 6 is a short description of the soils listed in the table.

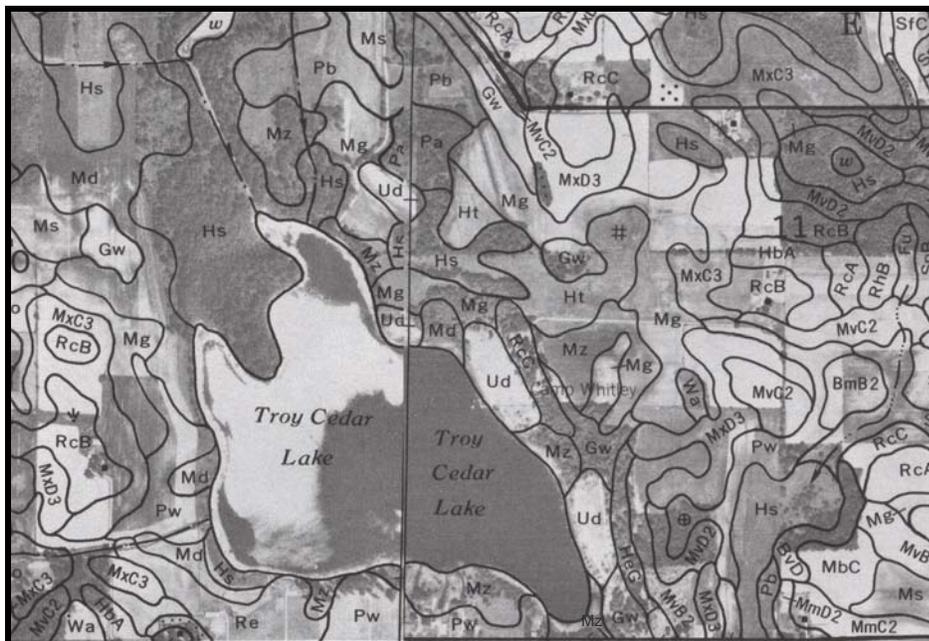
Figure 10. Soil series bordering Troy Cedar Lake.

Figure 10 shows the soil units surrounding Troy Cedar Lake, while Table 8 summarizes the soils' suitability for use as septic tank absorption fields. Following Table 8 is a short description of the soils listed in the table.

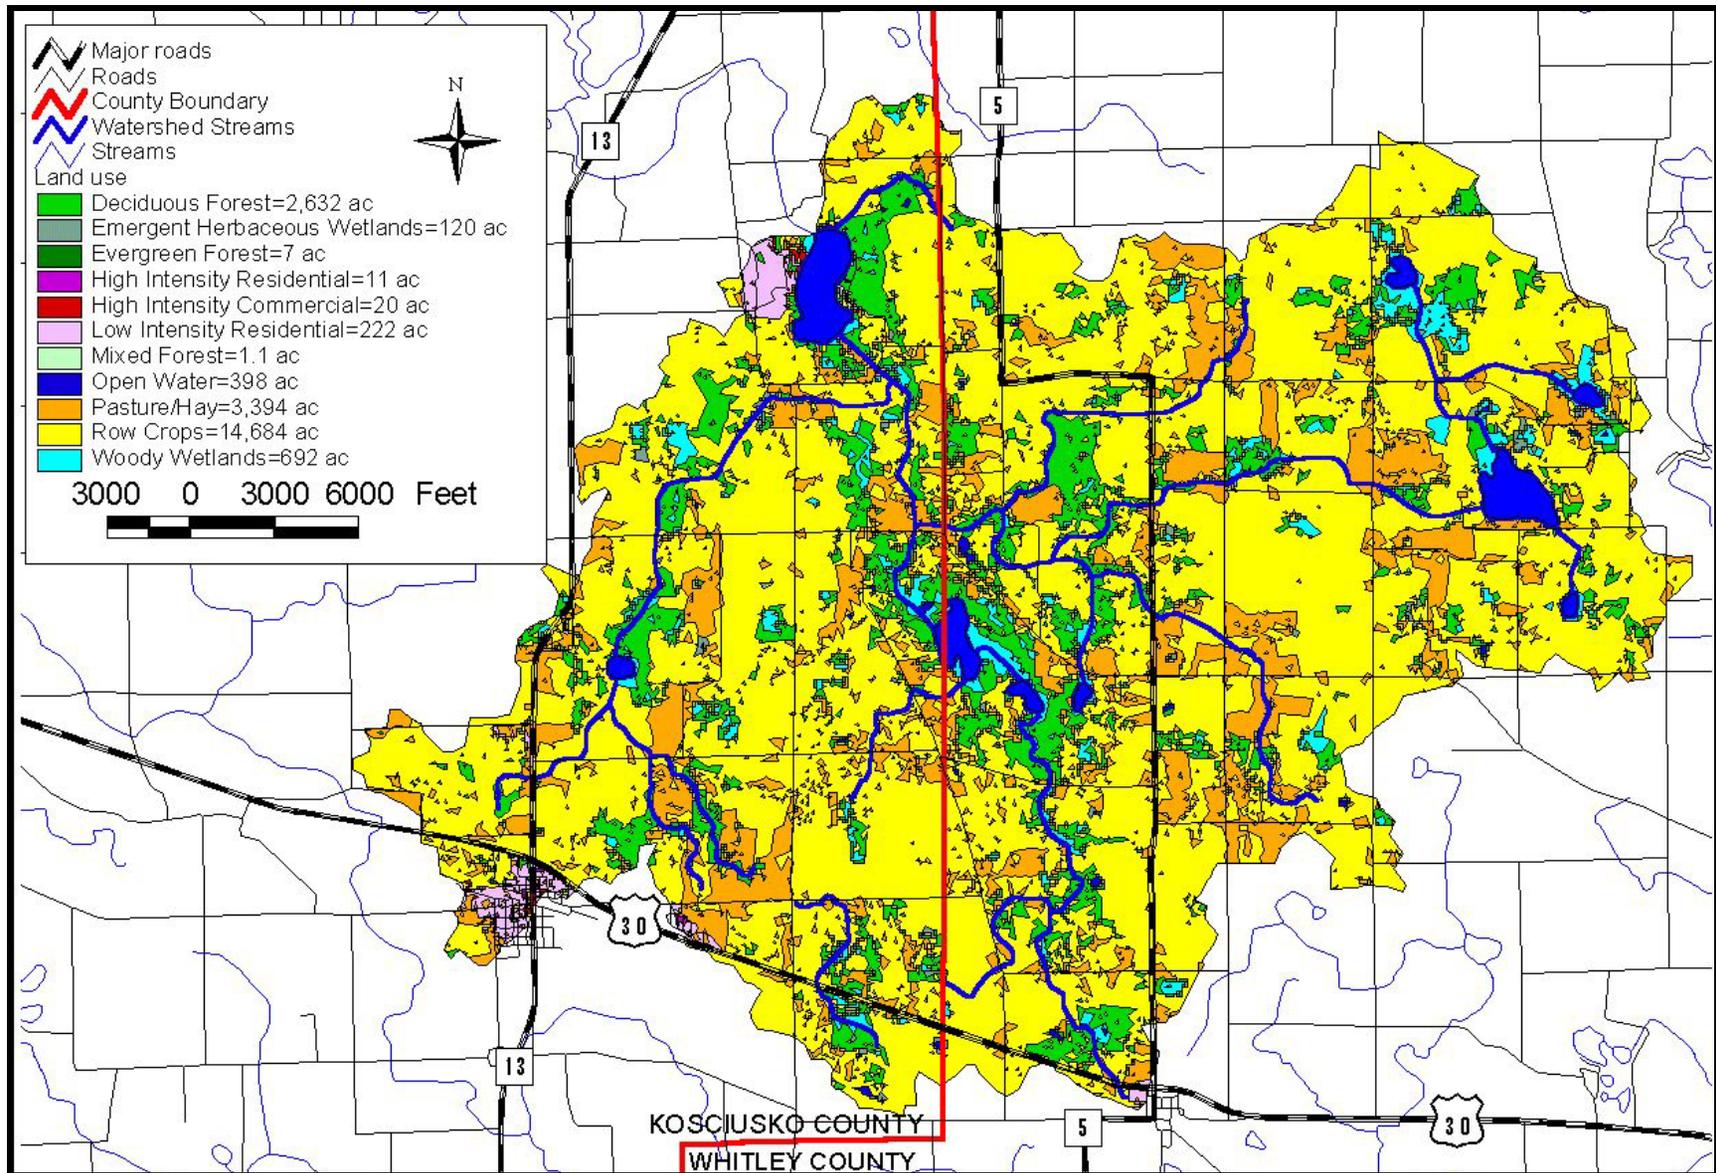
Figure 11. Land use in the Ridinger Lake watershed.

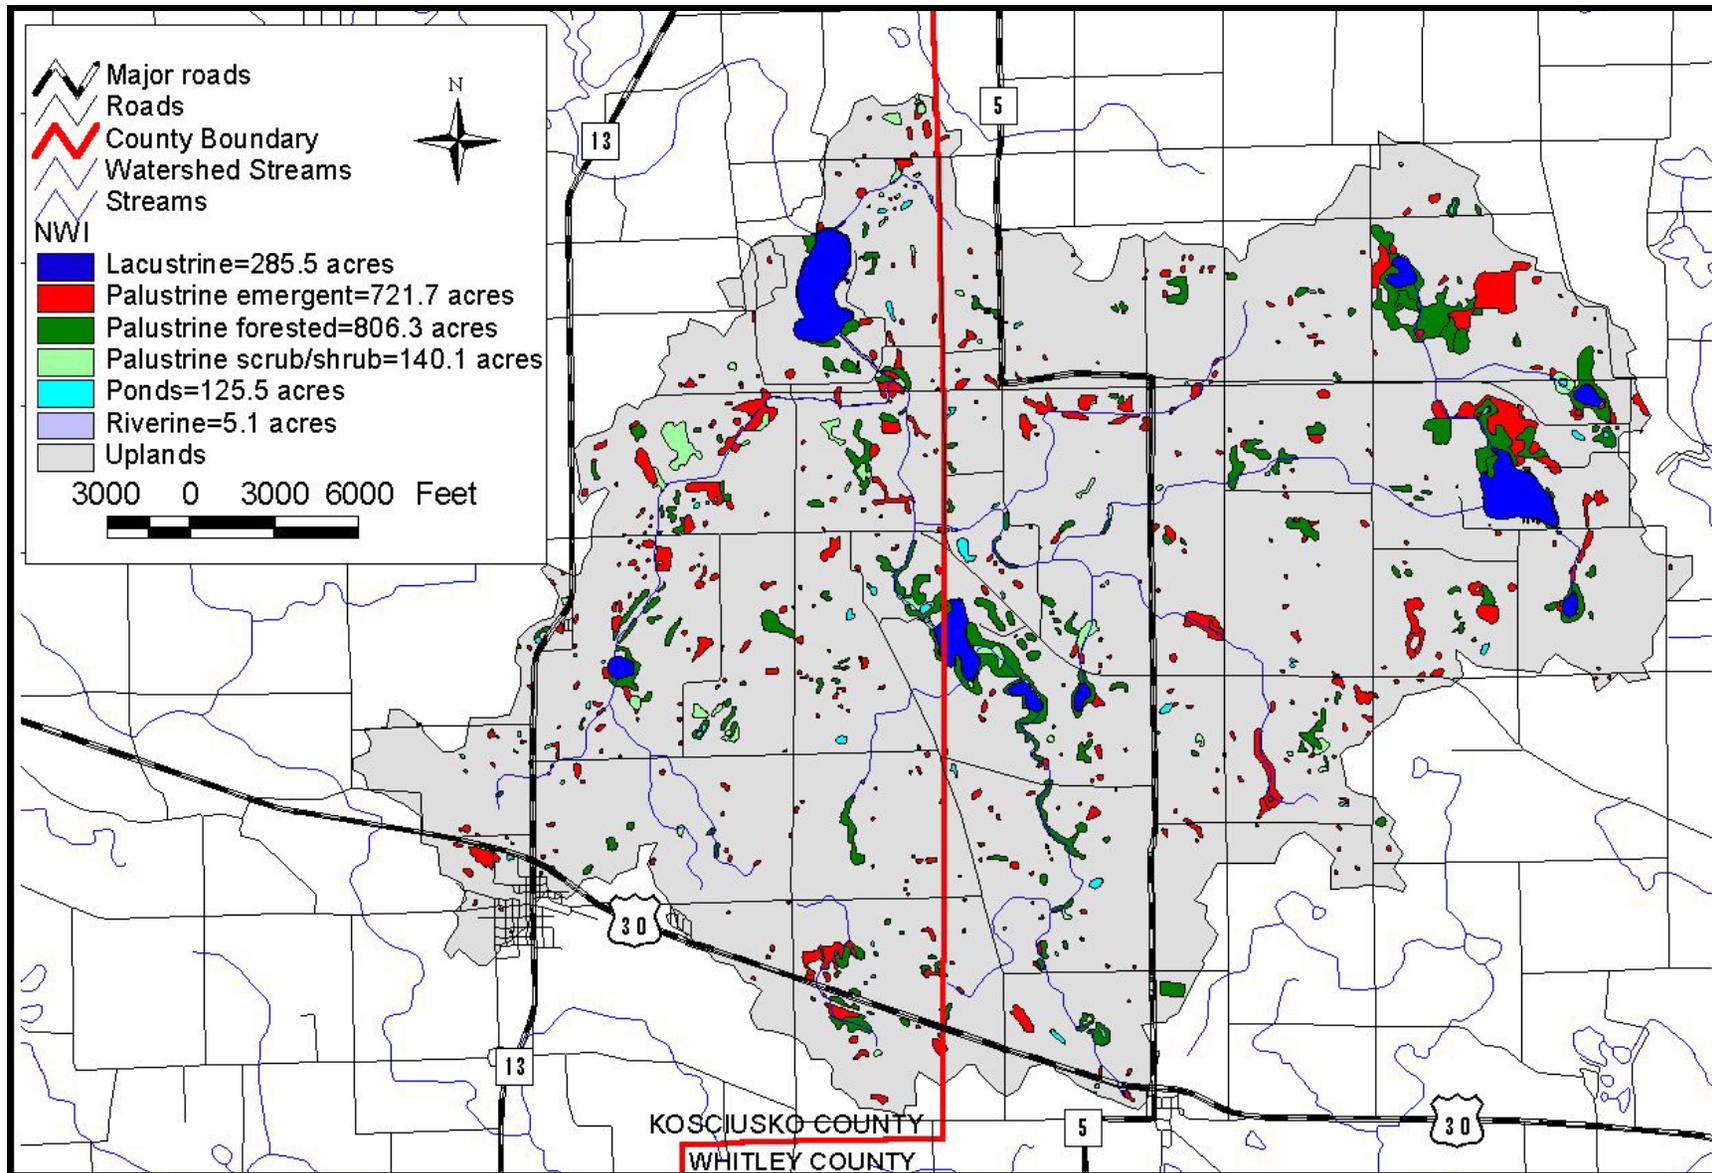
Figure 11. Wetlands in the Ridinger Lake watershed.

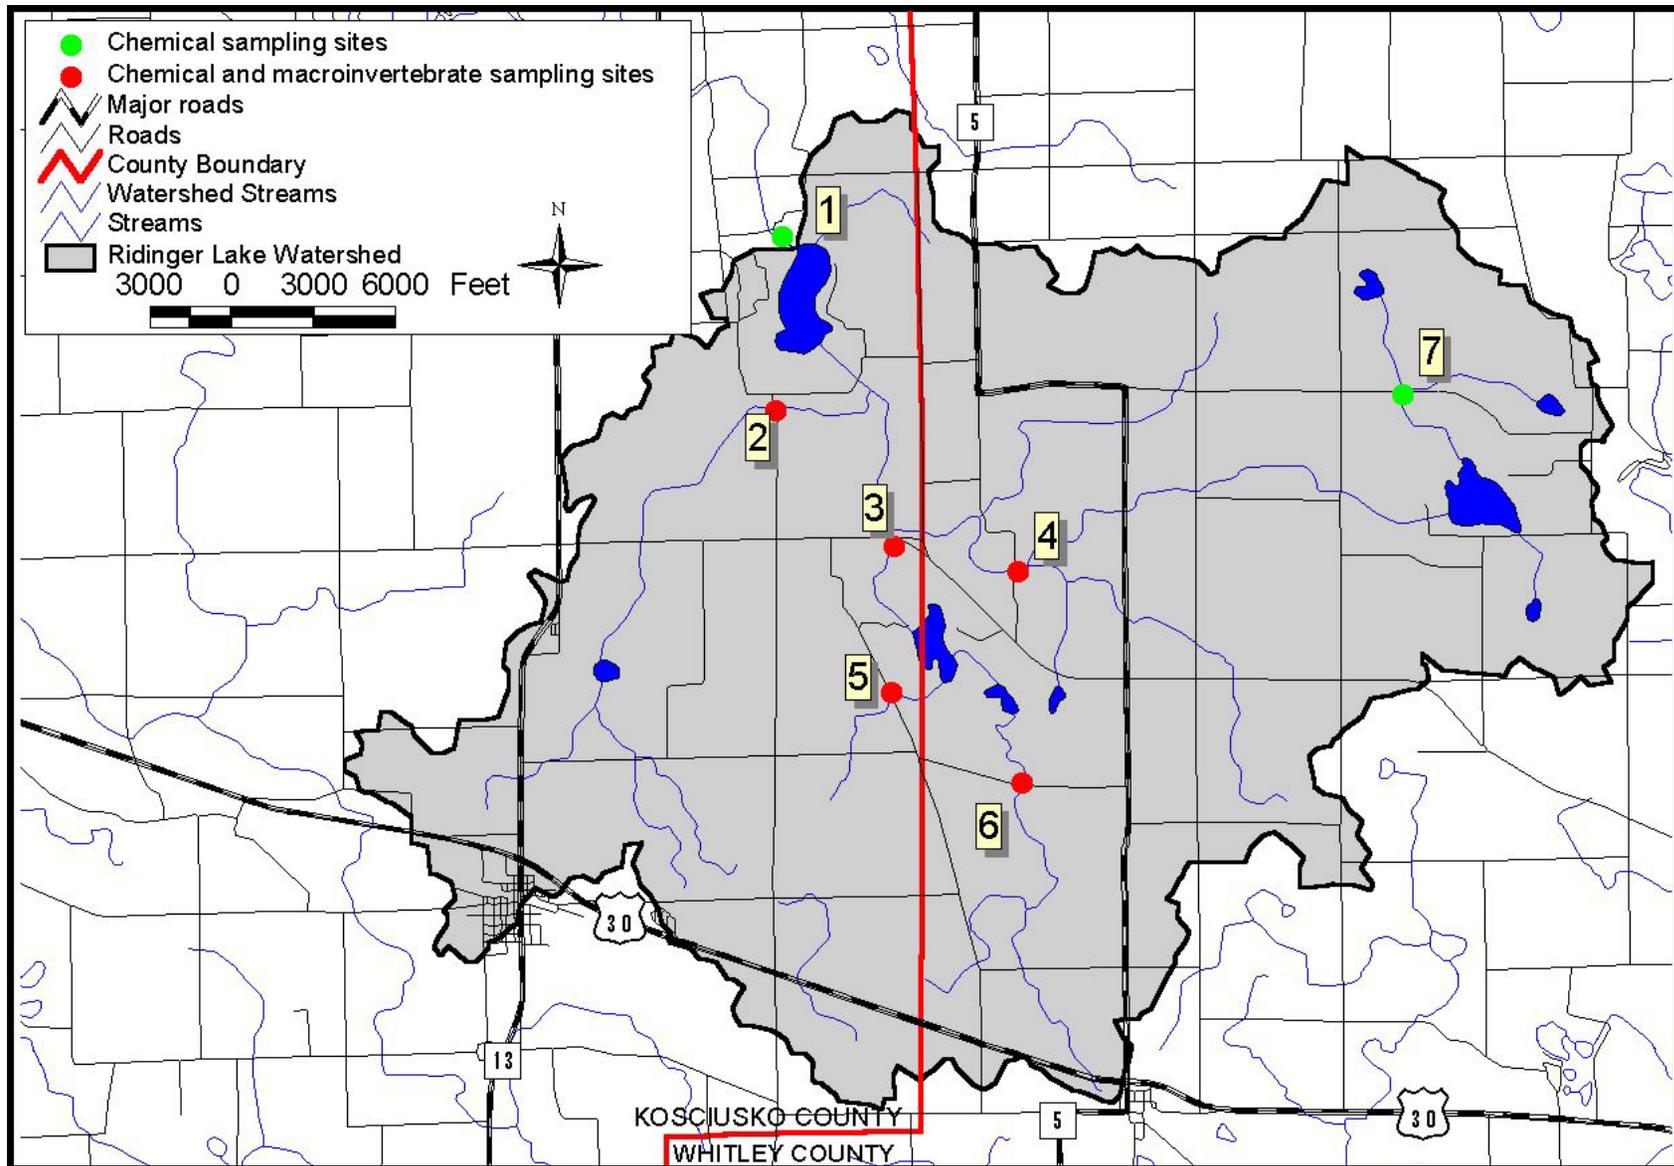
Figure 13. Stream sampling sites.

Water samples were collected and analyzed for various parameters from seven streams in the Ridinger Lake watershed (Table 13 and Figure 13). The LARE sampling protocol requires assessing the water quality of each designated stream site once during base flow and once during storm flow. This is because water quality characteristics change markedly between these two flow regimes. A storm flow sample will be influenced by runoff from the landscape and usually contains higher concentrations of soil and soil-associated nutrients. A base flow sample represents the 'usual' water characteristics of the stream. Storm flow samples were collected on May 1, 2003, following 1-2 inches (2.5-5 cm) of rain. (The National Weather Service office in North Webster, Indiana reported 2.16 inches of rain on April 30, 2003.) Base flow samples were collected on August 6, 2003 following a period of little precipitation.

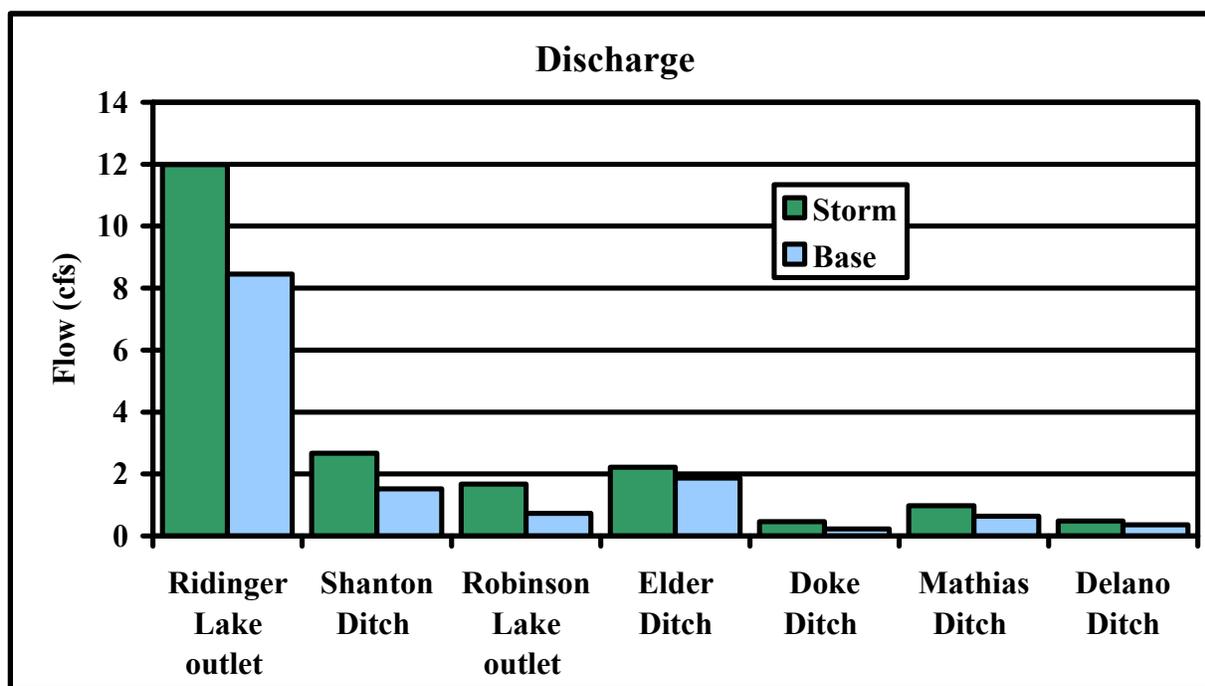
Figure 14. Discharge measurements during base flow and storm flow sampling of Ridinger Lake watershed streams.

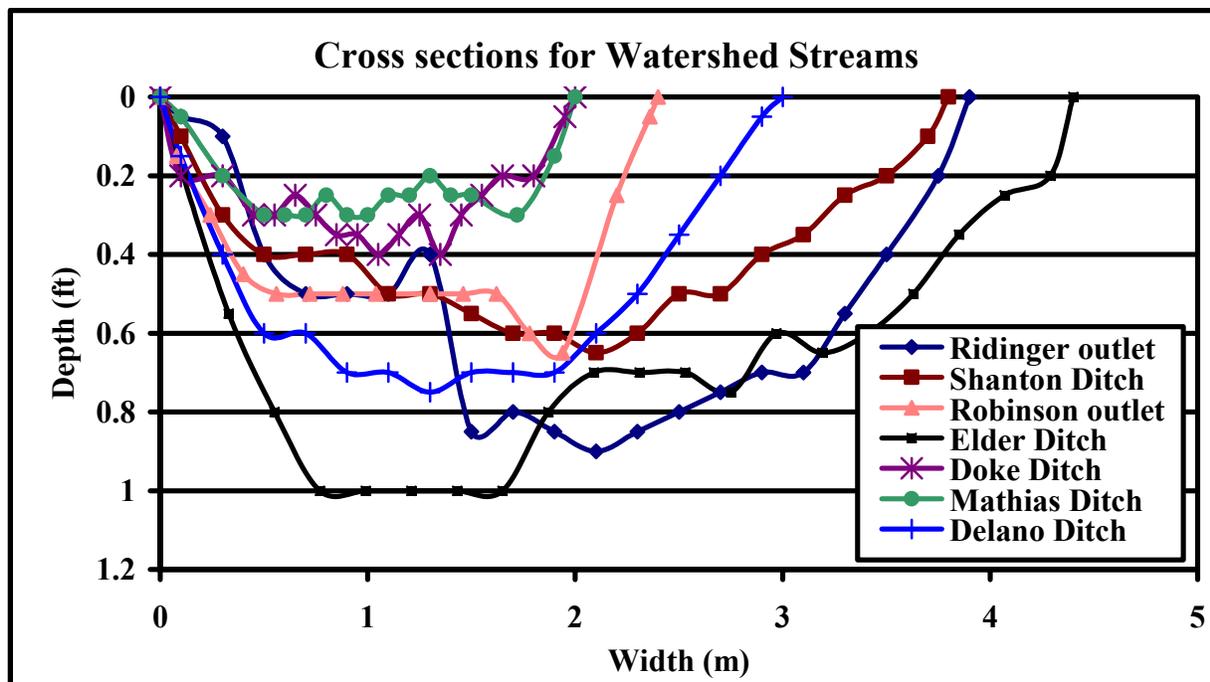
Figure 15. Physical dimensions at the sampling locations of Ridinger Lake watershed streams.

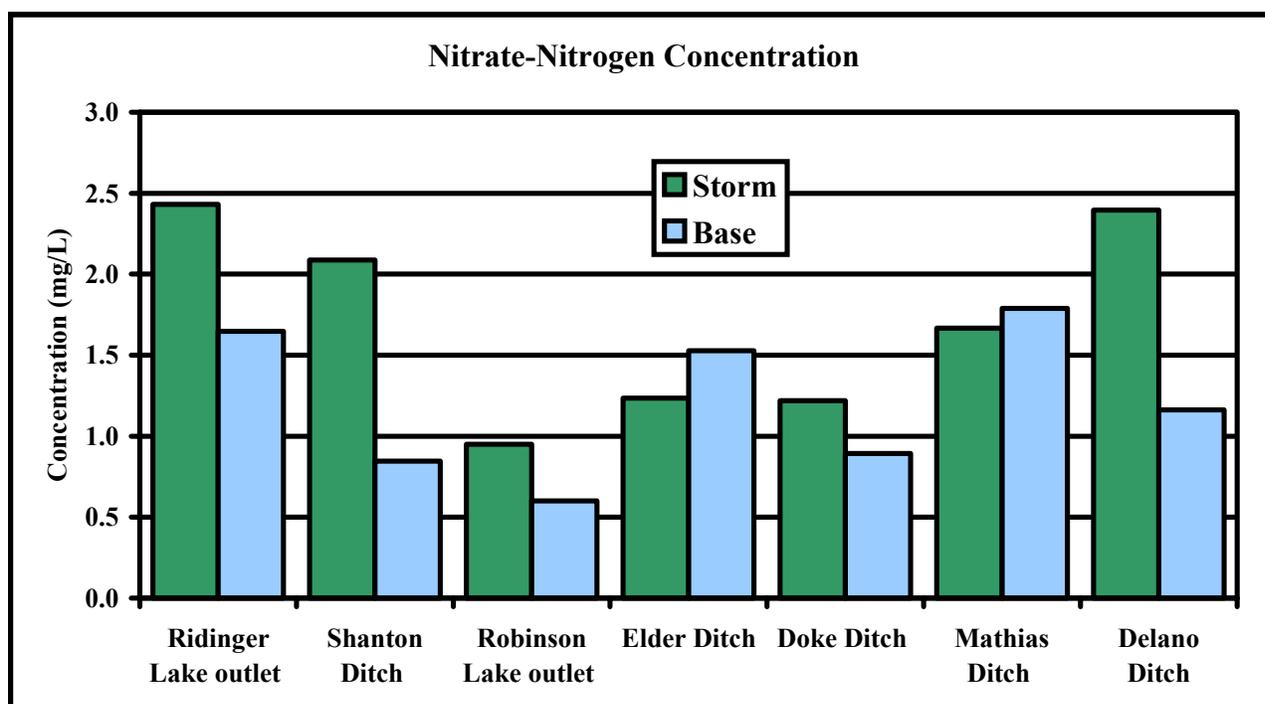
Figure 16. Nitrate-nitrogen concentrations in Ridinger Lake watershed streams as sampled 5/1/03 and 8/6/03. Detection limit is 0.022 mg/L.

Nitrate-nitrogen concentrations in the Ridinger Lake watershed streams were slightly elevated for Indiana streams. Nitrate-nitrogen concentrations ranged from a low of 0.6 mg/L in the Robinson Lake outlet stream during base flow to a high of 2.4 mg/L in the Ridinger Lake outlet stream during storm flow. Many sites exceeded the Ohio EPA recommended nitrate-nitrogen concentration to protect aquatic life. Nitrate-nitrogen concentrations in the Ridinger Lake outlet stream, Elder Ditch, Mathias Ditch, and Delano Ditch exceeded the Ohio EPA criterion during both base flow and storm flow conditions. Nitrate-nitrogen concentrations in Doke Ditch and Shanton Ditch exceeded the Ohio EPA recommended criterion during storm flow. Nitrate-nitrogen concentrations in the Robinson Lake outlet were generally good. Despite the fact that many of the streams exceeded the Ohio EPA's recommendation for nitrate-nitrogen concentration, none of the streams possessed nitrate-nitrogen concentrations of 3-4 mg/L, the threshold at which Ohio EPA found to definitively impair biotic communities (Ohio EPA, 1999). Similarly, none of the watershed streams possessed nitrate-nitrogen concentrations that violated the Indiana state water quality standards.

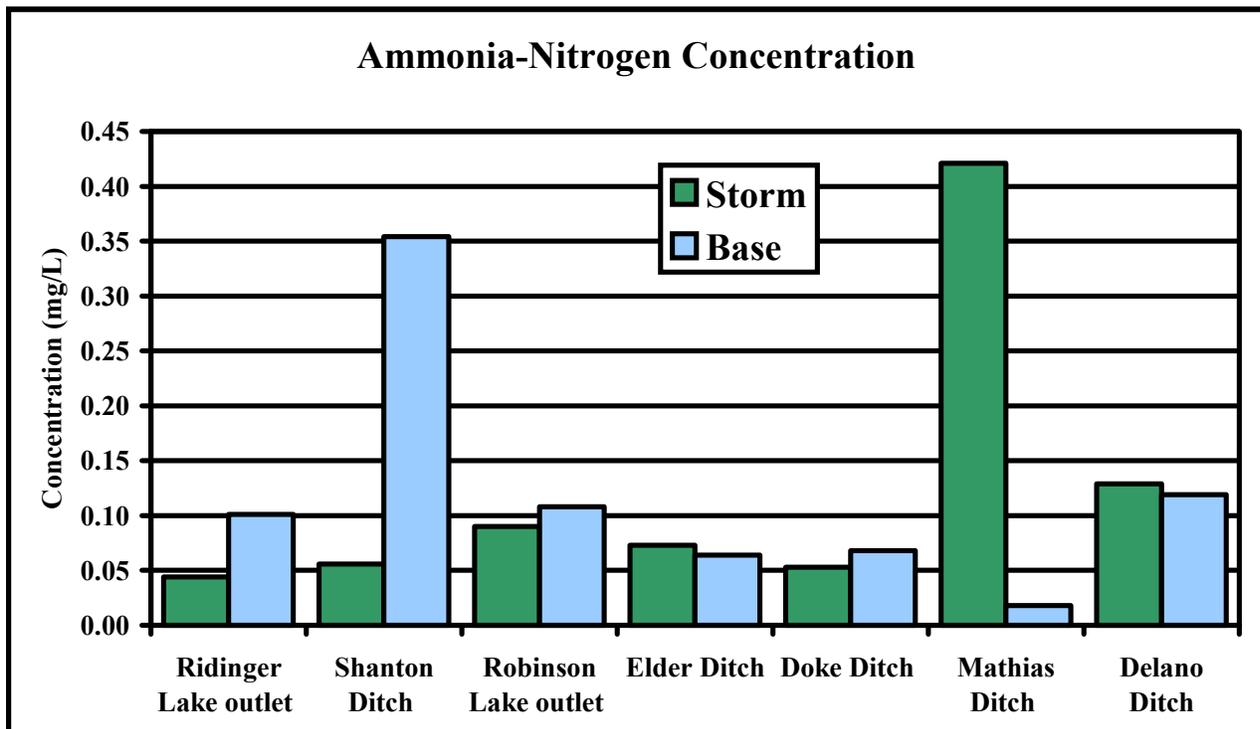
Figure 17. Ammonia-nitrogen concentrations in Ridinger Lake watershed streams as sampled 5/1/03 and 8/6/03. Detection limit is 0.018 mg/L.

Ammonia concentrations ranged from below the laboratory detection limit in Mathias Ditch at base flow to 0.421 mg/L in Mathias Ditch during storm flow. Relatively high ammonia concentrations were also observed in Shanton Ditch during base flow and Delano Ditch during both base and storm flow conditions. Ammonia is a by-product of decomposition and therefore streams with high levels of organic material are expected to have higher ammonia concentrations. Both Mathias Ditch and Shanton Ditch possessed high total phosphorus concentrations during the same sampling event that they registered the high ammonia concentrations. High total phosphorus concentrations are indicative of high levels of organic matter. Similarly, Delano Ditch possessed high total organic nitrogen (total Kjeldahl nitrogen minus ammonia) levels during both base flow and storm flow conditions, suggesting the presence of organic matter. Delano Ditch's substrate is composed largely of muck and silty organic matter, so the high ammonia concentration in that stream is not surprising. Additionally, the sluggish nature of Delano Ditch compounds the ammonia problem. Small, natural streams are typically well oxygenated because of the turbulent flow. In well oxygenated streams, ammonia is usually oxidized to nitrate. However, oxygen does not readily diffuse into the slow flowing Delano Ditch, and this chemical reaction likely does not occur there.

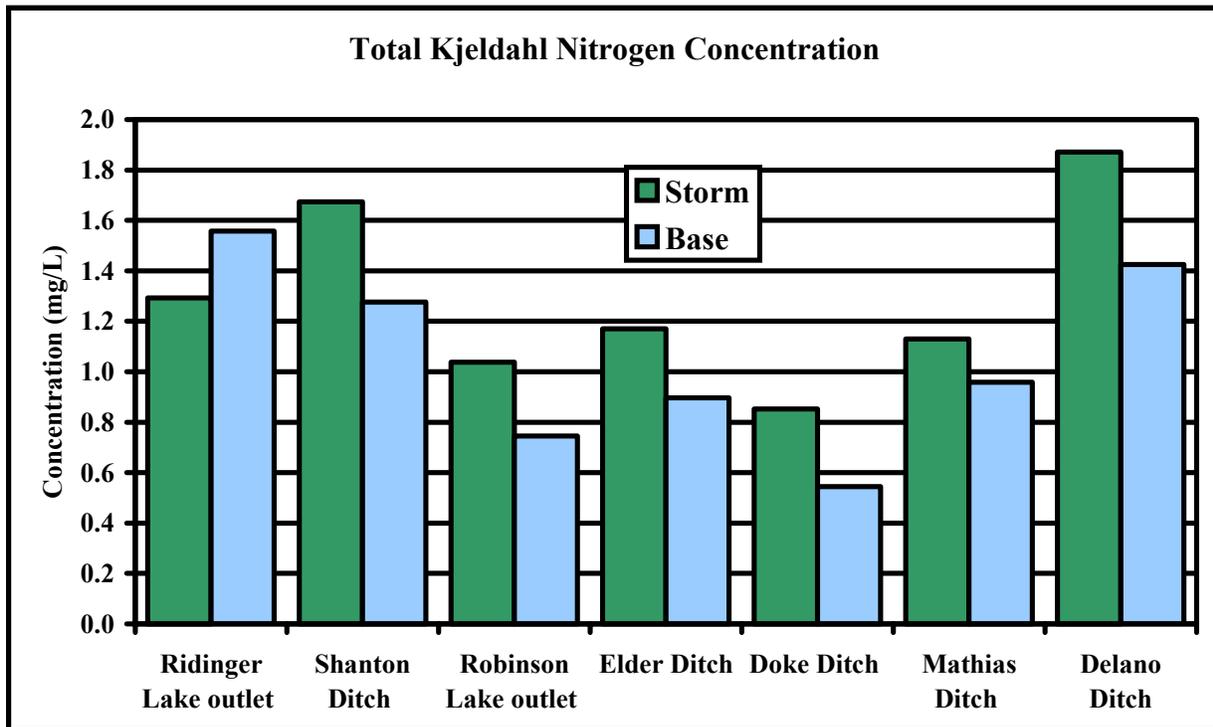
Figure 18. Total Kjeldahl nitrogen concentrations in Ridinger Lake watershed streams as sampled 5/1/03 and 8/6/03. Detection limit is 0.230 mg/L.

Total Kjeldahl nitrogen levels in the Ridinger Lake watershed streams were roughly average for northern Indiana streams. TKN concentrations ranged from 0.545 mg/L in Doke Ditch at base flow to 1.872 mg/L in Delano Ditch during storm flow. Relatively high TKN concentrations were also observed in Delano Ditch at base flow and Shanton Ditch and the Ridinger Lake outlet at both base and storm flow. Typically storm flow concentrations of TKN exceed base flow concentrations since runoff liberates significant organic material stored within the stream and in riparian areas adjacent to the stream. This relationship occurred at all sampling sites except the Ridinger Lake outlet stream. The Ridinger Lake outlet stream exhibited relatively similar base flow and storm flow TKN concentrations. All of the streams exhibited TKN concentrations greater than the target concentration of 0.24 mg/L recommended by the USEPA (2000a).
