Ridinger Lake Watershed Diagnostic Study

KOSCIUSKO AND WHITLEY COUNTIES, INDIANA

November 1, 2004

RIDINGER LAKE WATERSHED DIAGNOSTIC STUDY EXECUTIVE SUMMARY

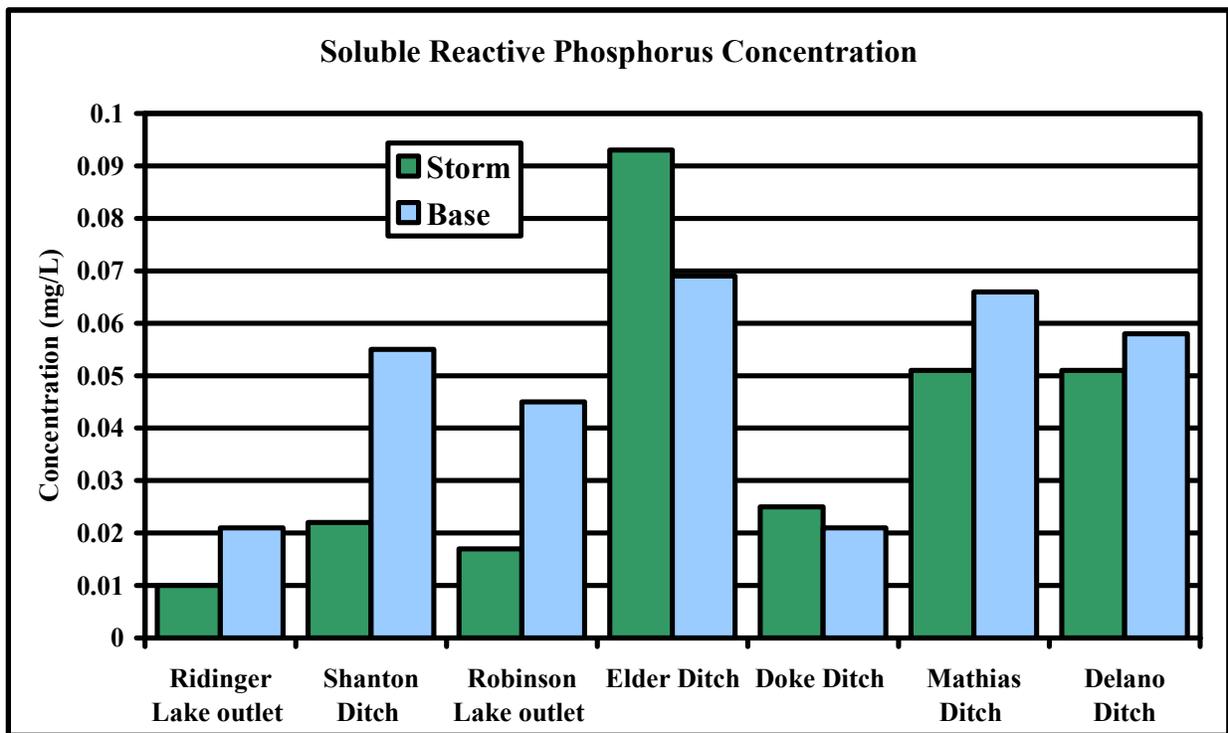
Figure 19. Soluble reactive phosphorus concentrations in Ridinger Lake watershed streams as sampled 5/1/03 and 8/6/03. Detection limit is 0.010 mg/L.

Soluble reactive phosphorus (SRP) is the dissolved component of total phosphorus. Understanding what portion of the total phosphorus concentration is dissolved aids in directing management efforts. Dissolved phosphorus usually comes from fertilizer and waste (wildlife and human). Chemical reactions within the stream can also contribute to the dissolved phosphorus levels in the stream. SRP concentrations in the Ridinger Lake watershed streams were higher than desired for headwater streams. (All of the Ridinger Lake watershed streams, except the Ridinger Lake outlet, have drainages less than 20 square miles thus defining them as headwater streams.) SRP concentrations in the Ridinger Lake watershed streams ranged from at or below the detection limit of 0.010 mg/L in the Ridinger Lake outlet during storm flow to 0.093 mg/L in Elder Ditch at storm flow. Elder Ditch also exhibited the highest base flow SRP concentration, which was higher than the SRP concentrations at all the other sites during base or storm flow. High SRP concentrations were also observed in Mathias Ditch and Delano Ditch during both base and storm flow. Elder Ditch, Mathias Ditch, and the Troy Cedar Lake also possessed relatively high *E. coli* concentrations during base and/or storm flow. Waste (wildlife and/or human) may be increasing the SRP concentrations in these streams. Management efforts should focus on reducing the waste reaching these streams. Nutrient (fertilizer) management should also be a priority on agricultural and residential land in these subwatersheds.

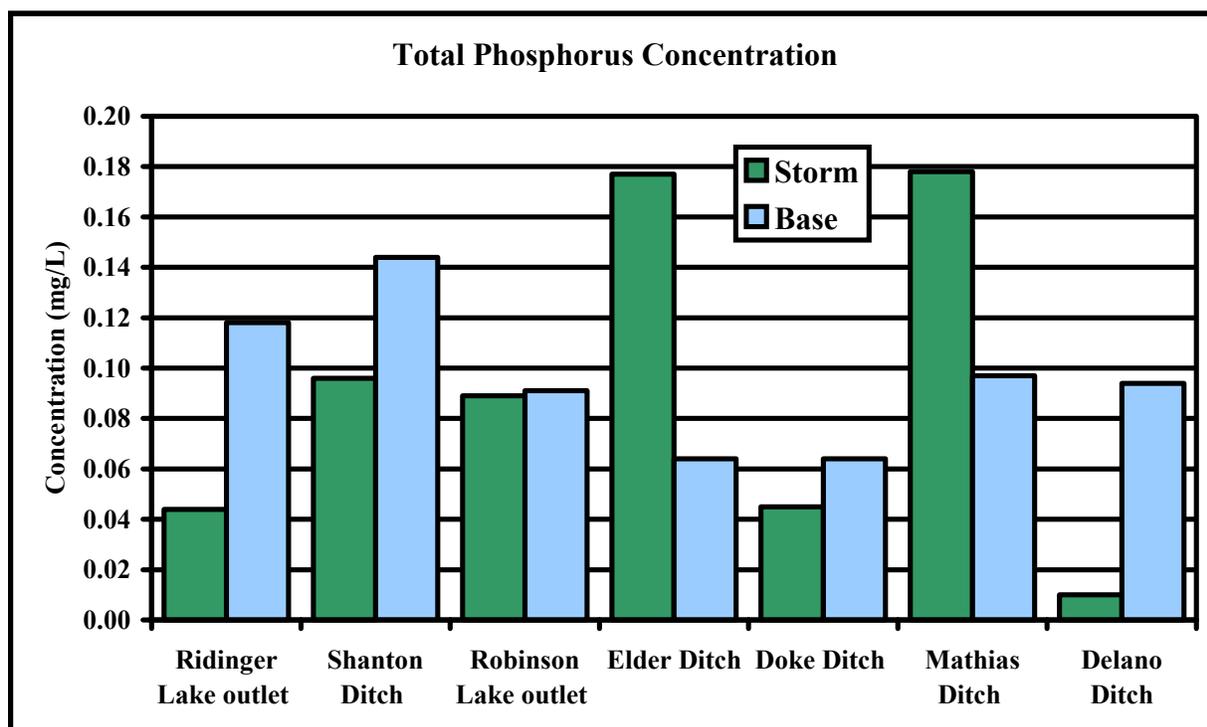
Figure 20. Total phosphorus concentrations in Ridinger Lake watershed streams as sampled 5/1/03 and 8/6/03. Detection limit is 0.010 mg/L.

Like the TKN levels, total phosphorus concentrations in the Ridinger Lake watershed streams were average for northern Indiana streams (Figure 20). Total phosphorus concentrations ranged from 0.044 mg/L in the Ridinger Lake outlet during storm flow to 0.178 mg/L in Mathias Ditch during storm flow. Mathias Ditch also exhibited a relatively high base flow total phosphorus concentration of nearly 0.1 mg/L. Like Mathias Ditch, Shanton Ditch and the Robinson Lake outlet possessed high total phosphorus concentrations during both base and storm flow conditions. Elder Ditch exhibited a storm flow total phosphorus concentration of nearly equal magnitude to the storm flow total phosphorus concentration observed in Mathias Ditch. The Ridinger Lake outlet possessed a relatively high base flow total phosphorus concentration. Doke Ditch total phosphorus concentrations were the lowest. Neither the storm or base flow total phosphorus concentrations in Doke Ditch were of concern.

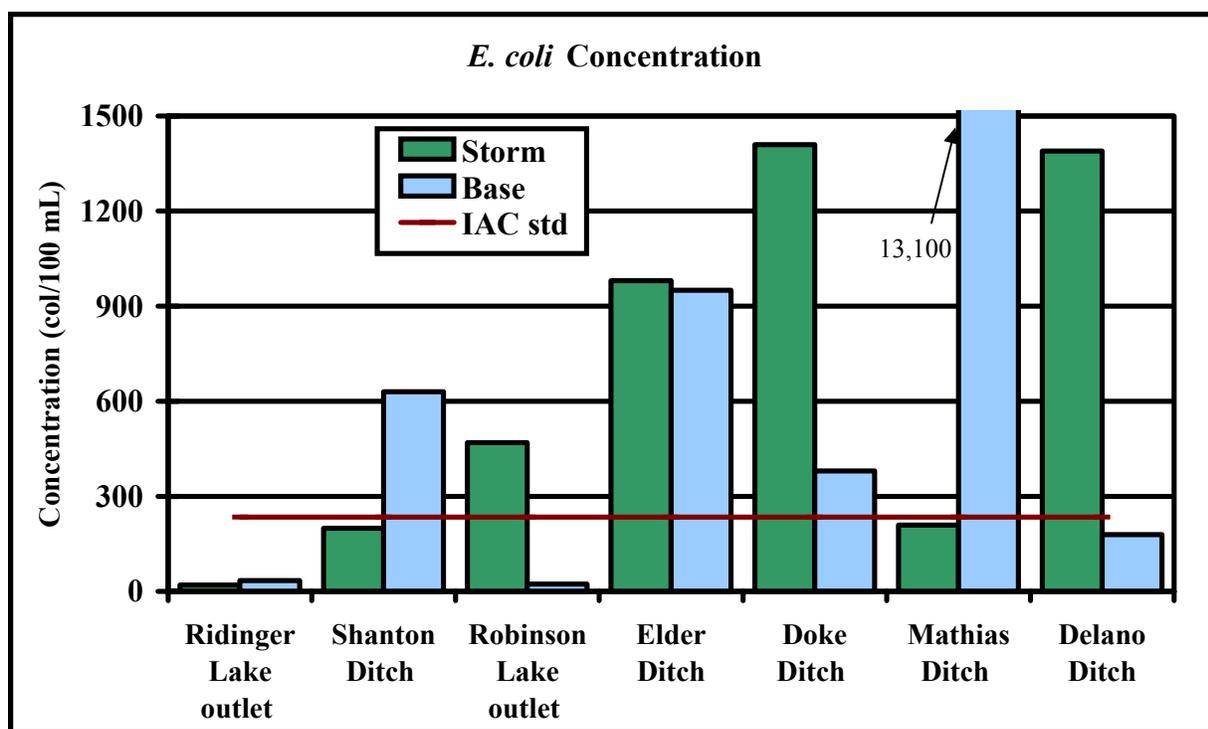
Figure 21. *E. coli* concentrations in Ridinger Lake watershed streams as sampled 5/1/03 and 8/6/03. The red line indicates the Indiana state standard (235 colonies/100 mL).

E. coli concentrations in the Ridinger Lake watershed streams were relatively high. More than half of the water quality samples collected from the Ridinger Lake watershed streams contained *E. coli* concentrations that violated state water quality standards (Figure 21). In addition to violating the state standard, *E. coli* concentrations at four of the sampling sites were above the average *E. coli* concentration of 650 col/100mL found in Indiana waters (White, unpublished data). *E. coli* concentrations in the Ridinger Lake watershed streams ranged from 20 col/100mL in the Ridinger Lake outlet stream during storm flow to 13,100 col/100mL in Mathias Ditch at base flow. Elder Ditch and Doke Ditch exhibited high *E. coli* concentrations during both base and storm flow sampling efforts. Only *E. coli* concentrations in the Ridinger Lake outlet stream during both storm and base flow and the Robinson Lake outlet during base flow could be considered low. Because *E. coli* is killed by UV light, it is not unusual to observe low *E. coli* concentration downstream of lakes, particularly under normal or base flow conditions. Water in lakes is exposed to light for a prolonged period.

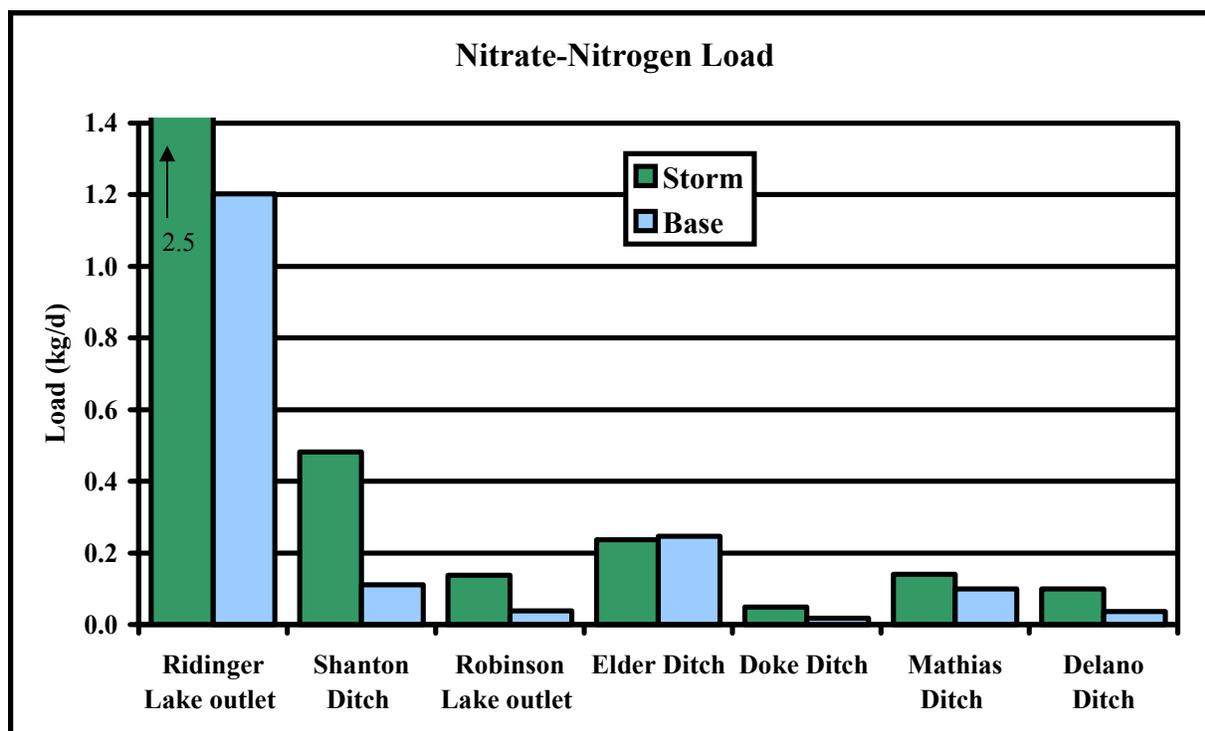
Figure 22. Nitrate-nitrogen loads in Ridinger Lake watershed streams as sampled 5/1/03 and 8/6/03.

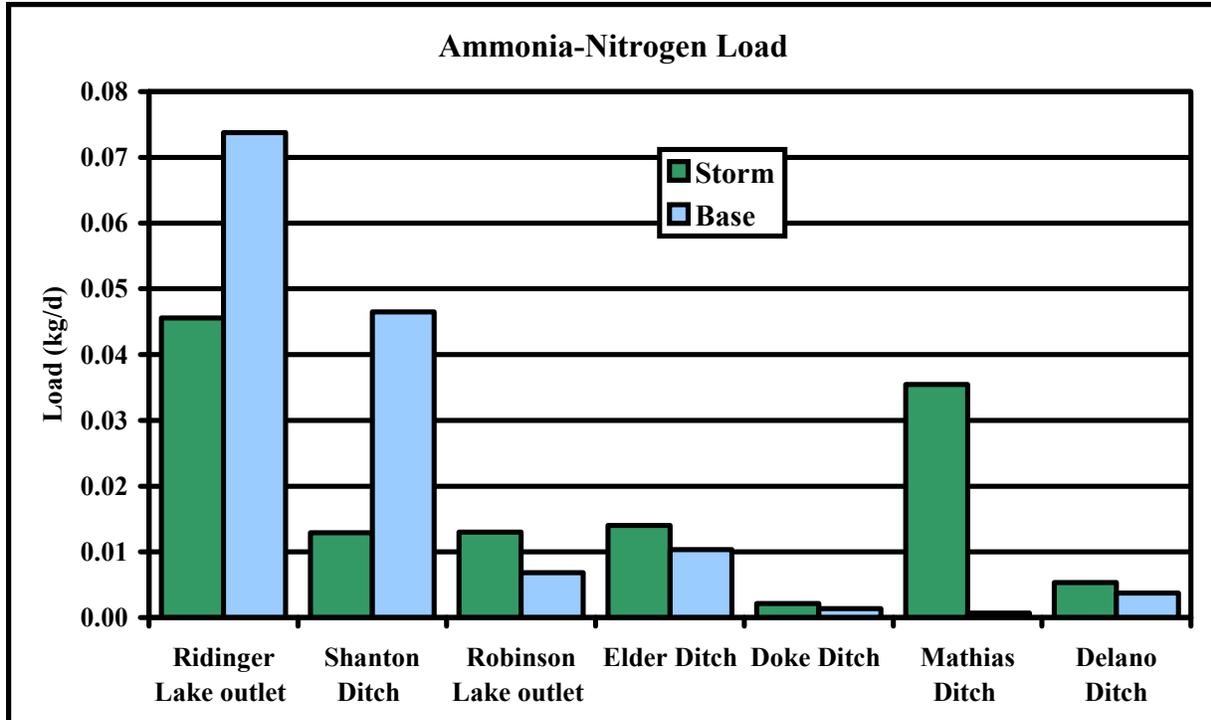
Figure 23. Ammonia-nitrogen loads in Ridinger Lake watershed streams as sampled 5/1/03 and 8/6/03.

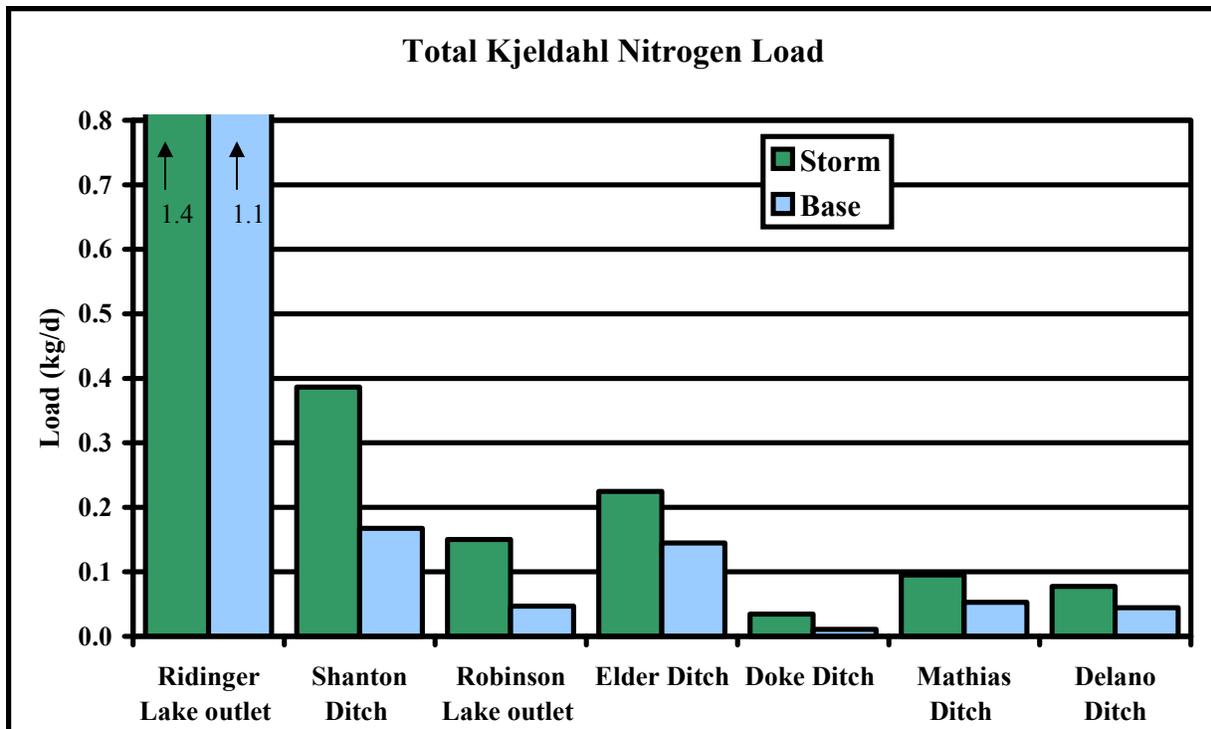
Figure 24. Total Kjeldahl nitrogen loads in Ridinger Lake watershed streams as sampled 5/1/03 and 8/6/03.

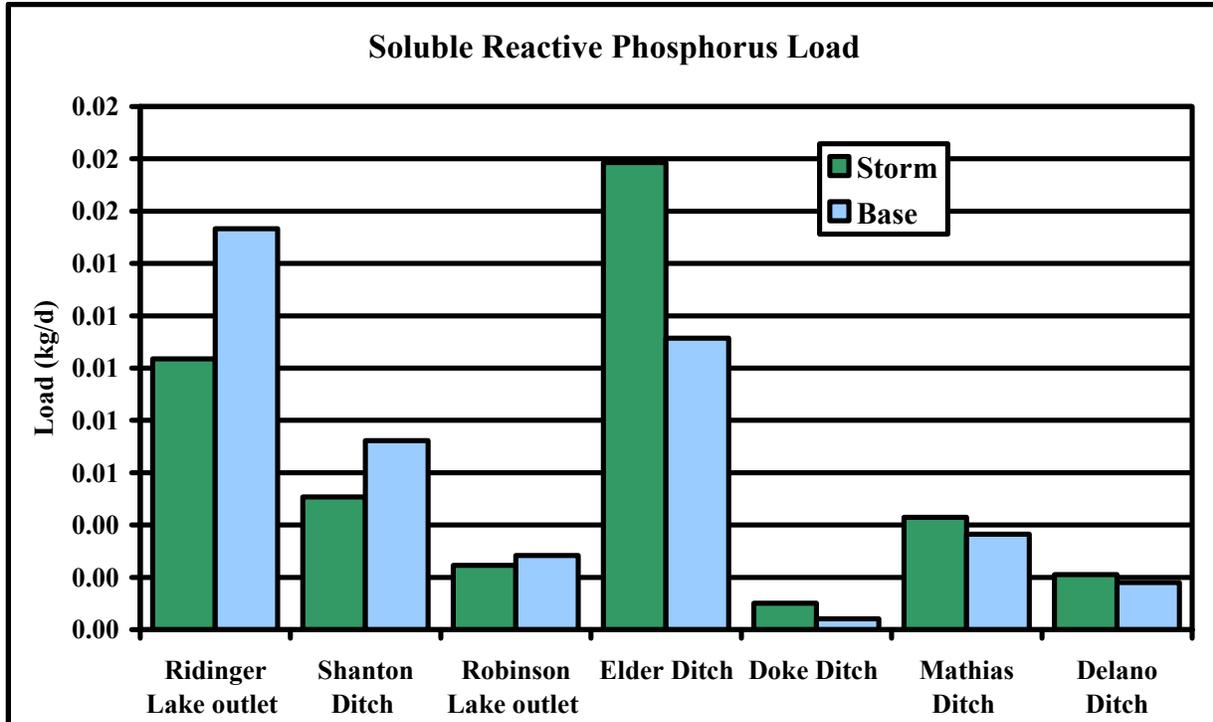
Figure 25. Soluble reactive phosphorus loads in Ridinger Lake watershed streams as sampled 5/1/03 and 8/6/03.

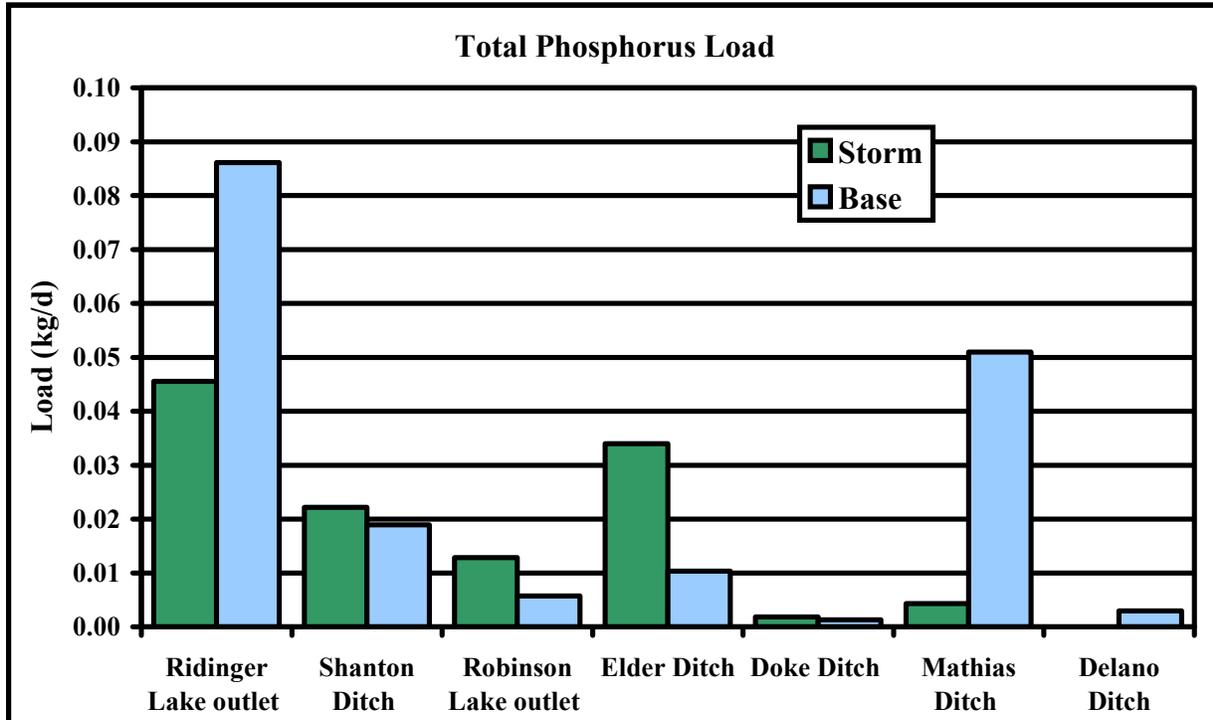
Figure 26. Total phosphorus loads in Ridinger Lake watershed streams as sampled 5/1/03 and 8/6/03.

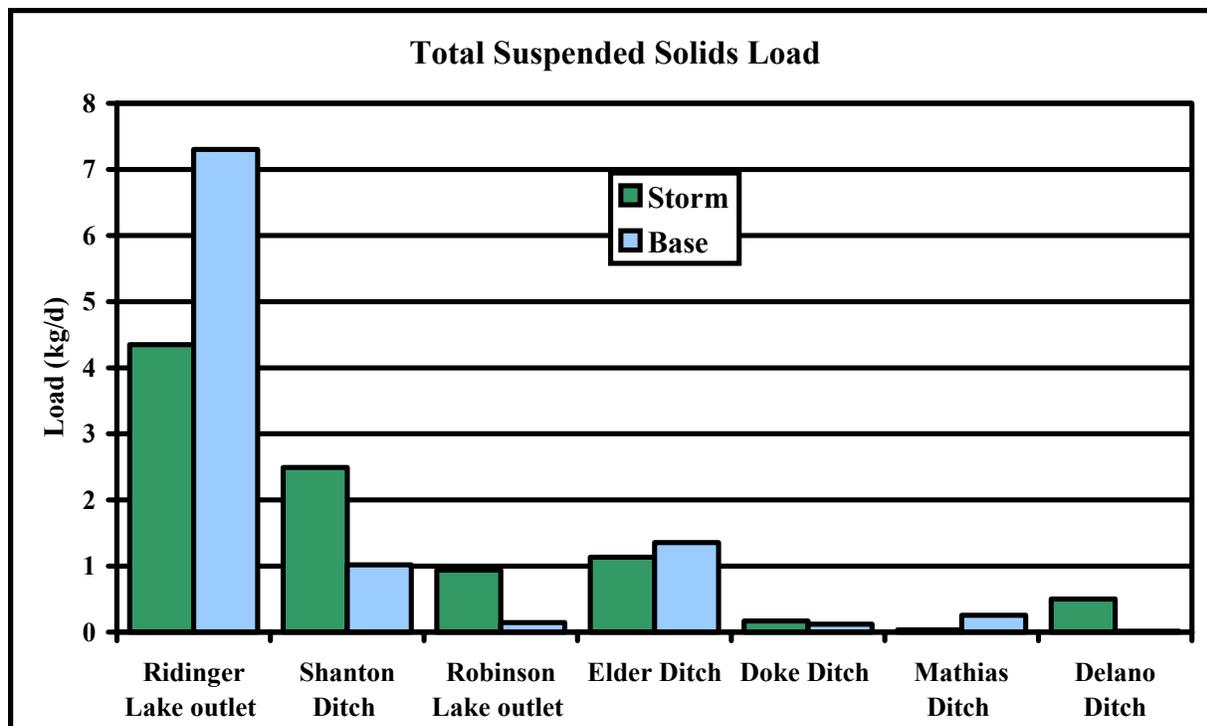
Figure 27. Total suspended solids loads in Ridinger Lake watershed streams as sampled 5/1/03 and 8/6/03.

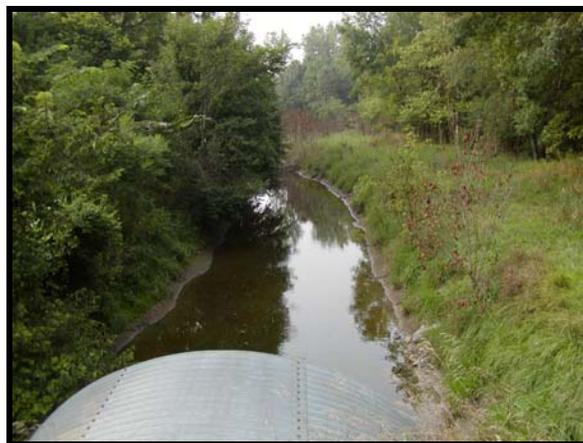
Figure 28. Ridinger Lake outlet (Site 1) sampling location.

Open pasture and forest surround the Ridinger Lake outlet stream at the sampling site (Figure 28). A residential campground, home to several thousand permanent and seasonal residents, is located immediately upstream from the sampling site. The riparian buffer zone is wide on along both banks reaching widths greater than 150 feet (45 m). Within the riparian buffer, the vegetation consists mostly of trees and shrubs with some grasses adjacent to the stream banks. In-stream cover at the site is sparse with the presence of one deep pool, some overhanging vegetation, aquatic macrophytes, and woody debris. Bank erosion is moderate. The stream lacks sinuosity and has poorly developed pools. This is a result of recent dredging operations. There is no riffle habitat in the study reach. These are characteristic of a channelized stream. A mixture of sand and gravel covers the stream channel. The gravel is moderately to extensively embedded. The stream's QHEI score was 53 out of 100. It received the third highest habitat score of the Ridinger Lake watershed streams.

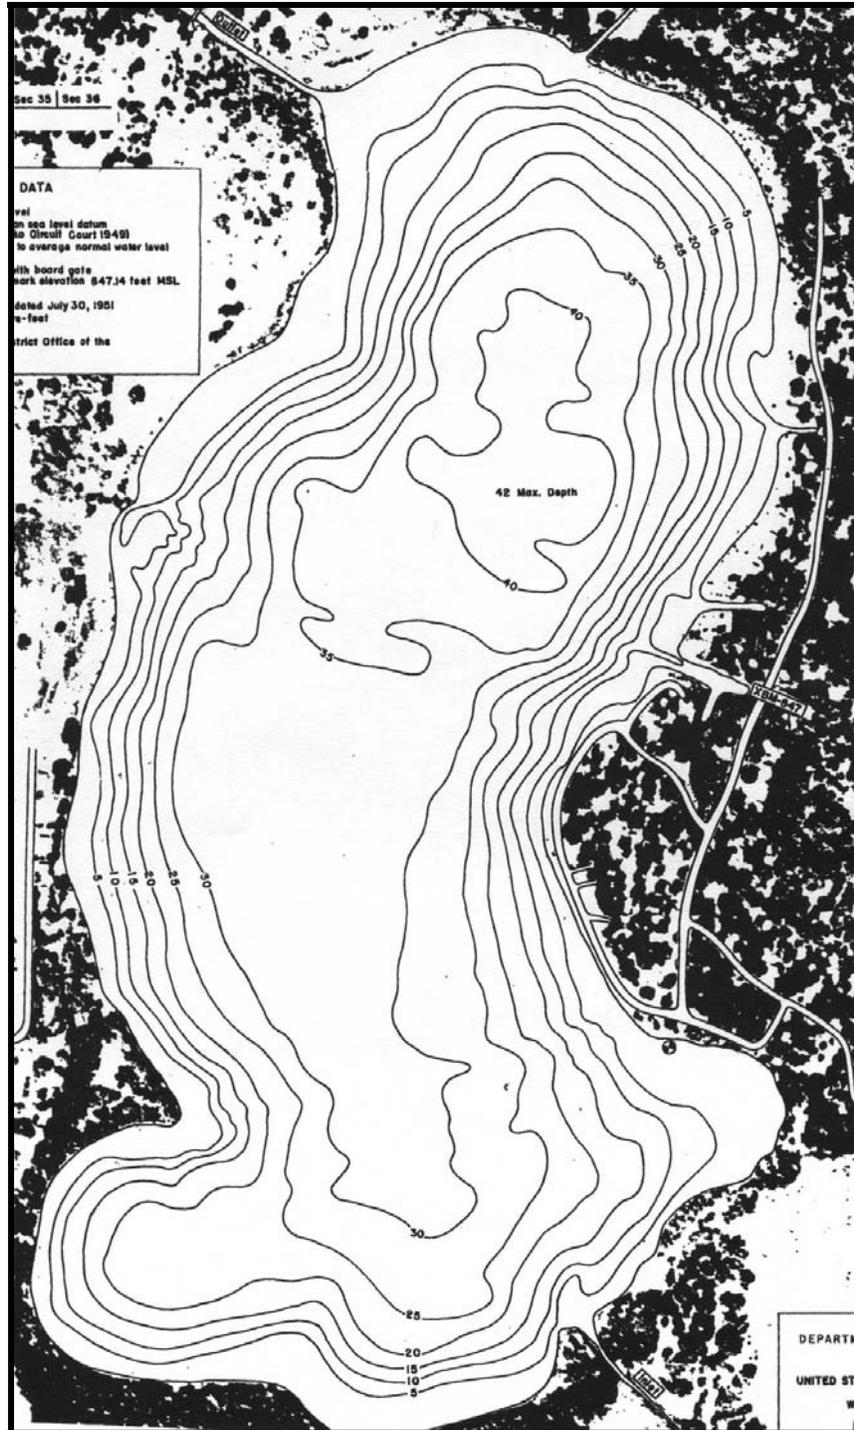
Figure 35. Bathymetric map of Ridinger Lake. Source: IDNR, 1954. Scale: 1"=800'.

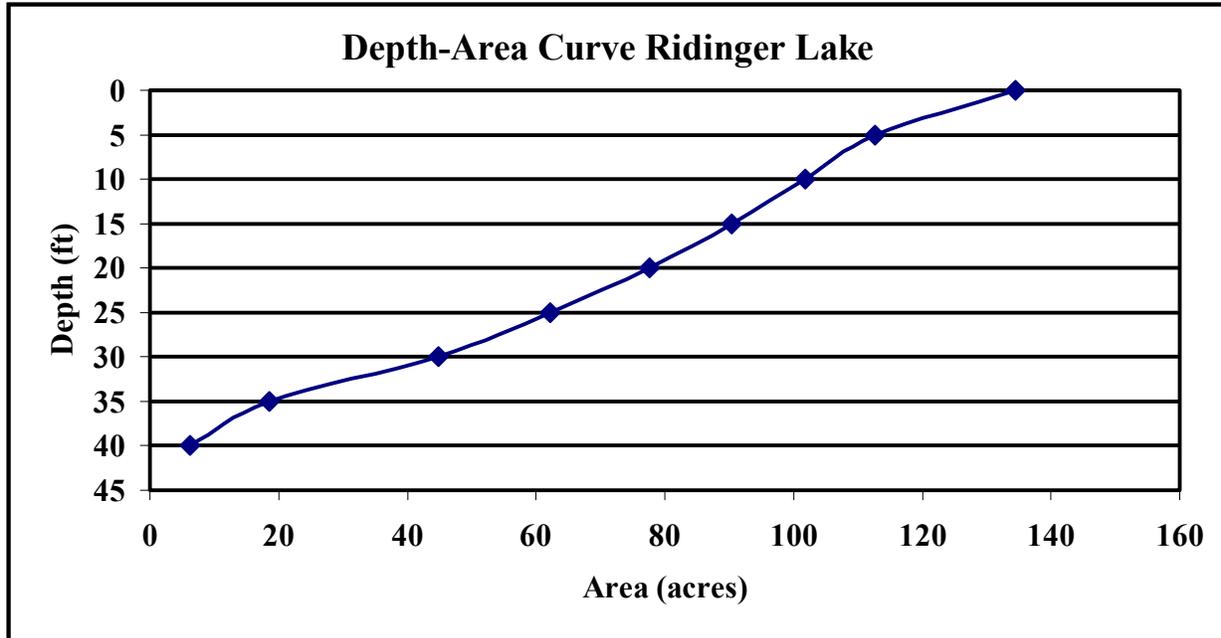
Figure 36. Depth-area curve for Ridinger Lake.

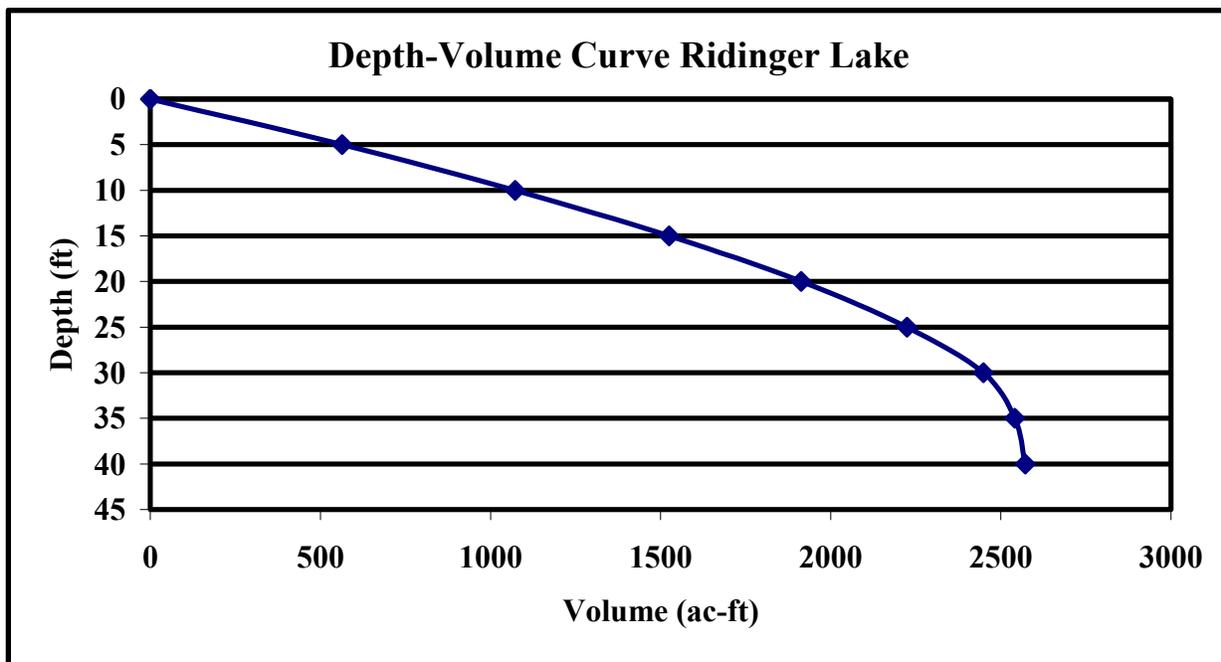
Figure 37. Depth-volume curve for Ridinger Lake.

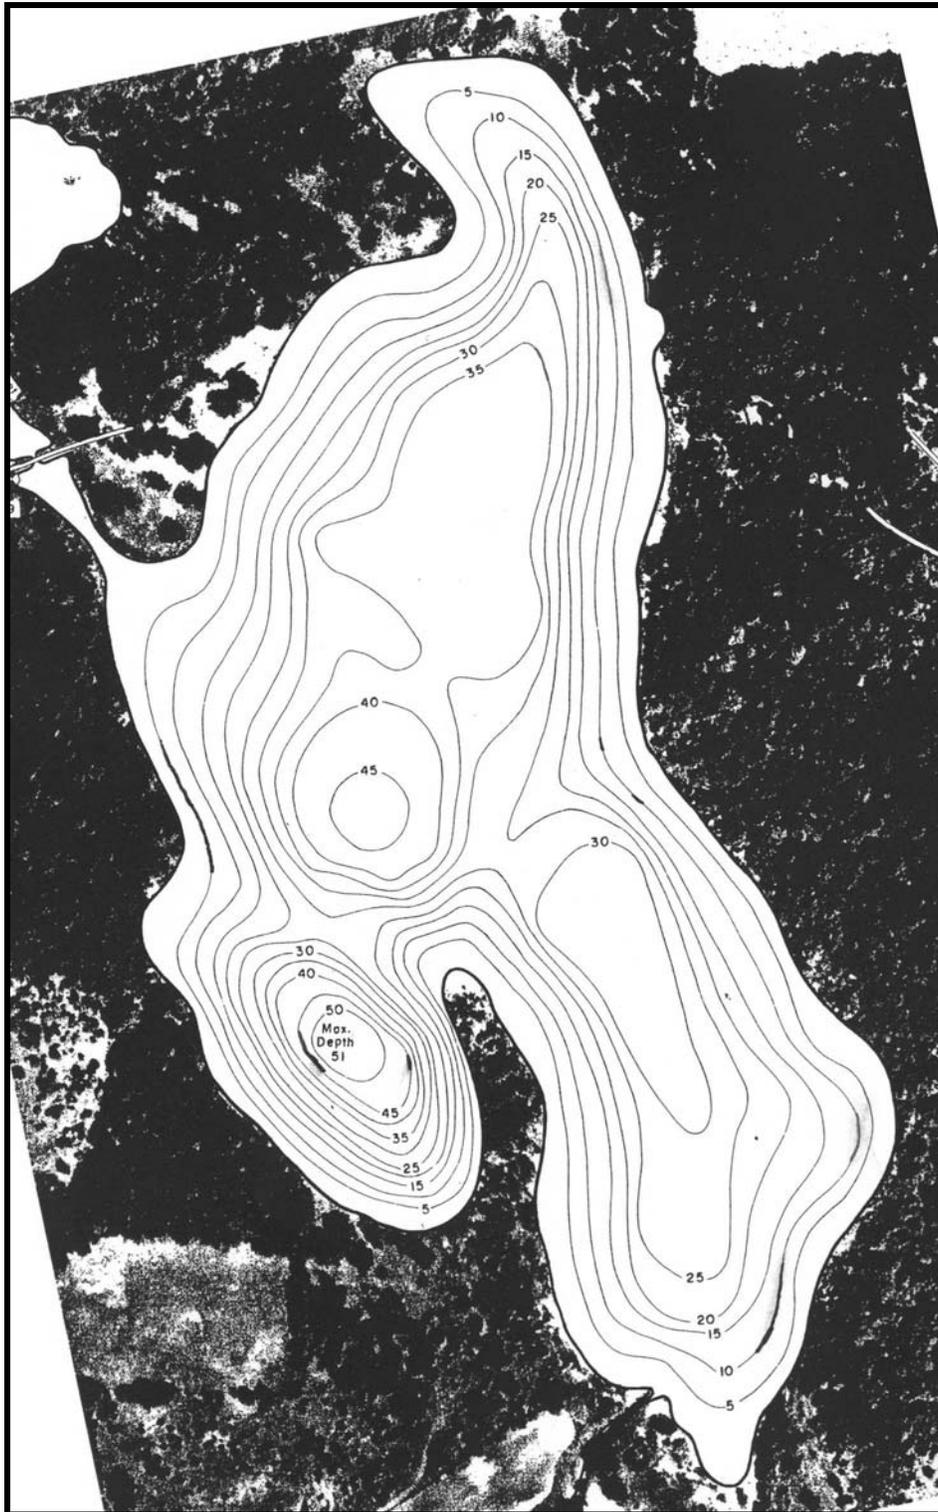
Figure 39. Bathymetric map of Robinson Lake. Source: IDNR, 1959. Scale: 1"=440'

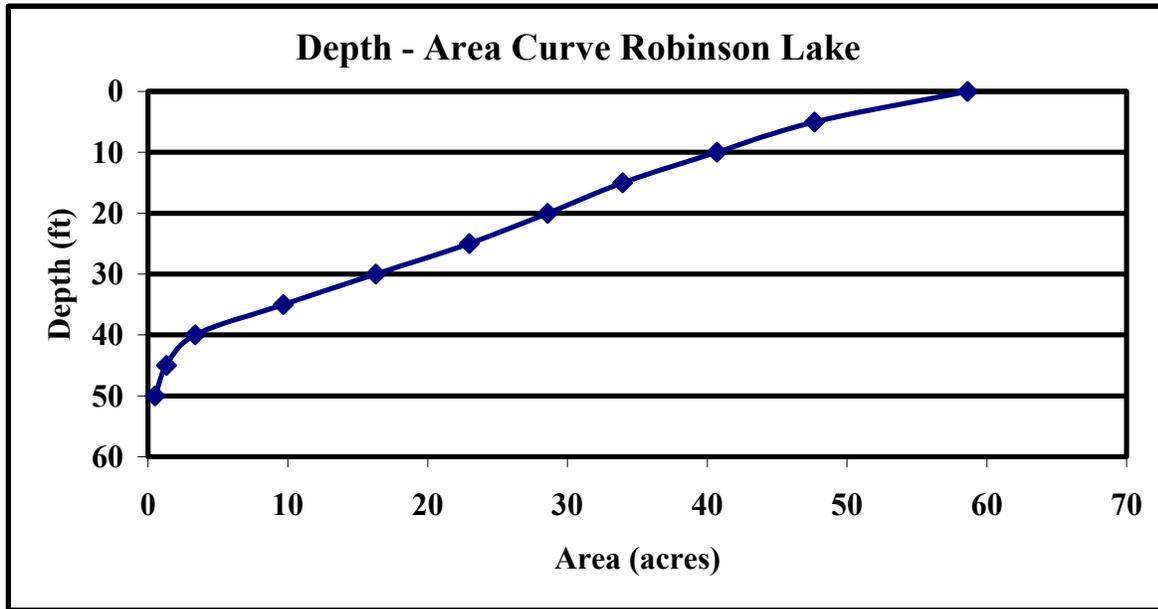
Figure 40. Depth-Area curve for Robinson Lake.

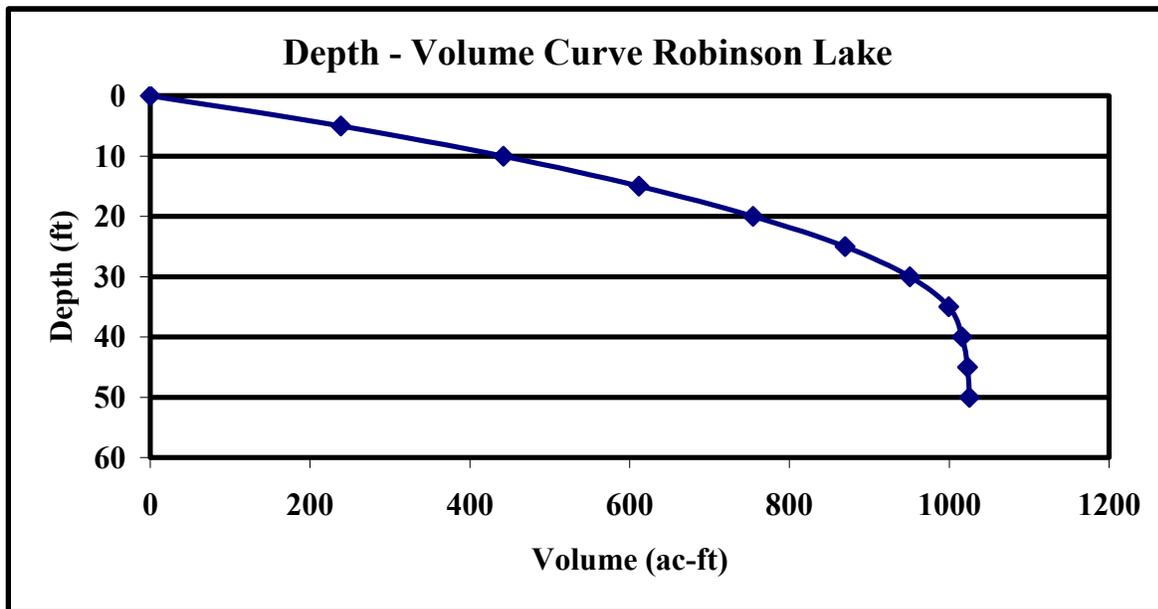
Figure 41. Depth-volume curve for Robinson Lake.

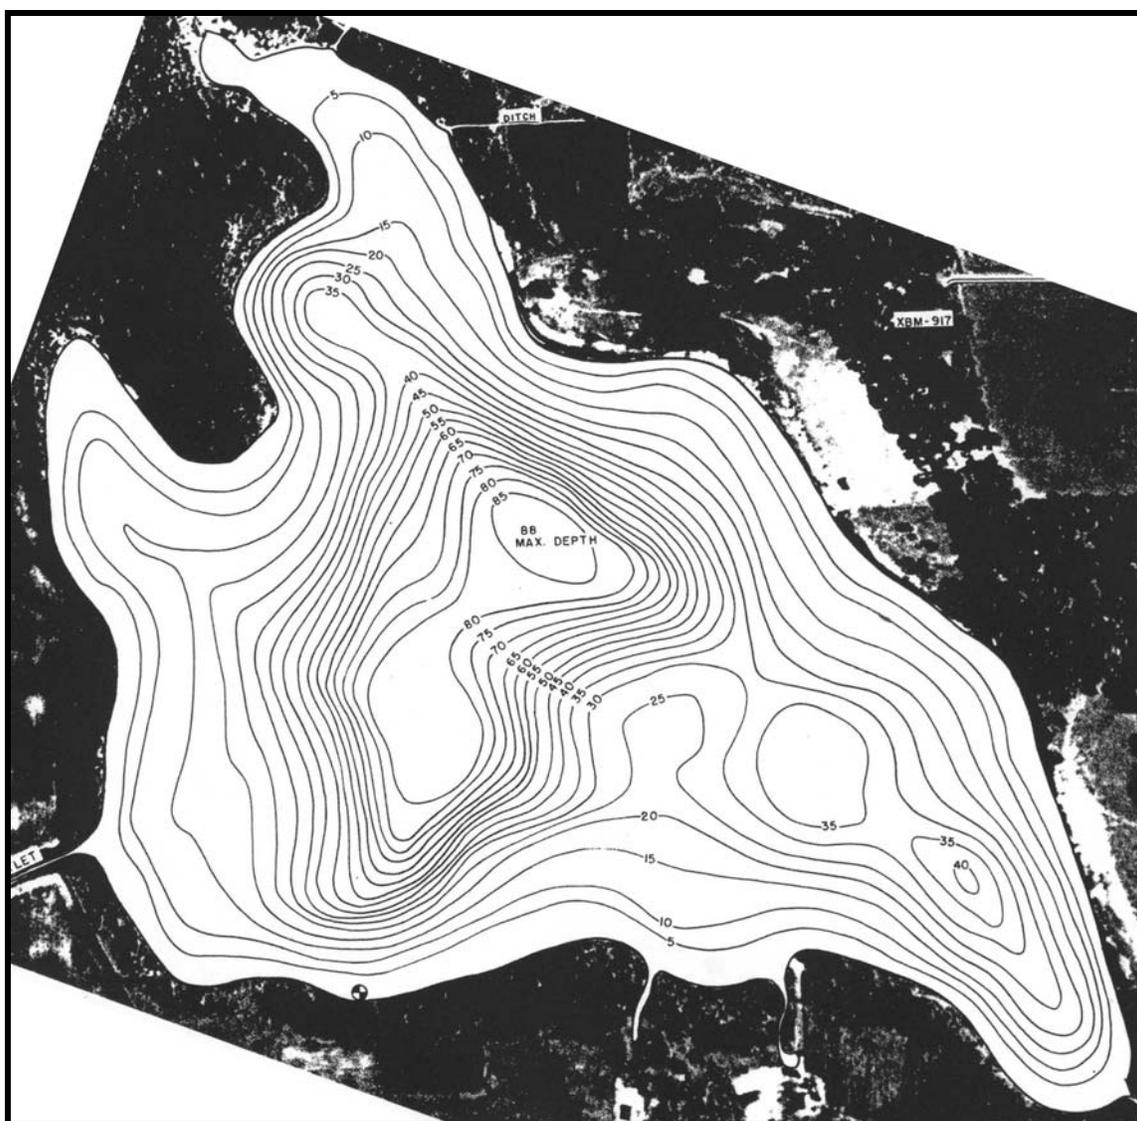
Figure 42. Bathymetric map of Troy Cedar Lake. Source: IDNR, 1956. Scale: 1"=400'.

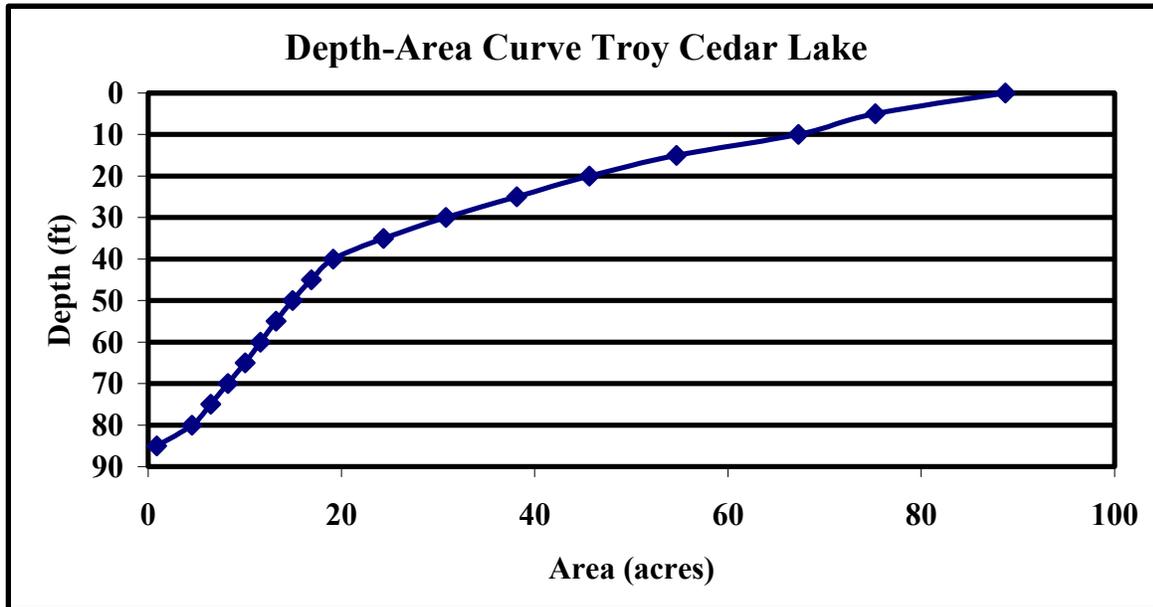
Figure 43. Depth-area curve for Troy Cedar Lake

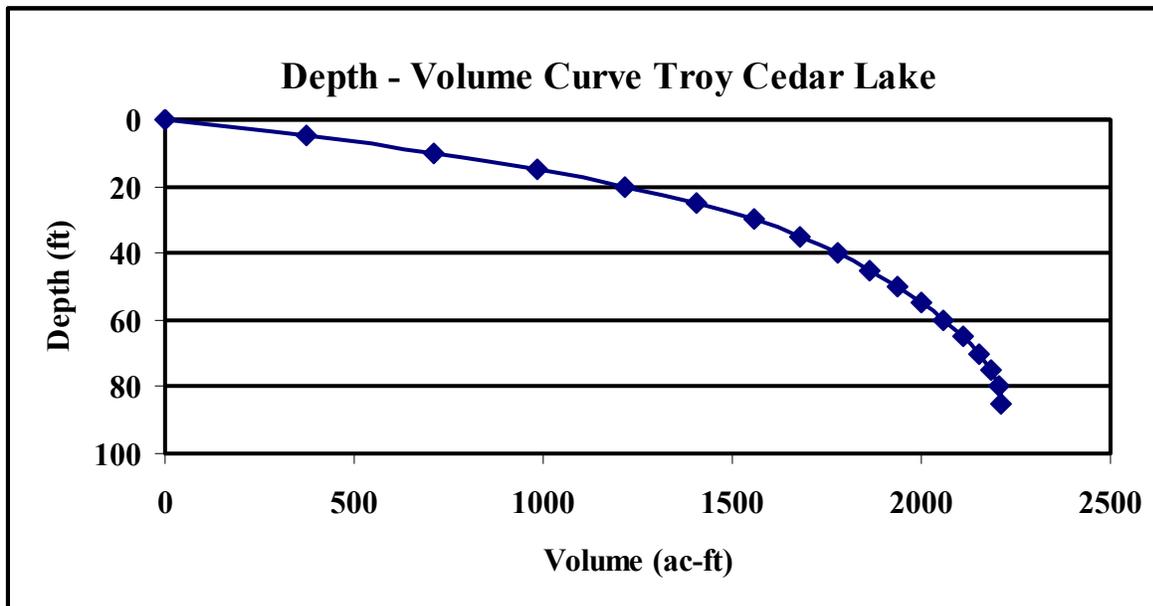
Figure 44. Depth-volume curve for Troy Cedar Lake

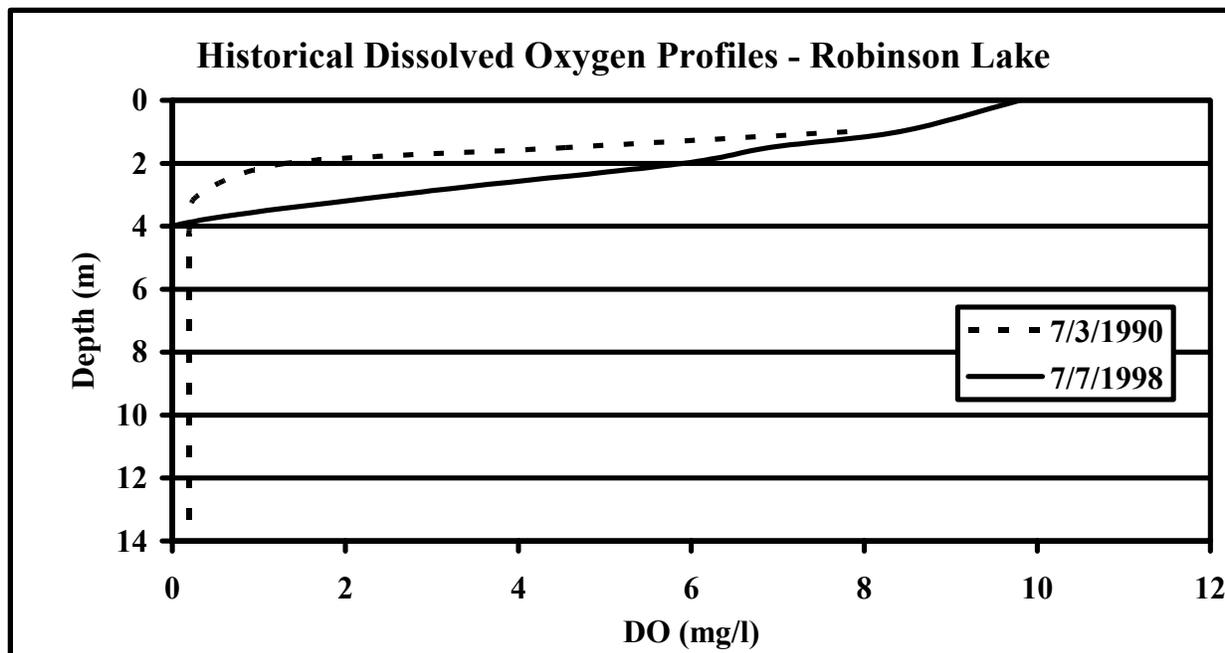
Figure 48. Historical dissolved oxygen profiles for Robinson Lake, which were sampled by the Clean Lakes Program during 1990 and 1998.

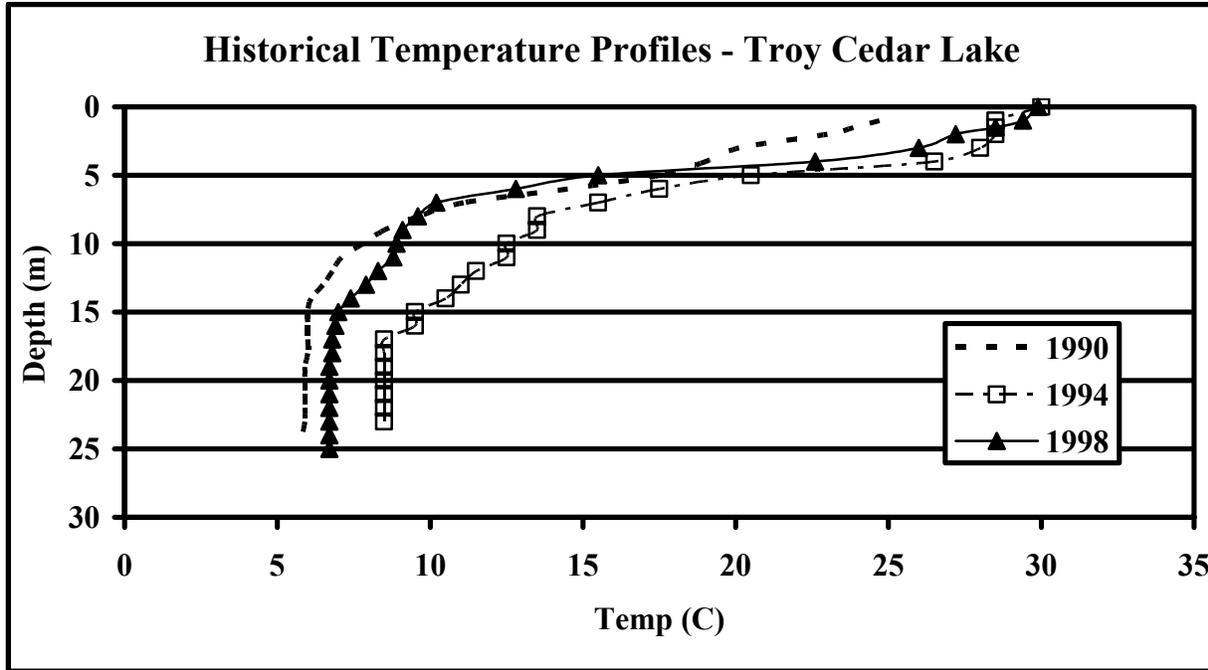
Figure 49. Historical temperature profiles for Troy Cedar Lake, 1990, 1994, and 1998.

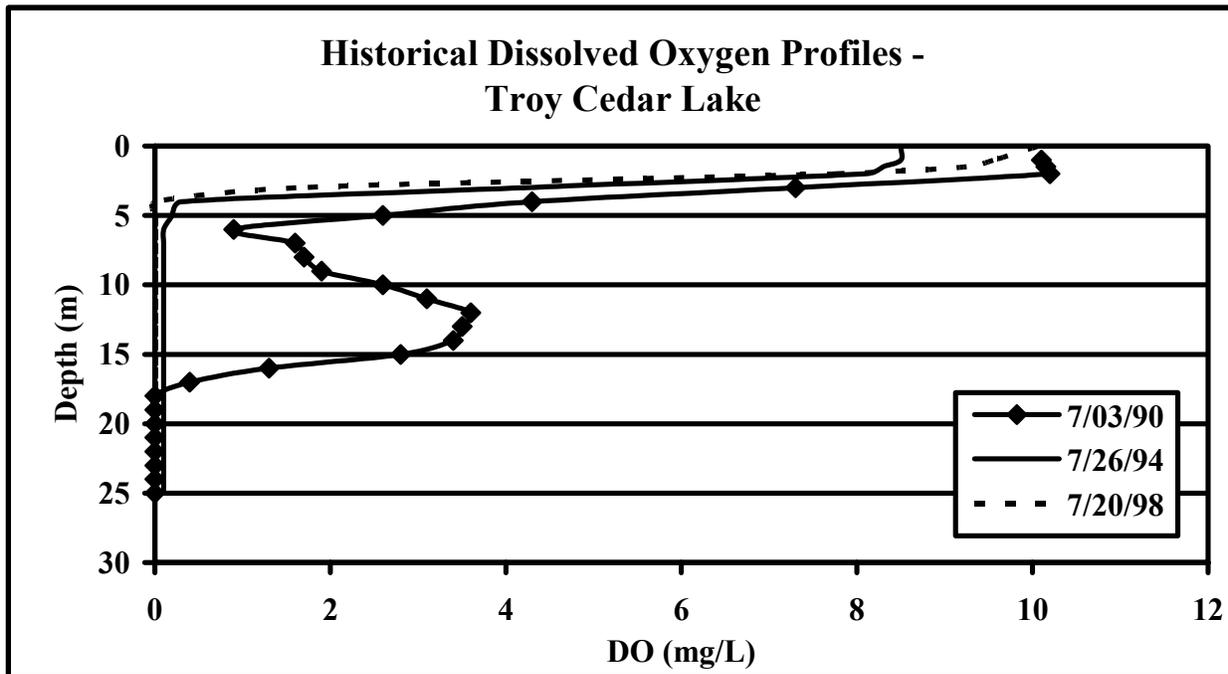
Figure 50. Historical dissolved oxygen profiles for Troy Cedar Lake, 1990, 1994, and 1998.

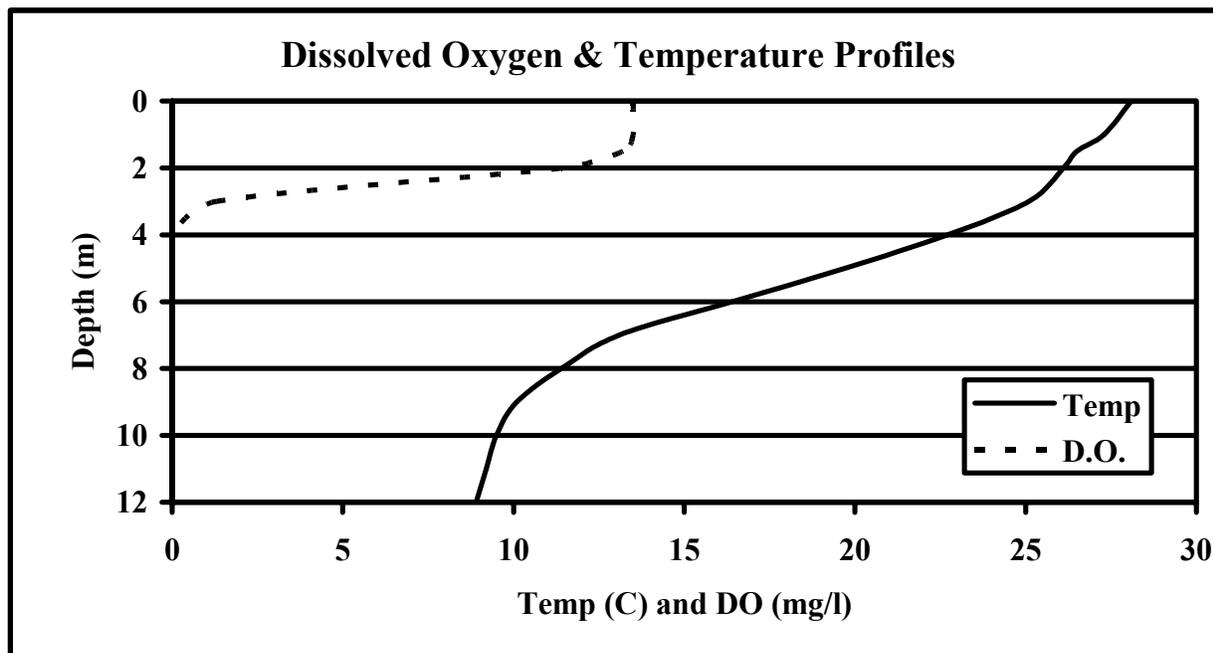
Figure 51. Temperature and dissolved oxygen profiles for Ridinger Lake on August 19, 2003.

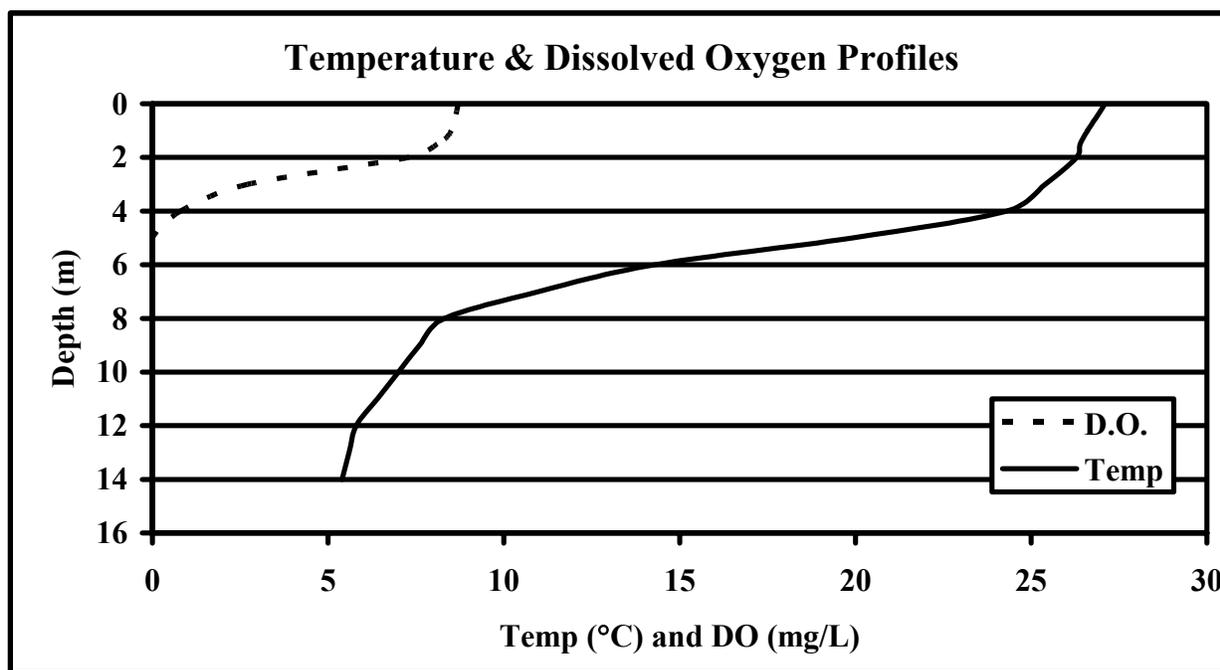
Figure 52. Temperature and dissolved oxygen profile for Robinson Lake, August 19, 2003.
