Ridinger Lake Watershed Diagnostic Study

KOSCIUSKO AND WHITLEY COUNTIES, INDIANA

November 1, 2004

RIDINGER LAKE WATERSHED DIAGNOSTIC STUDY EXECUTIVE SUMMARY

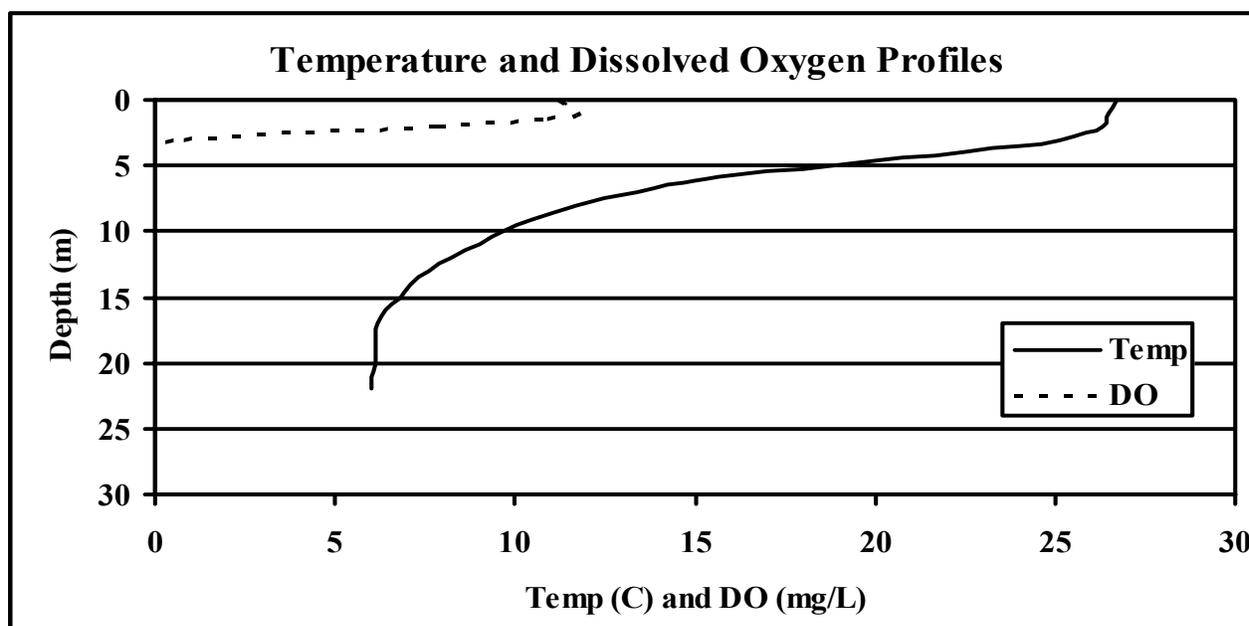
Figure 53. Temperature and dissolved oxygen profiles for Troy Cedar Lake, August 19, 2003.

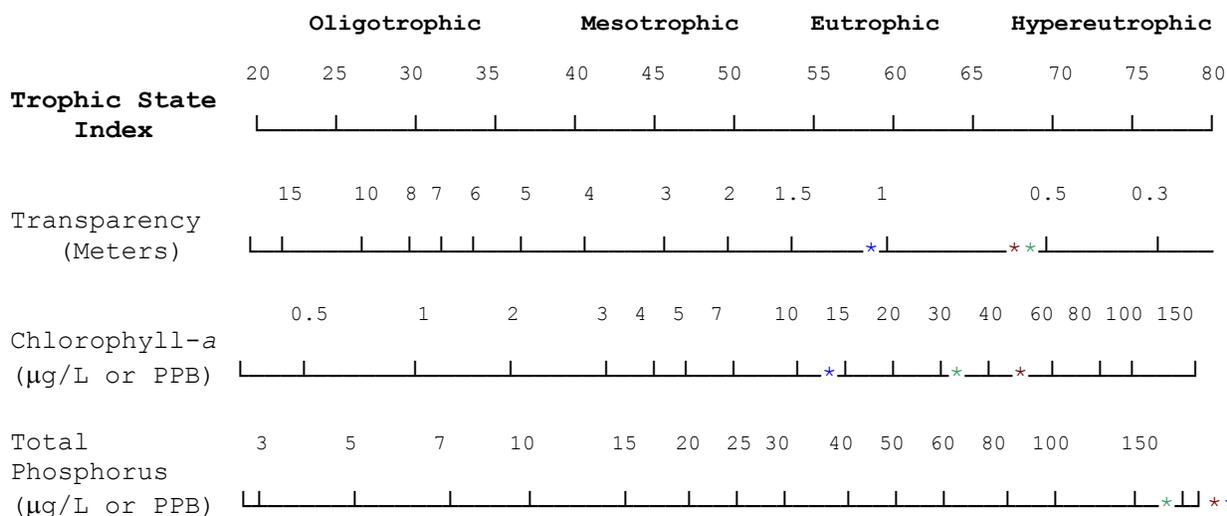
Figure 54. Carlson's Trophic State Index with Ridinger (*), Robinson (*), and Troy Cedar (*) Lakes indicated by asterisks.

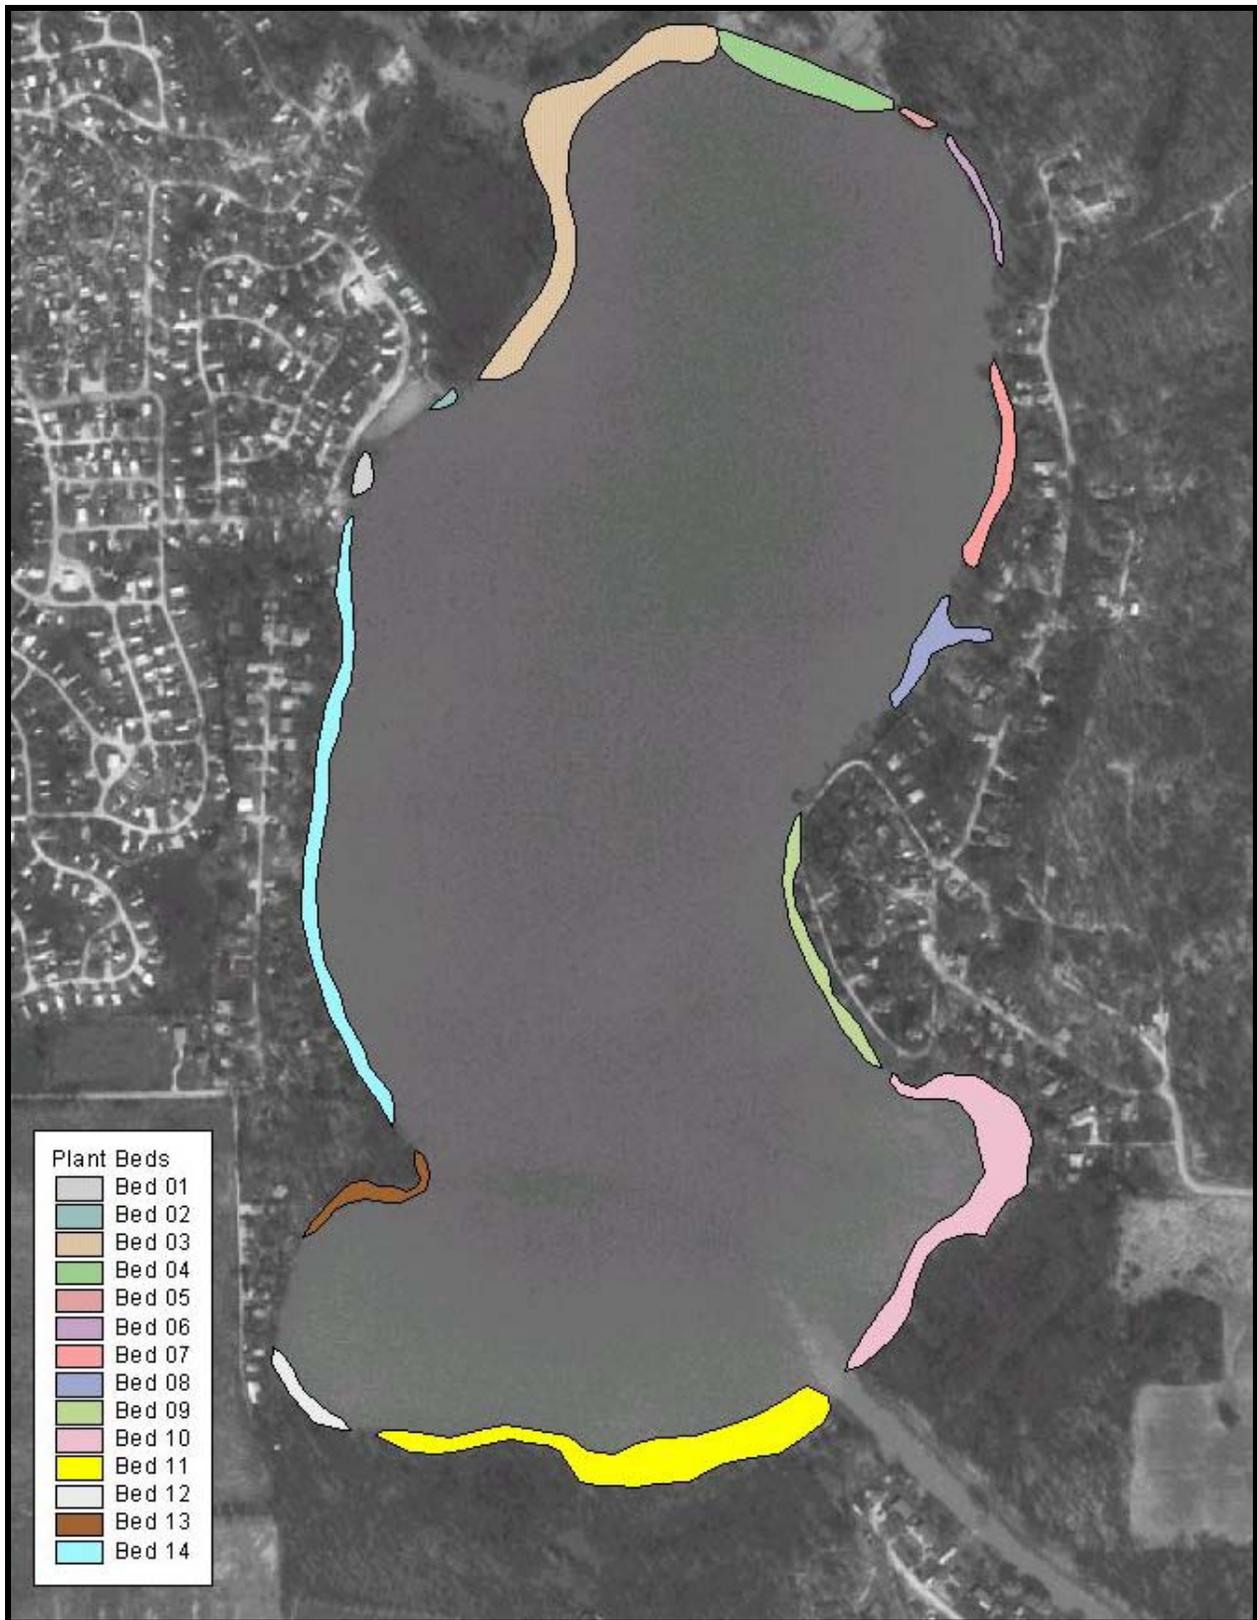
Figure 55. Ridinger Lake plant beds as mapped August 26, 2003. Scale: 1"=750'.

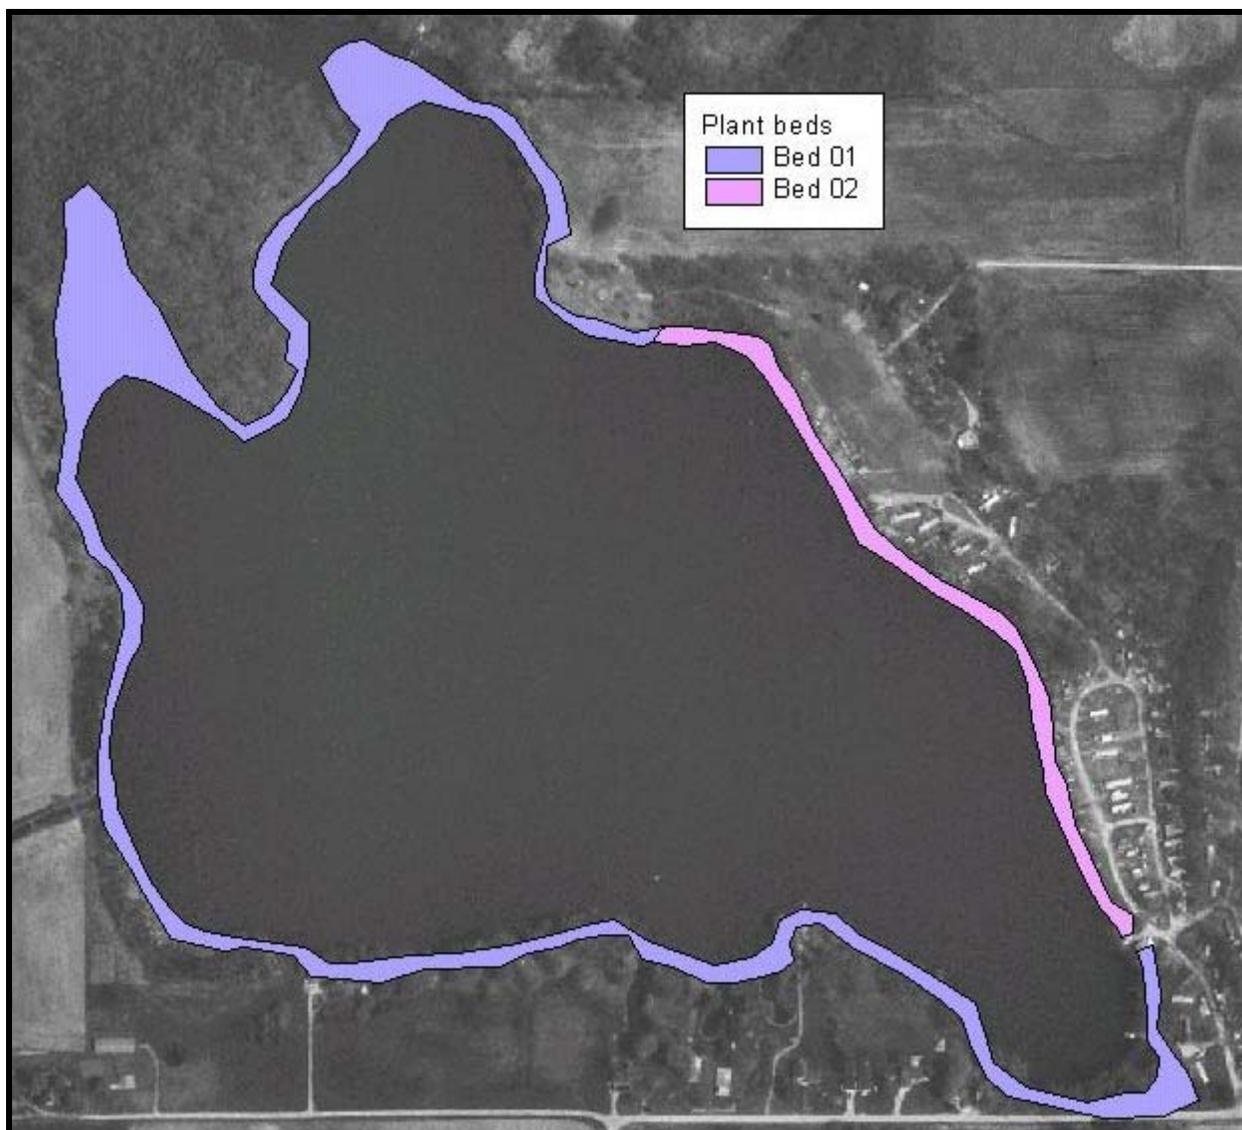
Figure 56. Troy Cedar Lake plant beds as mapped August 26, 2003. Scale: 1"=500'.

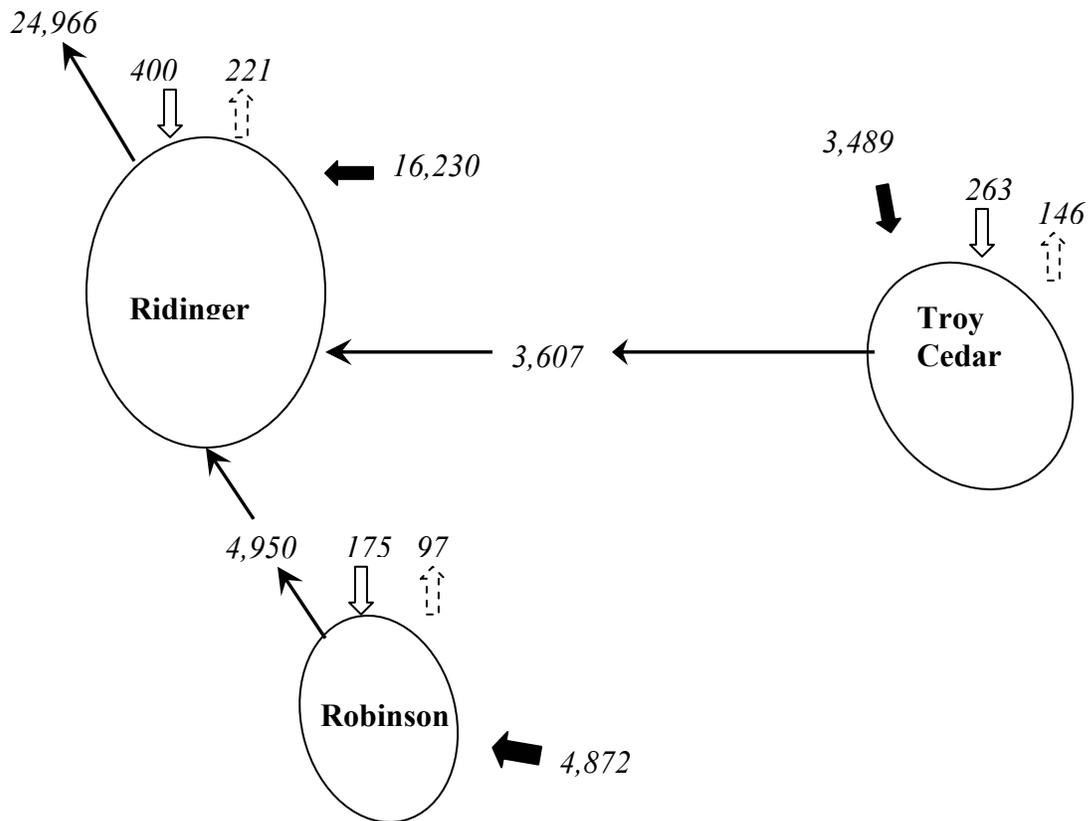
Figure 62. Water Budget Flow Chart for the Ridinger Lake Watershed.

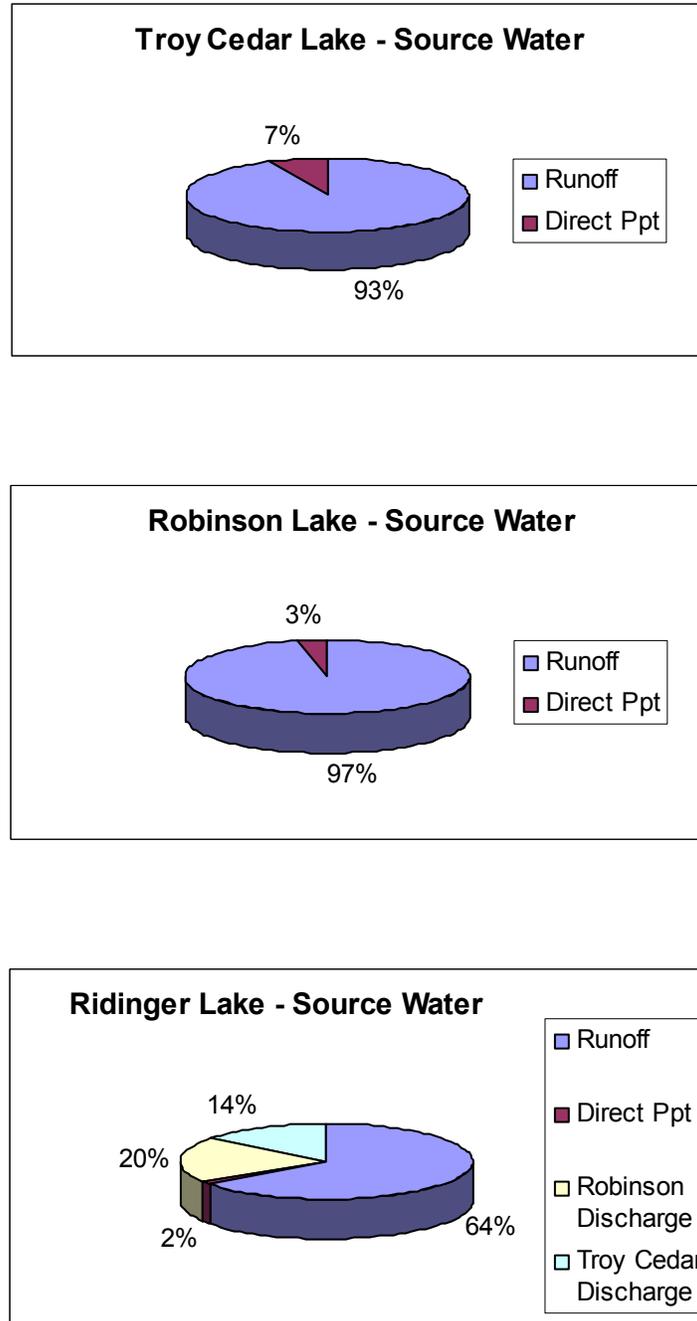
Figure 63. Distribution of water inputs to Ridinger, Robinson, and Troy Cedar Lakes.

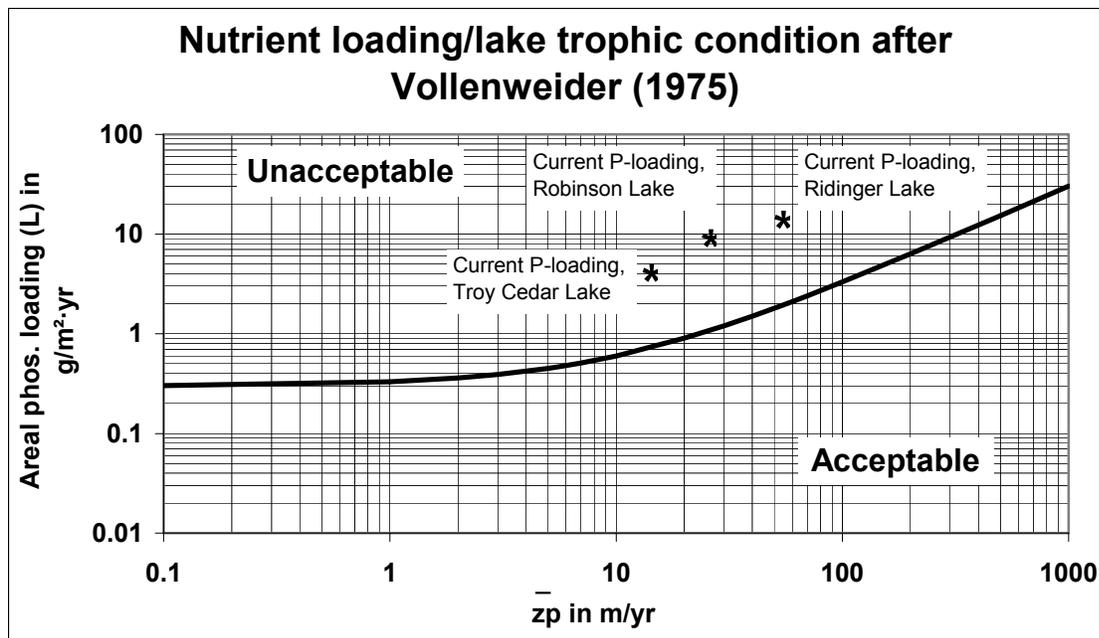
Figure 64. Phosphorus loadings to Ridinger(*), Robinson(*), and Troy Cedar (*) Lakes compared to acceptable loadings determined from Vollenweider’s model. The dark line represents the upper limit for acceptable loading.

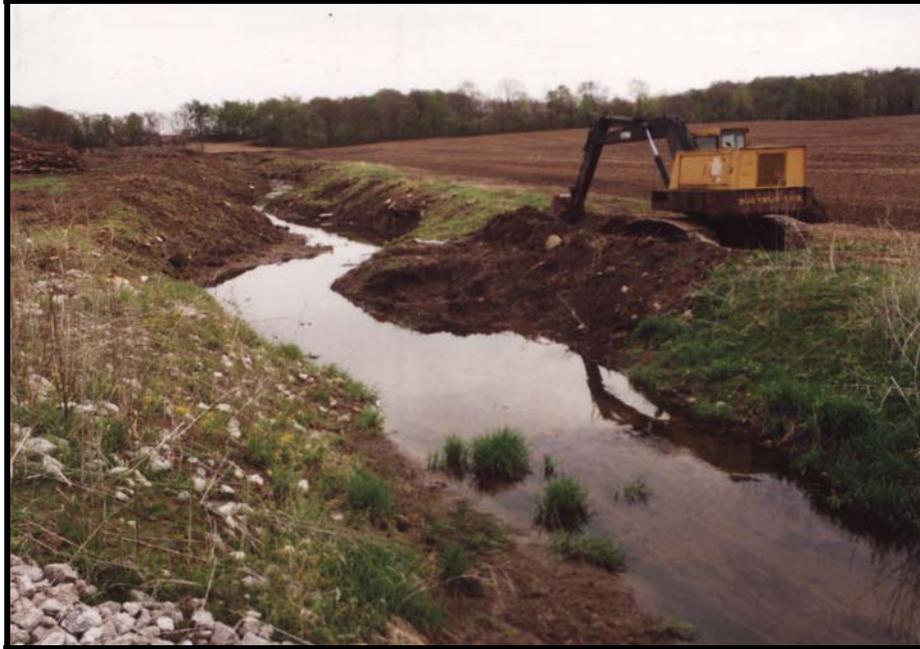
Figure 65. View of Elder Ditch showing riparian damage including tree removal and bank slumping. Farming operations also occur right along the stream's edge.

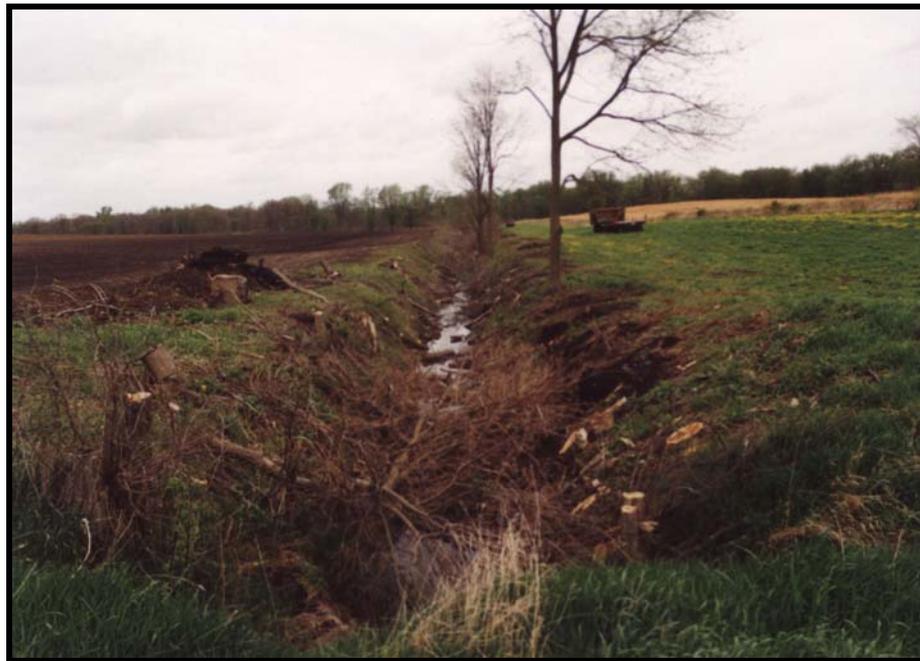
Figure 66. View of Delano Ditch showing the removal of woody riparian vegetation from both sides of the stream.

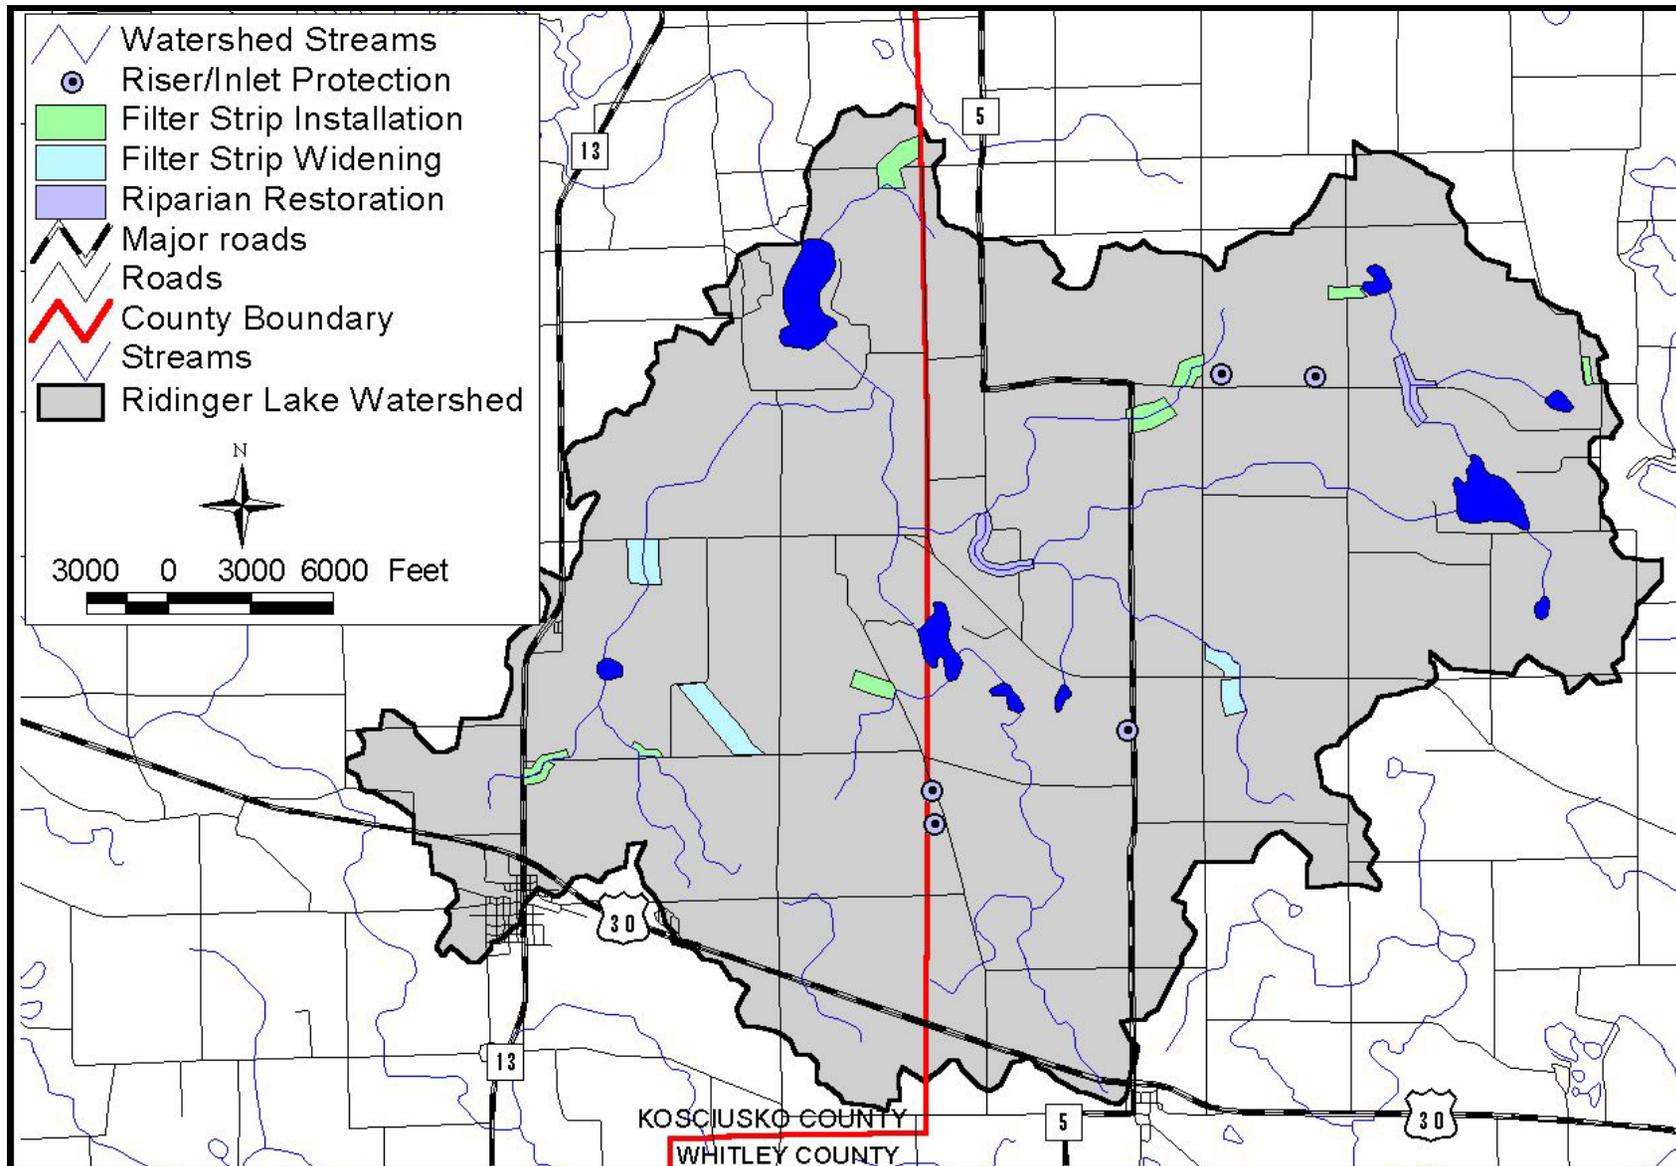
Figure 67. Locations in the Ridinger Lake watershed where riparian restoration or filter strip installation/widening is recommended. Source: See GIS sources appendix (Appendix A). Scale: 1"=7,000'.

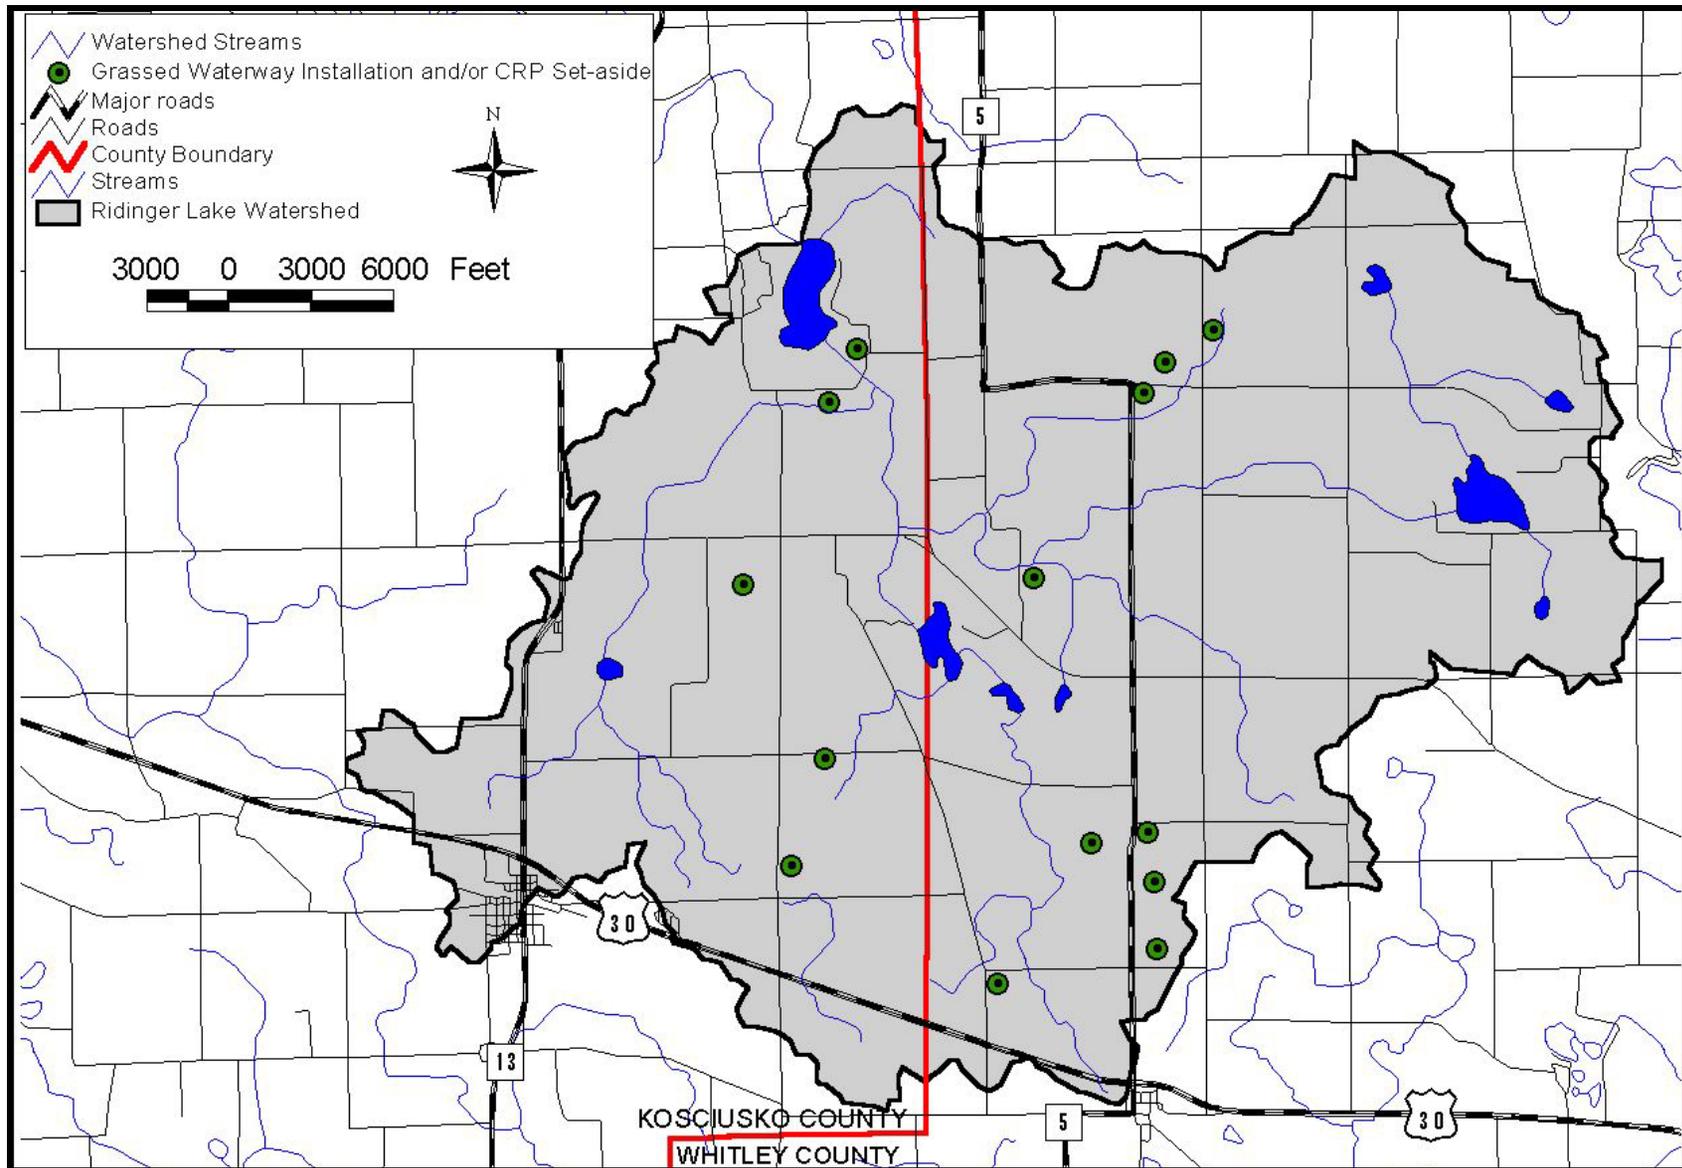
Figure 68. Locations in the Ridinger Lake watershed where grassed waterway installation or set-aside in the Conservation Reserve Program is recommended. Source: See GIS sources appendix (Appendix A). Scale: 1"=7,000'.

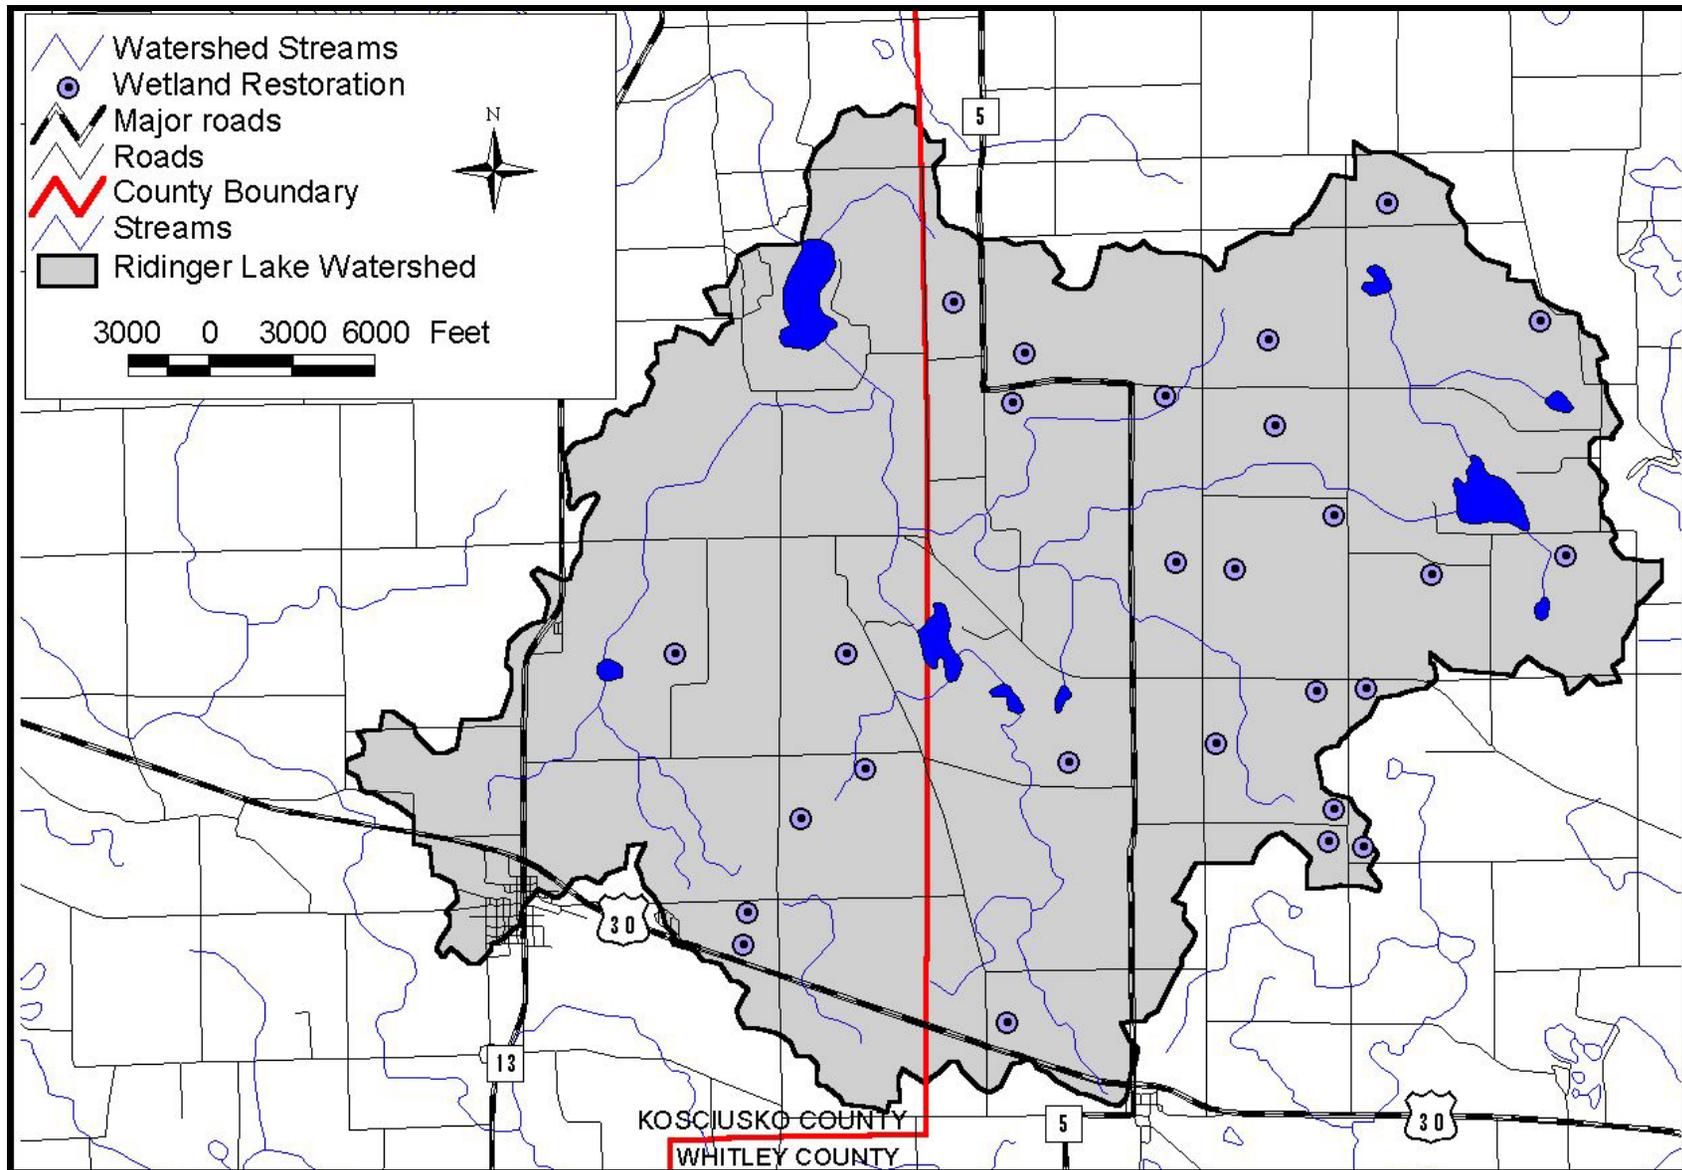
Figure 69. Locations in the Ridinger Lake watershed where wetland restoration is recommended. Source: See GIS sources appendix (Appendix A). Scale: 1"=7,000'.

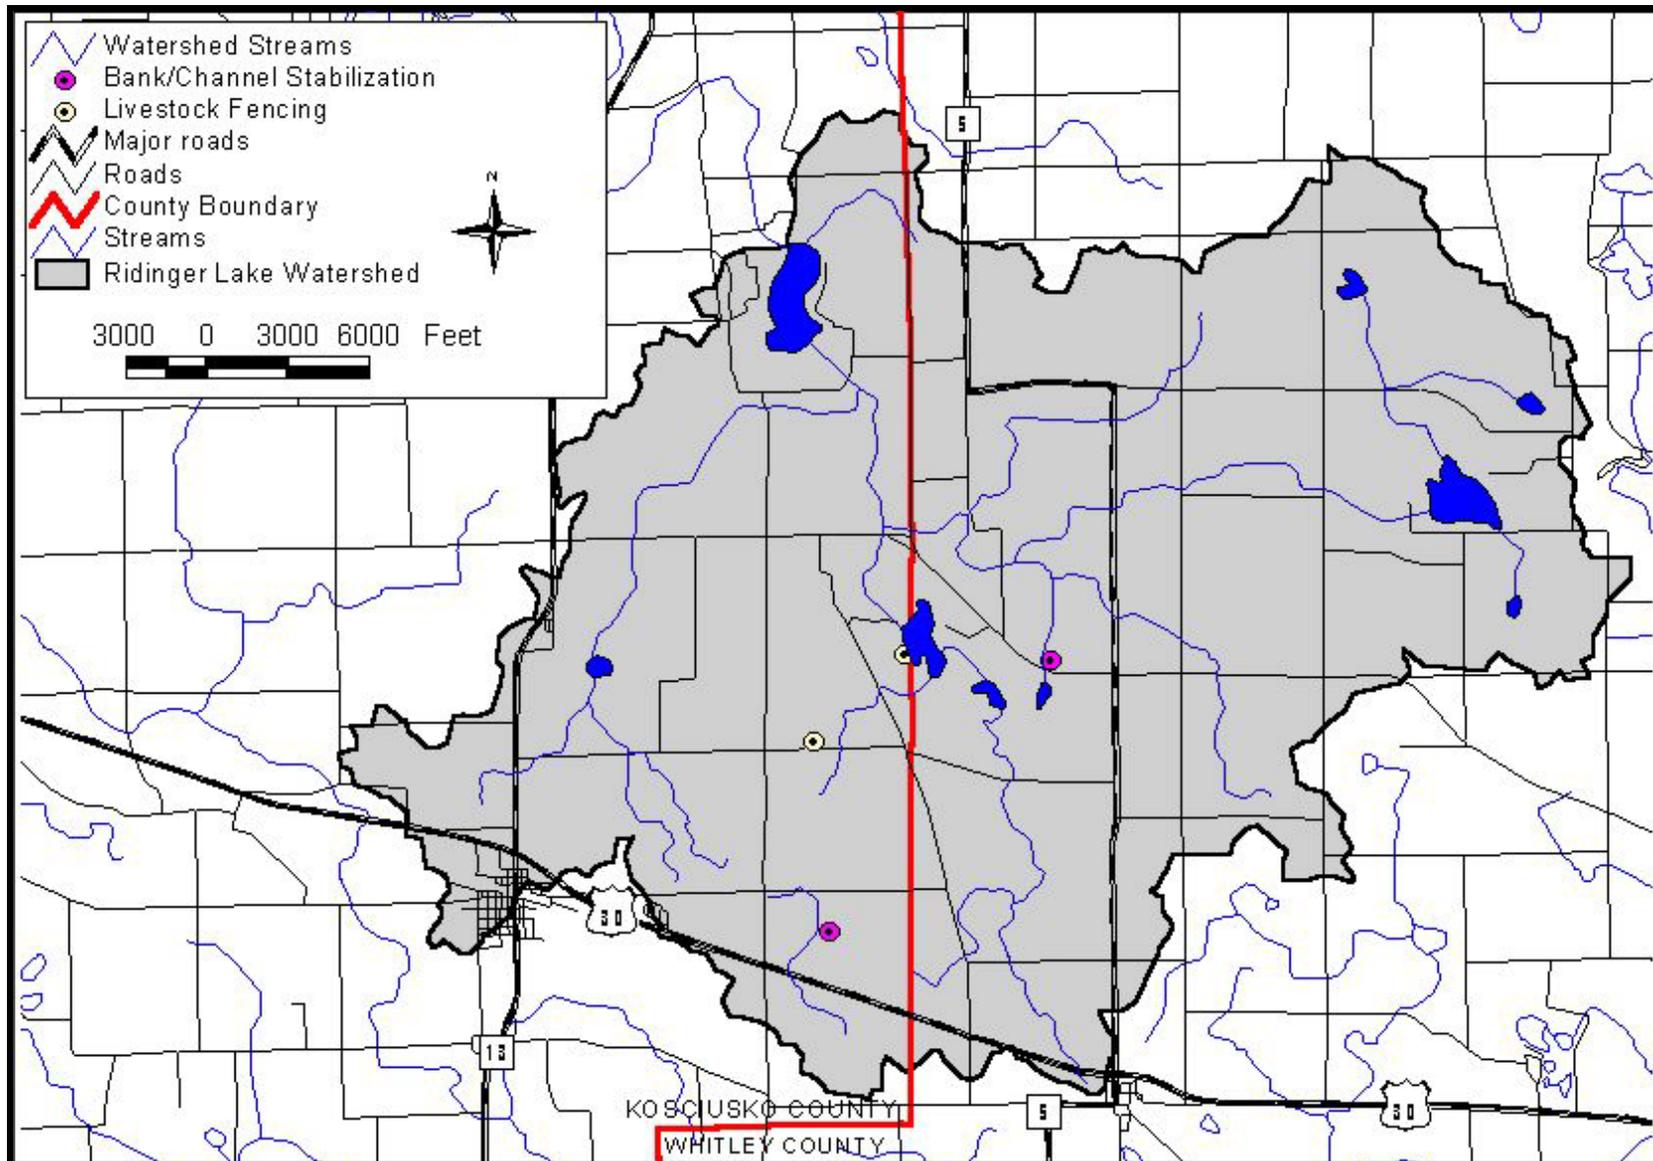
Figure 71. Locations where livestock exclusion fencing and stream bank/channel stabilization is recommended. Source: See GIS sources appendix (Appendix A). Scale: 1"=7,000'.

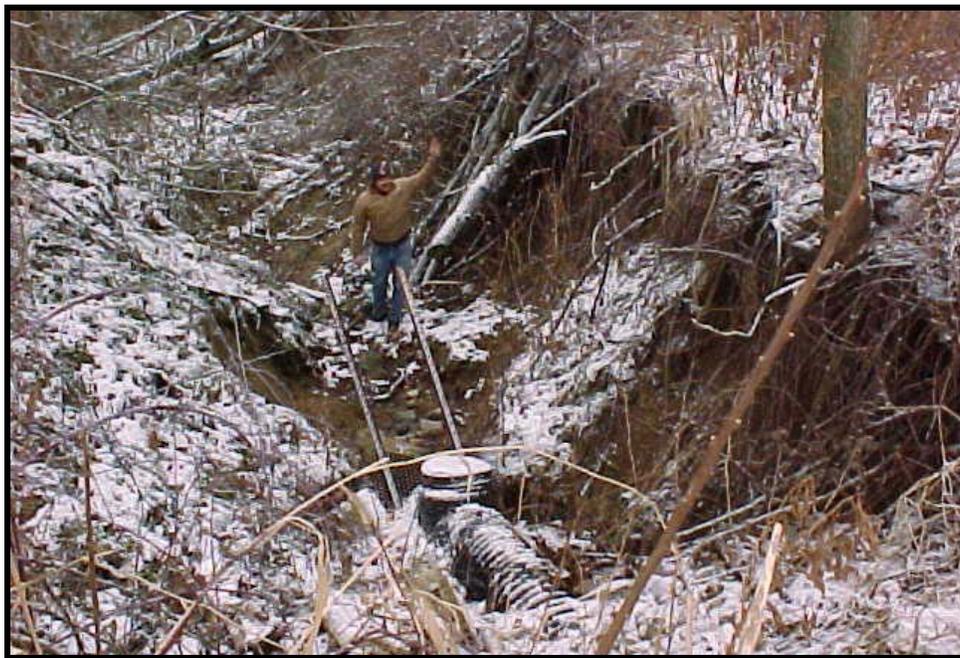
Figure 72. Eroding ravine near Ridinger Lake.

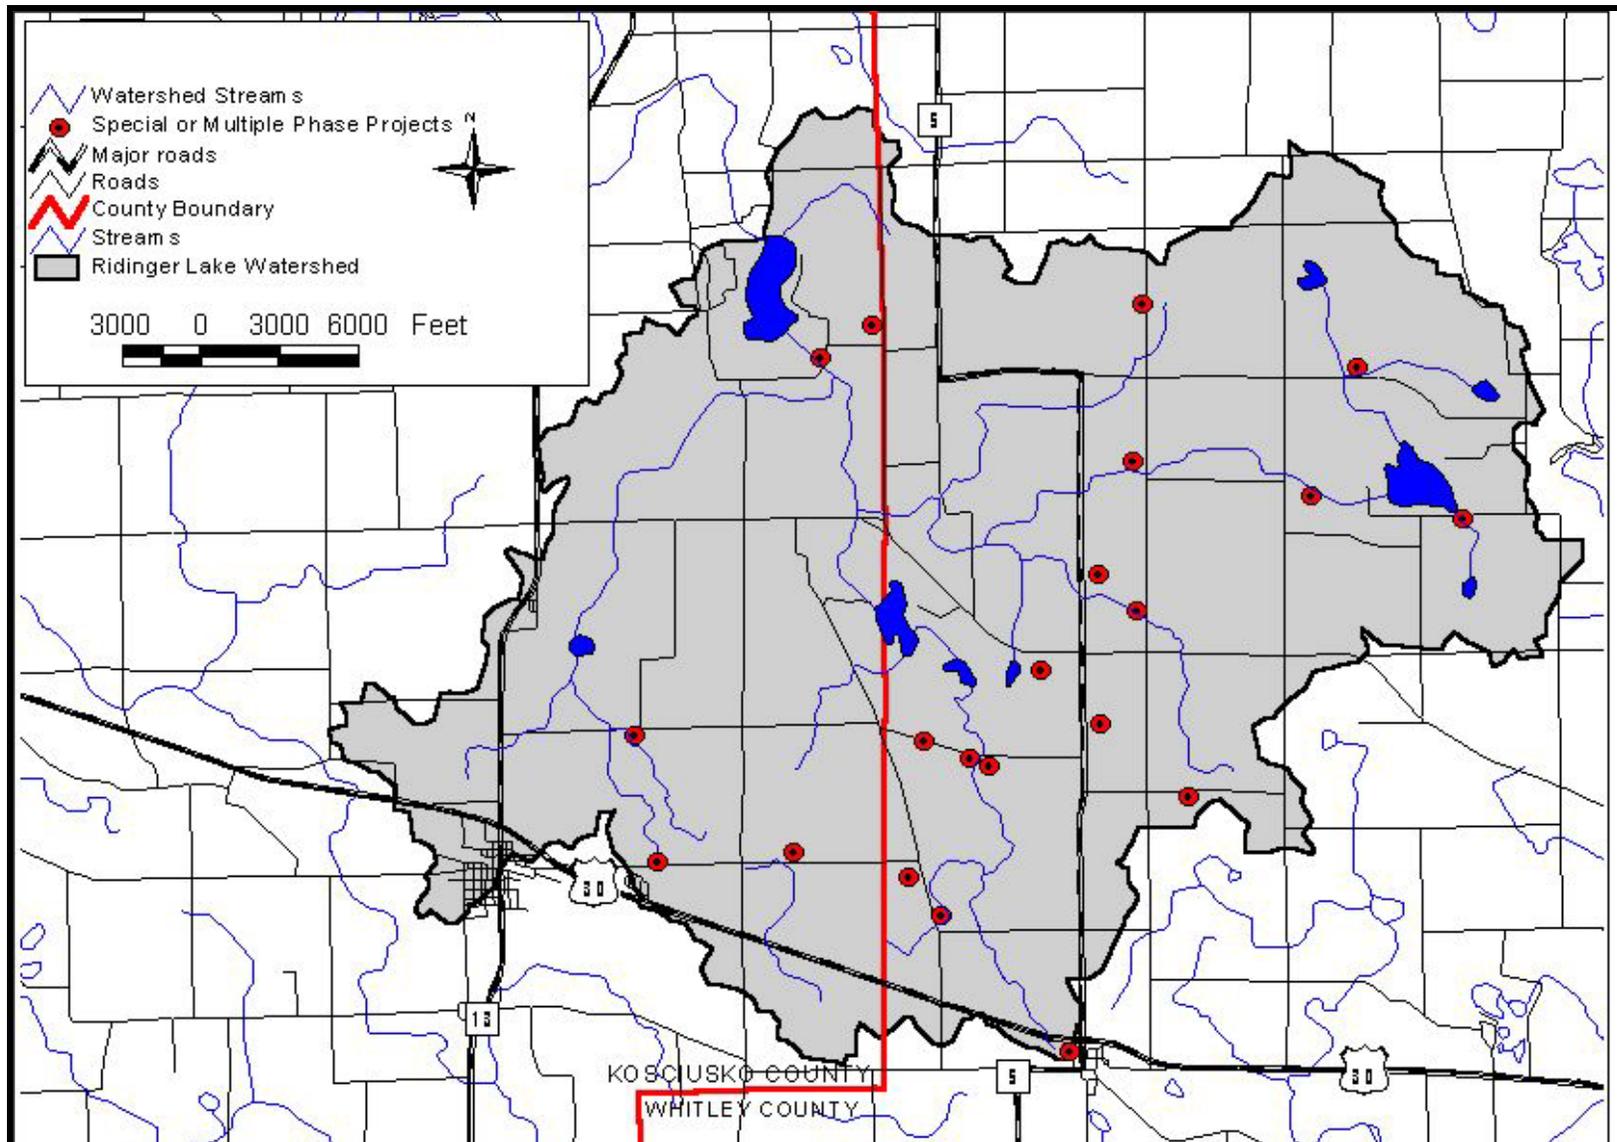
Figure 73. Locations in the Ridinger Lake watershed where implementation of special or multiple phase projects is recommended. Source: See GIS sources appendix (Appendix A). Scale: 1"=7,000'.
