HEATON LAKE, ELKHART COUNTY
AQUATIC VEGETATION MANAGEMENT
PLAN UPDATE - 2008

FEBRUARY 27, 2009

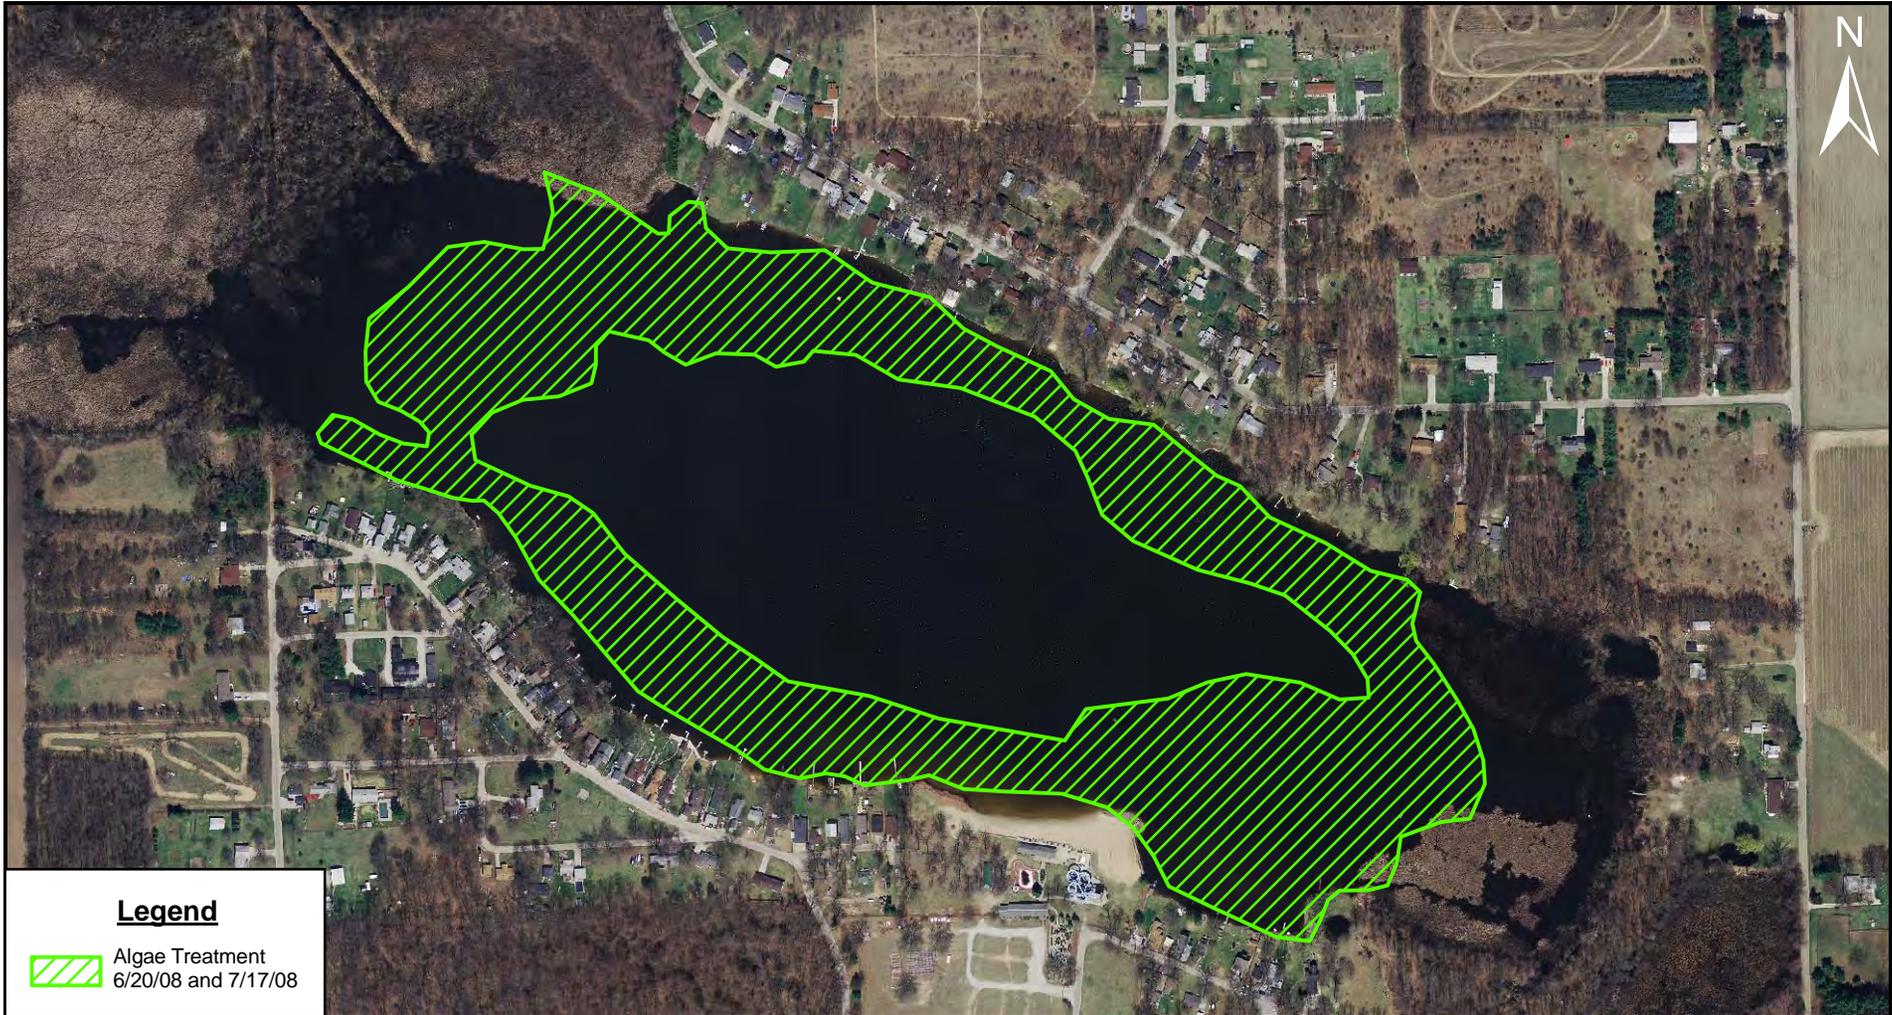
Algae Treatment
6/20/08 and 7/17/08

Weed Patrol treated 25 acres of chara algae on June 20th and July 17th, 2008 using copper sulfate at 2.6 lbs per acre foot (Figure 2). Weed Patrol performed three reconnaissance surveys for exotic species; however, exotic species were not found until the July 17th chara treatment. Weed Patrol created an exotic species map which was used to locate areas that required treatment (Figure 3).

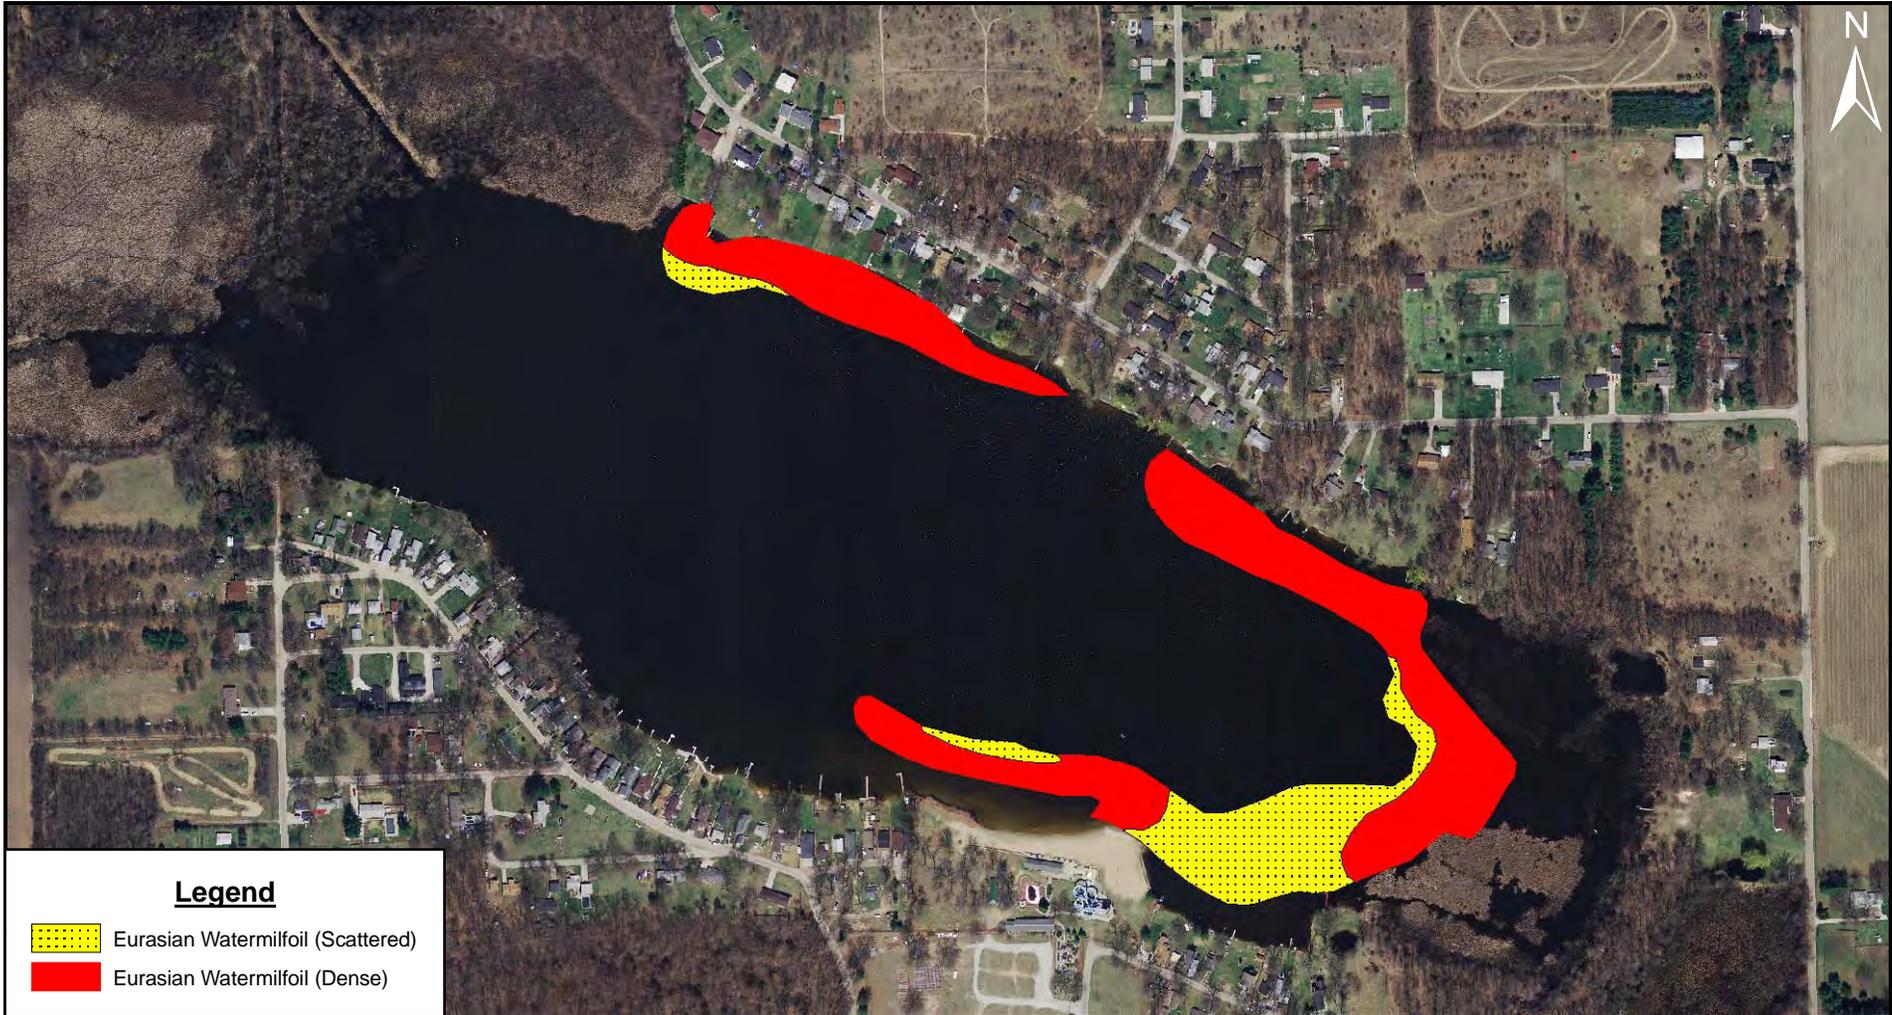
Eurasian Watermilfoil (Scattered)
-

Eurasian Watermilfoil (Dense)

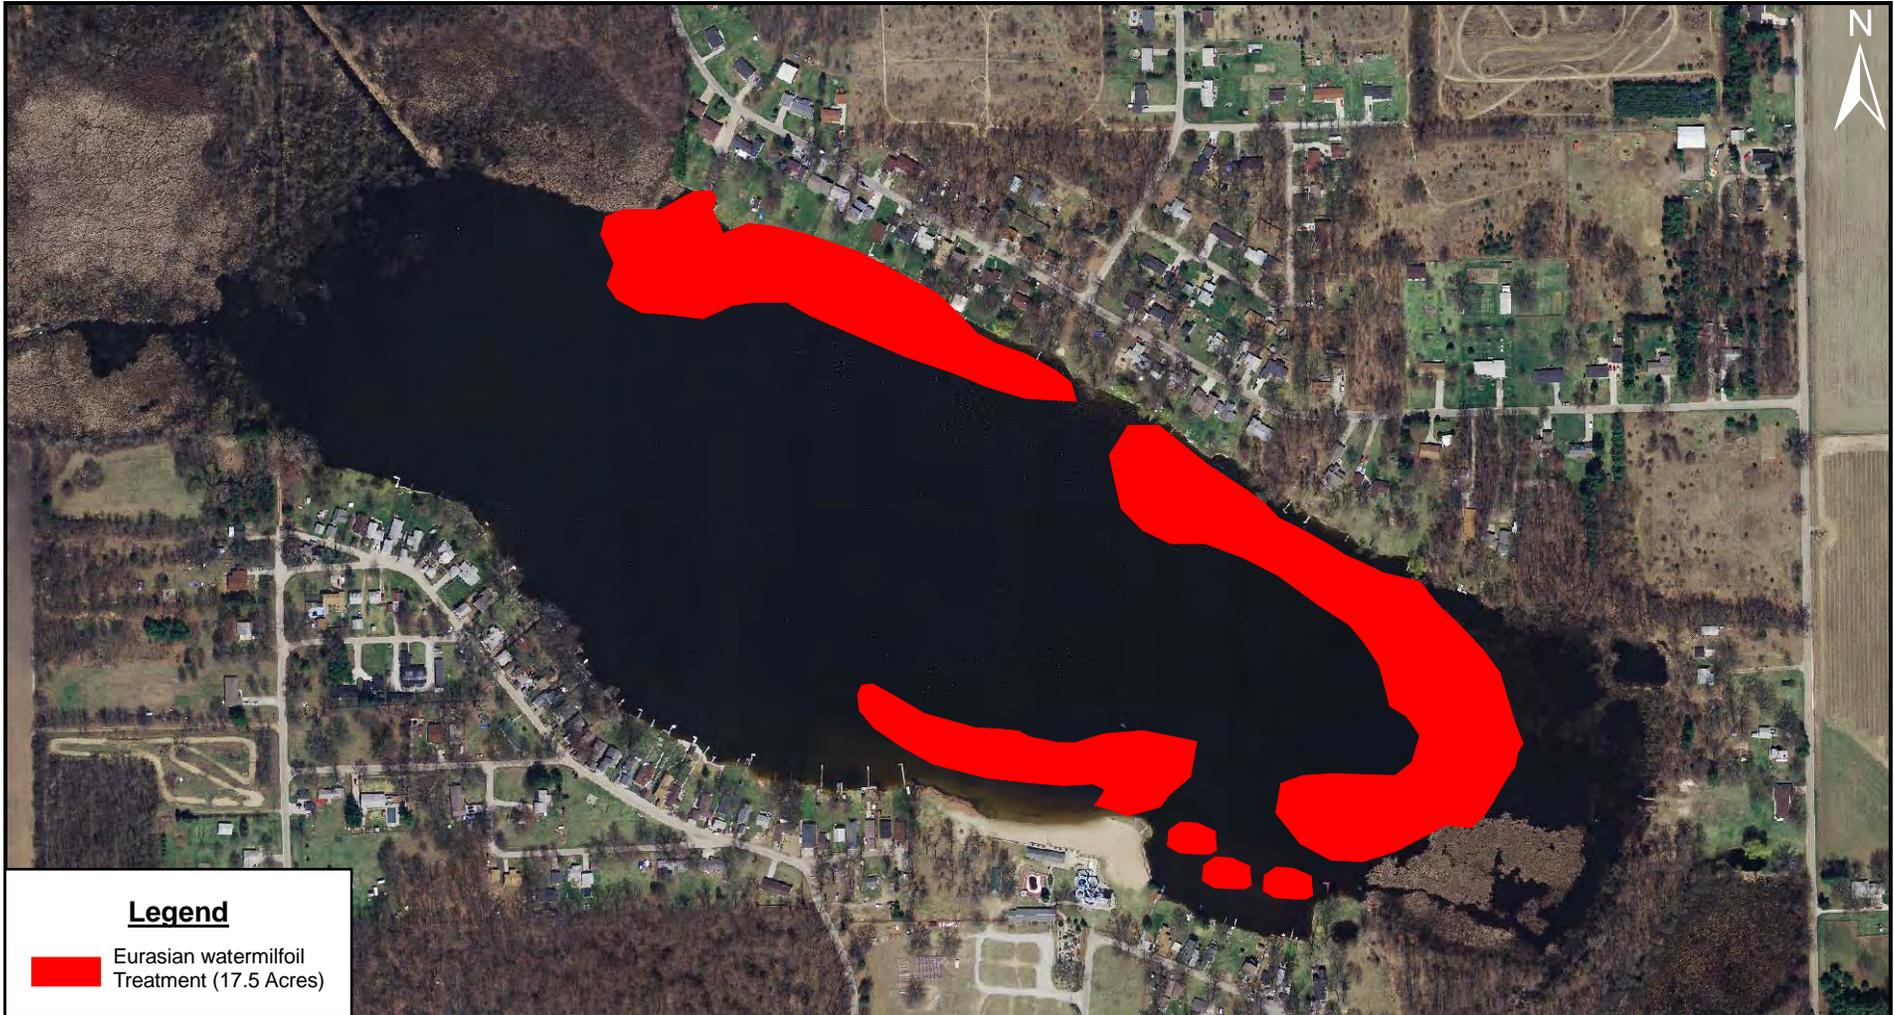
Eurasian watermilfoil Treatment (17.5 Acres)

Weed Patrol performed reconnaissance surveys for exotic species on Heaton Lake on April 18th, May 23rd, and June 20th; exotic species were not found until the chara treatment on July 17th. Weed Patrol applied granular 2,4-D (Navigate ®) to 17.5 acres of Eurasian watermilfoil on August 18, 2008 (Figure 4). The dosage of 2,4-D was 100 lbs per acre. V3 conducted the post-treatment Tier II survey on August 27, 2008 to evaluate the vegetative community at Heaton Lake and determine the extent of exotic species. The results of the 2008 Tier II survey had Eurasian watermilfoil present at 22.5% of sampling locations at depths ranging from 0 to 7 feet.

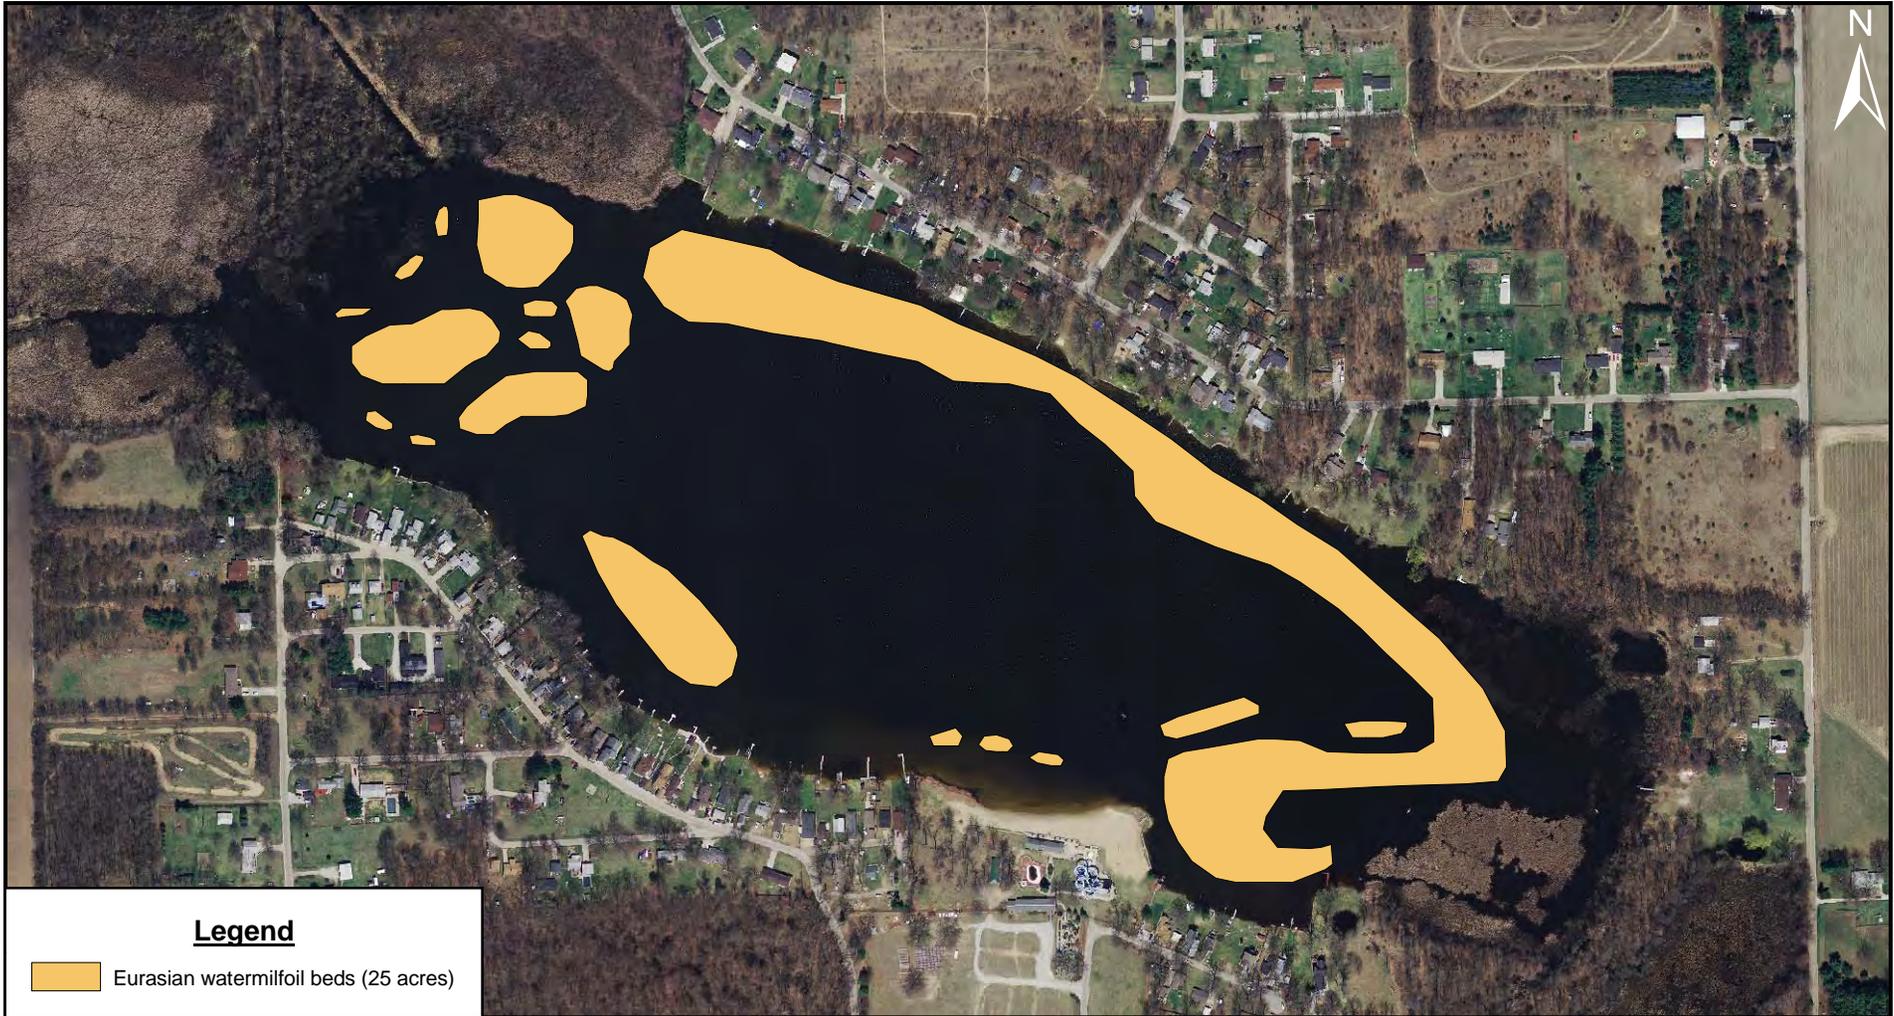
Eurasian watermilfoil beds (25 acres)

The current level of Eurasian watermilfoil indicates a return towards pre-fluridone densities. The 2005 site frequency of Eurasian watermilfoil was 30% (figure 5). The high site frequency of Eurasian watermilfoil in 2005 prompted the whole lake fluridone treatment in 2006. A whole lake fluridone treatment of Sonar AS was performed on May 24, 2006, with a concentration of 6 parts per billion (ppb). A second treatment of 1.46 ppb, or bump, was applied on June 16, 2006, to maintain a fluridone concentration of 6 ppb within the lake. The fluridone treatment was effective in 2007 as only 0.1 acres of Eurasian watermilfoil required treatment.

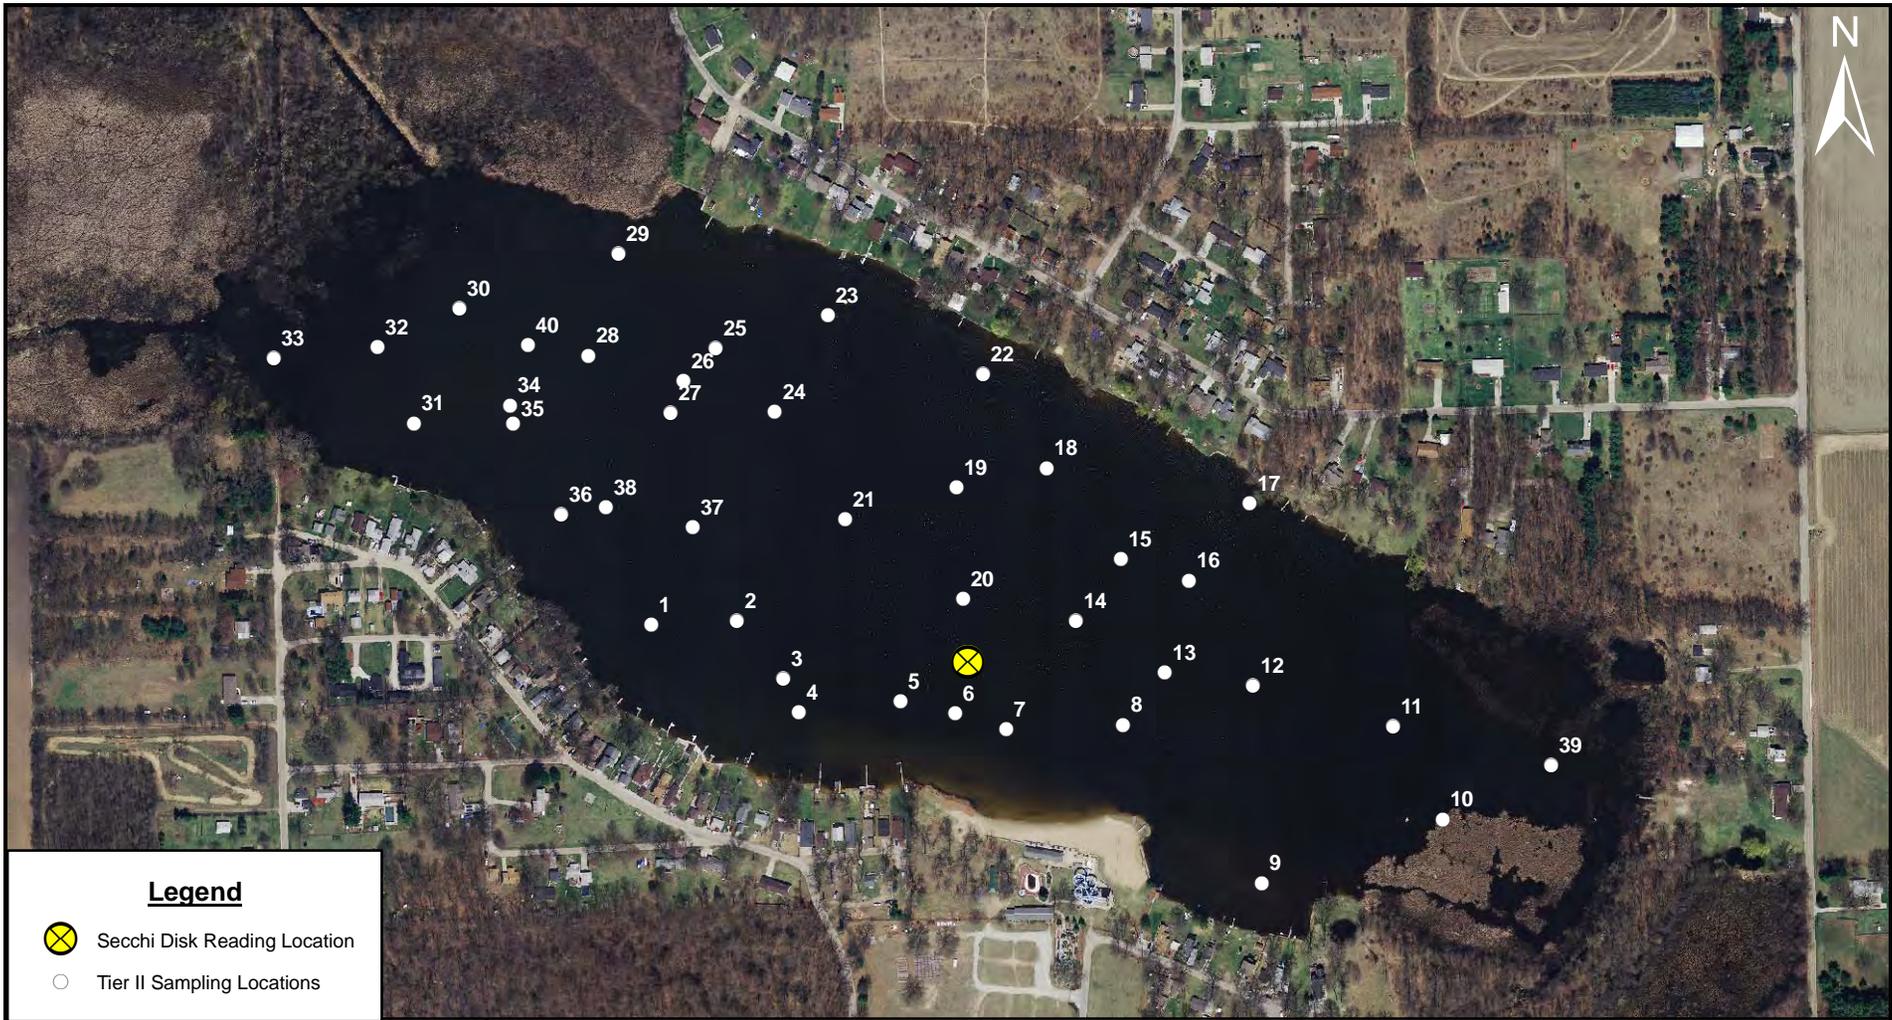
Secchi Disk Reading Location
-

Tier II Sampling Locations

At each station a sampling rake is used for collecting vegetation samples. Once a species is identified, vegetation abundance is scored as a 1 (1-19%), 3 (20-100%), or 5 (>100%) based on the vegetation density on the rake. Species are scored as a 9 if they are observed within the vicinity of the sampling station but not collected. After completion of the sampling effort a secchi disk reading and water quality measurements are taken (Figure 6).

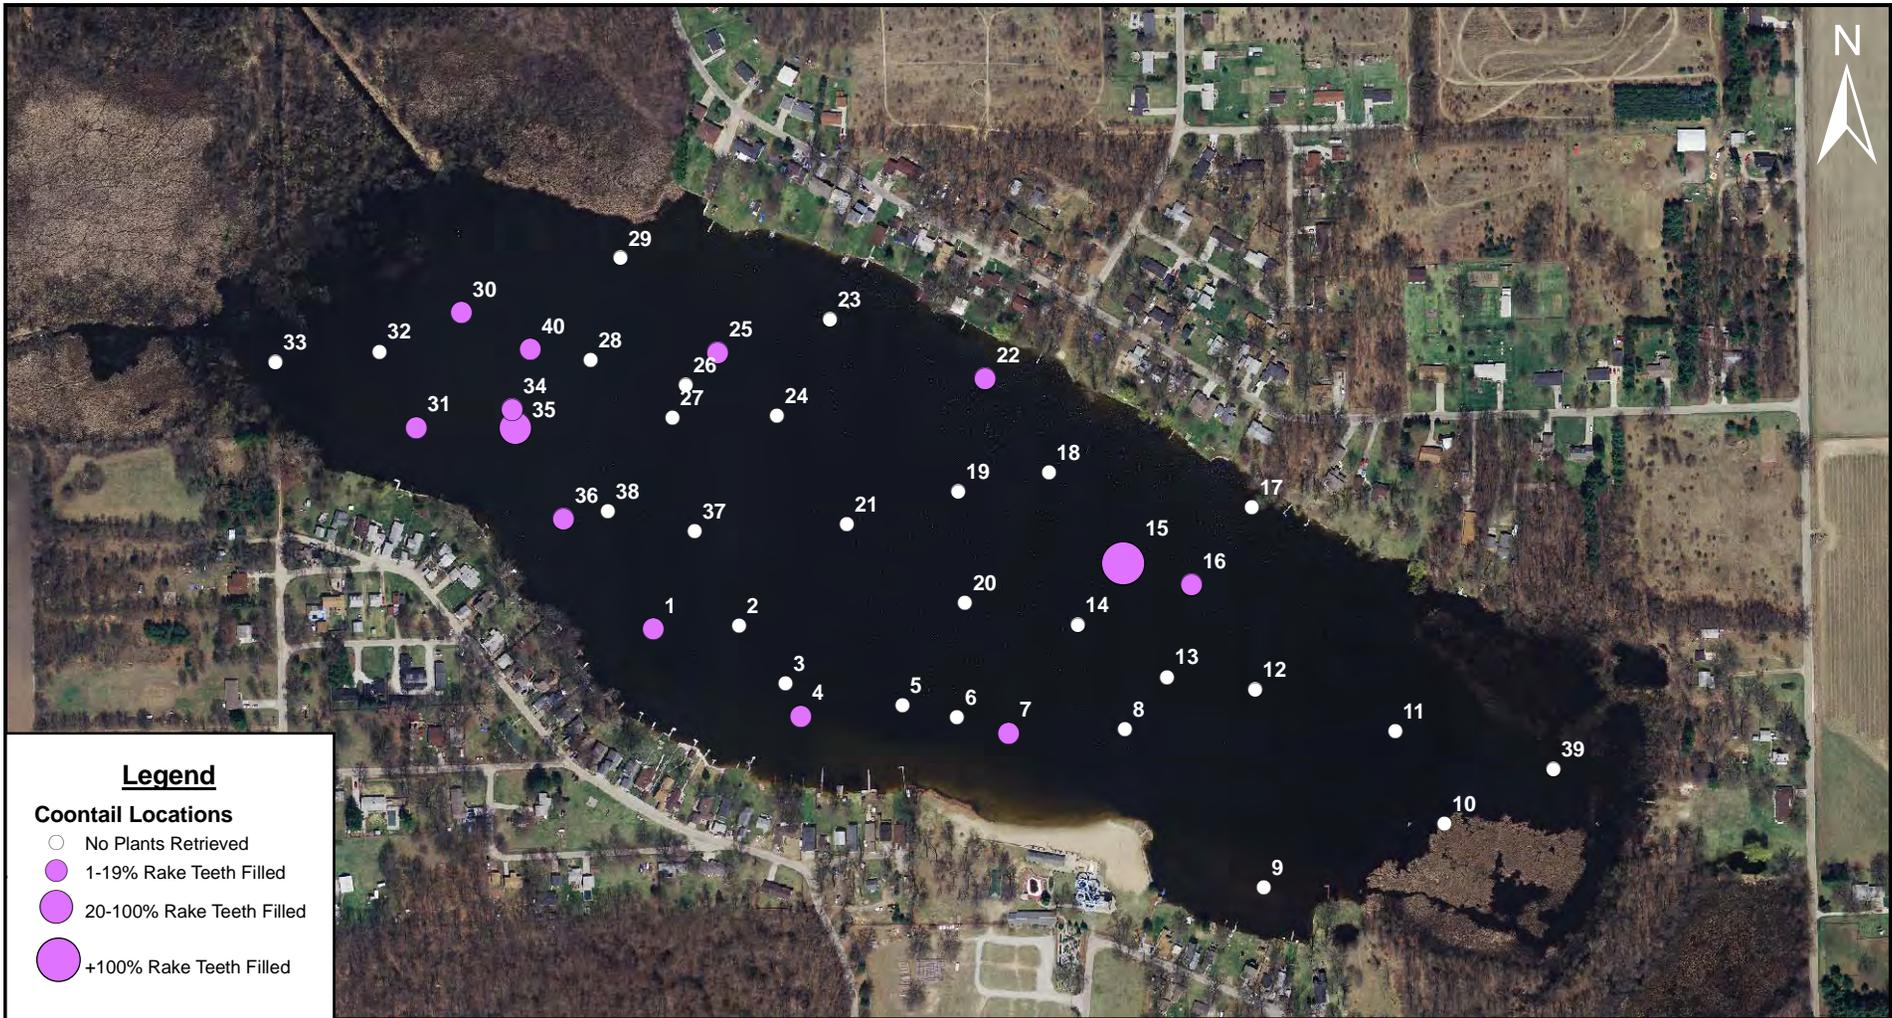
Coontail Locations

- No Plants Retrieved
- 1-19% Rake Teeth Filled
- 20-100% Rake Teeth Filled
- +100% Rake Teeth Filled

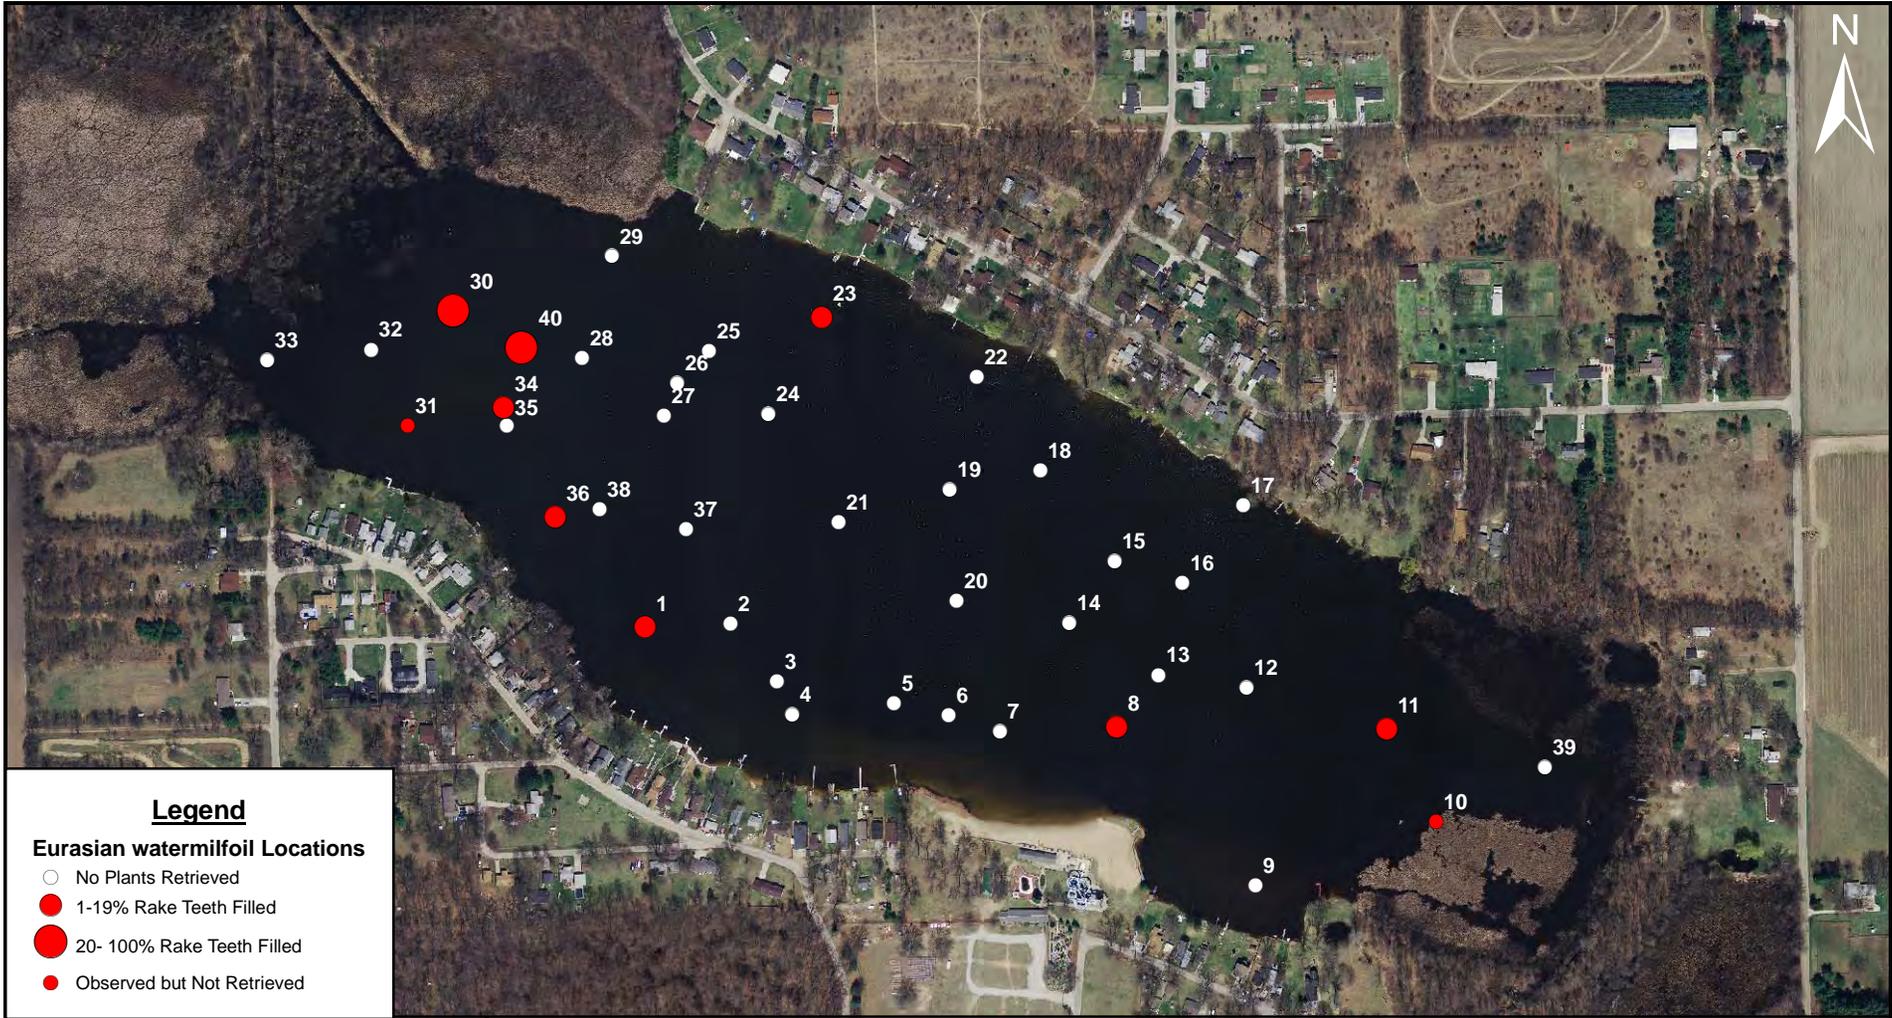
Eurasian watermilfoil Locations

- No Plants Retrieved
- 1-19% Rake Teeth Filled
- 20- 100% Rake Teeth Filled
- Observed but Not Retrieved

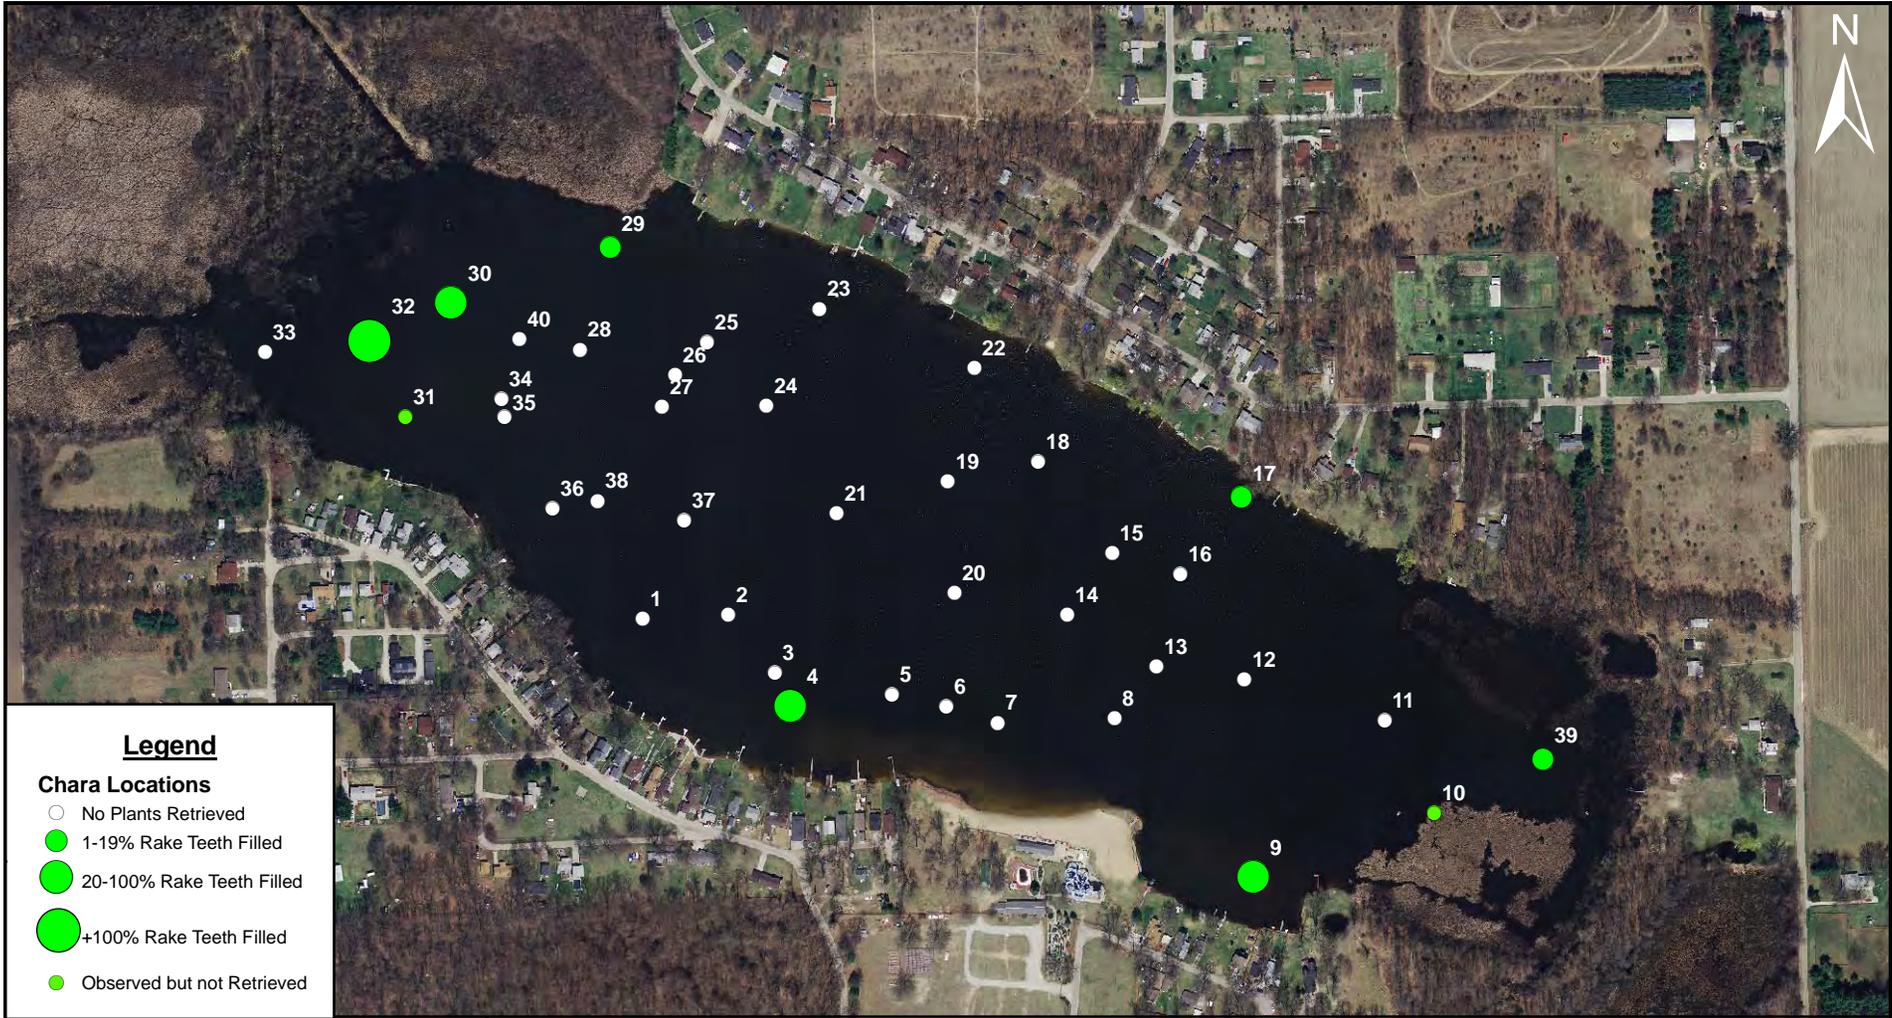
TITLE:	Post-treatment Distribution and Abundance of Chara		
BASE LAYER:	Indiana Spatial Data 2006 Orthophotography		
CLIENT:	Heaton Lake Conservation Club 22892 Lake Shore Drive Elkhart, IN 46514

Chara Locations

- No Plants Retrieved
- 1-19% Rake Teeth Filled
- 20-100% Rake Teeth Filled
- +100% Rake Teeth Filled
- Observed but not Retrieved

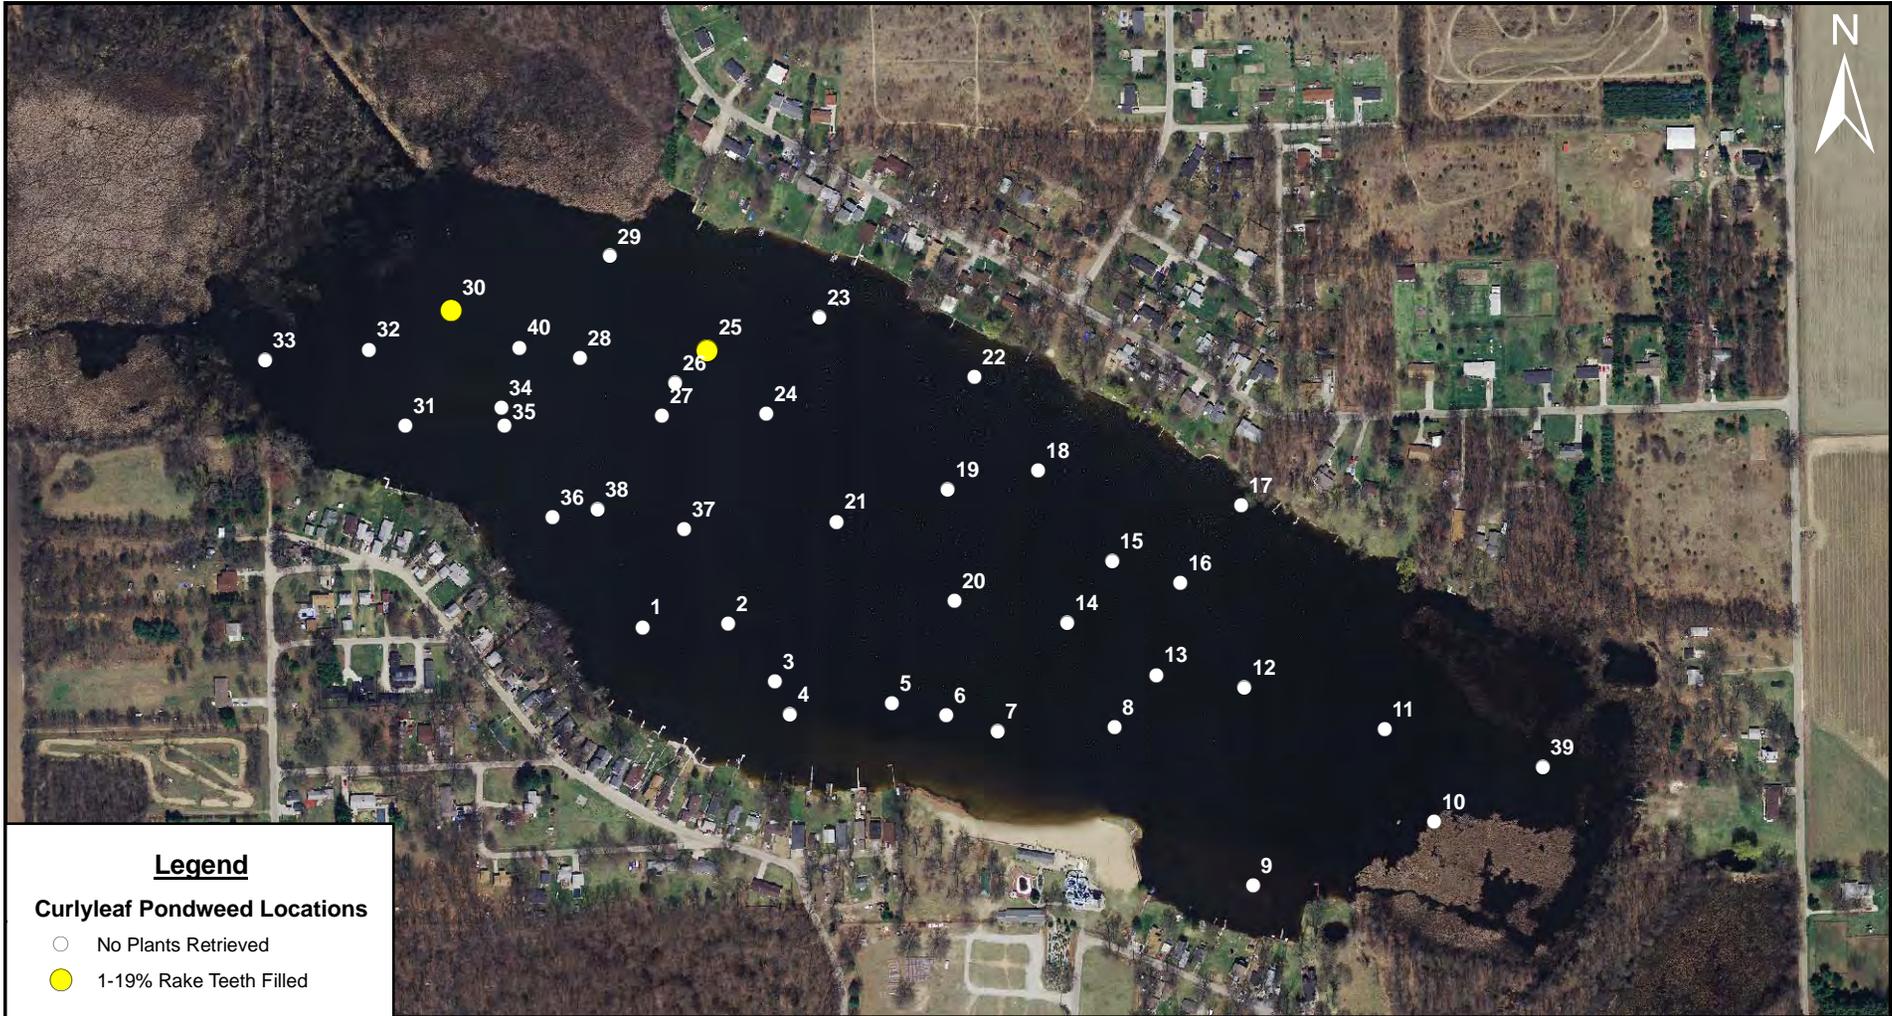
Curlyleaf Pondweed Locations

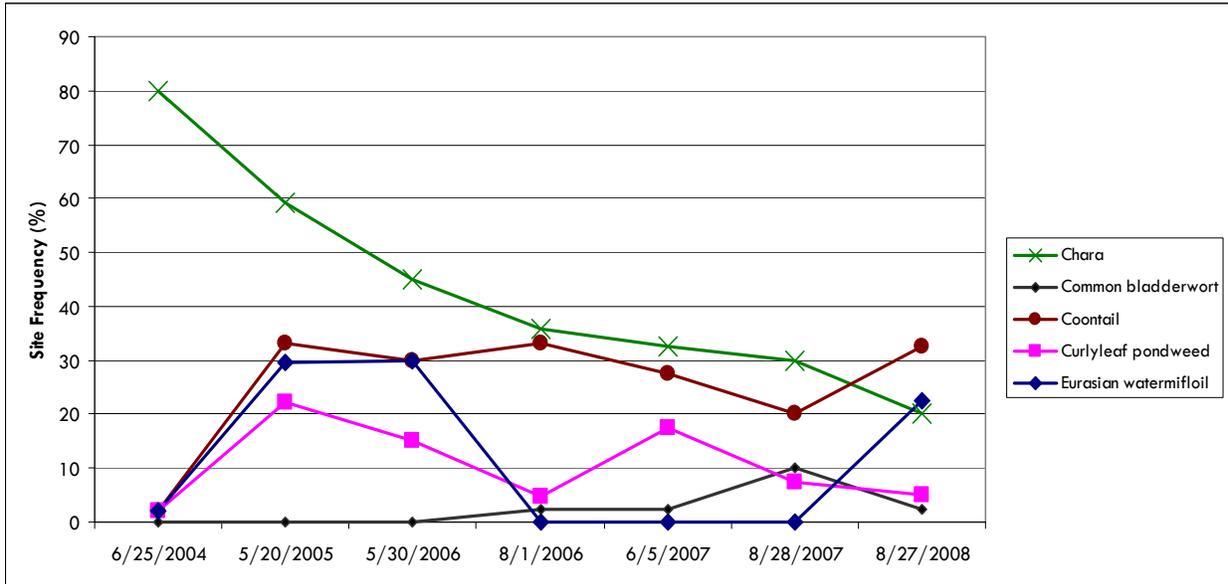
Figure 11a: Frequency of occurrence of dominant species within Heaton Lake from 2004-2008.

Figures 11a-11d displays individual species frequency of occurrence over time. Graphs were created using the frequency of occurrence provided in Table 4. Fluctuations in frequency of occurrence for Eurasian watermilfoil and chara are likely a response to herbicide treatments.

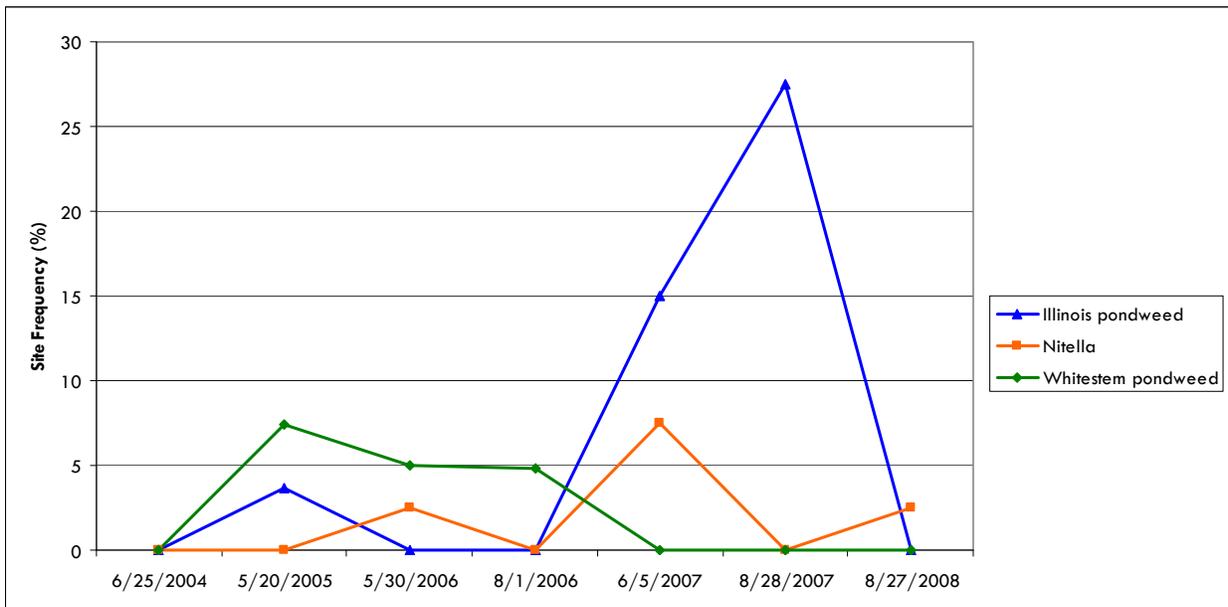
Figure 11b: Frequency of occurrence of species collected three times within Heaton Lake from 2004-2008.

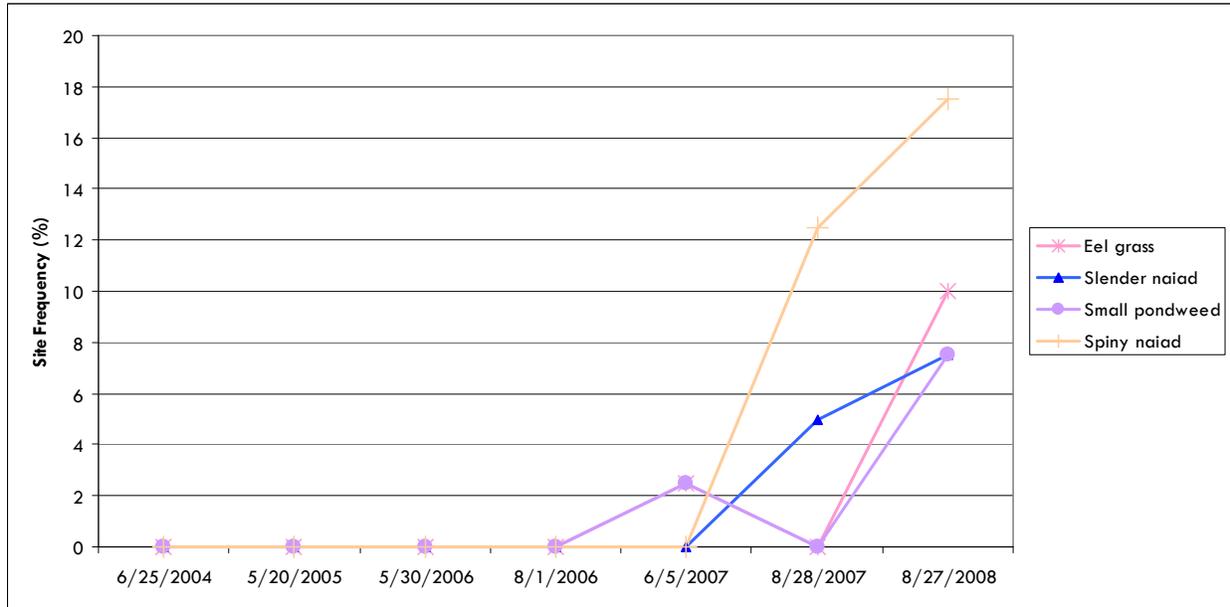
Figure 11c: Frequency of occurrence of species collected twice within Heaton Lake from 2004-2008.

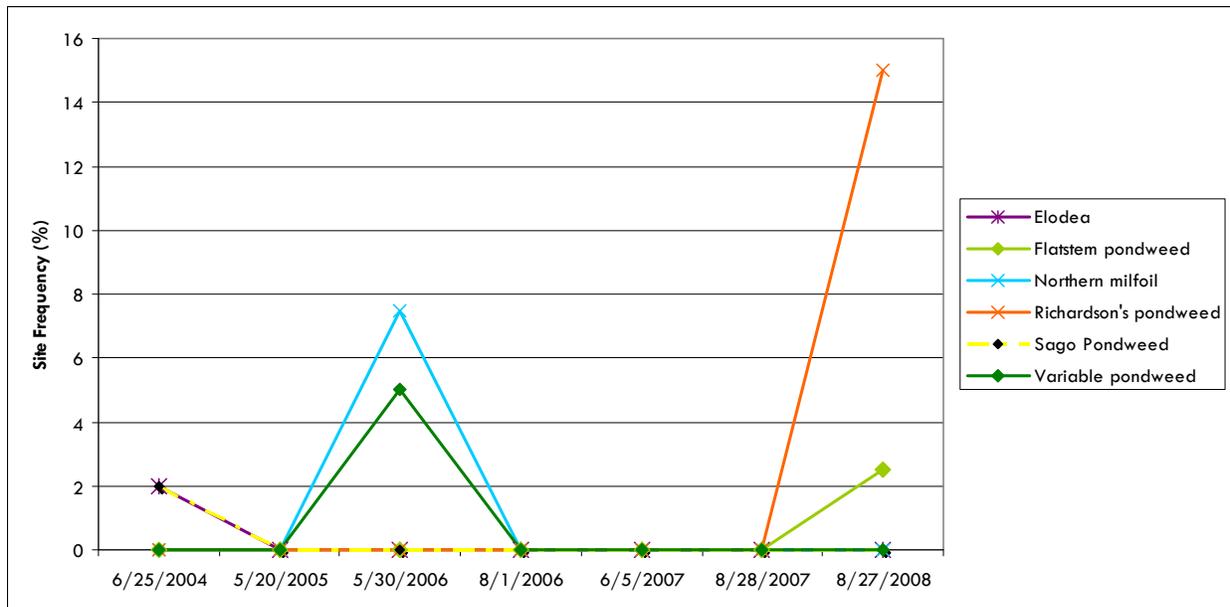
Figure 11d: Frequency of occurrence of species collected once within Heaton Lake from 2004-2008.

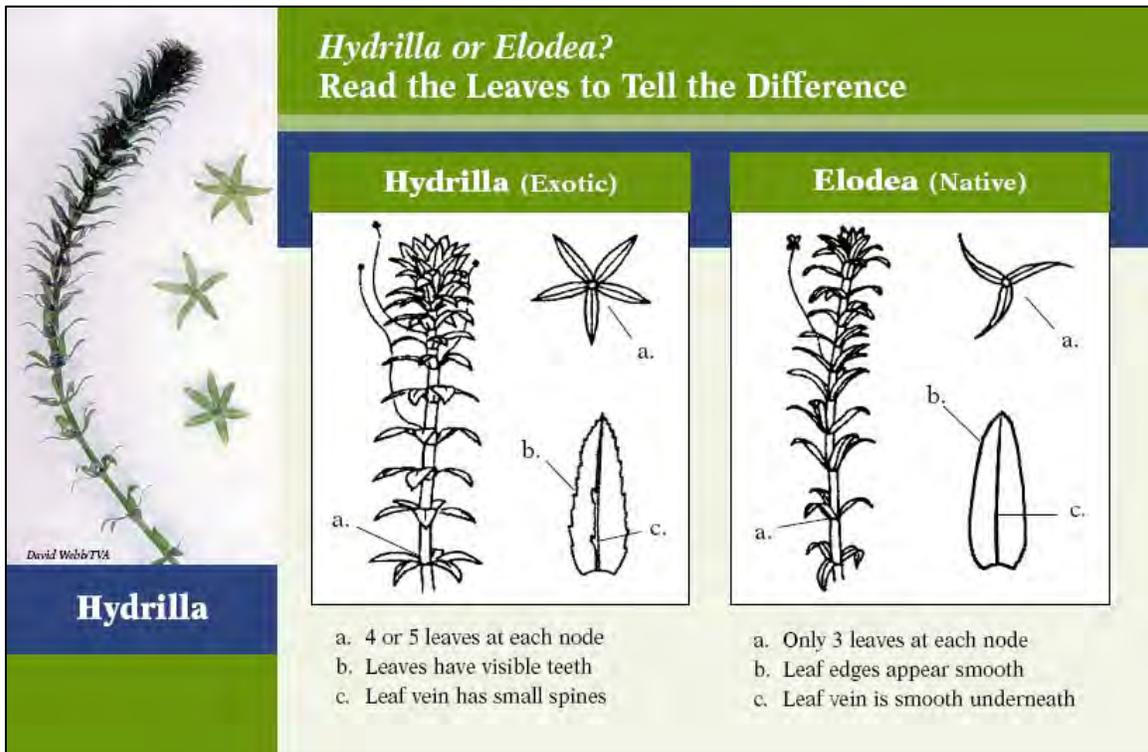
Figure 13: Illustration of Hydrilla compared to native elodea. (Illustrations provided by Michigan Sea Grant)

Public involvement and educational needs are critical with respect to a new threat to Indiana lakes from an invasive aquatic species called Hydrilla (*Hydrilla verticillata*). Hydrilla can be differentiated from the native elodea in that there are typically 3 leaves per whorl on the native elodea and there are as many as eight leaves per whorl in Hydrilla. Elodea is also smooth to the touch where as Hydrilla is rough. Figure 13 (Michigan Sea Grant 2007) demonstrates a means of comparative identification.

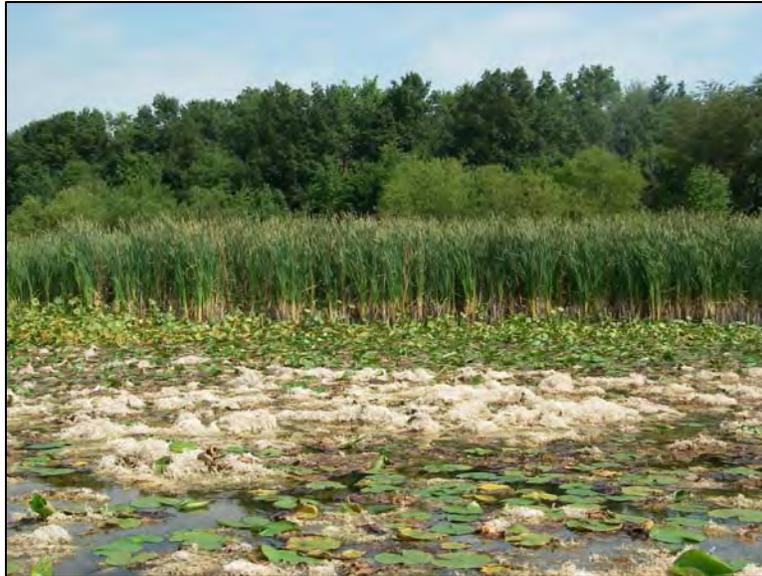
Figure 15: Photograph from V3 Tier II sampling effort of low water condition.

A desire for emergent bed mapping in the eastern and western portions of Heaton Lake was expressed at the meeting. Some residents felt the spread of emergent beds was negatively impacting the inlet in the southeast corner (Figure 14). Some residents noted that navigation was inhibited by the emergent beds and boats were at the weed level during periods of low lake level. During the Tier II sampling effort some locations were unable to be sampled because of the low water level made the location unable to be accessed (Figure 15). The vegetation that appears white represents chara that was exposed and dried due to reduced lake level.
