HEATON LAKE, ELKHART COUNTY
AQUATIC VEGETATION MANAGEMENT
PLAN UPDATE - 2008

FEBRUARY 27, 2009

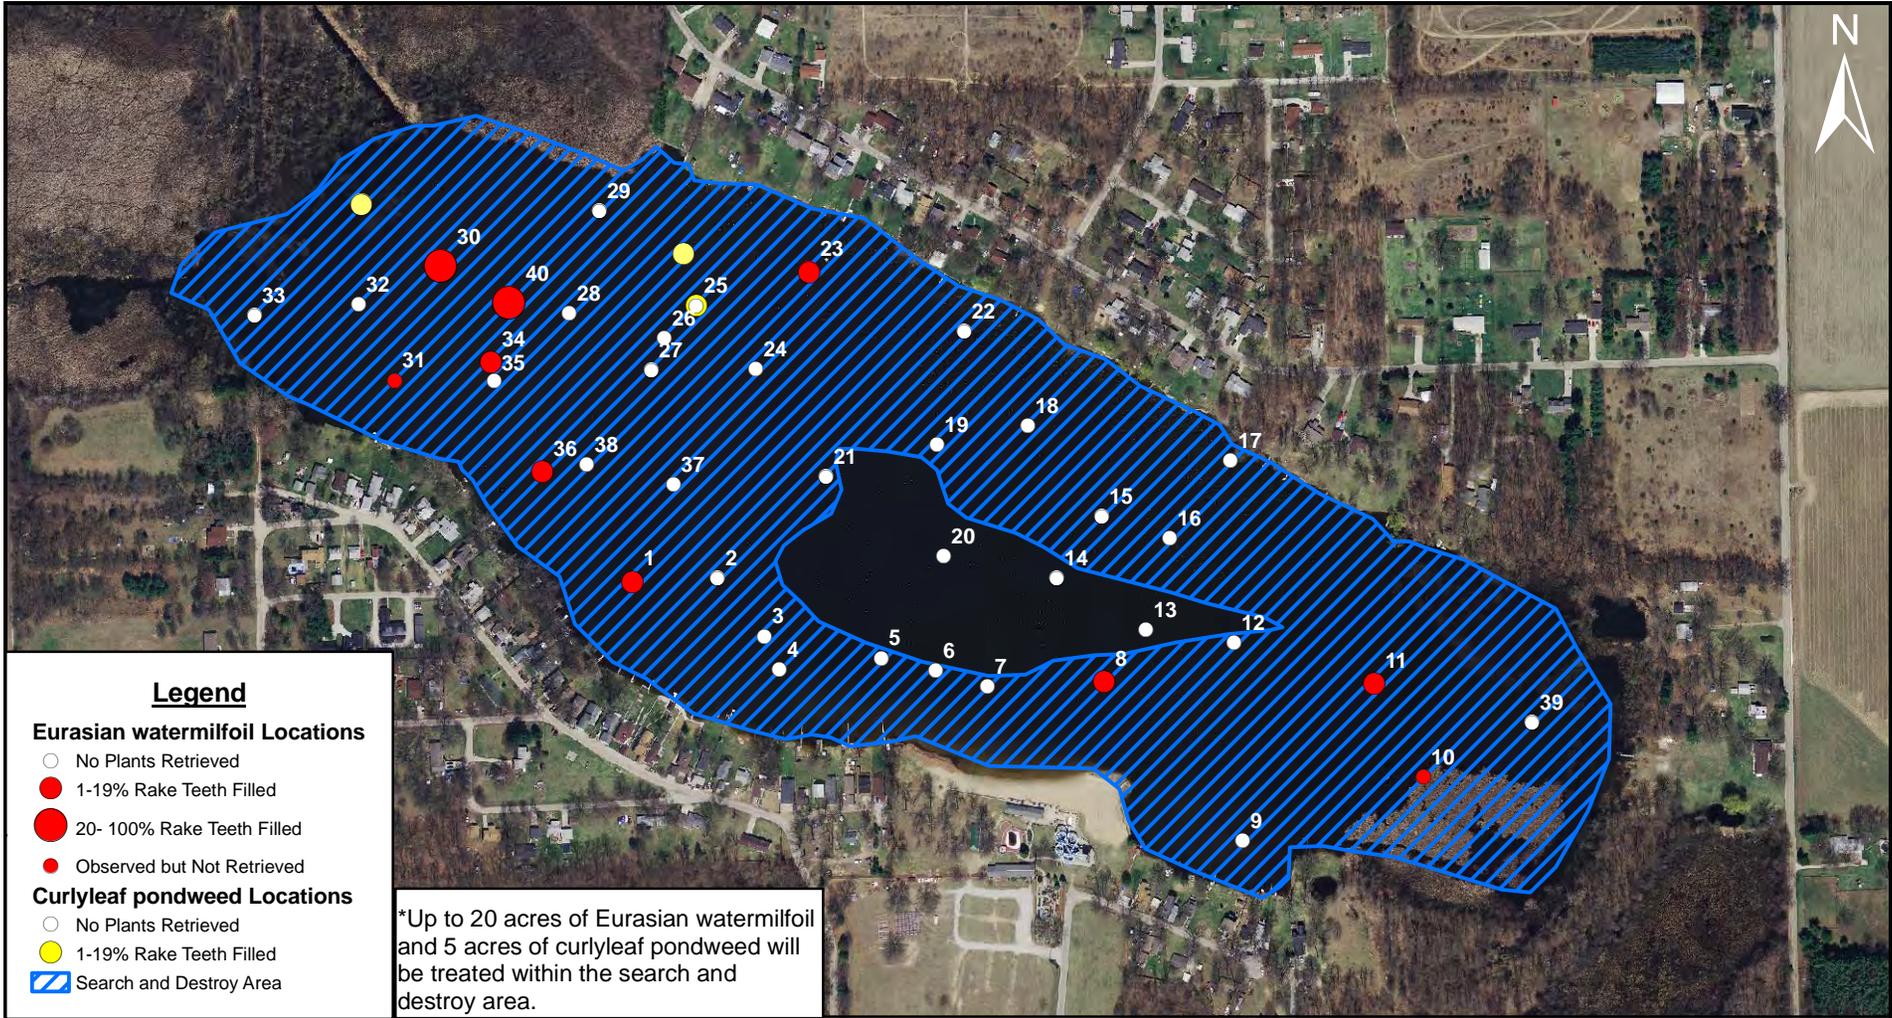
Eurasian watermilfoil Locations

- No Plants Retrieved
- 1-19% Rake Teeth Filled
- 20- 100% Rake Teeth Filled
- Observed but Not Retrieved
