Indiana Classified Forest & Wildlands Forestry Best Management Practices

Monitoring Results • 1996-2021

By: Jennifer Sobecki & Duane McCoy

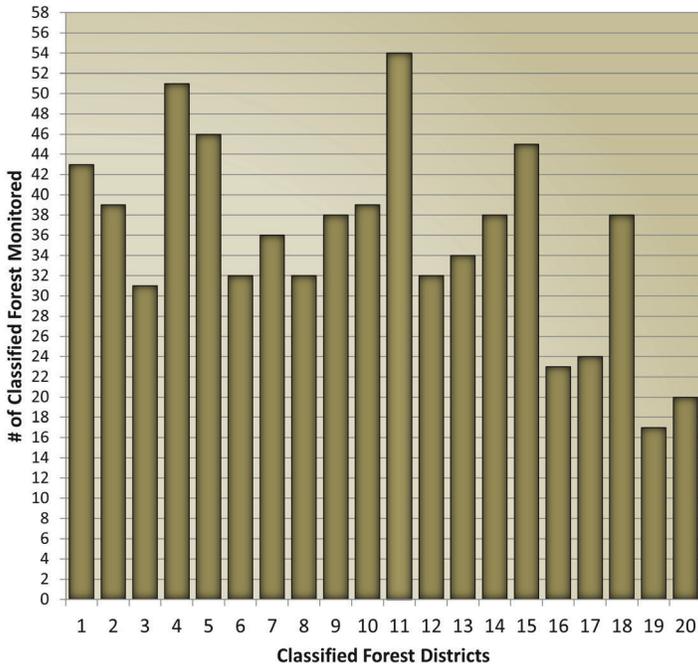
FIGURE 2

Classified Forest Sites Monitored by District

Figure 2. Number of CLFW timber-harvest sites monitored for BMPs by district through the 25-year history of the BMP program.

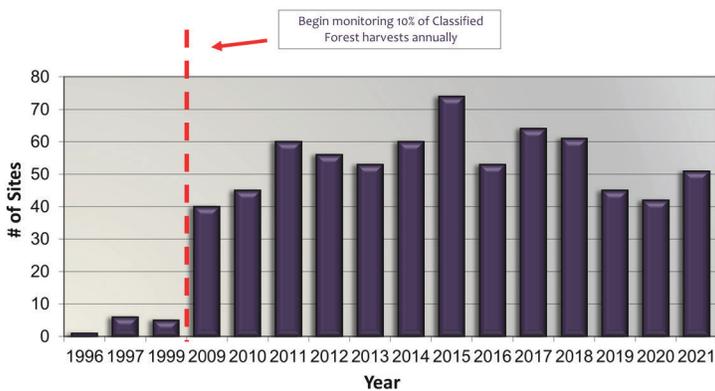
FIGURE 3

Classified Forest & Wildlands Sites Monitored for BMPs

Figure 3. Total number of sites monitored each year since the program began.

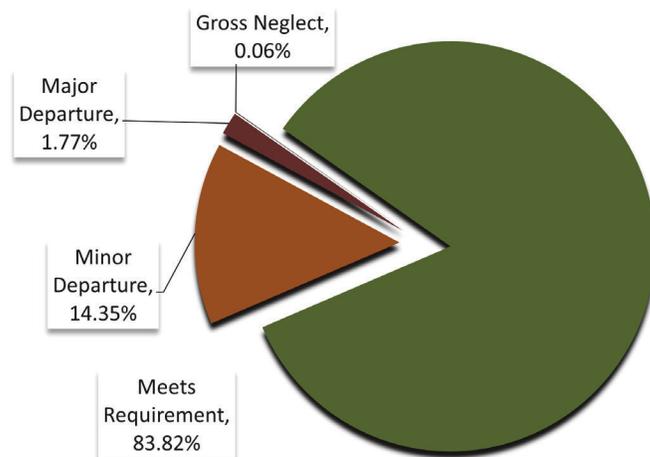
FIGURE 4

Classified Forest & Wildland BMP Application

Figure 4. BMP Application for all 716 CLFW sites monitored from 1996 through 2021.

A total of 83.82% of the BMPs were applied as directed in the BMP guidelines, and 14.35% had minor departures as defined in the monitoring sheet. There have been 494 major departures, which add up to 1.77% of all practices monitored. Of the total 716 sites monitored on CLFW sites, 16 practices scored “Total Negligence” for 0.06%, as shown in Figure 4.

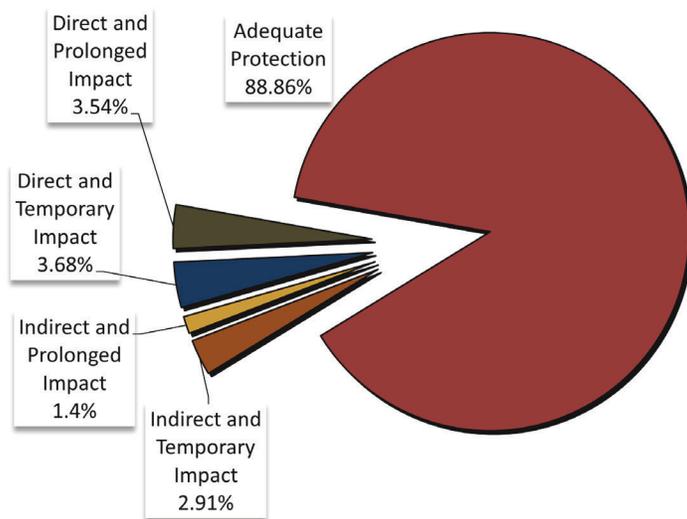
FIGURE 5

Classified Forest & Wildland BMP Effectiveness

Figure 5. BMP Effectiveness for all 716 CLFW sites monitored from 1996 through 2021.

Effectiveness rates are used to evaluate the success of the BMPs applied to a site. The effectiveness rate for the 716 sites monitored is 88.46%. Indirect and temporary impacts to water quality were found 2.91% of the time. Indirect and prolonged impacts were found 1.4% of the time. Direct and temporary impacts occurred 3.68% of the time, and there were 3.54% direct and prolonged impacts to water quality. All of this is shown in Figure 5.

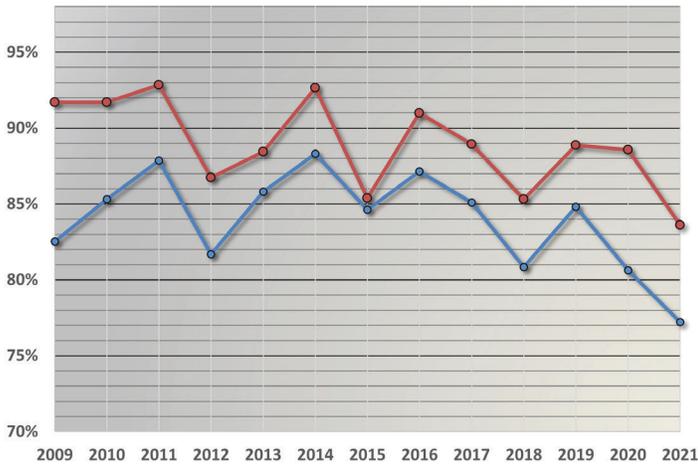
FIGURE 6

Yearly Classified Forest BMP Overall Application & Effectiveness Rates

Figure 6. Yearly trends of overall BMP application and effectiveness scores on CLFW sites. These percentages are calculated for each year’s data separately, rather than being combined with the running totals from previous years.

Application and effectiveness rates of sites monitored vary from year to year, and no real positive or negative trend can be extrapolated; however, there are several conclusions one can draw from Figure 6. First, effectiveness rates are commonly higher than application rates. Second, the rates seem to generally mirror one another.

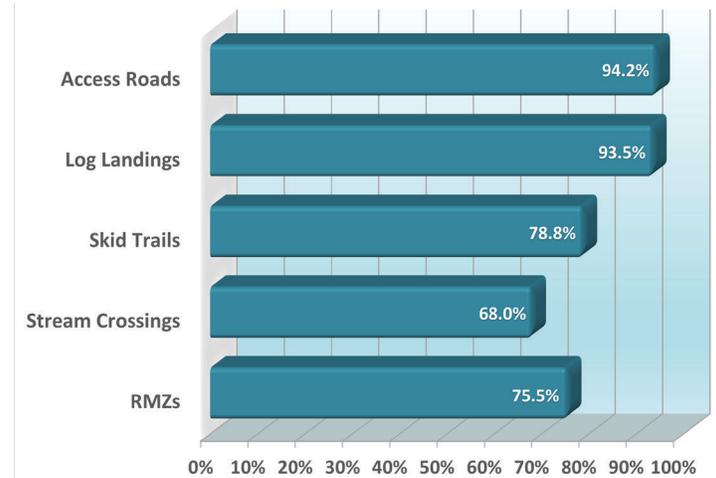
FIGURE 7

Classified Forest BMP Application

Figure 7. Overall BMP application percentages by BMP category.

Access roads and landings are timber harvest areas where much of the machine activity is concentrated, including the use of tractor trailers, which cannot handle much variation in the terrain when traveling. Because of this, access roads and log landings are often well drained, stabilized, and located in areas that have established travel routes that avoid water bodies as much as possible. BMP application trends remain consistently high for access roads and log landings through the 25 years of monitoring. Skid trails are usually over rough ground that may have been traveled at some point in the past and then left alone, so they tend to be harder to engineer effective drainage for, given the trees, rough terrain, and soil-structure variability. Since 2011, skid trails have had applications scores near 80%. Skid trails usually lead to stream crossings and RMZ areas and are close to the water bodies. This means there is an increased chance for water quality impact, regardless of whether there is an application problem. RMZ application has generally stayed in the mid- to high 70s. Stream crossings have the lowest application scores on CLFW lands with a 68% overall application.

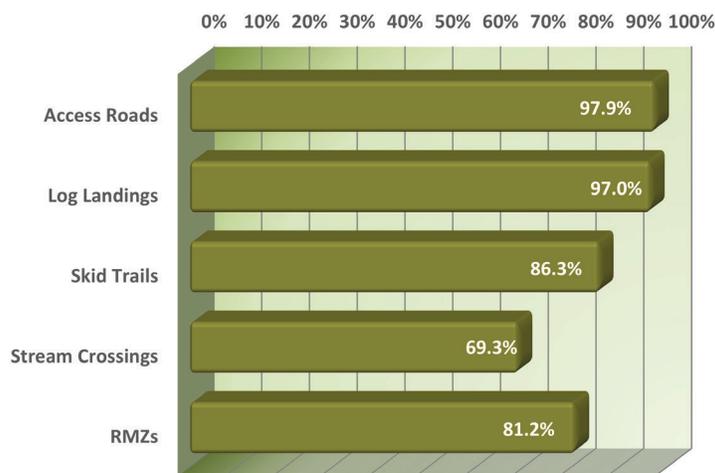
FIGURE 9

Classified Forest BMP Effectiveness

Figure: 9. Overall BMP effectiveness percentages by BMP category.

The overall BMP application and effectiveness for the five categories, access roads and log landings were the highest ranked, with access roads having a 94.2% application and 97.9% effectiveness rate. Log landing application rate was 93.5% and effectiveness was 97%. The third-highest category was skid trails, with 78.8% application and 86.3% effectiveness rates. RMZs ranked next to last, with 75.5% application and 81.2% effectiveness. The BMP area with the most difficulty was stream crossings, with an application of 68.0% and effectiveness of 69.3%. Because of the direct impact all crossings can have on water resources, BMP application and effectiveness are most critical in this area. Small problems in application on stream crossings can lead to large-scale disturbance. Wet conditions can also lead to departures from effective management with stream crossings.

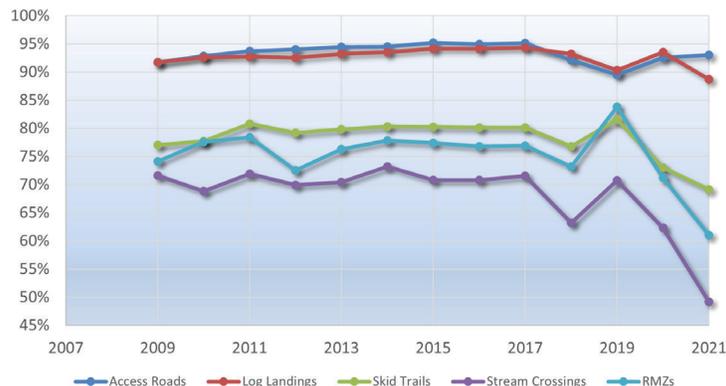
FIGURE 8

Classified Forest BMP Application Yearly Trends

Figure 8. Yearly BMP application trends by category.

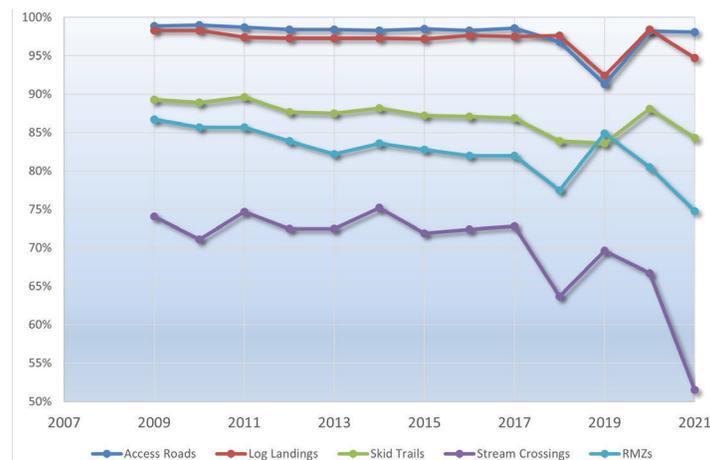
FIGURE 10

Classified Forest BMP Effectiveness Yearly Trends

Figure 10. Overall BMP effectiveness yearly trends by BMP Category.

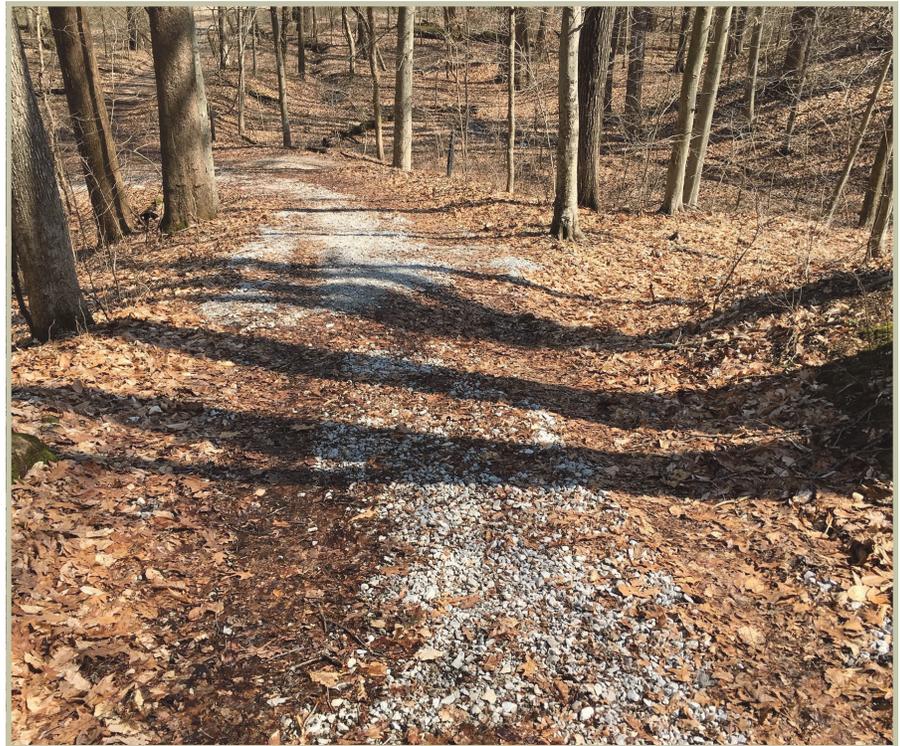
Stable access road with rock and water diversions.

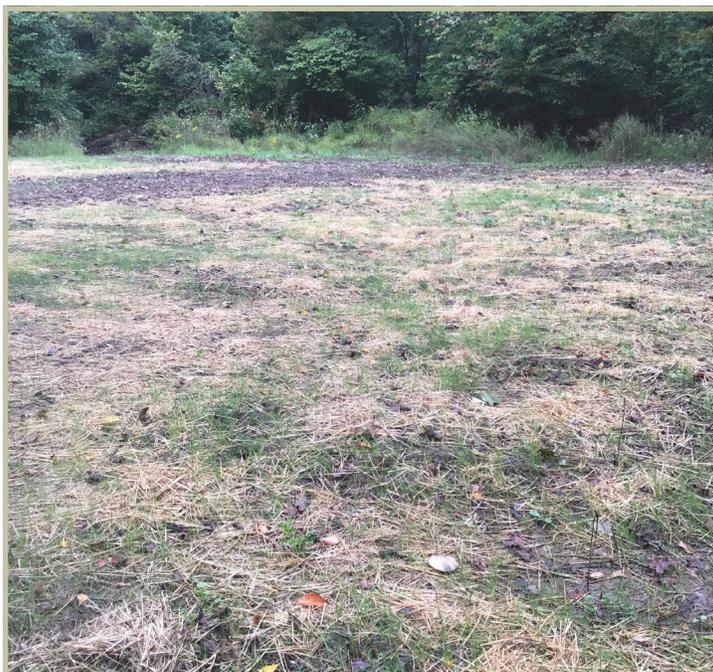
A well-closed-out log landing, smoothed, strawed, and seeded. *Photo by Duane McCoy.*

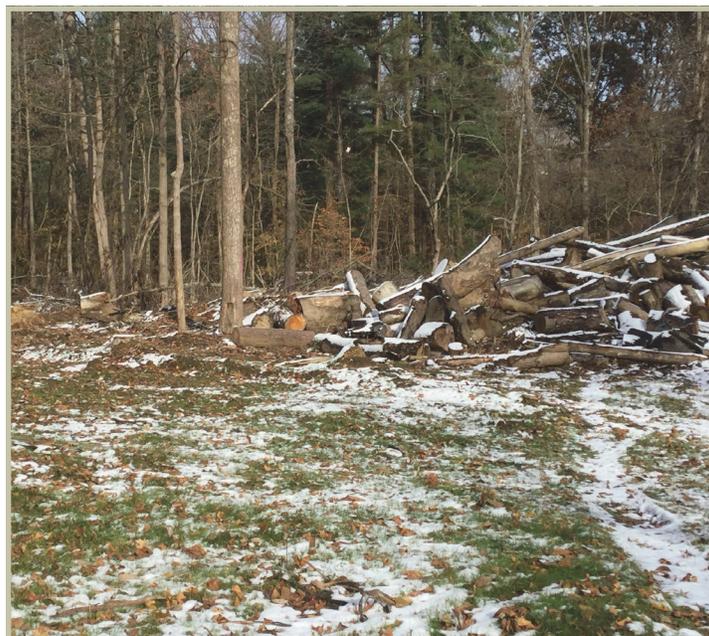
Log landing was properly closed out, smoothed, and seeded in the fall. The resulting grass has protected the landing during the winter. *Photo by Duane McCoy.*

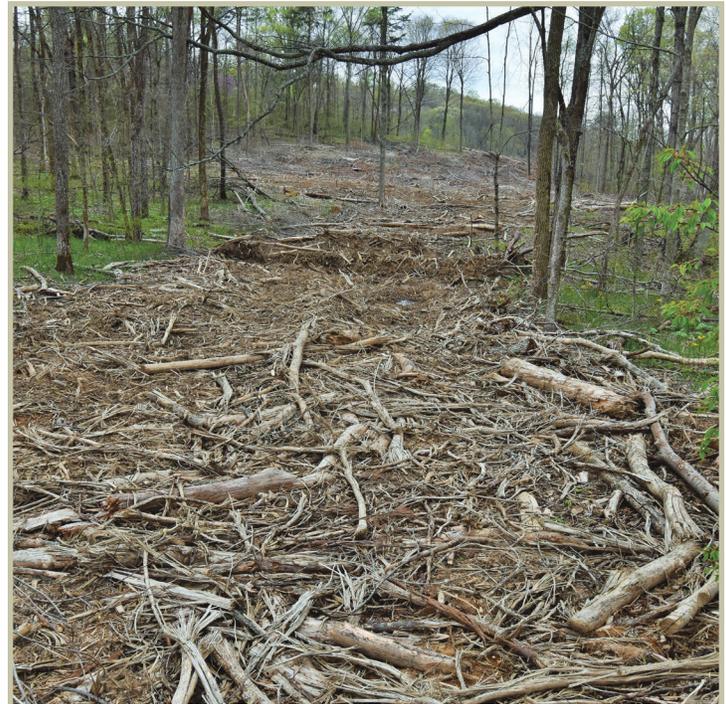
Harvest debris can be a great way to armor a trail and create water diversions. *Photo by Evan McDevitt.*

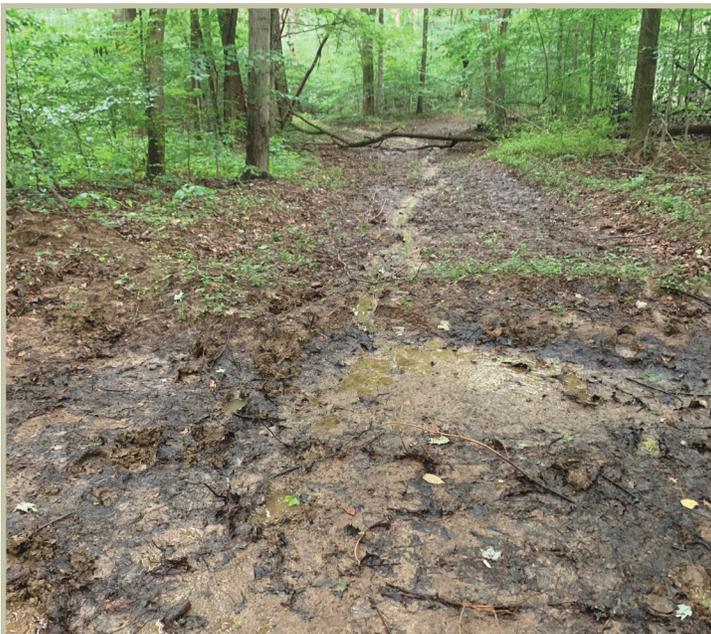
This waterbar at the top of a hill was poorly constructed, leading to a breach of the waterbar, which allowed water to run down the trail, causing erosion.

The main area of concern on CLFW skid trails was the installation of appropriate drainage and diversions (S7). The application rate of this BMP for CLFWs was 44.3%, but this is a 16.1% increase from 28.2% in the 2011 report.

The effectiveness rate for appropriate drainage and diversions installed was 62.3%. These numbers indicate that implementation departures in this area may be having some impact on water quality on CLFW harvest sites. Trends are showing improvement in application of drainage and diversion installation. Other skid-trail BMPs in CLFWs that need further attention are: S2, S8 and S9. These have application rates of 70.9%, 73.9% and 70.1%, respectively. Effectiveness rates for S2 are 86.5%, 81.5% for S8, and 76% for S9. These departures in application seem to have minimal total effect on water resources of the sites, with overall effectiveness at 86.3%.

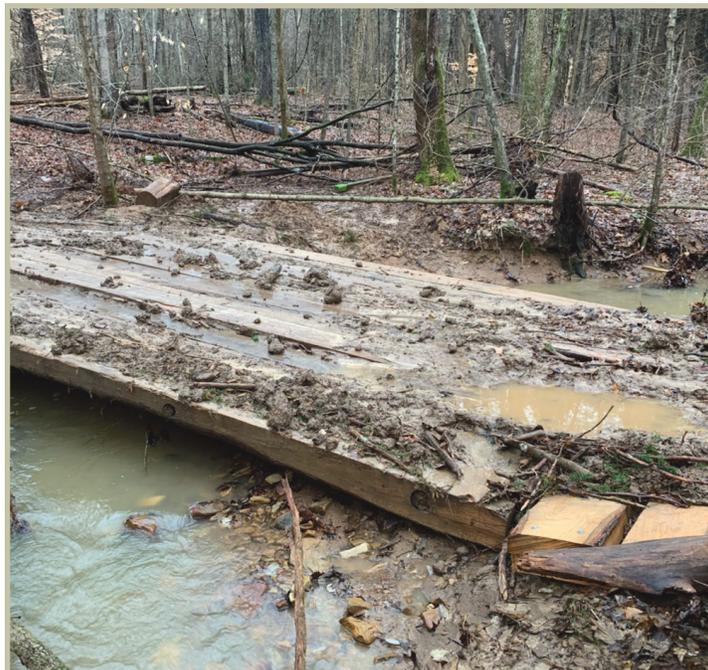
Using this bridge to cross a small intermittent stream protects the stream banks and reduces the amount of soil entering the water.

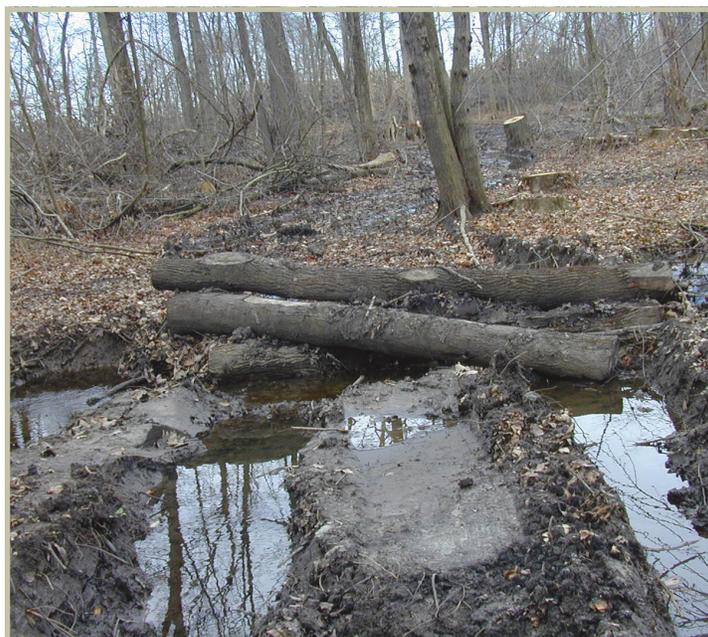
Corduroy logs not removed from a stream after harvest.

crossing structures and resulting obstructions, and reported application and effectiveness rates were 60.6% each. Many of these cases result when log corduroy bridges and/or fill used for stream crossings are not pulled out after harvest is closed. X13 can have an impact on X2 as well.

The difference in removal of temporary structures from a stream crossing after a harvest (generally corduroy logs) is 19% lower for Classified Forest harvests than state forest sites. Importance of removal of these obstructions to stream flow needs to continue to be emphasized to landowners and loggers.
