## **Section IV. Benchmark Water Quality Assessment**

### **4.01 Land & Stream Inventory**

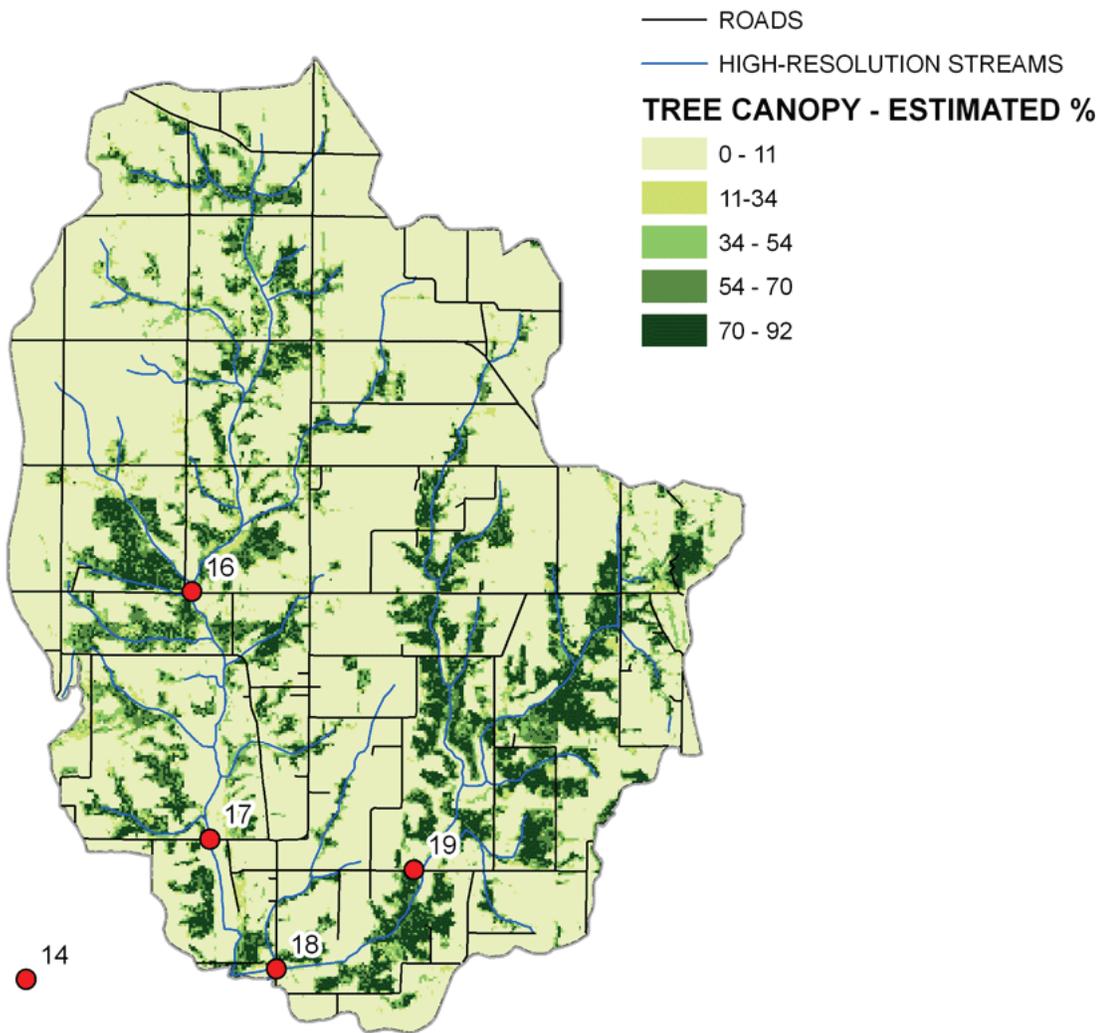
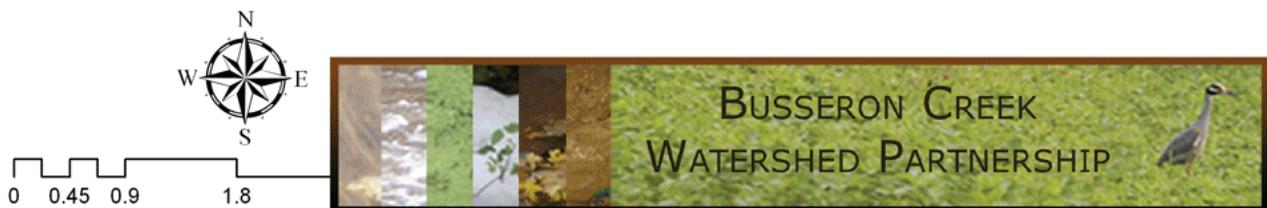
Figure IV-1 – Chowning Creek Tree Canopy and Habitat Evaluation

AVERAGE HABITAT ASSESSMENTS (HOOSIER RIVERWATCH)  
- CQHEI 42.2

- Biological Monitoring
  - PTI Rating 18.2 (Good)
  - Diversity Index 11.8 (Poor)

In addition, analysis of geo-referenced tree cover data provided a strong benchmark for relative stream health. The geo-referenced tree cover data was clipped to represent riparian corridors along high-resolution streams and analyzed for percentage of tree canopy. Tree canopy data was ground-truthed via windshield surveys conducted during June and July 2009. Tree cover at stream / public road crossings was compared to tree-cover maps. Except for variations found in areas of active coal extraction (West Fork Busseron), commodity crop production (Middle Fork Creek, West Fork Busseron, Sulfur Creek – Busseron Creek, Buttermilk Creek) and landowner-directed clearing in apparent anticipation of coal extraction activities (Middle Fork Creek), the GIS-based analysis was accurate.

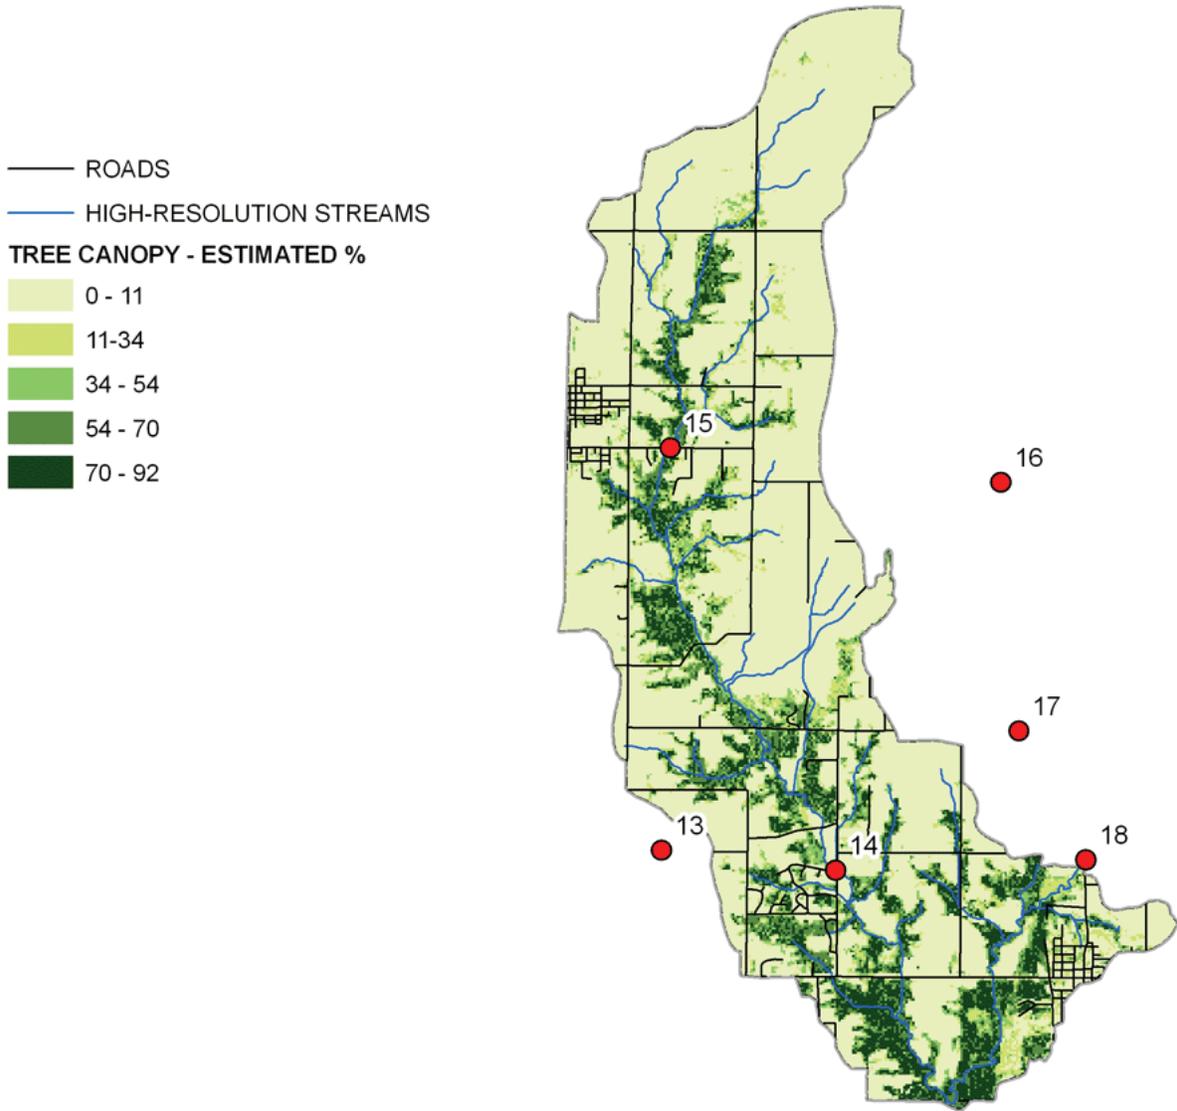
Figure IV-2 – West Fork Busseron Tree Canopy and Habitat Evaluation

AVERAGE HABITAT ASSESSMENTS (HOOSIER RIVERWATCH)  
- CQHEI 59.7

- Biological Monitoring
  - PTI Rating 18.0 (Good)
  - Diversity Index 12.5 (Poor)

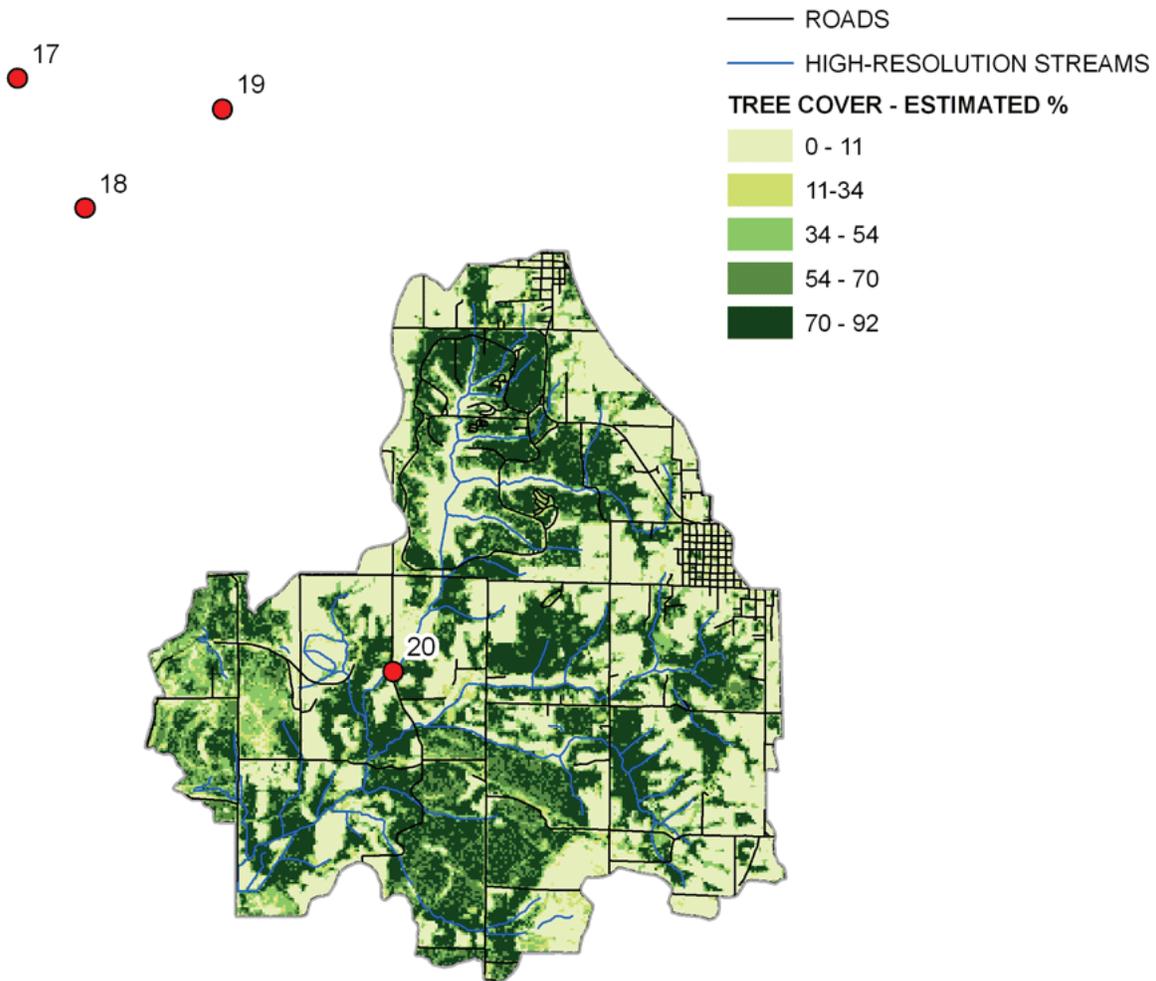
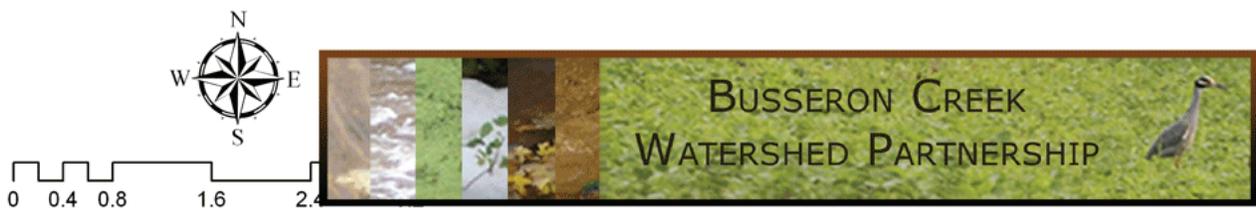
Figure IV-3 – Headwaters Big Branch Tree Canopy and Habitat Evaluation

AVERAGE HABITAT ASSESSMENTS (HOOSIER RIVERWATCH)  
- CQHEI 75.5

- Biological Monitoring
  - PTI Rating 34 (Excellent)
  - Diversity Index 18.3 (Poor)

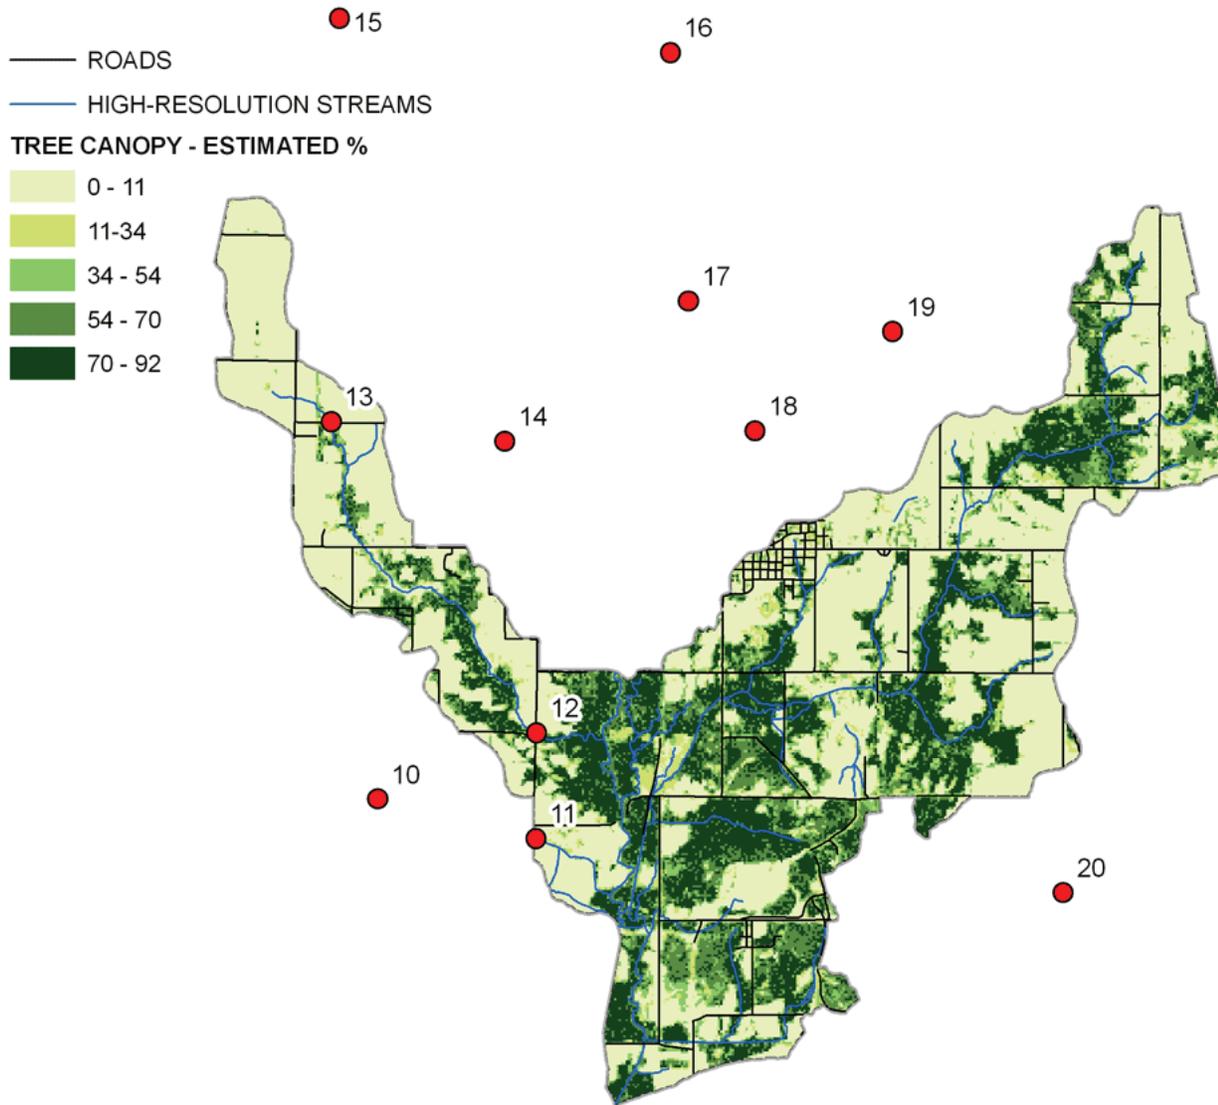
Figure IV-5 – Sulfur Creek Tree Canopy and Habitat Evaluation

AVERAGE HABITAT ASSESSMENTS (HOOSIER RIVERWATCH)  
- CQHEI 56.3

- Biological Monitoring
  - PTI Rating 15.5 (Fair)
  - Diversity Index 6.6 (Poor)

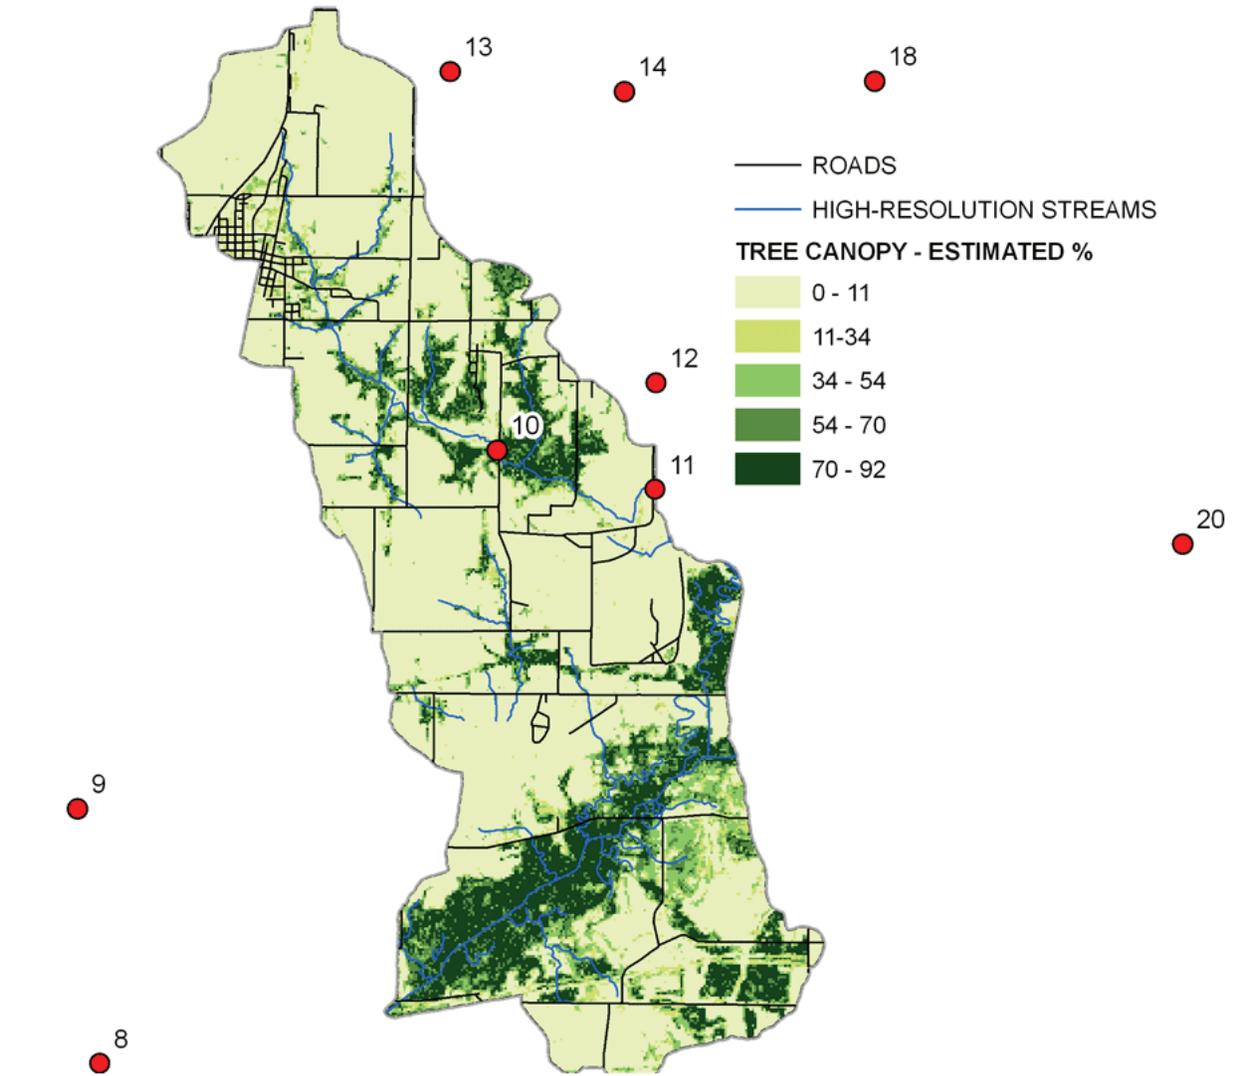
Figure IV-6 – Kettle Creek Tree Canopy and Habitat Evaluation

AVERAGE HABITAT ASSESSMENTS (HOOSIER RIVERWATCH)  
- CQHEI 70.8

- Biological Monitoring
  - PTI Rating 9.5 (Poor)
  - Diversity Index 11.5 (Poor)

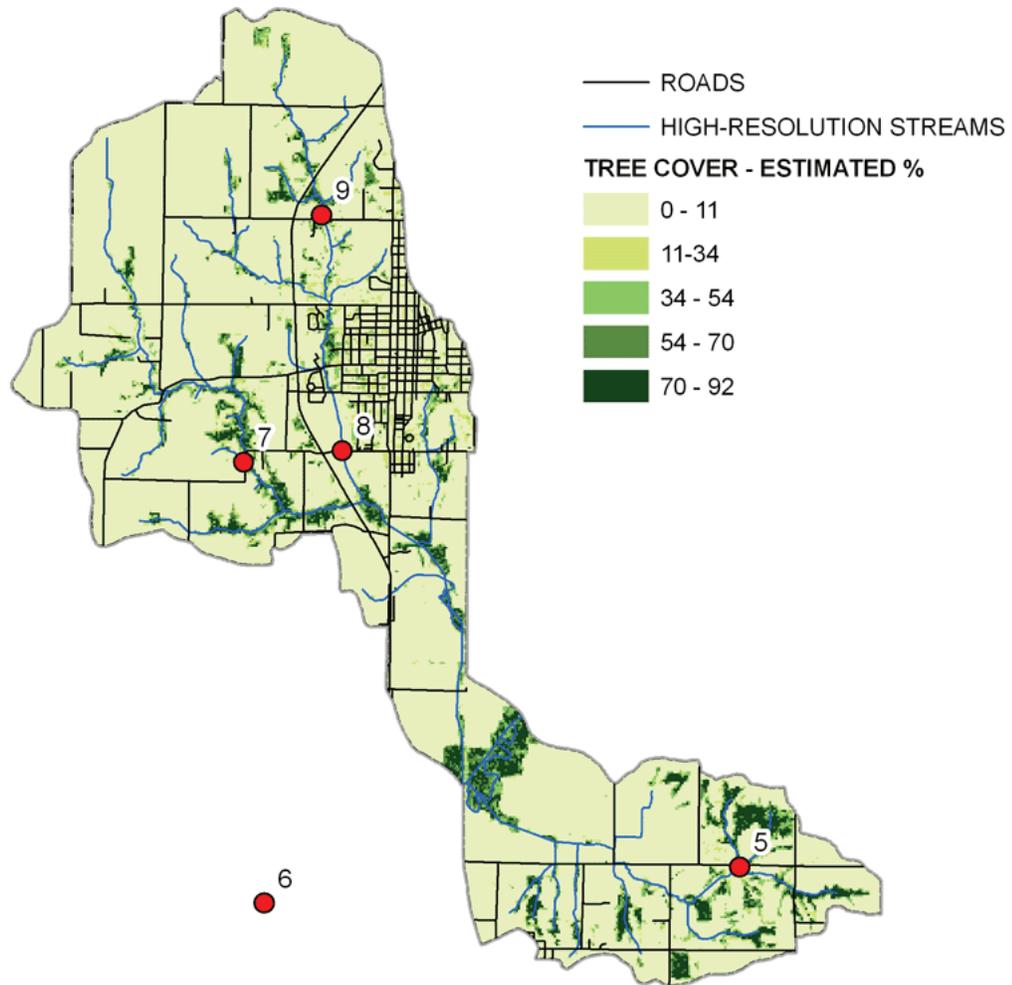
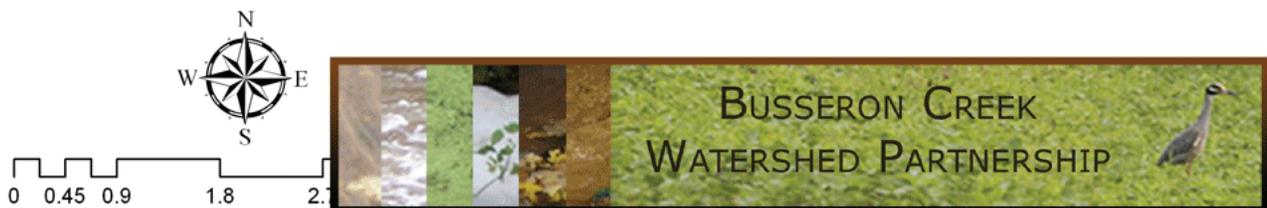
Figure IV-9 – Buck Creek Tree Canopy and Habitat Evaluation

AVERAGE HABITAT ASSESSMENTS (HOOSIER RIVERWATCH)  
- CQHEI 43.6

- Biological Monitoring
  - PTI Rating 8.3 (Poor)
  - Diversity Index 17.1 (Poor)

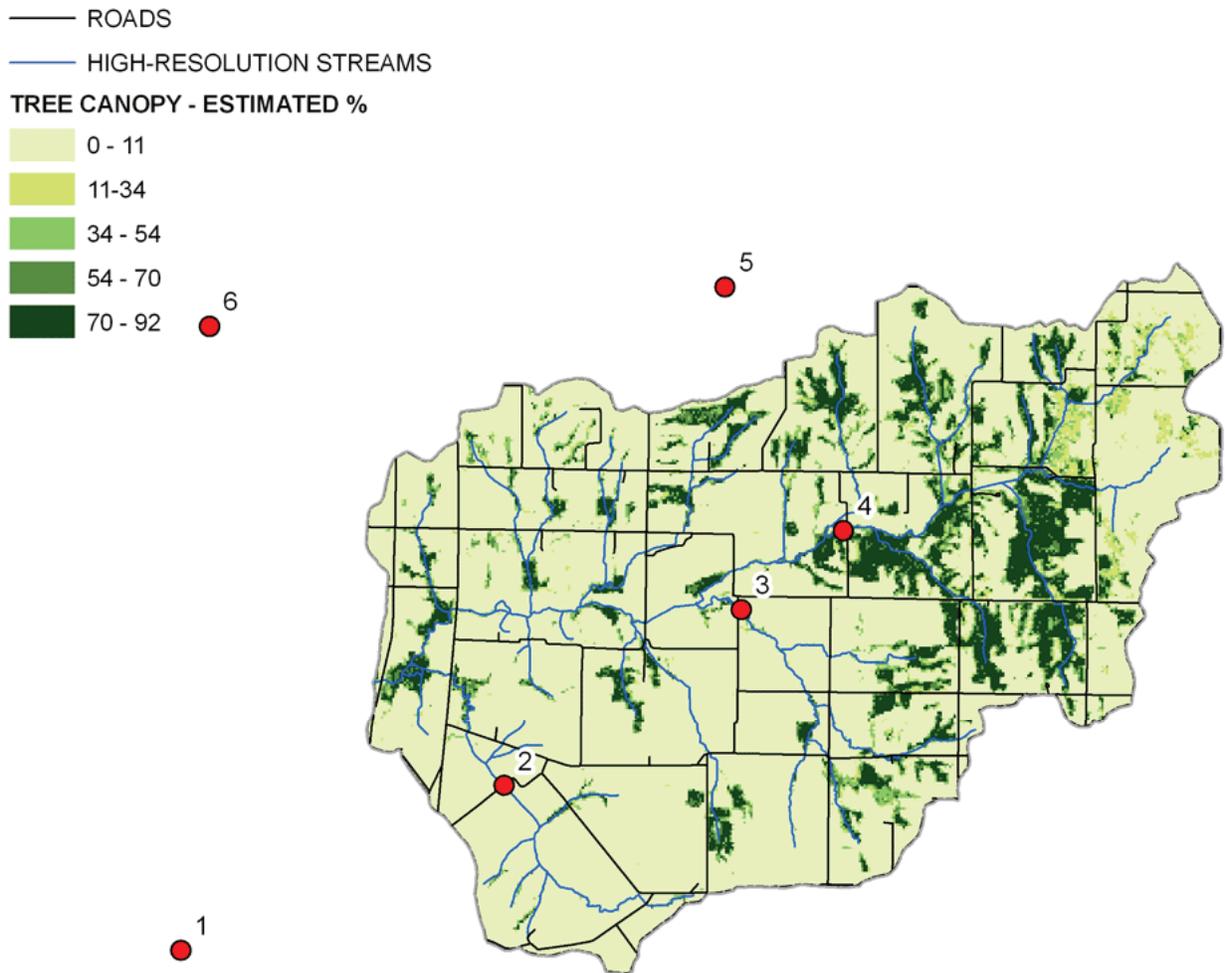
Figure IV-10 – Middle Fork Creek Tree Canopy and Habitat Evaluation

AVERAGE HABITAT ASSESSMENTS (HOOSIER RIVERWATCH)  
- CQHEI 49.0

- Biological Monitoring
  - PTI Rating 18.7 (Good)
  - Diversity Index 16.2 (Poor)

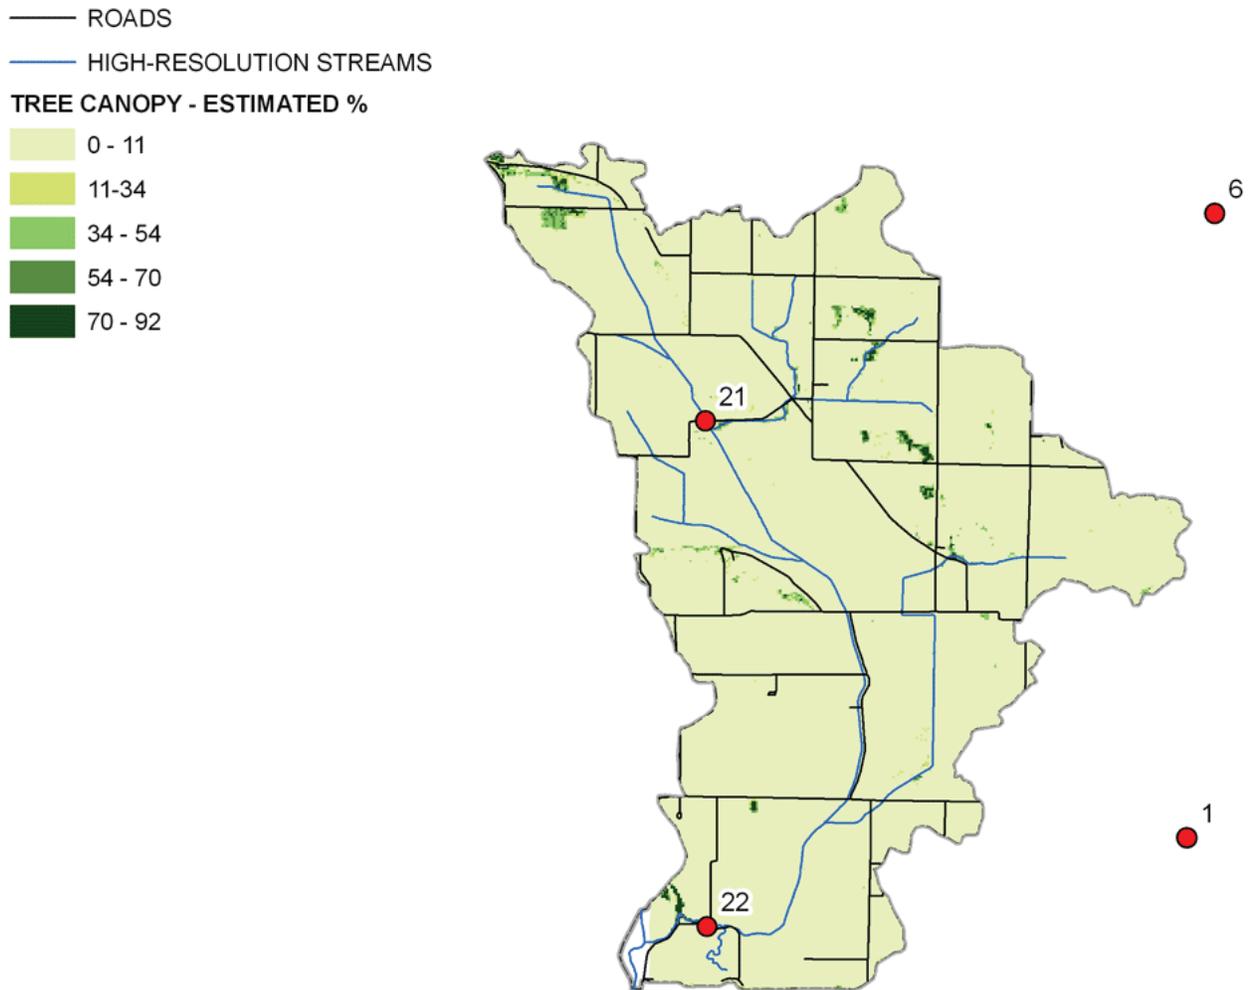
Figure IV-11 – Rogers Ditch Tree Canopy and Habitat Evaluation

AVERAGE HABITAT ASSESSMENTS (HOOSIER RIVERWATCH)  
- CQHEI 23.8

- No Biological Monitoring (Safety)

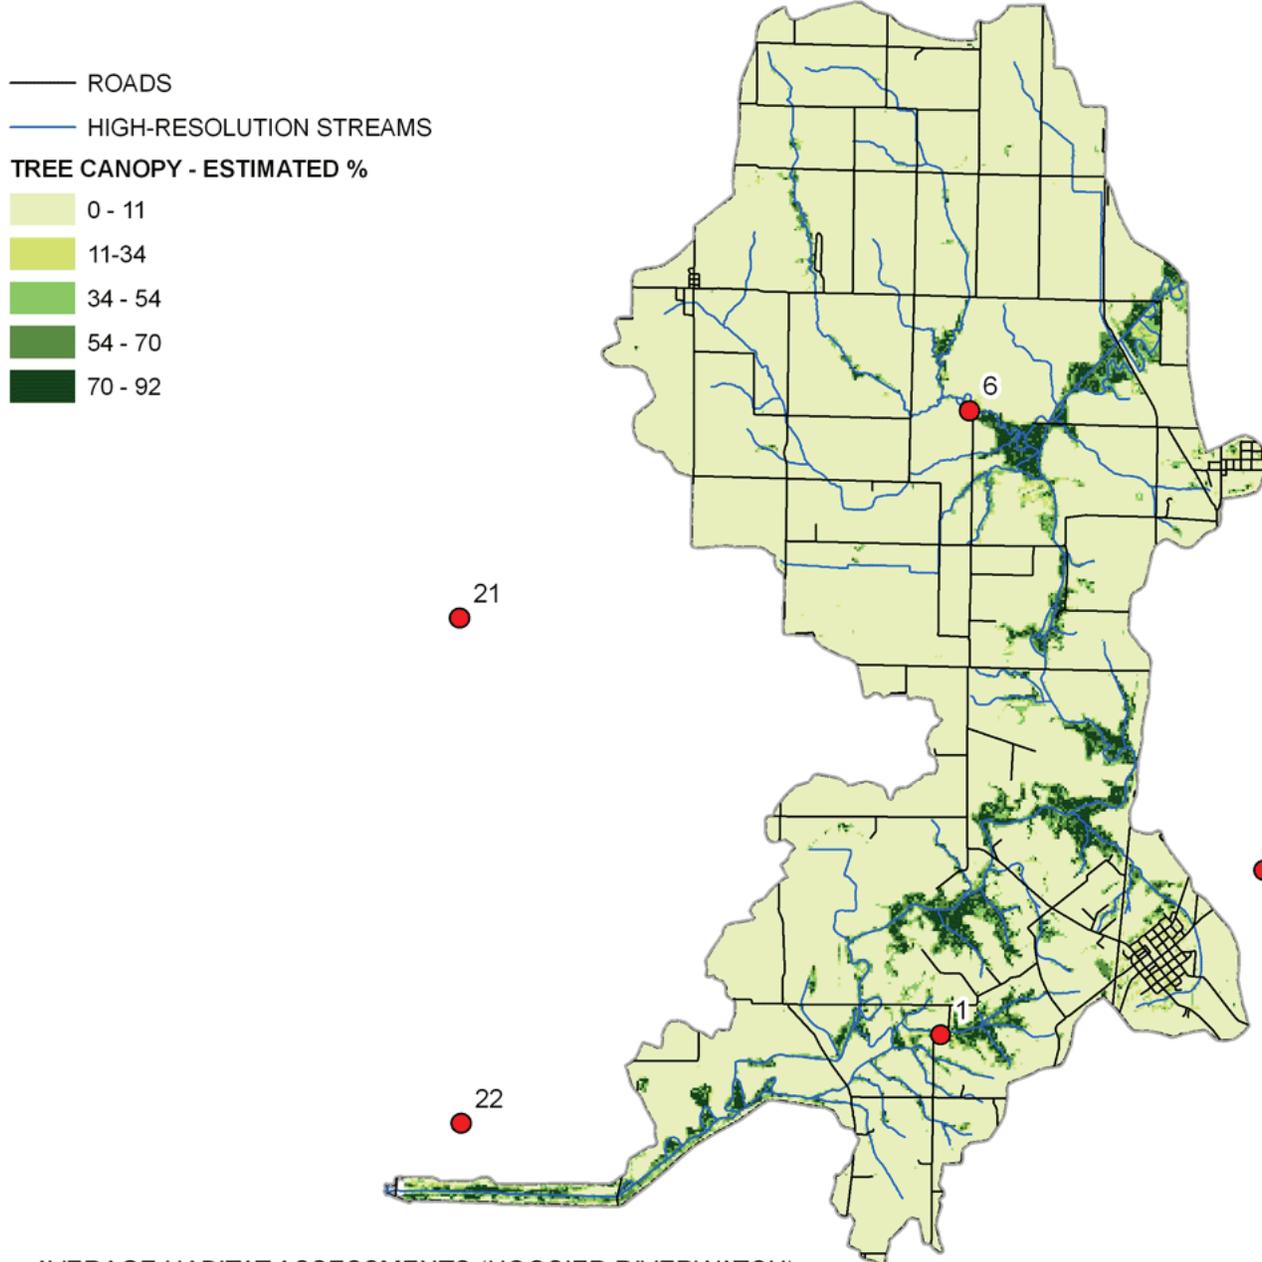
Figure IV-12 – Tanyard Branch Tree Canopy and Habitat Evaluation

AVERAGE HABITAT ASSESSMENTS (HOOSIER RIVERWATCH)  
- CQHEI 42.8

No Biological Monitoring (Health / Safety)

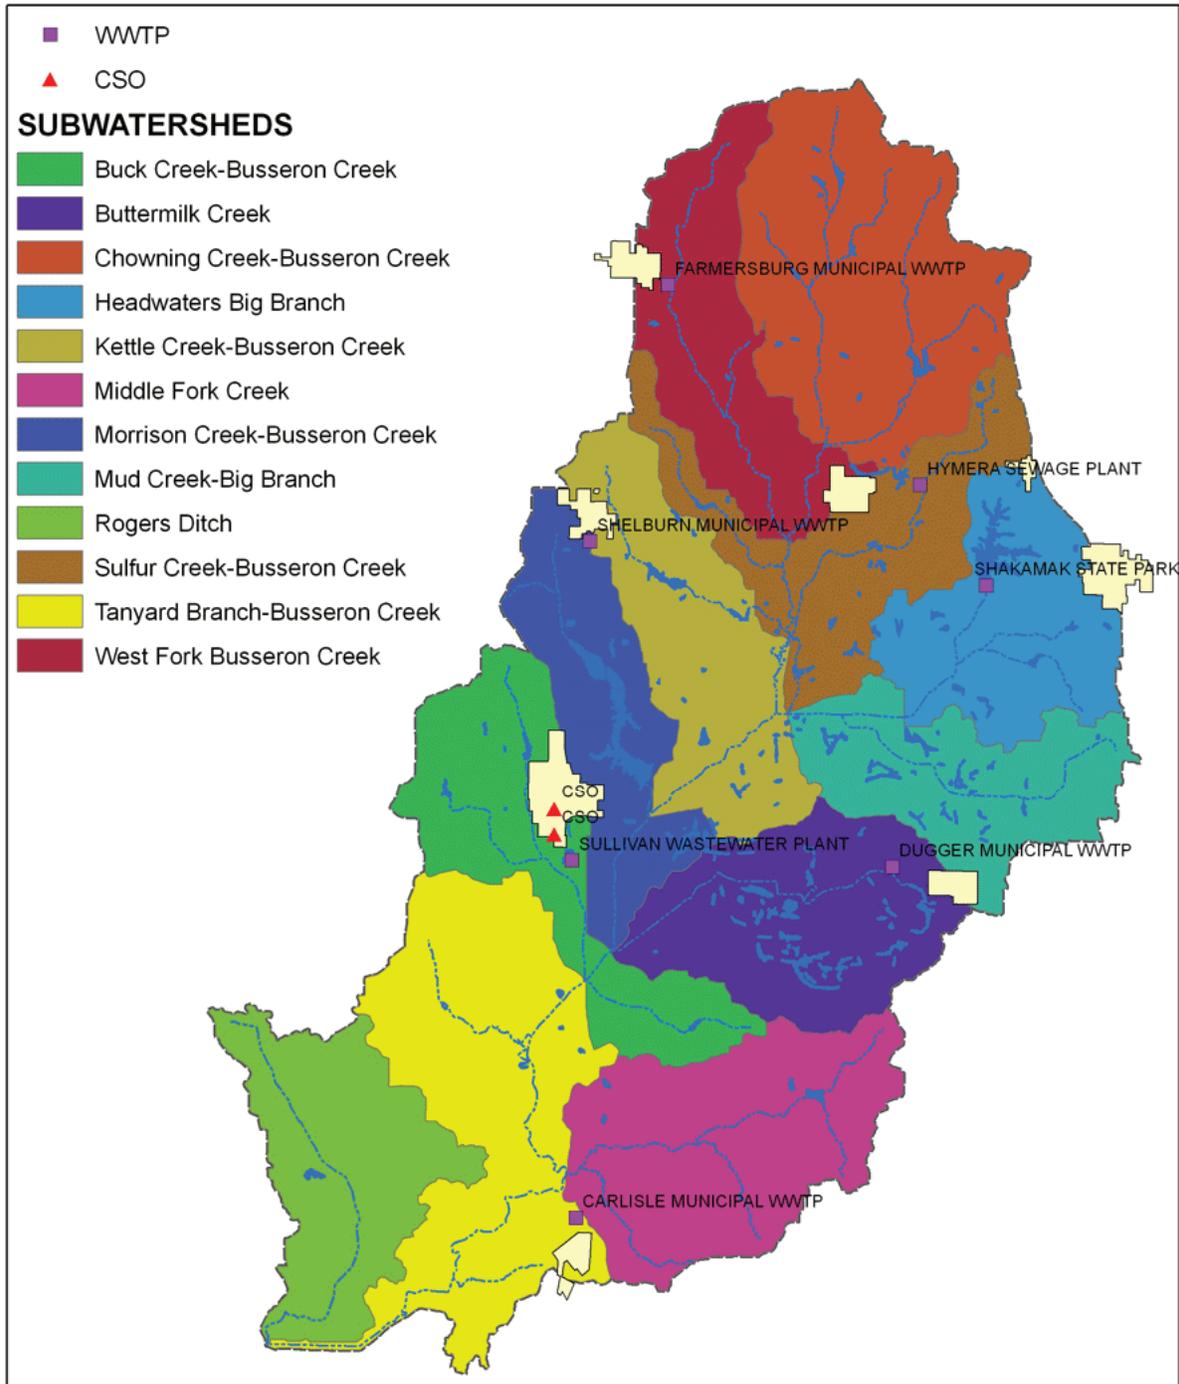
Figure IV-13 – Waste Water Treatment Plant and Combined Sewer Overflow Locations

The bulk of NPDES permit violations have been from municipal wastewater treatment facilities *Table IV-1 NPDES Permit Violations* summarizes industrial, active mining, and wastewater treatment facility violations for a four-year period ending December 2007. Exceedingly large numbers of violations across all WWTPs in the watershed may indicate point source concerns in undiluted areas downstream from these facilities. In addition, the two Combined Sewer Overflow locations in the town of Sullivan most likely exacerbate raw sewage-related conditions in the Buck Creek Subwatershed. See *Figure IV-13 – Waste Water Treatment Plant and Combined Sewer Overflow Locations*. Additional violation information is listed in Appendix D(b)

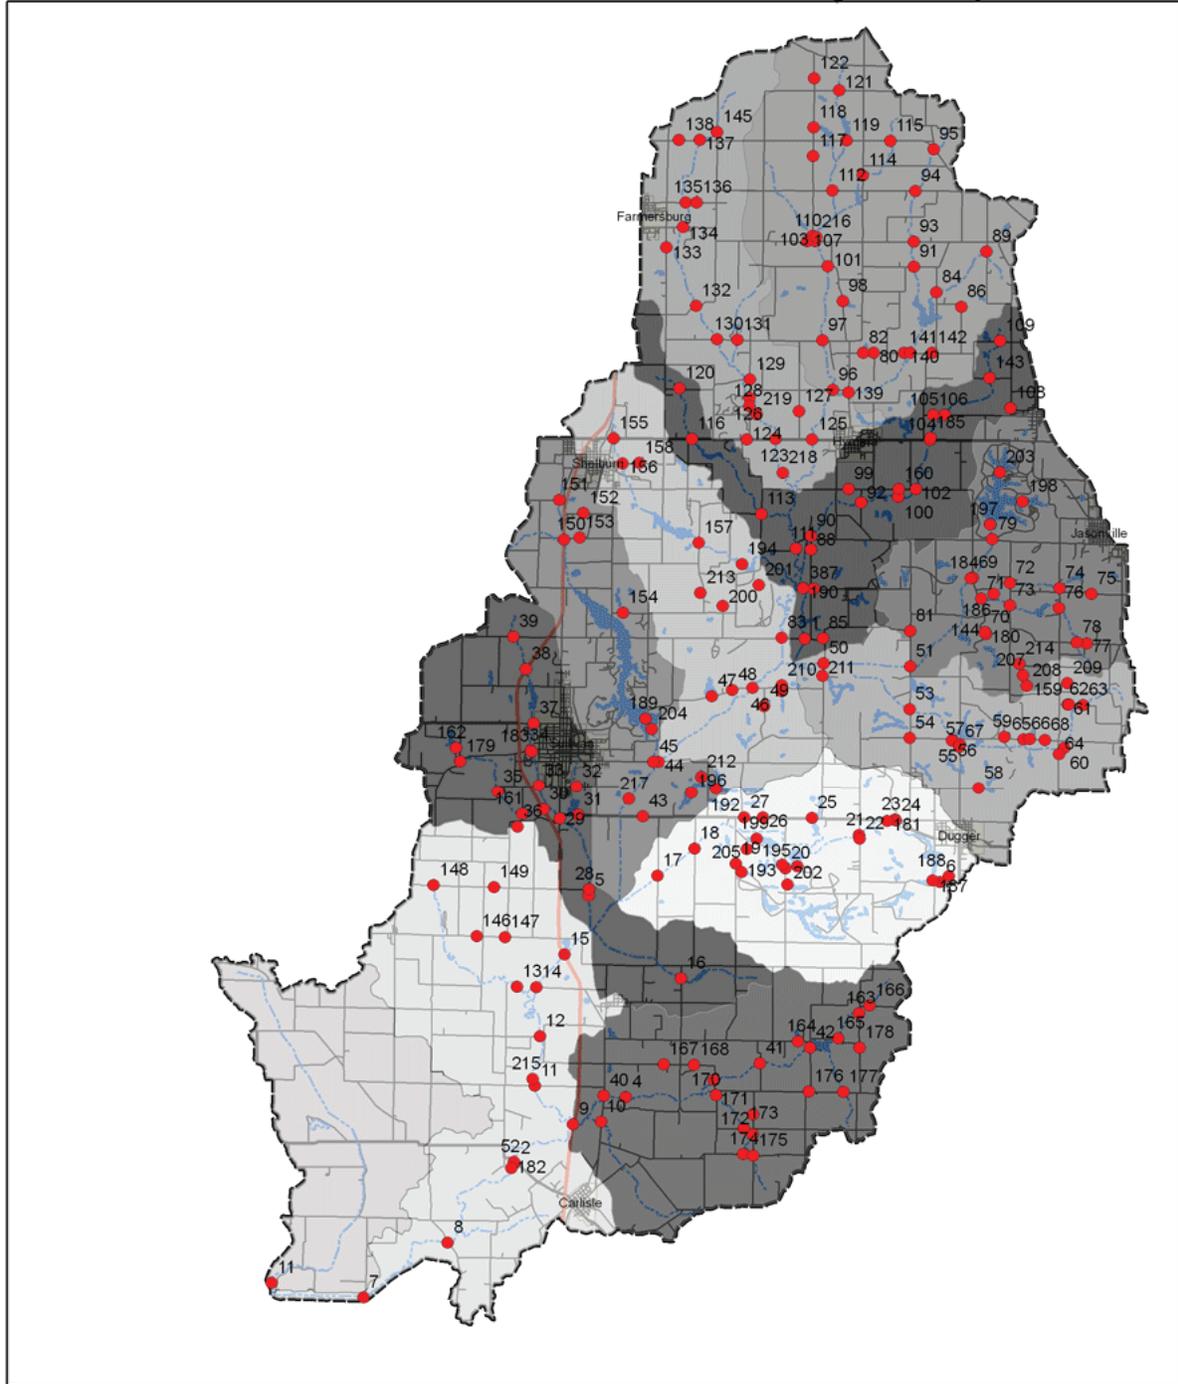
Figure IV-14 – 2000 IDEM Source Identification Study Sample Sites

In order to investigate sulfate, total dissolved solids, and ammonia stream standard violations, 115 sites were sampled over a period of three days in October of 2000 (*Figure IV-14 – 2000 IDEM Source Identification Study Sample Sites*). The focus of this study was to determine the sources and magnitude which these sources were impacting Busseron Creek for sulfate and total dissolved solids, and ammonia in Buck Creek. The three largest contributing tributary systems of total dissolved solids and sulfate were Sulfur Creek (2.6% TDS, 3.4% Sulfate), Big Branch – Mud Creek (19% TDS, 55% Sulfate), and Buttermilk Creek (5.2% TDS, 8.2% Sulfate). These results can be attributed to known acid mine drainage issues in the Sulfur Creek and Big Branch-Mud Creek watershed. Upstream sites in the Buttermilk Creek watershed also appeared to indicate issues associated with acid mine drainage.

No ammonia violations were observed. It should be noted that although pre-survey work observed cattle wading upstream of Buck Creek sampling sites – a possible cause of earlier violations - no mention was made of the 2 CSOs upstream of Buck Creek sampling sites – another possible cause of earlier violations.

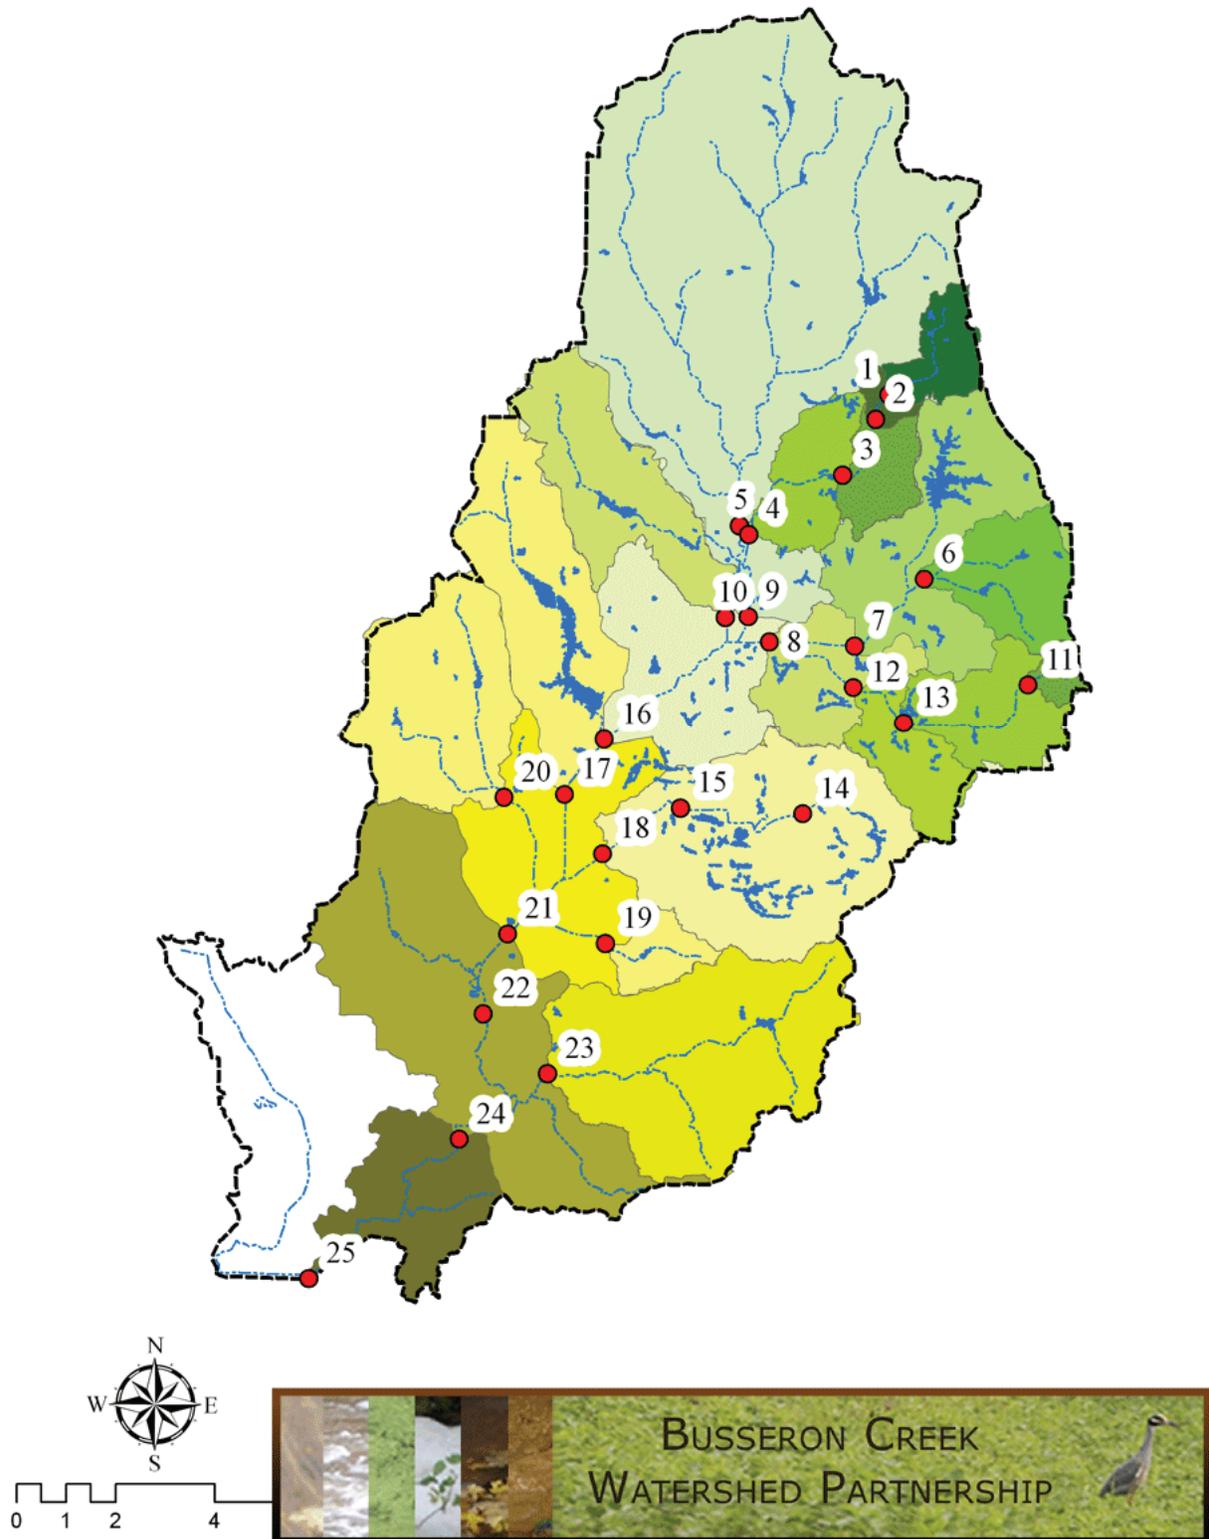
Figure IV-15 – TMDL Sample Sites

In 2006, samples were collected from 25 sites in the Busseron Creek Watershed as part of a Total Maximum Daily Load Development (See *Figure IV-15 – TMDL Sample Sites*). As a result of this study, seven of the twelve BCW subwatersheds contain streams which have been listed on the 303d list and classed as 5A (See *Figure IV-16 – 303(d) Impaired Streams – identical to Figure III-25*). *Table IV-2 303(d) Causes of Impairment* identifies both 2006 and 2008 causes for impairment listings.

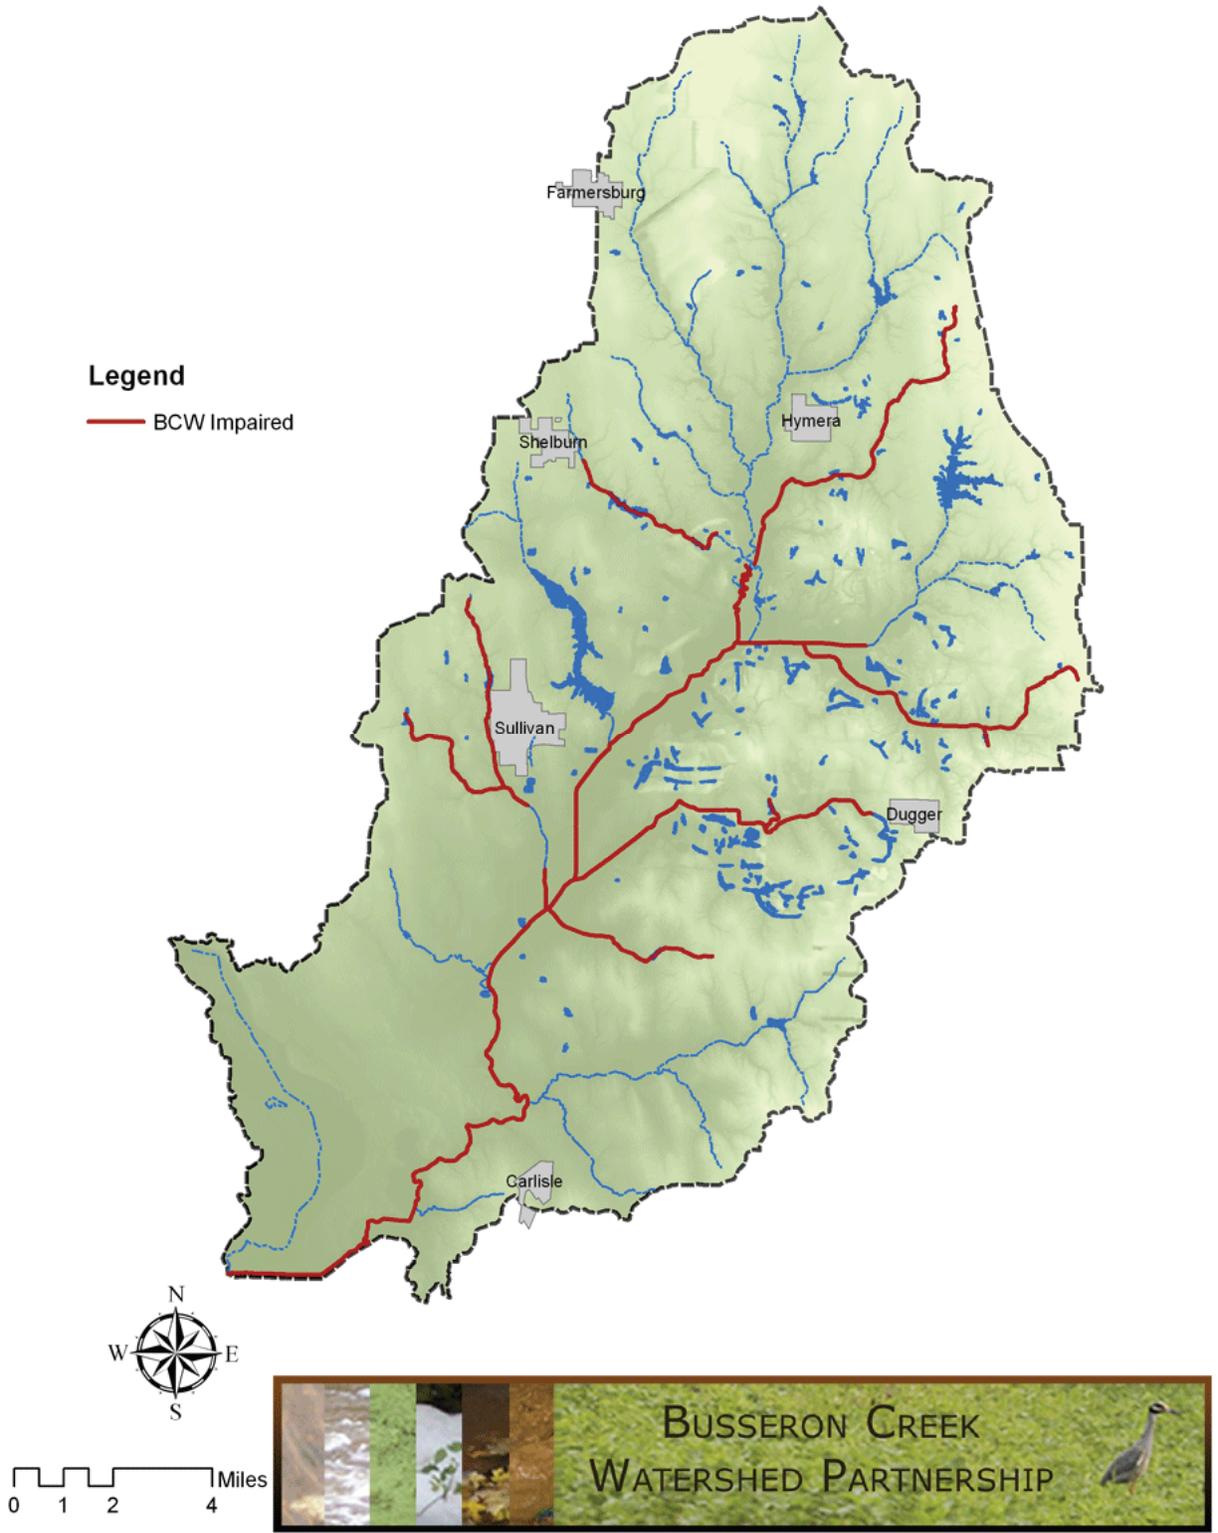
Figure IV-16 – 303(d) Impaired Streams

# 303(d) Impaired Streams

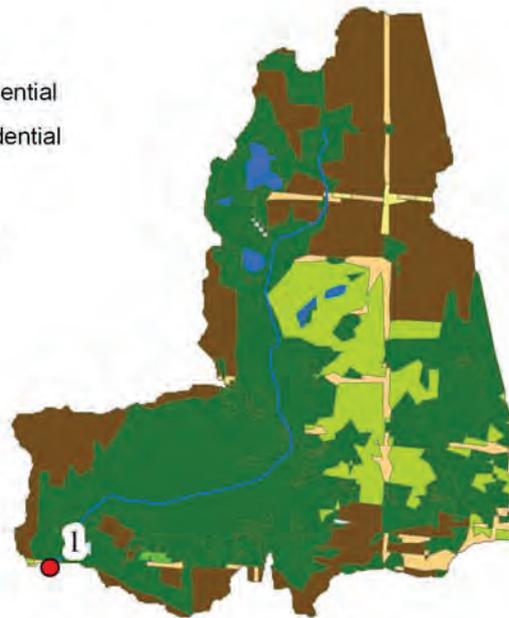
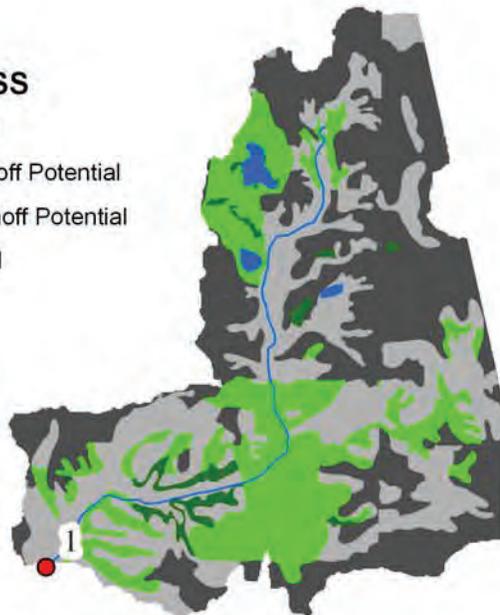
Figure IV-17 – TMDL Sample Site 1 Drainage Basin

For further review, sample point drainage basins were delineated along with land uses and soil drainage classes for each point (*Figure IV-17 – TMDL Sample Site 1 Drainage Basin through Figure IV-41 - TMDL Sample Site 25 Drainage Basin*). As noted in Section 3.01(e), the majority of land uses are either agricultural (58%) or forested (31%), followed by developed property (7%). Although the abandoned mine lands are not classified as a separate land use, locations of samples exceeding standards for metals were generally located downstream from known sites of acid mine drainage. In other areas, exceedance of dissolved oxygen, total phosphorus, and total suspended solids appeared to correlate with land uses.
