# Conns Creek Watershed Management Plan

Prepared for Conns  
Creek Watershed  
June, 2003

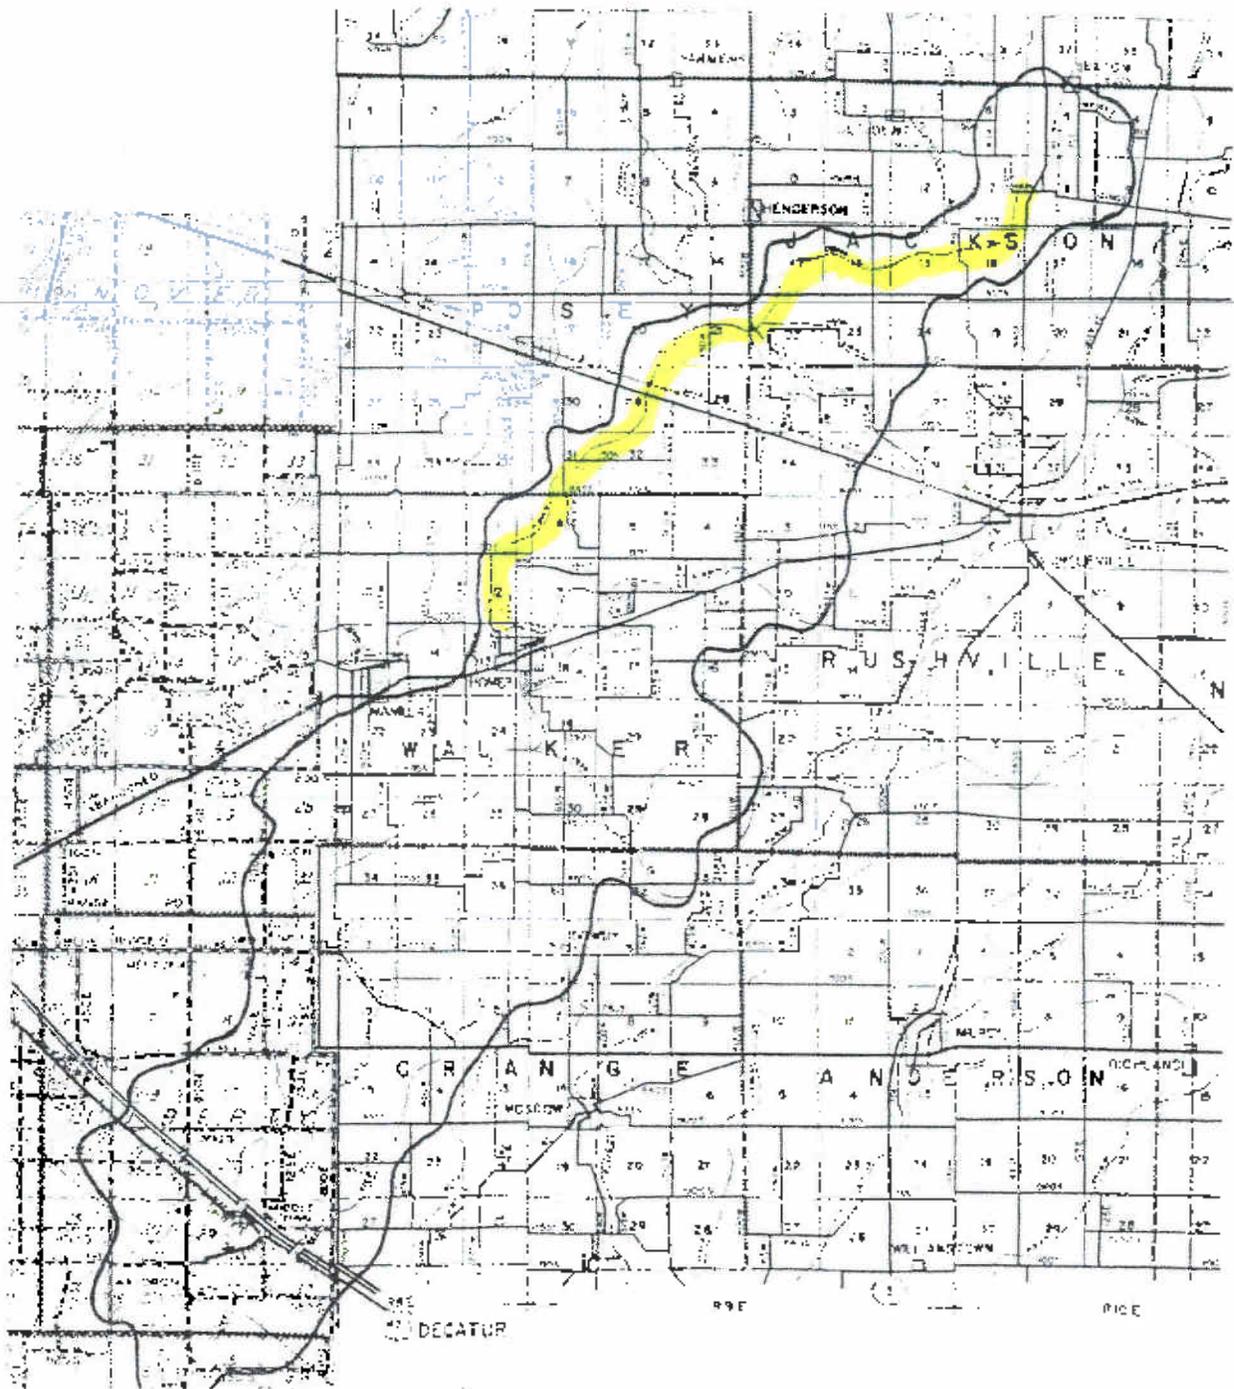
Figure 3. Map showing legal drain designation.

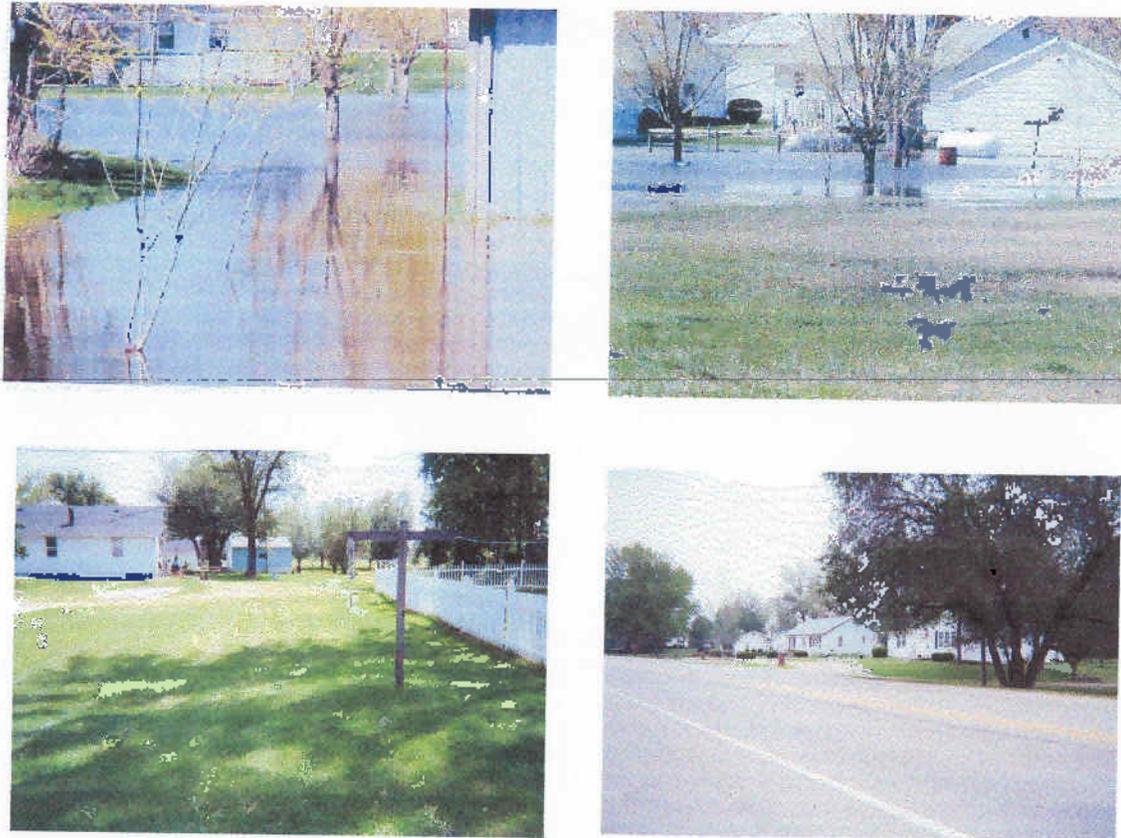
**Figure 4. Before and after pictures of Homer, Indiana, cooperative drain repair project.**

Homer residents accomplished their own mini project during this time frame. During the spring of 2002, the watershed area along with the entire two-county area was inundated with twenty inches of rain. The town of Homer relied on an antiquated tile system to remove storm water and septic system drainage to Mud Creek. Homeowners were specifically invited by letter and general postings to attend a public meeting with the steering committee to discuss their situation. Homer residents knew it was important to drain the flood water to reduce property damage. Working together as private citizens, the homeowners were able to finance and replace damaged/plugged tiles throughout the town and remove standing water for individual property owners. It was discovered that the septic systems were tied into these drainage tiles, allowing the effluent to directly enter Mud Creek. **Figure 4.** illustrates the extent of the standing water problem in Homer and the resulting change in the landscape following the repairs.

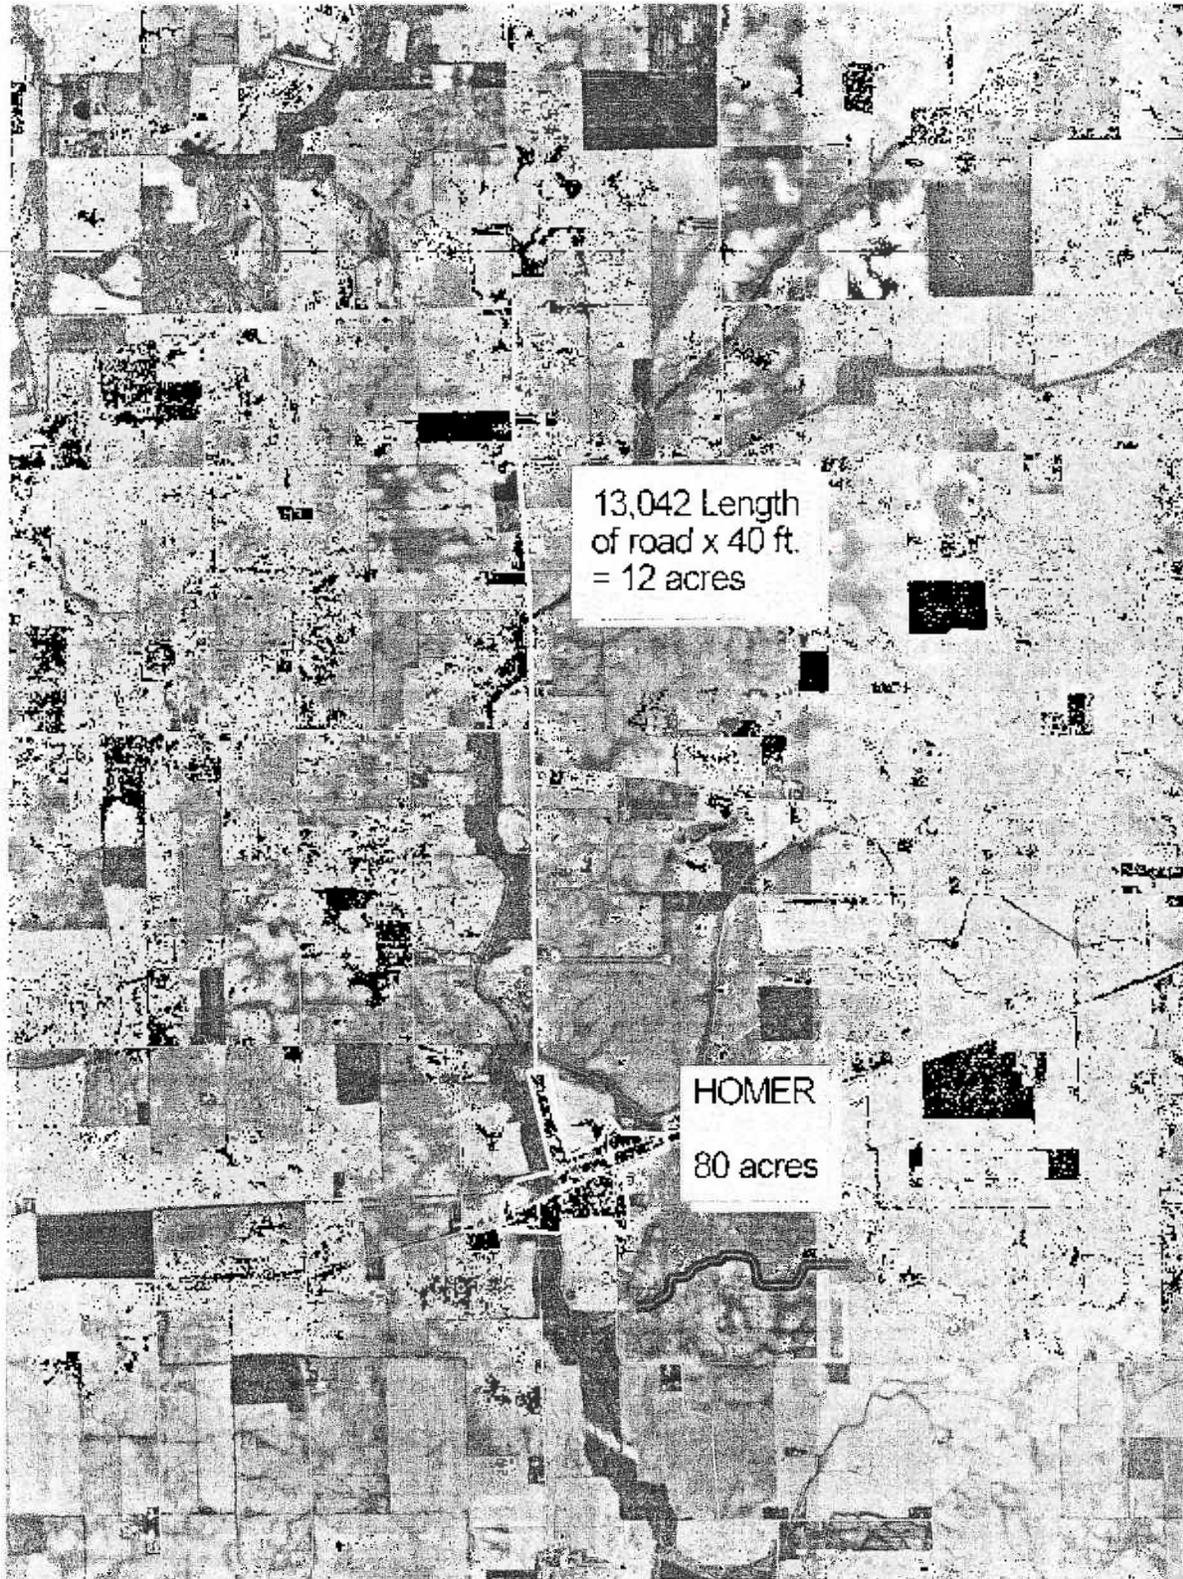
Figure 7. Western Rush County Regional Sewer District Acreage Map

Septic discharge from residential systems is a cause of pollutants to the stream. Successful completion of the Western Rush County Regional Sewer and Water District will rectify the sewage discharge problem for the residents of Homer. Also, proper maintenance of the Waldron Conservancy District sewer system will be necessary to continue the water quality safety for its patrons. However, sewage discharge from private systems outside the regional district or the conservancy district continues to be of concern. As indicated in Figure 7, and Figure 8., of the 54,040.4 acres in the watershed, only 287 acres are in the sewage districts, leaving 53,753.4 acres outside the regional and conservancy districts.

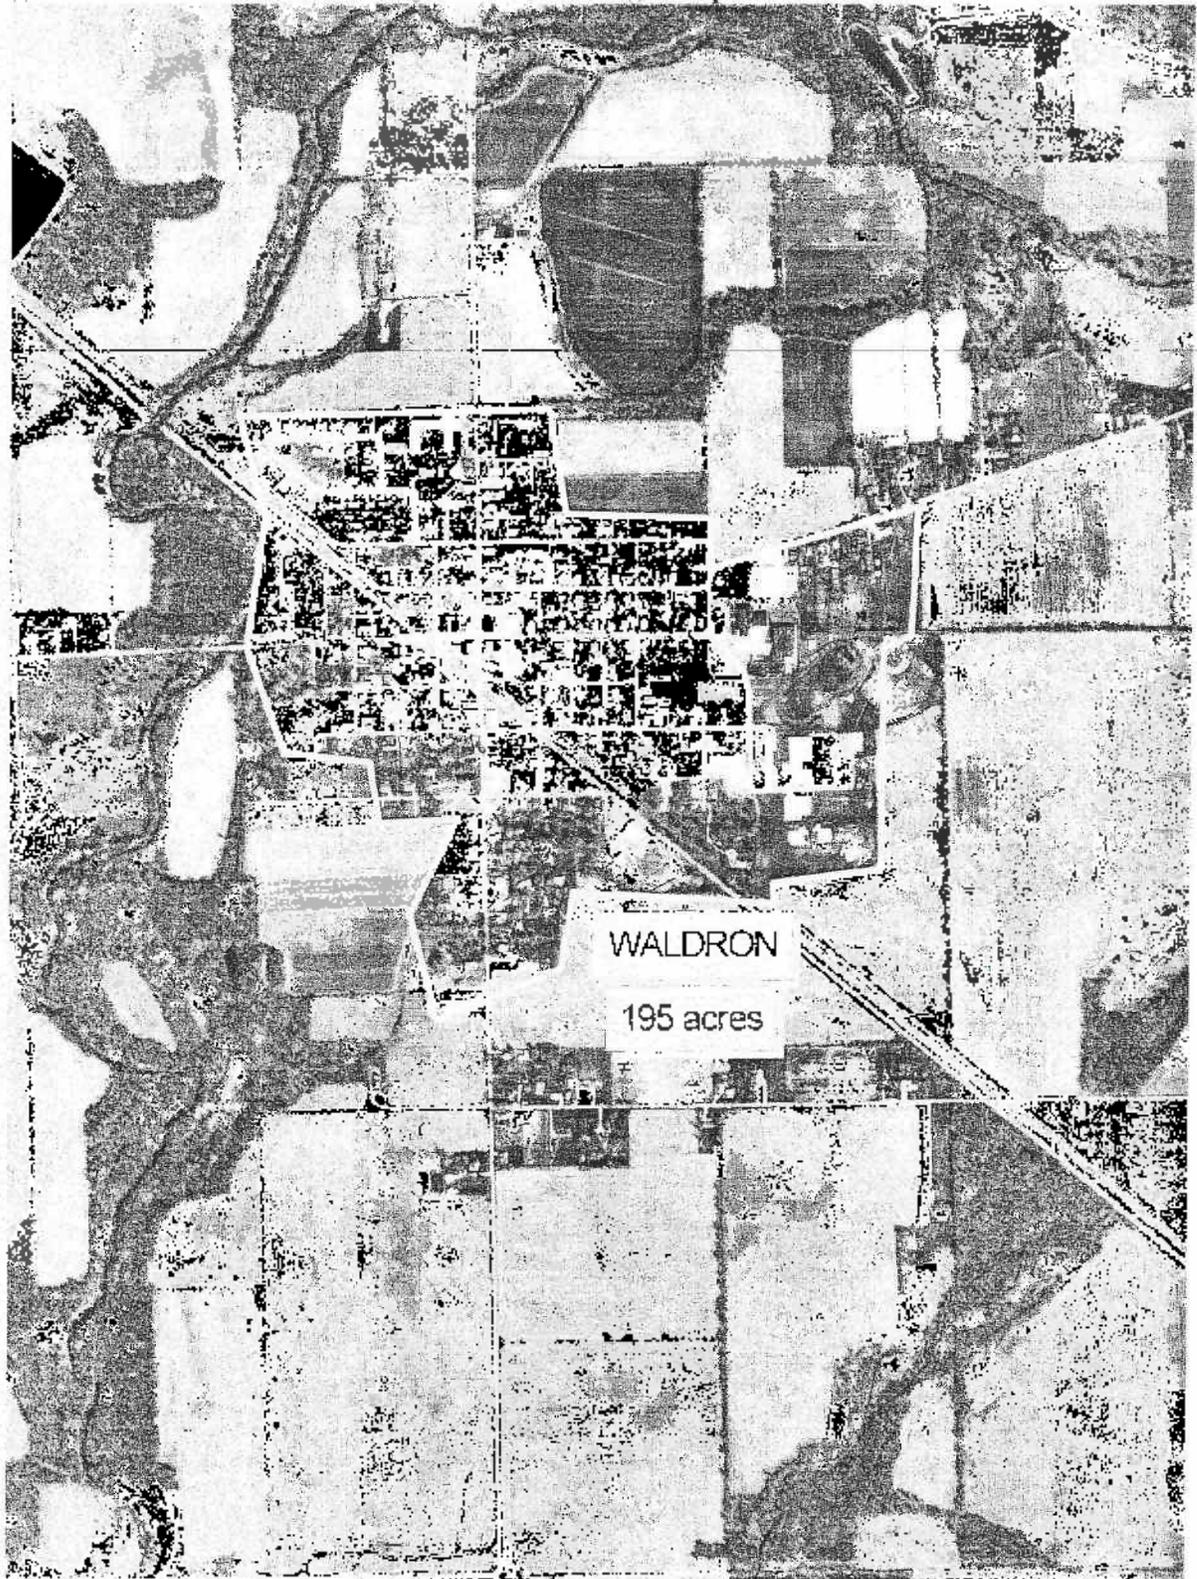
Figure 8. Waldron Conservancy District Acreage Map

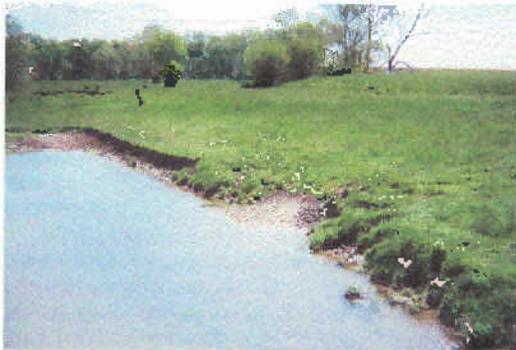
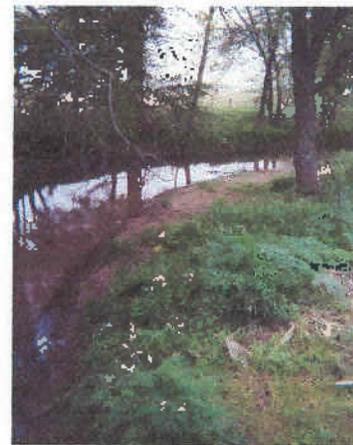
**Figure 9.**

Livestock access for watering along the stream is one of the sources of erosion of stream banks in livestock pasturing areas. As the livestock enter the stream, their access is generally down the slope and directly into the water. These bank sections tend to be less steep in slope, but are subject to repeated erosion by livestock in the adjacent pasture. Fencing to restrict livestock access, along with stabilizing the banks by reseeding, would improve the stream bank stability in a wider area. The pasturing of livestock along the stream is minimal and localized. There is one active location and one inactive location where livestock have access to the stream. However, as evidenced in **Figure 9.**, the evidence of bank erosion is especially prevalent in these areas.

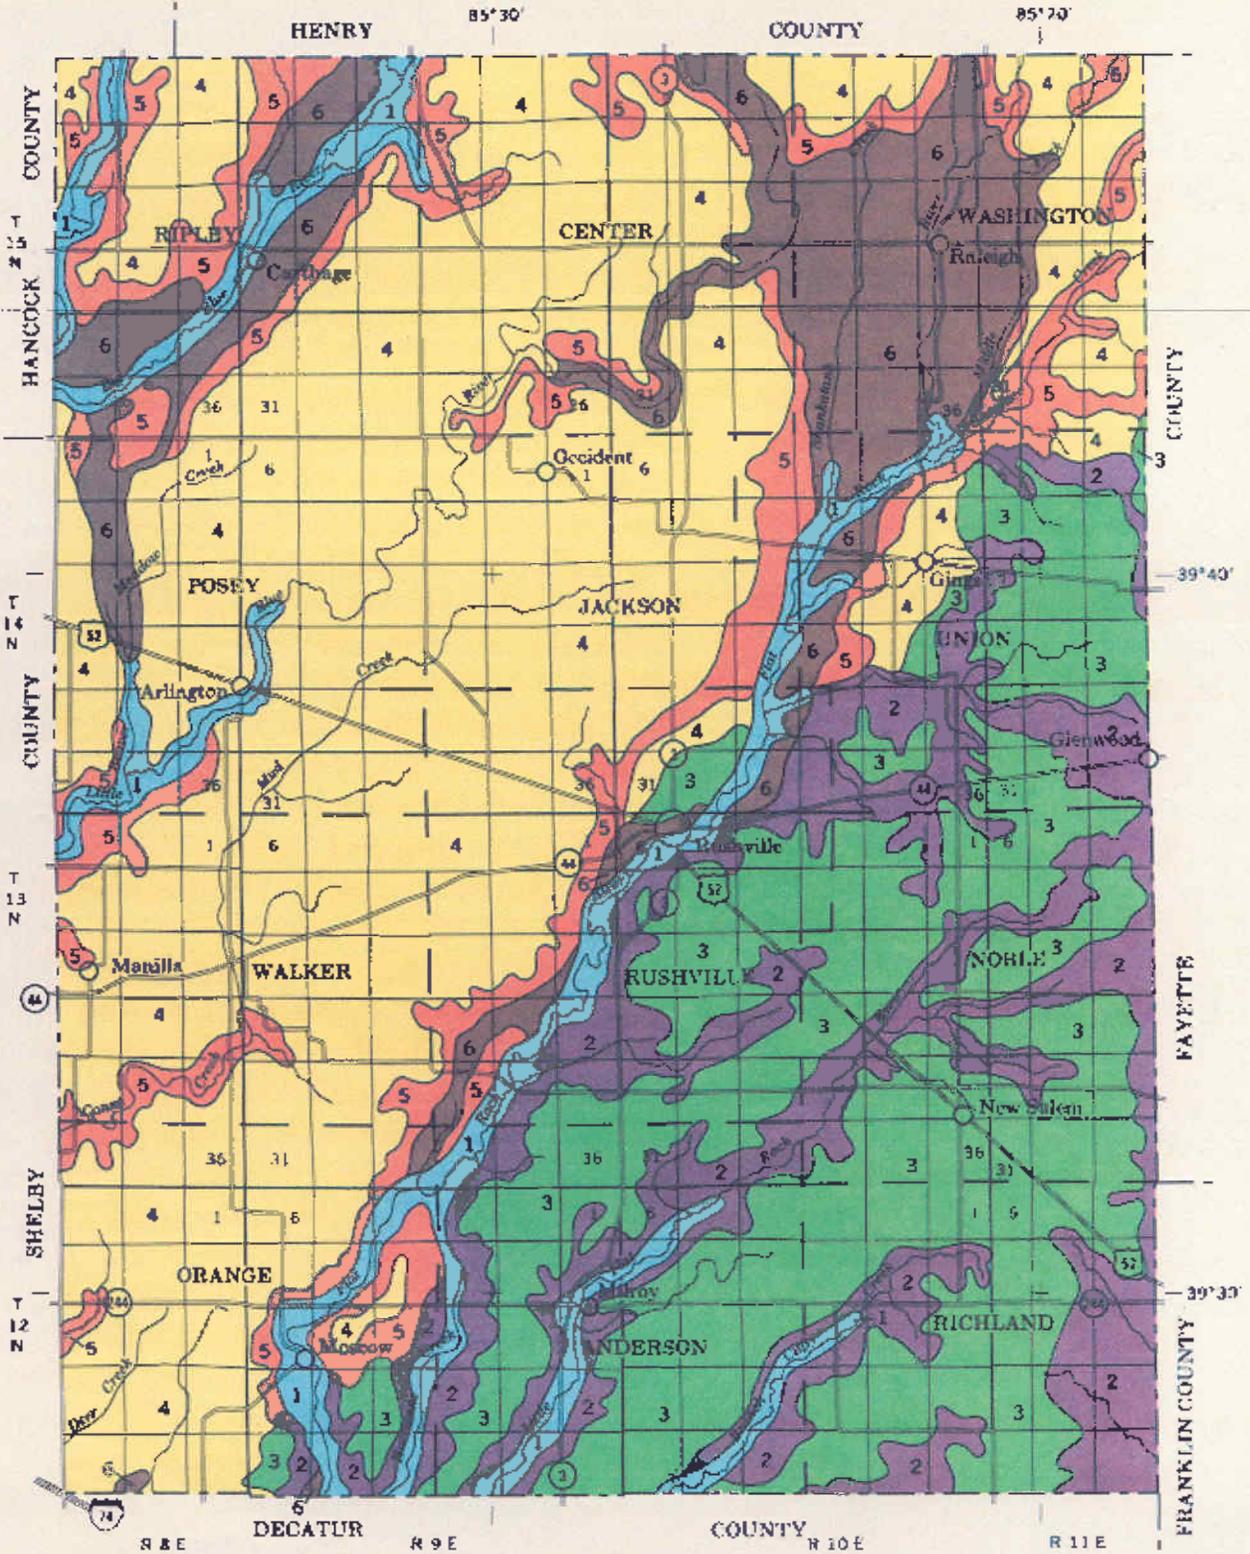
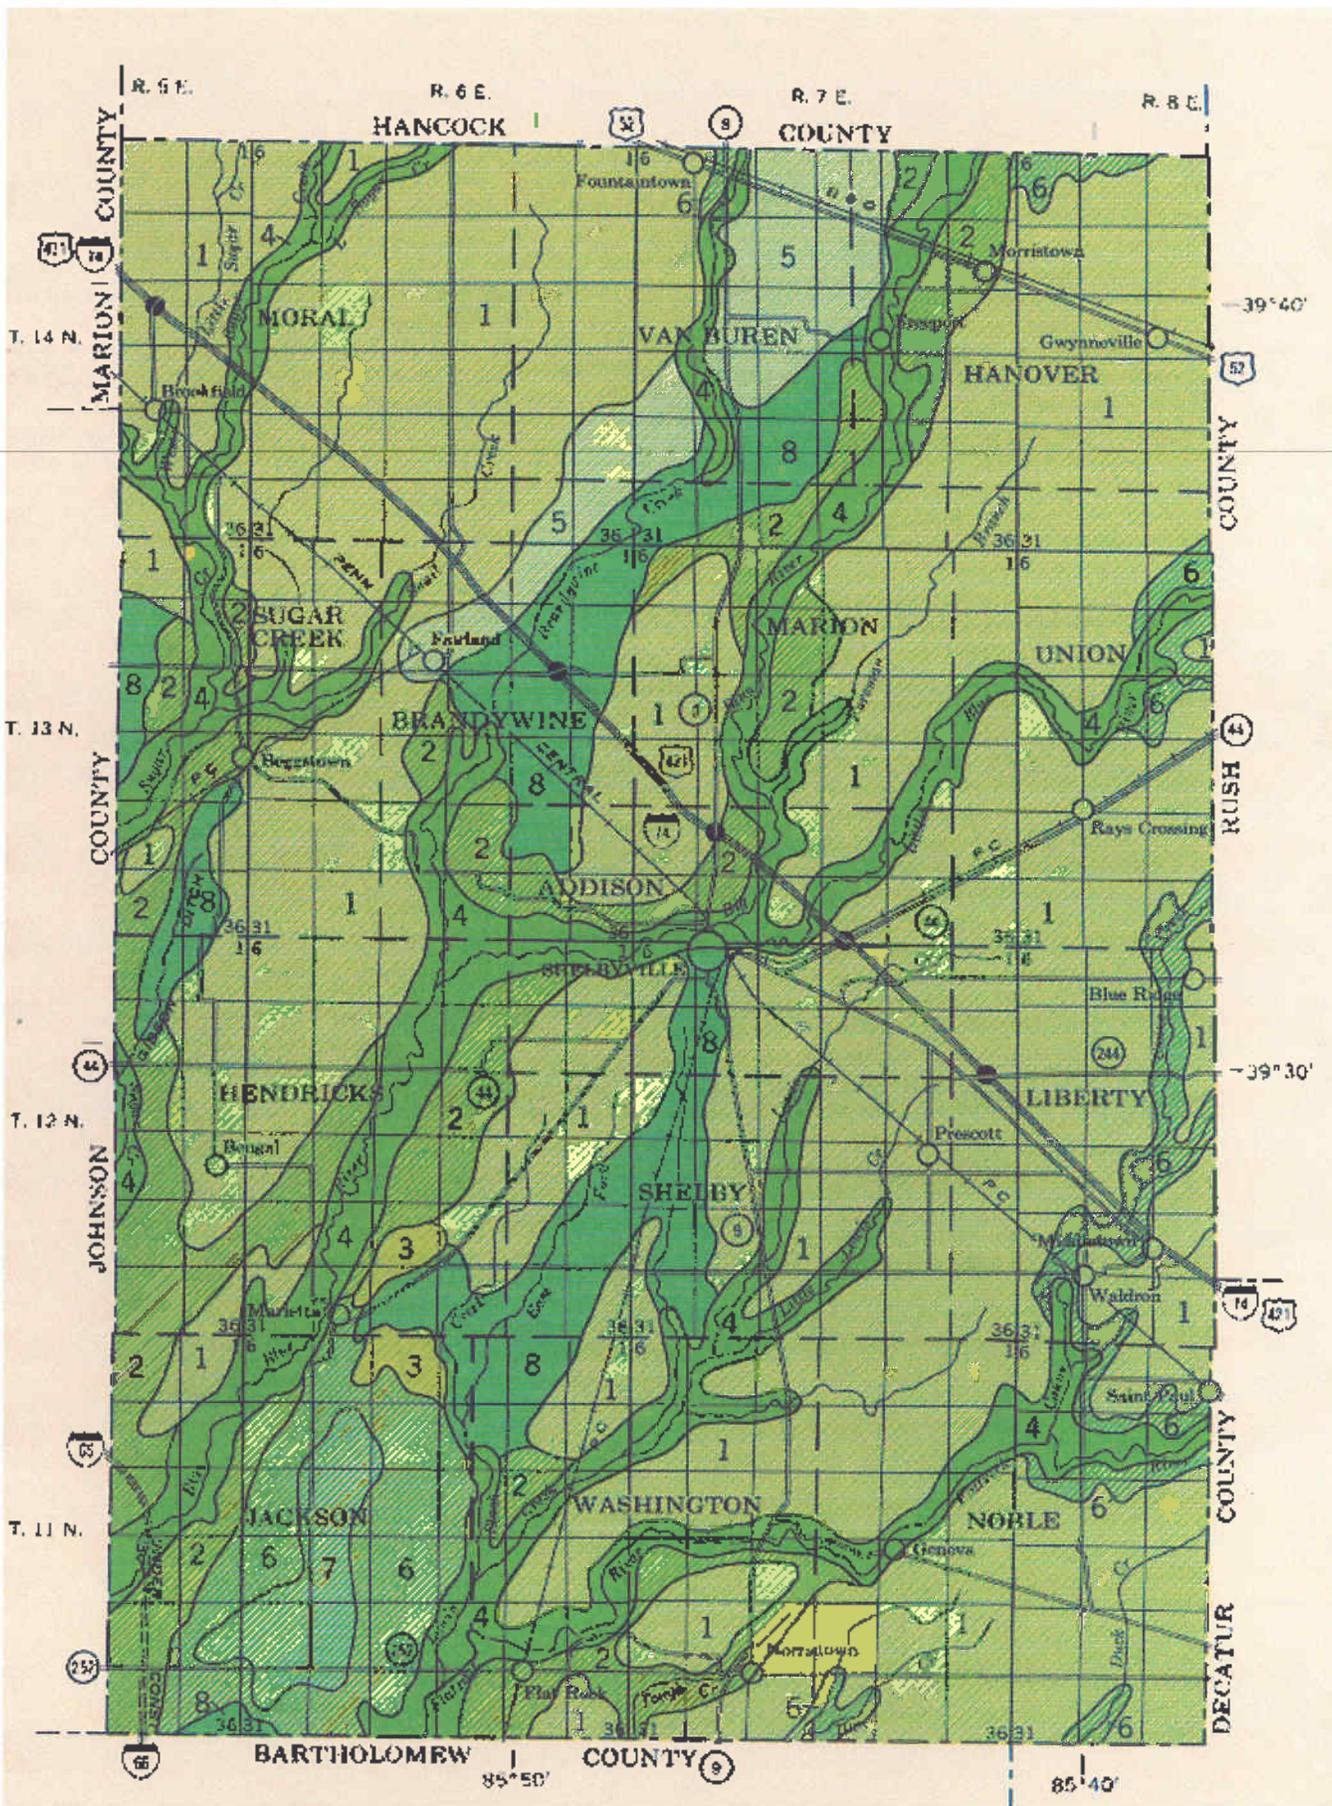
## GENERAL SOIL MAP RUSH COUNTY, INDIANA

this grant period of 2001-2002. Heavy rainfall during the 2002 planting season delayed field work and encouraged heavy weed growth in unplanted fields. Herbicide amounts were increased to handle the extra weed pressure in farm fields. Soil types in the watershed have been identified through general soil maps in the soil survey. **Figure 10.** shows general soils maps for Rush County and Shelby County.

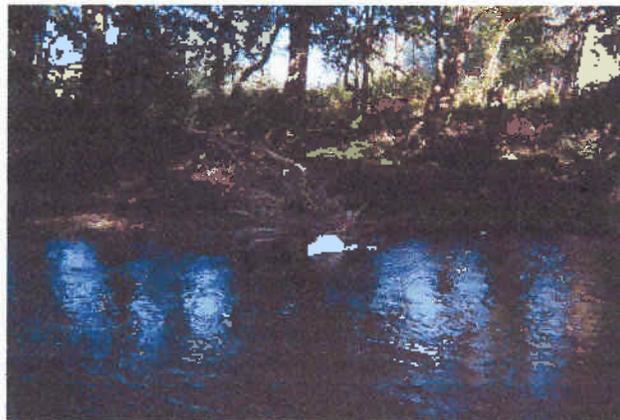
**Figure 12.**

As a trash problem, the practice of dropping the old bridge directly into the stream has been addressed under the streambank erosion and sedimentation section. However, these concrete pieces are wastes, but could be used for stabilization of stream banks in the area around the bridges. Trash was also inventoried as in Figure 12. along Conns Creek between Middletown and Waldron. This trash was estimated at being at least ten to fifteen years old. There is no evidence of new trash being added.

These remaining concrete pieces that restrict the flow of water underneath the bridge contribute to the sediment problem in the stream. The county has been approached about relocating the pieces to the stream bank on three bridges in the watershed. These concrete pieces would help conserve the integrity of the bank and prevent further erosion around the bridge area.

Because of the estimated age of the trash observed in the stream, dumping is not still occurring in the area. Removal of the existing trash is the only issue that needs to be resolved in this area. There are two major trash sites that need to be cleaned up.
