Eel River-Tick Creek Watershed Management Plan

Cass County, Indiana

September 13, 2005

EEL RIVER-TICK CREEK WATERSHED MANAGEMENT PLAN CASS COUNTY, INDIANA

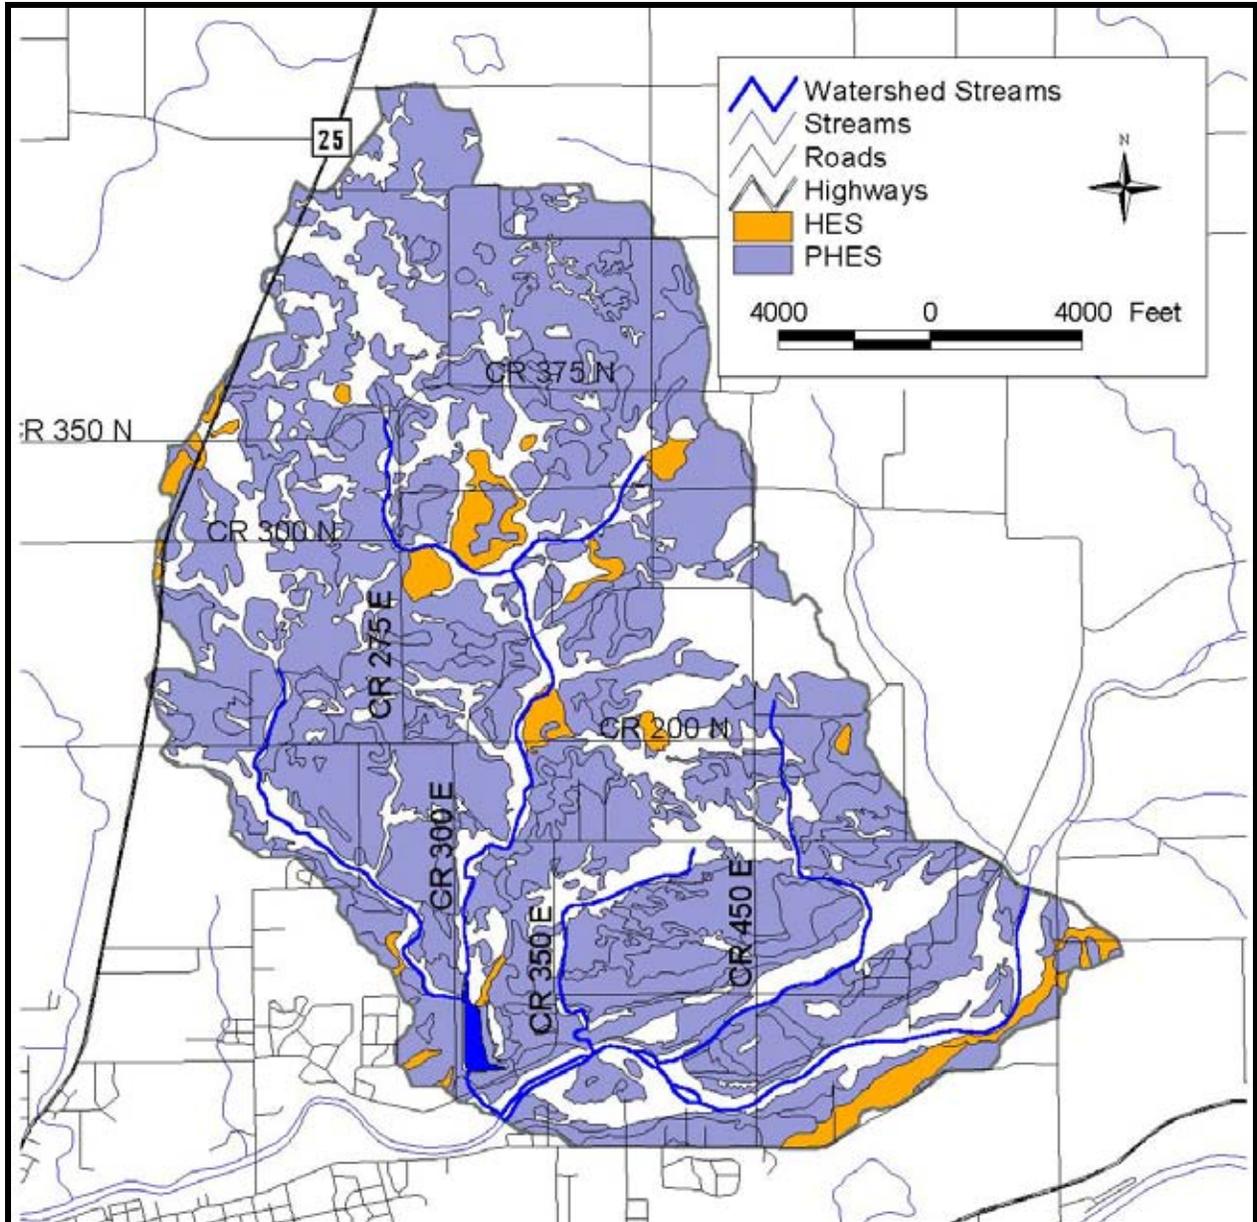
Figure 6. Highly erodible (orange) and potentially highly erodible (lavender) soils in the Eel River-Tick Creek watershed. Source: See Appendix A. Scale: 1"=4,000'.

Highly erodible and potentially highly erodible soil units cover much of the Eel River-Tick Creek watershed. The Cass County Soil Survey (Douglas, 1981) shows that that majority of the potentially highly erodible soils lie within the Tick Creek and Laird Ditch subwatersheds, along the lower portion of the Howard Ditch subwatershed, and in the Shackelford Ditch headwaters. Of the potentially highly erodible soils present within the watershed, Metea loamy fine sand (MkC), Rush silt loam (RtB), Riddles silt loam (RsB-RsC), and Wawasee sandy loam (WeB) soils are particularly dominant. Highly erodible soils are also present within the Eel River-Tick Creek watershed. The majority of the areas mapped as highly erodible soils are located along the State Road 25 corridor north and south of County Road 300 North, in the Tick Creek subwatershed east of County Road 275 East between County Road 200 North and County Road 325 North, and along the southeastern boundary of the watershed directly adjacent to the Eel River. Three other small areas of highly erodible soils are located in the immediate vicinity of or adjacent to Lake Perry (Figure 6).

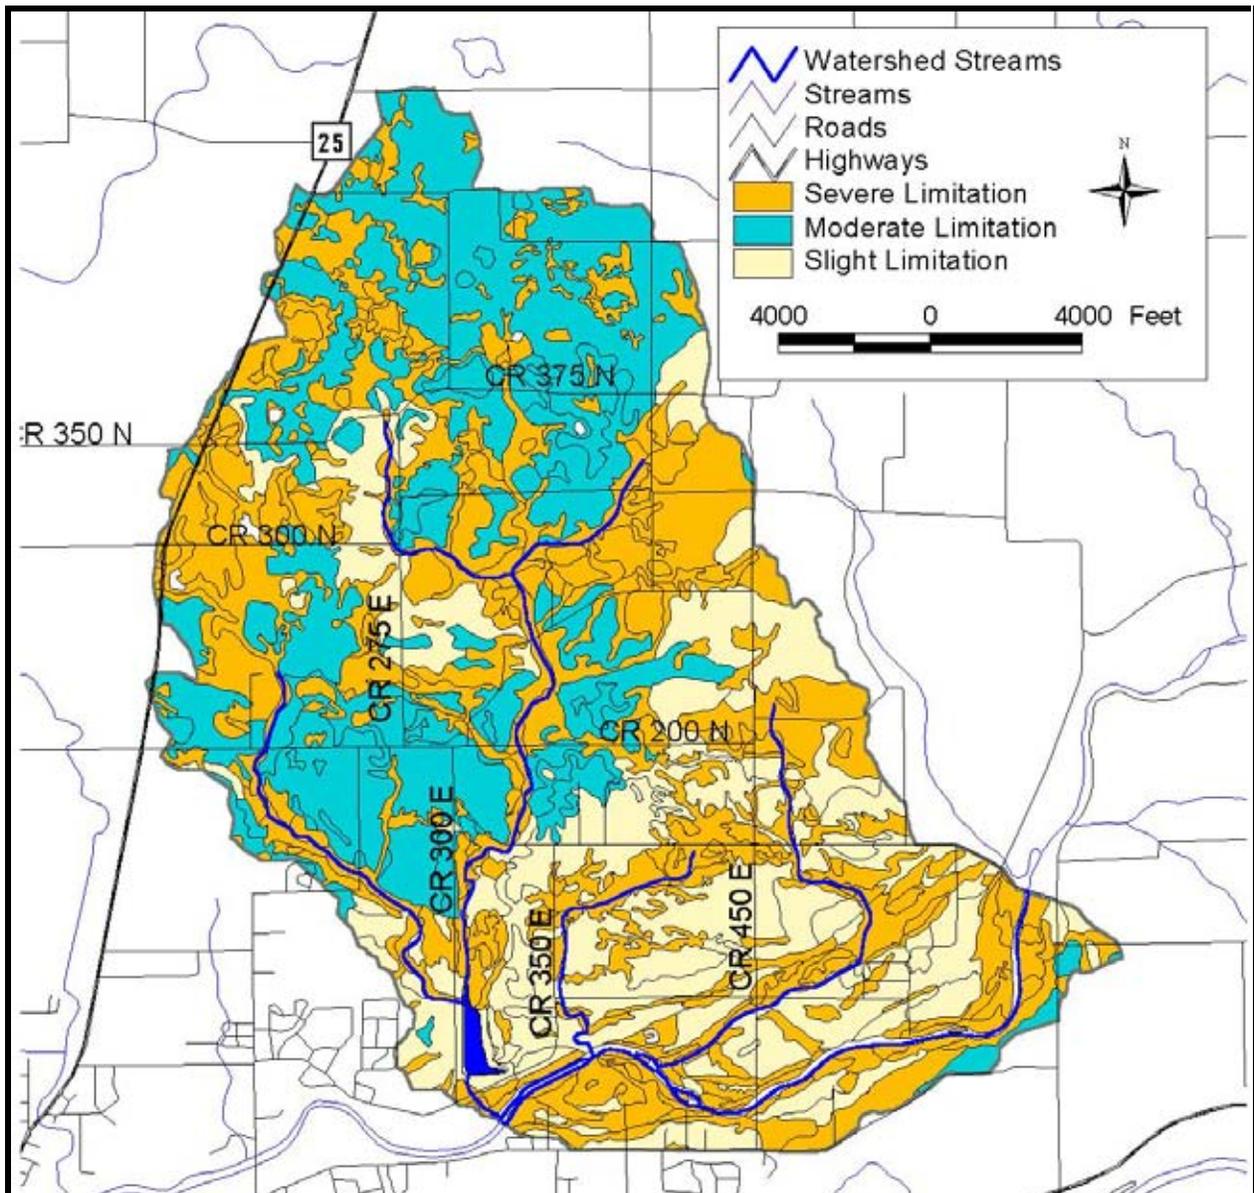
Figure 7. Soil septic field absorption suitability in the Eel River-Tick Creek watershed.
 Source: See Appendix A. Scale: 1"=4,000'.

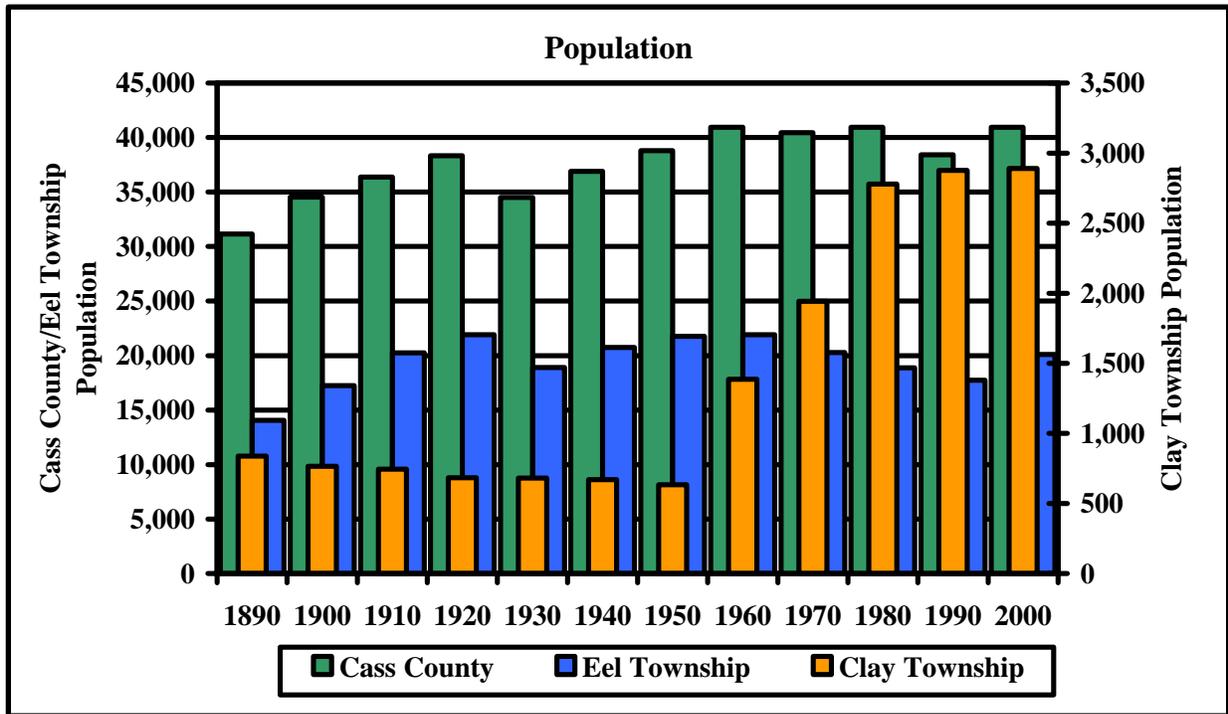
Figure 12. Populations of Clay Township (Eel River-Tick Creek watershed), Eel Township (City of Logansport), and Cass County from 1890 through 2000.

Generally, both Clay and Eel Townships have shown steady growth over the past 110 years. Clay Township, within which lies the Eel River-Tick Creek watershed, experienced its greatest growth rate between 1950 and 1960 when the township's population grew by nearly 115%. Growth between 1960 and 1980 was also strong (approximately 40-45%). Conversely, Eel Township experienced its greatest growth rate between 1890 and 1900. This period of growth corresponds with heavy manufacturing growth within Logansport. Growth in Cass County also shows similar results; the greatest period of growth occurred from 1890 to 1900. Figure 12 details the population levels in the two townships and Cass County from 1890 through 2000.

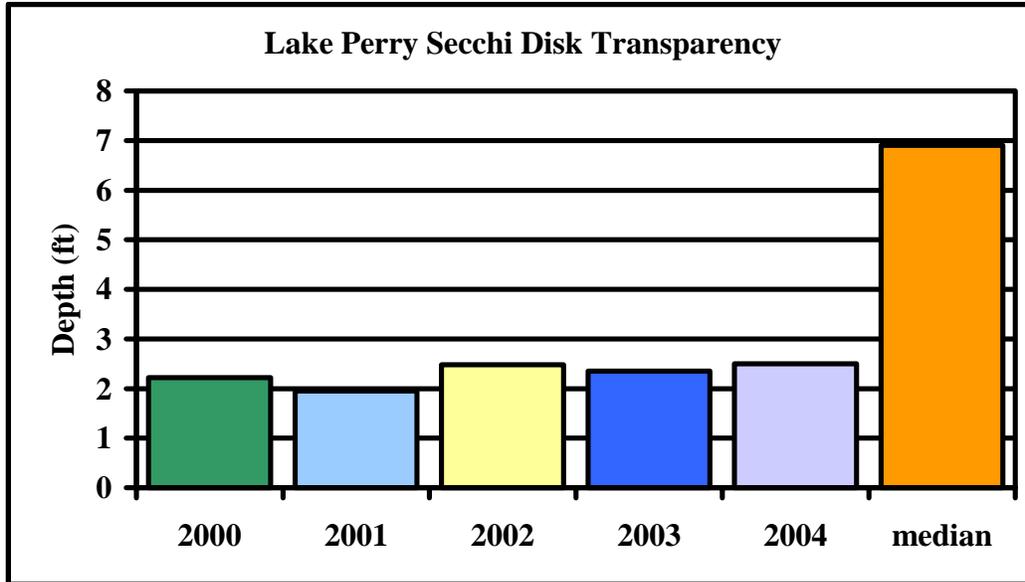
Figure 14. Water clarity in Lake Perry from 2000 to 2004. July/August Secchi disk averages for Lake Perry are compared to the median Secchi disk reading for Indiana lakes (based on Indiana Clean Lakes Program data).

The results of this testing indicate that the lake suffers from poor but relatively stable water clarity. Most of the Secchi disk measurements for the lake were between 1.8 and 2.8 feet, although in two instances readings better than 3 feet were obtained. The lake's July/August average Secchi disk depth ranged from a low of 1.9 in 2001 to a high of 2.5 in 2004. These averages are well below the median Secchi disk depth for Indiana lakes of 6.9 feet (Figure 14).

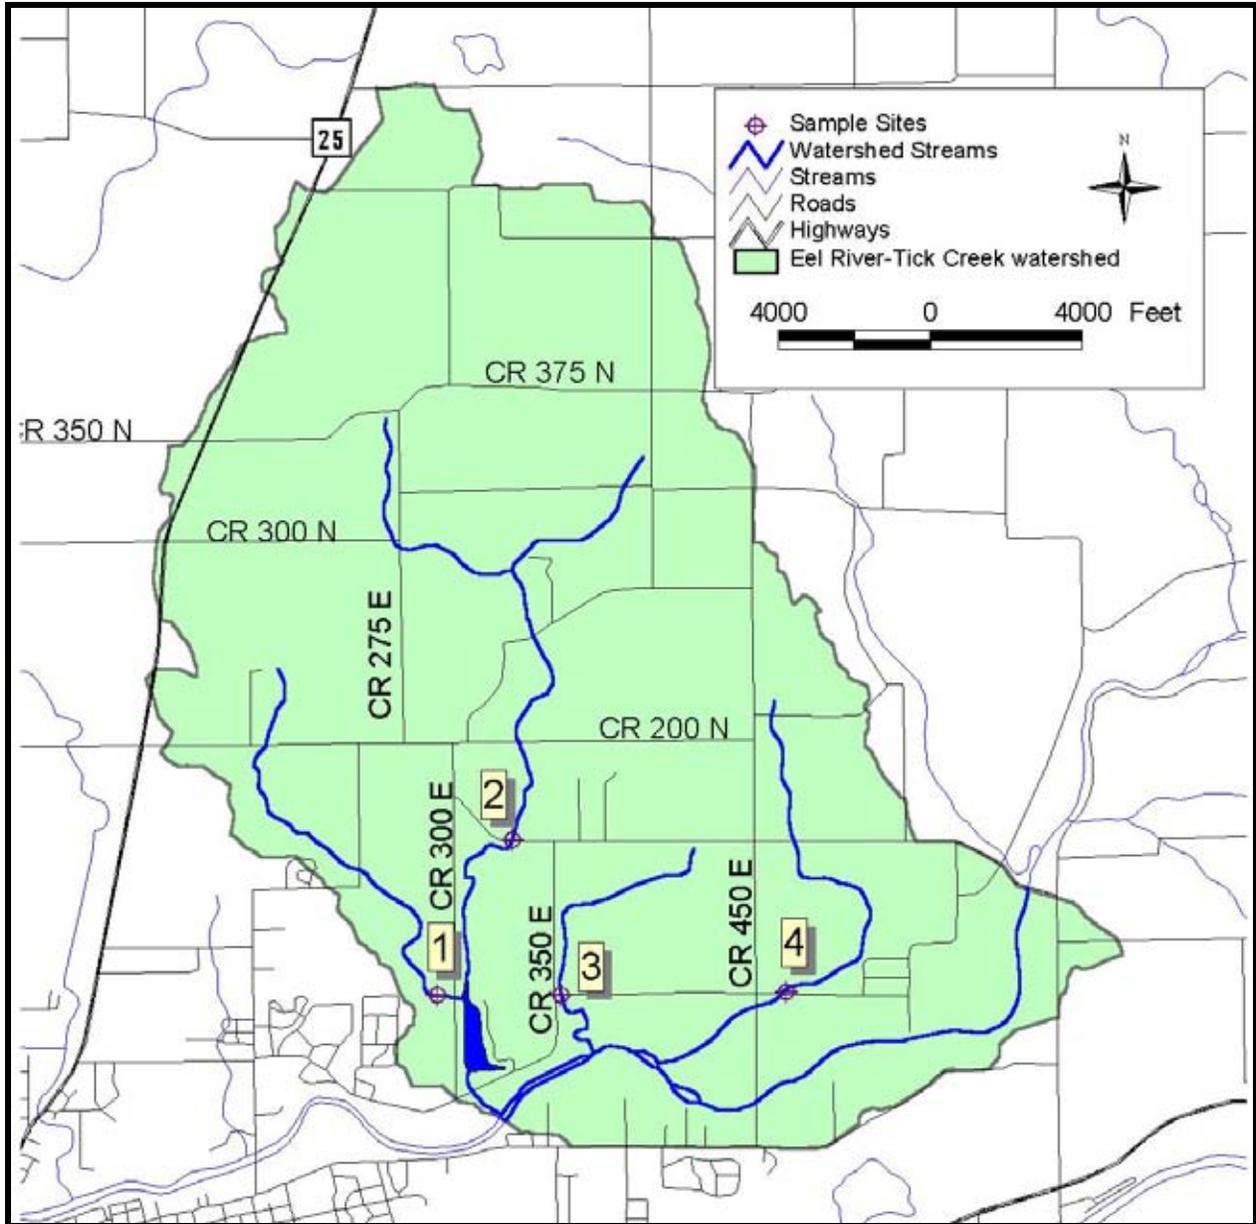
Figure 15. Stream sampling locations. Source: See Appendix A. Scale: 1"=4,000'.

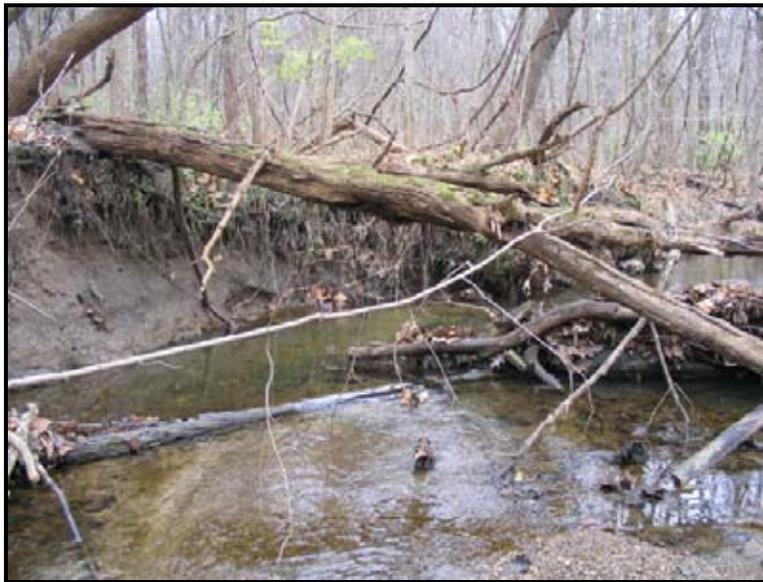
Figure 16. Typical stream bank erosion observed along Laird Ditch during a walking tour of the ditch.

The 2004 sampling of Laird Ditch highlighted a few areas of concern. First, the ditch exhibited *E. coli* concentrations above the Indiana state standard of 235 cfu/100mL during both the storm flow and base flow sampling events. While exceeding the state standard is of concern, the concern should be tempered by the fact that the *E. coli* concentrations observed in Laird Ditch were below the average *E. coli* concentration found in Indiana streams. In reviewing ten years worth of data from Indiana fixed monitoring stations, White (unpublished) found the average *E. coli* concentration in Indiana streams to be approximately 650 cfu/100mL. Also of concern is Laird Ditch's nitrate-nitrogen concentration. While the concentration does not exceed the state standard, the concentration under both storm and base flow conditions was above the concentration recommended by the Ohio EPA to protect aquatic life. In a study correlating nutrient concentrations to biotic health, the Ohio EPA (1999) recommended keeping nitrate concentrations below 1.0 mg/L in most streams. Finally, although the pollutant loads in Laird Ditch were low compared to the other watershed streams, Laird Ditch exhibited the second highest total suspended solids areal loading rate during storm flow. (Areal loading rate is the pollutant loading rate divided by drainage area. This allows for a comparison of loading rates in different sized drainages. Normally, pollutant loading rates in larger drainages are expected to be higher than the pollutant loading rates in smaller drainages.) The high (relative to other watershed streams) total suspended solids areal loading rate suggests that the stream may carry a significant suspended solid load and/or stream erosion during storm flow may be a considerable source of sediment in the ditch (Figure 16).

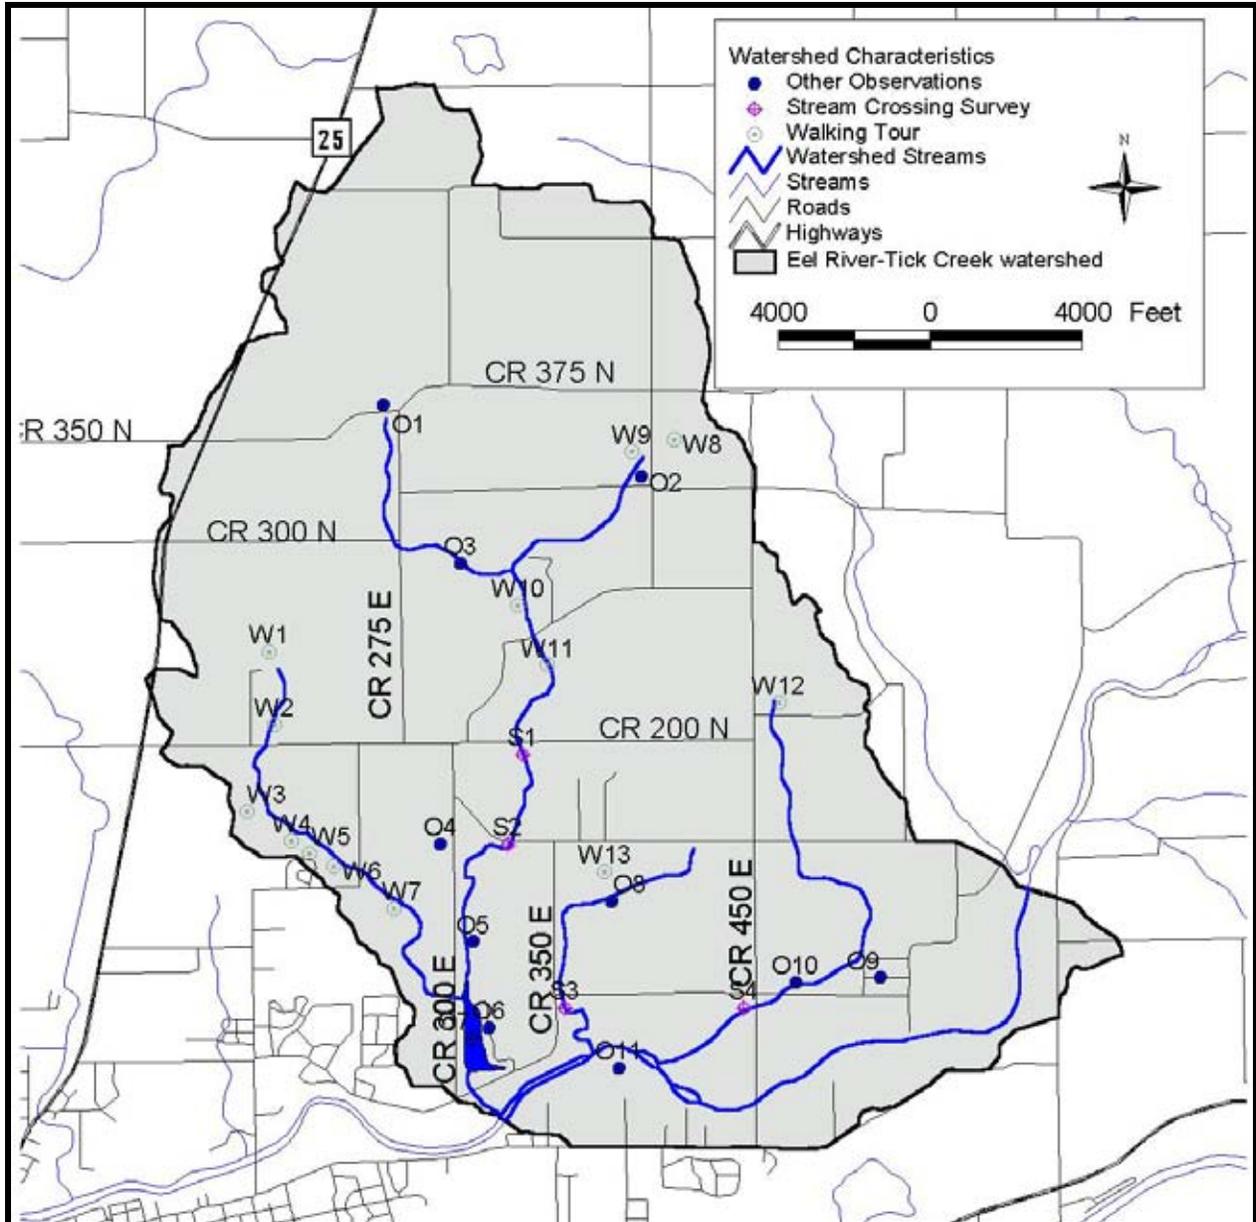
Figure 17. Watershed concerns identified during various watershed surveys in the Eel River-Tick Creek watershed. Source: See Appendix A. Scale: 1"=4,000'.

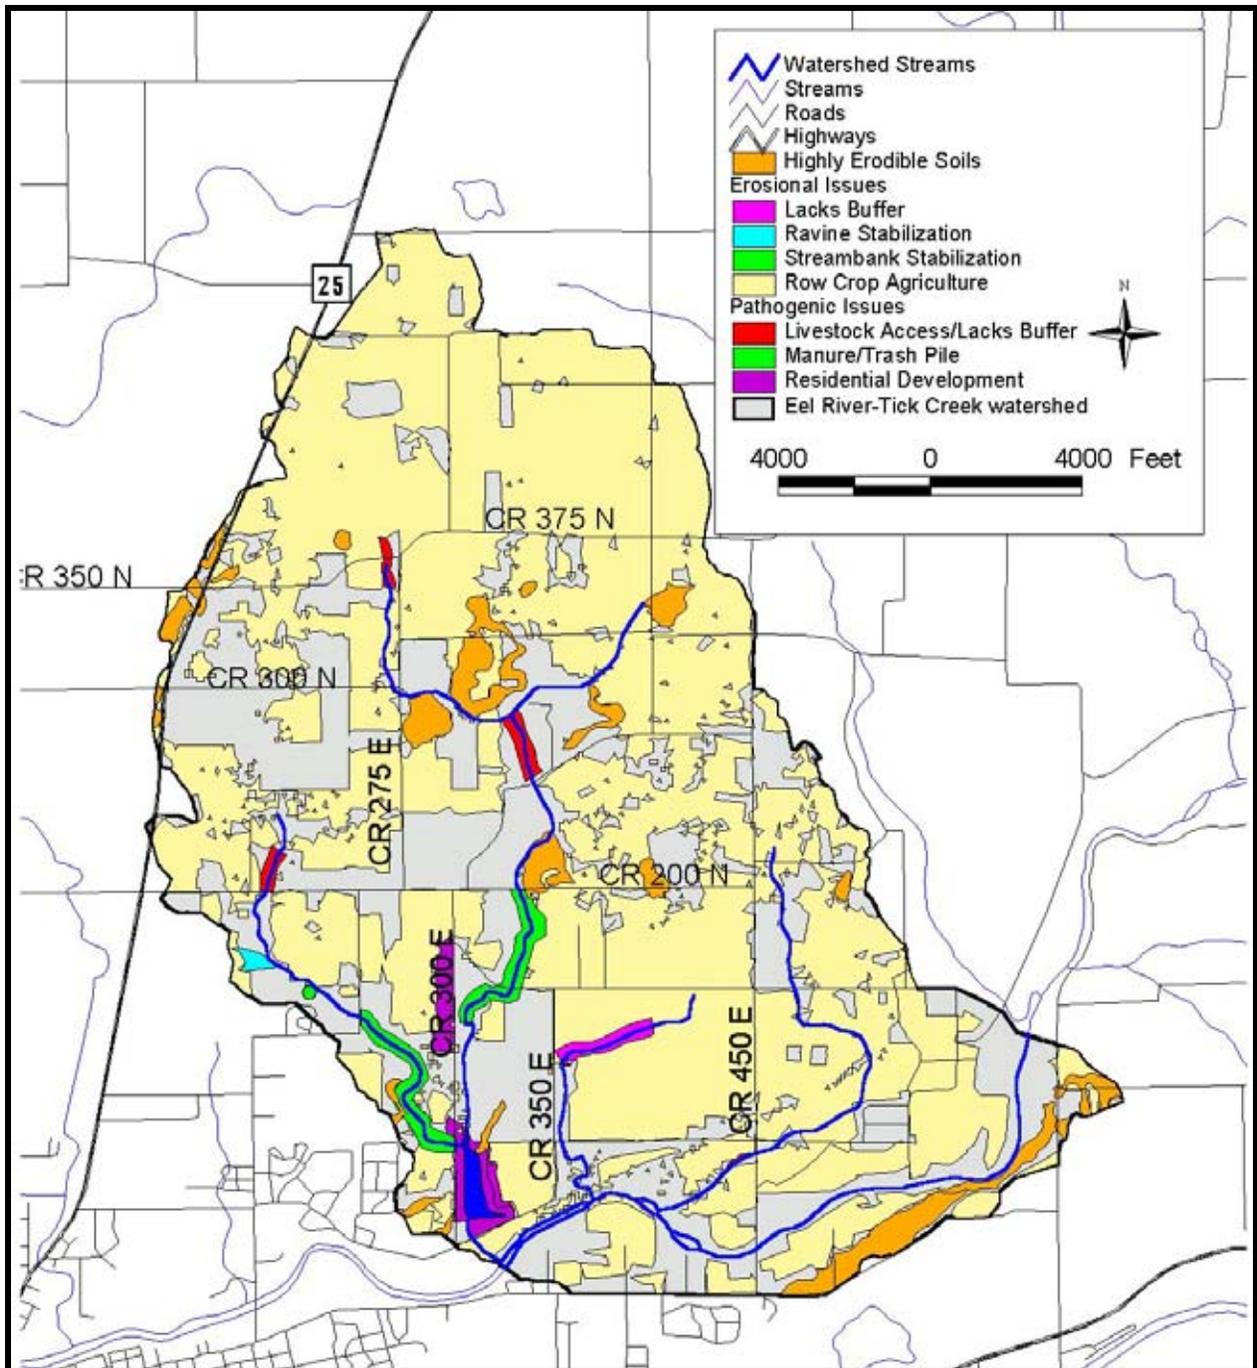
Figure 18. Critical areas targeted for sediment loading reduction in the Eel River-Tick Creek watershed. Source: See Appendix A. Scale: 1"=4,000'.

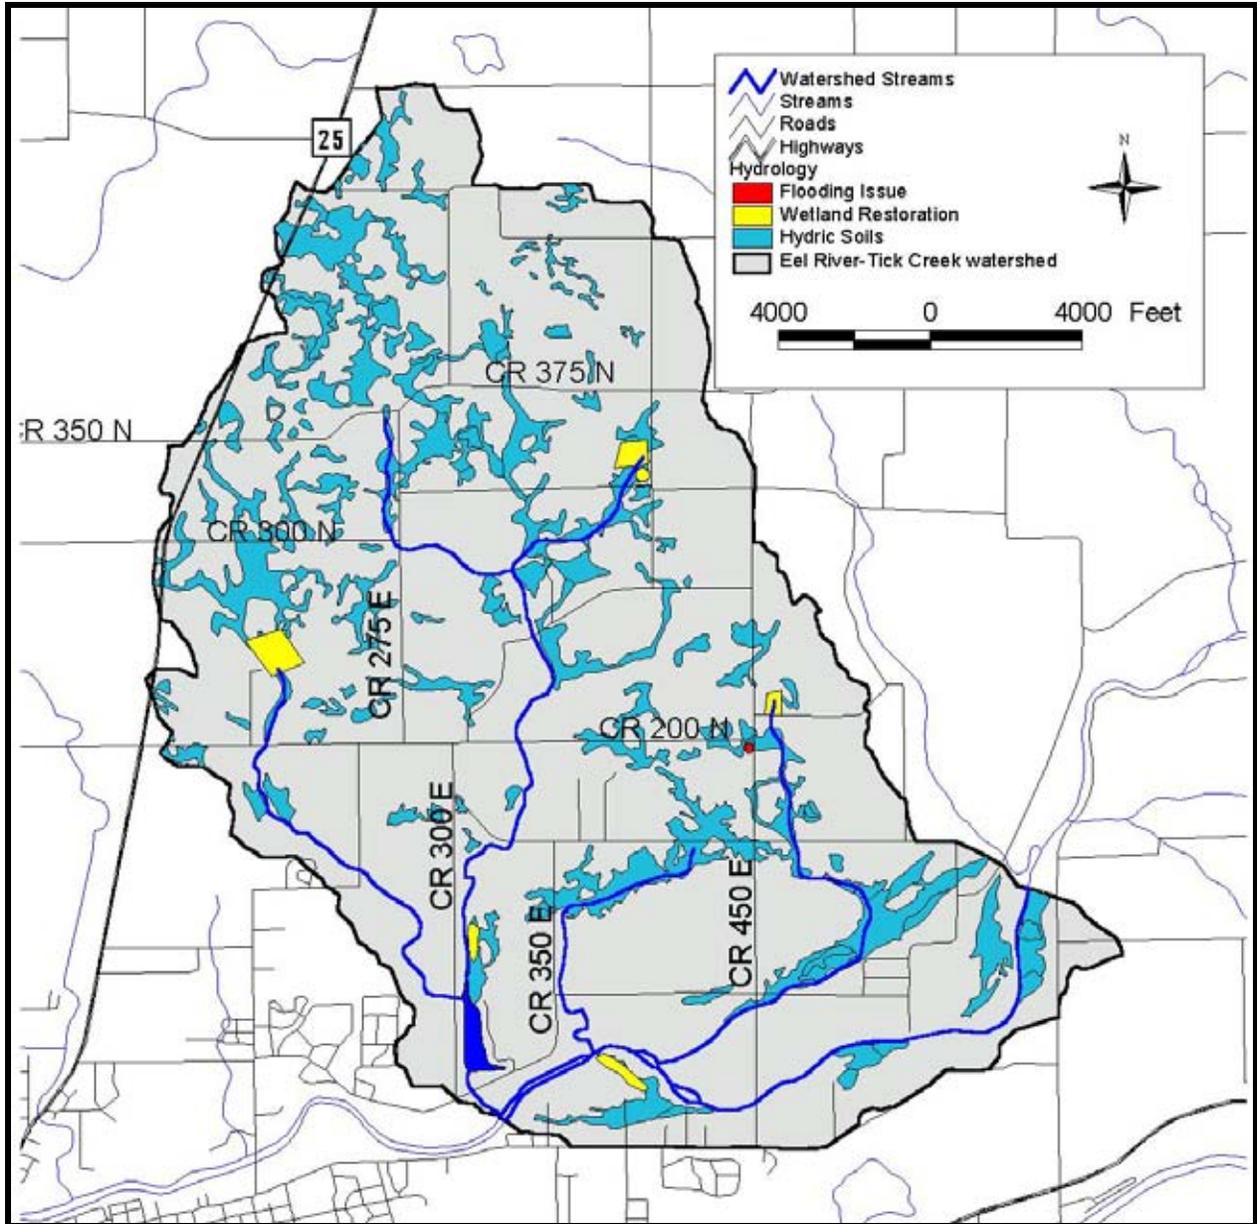
Figure 19. Critical areas targeted for wetland restoration and flood control in the Eel River-Tick Creek watershed. Source: See Appendix A. Scale: 1"=4,000'.

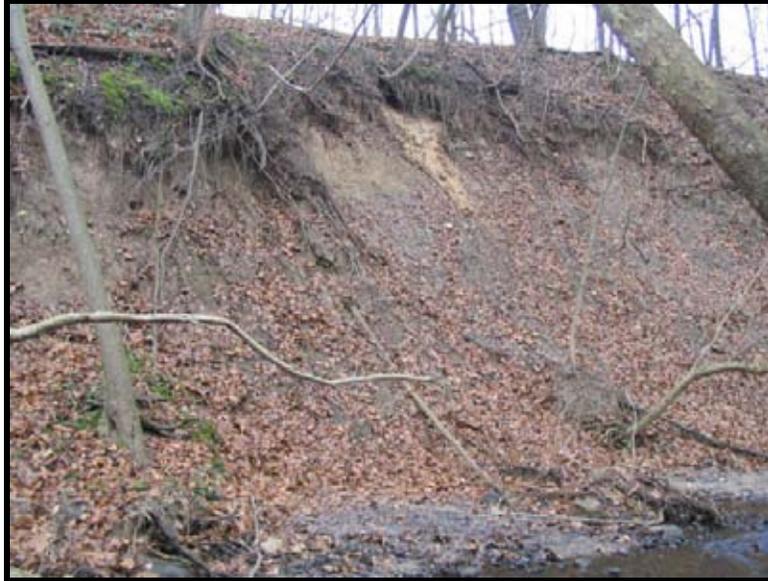
Figure 20. Streambank erosion along Laird Ditch between County Road 250 East and County Road 300 East.

Source: Streambank erosion (Figures 20 and 21)
Ravine erosion
Active construction sites
Current land use (lack of buffers)
Changes in land use (future development)
Hydrological changes in watershed (loss of wetlands)
Row crop agricultural areas (especially those farmed on Highly Erodible Soils)
Livestock access locations

Hot spots/Critical areas: Laird Ditch and some ravines between County Road 250 East and County Road 300 East (Figure 20)
Tick Creek south of County Road 200 North (Figure 21)
Residential areas along County Road 300 East
Future residential development sites

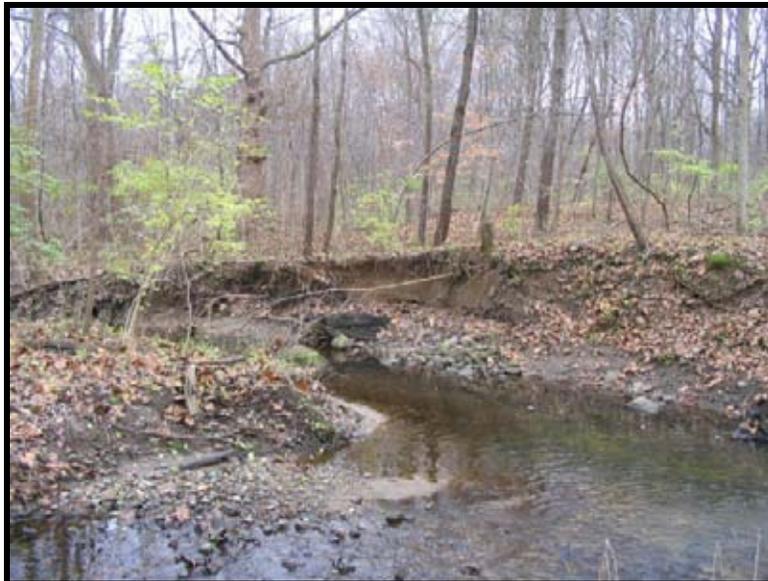
Figure 21. Streambank erosion along Tick Creek south of County Road 200 North.

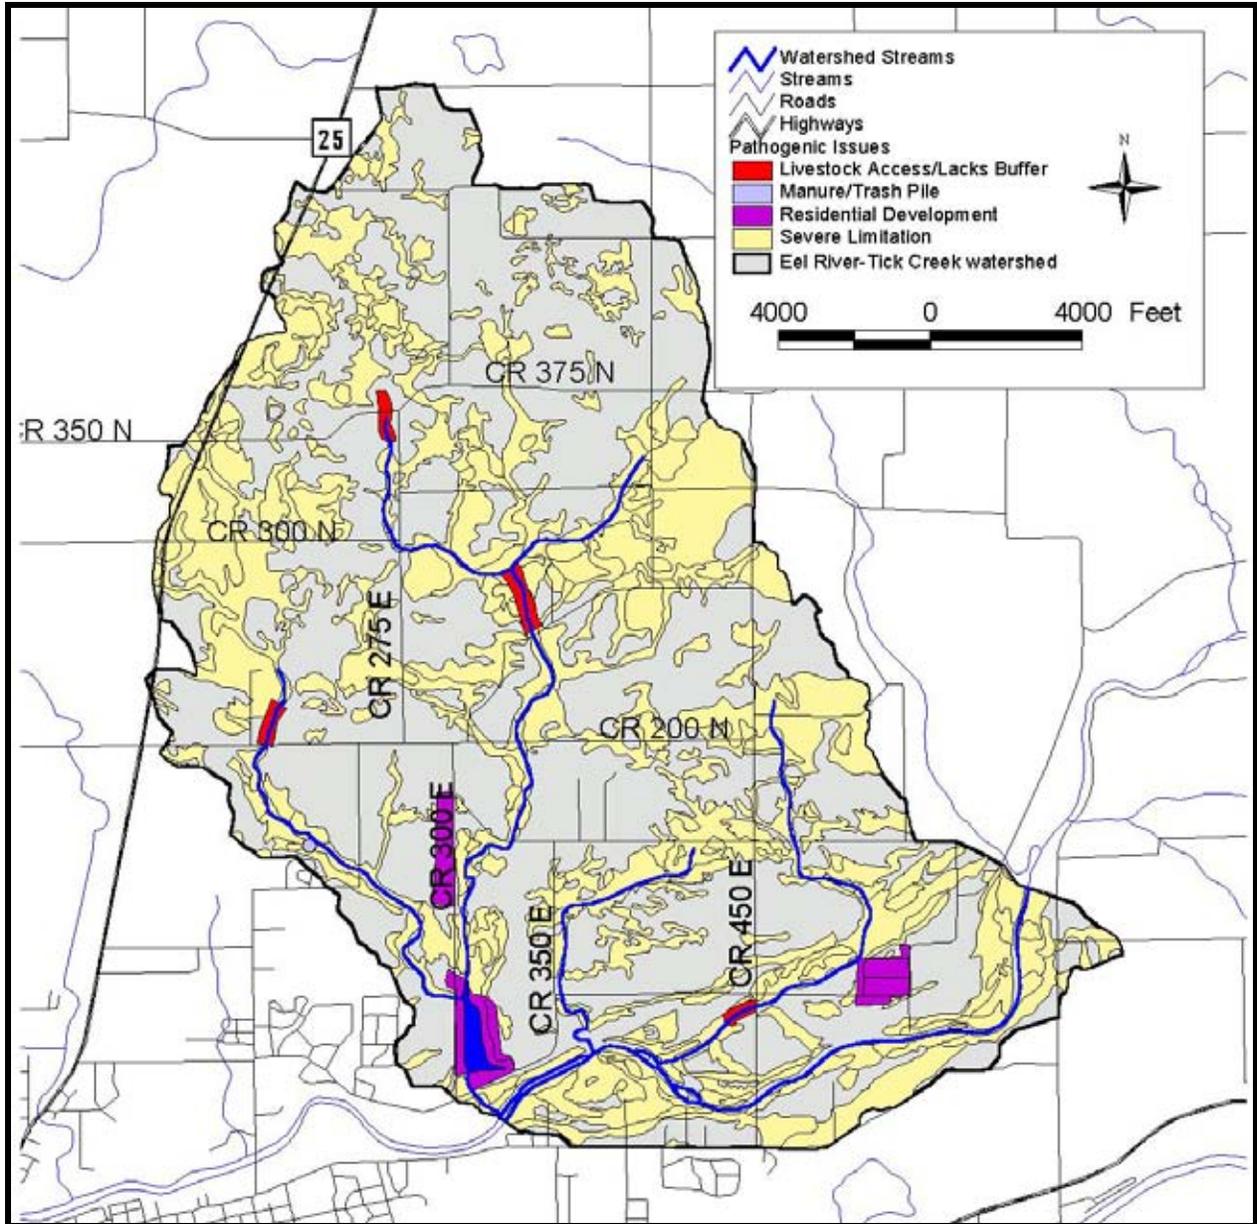
Figure 22. Critical areas targeted for nutrient loading and pathogen concentration reduction in the Eel River-Tick Creek watershed. Source: See Appendix A. Scale: 1"=4,000'.

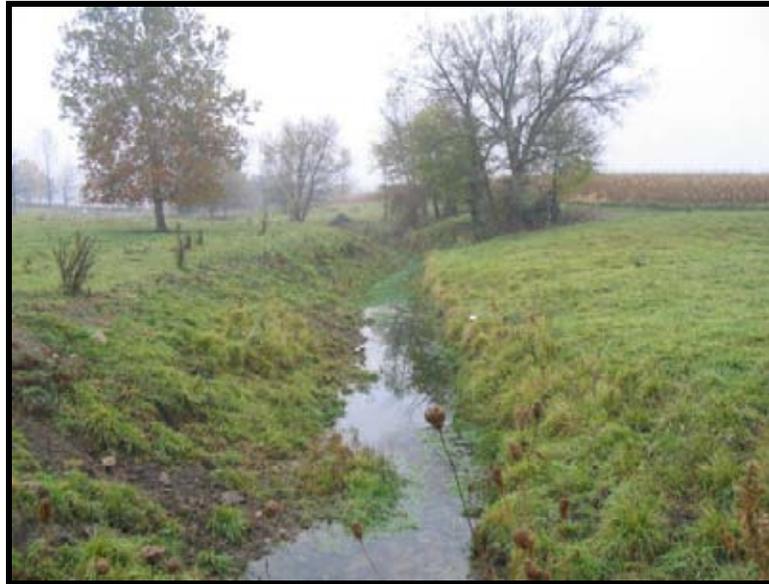
Figure 23. Representative location where livestock have access to waterbodies within the Lake Perry subwatershed.

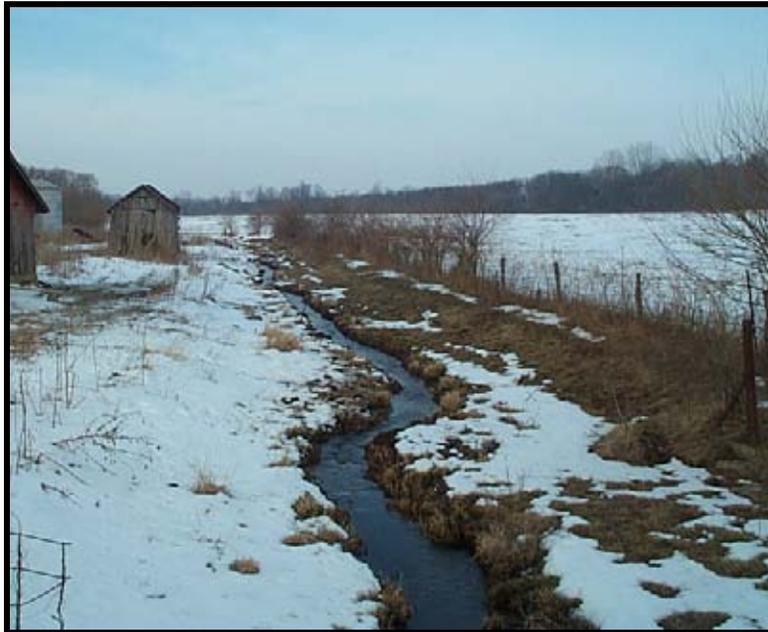
Figure 24. Representative location where livestock have access to waterbodies within the Shackelford Ditch subwatershed.

Hot spots/Critical areas: Livestock access to streams (Figure 24)
Manure disposal behind 4-H
Failing septic systems – particularly any adjacent to watershed waterbodies (The Cass County Health Department has not documented any failed septic systems within the Eel River-Tick Creek watershed (personal communication).)
