# Appendix 16

## Stream Reach Survey Photos

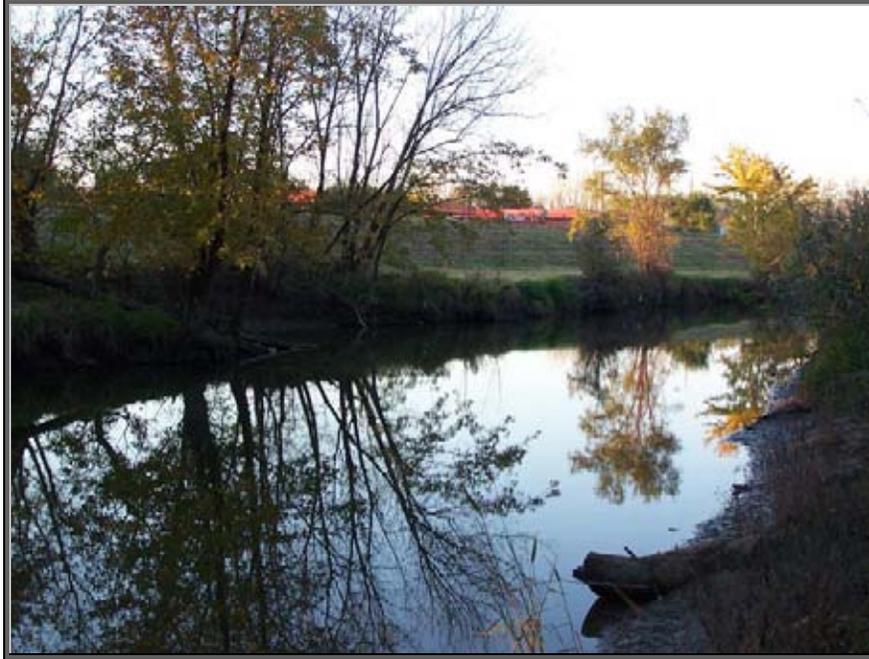
Figure 2 (Stream Reach Survey Location 1): Little Calumet River at sampling location 42 on far west side of watershed located at approximately the intersection of U.S. Highway 41 and Interstate 80.

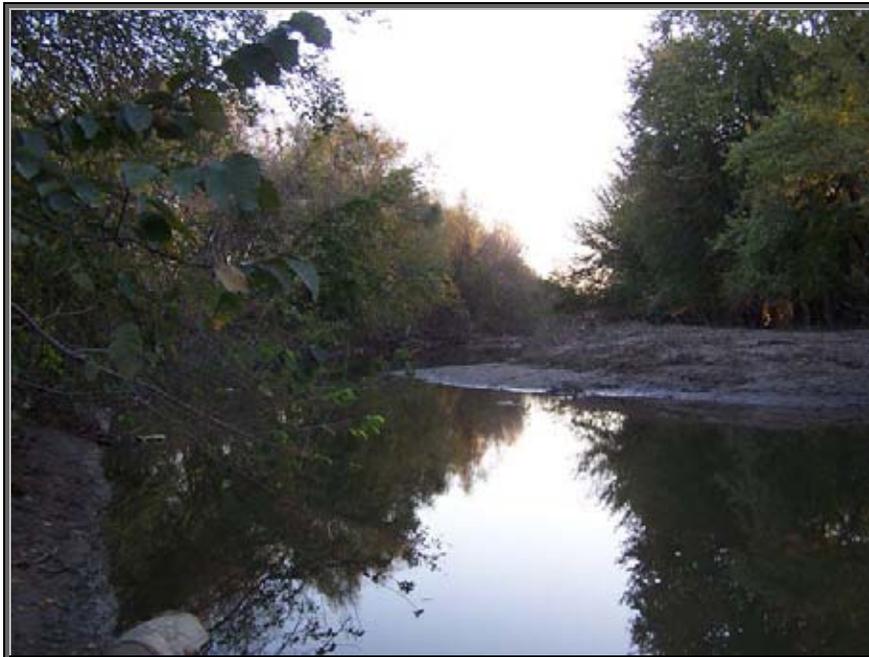
Figure 3 (SRS Location 1): Sampling Location 42 showing the forest buffer and decent floodplain that is present at this location.

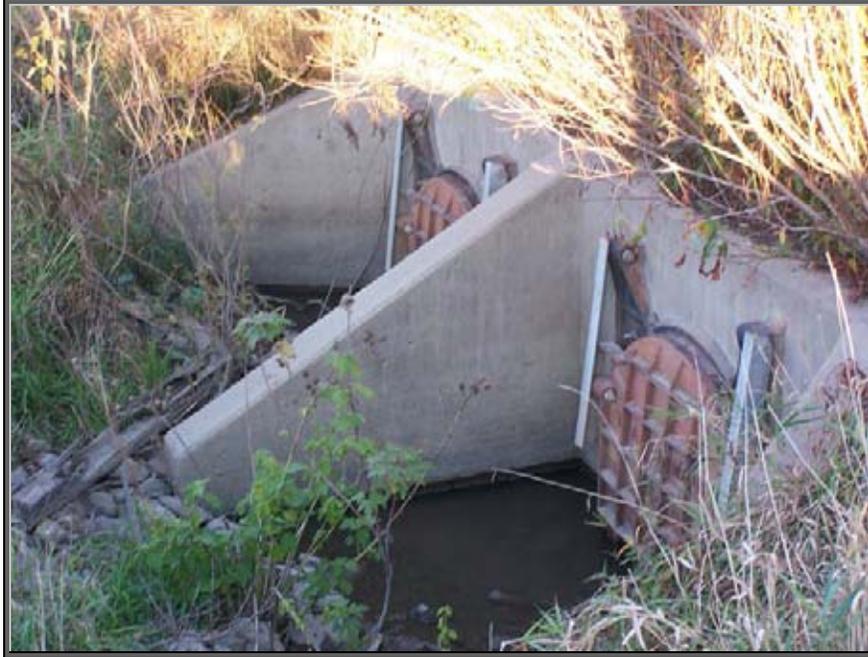
Figure 4 (SRS Location 2): Combined spill overflow structures at sampling location 38 that drain directly into the Little Calumet River without any type of treatment.

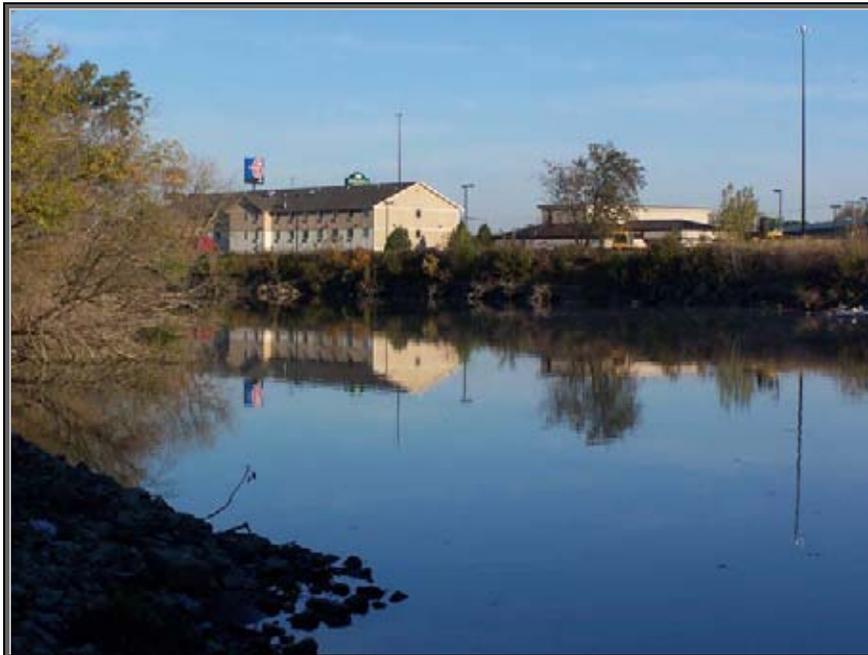
Figure 7 (SRS Location 6): Sample location 39 along the Little Calumet River located approximately at the intersection of Cline Avenue and Interstate 80 in Highland, Indiana.

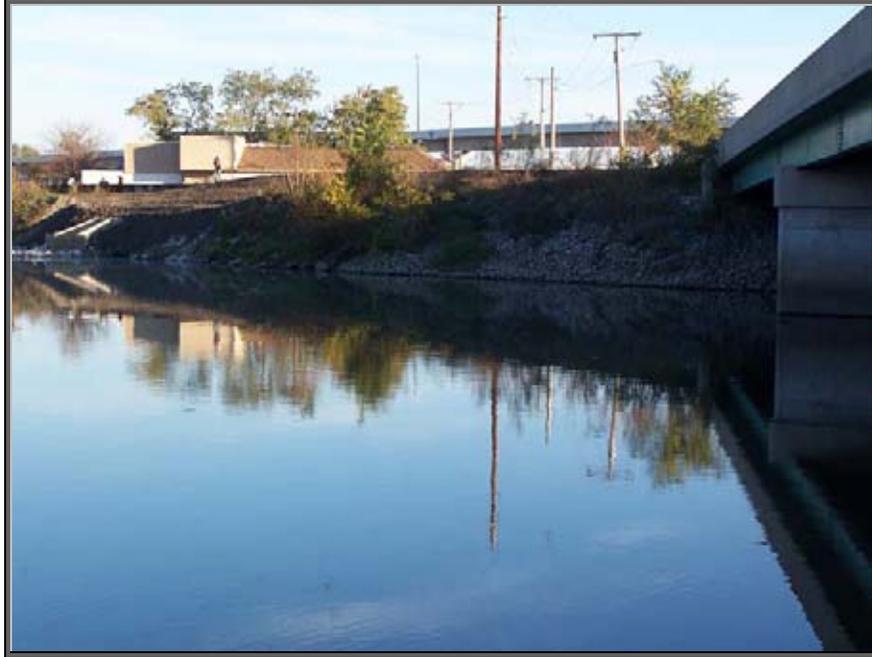
Figure 8 (SRS Location 6): Minimal buffer present at sample location 39 as evidenced by the adjacent land-use shown.

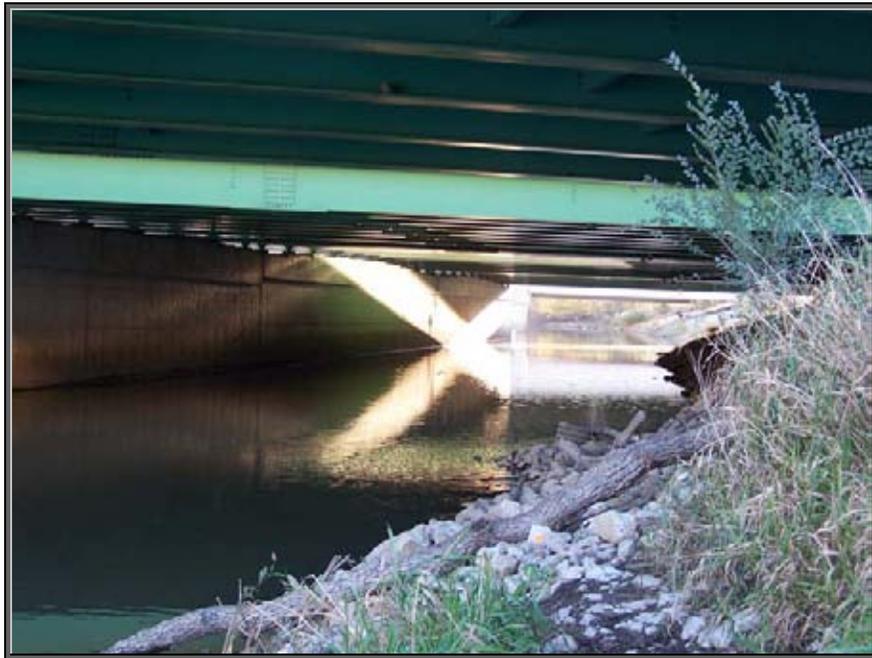
Figure 9 (SRS Location 6): Steep bank at sample location 39 along Little Calumet River.

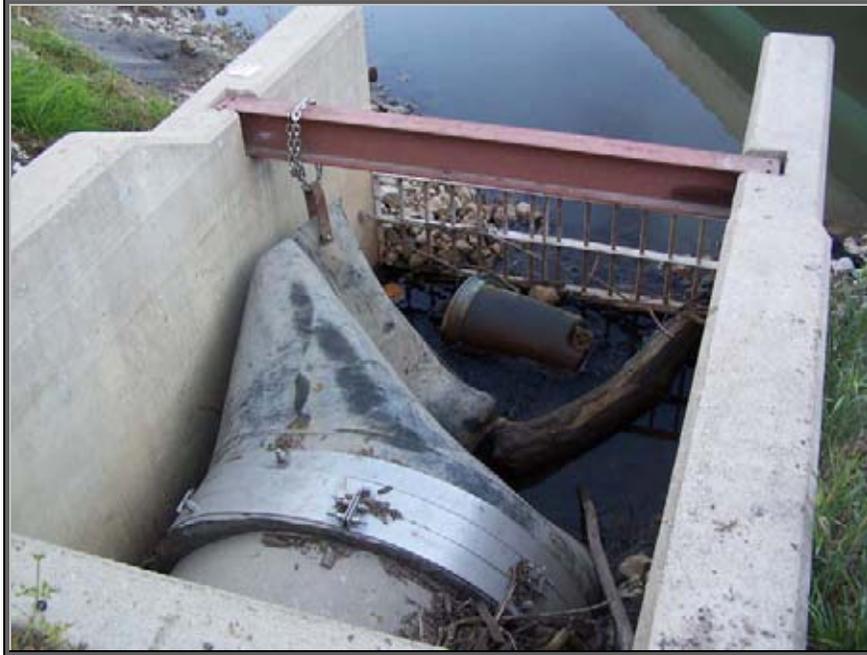
Figure 10 (SRS Location 6): Degraded storm outfall structure into the Little Calumet River. The bank at this location also seems to be eroding.

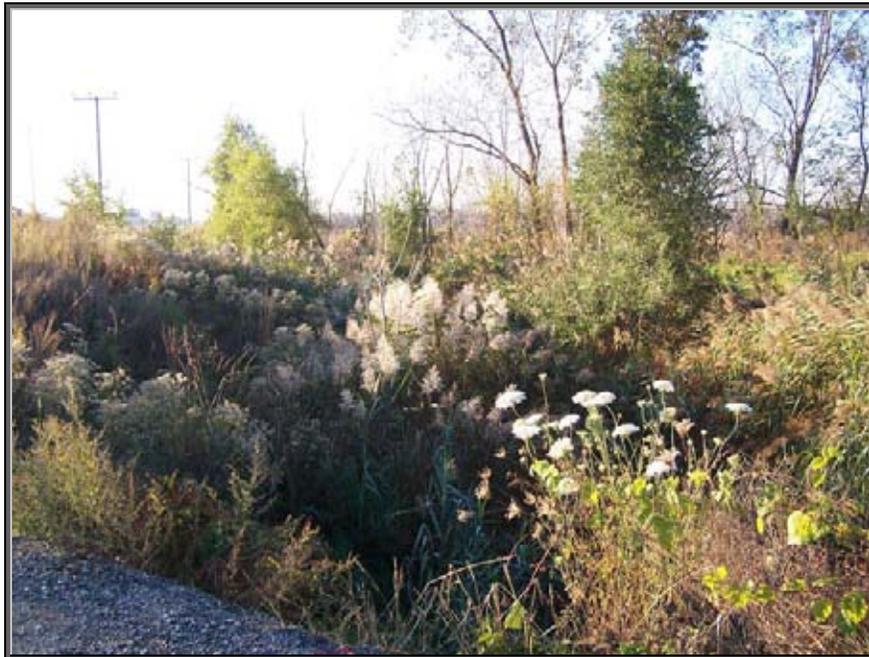
Figure 11 (SRS Location 6): Natural vegetation present at sample location 39 that provides limited natural buffer for the Little Calumet River.

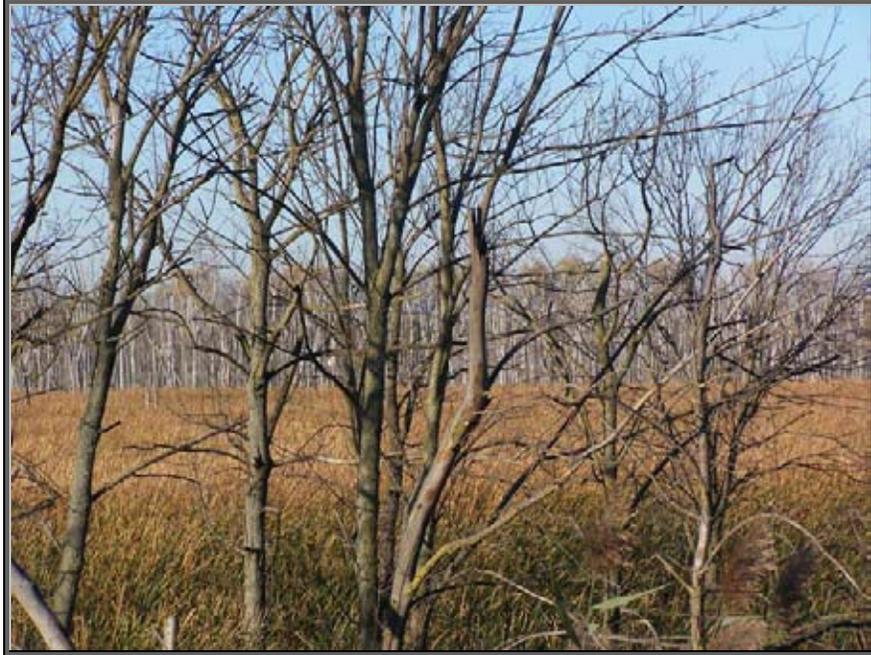
Figure 14 (SRS Location 5): A large number of cattails can be found in the Heron Rookery, helping the land to act as a natural wetland.

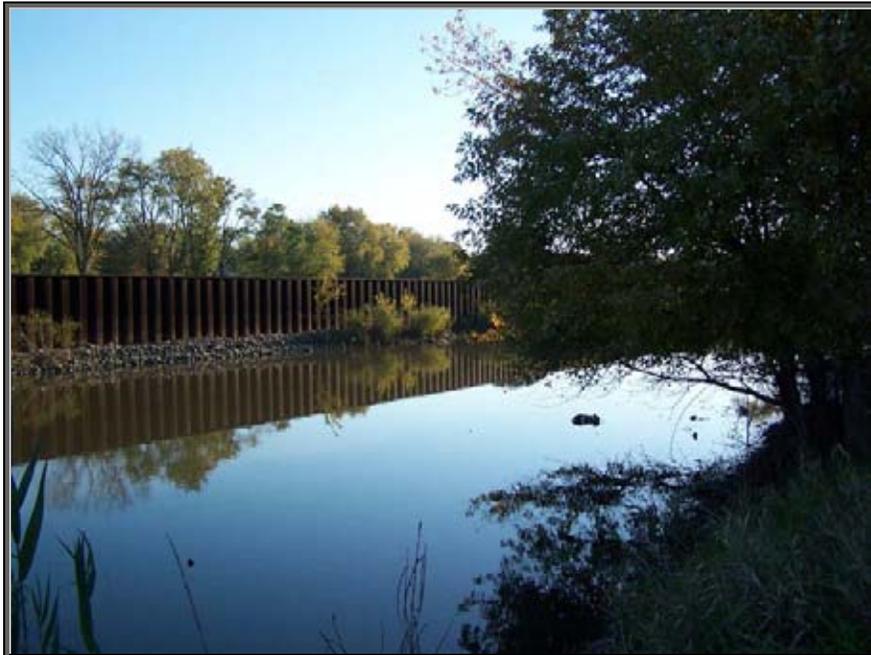
Figure 19 (SRS Location 7): Natural habitat present as you look downstream at sample location 37.

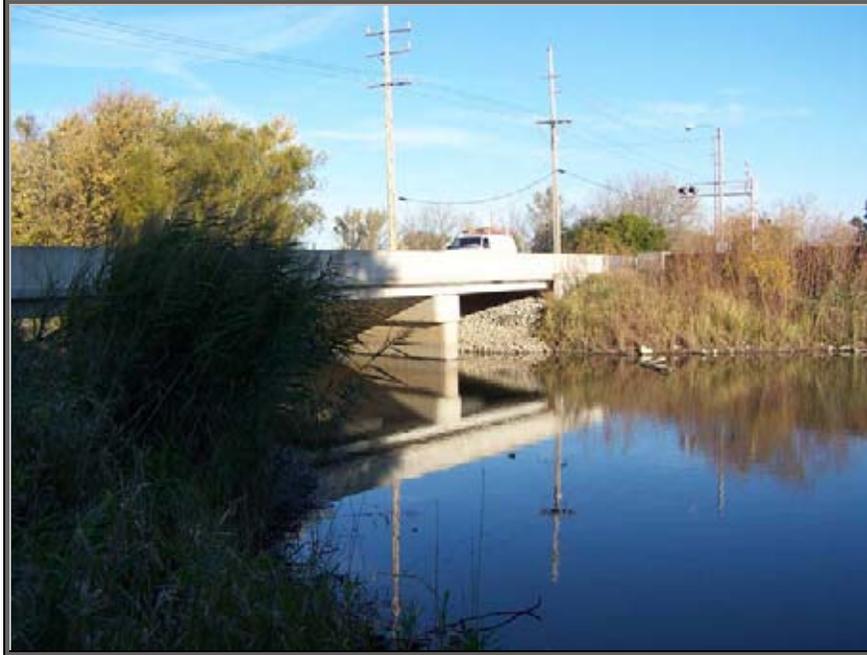
Figure 20 (SRS Location 7): Colfax Street bridge over the Little Calumet River.

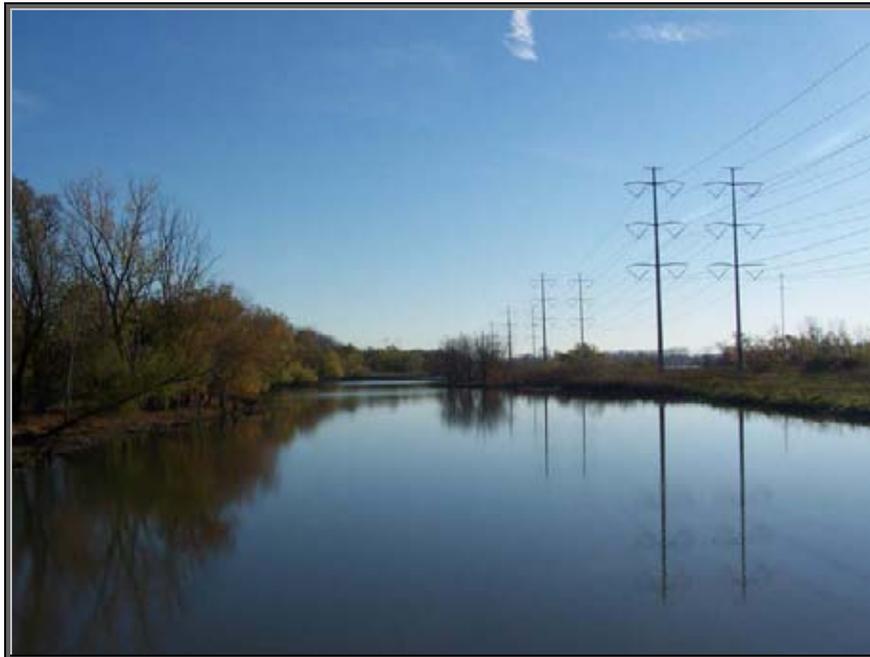
Figure 25 (SRS Location 8): River has free flowing movement around Clark Street. No development has been made along the banks of the river or in the natural flood zones.

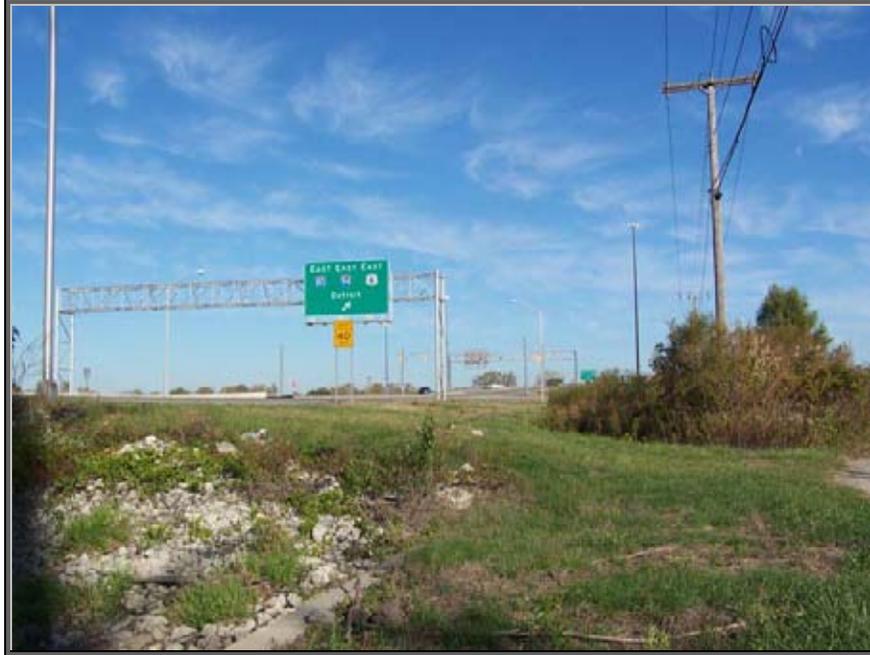
Figure 32 (SRS Location 11): The bank in the foreground is the side of the bridge just shown. This shows the proximity to the interstate at sampling location 17.

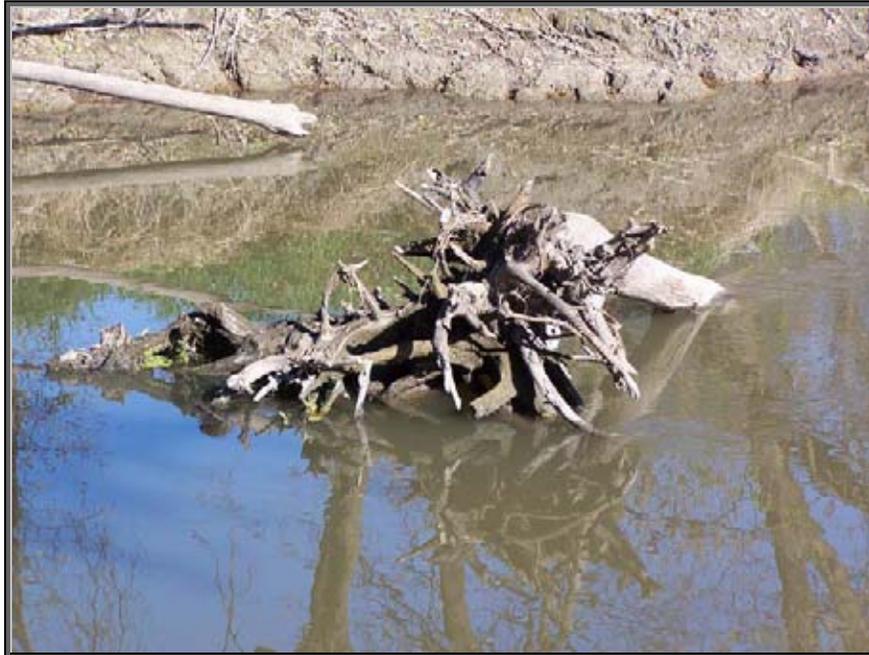
Figure 37 (SRS Location 13): Debris matter that can be found in the tributary to the Little Calumet River includes large branches that have fallen off of surrounding trees.

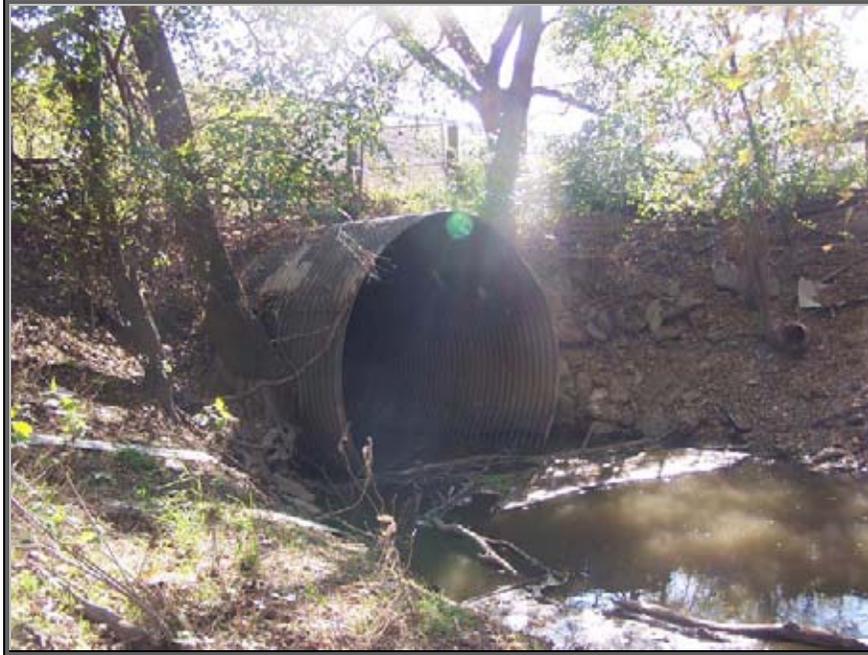
Figure 40 (SRS Location 14): A large culvert is used to channel the water underneath the ramps at this location, Sample location 14.

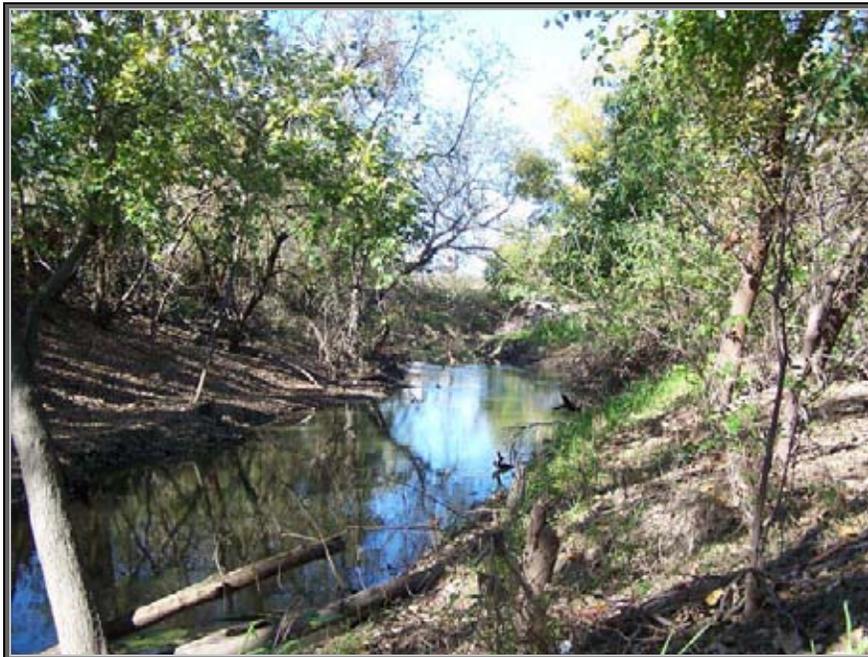
Figure 41(SRS Location 14): Photo looking downstream at sampling location 14. This is the beginning of the channelized portion of the Little Calumet River.

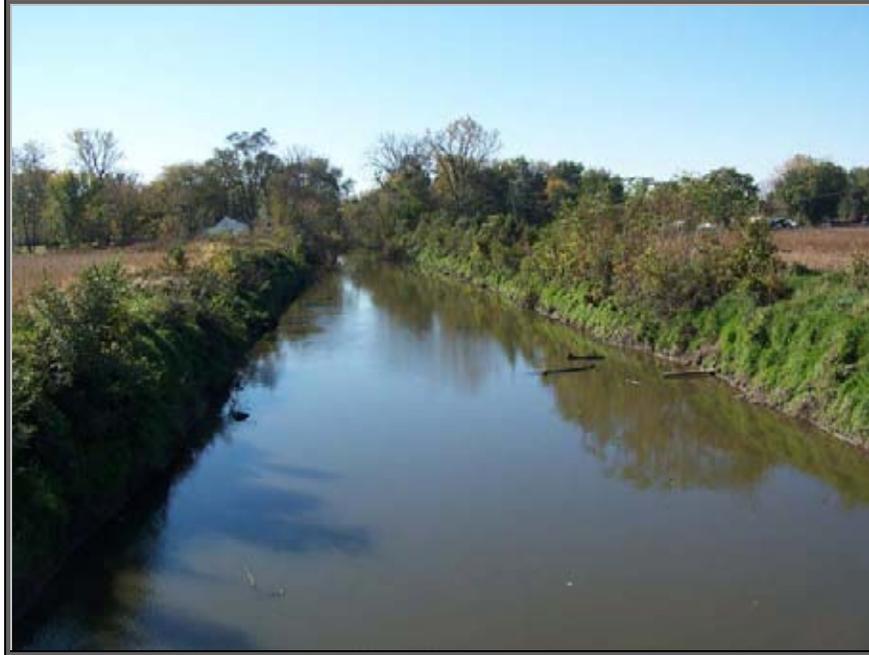
Figure 42 (SRS Location 15): Little Calumet River at sampling location 12 located along Central Avenue. This is the boundary between the Little Calumet River/Deep River Watershed and the Willow Creek/Burns Ditch Watershed.

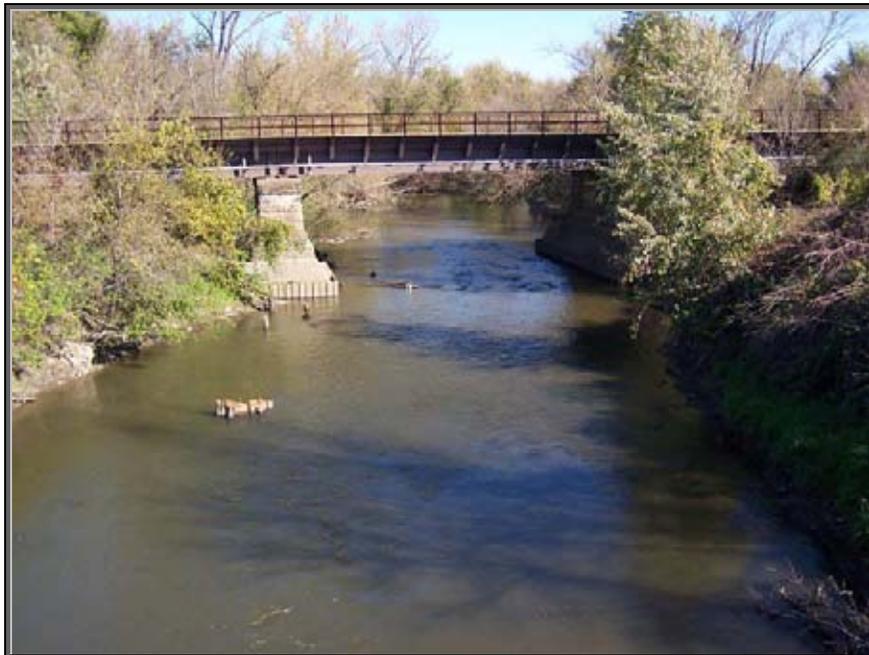
Figure 43 (SRS Location 15): The Little Calumet River (Burns Ditch) is very channelized in this area.

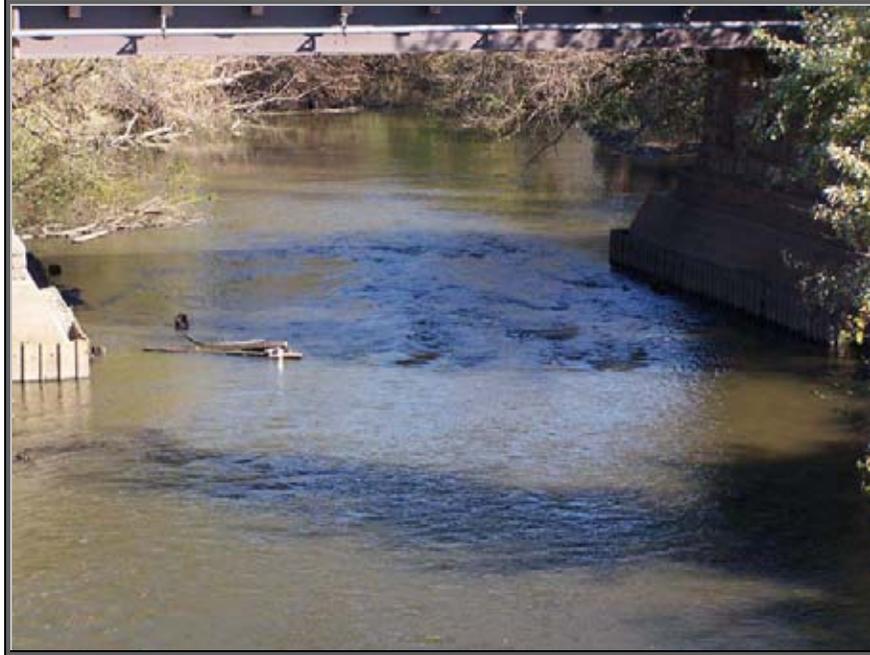
Figure 44 (SRS Location 15): Areas around sample location 12 have limited habitat due to the extensive channelization; however, many people can be seen fishing in this area.

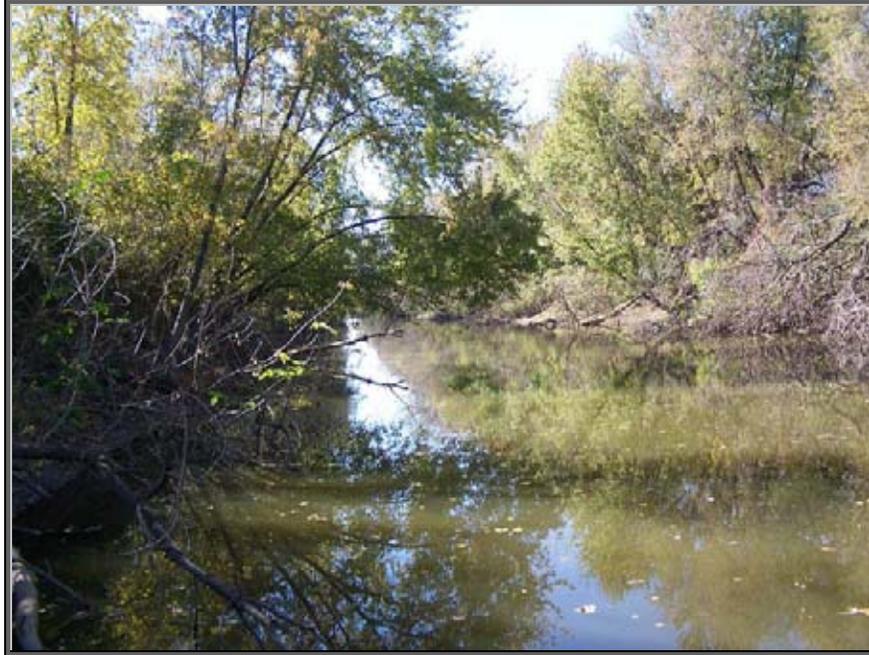
Figure 48 (SRS Location 17): Sampling location 8 is in a very channelized portion of the river where there is limited habitat and a lack of natural buffer.

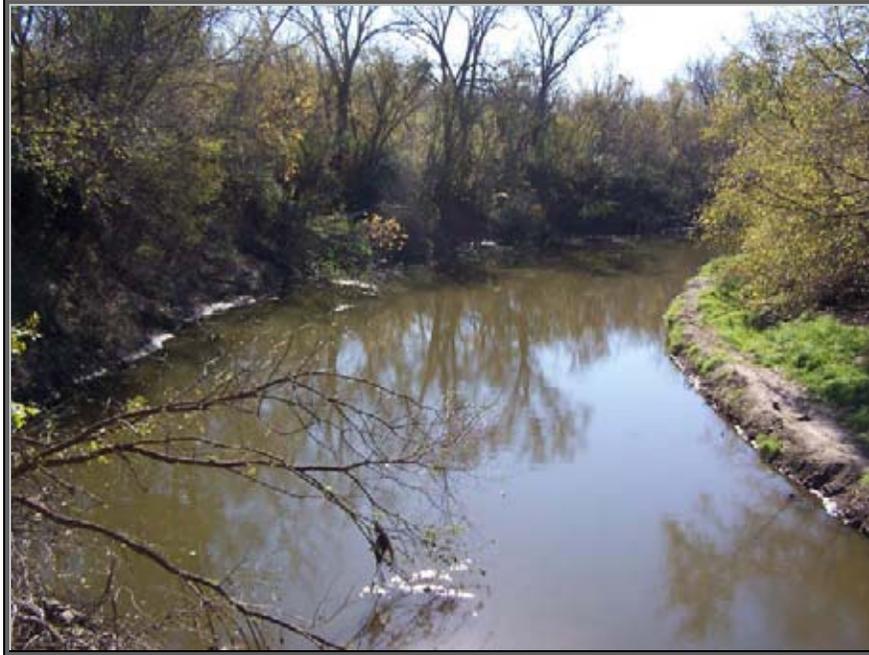
Figure 50 (SRS Location 18): Looking at the condition of the banks in this photo you can see that Burns Ditch is channelized in this sampling location, as is the rest of the Ditch.

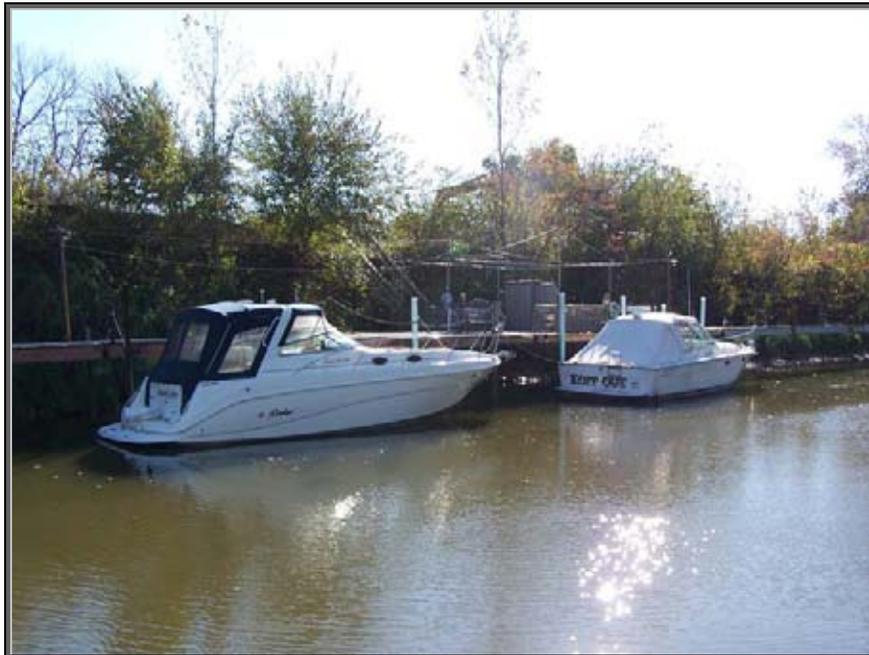
Figure 53 (SRS Location 19): This area is still very channelized with a minimal amount of natural buffer being offered, despite the boats being able to dock in the area.

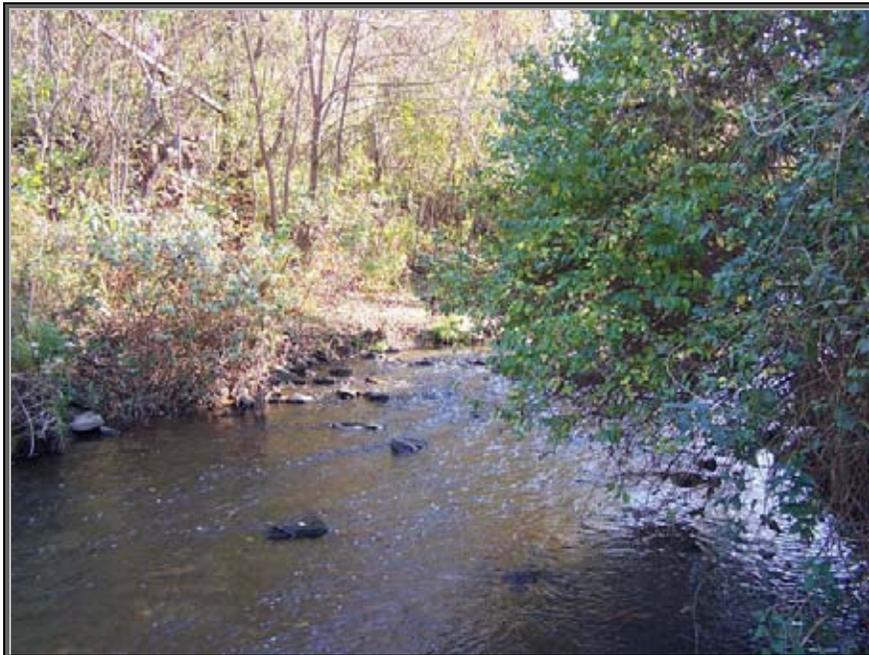
Figure 57 (SRS Location 31): Due to the natural buffer and the fact that Willow Creek has not been channelized sample location 5 can support local habitat.

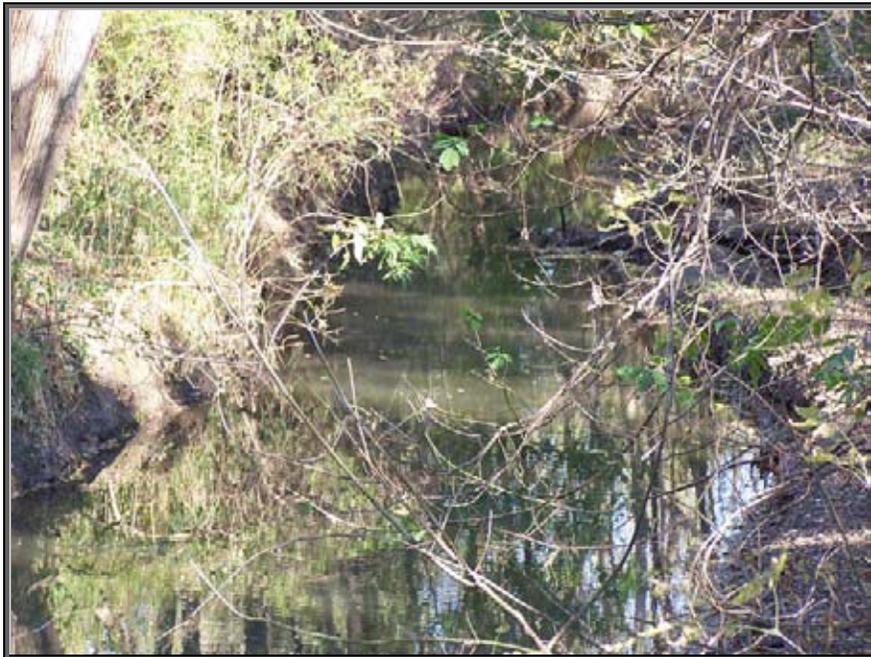
Figure 59 (SRS Location 30): Willow Creek in this location has a narrow spread but riffles and pools are beginning to be seen in this area and therefore it will support habitat.

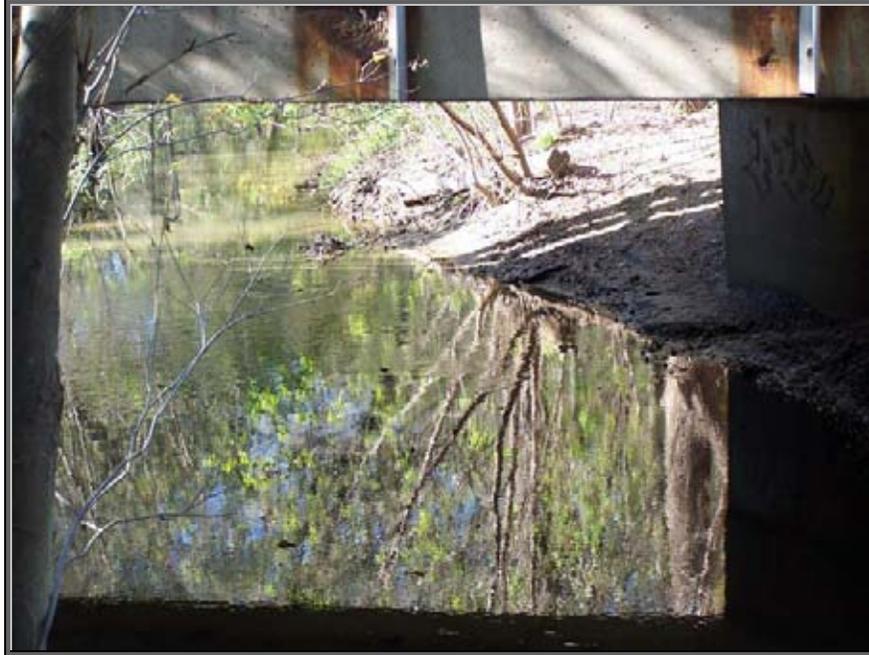
Figure 60 (SRS Location 30): Looking underneath the bridge at sample location 4 you can see the bank that provides a good natural buffer.

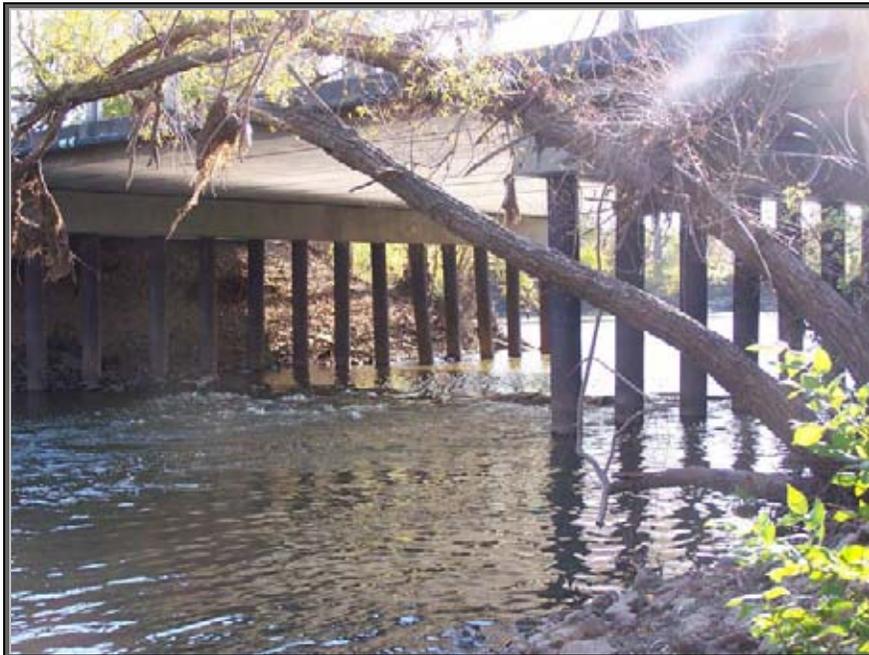
Figure 63 (SRS Location 20): Deep River is in a better condition than the Little Calumet River due to the unaltered state.

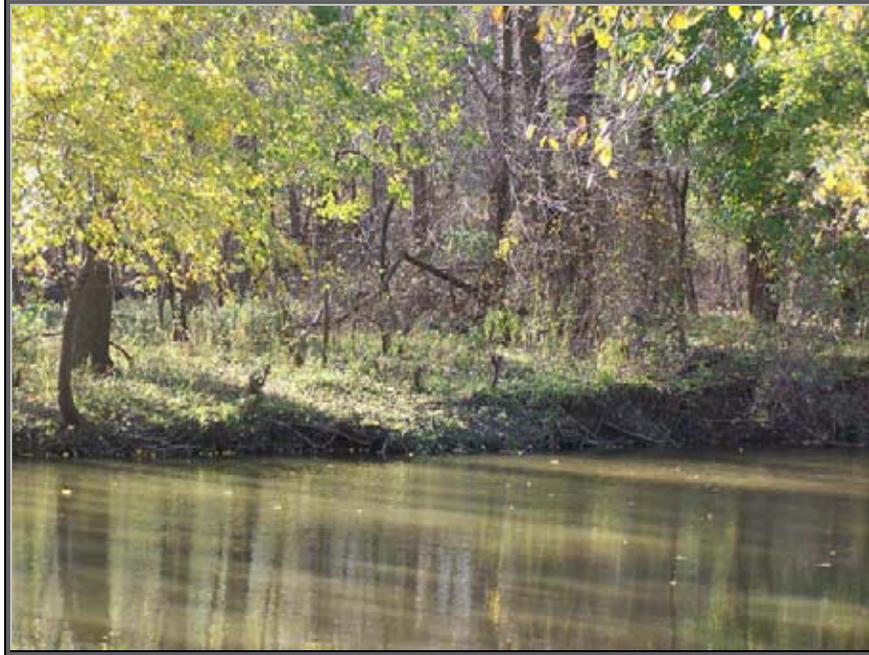
Figure 66 (SRS Location 22): There is excellent habitat in the area and in general Deep River is nicer than the Little Calumet River due to its unaltered state.

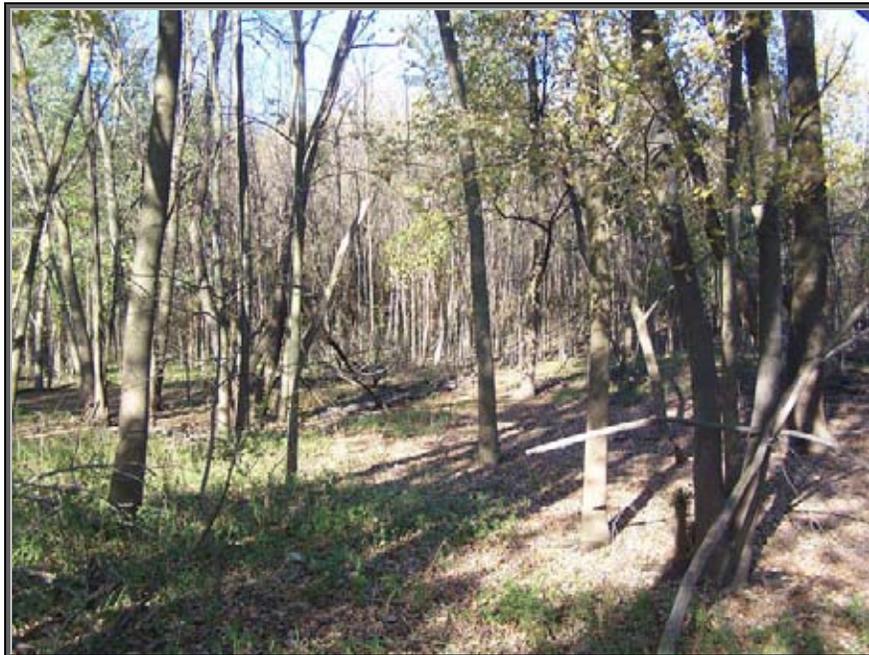
Figure 67 (SRS Location 22): This photo shows the excellent natural buffer that exists at sample location 24 along Deep River.

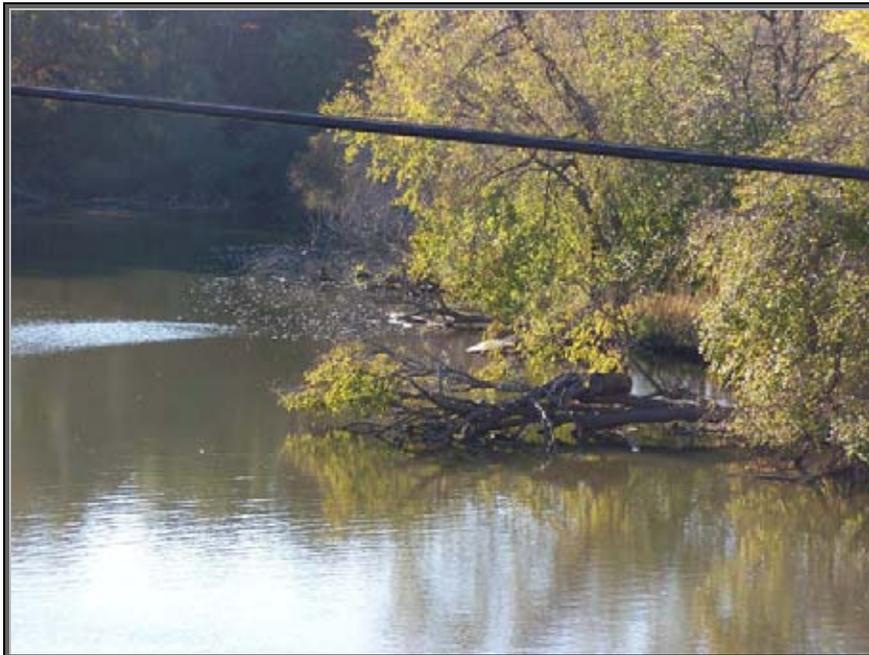
Figure 69 (SRS Location 26): The stream banks in this location are still in a natural state and offer great protection for local habitat.

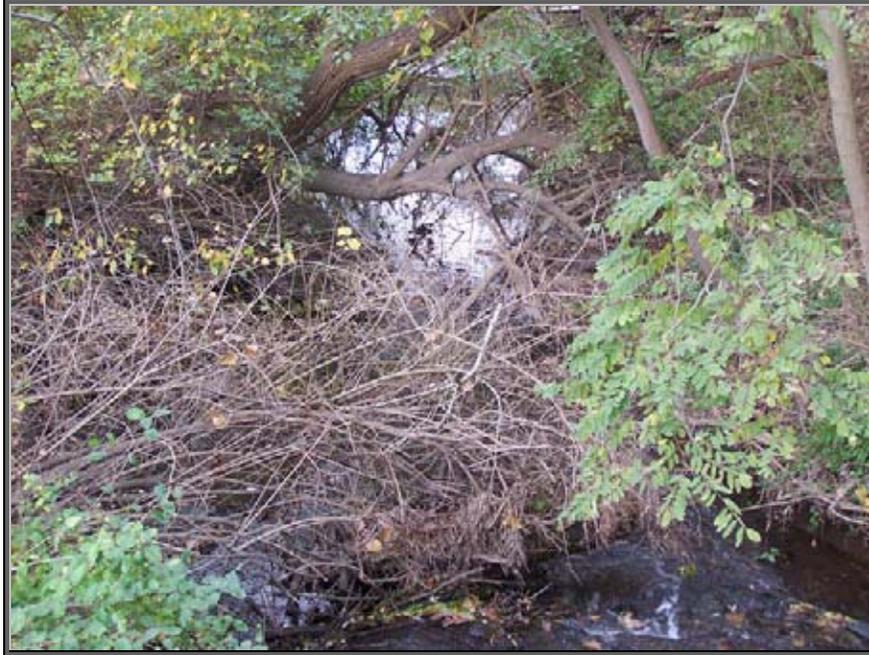
Figure 76 (SRS Location 23): This Deep River tributary is a legal drain in Porter County but not in Lake County where this sampling location can be found.

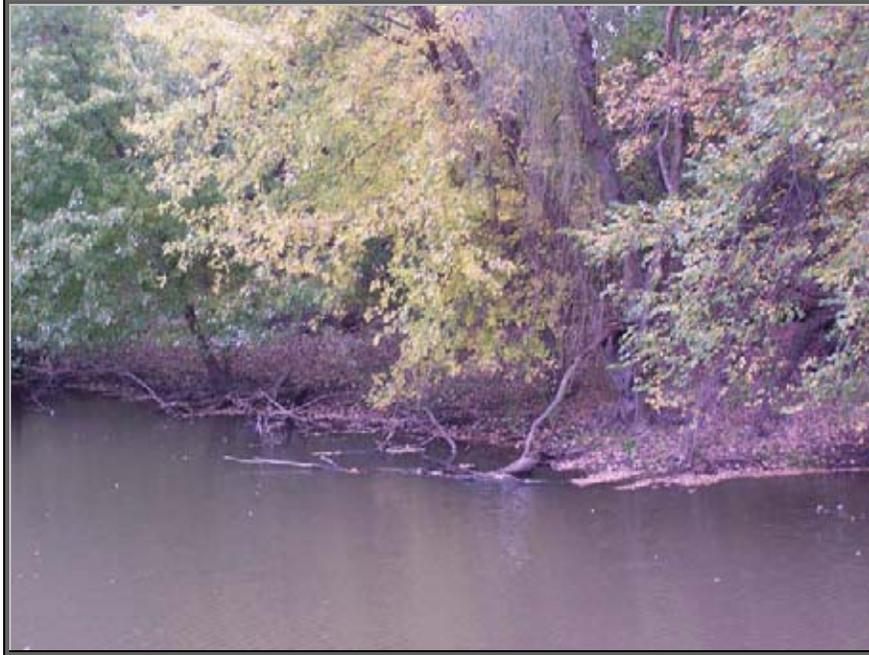
Figure 78 (SRS Location 24): Deep River is not channelized and has a good natural buffer associated with it in this area.

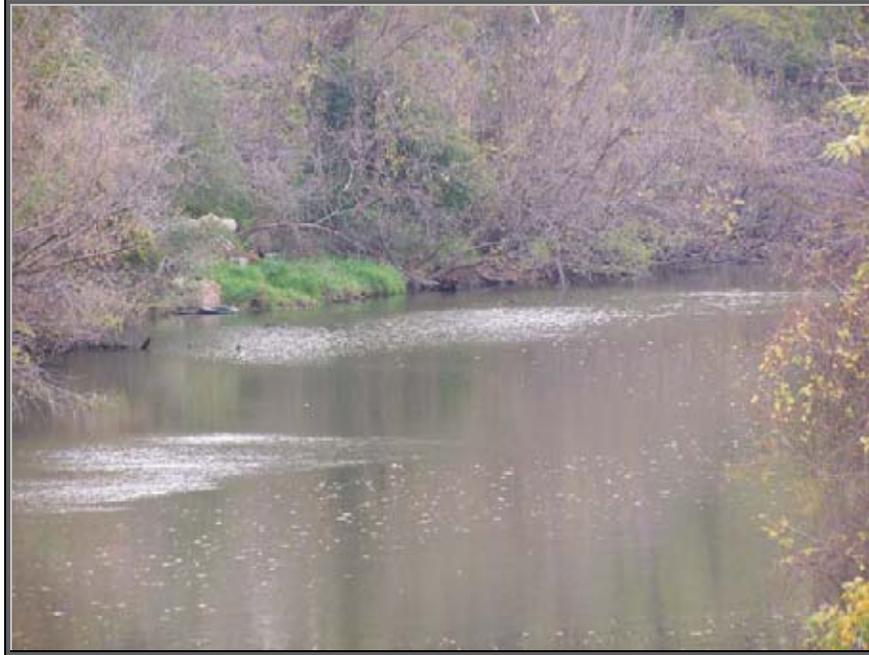
Figure 82 (SRS Location 25): The free movement of Deep River can be seen as the width varies and the natural landscape is still present around sample location 28.

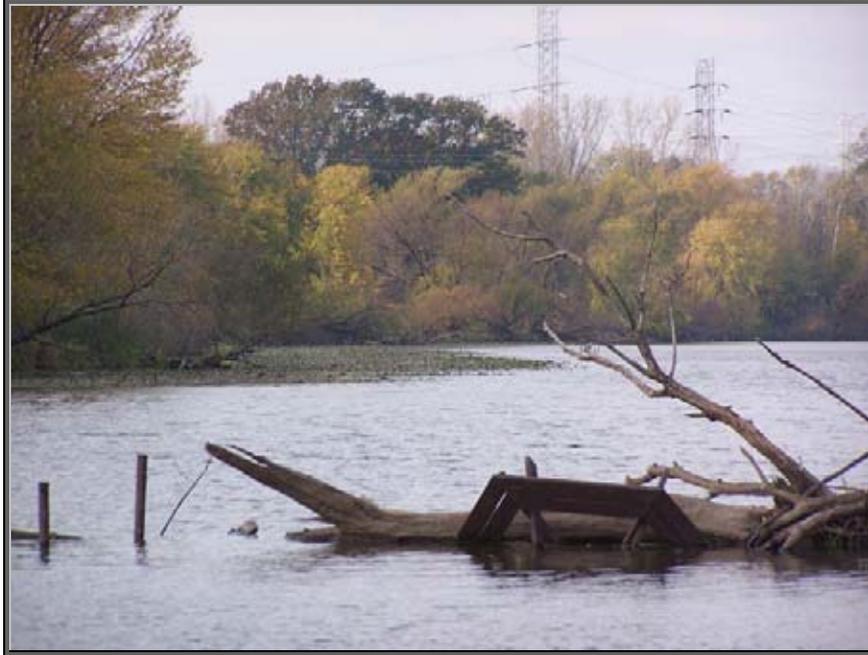
Figure 84 (SRS Location 27): This portion of Deep River is not considered to be a legal drain in Lake County so debris is expected to be found in some areas.

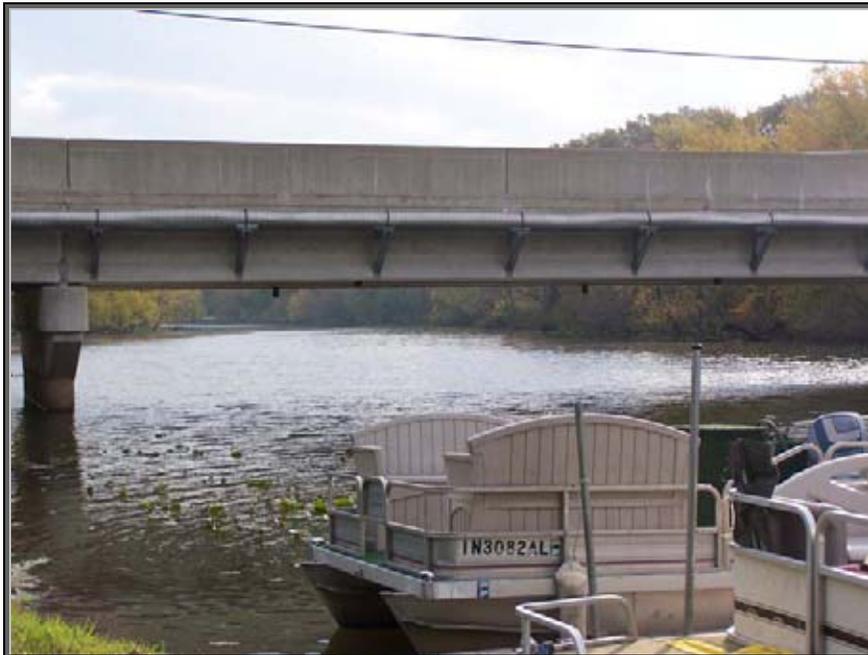
Figure 85 (SRS Location 27): Deep River has excellent habitat and good recreational value. Fishing boats are no surprise to be found in this area.

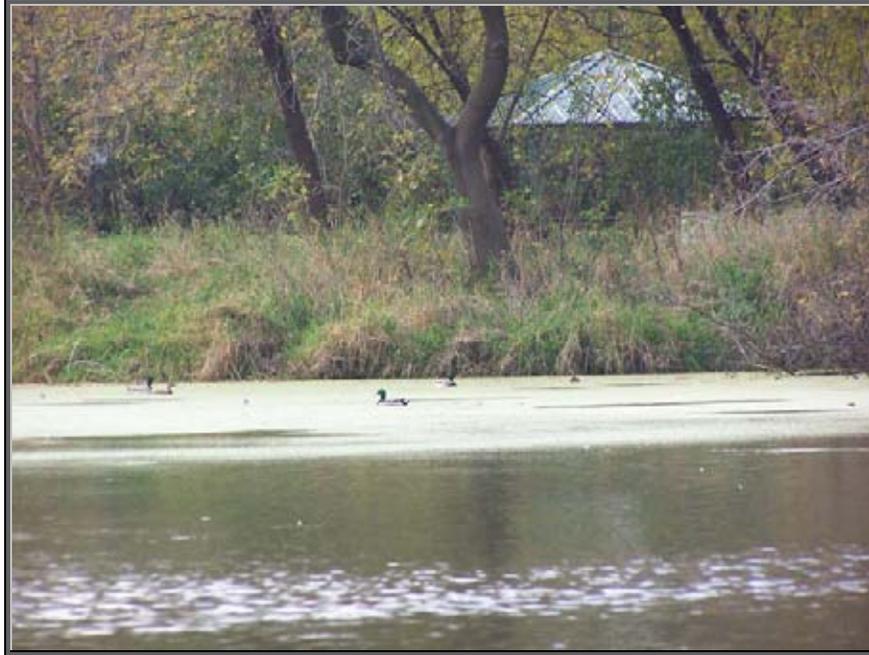
Figure 86 (SRS Location 3): On the Highland-Hammond border Cline Oxbow Park can be found. A portion of this park is located north of the Little Calumet River and some on the south bank of the river. A large variety of habitat can be found in this beautiful recreational area.

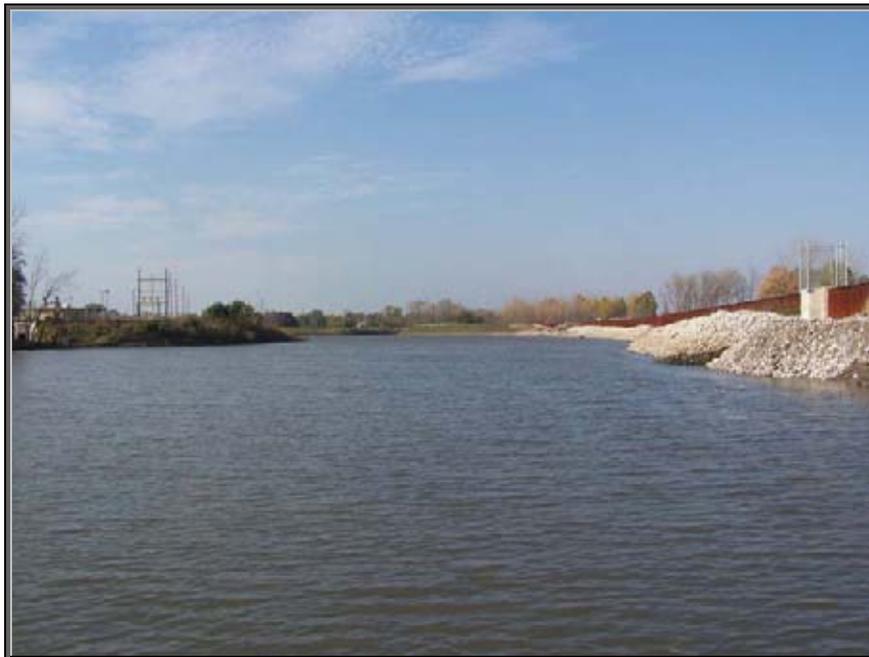
Figure 103 (SRS Location 4): Cline Oxbow Park from the levee system surrounding it.

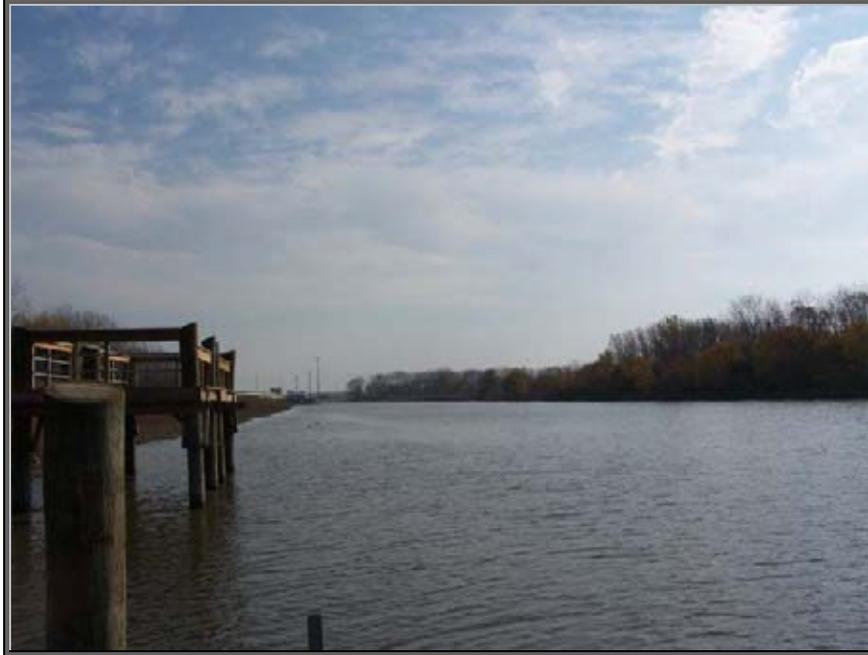
Figure 104 (SRS Location 4): Cline Oxbow Park from the levee system.

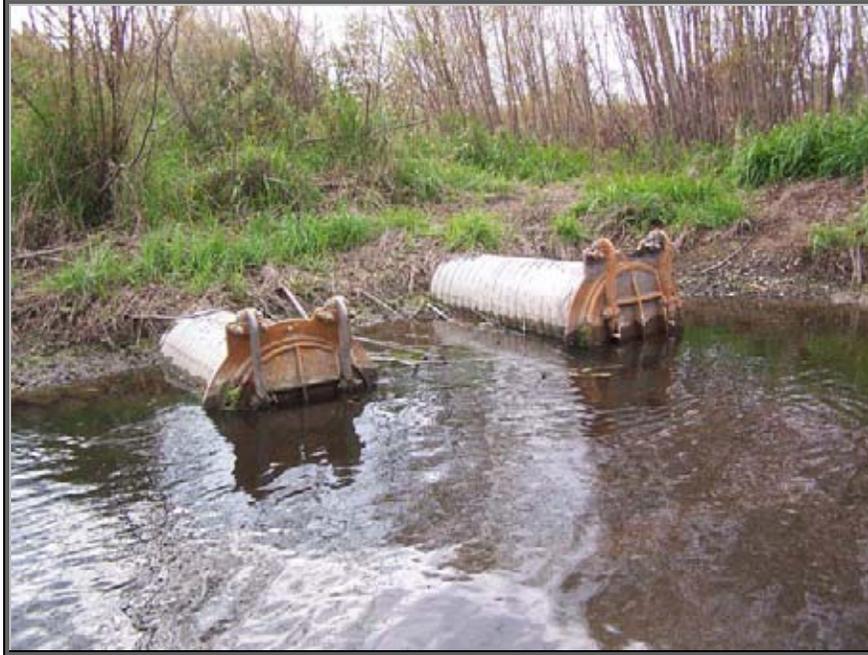
Figure 112 (SRS Location 10): Storm inlets located along Grant Street draining into the Little Calumet River.
