# Appendix 16

## Stream Reach Survey Photos

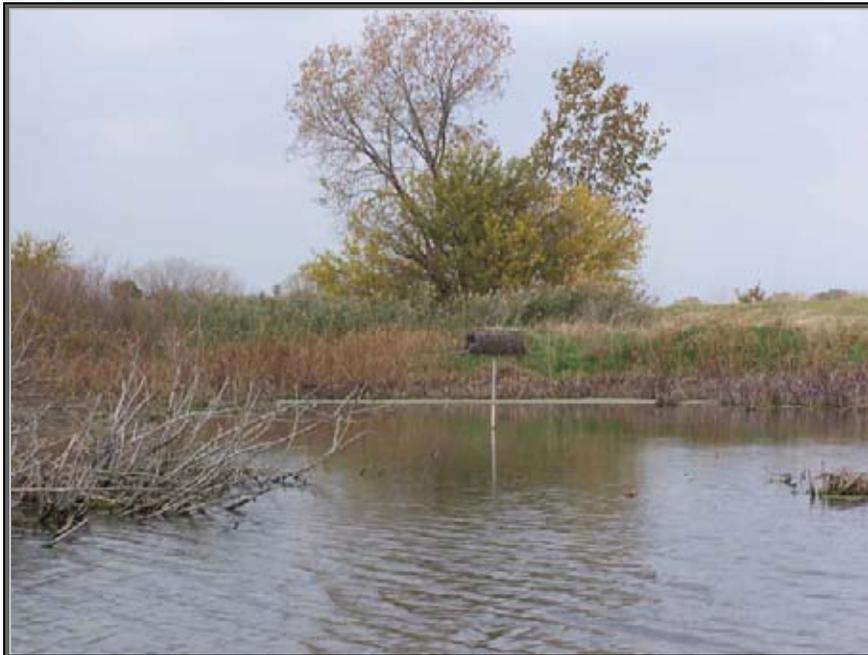
Figure 113 (SRS Location Grant Street): Photos stretching from Riverside Drive to Grant Street along the Little Calumet River, parallel to 29<sup>th</sup> Street.

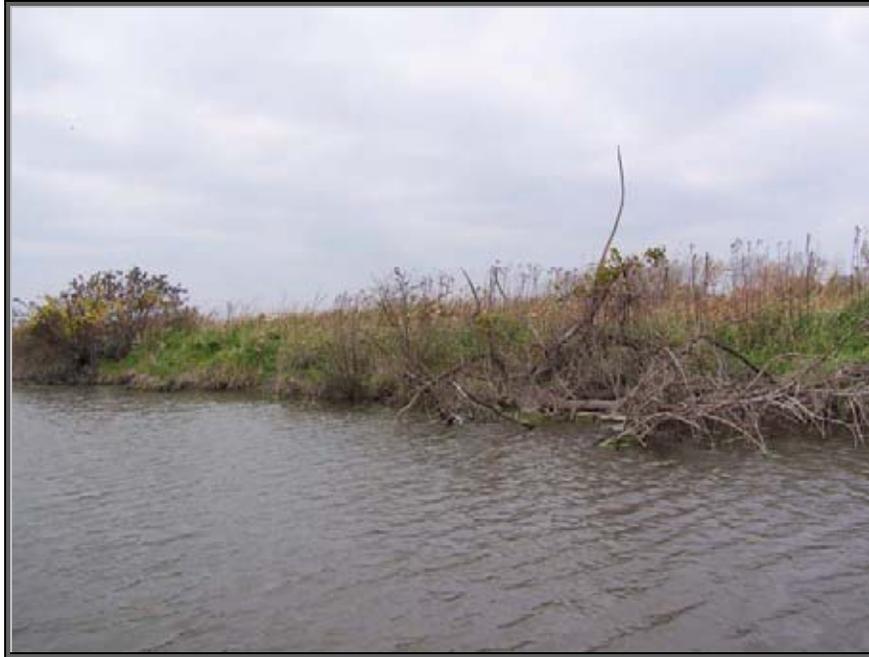
Figure 114 (SRS Location Grant Street): Photos stretching from Riverside Drive to Grant Street along the Little Calumet River, parallel to 29<sup>th</sup> Street.

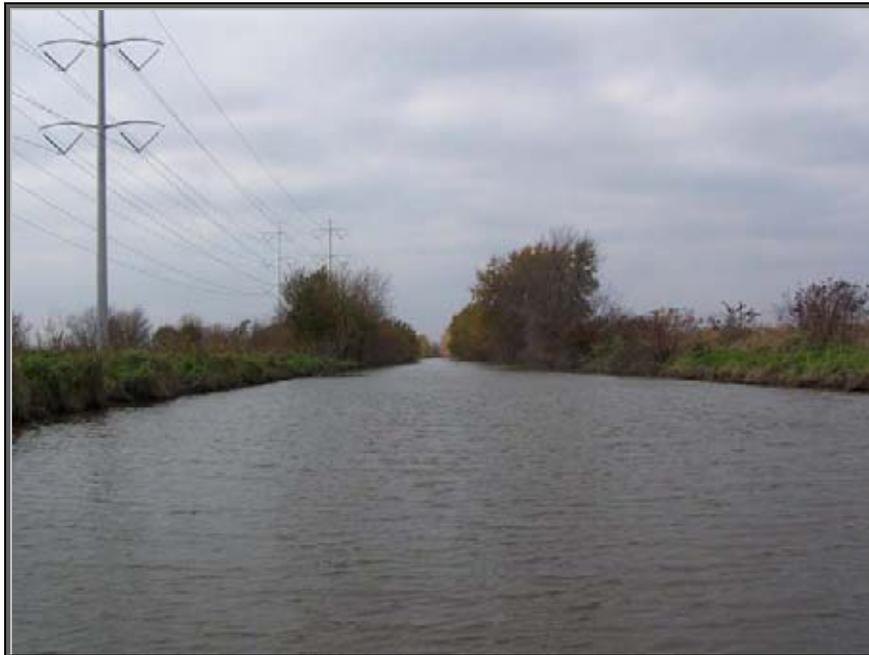
Figure 115 (SRS Location Grant Street): Photos stretching from Riverside Drive to Grant Street along the Little Calumet River, parallel to 29<sup>th</sup> Street.

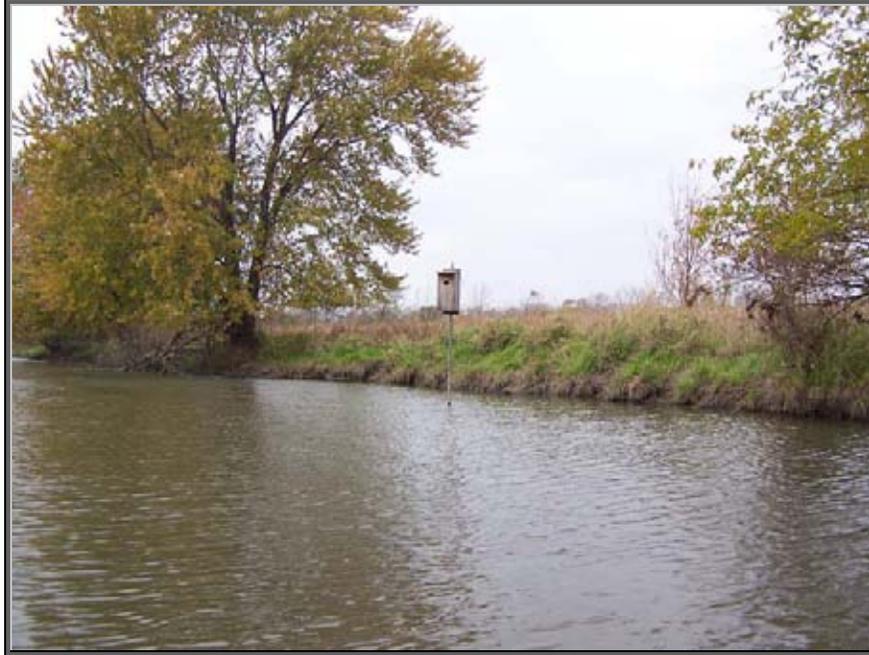
Figure 116 (SRS Location Grant Street): Photos stretching from Riverside Drive to Grant Street along the Little Calumet River, parallel to 29<sup>th</sup> Street.

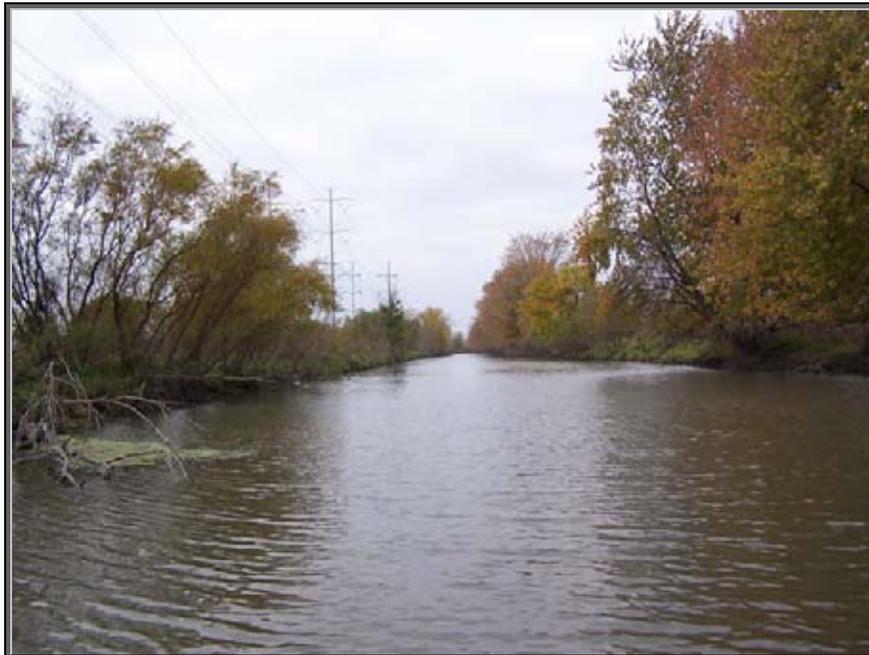
Figure 117(SRS Location Grant Street): Photos stretching from Riverside Drive to Grant Street along the Little Calumet River, parallel to 29<sup>th</sup> Street.

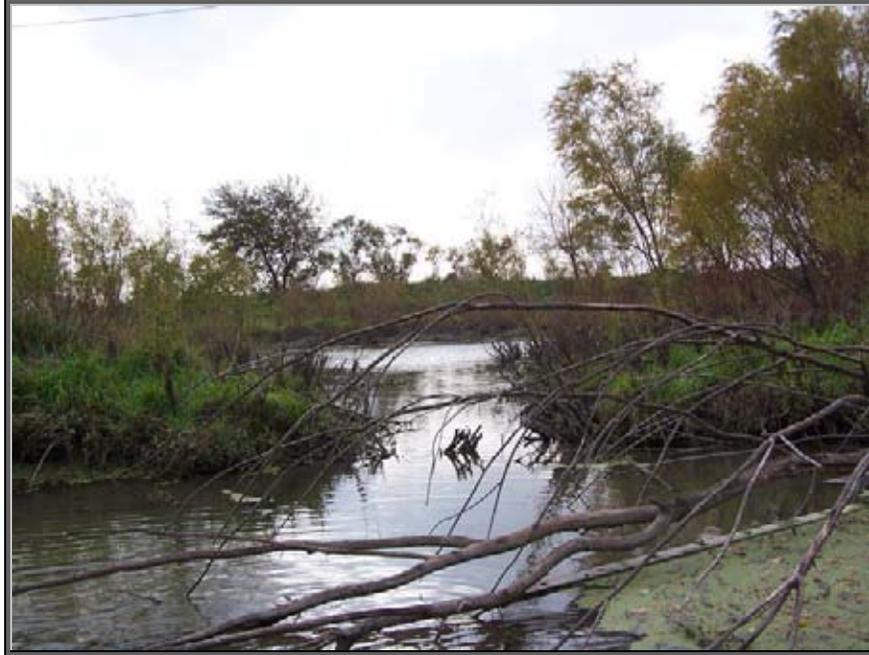
Figure 118 (SRS Location Grant Street): Photos stretching from Riverside Drive to Grant Street along the Little Calumet River, parallel to 29<sup>th</sup> Street.

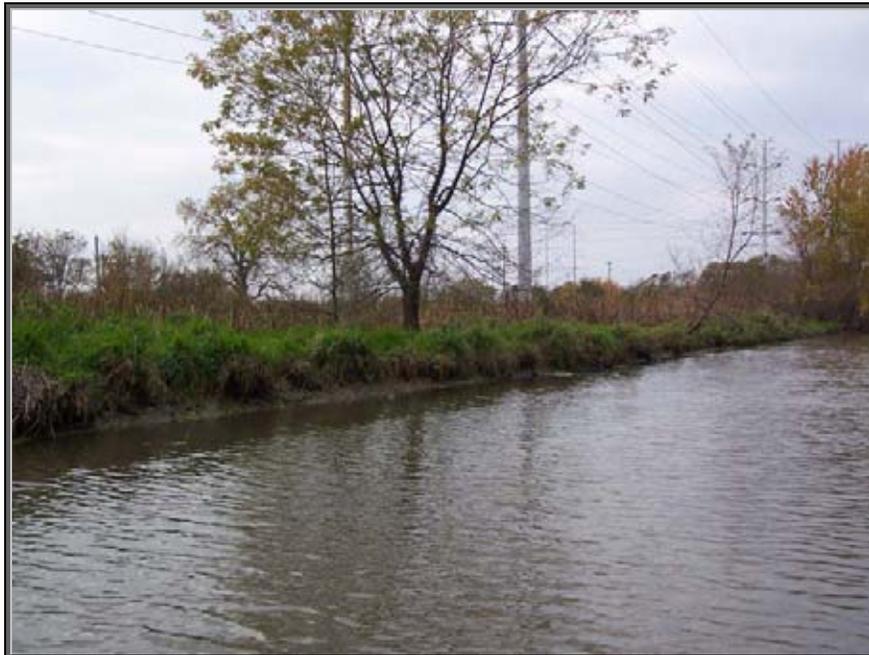
Figure 119 (SRS Location Grant Street): Photos stretching from Riverside Drive to Grant Street along the Little Calumet River, parallel to 29<sup>th</sup> Street.

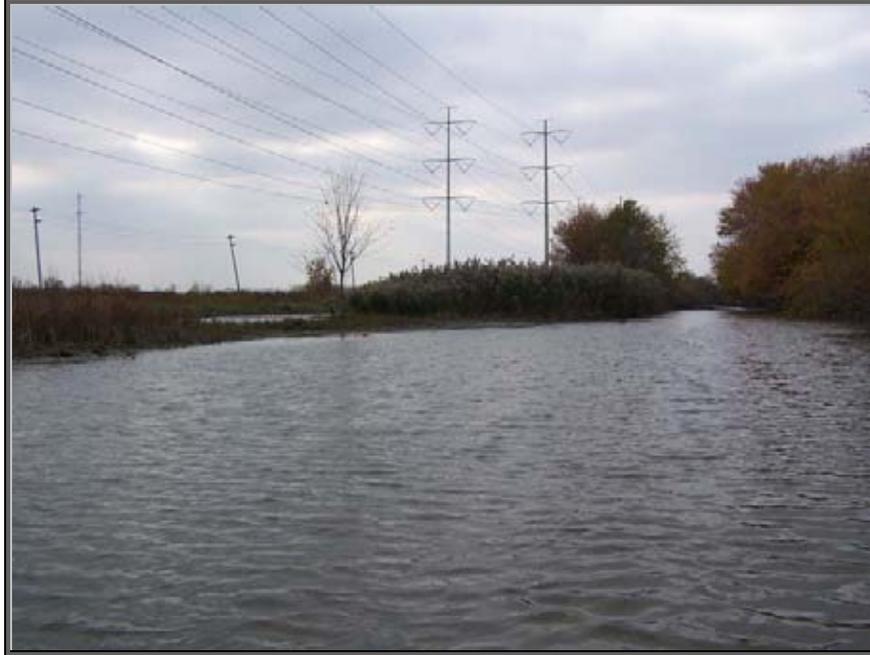
Figure 120 (SRS Location Grant Street): Photos stretching from Riverside Drive to Grant Street along the Little Calumet River, parallel to 29<sup>th</sup> Street.

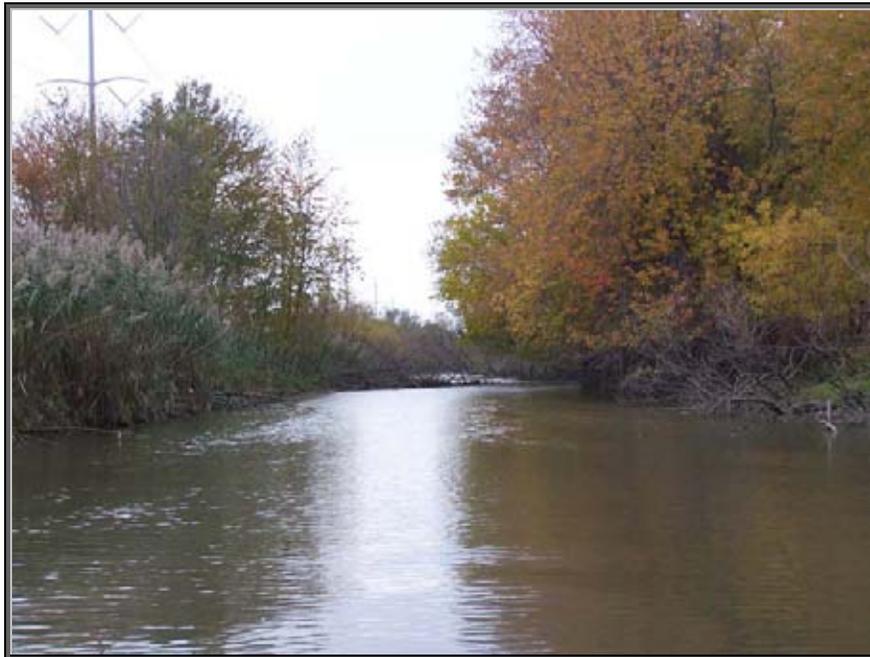
Figure 121 (SRS Location Grant Street): Photos stretching from Riverside Drive to Grant Street along the Little Calumet River, parallel to 29<sup>th</sup> Street.
