REMEDIATION WORK PLAN

RLF Subgrant – Arnolt Corporation
2525 Durbin Street
Warsaw, Kosciusko County, Indiana
Brownfield Site #4211002
Revolving Loan Fund RLF BF-00E48101-D

April 2022

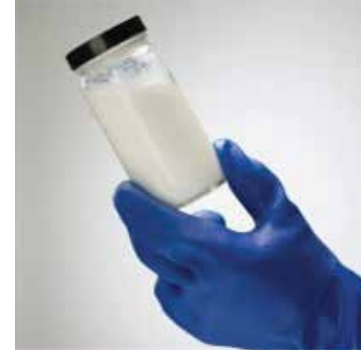
Example of 3-D Microemulsion

3-D Microemulsion (3DME®) is comprised of a patented molecular structure containing oleic acids (i.e., oil component) and lactates/poly lactates, which are molecularly bound to one another (figure 1). The 3DME molecule contains both a soluble (hydrophilic) and in-soluble (lipophilic) region. These two regions of the molecule are designed to be balanced in size and relative strength. The balanced hydrophilic/lipophilic regions of 3DME result in an electron donor with physical properties allowing it to initially adsorb to the aquifer material in the area of application, then slowly redistribute via very small 3DME “bundles” called micelles. These 3DME micelles spontaneously form within sections of the aquifer where concentrations of 3DME reach several hundred parts per million. The micelles’ small size and mobility allow it to move with groundwater flow through the aquifer matrix, passing easily through the pore throats in between soil grains resulting in the further redistribution of 3DME within the aquifer. This allows for advective distribution of the oleic acids which are otherwise insoluble and unable to distribute in this manner, allowing for increased persistence of the lactate/poly lactates component due to their initial attachment to the oleic acids.

FIGURE 1: THE 3-D MICROEMULSION MOLECULAR STRUCTURE

Suspension of 3DME generated by this mixing range from micelles on the order of .02 microns to .05 microns in diameter, to “swollen” micelles, (termed “microemulsions”) which are on the order of .05 to 5 microns in diameter. Once injected into the subsurface in high volumes, the colloidal suspension mixes and dilutes in existing pore waters. The micelles/microemulsions on the injection front will then begin to sorb onto the surfaces of soils as a result of zeta potential attraction and organic matter within the soils themselves. As the sorption continues, the 3DME will “coat” pore surfaces developing a layer of molecules and in some cases a bilayer. This sorption process continues as the micelles/microemulsion moves outward and disassociates into their hydrophilic/hydrophobic components. The specialized chemistry of 3DME results in a staged release of electron donors: free lactate (immediate); polylactate esters (mid-range) and free fatty acids & fatty acid esters (long-term). Material longevity of three years or greater has been seen at most sites as determined from biogeochemical analyses.
