January 2025 to December 2025

ANNUAL STATE OF THE ITR REPORT

This 2025 Indiana Toll Road (ITR) *Annual State of the ITR Report* has been prepared in accordance with the Amended and Restated *Concession and Lease Agreement* (CLA) for the Indiana Toll Road.

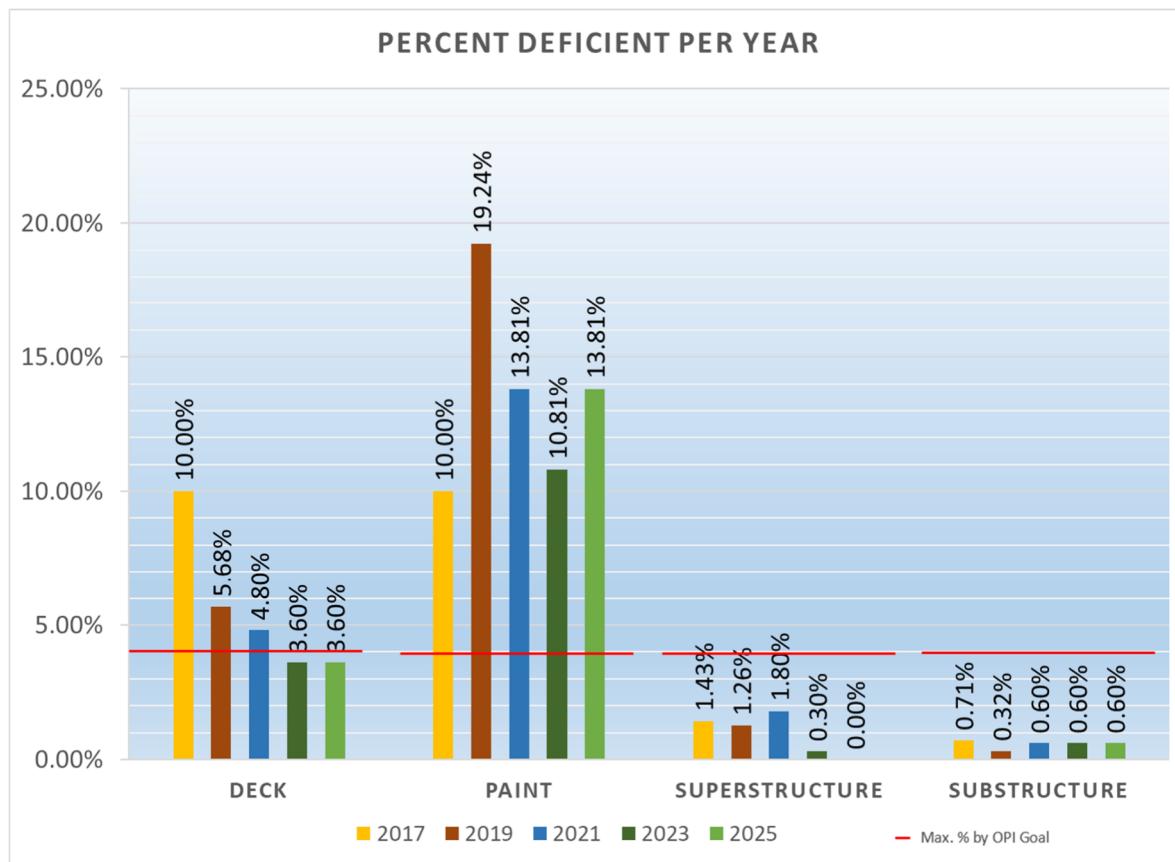
Figure 1.1: Bridge Condition Ratings

The 2025 inspections for the state of the ITR structures have maintained relatively consistent with the 2023 inspection data. A much lower Wearing Surface deficiency percentage has been reported. Deck, Superstructure, and Substructure have remained nearly the same.

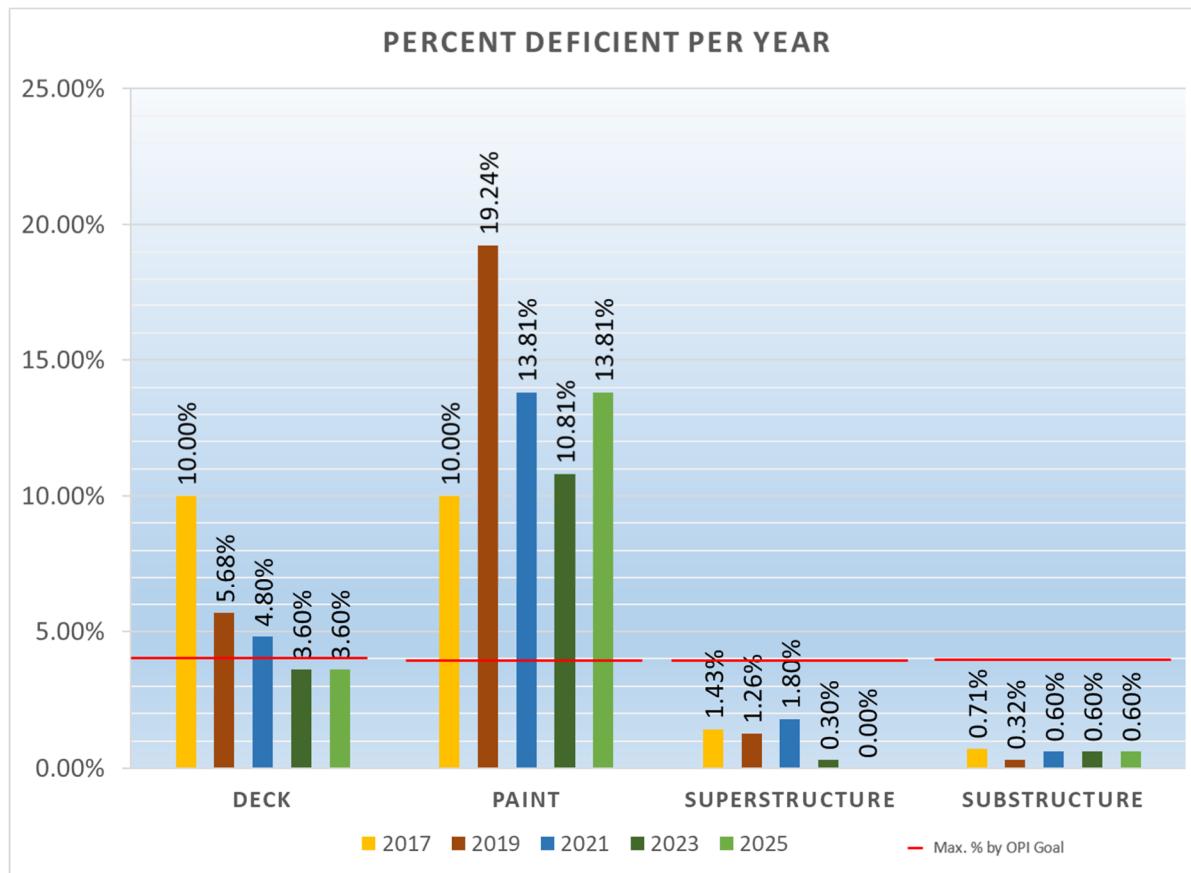
Figure 3.0: Bridge Condition Ratings illustrates that the overall decrease in deficiencies in several of the individual items compared to previous years has continued once again in 2025. This pattern is due to the implementation of the PUSH projects and additional job order contracts. The four phases of PUSH have addressed over 35% of the structures within the ITR corridor.

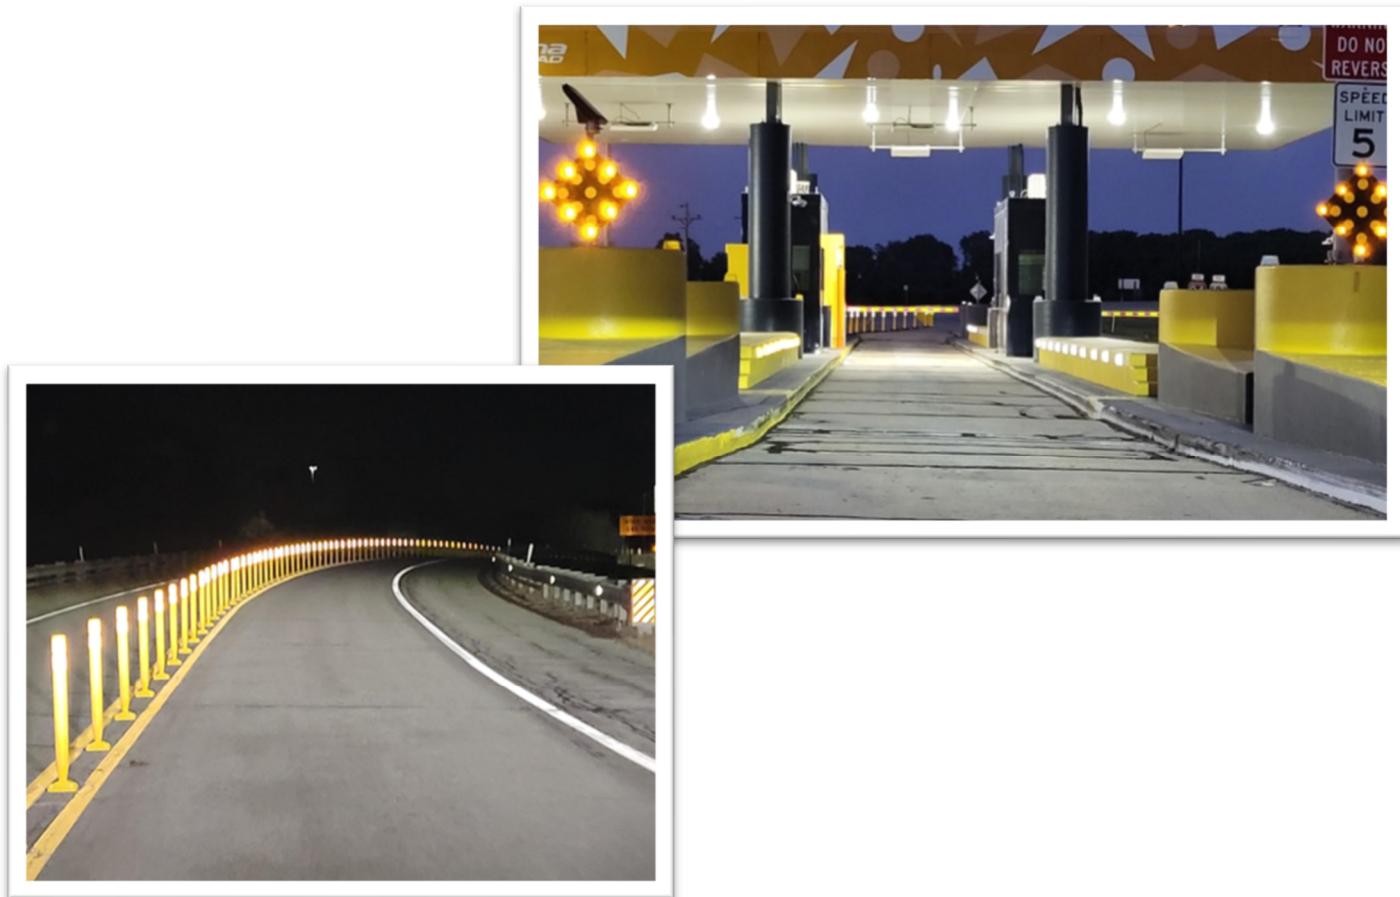
As part of an ongoing effort by the ITR to increase roadway delineation and highway safety toll plazas received additional channeling devices placed in the medians of the approaches of the tolling booths. These include the use of water wall at the mainline toll plazas at West Point, Portage, and Eastpoint, and candlestick reflectors at the entrance/exit toll plazas. These permanent devices increase safety for the traveling public as well as help to delineate the roadway for maintenance operations during major weather events. The below pictures represent the devices placed at

mainline and entrance/exit toll plazas.

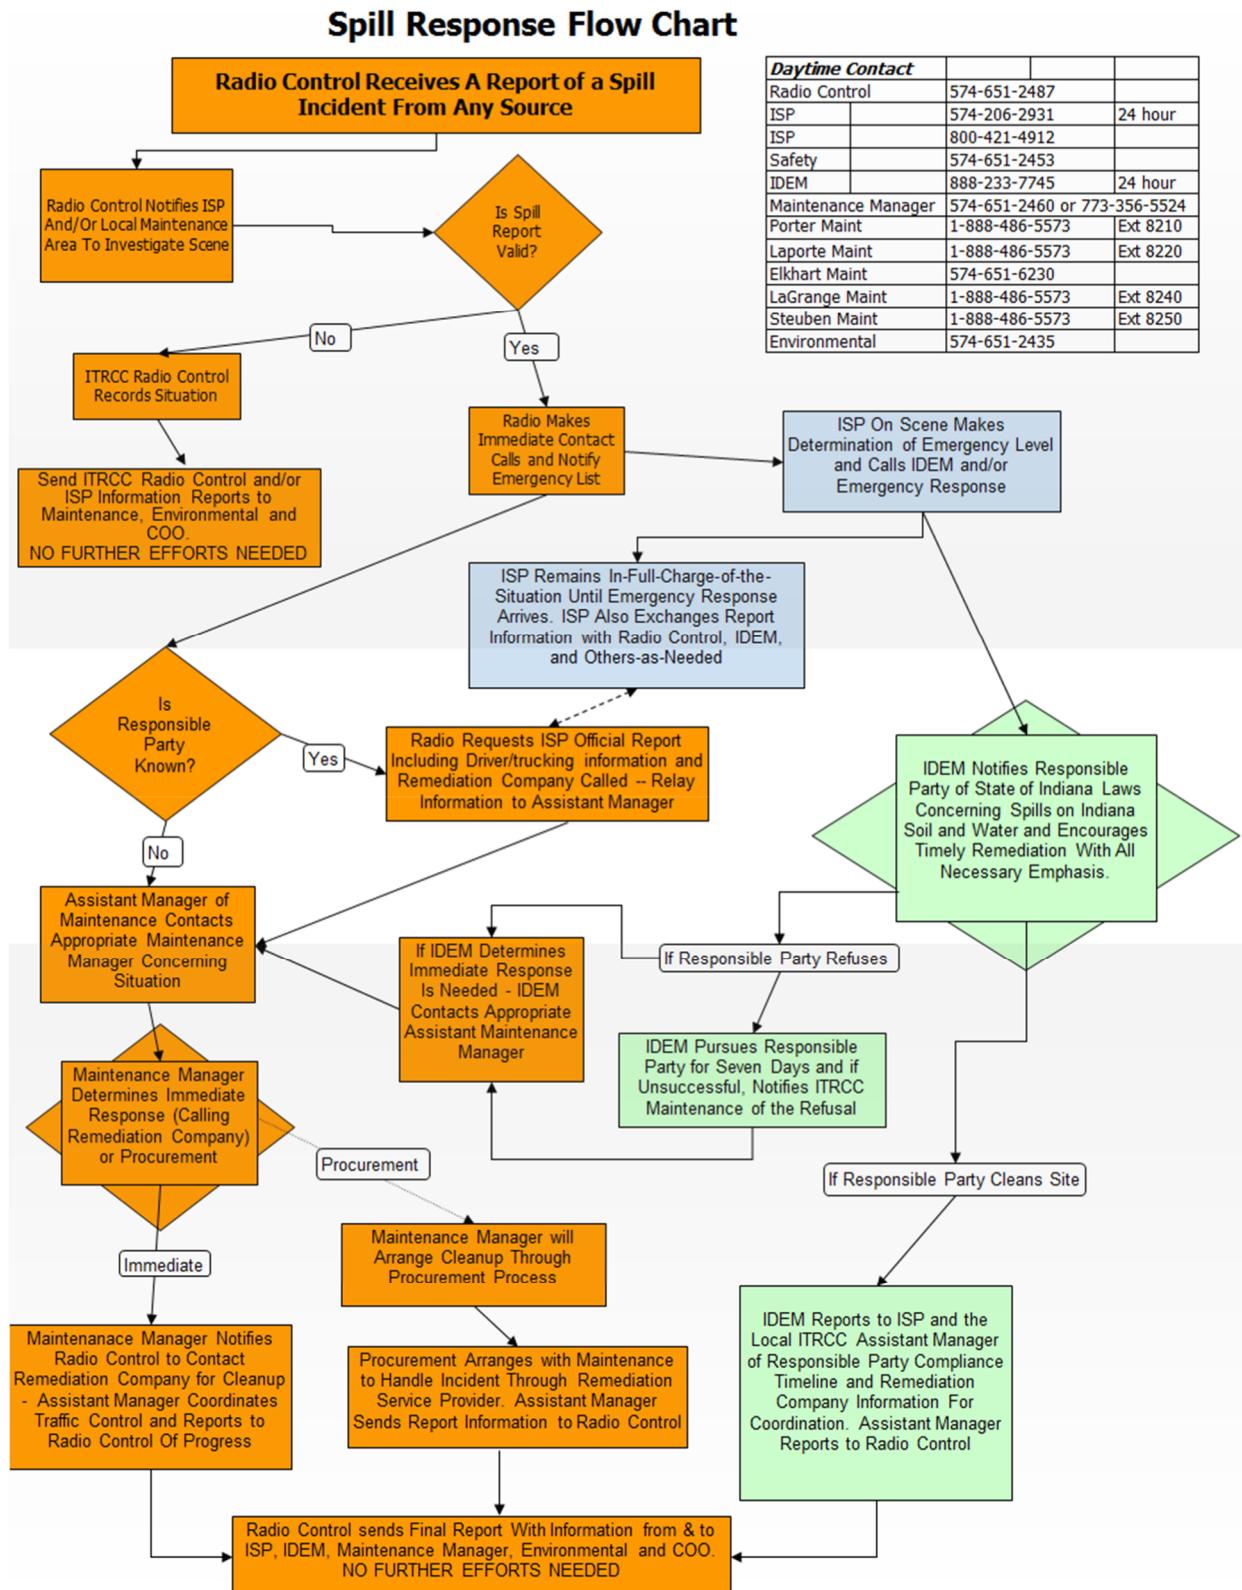
Figure 7.2: Spill Response Flow Chart

Each reported incident is added to a spill incident tracking spreadsheet kept on the ITRCC network L drive. The spill tracking spreadsheet includes information such as the date, location, type of spill or release, responsible party, IDEM Incident number, and other additional information. All major spills are handled by a third-party spill response contractor hired by either the ITRCC or responsible party. In general, the spill response contractor or the responsible party will forward the spill cleanup report to the ITRCC, however not all of
