SUBGRADE STABILITY CHALLENGES WITH RUBBLIZE AND ROLL PAVEMENT REHABILITATION

Christopher Merklin, PE, Administrator, ODOT
Office of Geotechnical Engineering

Department of
Transportation

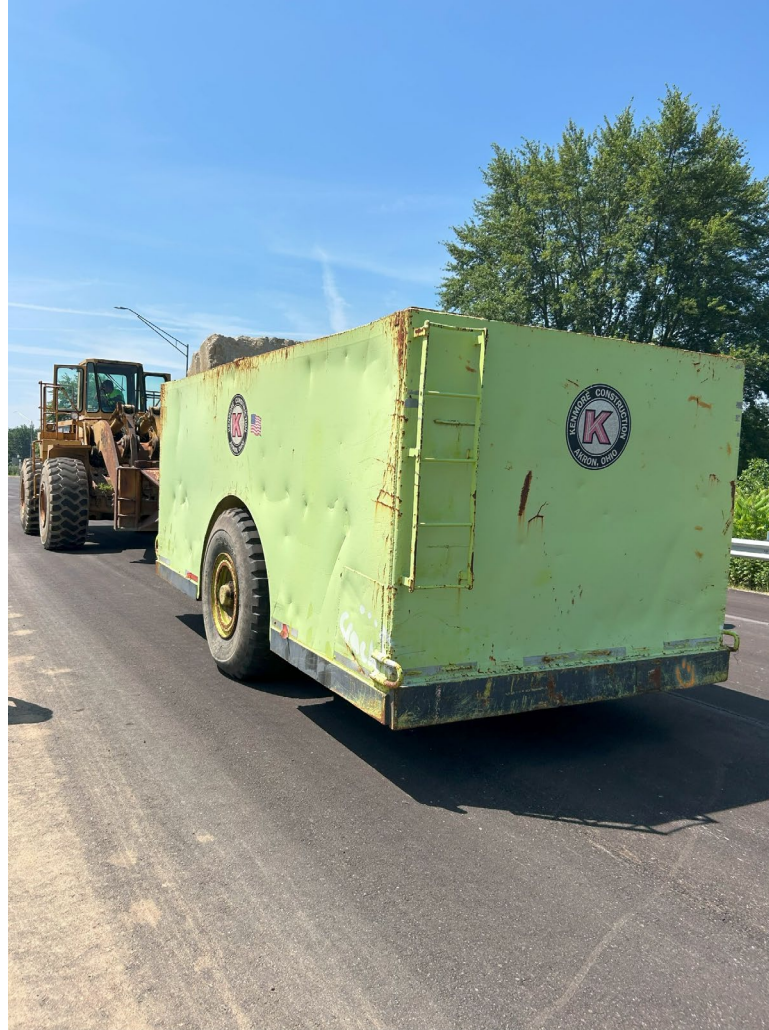
HOW DID WE GET HERE?

- Major arterial route – 6 miles of major rehab
 - 4-Lane divided road
 - 2 Proposed R-cut intersections, 2 Proposed at grade intersections, 4 Bridge rehabilitations
 - \$30M DB contract, but...
 - ODOT performs borings, designs pavement (9" Rubblize and Roll, 7.25" asphalt), intersections, etc.
 - Full depth replacement at outside shoulder widenings, intersections, bridge approaches with 14" cement stabilization

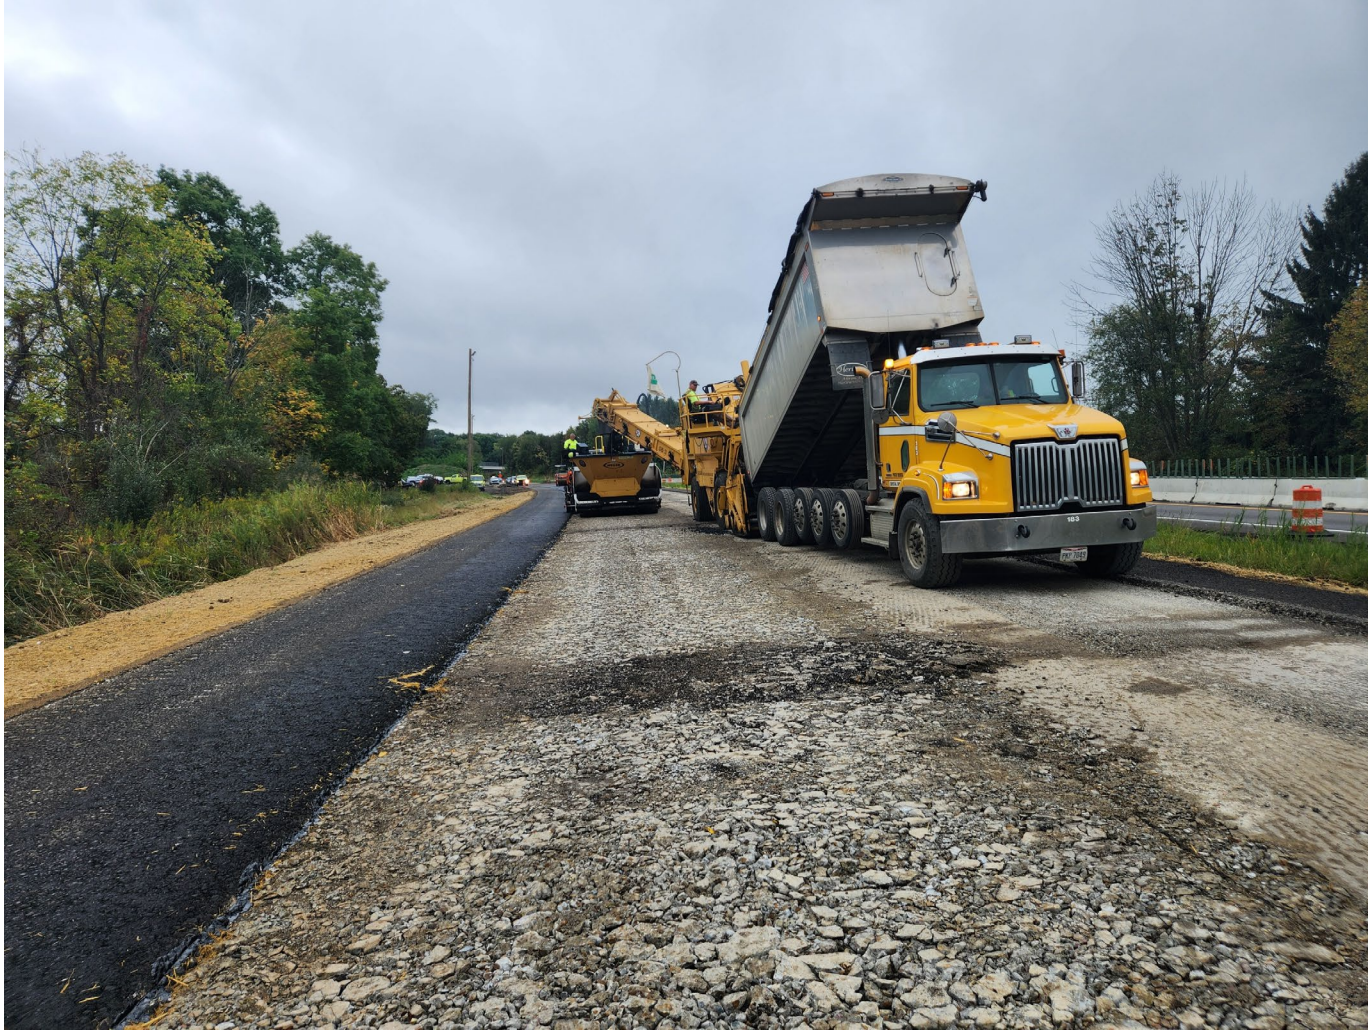
- Rubblize and Roll requirements
 - $\geq 75\%$ with maximum dimension < 3 inches above steel
 - $\geq 90\%$ with maximum dimension < 9 inches below steel (100% < 12 inches)
- All of the rubblized concrete met the gradation requirements, so no problem with the subgrade, right?

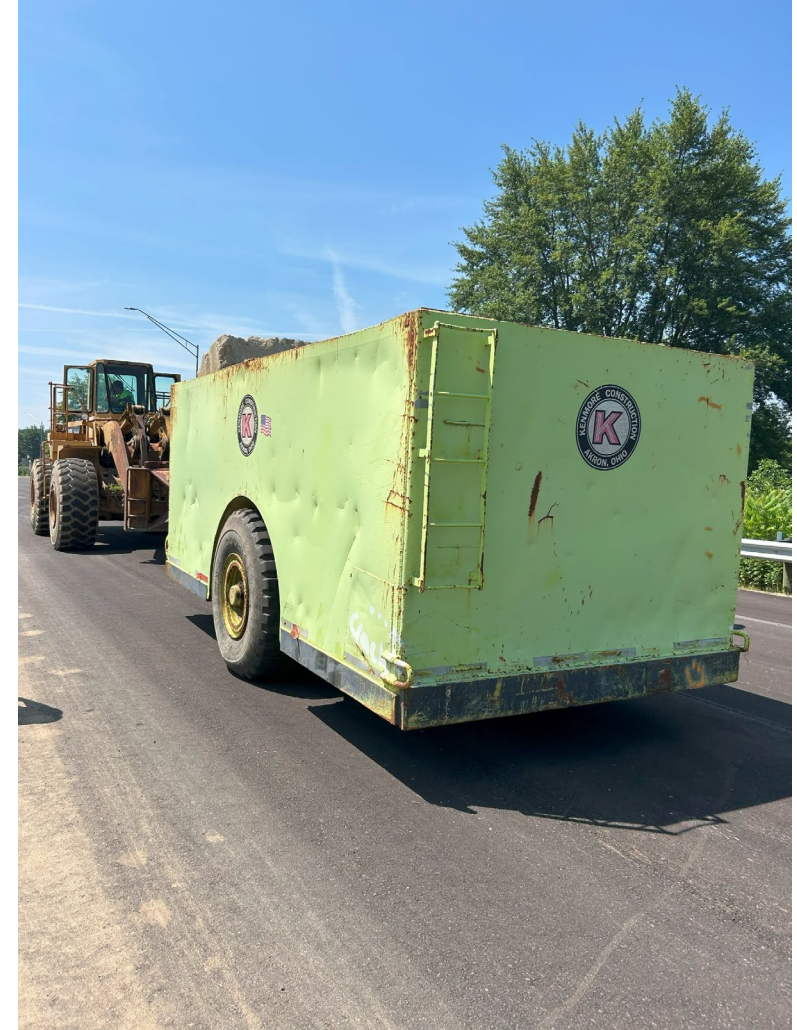
- Now you know how we got here
- 7/14/2025 – Proof roll 5 miles of pavement
- Much improved in the last month (drainage?)
- Isolated (and few) 1/8-1/4” deflection

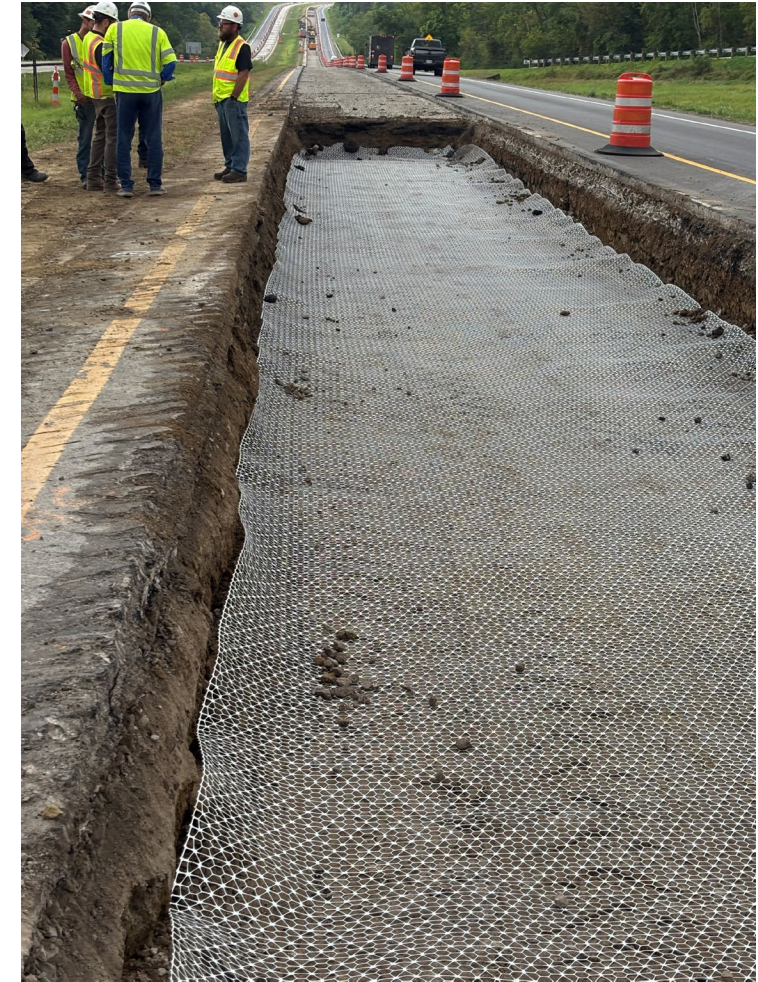
- Geogrid QPL – Type 2
 - Tensar SQ2020
 - \$2.75/SY installed
- Interax NX750
 - \$9.13/SY installed
 - “We observed some slight waving / rolling...due to pore pressure”
