Waters of the U.S. Report Excerpts

SR 912 and Michigan Avenue Bridges Project

Lake County, Indiana

WATERS OF THE U.S. REPORT

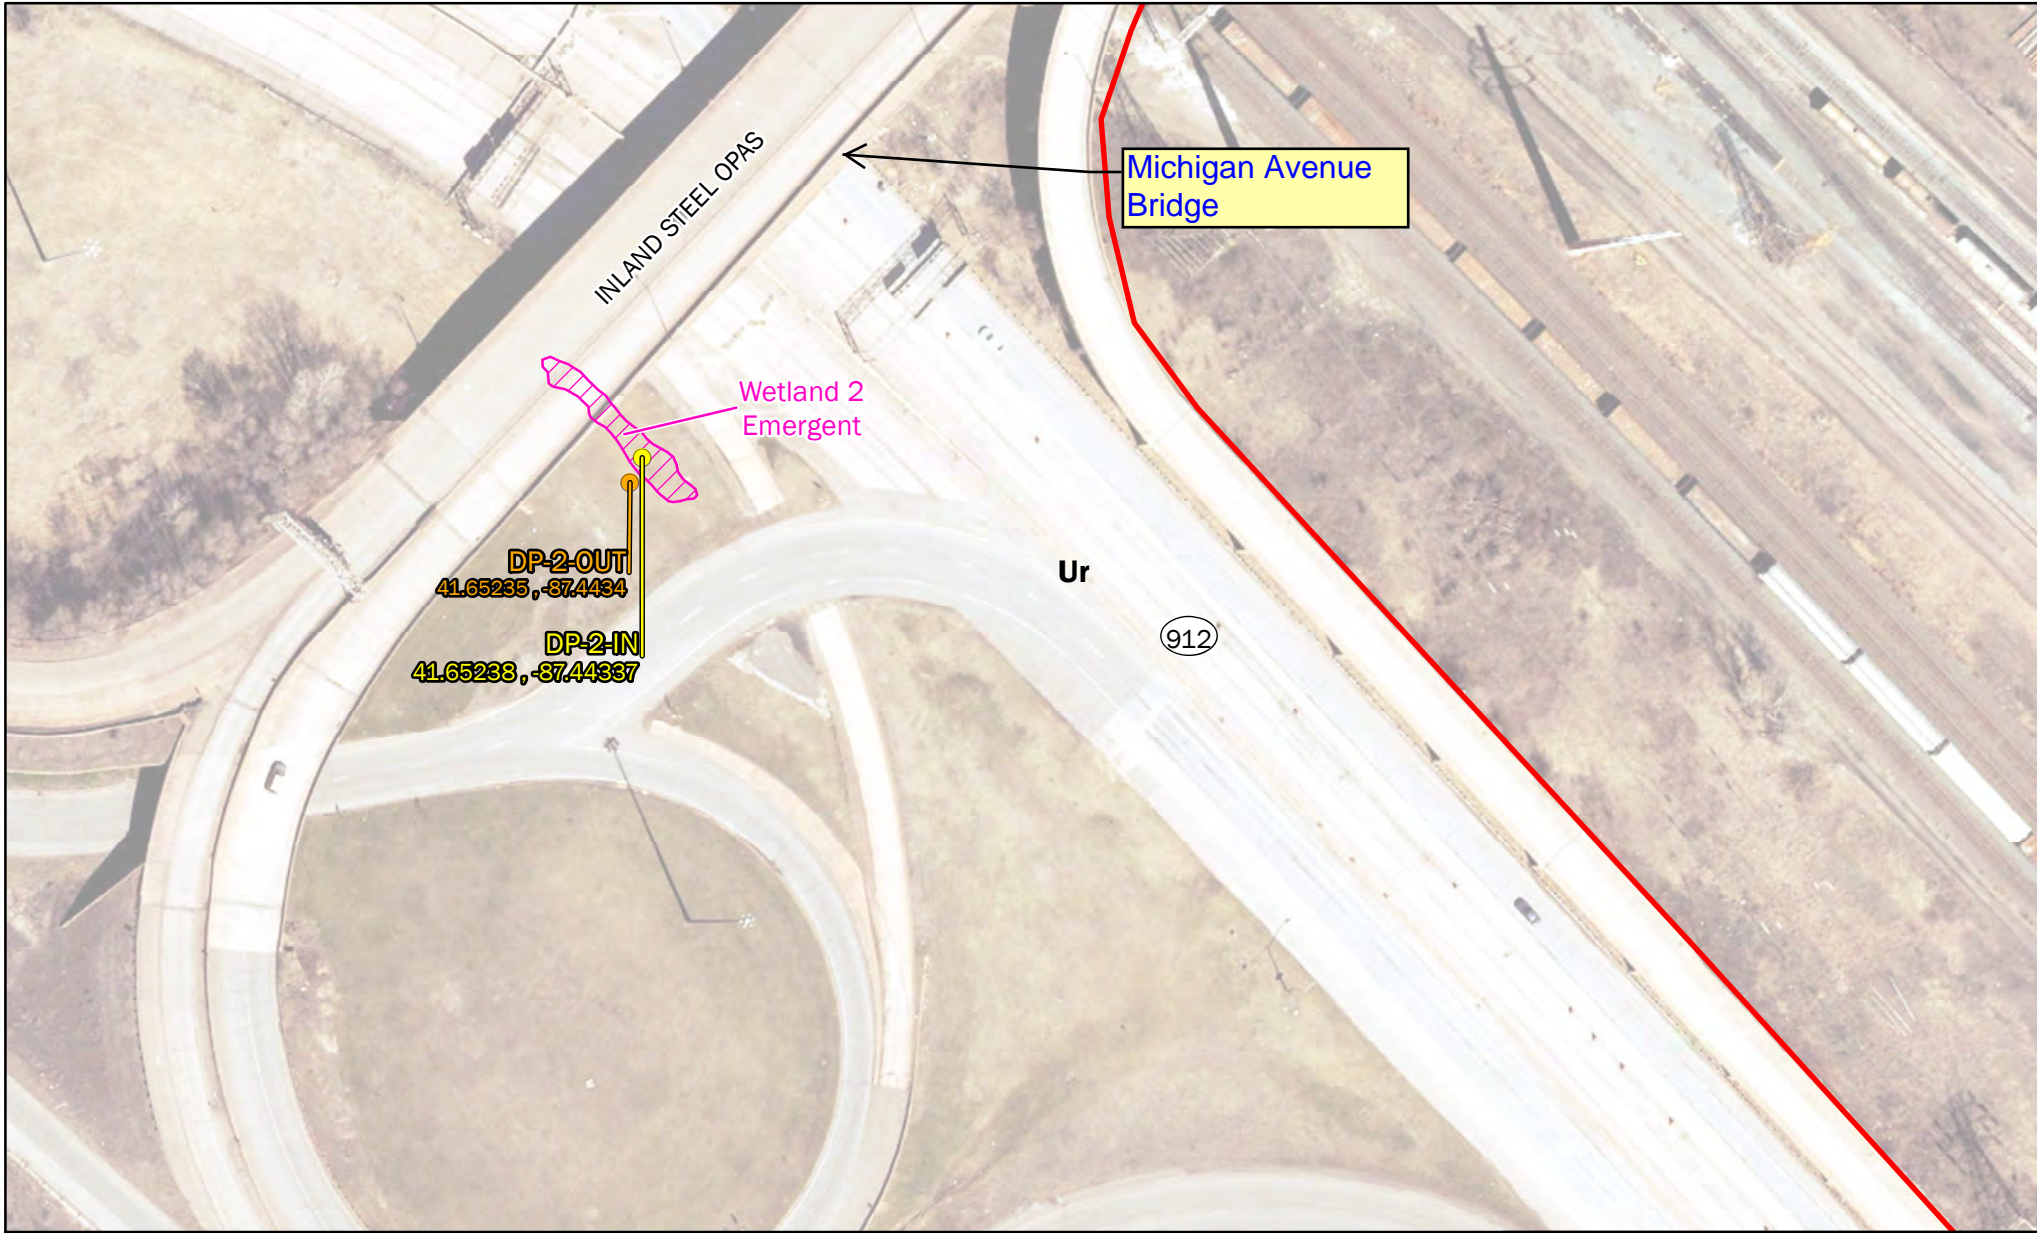
Sheet 9 of 20
 Section B

Upland Data Point 1 (UPL-1) was taken within the emergent in-field of the SR 912 westbound off-ramp to Michigan Avenue (Appendix B, page 9, Section B). The herbaceous stratum was dominated by *Phragmites australis* (common reed, FACW, 50%) and *Solidago altissima* (tall goldenrod, FACU, 35%). This point did not meet the hydrophytic vegetation criterion. The soil profile met the hydric soil criterion because it exhibited the Depleted Below Dark Surface (A11), Depleted Matrix (F3),

SR 912 and Michigan Avenue
 Bridges Project
 Lake County, Indiana
Field Identified Resources/NRCS Soils

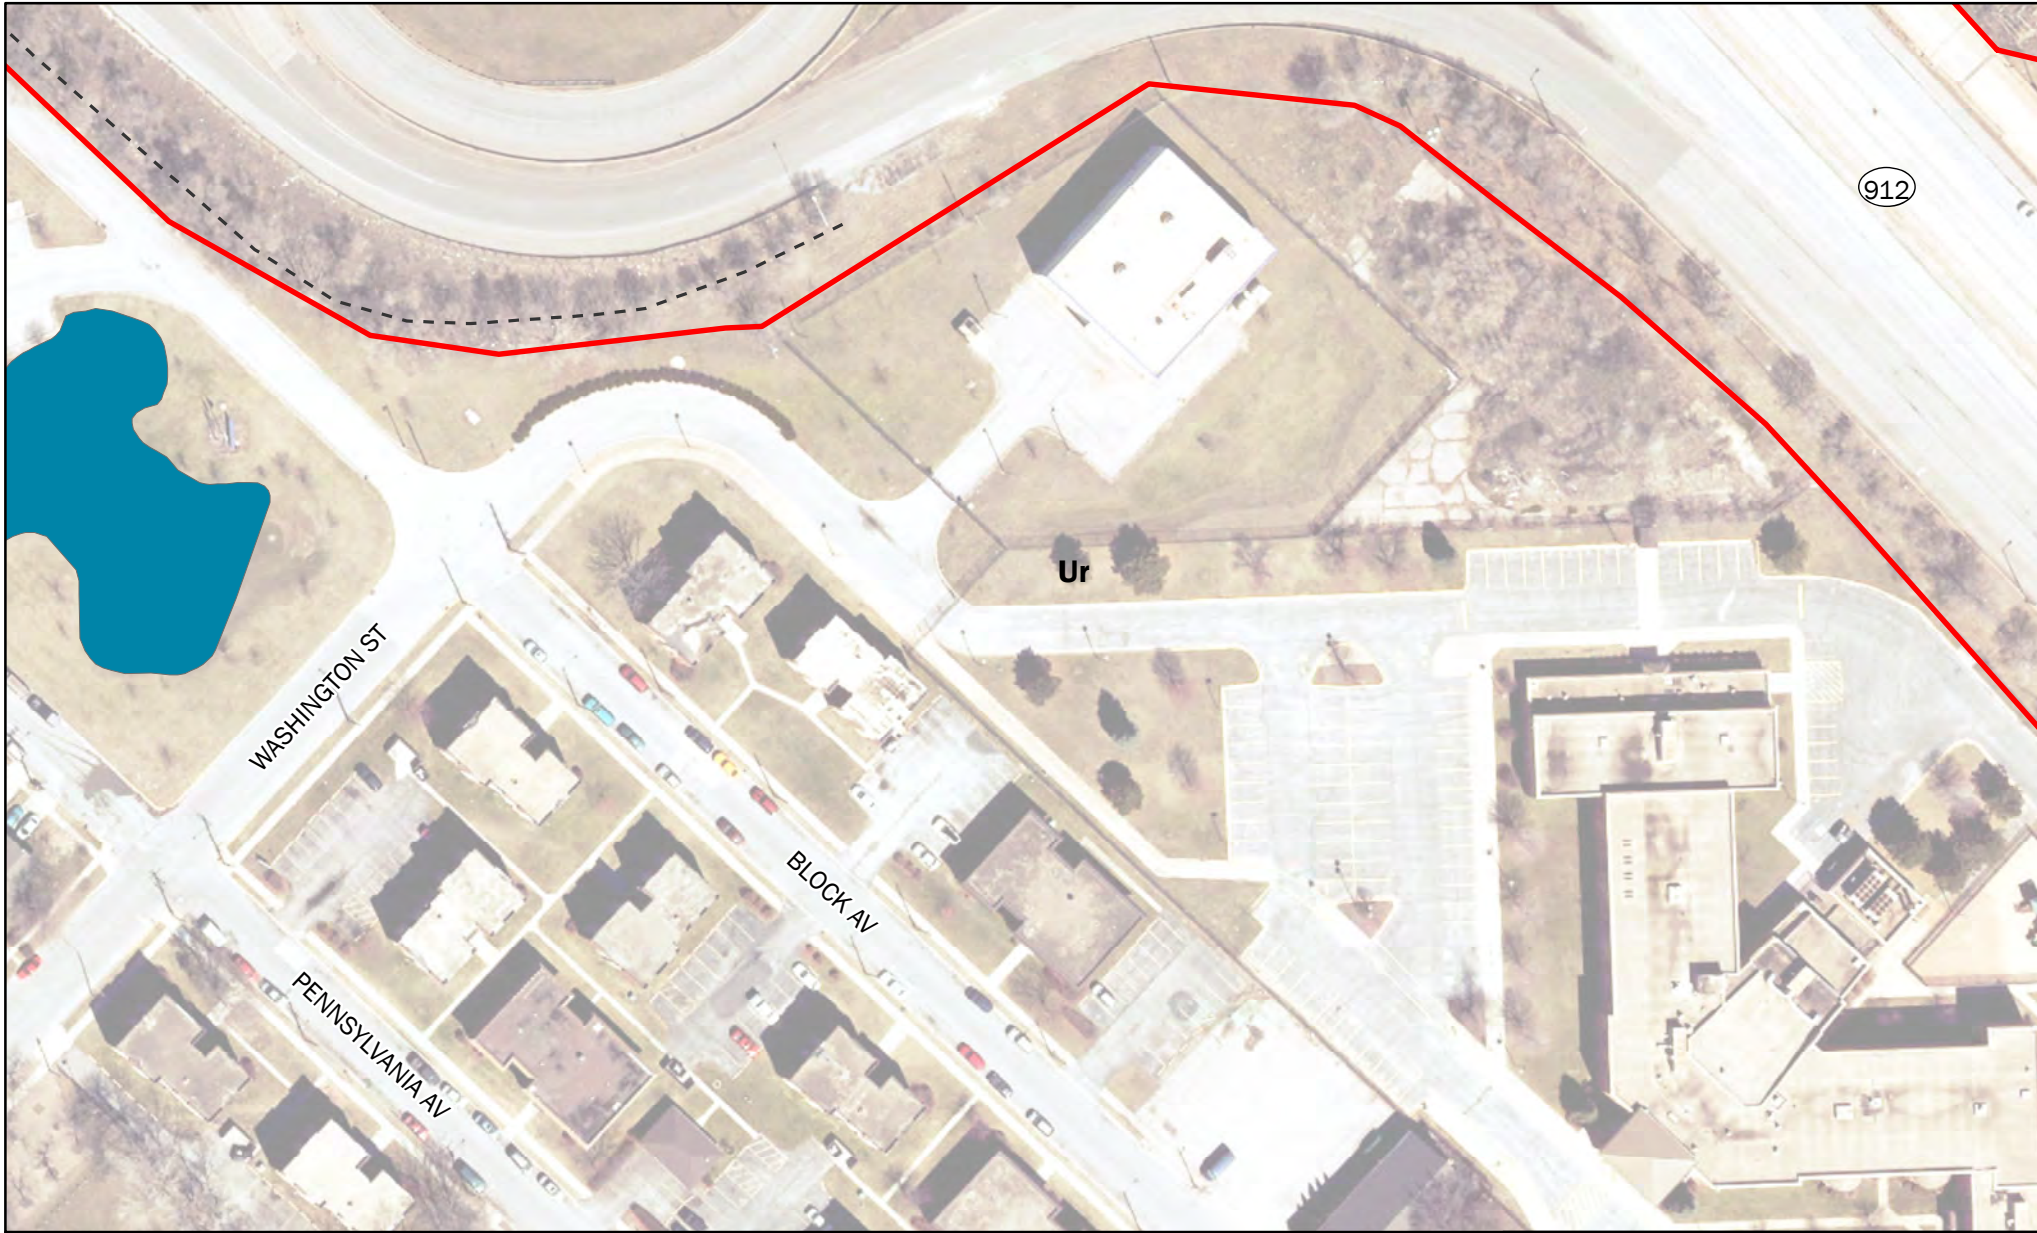
Sheet 10 of 20
 Section B

**SR 912 and Michigan Avenue
 Bridges Project
 Lake County, Indiana
 Field Identified Resources/NRCS Soils**
