Pavement Condition Report

Lebanon-Boone County Airport

Project 15805741

Applied Research Associates, Inc.
 6314 Odana Rd.
 Madison, WI 53719
 (608) 274-6409

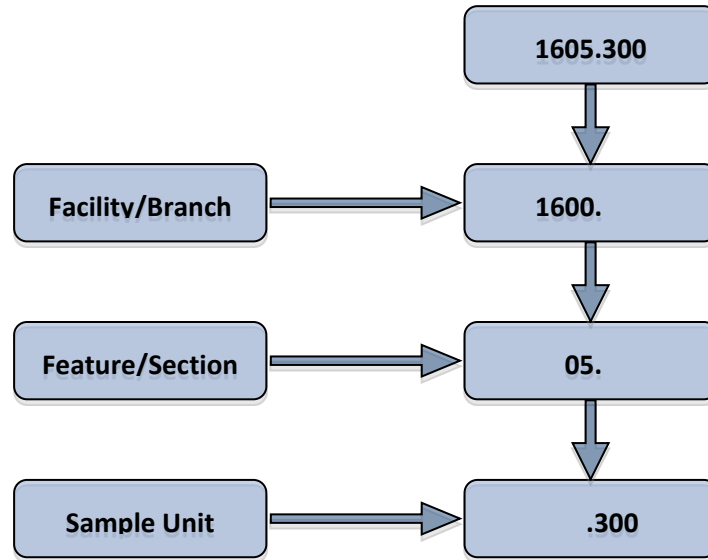
Figure 1-1. Pavement Numbering System

As the surveyors inspected the pavement, they were mindful to ensure that the pre-survey airfield map depicted the actual pavement, otherwise known as a “ground-truth” survey. Noticeable differences between what was present in the field and what was displayed on the maps were adjusted by a CADD technician.

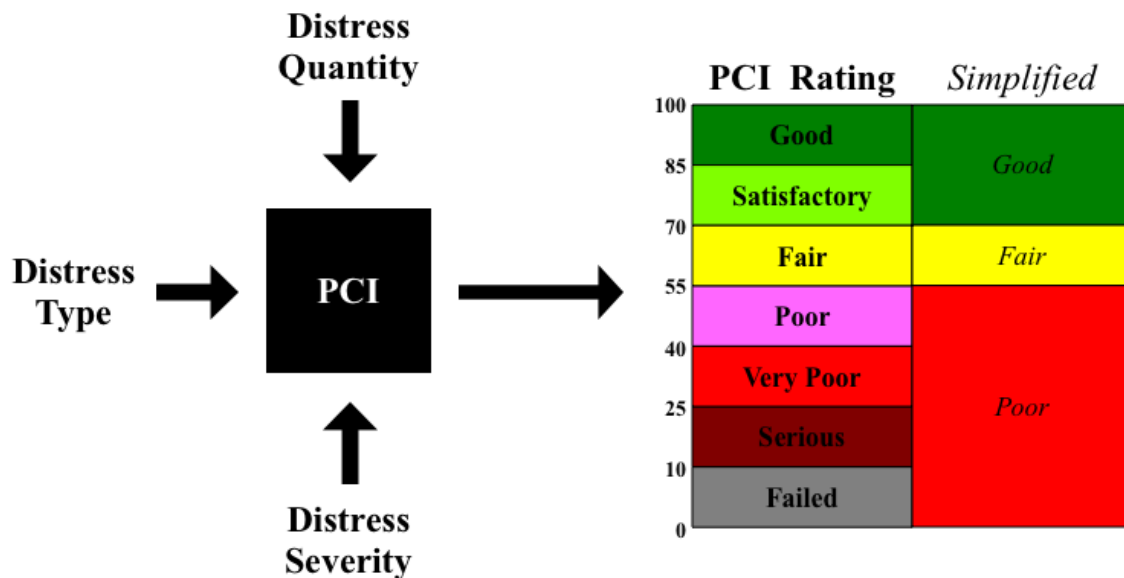
Figure 1-2. PCI Value and Descriptive Rating

Figure 1-2 shows the relationship between PCI values and descriptive ratings. Generally, pavement maintenance is most cost-effective when the pavement is still in satisfactory condition. Rehabilitation, such as an asphalt mill and inlay, is typically performed for pavements with PCI values between 55 and 70. When the PCI value drops below 55, a mill an inlay may not provide the desired performance and complete reconstruction often becomes the most cost-effective means of repairing the pavement.

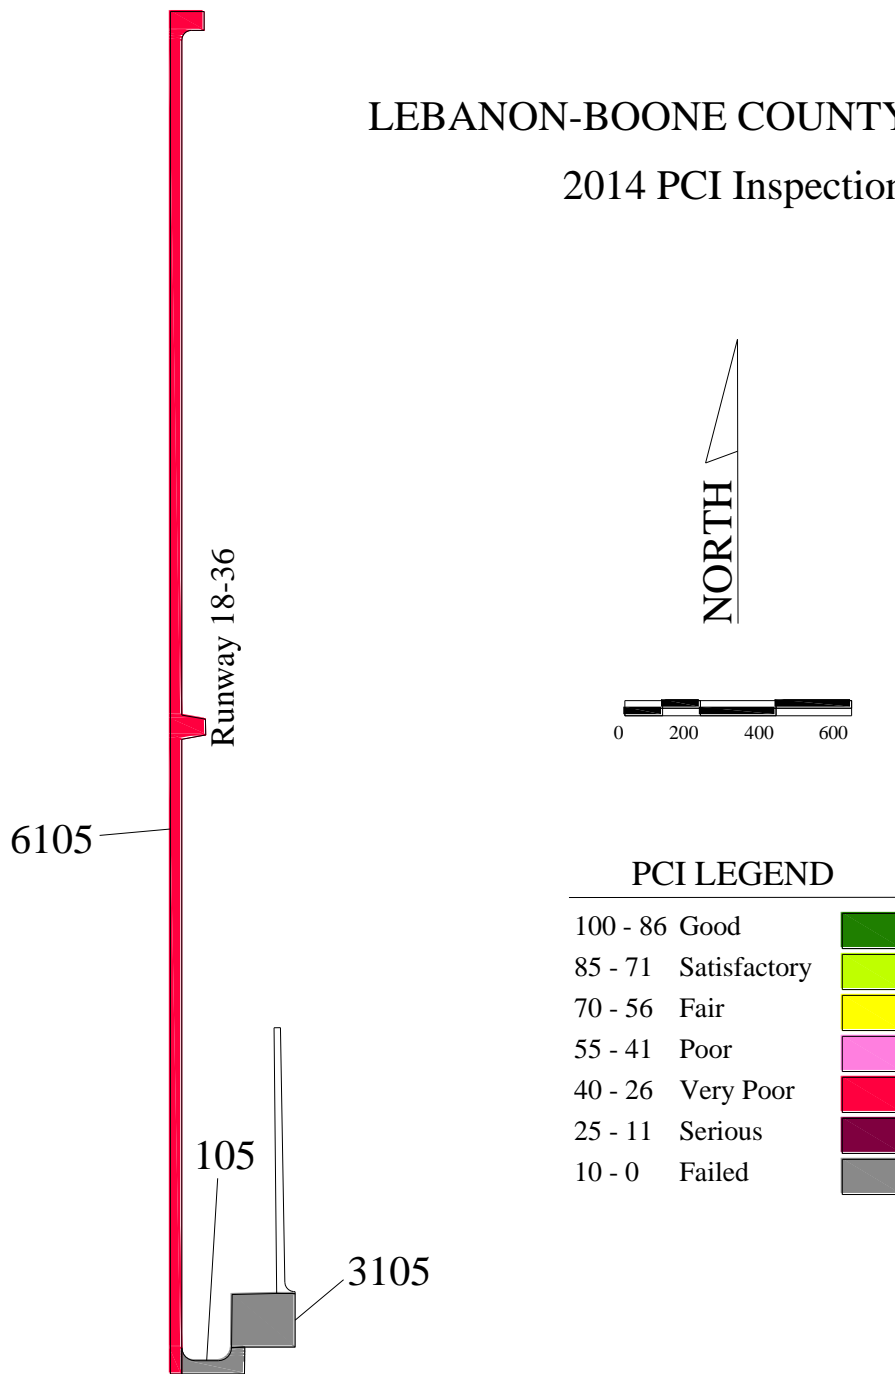
Figure 2-1. Inspected Pavement Condition

Approximately 150,000 ft² of airside pavement is represented herein. Using statistical sampling methods approximately 61,000 ft² of PCC pavement was surveyed as part of this assessment. The average inspected PCI for all pavements was 29 (Very Poor). The average inspected PCI for the runways, taxiways, and ramps were as follows: 36 (Very Poor), 0 (Failed), and 4 (Failed).

The pavement within each of the PCI condition categories is shown in Figure 2-1. The inspected PCI is summarized by branch use in Figure 2-2, and the photographs in Figure 2-3 through Figure 2-5 provide examples of the condition categories.

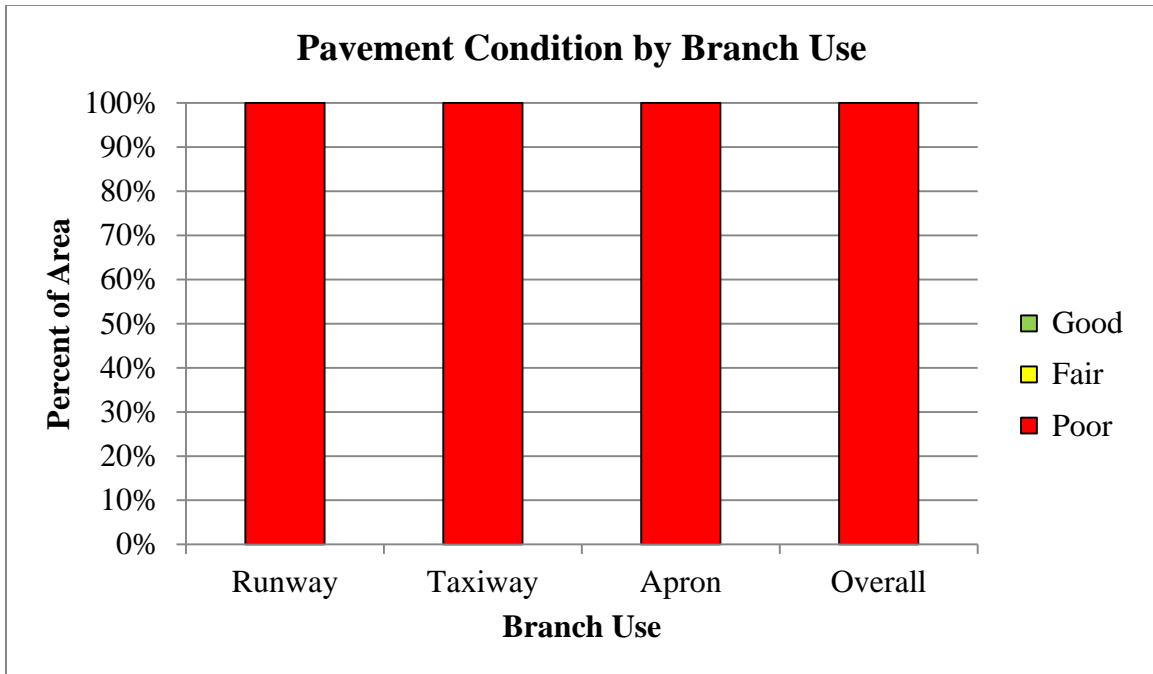
Figure 2-2. Pavement Condition by Branch Use

The overall inspected Pavement Condition Index (PCI) for the airfield pavements was 29. Runways had an average inspected PCI of 36 and were below the desired MSL of 55. Taxiways had an average inspected PCI of 0, and ramps had an average inspected PCI of 4.

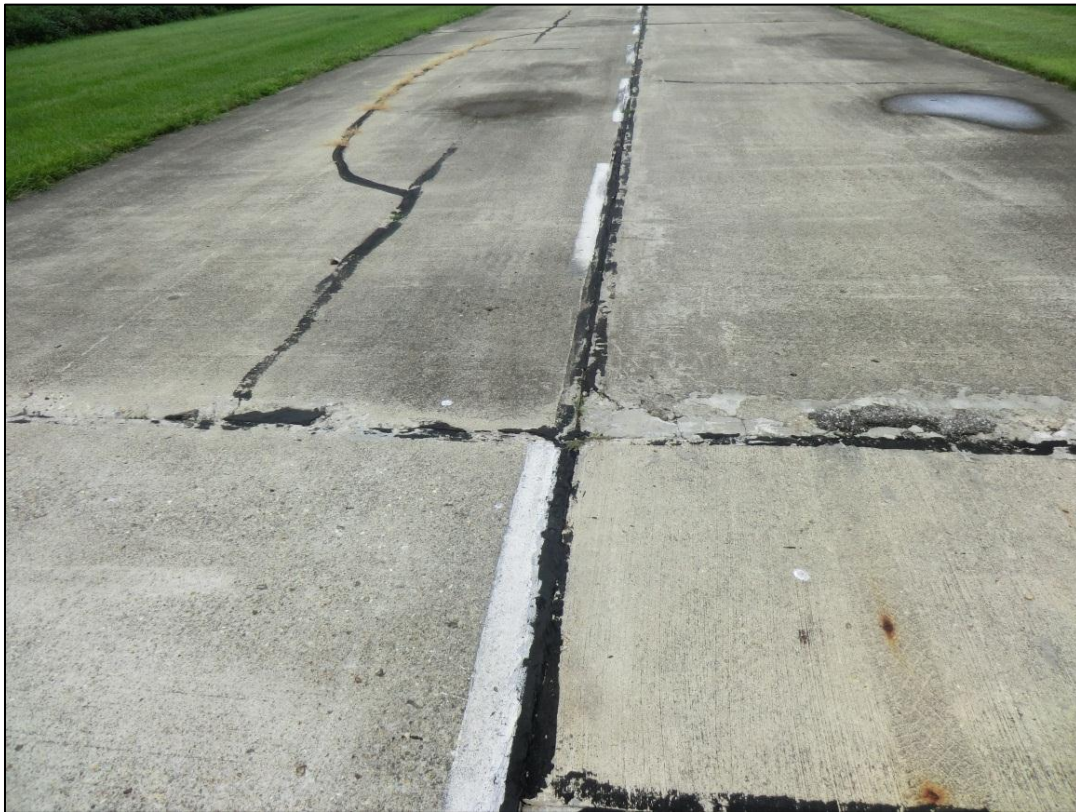
Figure 2-3. Typical Runway PCC Pavement (Feature 6105)

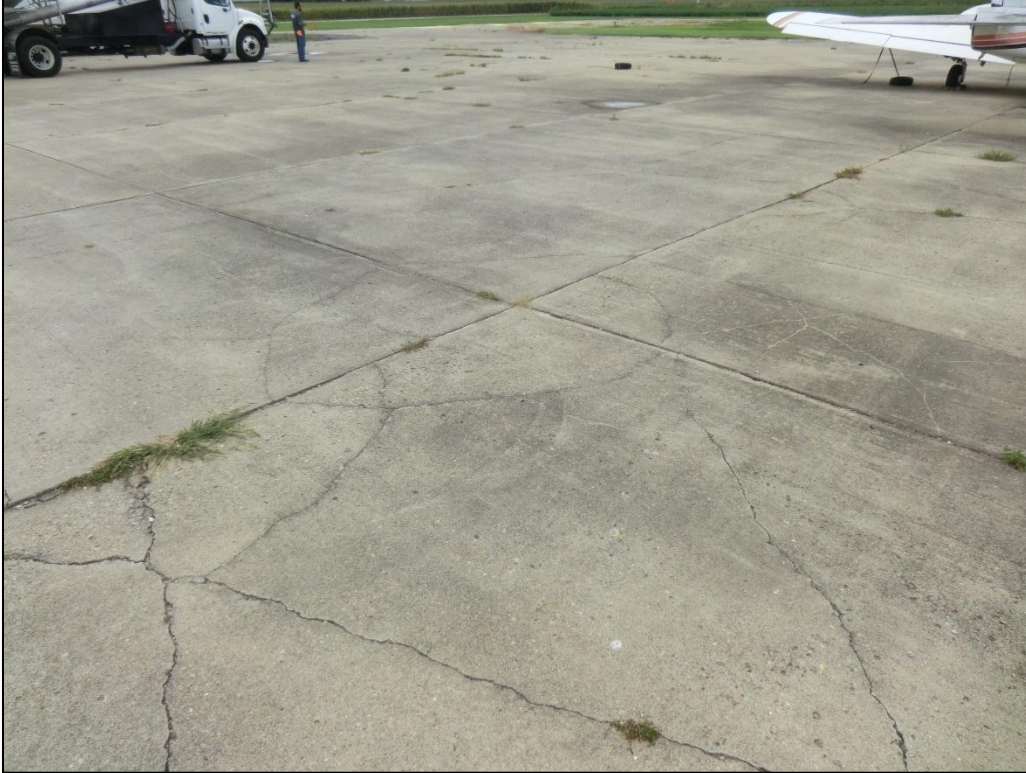
Figure 2-4. Typical Ramp PCC Pavement (Feature 3105)

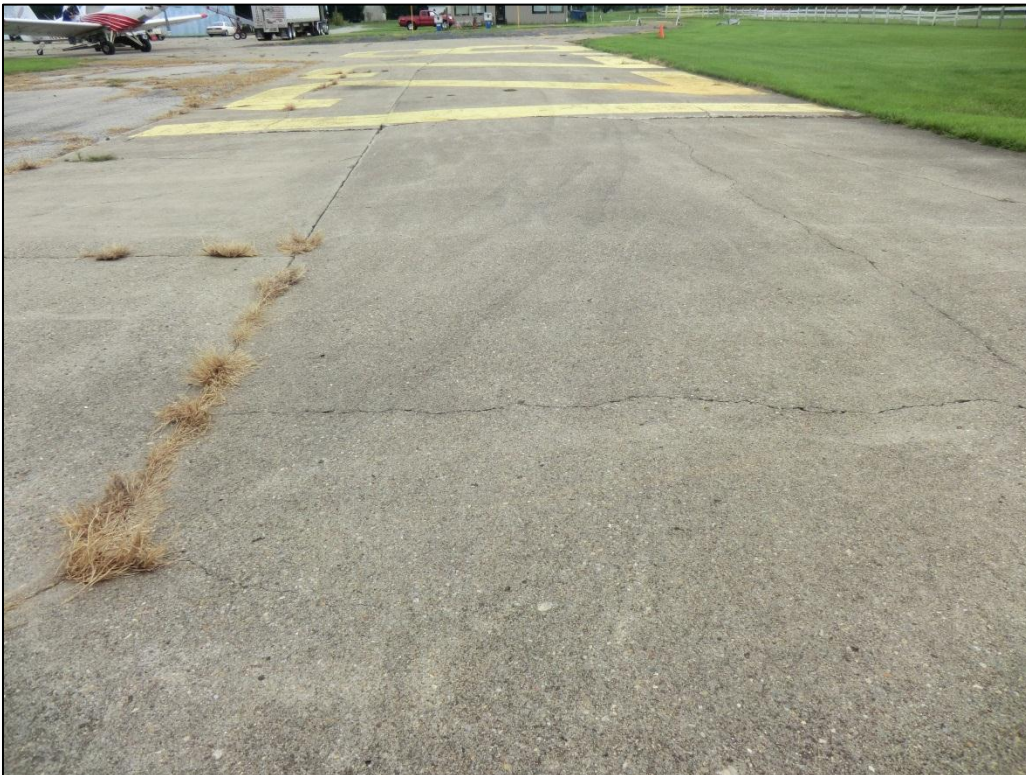
Figure 2-5. Typical Taxiway PCC Pavement (Feature 105)

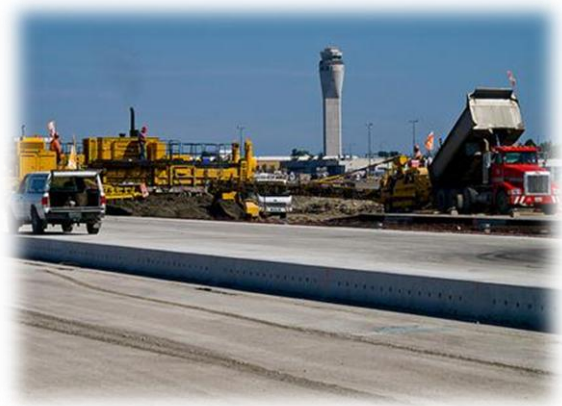
3.2.1.1 Reconstruction

Reconstruction is recommended when the pavement defects would not be corrected by less extensive measures. Unit prices assume removal of the existing pavement to the subgrade and reconstruction with 8 inches of high strength PCC pavement on 6 inches of aggregate subbase.

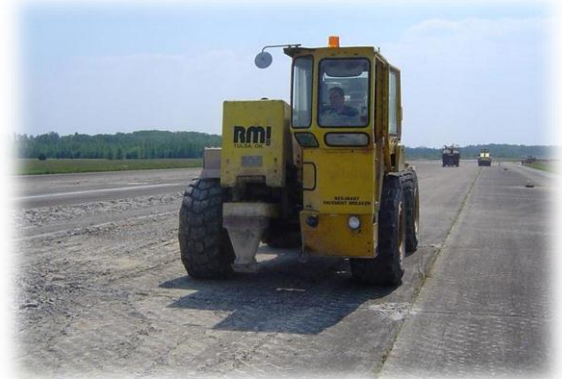
3.2.1.2 Repair and Overlay

This procedure usually consists of a rubblize or a crack and seat process, where the existing pavement is broken into segments of approximately 2 ft on a side by dropping a heavy breaker bar onto the pavement. Properly done, aggregate interlock between pavement segments is retained and reflective cracking is reduced. A flexible surface is then placed over the recycled PCC base.

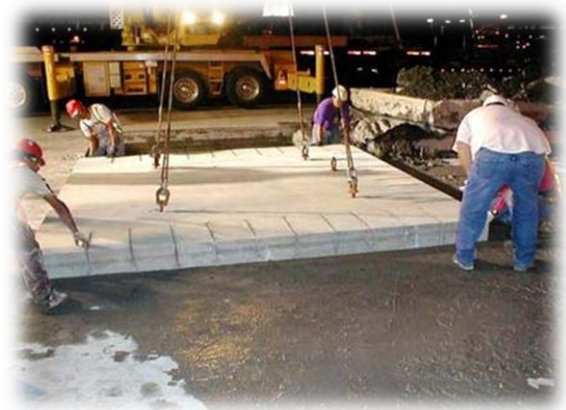
3.2.1.3 Slab Replacement

Slab replacements are typically required for high-severity blow ups, scaling, and shattered slabs. Unit prices assume removal of the selected slab to the subgrade. Prepare subgrade to bearing strength equivalent to surrounding subgrade. Provide subbase support equivalent to existing and install load transfer steel as required. Place PCC pavement level with existing surface.

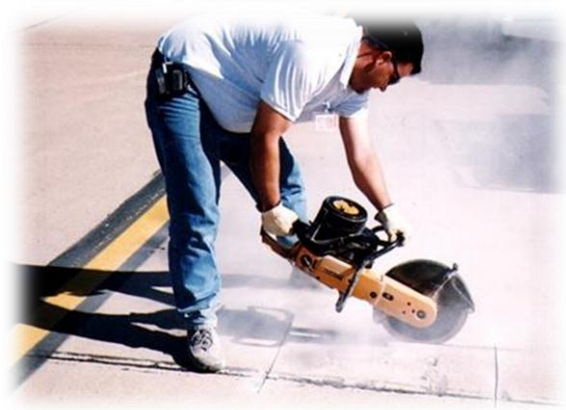
3.2.1.4 Patching (Partial Depth)

While partial depth patching is most commonly used to repair joint and corner spalls, it is effective for a wide variety of distress types. Saw cut and remove area of pavement to sound concrete above reinforcing steel. Treat existing concrete to ensure firm bond. Place PCC level with existing surface.

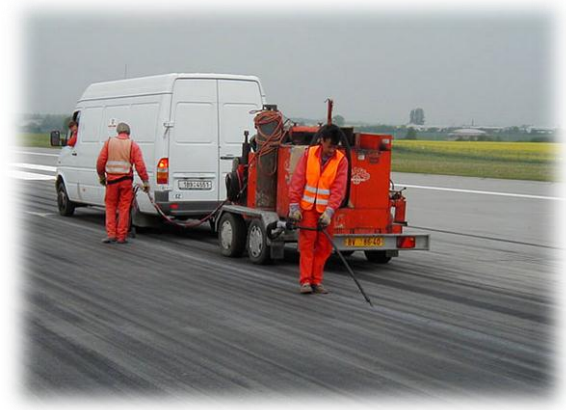
3.2.1.5 Joint Seal Replacement

Rout joints and cracks to a depth of at least 1-1/4 inches, clean joint wall surfaces to expose fresh vital concrete, install backing rope, and apply rubberized sealant meeting ASTM D3405 specification, or equivalent.

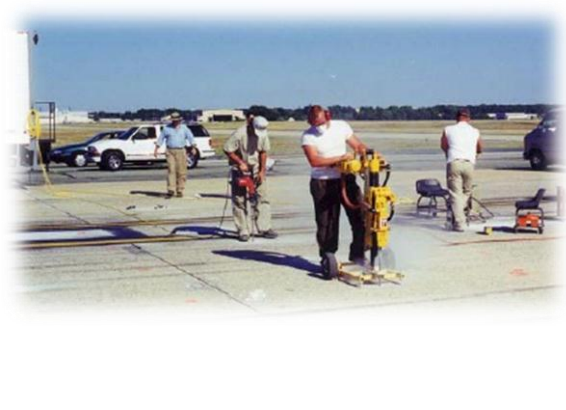
3.2.1.7 Undersealing

Undersealing is used to repair faulting between slabs or when corner breaks have settled relative to the slab. High-pressure injection is used to force material into the underlying voids and continues until the settled pavement is restored to its original elevation. Several materials have been used for undersealing, including cement grout, asphalt slurries, and proprietary formulations of expansive Styrofoam.

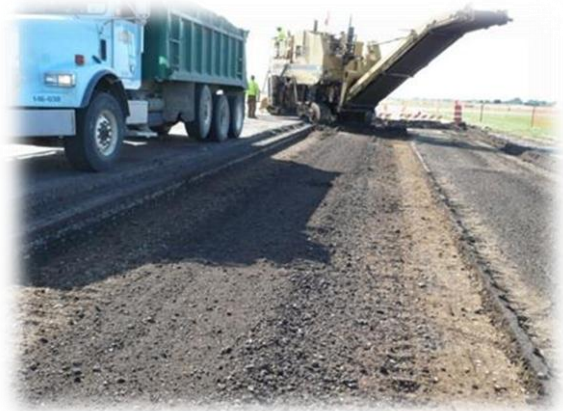
3.2.2.1 Reconstruction

Reconstruction is recommended when the pavement defects would not be corrected by less extensive measures. Unit prices assume removal of existing pavement to subgrade. Scarify and compact subgrade to 6-inch depth. Construct 4 inches of P401 AC surface course on 8 inches of aggregate base course.

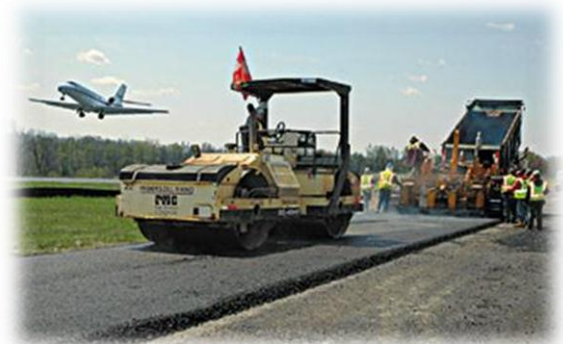
3.2.2.2 Resurfacing

Resurfacing assumes a nominal 2-inch asphalt mill and inlay on existing prepared pavement.

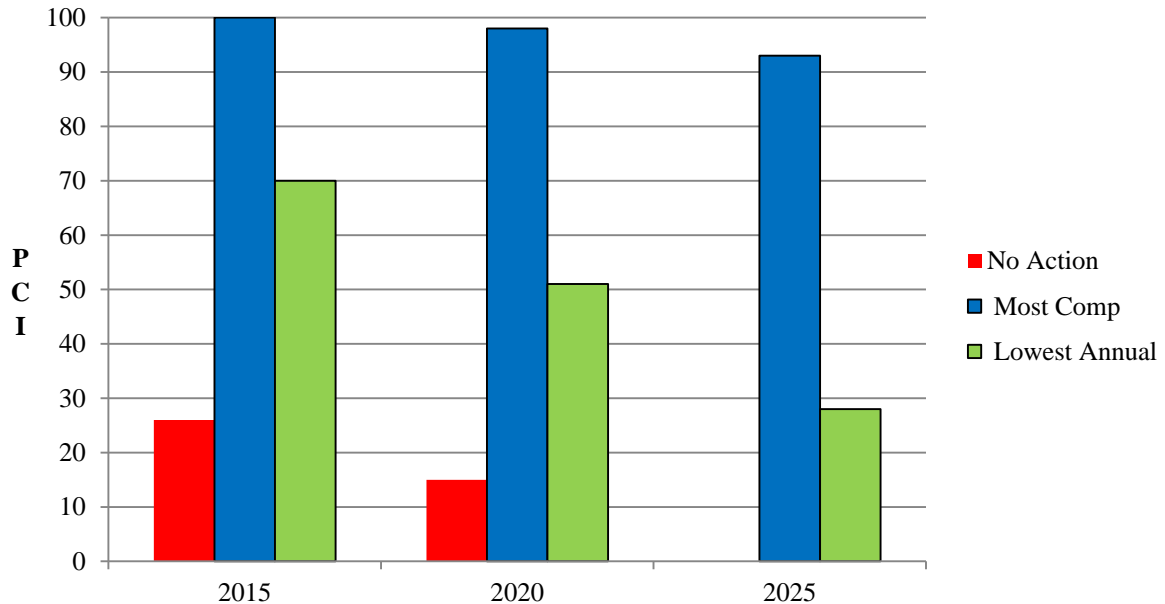
Figure 3-1. Programmed CIP

Figure 3-1 shows a projection of the overall airport pavement condition for the next 10 years based on implementing one of three capital improvement strategies:

- No Action: No capital improvement action is undertaken
- Longest Life: The most comprehensive repair and longest life rehabilitation option
- Lowest Cost: The rehabilitation option with the projected lowest annual cost

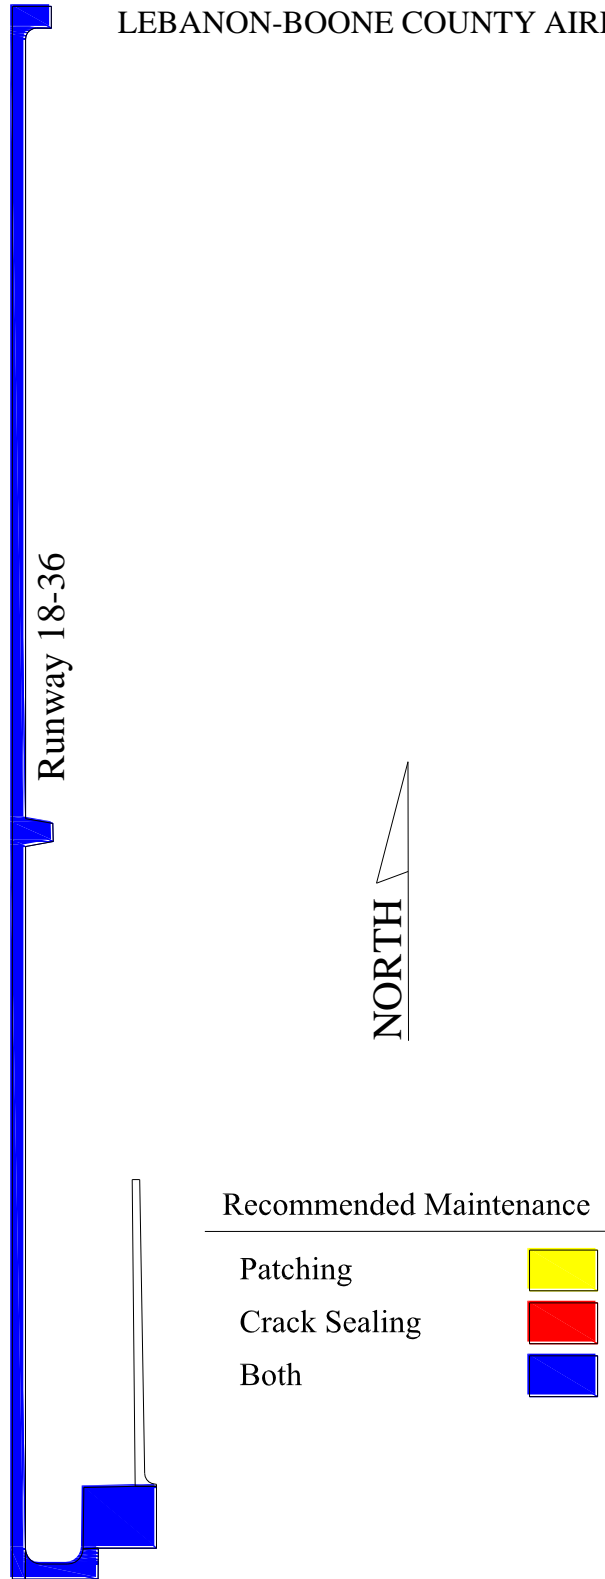
Figure 4-1. Recommended Maintenance

Specific recommendations to help prioritize airfield maintenance are found in chapter 4 of this report. A summary of all identified maintenance needs is shown in the table below and in the figure on the following page.

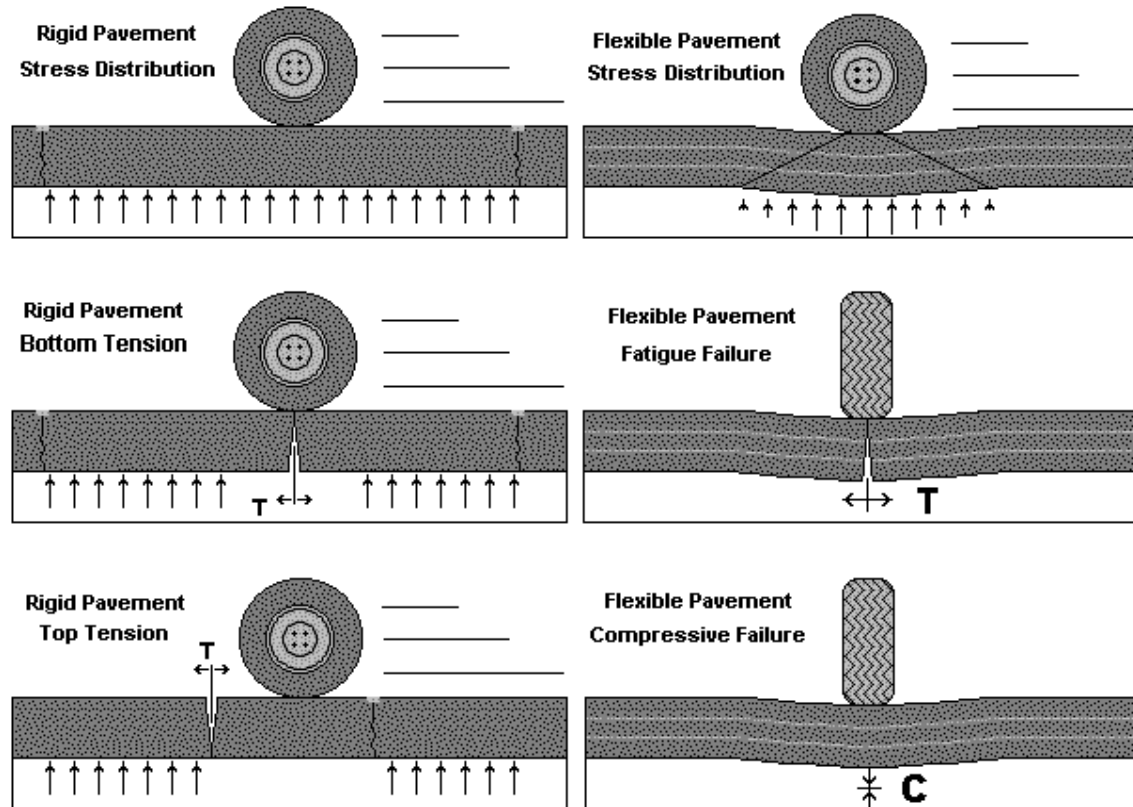
As illustrated below, rigid and flexible pavements differ in the way loads are distributed. A concrete slab resists bending and transfers loads evenly, while an asphalt pavement is designed to bend, gradually spreading loads over wider areas.

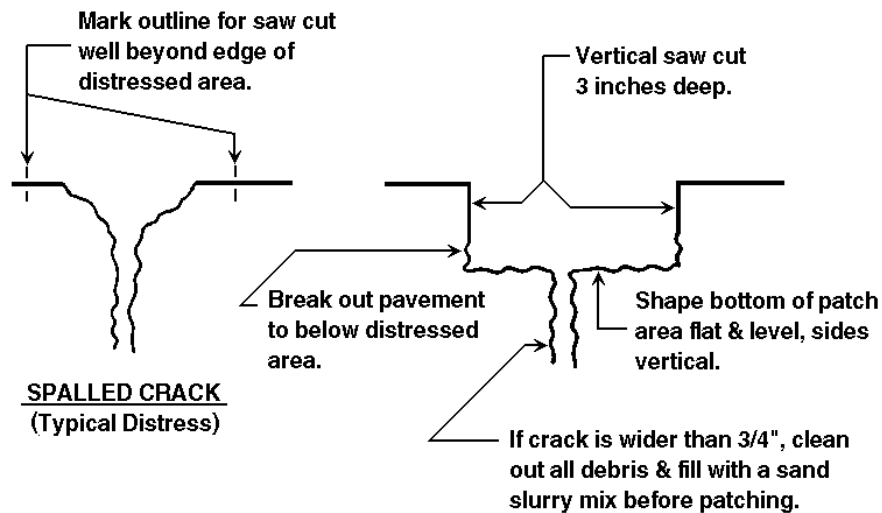
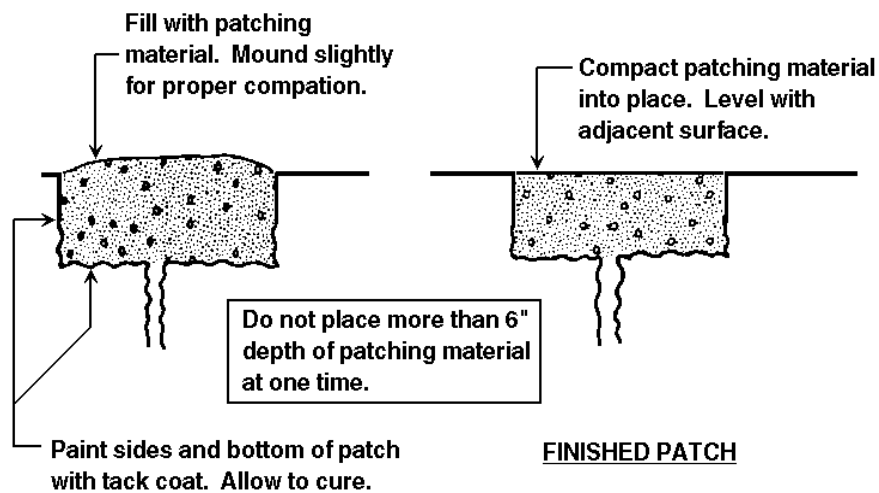
Patching (bituminous material)

- Examine distressed area and mark patch outline.
- Cut patch area with saw, no less than 3 inches deep.
- Remove enclosed pavement, leaving the vertical sawed edges undamaged.
- Clean sides and bottom and blow out with compressed air
- Paint sides and bottom with rapid curing asphalt tack coat. Prevent pooling on bottom.
- Allow tack coat to cure until it reaches a gummy consistency.
- Place hot mixed asphalt concrete and mound slightly, allowing for compaction.
- Compact with vibratory roller or plate compactor, in layers no greater than 6 inches.

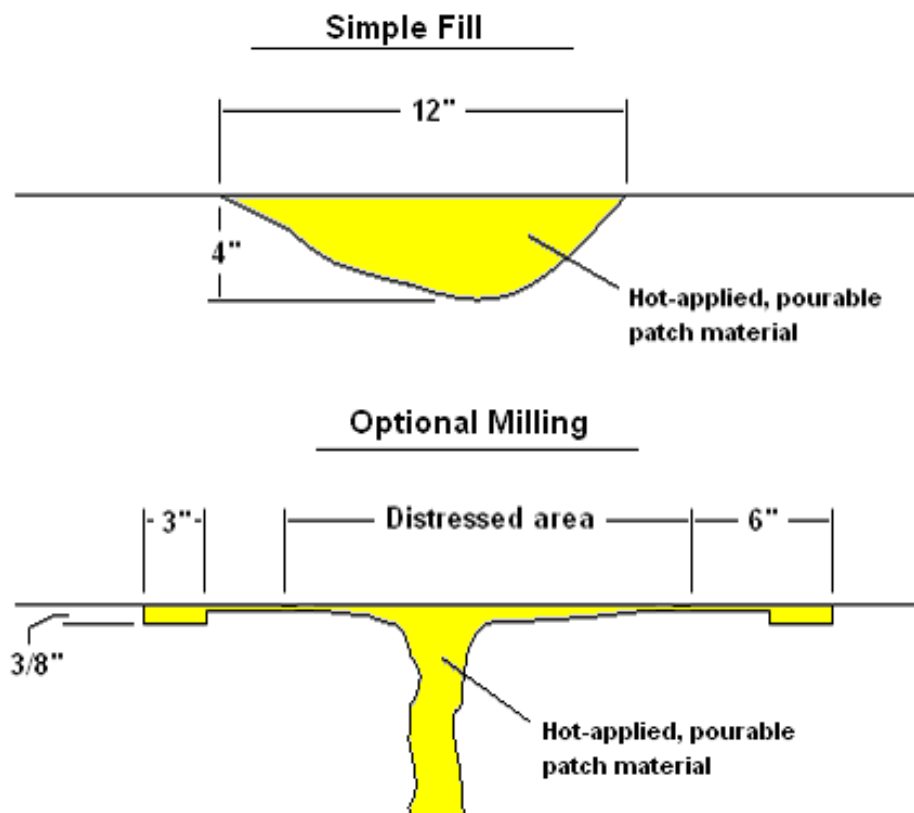
Patching (pourable materials)

Hot-applied, pourable materials generally are used to repair deficiencies larger than can be repaired by sealants, but smaller than those where traditional techniques would be required. Suggested uses for this type of repair include cracks over 2 inches wide, potholes less than 4 inches deep, as a leveling for small depressions, as a cap for settled utility cuts, and as a skin patch for areas of alligator cracking.

- Examine and mark the patch outline. Boundaries should extend to sound pavement.
- Apply patch material to clean, dry surfaces.
- A heating lance to preheat or dry existing pavement is recommended in cold or wet conditions.
- Patch material should be poured into the area to be repaired and leveled as appropriate.
- Patch edges should be sealed after application to assure good adhesion, preventing surface moisture from migrating under patch edges.

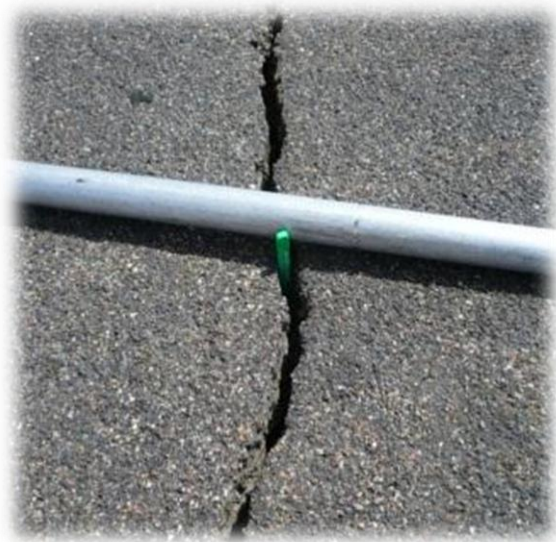
Longitudinal & Trans. Cracking

L&T cracks are caused by age, construction, and subsurface conditions. Age-related cracking occurs as oxidizing pavement loses components to the atmosphere and becomes more brittle. Consistent application of seal coats can help to prevent age-related cracks.

Construction-related cracking often develops along paving joints. Ensuring that joints are made when both sides are still hot, and near the same temperature, is one of the best ways to mitigate this potential problem.

Seasonal movement caused by changes in subsurface moisture or temperature differences also can cause pavement cracking. Asphalt pavement placed over a PCC pavement or cement stabilized base course may evidence reflective cracking from the underlying material. Wheel loads do not cause L&T cracks, although traffic may worsen their condition.

Low-severity L&T cracks are less than ¼ inch wide, or if sealed with suitable filler material in satisfactory condition can be any width less than 3 inches, if they are not spalled. Maintenance usually is not indicated for low-severity cracking. Moderately spalled cracks and cracks wider than ¼ inch which are not satisfactorily sealed are at medium severity. Medium-severity cracks should be sealed with a high-quality crack filling material. Severely spalled cracks and cracks wider than 3 inches are at high severity. High-severity L&T cracks normally require patching.

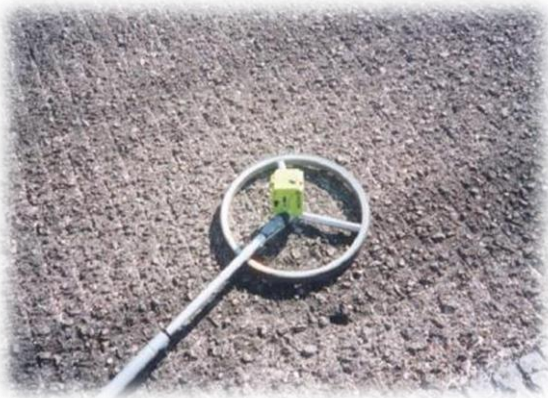
Raveling/Weathering

Raveling and weathering are the wearing away of the pavement surface. Failure can be caused by the dislodging of aggregate particles or the loss of asphalt binder. These distresses are usually evident over large areas and may indicate that the asphalt binder has hardened significantly.

Raveling: At low severity, 5 to 20 coarse aggregate particles are missing per square yard. Medium severity is defined by 20 to 40 missing coarse aggregate particles per square yard. At high severity, more than 40 coarse aggregate particles are missing per square yard, and the top layer of aggregate has eroded away.

Weathering: At low severity, edges of coarse aggregate are exposed less than 1 mm. At medium severity, loss of fine aggregate is noticeable and edges of coarse aggregate are exposed up to 6 mm (1/4 inch). High severity weathering has edges of coarse aggregate exposed > 6 mm, with considerable loss of fine aggregate matrix and potential for loss of coarse aggregate.

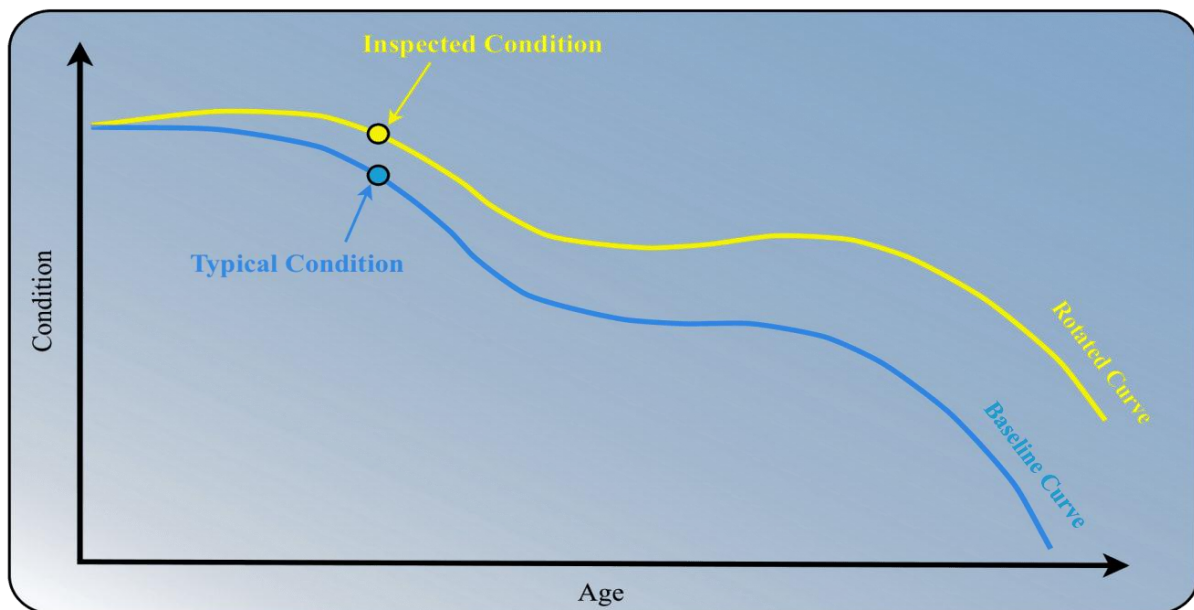
Starting with the baseline curve for comparison, current pavement condition is plotted, and the baseline curve is rotated to meet the current condition. The rotated curve provides the starting point for projecting the future pavement condition.

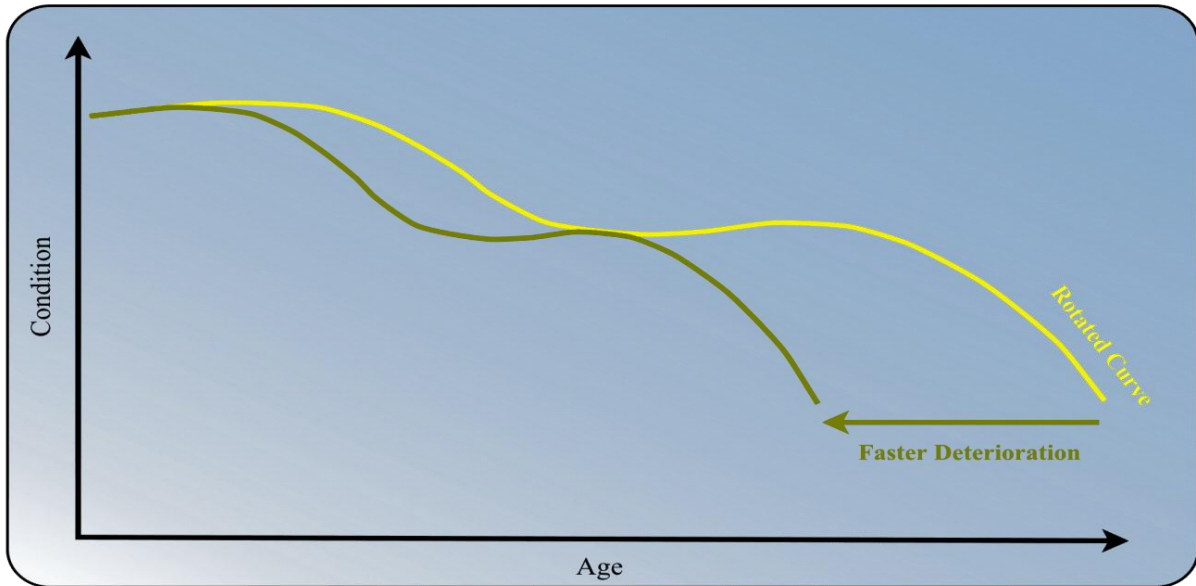
After current condition is accounted for with the curve rotation, pavement distress is addressed in the advanced analysis by compressing or expanding the baseline curve to account for the expected rate of pavement deterioration.

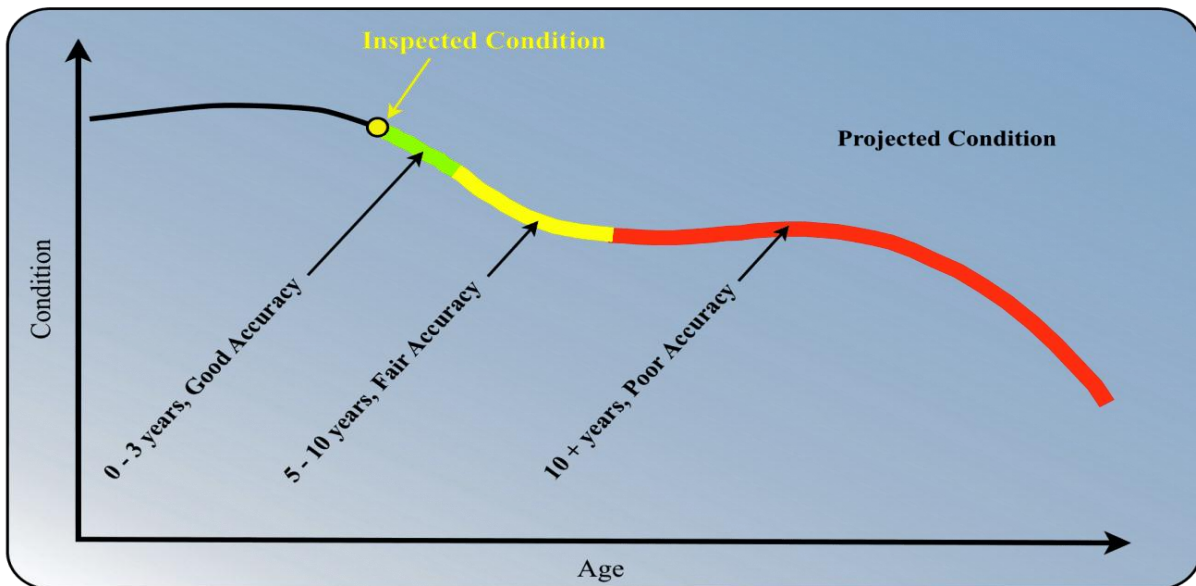
Projecting pavement condition with advanced analysis is a combination of rotating, expanding, and contracting the baseline curves. This projection method provides good short-term results for all pavement sections and fair long-term projections on pavement sections with conditions near the baseline model. The long-term accuracy of outlier data is discussed on the following page.

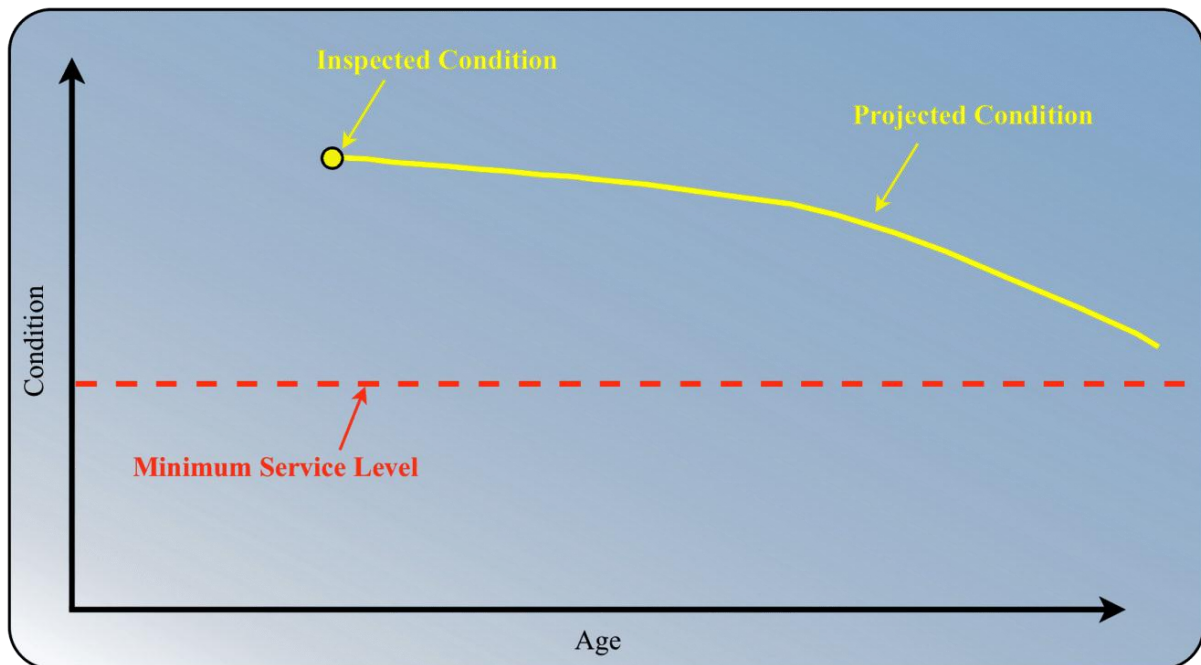
The curve below shows an example of a performance trend being overemphasized in the long-term projection. Because the pavement feature is performing much better than the baseline curve, the long-term projection shows the pavement lasting an additional 30+ years before reaching the MSL. Rotation of the curve to provide the most accurate projection over 3 to 5 years has resulted in a long-term projection that is likely unrealistic.

When long-term projections such as this are encountered, airport managers should not rely on projections in excess of 10 years. Managers can be confident that the pavement is performing much better than average and will not require rehabilitation within the current 5-year CIP planning window. As new distress develops over time, future PCI surveys will determine the ideal timing for rehabilitation.

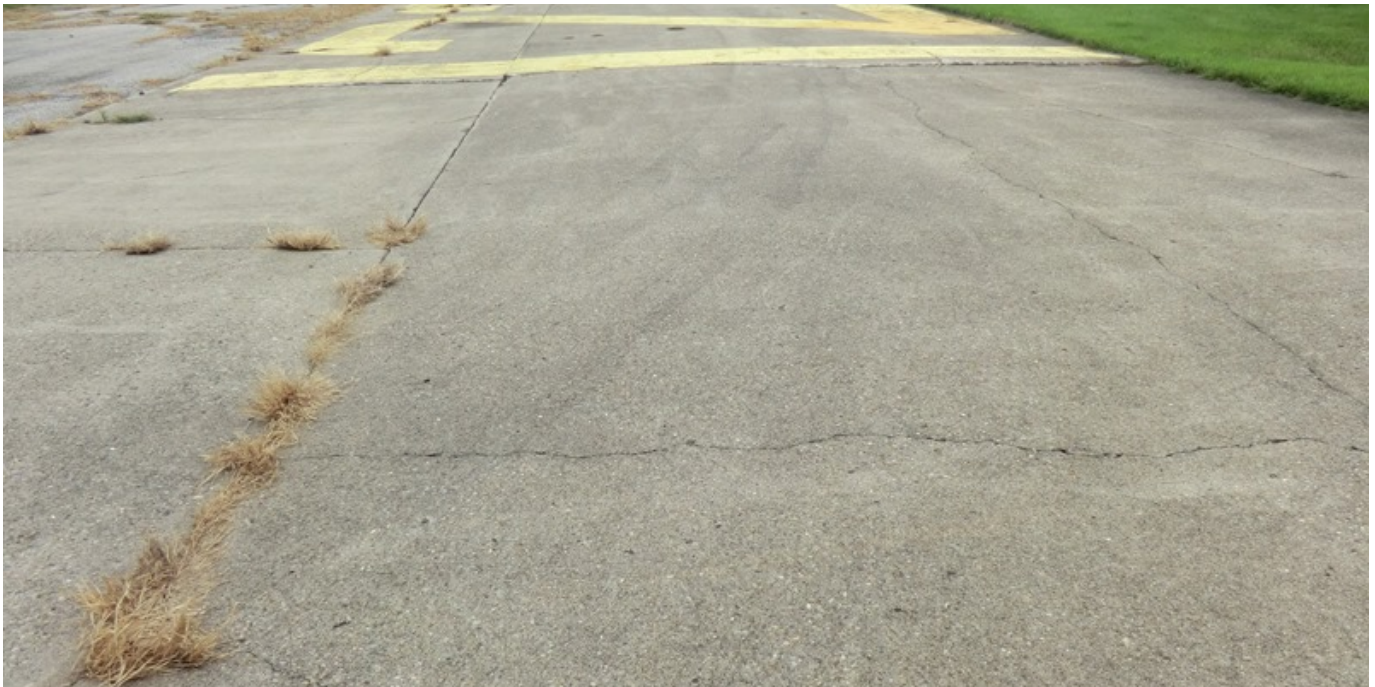
PROJECTED PERFORMANCE

AVERAGE PCI AT INSPECTION: 0 FAILED

LEGEND	DESCRIPTION	COST	LIFE EXTENSION
▲	RECONSTRUCTION	\$97,652	32 YEARS
▼	REPAIR AND/OR OVERLAY	\$41,710	19 YEARS
●	NO ACTION	N/A	N/A
-	MINIMUM SERVICE LEVEL, CURRENTLY 50

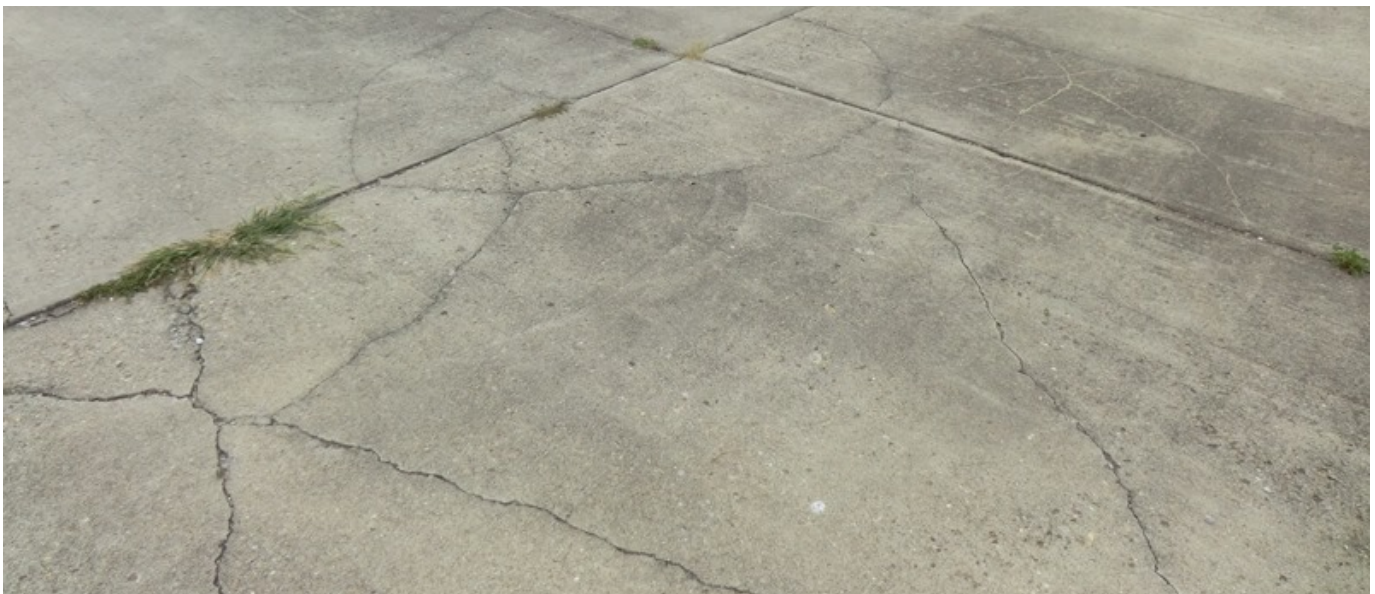
AVERAGE PCI AT INSPECTION: 4 FAILED

LEGEND	DESCRIPTION	COST	LIFE EXTENSION
▲	RECONSTRUCTION	\$303,704	32 YEARS
▼	REPAIR AND/OR OVERLAY	\$129,721	19 YEARS
●	NO ACTION	N/A	N/A
-	MINIMUM SERVICE LEVEL, CURRENTLY 50

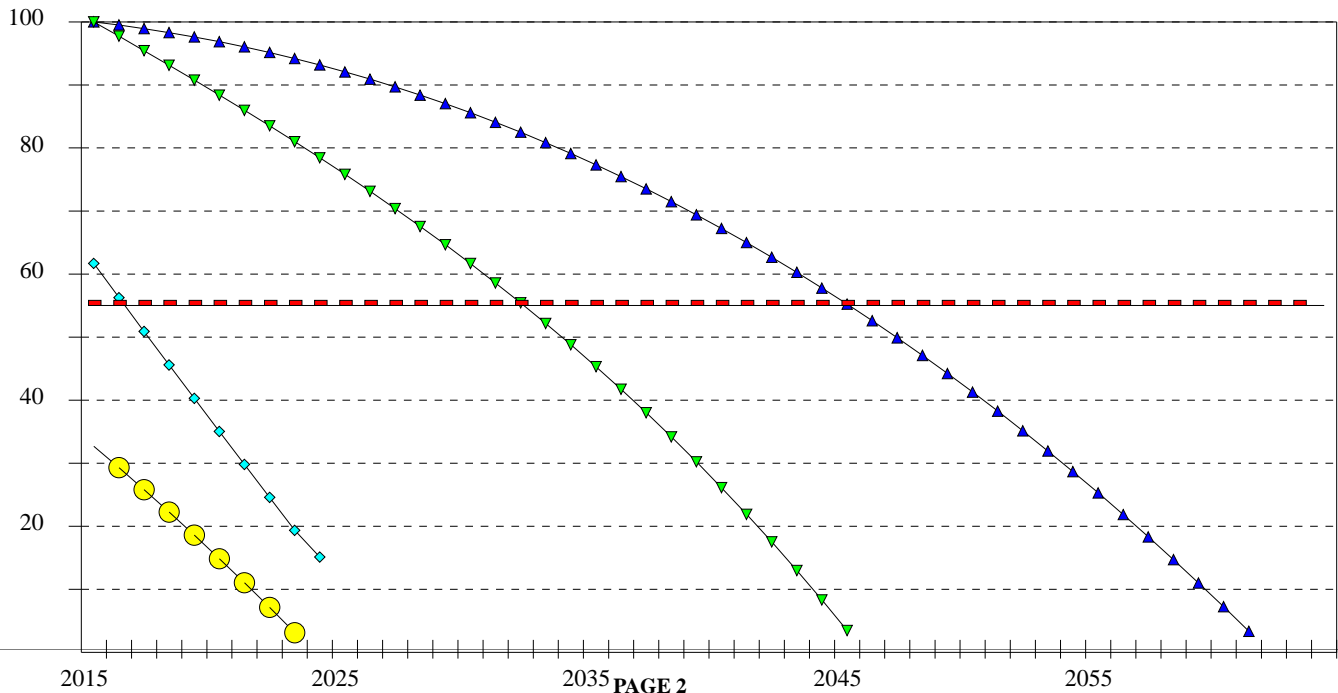
PROJECTED PERFORMANCE

LEGEND	DESCRIPTION	COST	LIFE EXTENSION
▲	RECONSTRUCTION	\$1,489,640	31 YEARS
▼	REPAIR AND/OR OVERLAY	\$636,272	18 YEARS
◆	SLAB REPLACEMENT/PATCHING/JOINT SEAL	\$141,943	2 YEARS
●	NO ACTION	N/A	N/A
-	MINIMUM SERVICE LEVEL, CURRENTLY 55
