PUBLIC WORKS PROJECT NO. 84003001-22-058-C1
 CLEAR CREEK WELCOME CENTER
 VIGO COUNTY, INDIANA

Appendix G: New Wastewater Pipe Alignment Schematic

Red Flag Investigation - Site Location
 I-70 Clear Creek Welcome Center
 Des. No. 1902855, Rest Area Modernization
 Vigo County, Indiana

Exhibit 5 - Waters Delineation Map
 I-70 Clear Creek Welcome Center
 Rest Area Modernization
 Sugar Creek Township, Vigo County, Indiana
 Des. No. 1902855
 Metric Project No. 21-0049-3
 Map Date: 5/12/2022
 Map Author: April Pape

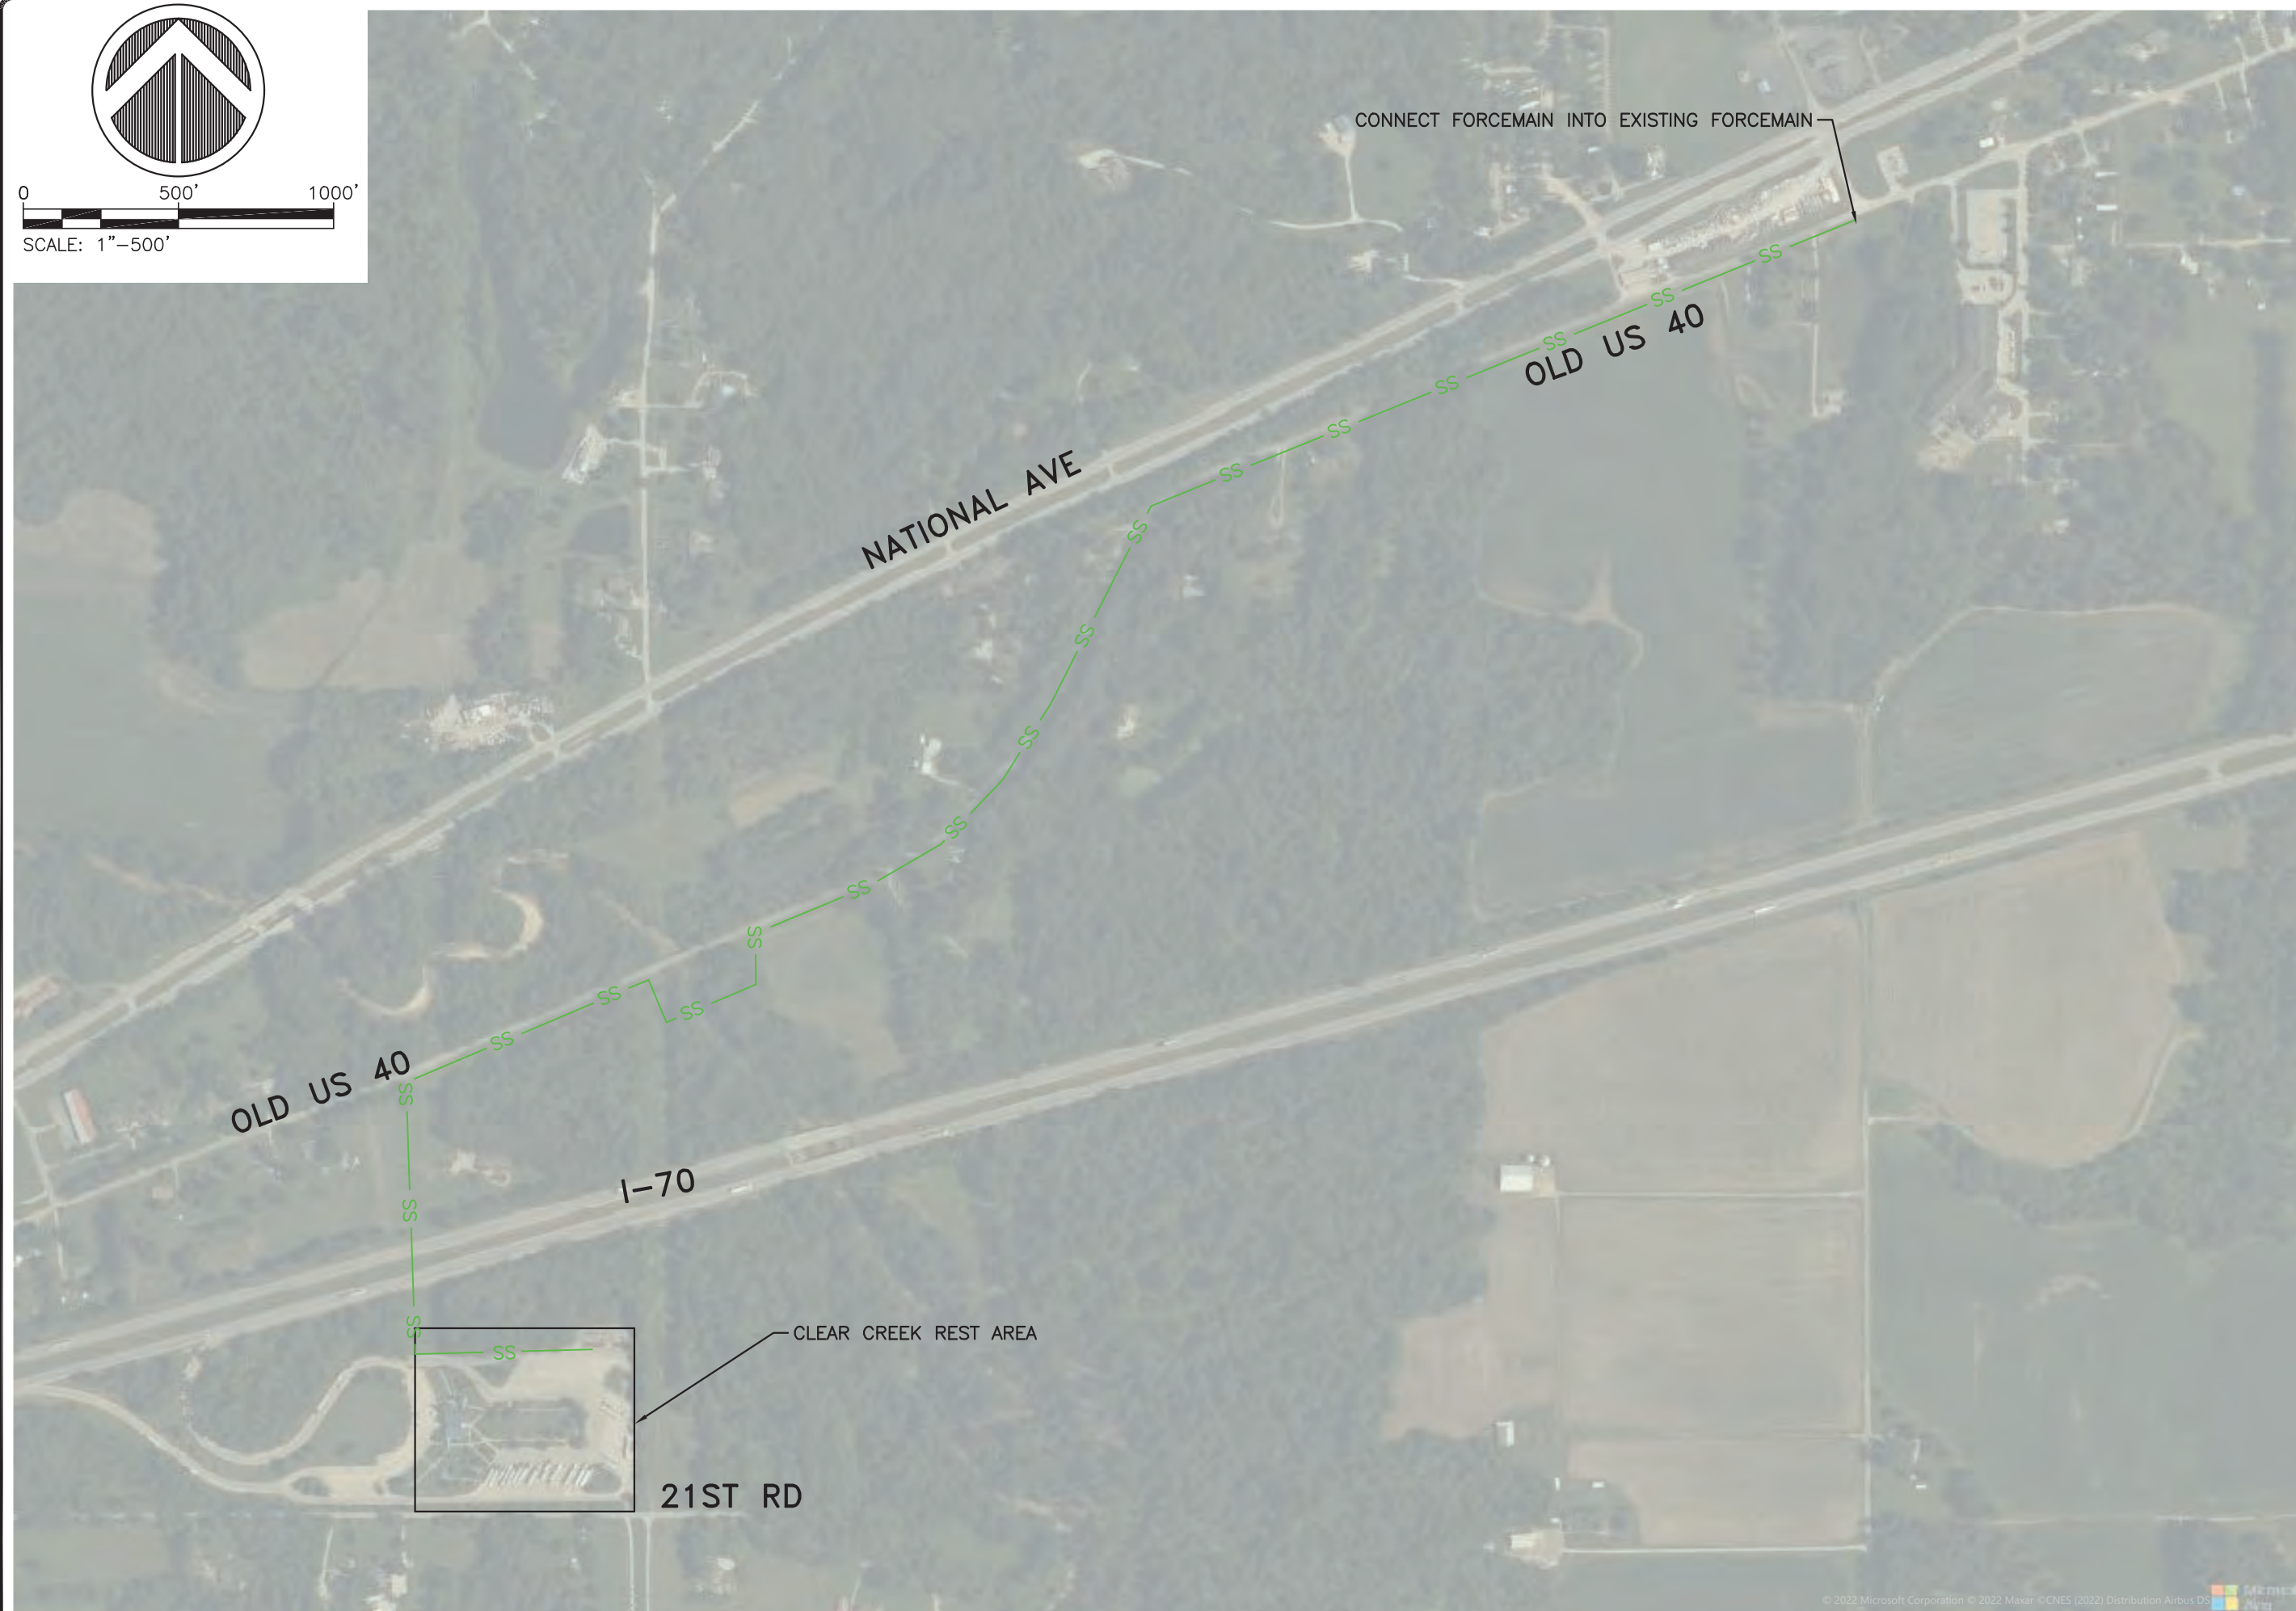
CONNECT FORCEMAIN INTO EXISTING FORCEMAIN

WASTEWATER ALIGNMENT

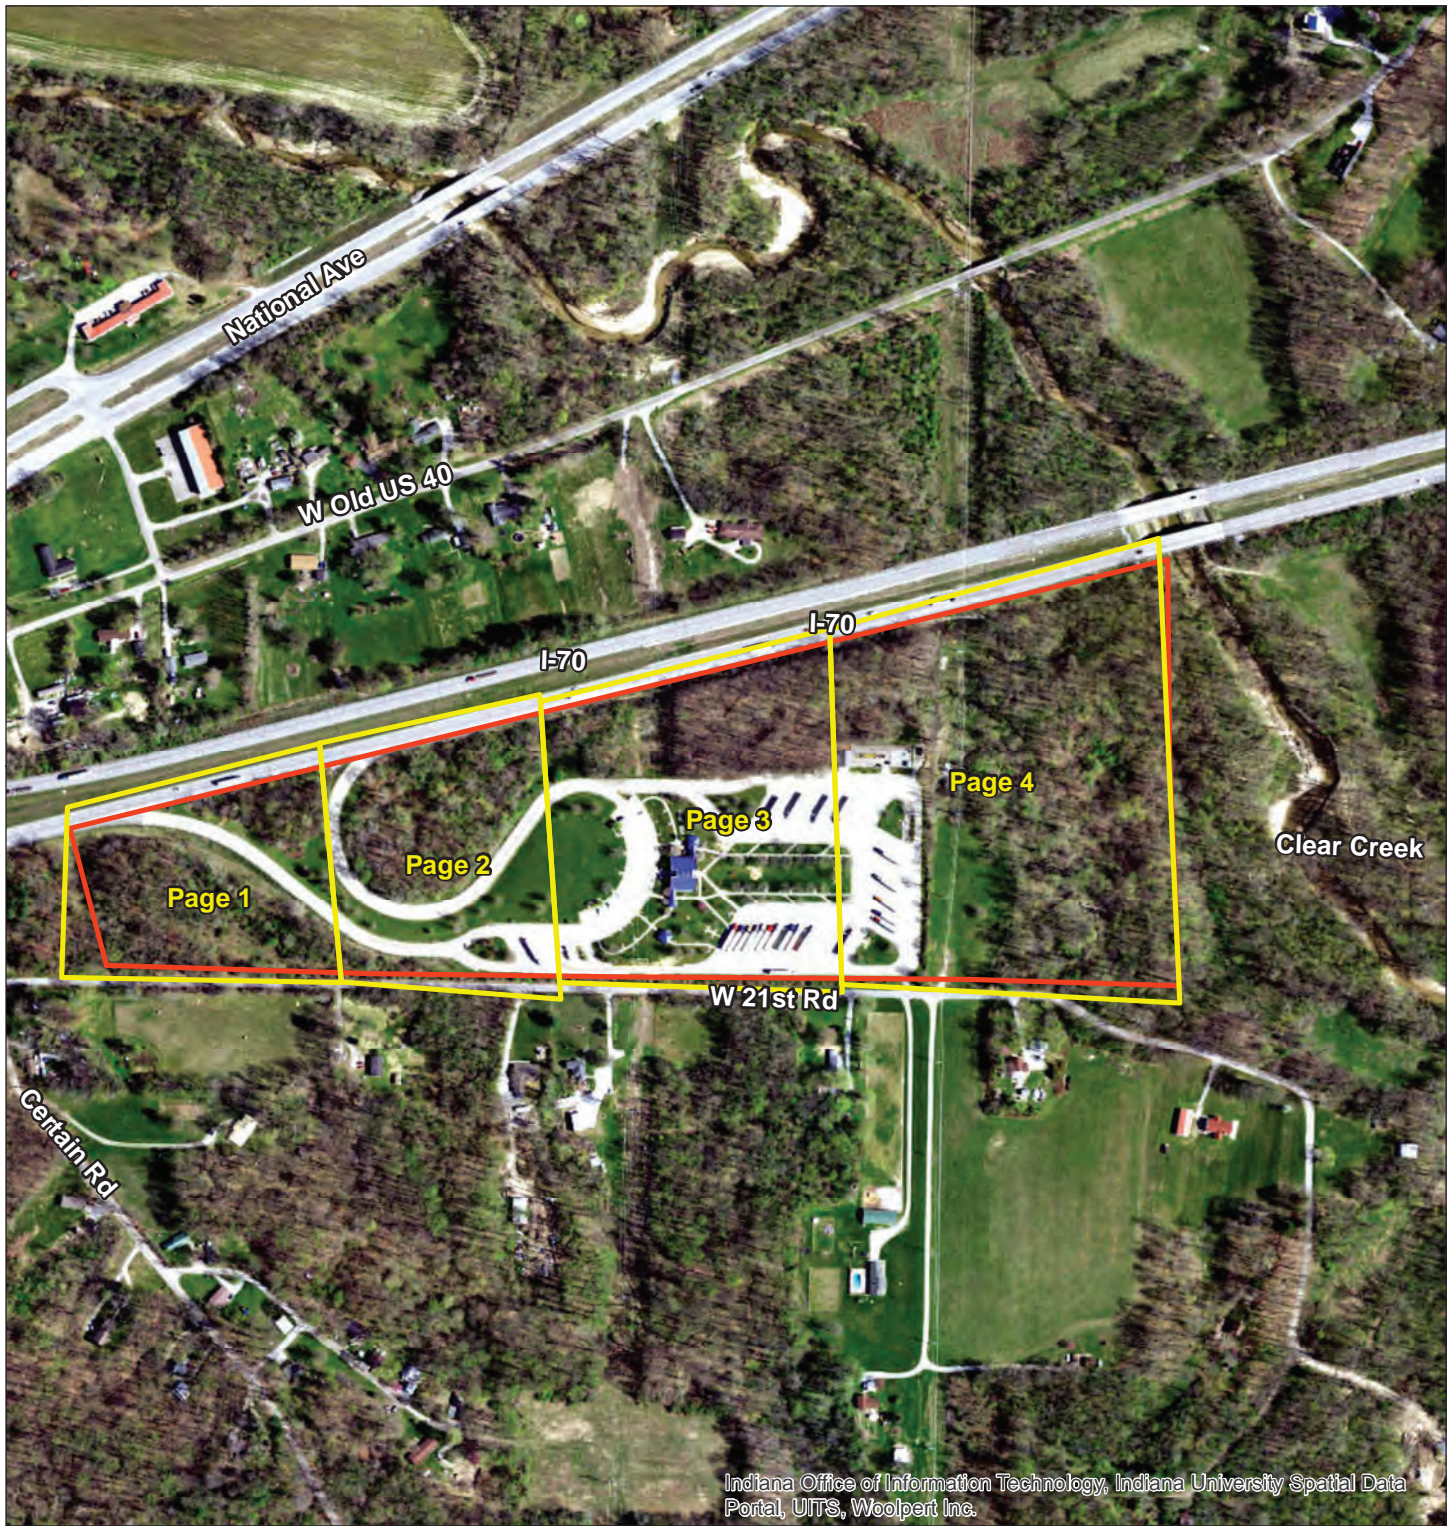
- Page
- Investigated Area (IA)

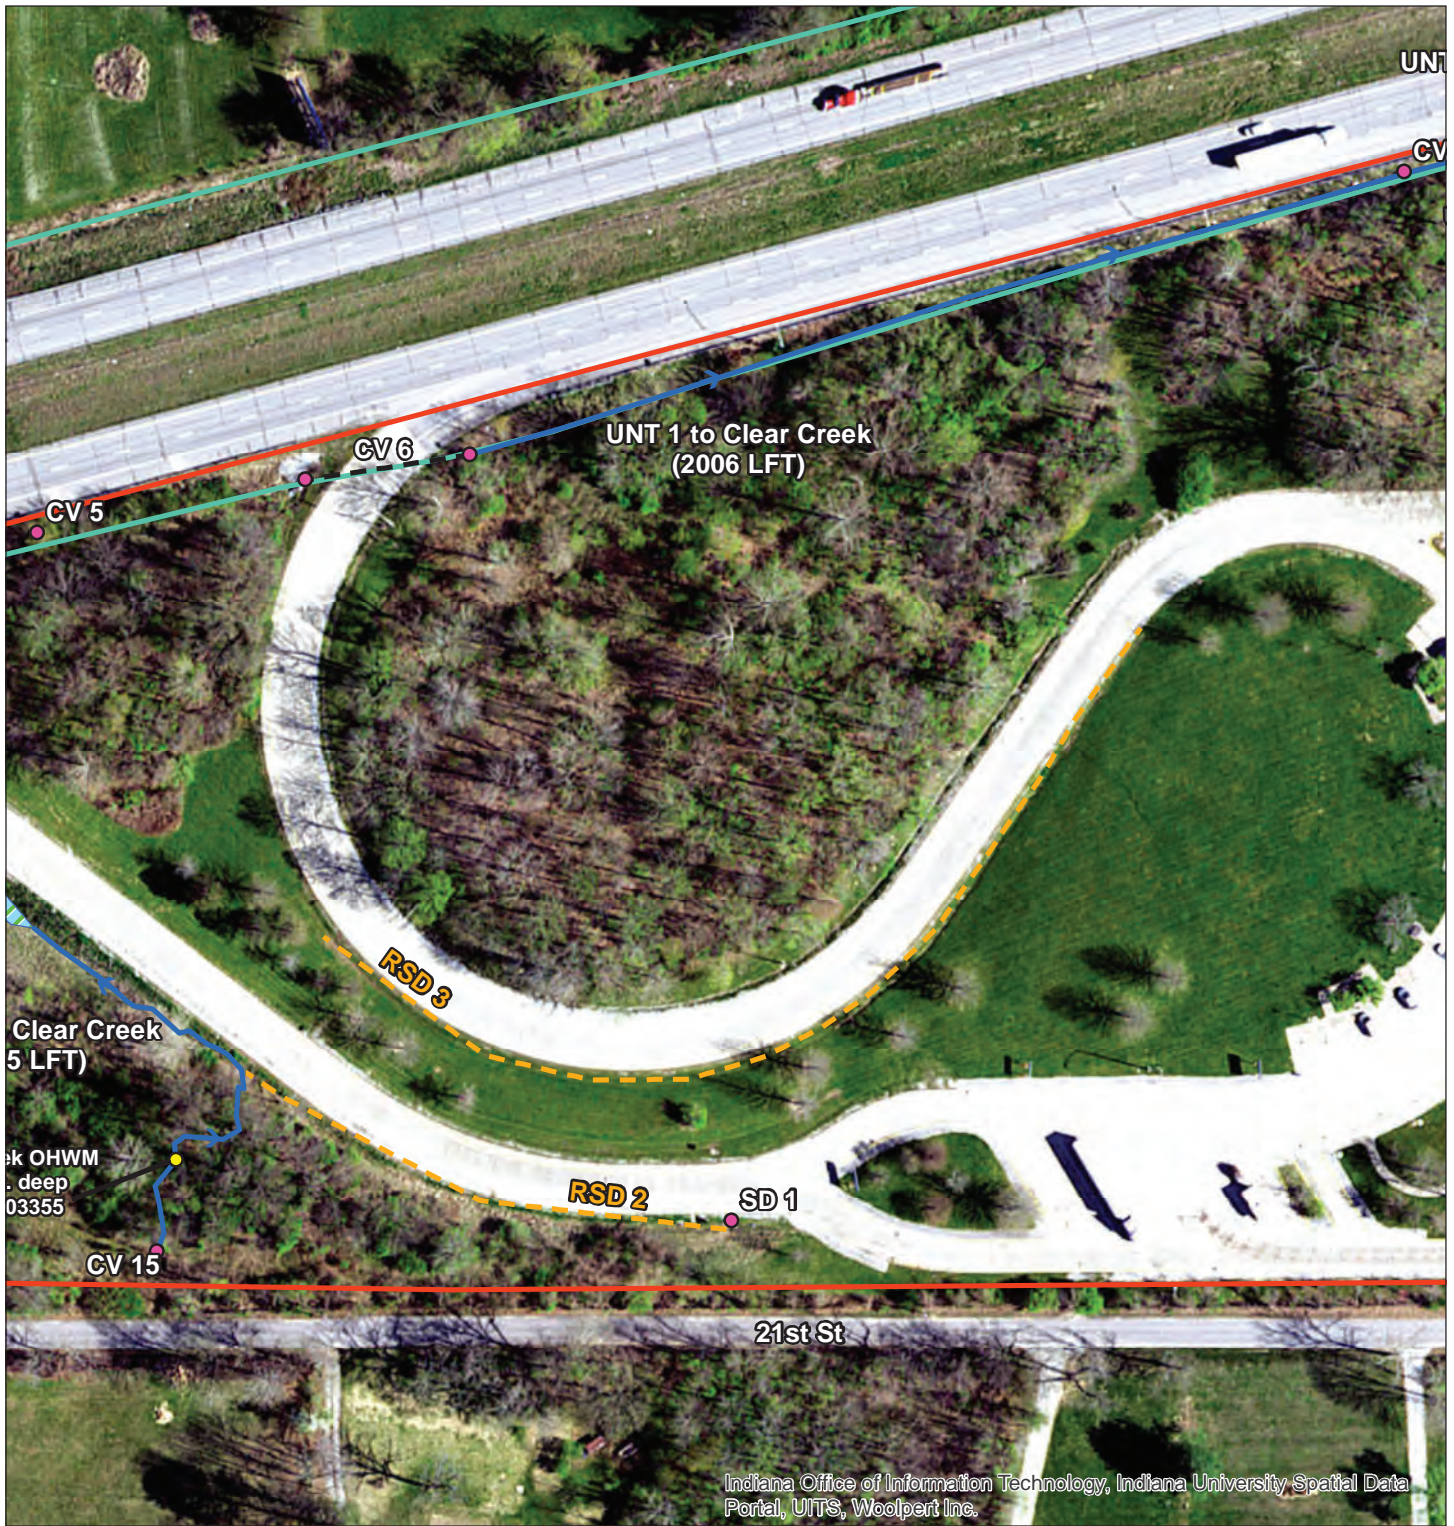
Exh. 5
 Page 2 of 4

Exhibit 5 - Waters Delineation Map
 I-70 Clear Creek Welcome Center
 Rest Area Modernization
 Sugar Creek Township, Vigo County, Indiana
 Des. No. 1902855
 Metric Project No. 21-0049-3
 Map Date: 5/12/2022
 Map Author: April Pape

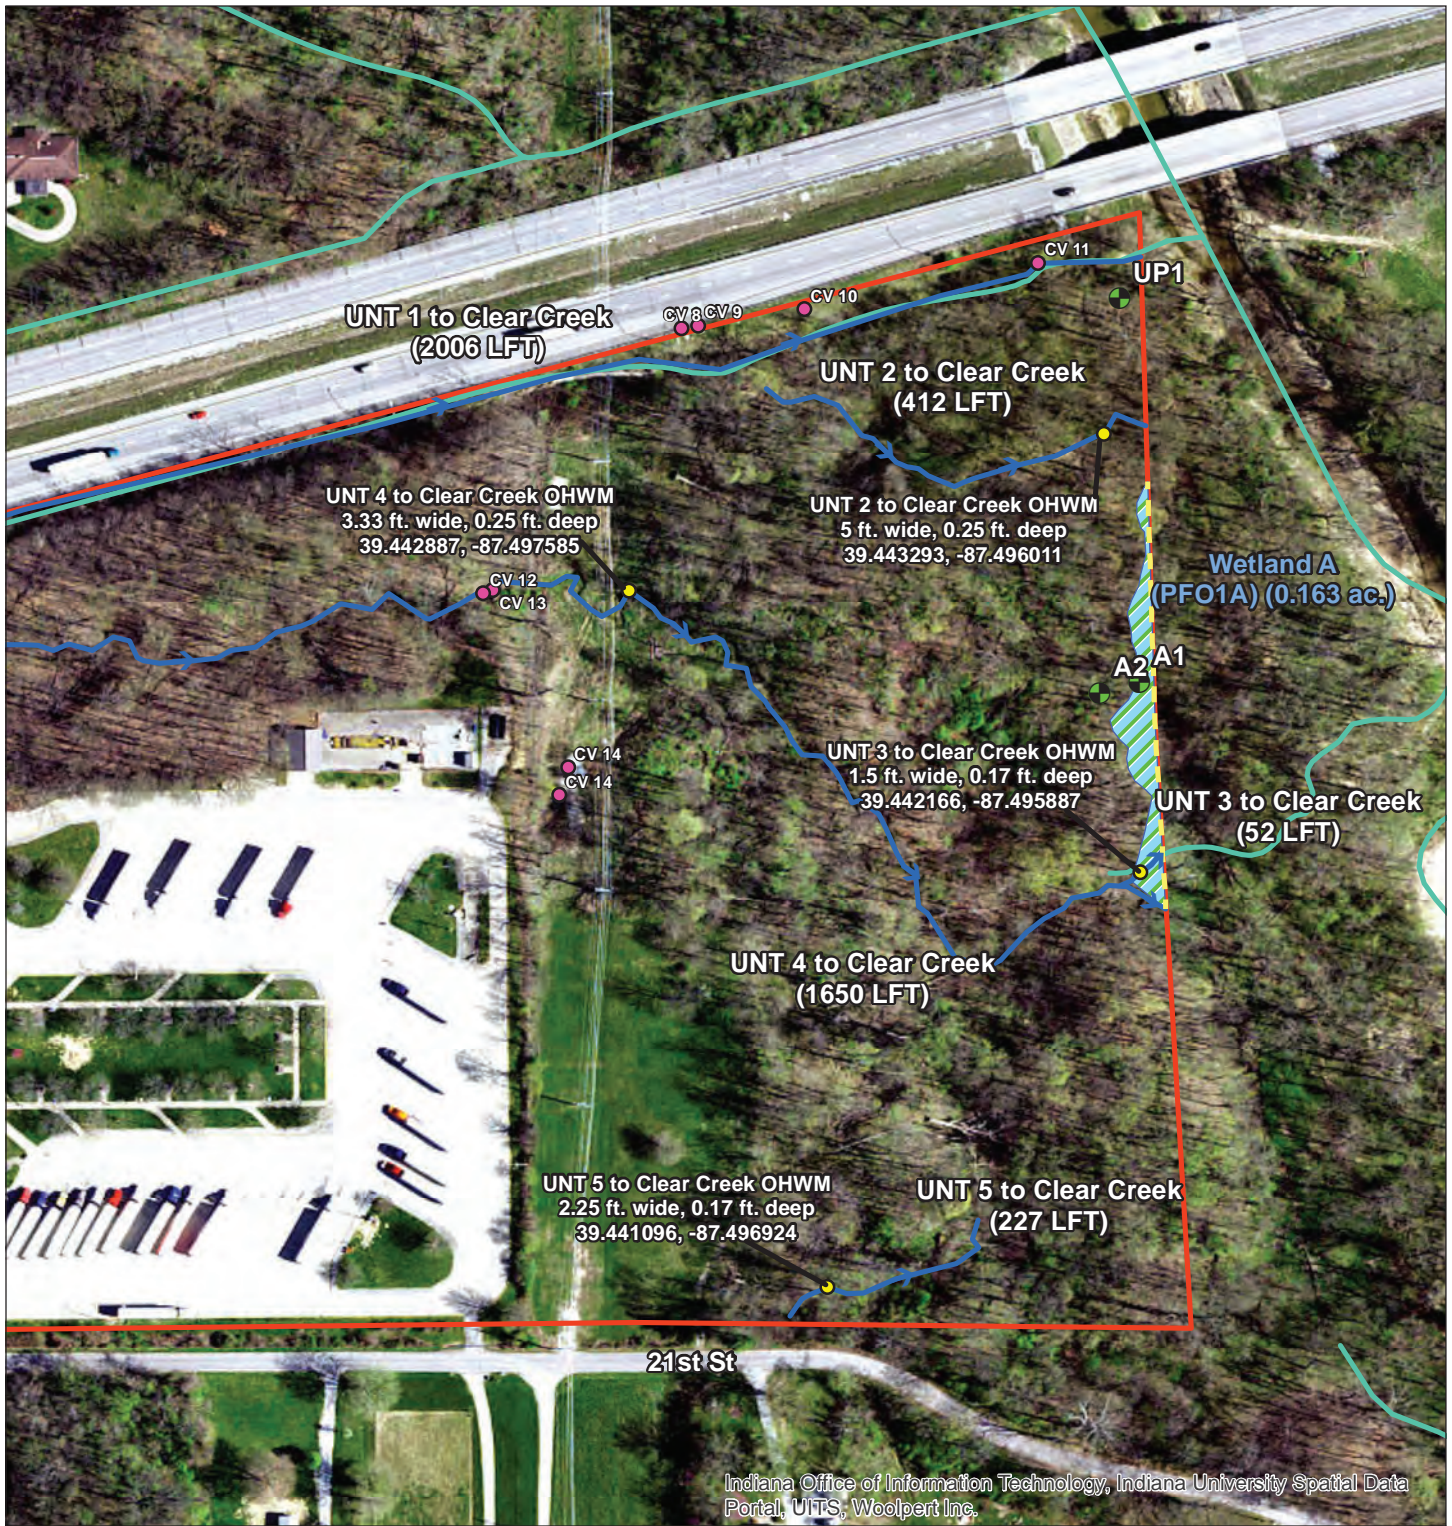
Exh. 5
 Page 3 of 4

- Investigated Area (IA)
- Delineated Wetland Continues Beyond IA
- OHWM Measurement
- Point
- Culvert
- Sampling Point
- Stream
- Roadside Ditch
- Wetland
- NHD Flowline

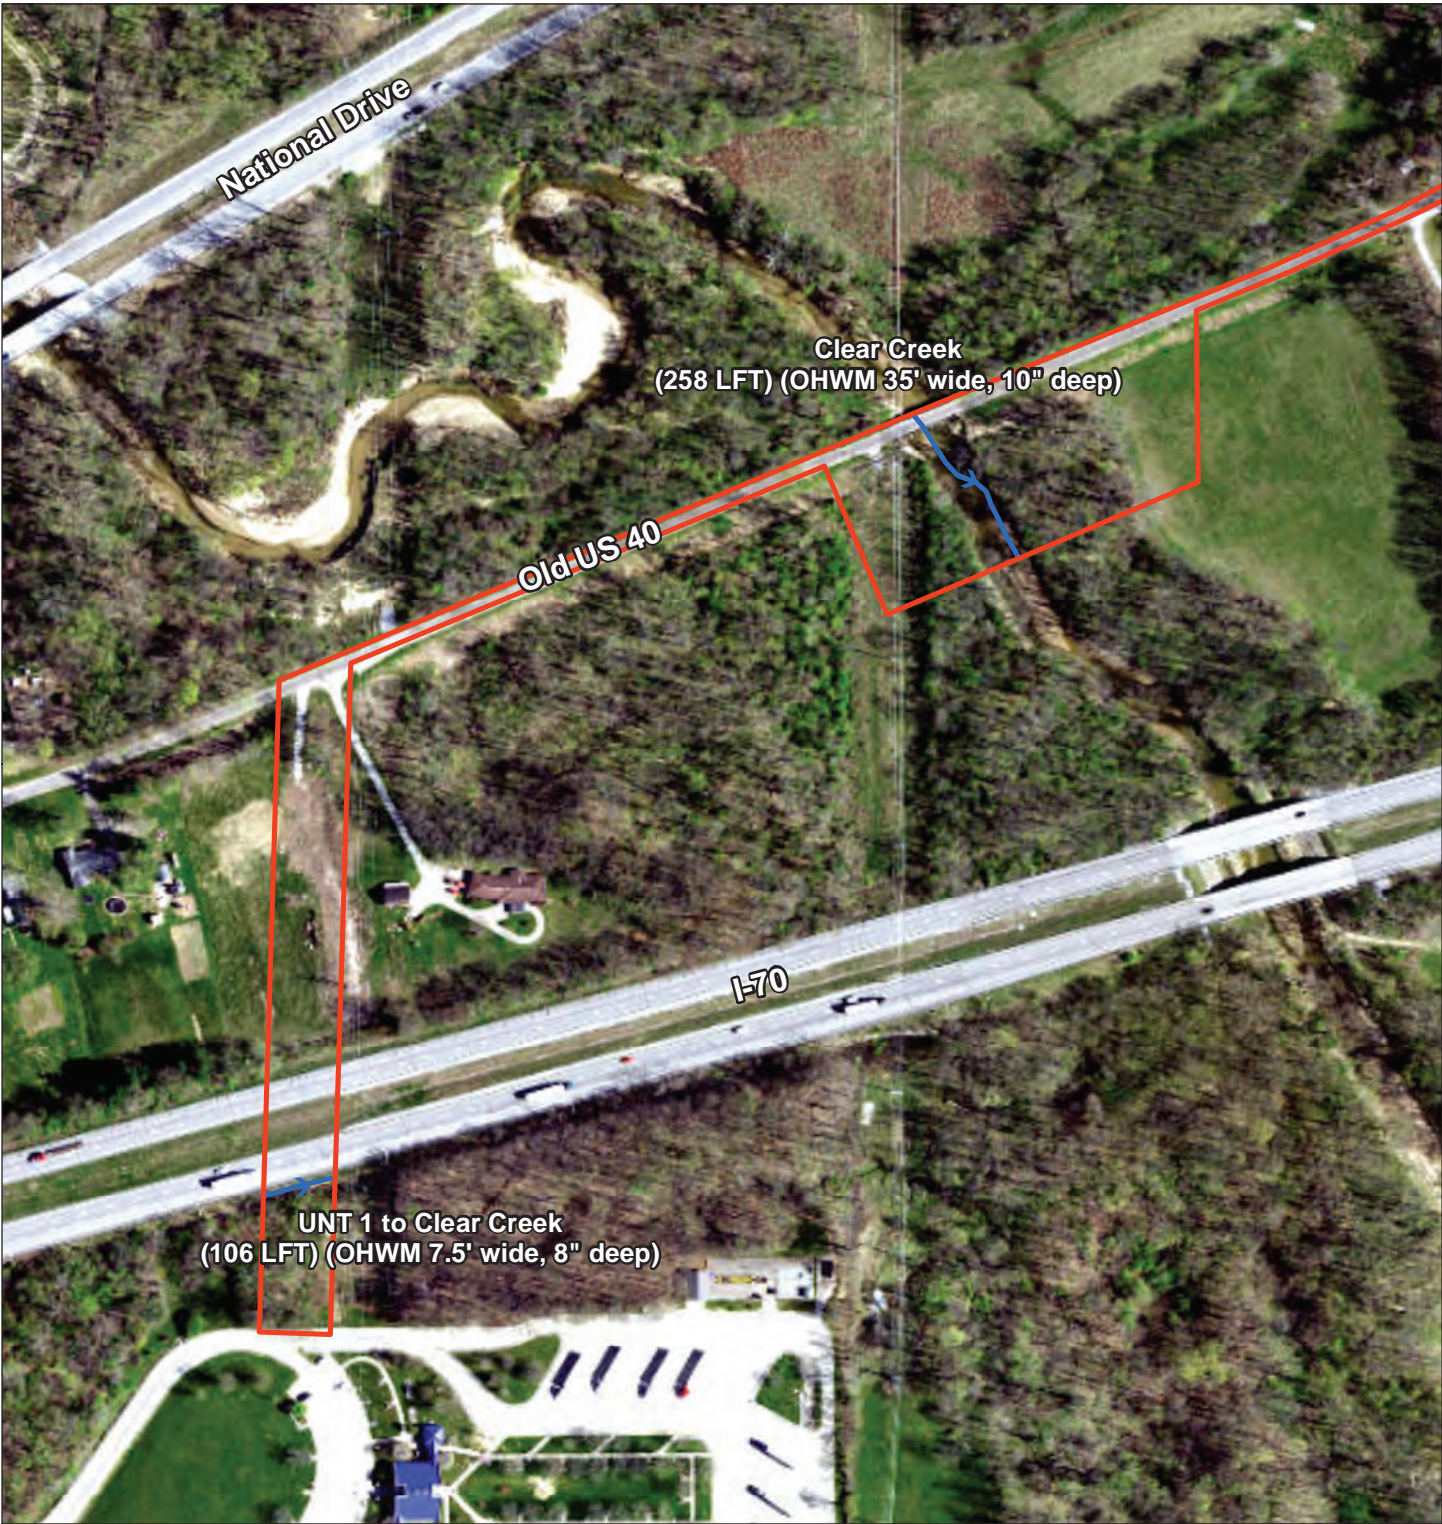
- Investigated Area
- Stream

Waters Delineation Map
 I-70 Clear Creek Welcome Center - Utilities
 Rest Area Modernization
 Sugar Creek Township, Vigo County, Indiana
 Des. No. 1902855
 Metric Project No. 21-0049-3b
 Map Date: 6/29/2022
 Map Author: April Pape

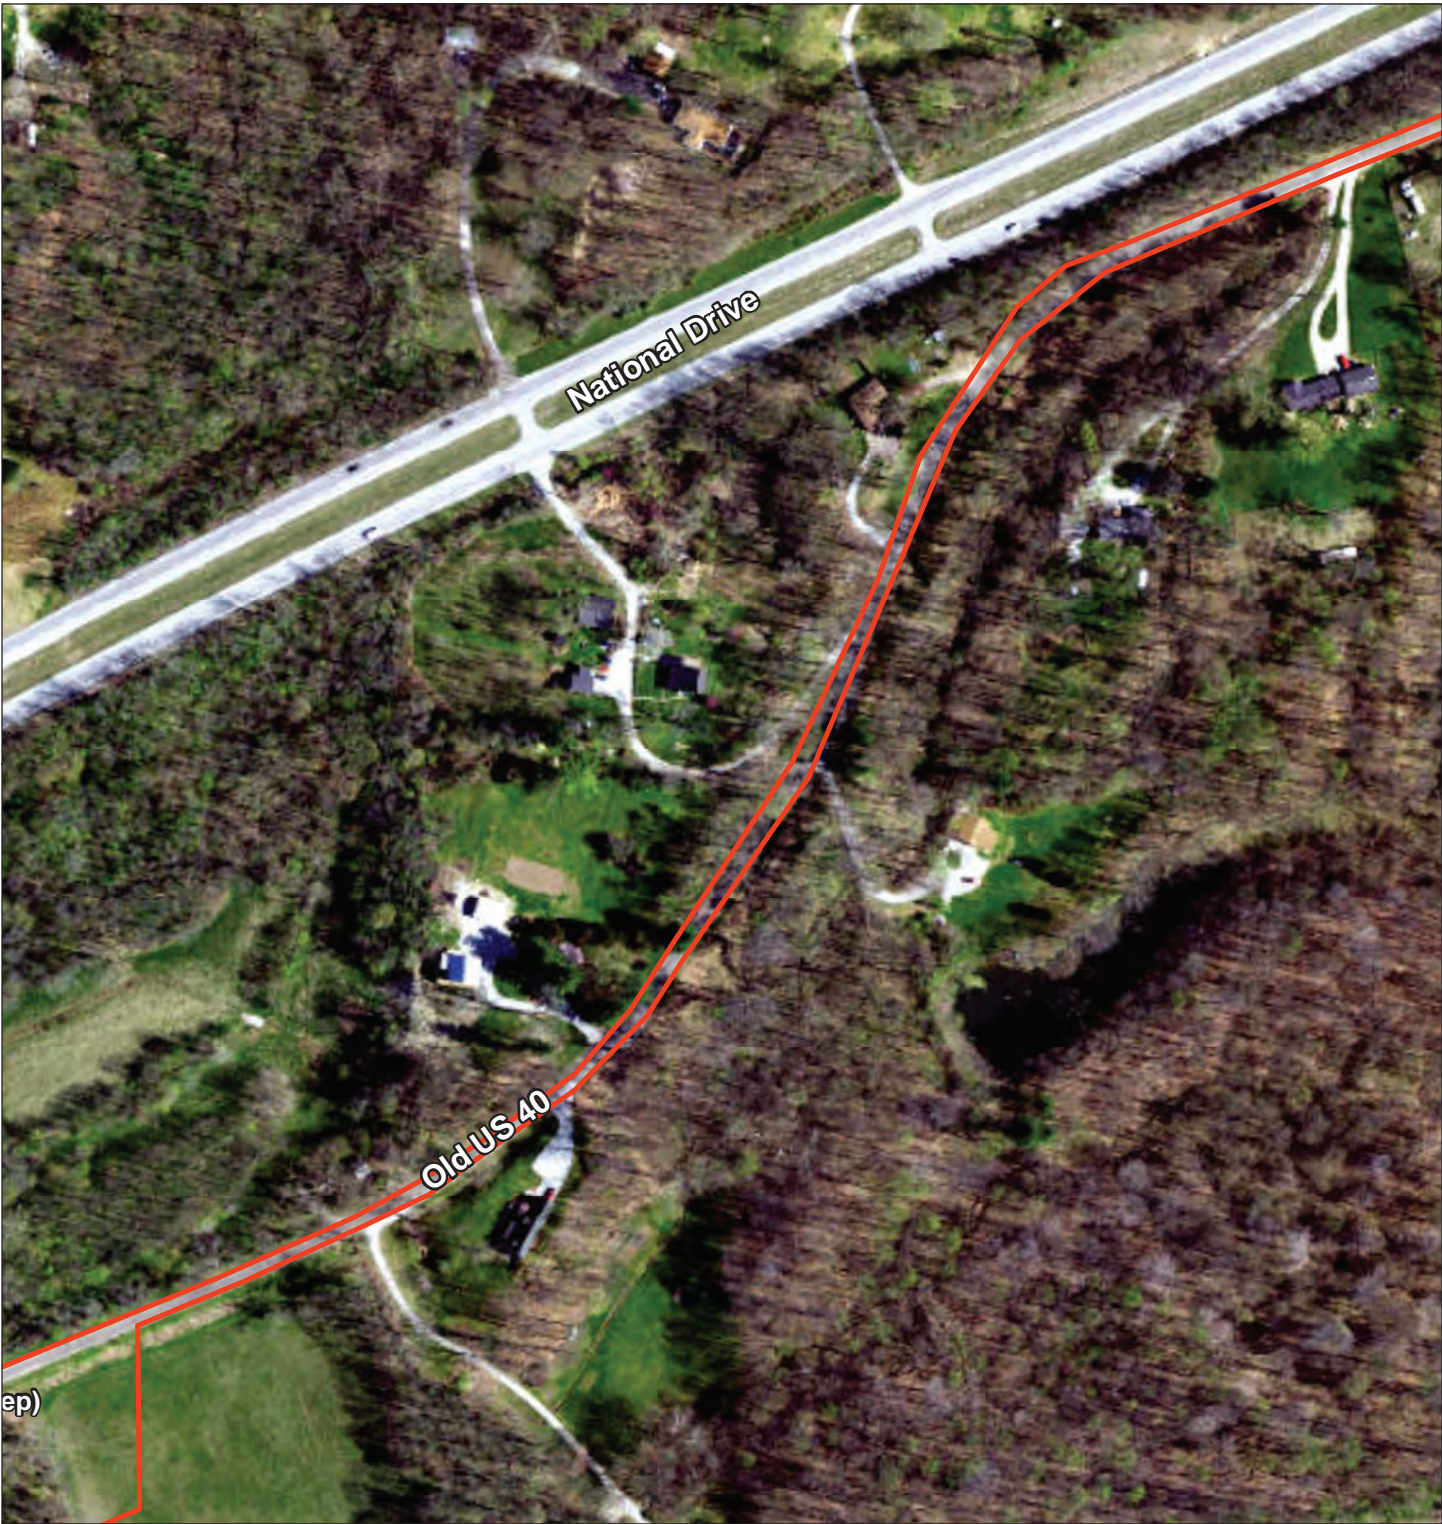
- Investigated Area
- Stream

Waters Delineation Map
 I-70 Clear Creek Welcome Center - Utilities
 Rest Area Modernization
 Sugar Creek Township, Vigo County, Indiana
 Des. No. 1902855
 Metric Project No. 21-0049-3b
 Map Date: 6/29/2022
 Map Author: April Pape
