Des. No. 1800210 Appendix F: Water Resources

# SR 56 at Boatman Road Des. No. 1800210

## WETLAND DETERMINATION DATA FORM - Midwest Region

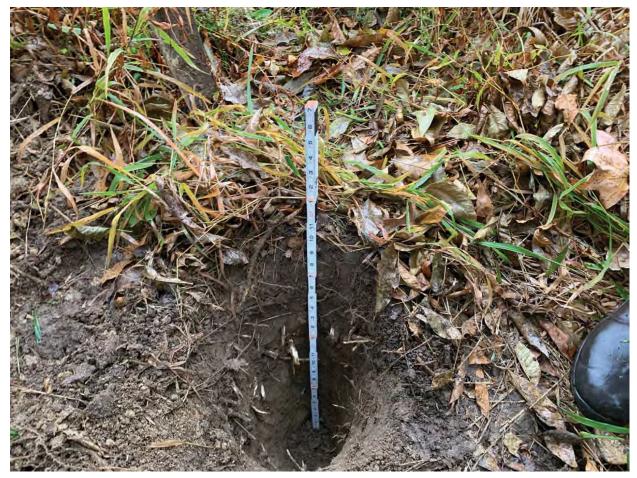
AW1 soil pit

Profile Des	cription: (Describe	to the depti				tor or o	confirm the absence	of indicators	.)	
Depth	Matrix		Redo	x Featur	es					
(inches)	Color (moist)		Color (moist)	_%_	Type <sup>1</sup>	Loc <sup>2</sup>	Texture		Remarks	
0-4	10YR 3/1	100					Loamy/Clayey			
4-16	10YR 5/1	85	10YR 5/6	15	C	M_	Loamy/Clayey	Prominer	nt redox conce	entrations
	oncentration, D=De	pletion, RM=I	Reduced Matrix, I	MS=Mas	ked Sand	d Grains			ning, M=Matri	
Hydric Soil									matic Hydric	Soils <sup>3</sup> :
— Histosol	` '		Sandy Gle	•				st Prairie Redo		
I —	pipedon (A2)		Sandy Re					Manganese M		
	istic (A3)		Stripped N		o)			Parent Materi		
	en Sulfide (A4)		Dark Surfa		. (54)				Surface (F22	)
	d Layers (A5)		Loamy Mu	-			Othe	er (Explain in F	Remarks)	
	uck (A10) d Below Dark Surfa	no (A11)	Loamy Gl	-						
I — ·	а веюw Dark Surra ark Surface (A12)	ce (ATT)	Redox Da	•	•		3 Indianta	ro of budrooks	tia vamatatian	and

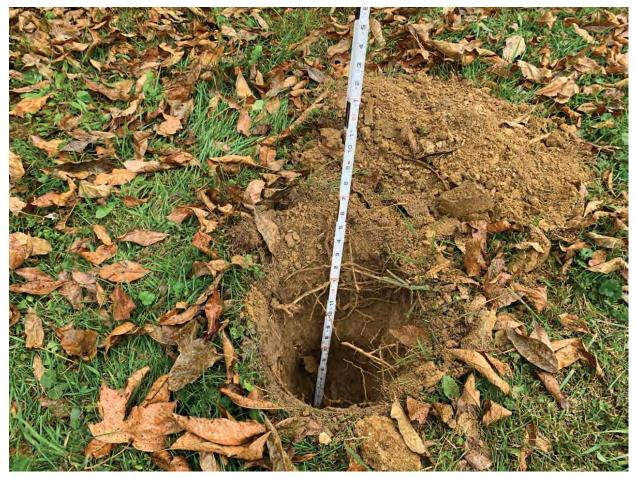
AU1 soil pit

Profile Des Depth	Matrix		Redo	x Featur	es					
(inches)	Color (moist)	%	Color (moist)	%	Type <sup>1</sup>	Loc <sup>2</sup>	Texture		Remarks	
0-5	10YR 4/1	100					Loamy/Clayey			
5-12	10YR 5/3	85	10YR 5/6	15	С	М	Loamy/Clayey	Distinct re	edox concent	rations
	_									
		;								
	·									
<sup>1</sup> Type: C=0	Concentration, D=De	- —— · pletion, RM		//S=Mas	ked Sand	Grains.	²Location	: PL=Pore Lini	ing, M=Matrix	
Hydric Soi	I Indicators:						Indicato	s for Problem	atic Hydric S	oils³:
Histoso	il (A1)		Sandy Gle	yed Mat	rix (S4)		Coas	t Prairie Redox	(A16)	
Histic E	pipedon (A2)		Sandy Red	dox (S5)			Iron-	Manganese Ma	sses (F12)	
Black H	listic (A3)		Stripped M	latrix (Sé	6)		Red	Parent Material	I (F21)	
Hydrog	en Sulfide (A4)		Dark Surfa	ce (S7)			Very	Shallow Dark S	Surface (F22)	
Stratifie	ed Layers (A5)		Loamy Mu	cky Mine	eral (F1)		Othe	r (Explain in Re	emarks)	
2 cm M	uck (A10)		Loamy Gle	yed Mat	rix (F2)
