## SR 445, from 0.39 Mile East of SR 54 to 0.62 Mile East of SR 54

### Des. No. 2100161, Guardrail Improvement

## Waters of the U.S. Determination Report

**SR 445, from 0.39 Mile East of SR 54 to 0.62 Mile East of SR 54**  
**Greene County, Indiana**  
**Guardrail Improvement**  
**Des. No. 2100161**  
**Asset # ID: CV 445-28-000.52**

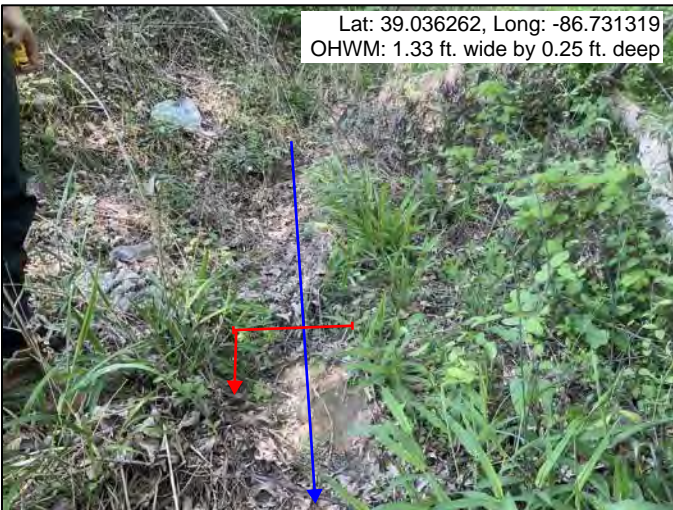
Photo 11. UNT 3 to Beech Creek OHWM measurement, facing upstream, viewing west, 5/13/2022

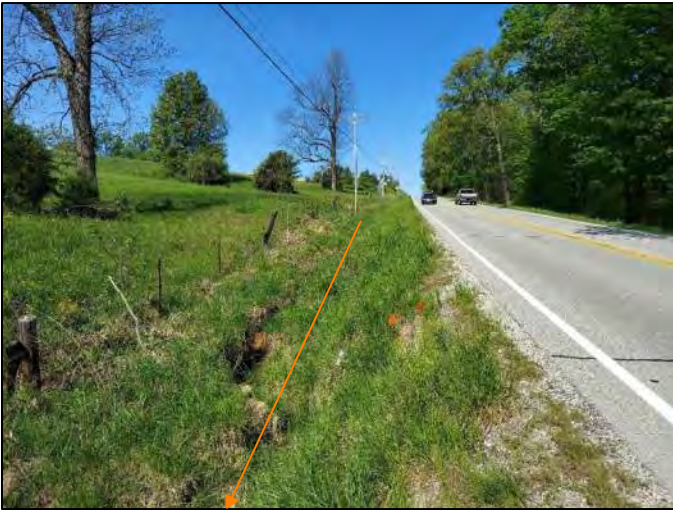
Photo 17. RSD 4 with eroded areas south of SR 445, viewing west, 5/13/2022

Five RSDs were observed within the investigated area. All ditches were vegetated or showed evidence of erosion. RSD 4 and RSD 5 show signs of heavy erosion and have exposed soils. RSDs 4 and 5 had water present but no apparent flow. No RSDs exhibited an OHWM or defined bed and bank. See Table 5 for details of the RSDs observed within the investigated area. Due to lack of an OHWM and defined bed and bank, the five RSDs are likely considered non-jurisdictional by the USACE.

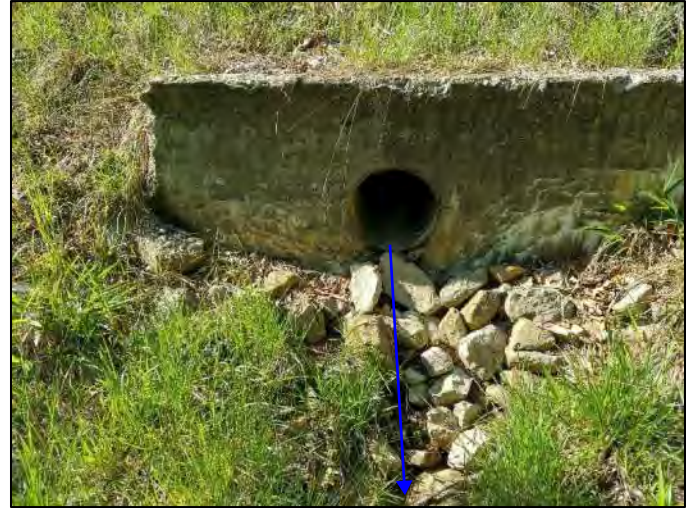
Photo 22. Outlet of CLV-67652 with UNT 2 to Beech Creek, facing upstream, viewing south, 5/13/2022

Existing riprap at Str. 3, CLV-67652, was present at the outlet of the structure, extending approximately two feet from the outlet (Photo 22). The remaining three structures had no existing riprap at the inlet or outlet. Str. 4, CV 445-28-000.52 had large cobble present within the stream bed at the inlet and outlet but would not be considered riprap from a constructability standpoint (Photos 43 and 45).

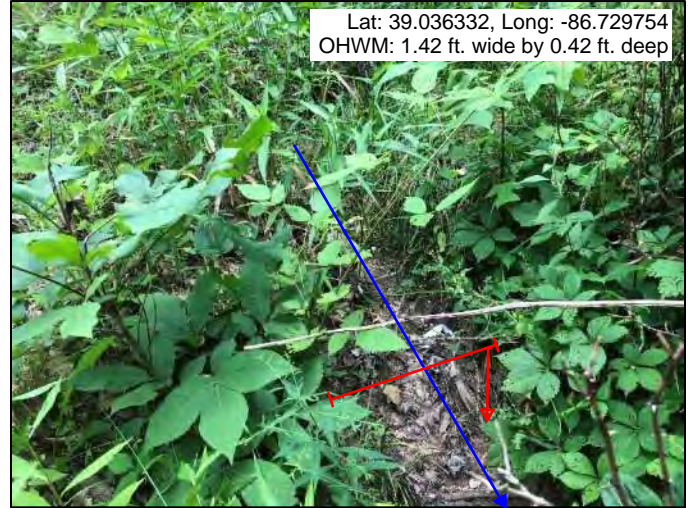
Photo 26. UNT 2 to Beech Creek and OHWM measurement, facing upstream, viewing southwest, 7/7/2022

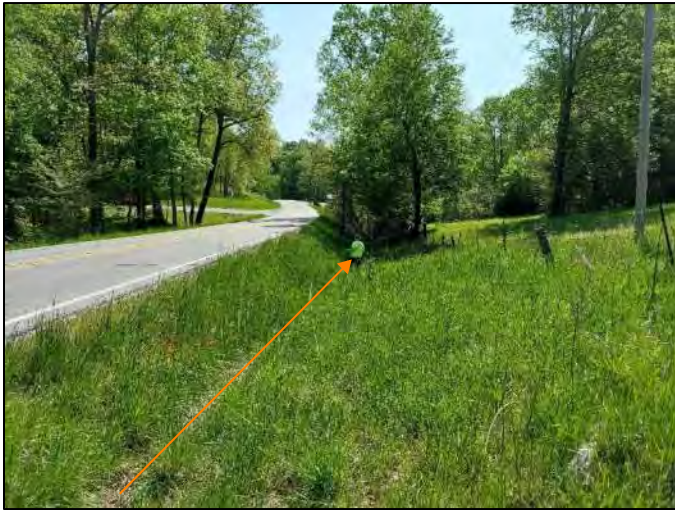
Photo 29. RSD 5 flowing towards UNT 1 to Beech Creek, eroded area starts at trees within the ditch line, viewing east, 5/13/2022

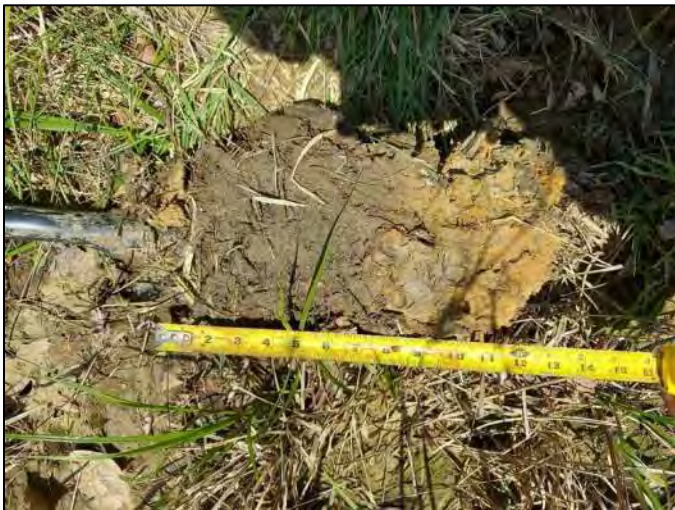
Photo 31. DP-3 potential wetland point soil profile, 5/13/2022

The area associated with DP-3 was evaluated because it appeared to exhibit hydrophytic vegetation and hydrology indicators. Dominant vegetation included broom sedge bluestem (*Andropogon virginicus*, FACU) and tall flatsedge (*Cyperus eragrostis*, FACW). Hydrophytic vegetation and hydric soils were not present. One secondary indicator (Geomorphic Position (D2)) was present but lacked additional secondary indicators. Therefore, wetland hydrology was not present. Due to the lack of all three wetland criteria, DP-3 was not a wetland point and required no further investigation.

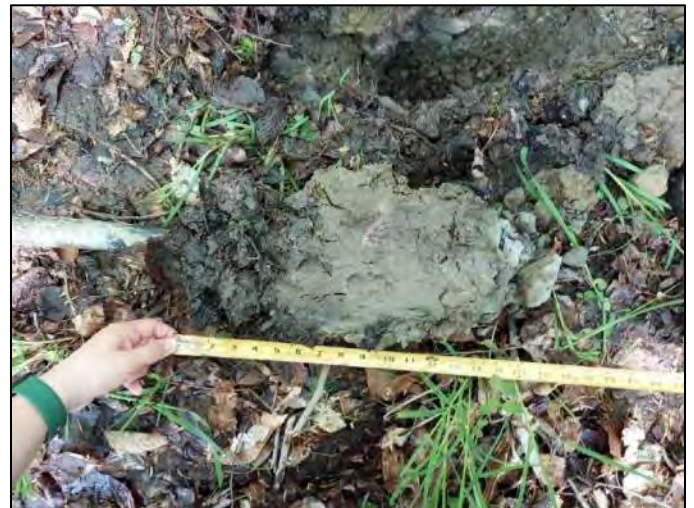
Photo 36. DP-1 wetland point soil profile for Wetland A, 5/13/2022

The area associated with DP-1 was evaluated because it exhibited hydrophytic vegetation and hydrology indicators. Dominant vegetation included white ash (*Fraxinus americana*, FACU), *G. striata*, and *I. capensis*. Hydrophytic vegetation was present due to passing the dominance test and prevalence index. Four hydric soil indicators were present (Stratified Layers (A5), Sandy Mucky Mineral (S1), Depleted Matrix (F3), Redox Depressions (F8)). Two primary indicators of hydrology (Saturation (A3), Water-Stained Leaves (B9)) and four secondary indicators of hydrology (Sparsely Vegetated Concave

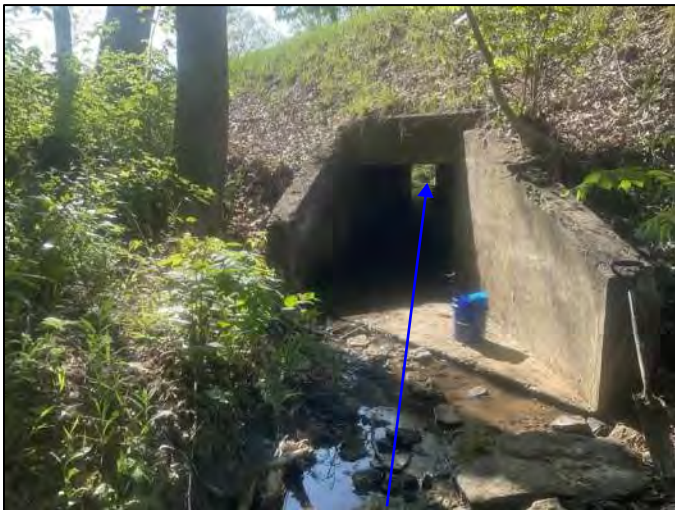
Photo 43. Inlet of culvert (CV 445-28-000.52) and UNT 1 to Beech Creek, facing downstream, viewing southeast, 5/13/2022

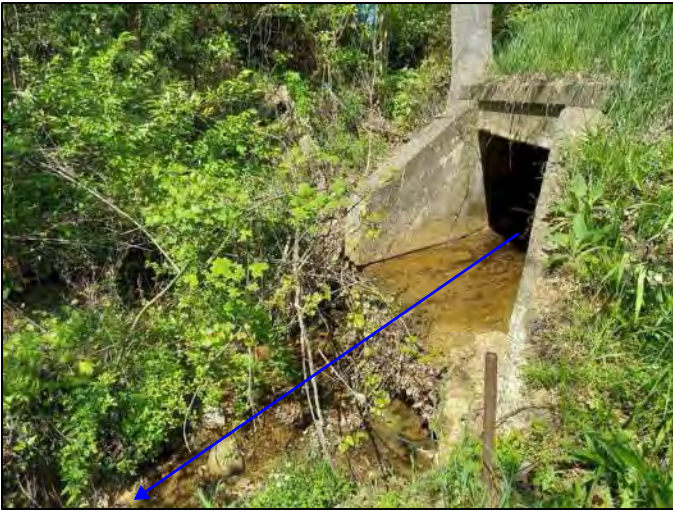
Photo 45. Outlet of culvert (CV 445-28-000.52) with UNT 1 to Beech Creek, viewing west, 5/13/2022

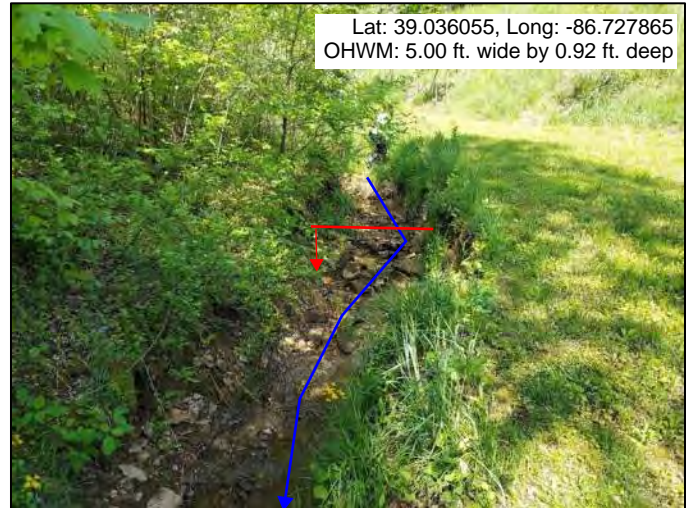
Photo 48. UNT 1 to Beech Creek OHWM measurement, facing upstream, viewing northwest, 5/13/2022

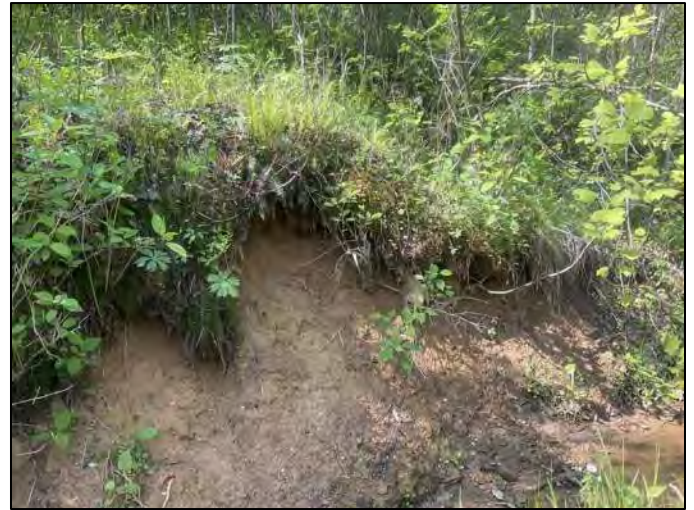
Photo 50. Eroded bank of UNT 1 to Beech Creek, viewing south, 5/13/2022
