Bridge Replacement on SR 58 over the East Fork of White Creek Project

Bridge Replacement on SR 58 over East Fork White Creek Located 3.35 Miles West of Interstate 65 Section 18, T-8-N, R-5-E, Ohio Township, Barthlomew County.

The Indiana Department of Transportation (INDOT) is planning to undertake a bridge replacement project, funded in part by the Federal Highway Administration (FHWA). The project is located on State Road (SR) 58 over the East Fork of White Creek, 3.35 miles west of Interstate 65 in Bartholomew County, Indiana.

Brief Description of Project: This bridge replacement project is located on State Road 58 over East Fork White Creek, approximately 3.35 miles west of I-65. The project involves the replacement of the existing two-span concrete bridge with a three-span continuous reinforced concrete slab bridge and installation of new approach slabs and guardrail. The new structure will be approximately 100 feet long with no skew.

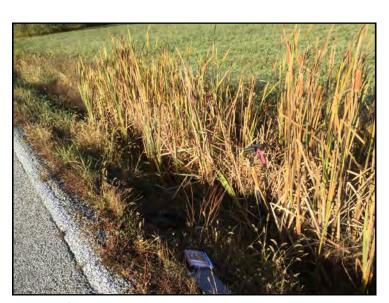
1. View of SP-A1, Wetland A, soil profile.

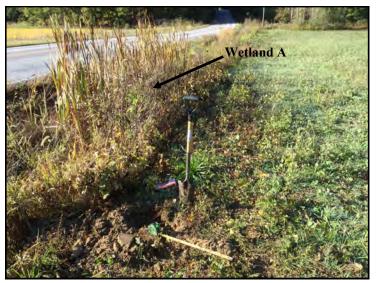
4. View of SP-A2, Wetland A upland, soil profile.

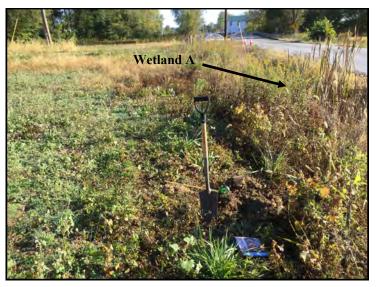
7. View of SP-B1, Wetland B, soil profile.

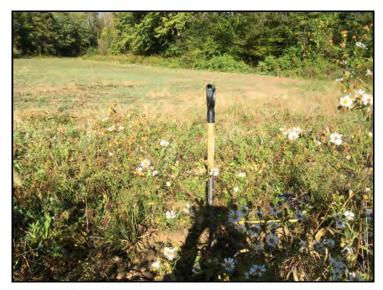
10. View of SP-B2, Wetland B upland, soil profile.

SP-B2 was located at the top of a slope northwest of Wetland B. The dominant vegetation at this sampling point was Queen Anne's lace (*Daucus carota*, UPL) and common dandelion (*Taraxacum officinale*, FACU) in the herb stratum. This did not meet any of the hydrophytic vegetation indicators. To a depth of 20 in., the soil in the test pit was a silty clay loam and exhibited a matrix color of 10YR 4/3 (100 percent). This did not meet any of the hydric soil indicators. No primary or secondary indicators of wetland hydrology were observed during the field reconnaissance. Since none of the three required wetland criteria were met, this area did not qualify as a wetland.

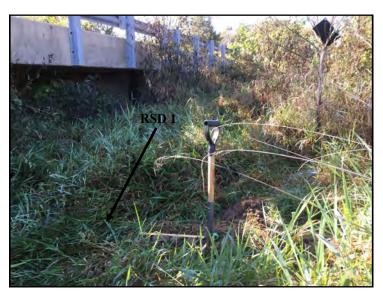
13. View of SP-1, upland sampling point 1, soil profile.

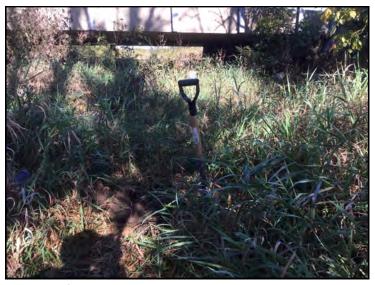
16. View of SP-2, upland sampling point 2, soil profile.

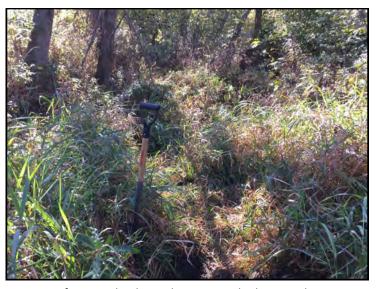
19. View of SP-3, upland sampling point 3, soil profile.

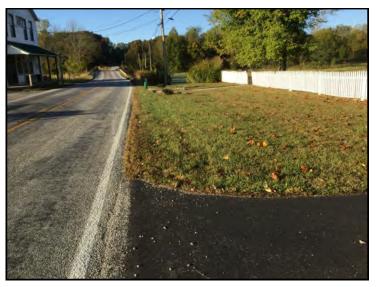
35. View of Culvert 1, looking northeast.

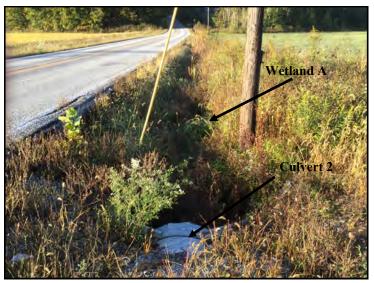
40. View of Culvert 2 and Wetland B, looking northeast.

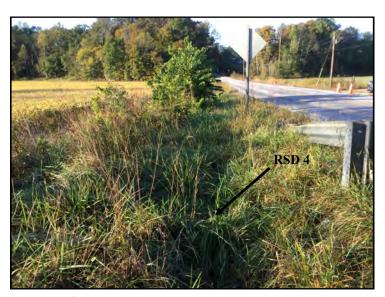
41. View of Culvert 2 and Wetland A, looking southwest.
