A PHASE IA ARCHAEOLOGICAL RECONNAISSANCE  
FOR PROPOSED ROAD IMPROVEMENTS ALONG  
SR 124 FROM SR 19 TO 7.32 MILES EAST OF  
SR 19 IN MIAMI COUNTY, INDIANA  
(INDOT DES. NO. 1800552)

### Des. No. 1800552, HMA Overlay and Preventative Maintenance

### SR 124 PREVENTATIVE MAINTENANCE PROJECT

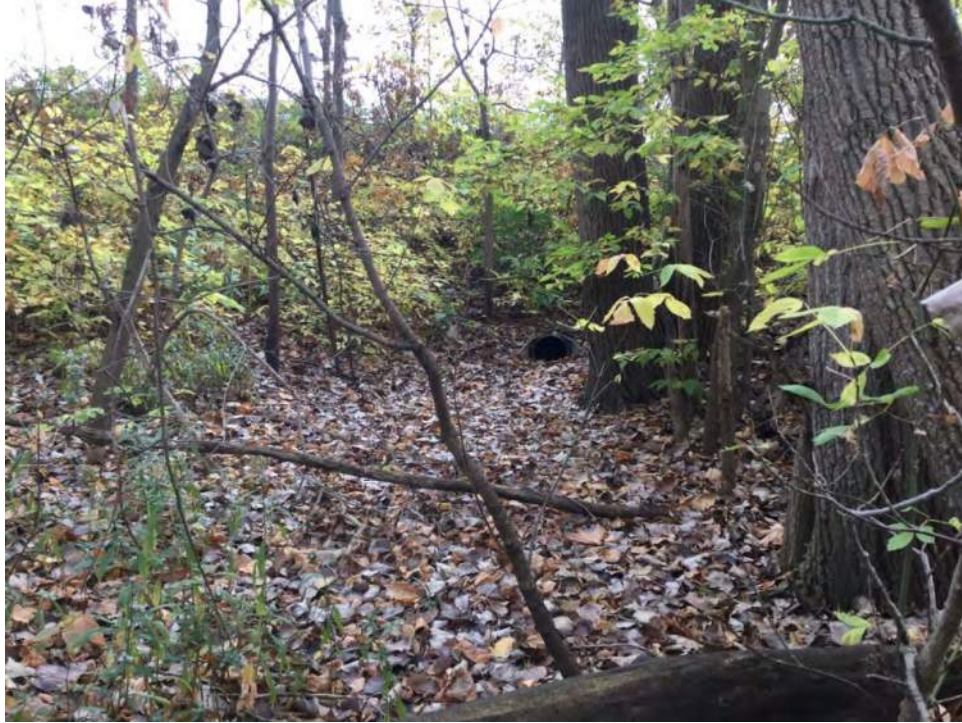
Figure 10. View of COID 19925, facing west.

- Replacement of an existing 15 inch metal pipe culvert, COID 19925, located under Circus Lane just north of the intersection with SR 124
- ~~Replacement of an existing 24 inch metal pipe culvert, COID 19879, located 4.50 miles east of SR 19~~
- Replacement of an existing 24 inch metal pipe culvert, COID 19871, located under SR 124 approximately 0.1 mile north of CR 200 South and CR 625 East.

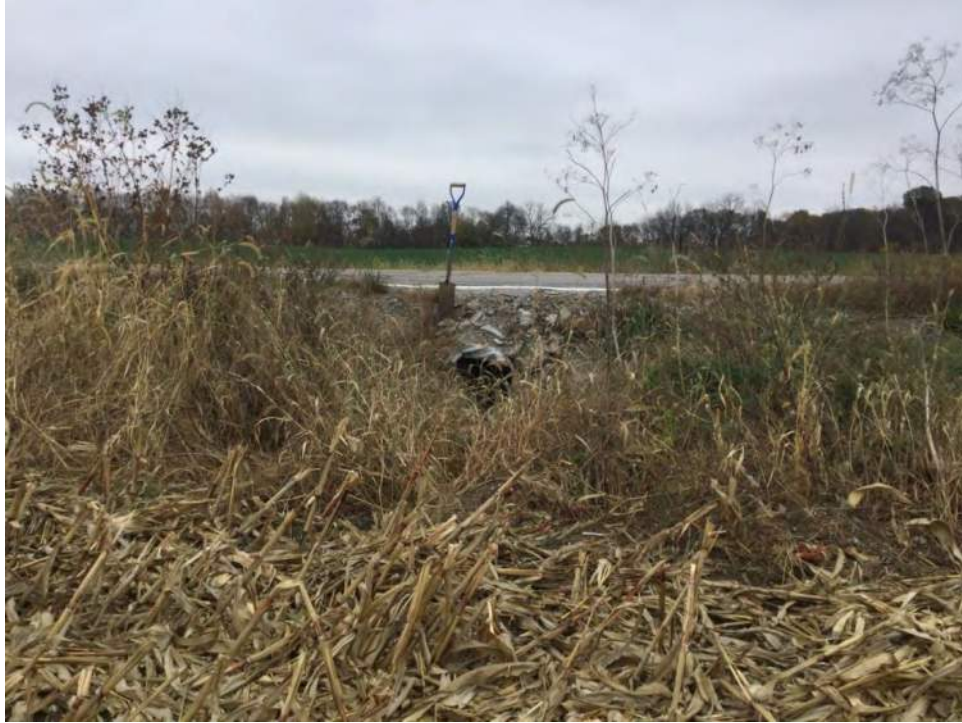
Figure 12. View of COID 19879, facing northeast.

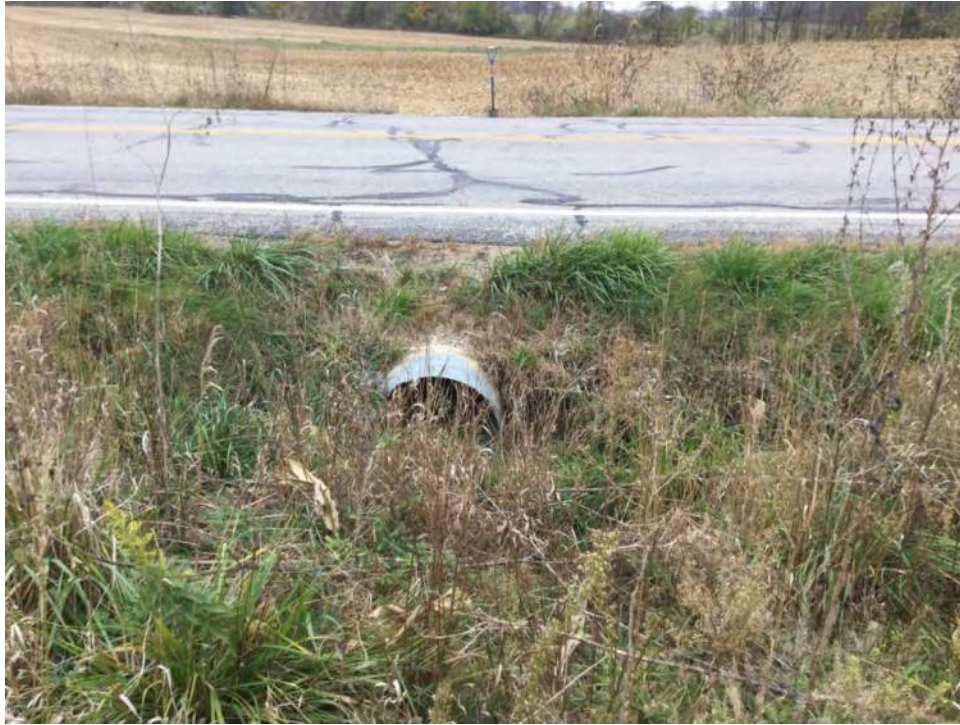
Figure 14. View of COID 19871, facing southwest.

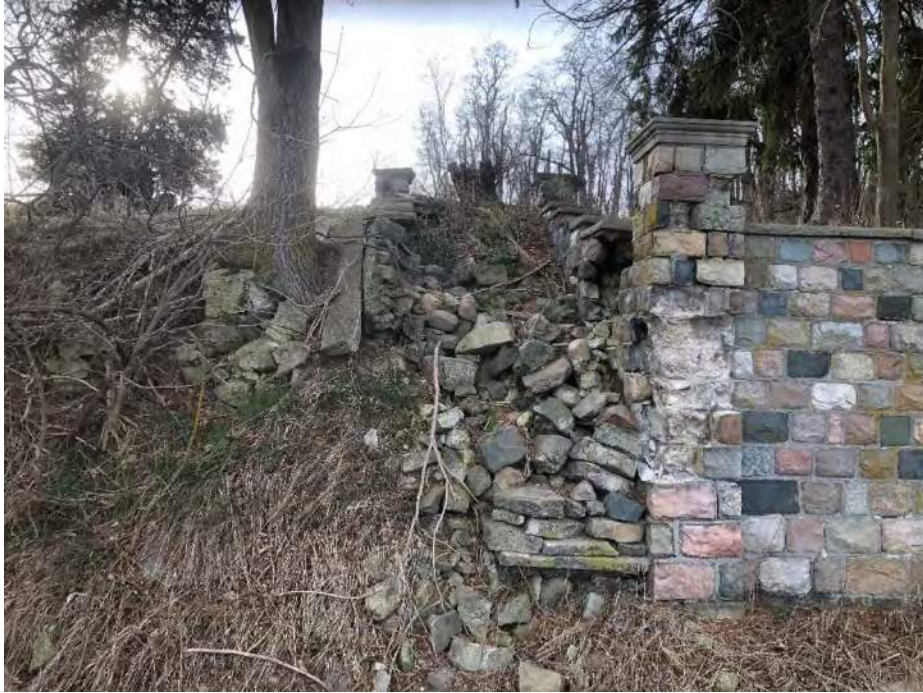
Figure 16. Historic, stone wall associated with IHSSI No. 103-507-40001, “contributing” near the location of new drainage features. The house is no longer extant as it was demolished in circa 2012. This compromises the historic integrity of the farm as it no longer retains its original structures and does not retain its ability to convey its agricultural significance nor its vernacular/construction significance. The wall has also been severely damaged and stones have been replaced.

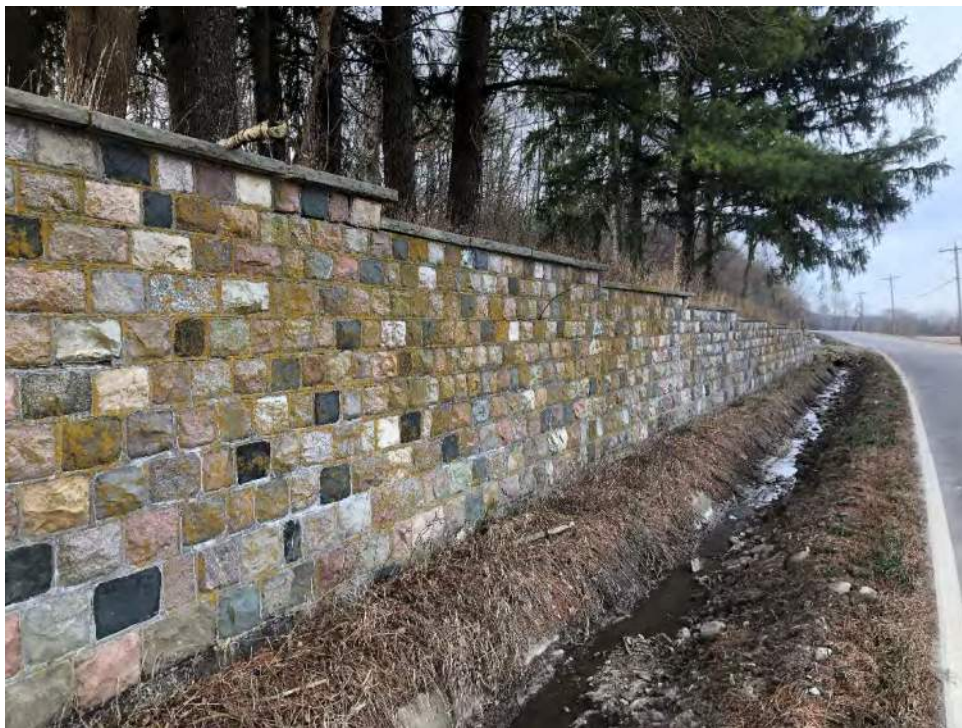
Figure 17. Detail of stone wall.

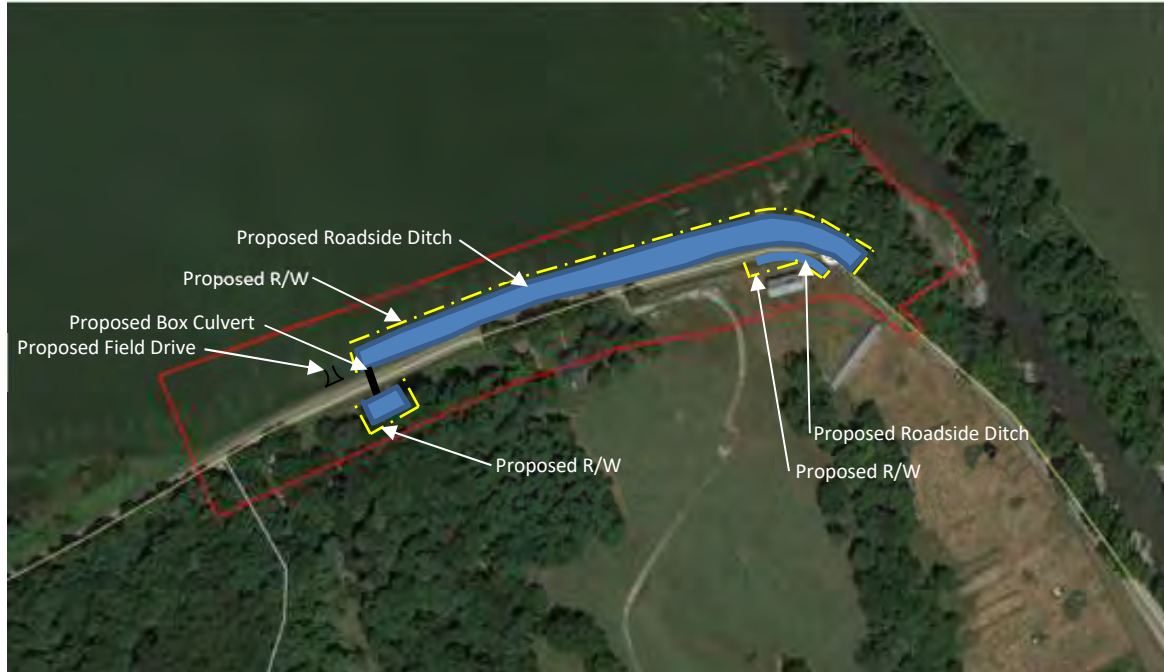
## EXHIBIT A

Existing drainage through the project is primarily sheet flow into roadside ditches. There are existing drainage issues at approximately RP 2+00, as well as shoulder widening, which will require additional right-of-way. A proposed 6'x4' box culvert will be constructed crossing SR 124, see Exhibit A. The proposed culvert is sized to provide access to maintenance in order to remove potential sediment build-up that originates from off-site private properties. Coordination will occur with the Miami County Soil and Water Conservation Office for assistance in minimizing the offsite soil erosion from entering INDOT right-of-way.

Additionally, at approximately RP 2+00, there are drainage concerns with existing ditch flow encroaching onto the edge of the existing pavement. There is also an existing ditch inlet that has been damaged by vehicles traversing over the inlet while making a sharp angle right turn on SR 124, and the outfall of this ditch to the Mississinewa River is failing. Construction of a roadside ditch/detention area along SR 124 approximately 0.36 mile northwest of the intersection of SR 124 and Mississinewa Road is anticipated.

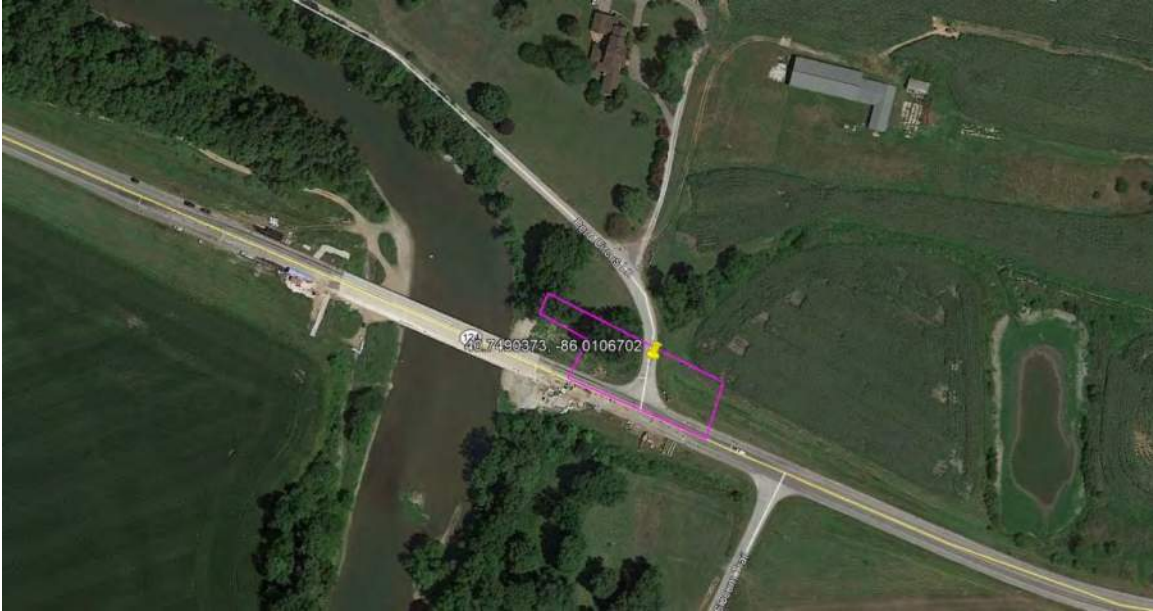
**EXHIBIT B** (Approx. 3.15 mi. East of SR 19)

There are three culverts in the corridor that will be replaced in kind. The culverts have a rating of 3 and are poor in condition and in danger of failing. The three culverts are east of SR 19 approximately 3.15 miles (15" Metal Pipe), 4.50 miles (existing culvert to be surveyed) and 6.50 miles (24" Metal Pipe). See Exhibit B, C, and D.
