**Des 1801013**  
**Appendix E**  
**Red Flag Investigation**

Re: RED FLAG INVESTIGATION  
DES 1801013, State Project  
Small Structure Project  
SR 250 over UNT to South Fork Laughery Creek, 9.11 Miles East of SR 129  
Switzerland County, Indiana

Aerial Map (1:2,400)  
Small Structure Project  
SR 250 over UNT to South Fork Laughery Creek  
Des. No. 1801013  
Switzerland County, Indiana  
Source: NAIP 2016 Imagery

Structure No. CV 250-078-55.80  
SR 250 Small Structure Replacement over UNT South Fork Laughery Creek  
Switzerland County, Indiana  
Contract B-41448, Des. No. 1801013

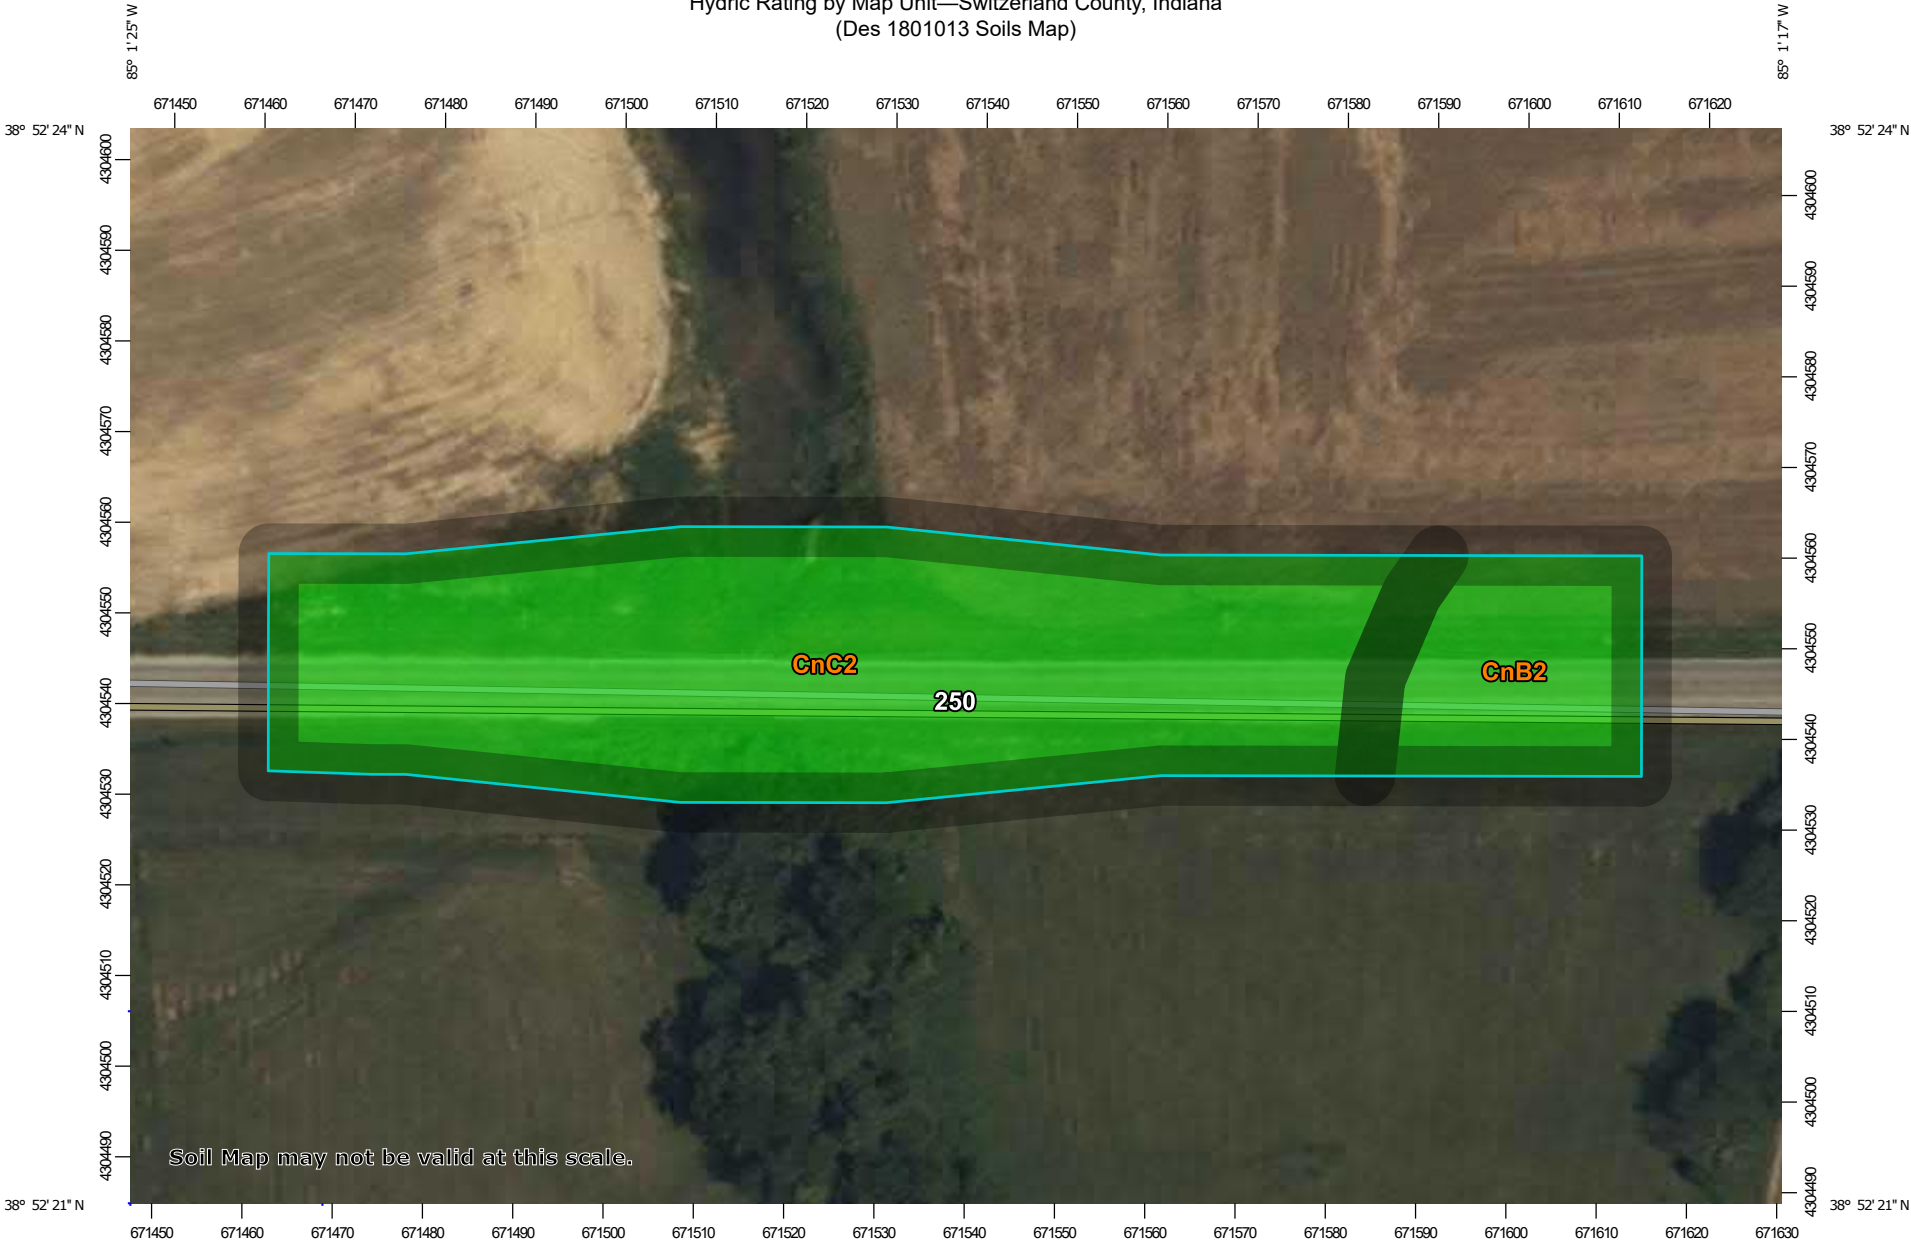
Hydric Rating by Map Unit—Switzerland County, Indiana  
(Des 1801013 Soils Map)

Map unit symbol	Map unit name	Rating	Acres in AOI	Percent of AOI
CnB2	Cincinnati silt loam, 2 to 6 percent slopes, eroded	0	0.2	16.9%
CnC2	Cincinnati silt loam, 6 to 12 percent slopes, eroded	0	0.8	83.1%
<b>Totals for Area of Interest</b>			<b>1.0</b>	<b>100.0%</b>

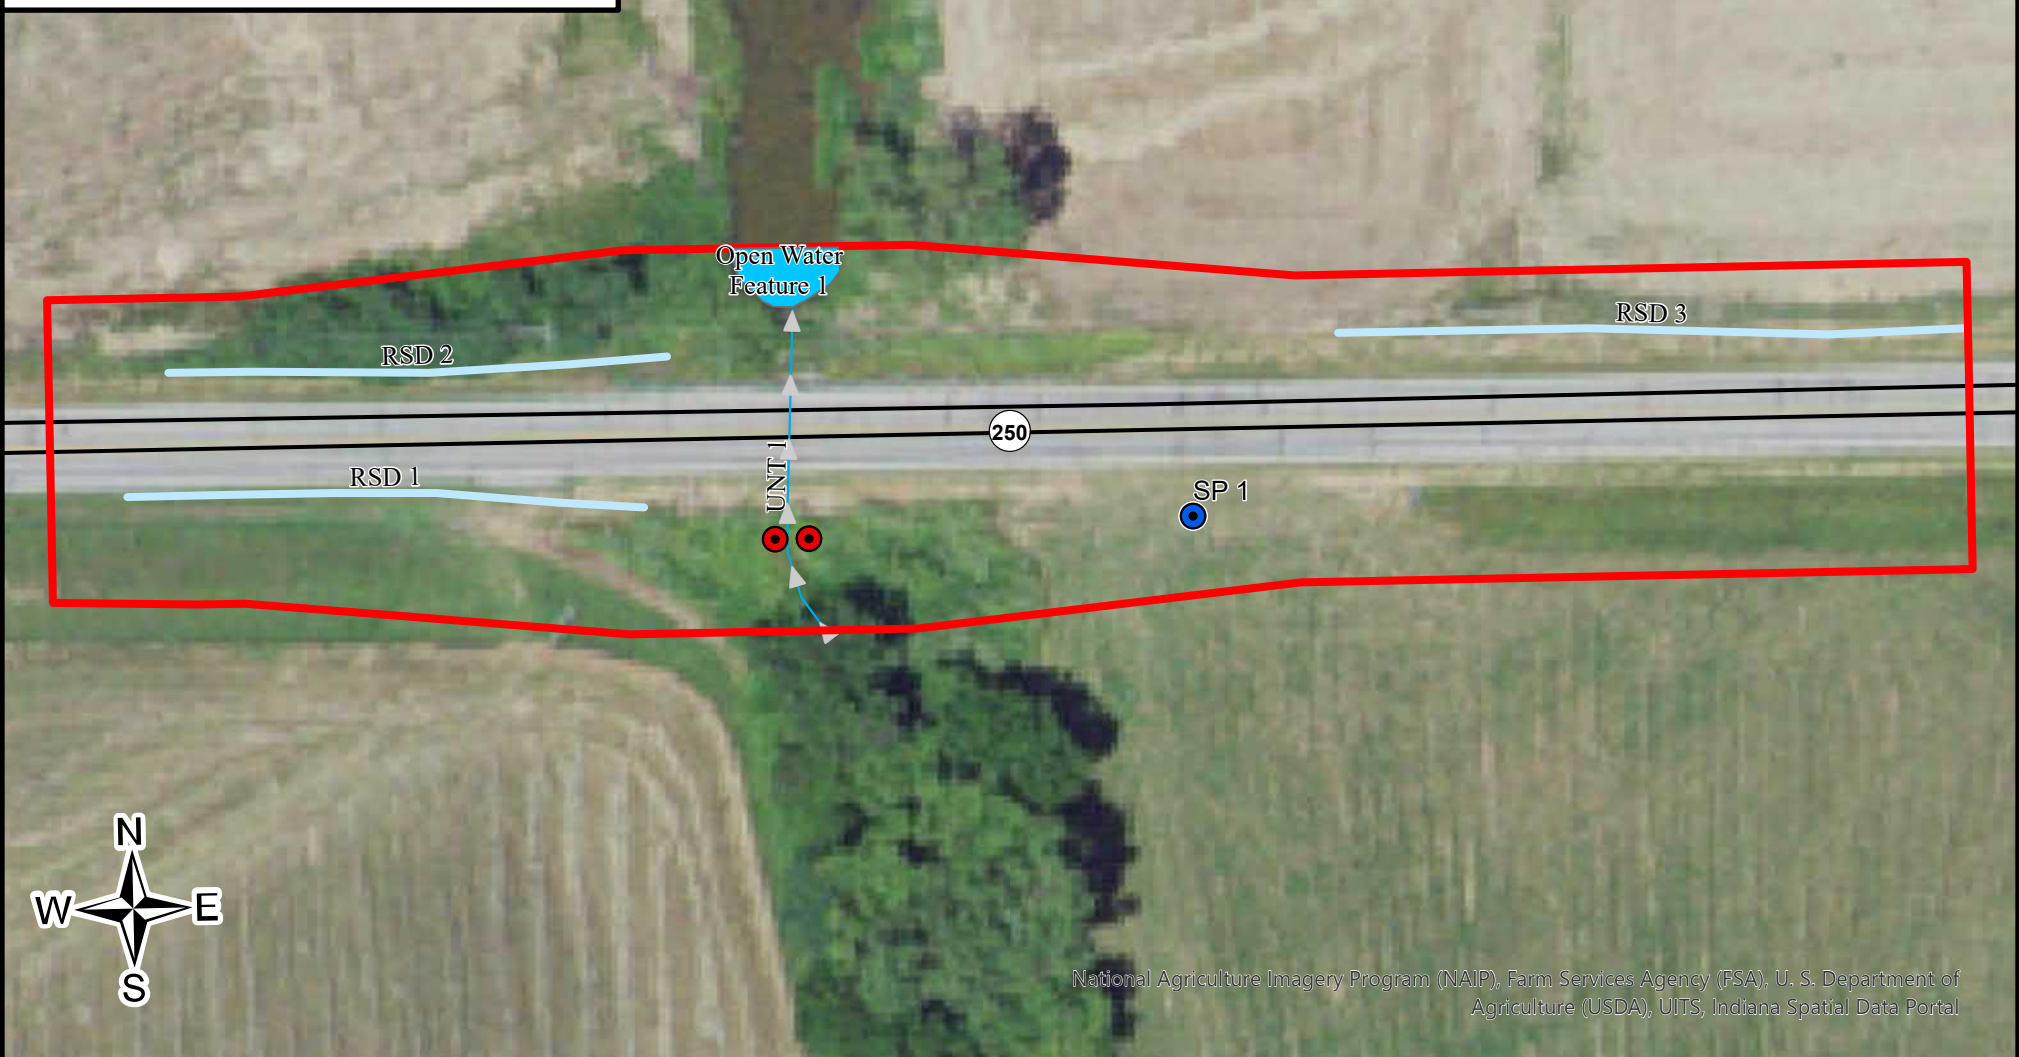
Water Resources Map (1:600)  
Small Structure Project  
SR 250 over UNT to South Fork Laughery Creek  
Des. No. 1801013  
Switzerland County, Indiana  
Source: SJCA Inc Field Survey

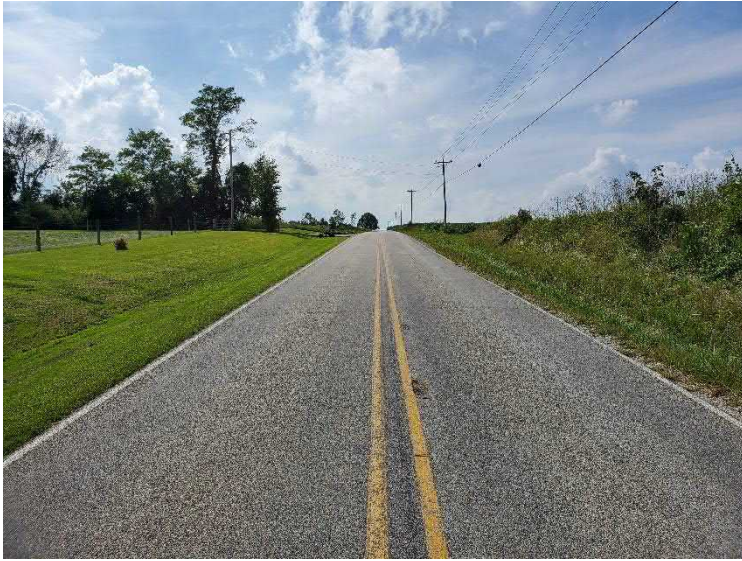
Photo 1: West project terminus facing west

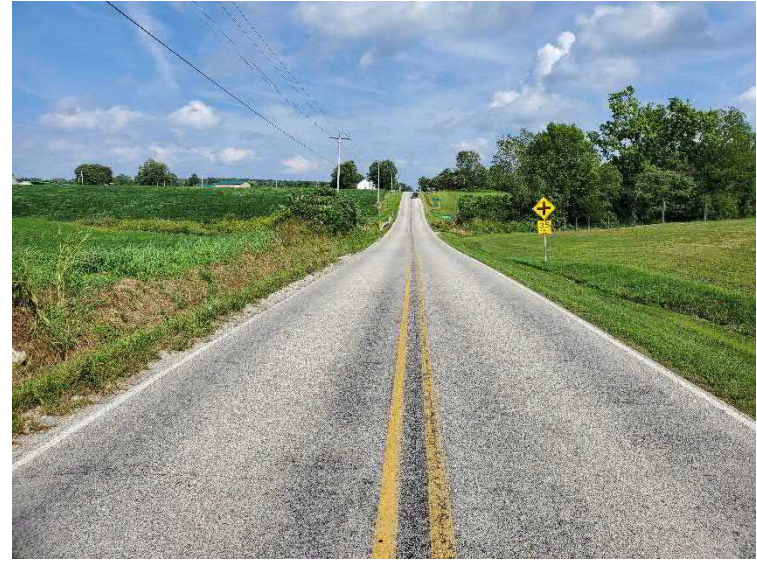
Photo 2: West project terminus facing east

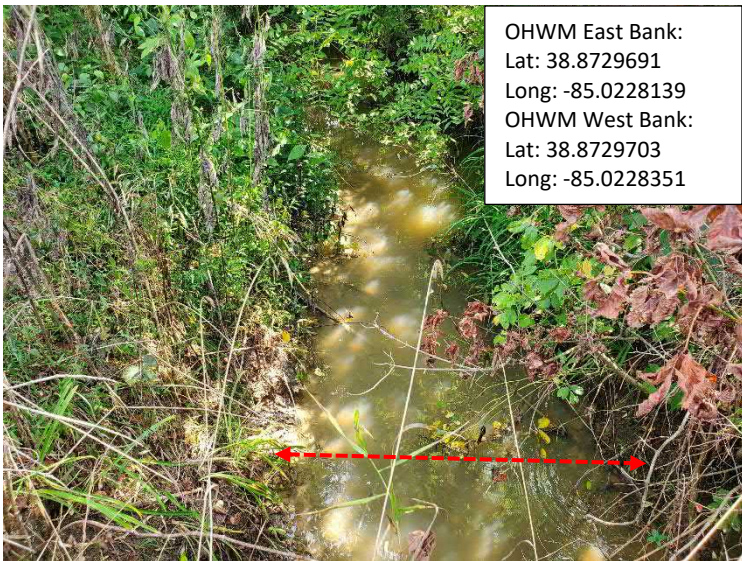
Photo 7: UNT 1 south of SR 250 facing south

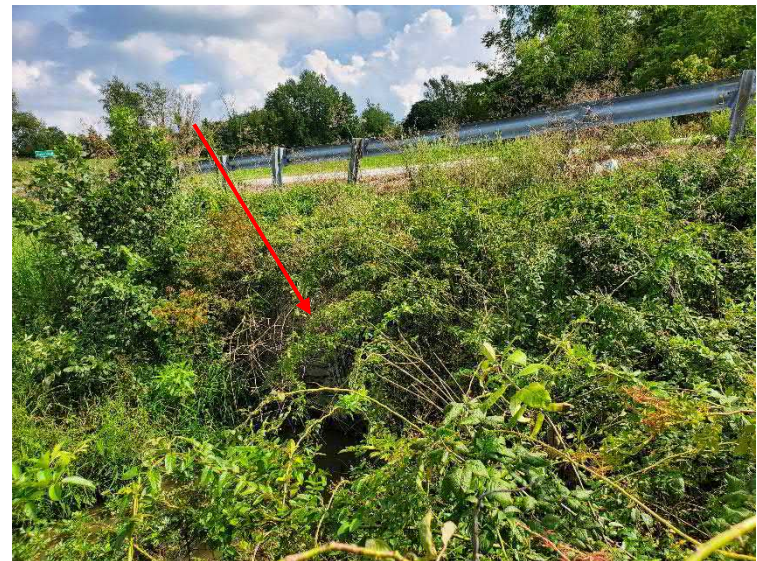
Photo 8: Culvert carrying UNT 1 north of SR 250 facing southeast

The existing structure is a 51-inch CMP approximately 45 feet in length. The original construction year is unknown. The structure has not been repaired since installation. The structure is a legal drain and flows through the open fields to the south to a pond to the north.

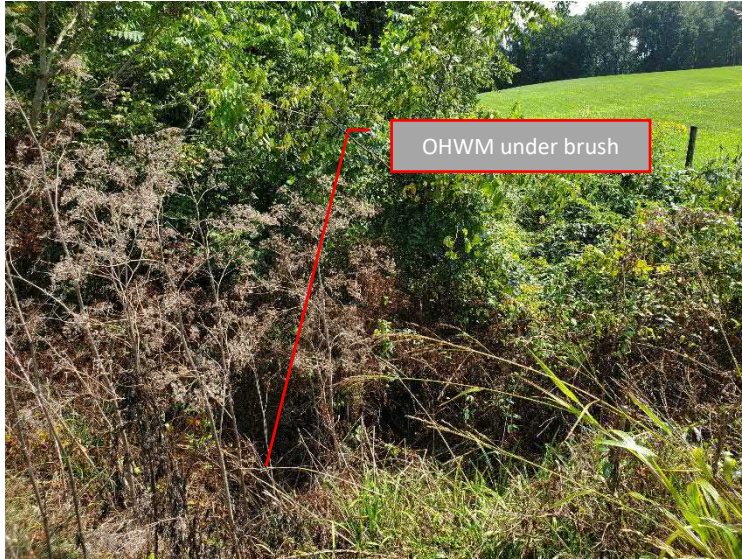
Photo 9: UNT 1 from roadway facing south (OHWM is under brush)

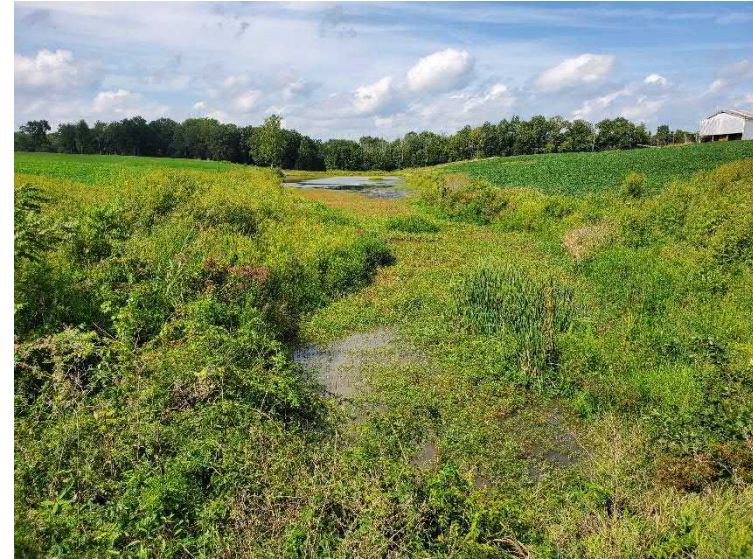
Photo 10: Open Water Feature 1 from SR 250 facing north

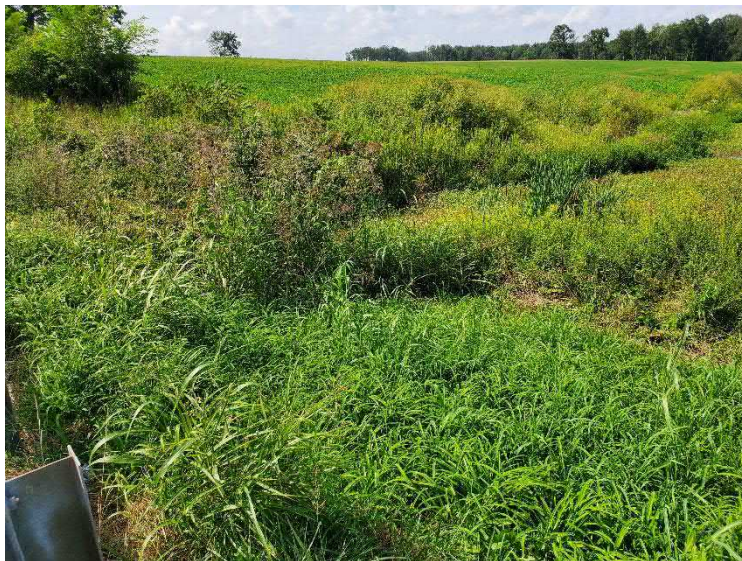
Photo 11: Open water feature from northeast quadrant facing northwest

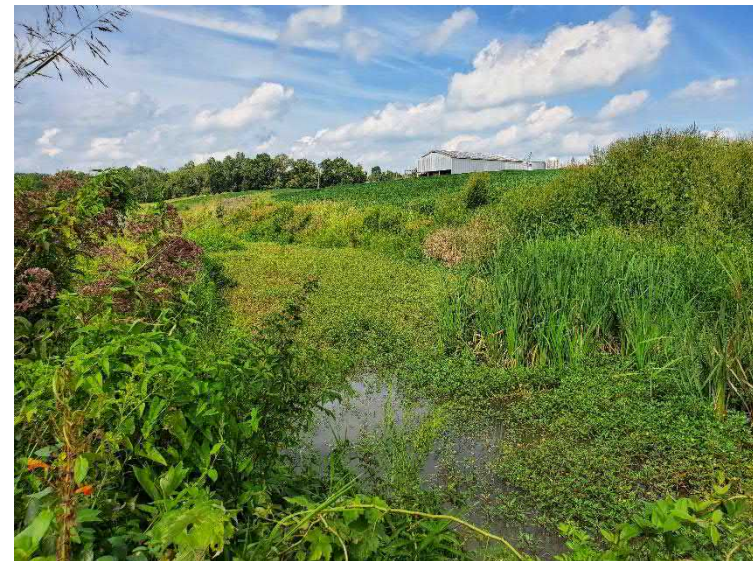
Photo 12: Confluence of UNT 1 and Open Water Feature 1 facing northeast

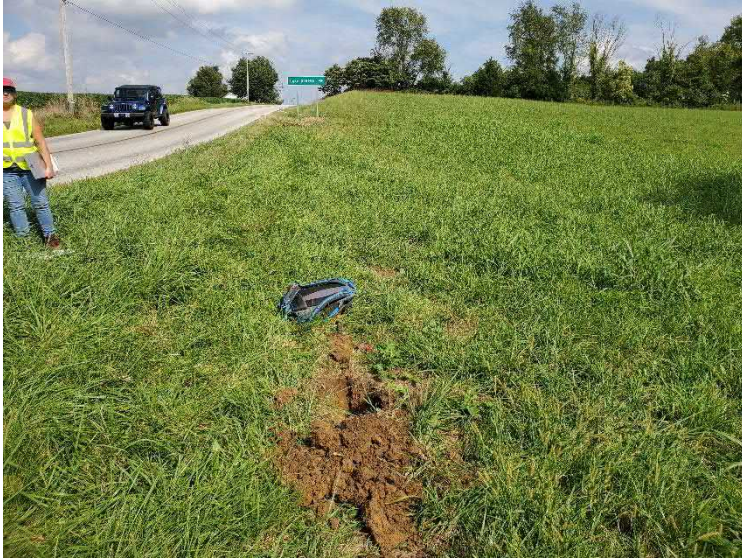
Photo 13: Sample Point 1 facing east

Sample Point 1 (SP1) was along the roadside on the south side of SR 250 and east of the project culvert. Vegetation at this sample point was dominated by Tall Fescue (*Schedonorus arundinaceus*, FACU). This vegetation community did not pass the rapid test, dominance test, or prevalence index for hydrophytic vegetation. Wetland hydrology indicators were not observed at SP1. Soils at SP1 were 10 YR 4/3 (100%) from 0-3 inches and had a texture of silt loam and were 10 YR 5/6 (100%) with a texture of silty clay loam from 3-16 inches. This does not meet any criteria for hydric soils. This sample point did not meet the criteria for hydrophytic vegetation, wetland hydrology, or hydric soils; therefore, it is not a wetland.

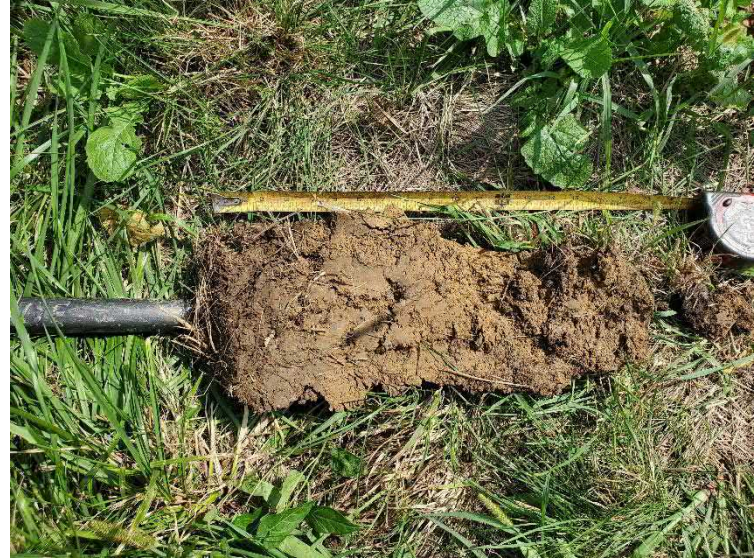
Photo 14: Sample Point 1 soil

Depth (inches)	Matrix		Redox Features				Texture	Remarks
	Color (moist)	%	Color (moist)	%	Type <sup>1</sup>	Loc <sup>2</sup>		
0-3	10 YR 4/3	100					SiL	
3-16	10 YR 5/6	100					SiCL
