### WETLAND DETERMINATION DATA FORM - Midwest Region

Project/Site: SR 15 at CR 18, Des. 1800039	City/County: Elkhart	Sampling Date: 8/14/20			
Applicant/Owner: Strand Associates, Inc.	olicant/Owner: Strand Associates, Inc.				
Investigator(s): K. McLane	_ Section, Township, Rai	nge: SEC 15, TWP 37 N	I, RNG 6 E		
	Local relief	(concave, convex, none):	Concave		
	Long:85.821001°		Datum: WGS 84		
Soil Map Unit Name: ReyA-Rensselaer loam, 0-1% slopes		NWI classifica			
Are climatic / hydrologic conditions on the site typical for this time of	year? Yes V No	(If no, explain in Re			
Are Vegetation, Soil, or Hydrology significan		'Normal Circumstances" p	resent? Yes V No		
Are Vegetation, Soil, or Hydrology naturally		eded, explain any answer			
SUMMARY OF FINDINGS - Attach site map showing	ng sampling point le	ocations, transects,	, important features, etc.		
Hydrophytic Vegetation Present? Yes ✓ No	]				
Hydric Soil Present? Yes V No	Is the Sampled		1		
Wetland Hydrology Present? Yes No	within a Wetlan	nd? Yes <u></u> ▼	No

### **Location and Project Description**

The project includes improvements to SR 15 at its intersection with CR 18, 1.03 miles south of US 20 (RP 86+26 to RP 86+69

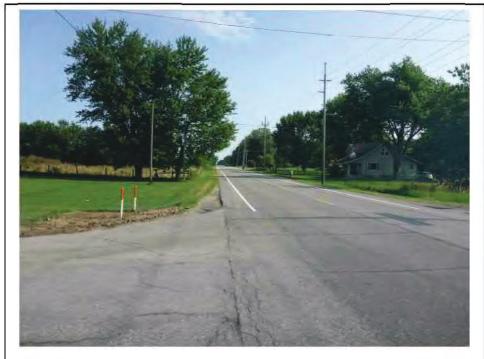
Figure 1 Intersection of SR 15 and CR 18, facing NB
