y Mor		nana bepe	ar arrorre or rrain	sportation	
y <u>19101</u>	rgan	Route	I-69 Section 6	_ Des.	No. <u>1801389</u>
САТ	TEGORICAL EXCI	LUSION /	ina Environmental D ENVIRONME PROJECT INFORM	ENTAL ASSE	ESSMENT FORM
Road N	No./County:		on 6 – Indian Cree gan County	k Landlocked E	nvironmental Mitigatio
Designa	ation Number:	1801389			
Project	Description/Termini:	Approxim	on 6 Indian Creek nately 130.3 acres l one mile south of N	ocated on the no	igation Site orth side of Burton Lan
	npleting this form, I conclude to prove if Level 4 CE):				al Exclusion (FHWA must
	Categorical Exclusion, L. Level 2 - table 1, CE Leve				tegorical Exclusion Manua ntal Scoping Manager)
	Categorical Exclusion, Level 3 - table 1, CE Leve				
X	Categorical Exclusion, Level 4 - table 1, CE Leve				
	Environmental Assessme is necessary to determine t				
	documents prepared by or for Env			sary for the ESM of the	district in which the project is

Date: March 19, 2020

Indian Creek Landlocked Mitigation Site

Designation (Des) No.: 1801389 I-69 Section 6 – Indian Creek Landlocked Mitigation Site Morgan County, IN

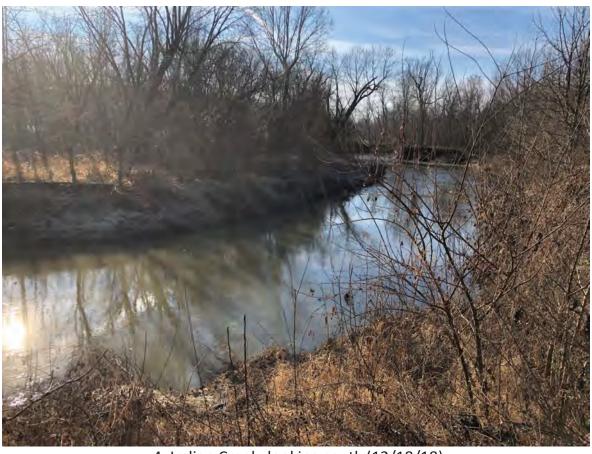
4. Indian Creek, looking south (12/18/18)

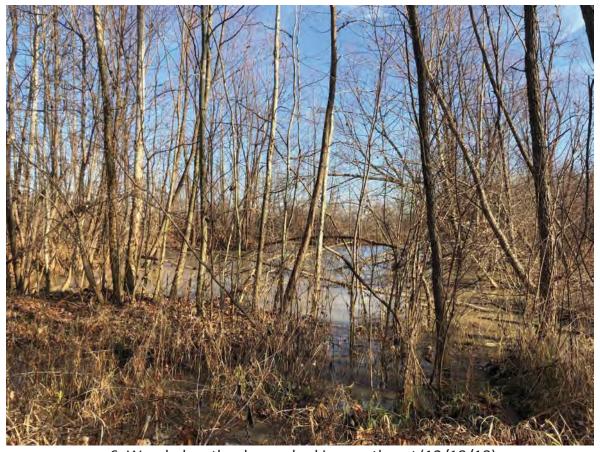
6. Wooded wetland area, looking northeast (12/18/18)

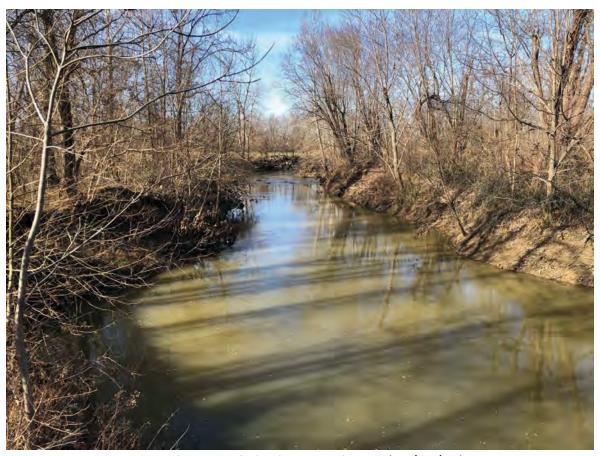
7. Indian Creek, looking northwest (12/18/18)

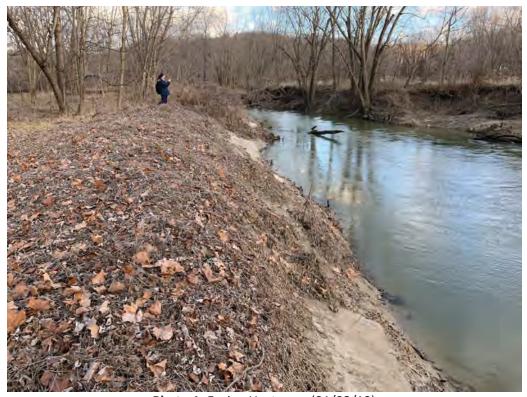
Photo 1: Facing Upstream (01/08/19)

Stream Assessment Photos Stream ID: S-IC1-Q

Nearly 8,000 feet of Indian Creek is located within the mitigation site boundary. A QHEI assessment was conducted for this stream on January 9, 2019 resulting in a score of 61.5, which indicates fair to good stream conditions (Appendix F, pages 3-5). Multiple locations along Indian Creek are severely eroded and scoured. Stream restoration activities (1,430 feet) along Indian Creek will include stone toe protection, bank grading, native seeding, and live staking. The Indian Creek riparian areas will be enhanced with native seeding and planting of hard-mast tree species to provide additional habitat diversity. Approximately 1.2 acres adjacent to the bank stabilization areas will require scattered tree clearing for access to the stream bank for installation of stone toe protection (Appendix B, page 4). The contractor will be required to mark trees for review prior to clearing. Cleared areas will be replanted and enhanced with supplemental plantings and invasive species treatments. All necessary erosion and sediment control measures will be implemented. The proposed activities will require an IDNR CIF Permit and an IDEM Rule 5 permit. Impacts to Indian Creek are expected to be temporary during construction and result in a positive increase in functionality and stability once construction is completed.

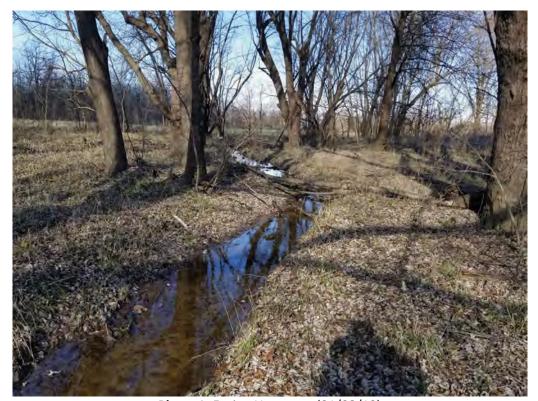
Photo 1: Facing Upstream (01/08/19)

Stream Assessment Photos Stream ID: S-IC2-H

UNT1 (S-IC2-H) is an ephemeral stream located in the south-central portion of the property. An HHEI assessment was conducted for this stream on January 8, 2019, resulting in a score of 36, which indicates poor stream condition (Appendix

F, pages 6-8). Stream enhancement activities will be performed on the entire 1,976-foot length of the stream located within the project area. Ephemeral stream enhancement to stream S-IC2-H will include invasive species treatments within the narrow riparian corridor present along the ephemeral stream, as well as, expansion of the riparian corridors on both sides of the stream. Impacts to the ephemeral stream S-IC2-H are expected to result in an improved condition of the stream.
