Pavement Condition Report

Brazil Clay County Airport

Project 1480370

January 2014

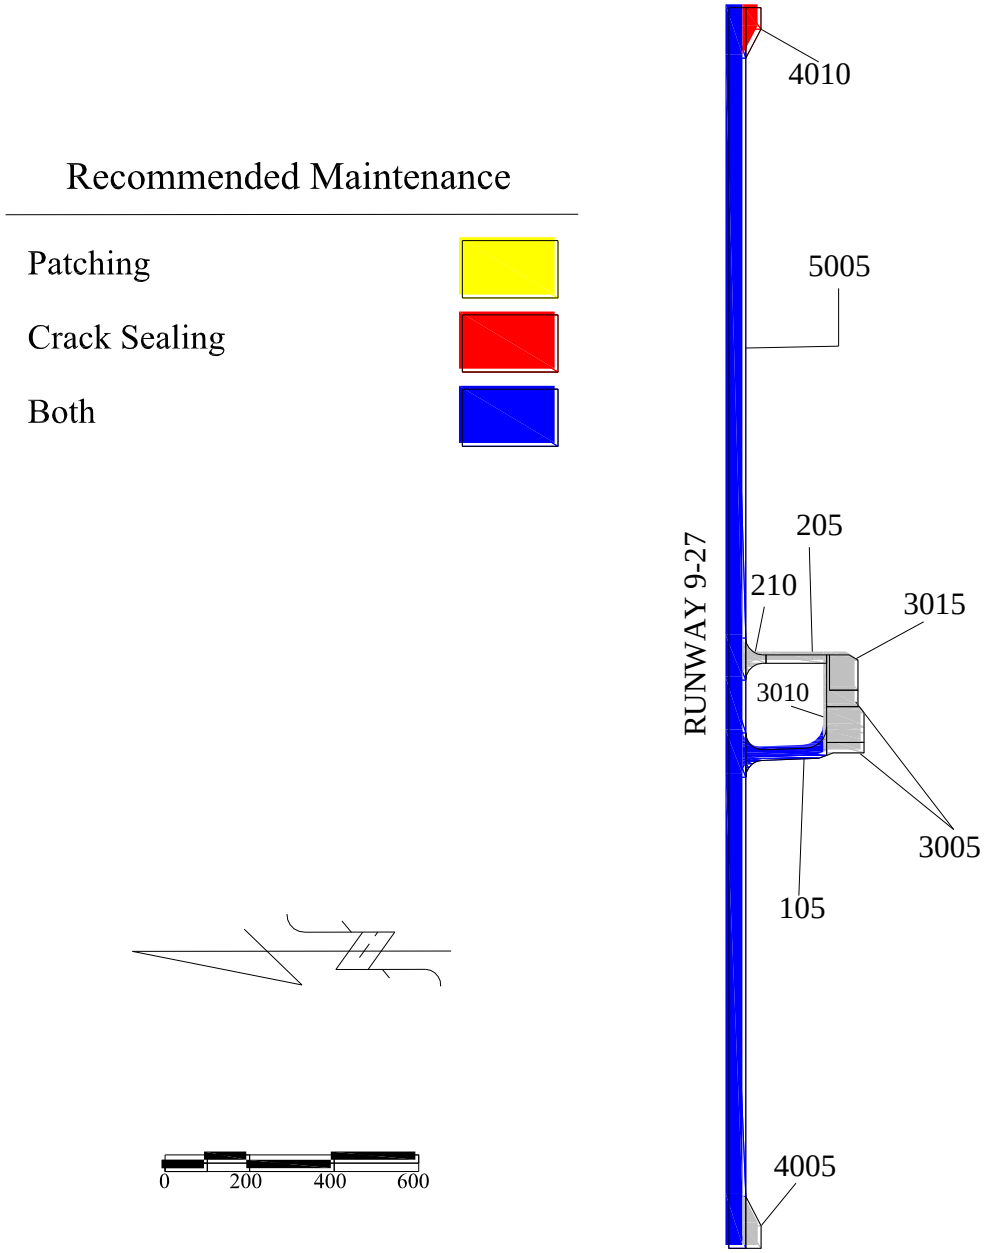
2013 PCI Inspection

The overall Pavement Condition Index (PCI) for the airfield pavements was 62. Runways had an average inspected PCI of 70 and were above the desired MSL of 55. Taxiways had an average inspected PCI of 55, and ramps had an average inspected PCI of 28.

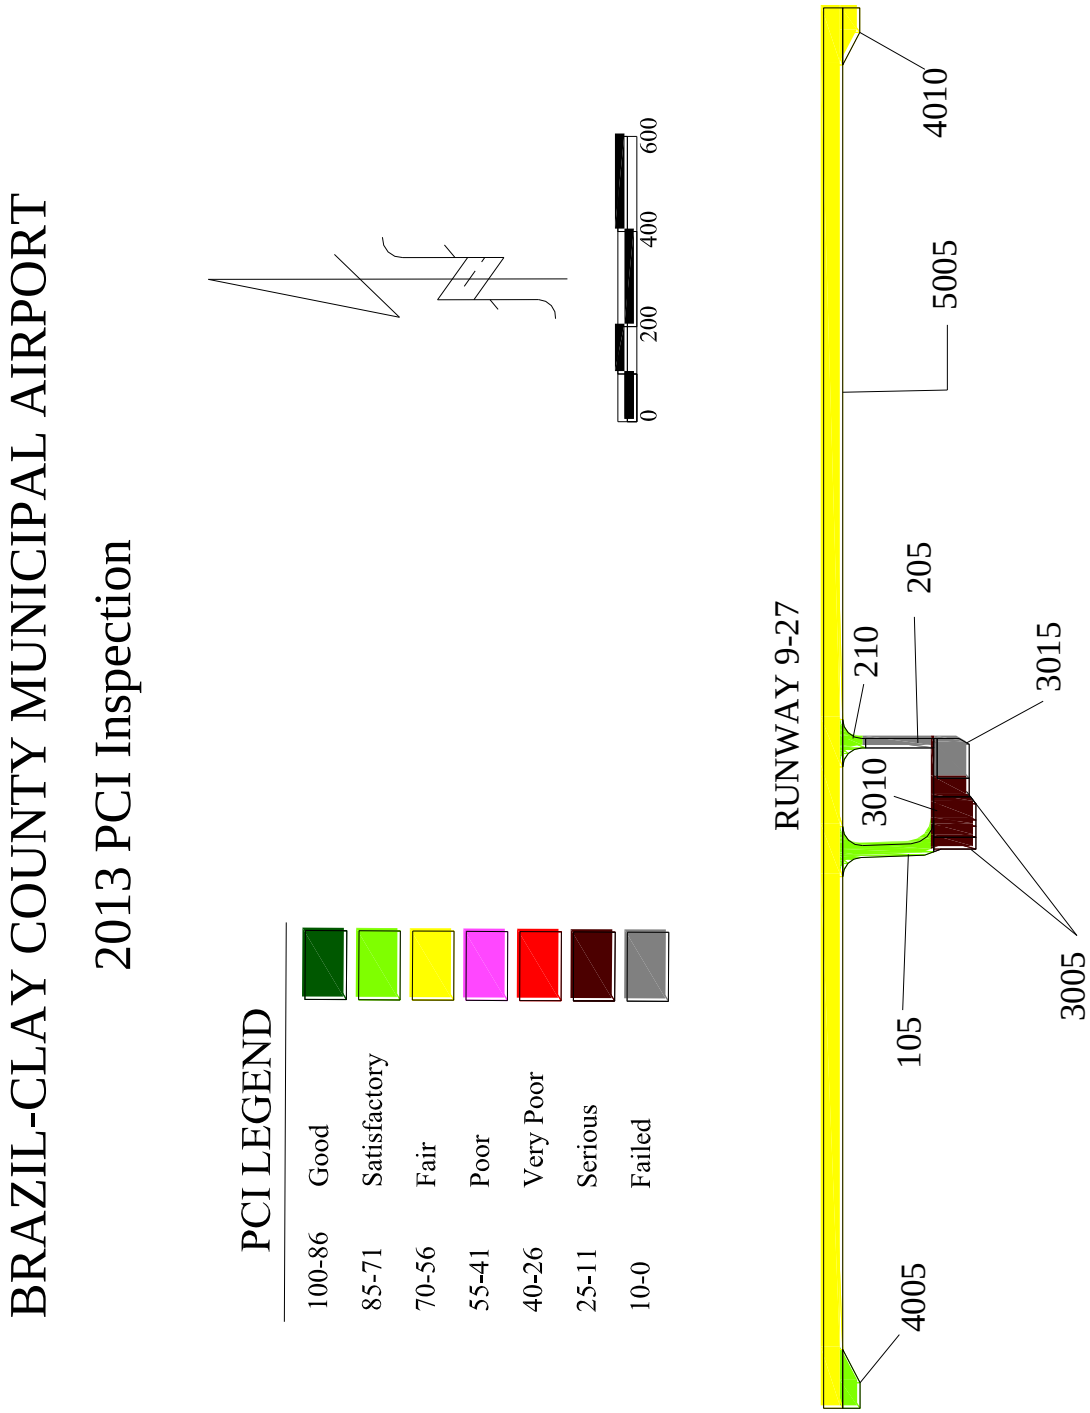
Figure 2-1. Inspected Pavement Condition

Four pavement sections had a PCI rating of serious or failed indicating that M&R needs will be intensive and that reconstruction will likely be required.

The pavement within each of the PCI condition categories is shown in Figure 2-1. The inspected PCI is summarized by branch use in Figure 2-2, and the photographs in Figure 2-3 through Figure 2-6 provide examples of the condition categories.

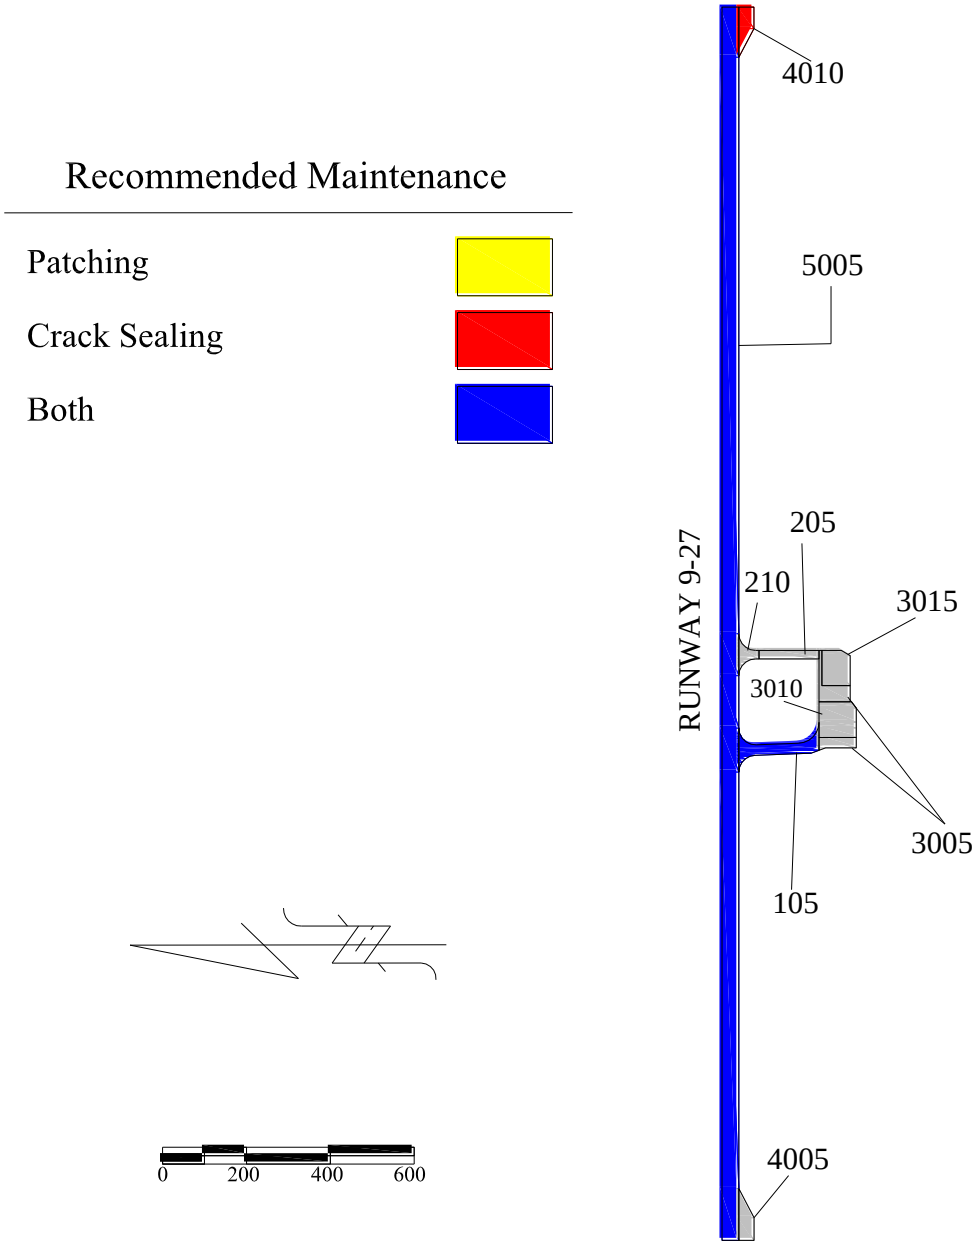
Figure 4-1. Recommended Maintenance

Analysis of potential maintenance projects identified approximately 8,200 square feet of patching needs and approximately 1,800 linear feet of crack sealing and crack repair needs, at an estimated total cost of approximately $100,000.

Specific recommendations to help prioritize airfield maintenance are found in chapter 4 of this report. A summary of all identified maintenance needs is shown in the table below and in the figure on the following page.

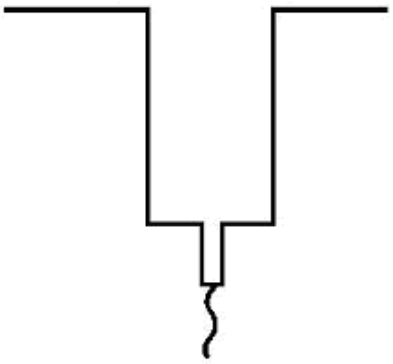
Clean joints exposing fresh, clean concrete and stone. Retain existing resevoir shape.

- Rout a reservoir for the sealant ½ inch wide and 1 inch deep.
- Cracks wider than ½ inch should have reservoirs ¼ inch wider than the crack. Reservoir height above backer rope should be less than reservoir width, or as recommended by manufacturer.
- Routed cracks should be cleaned to expose fresh, vital pavement on the vertical crack edge.
- Cracks should be cleaned to remove all sand, debris, and other materials from the crack.
- Backing material should be placed into the crack.
- Apply sealant to within ¼ inch of pavement surface, following manufacturer's instructions.
- Clean the surrounding pavement area.
