Pavement Condition Report

Washington-Daviess County Airport

Project 1480370

January 2014

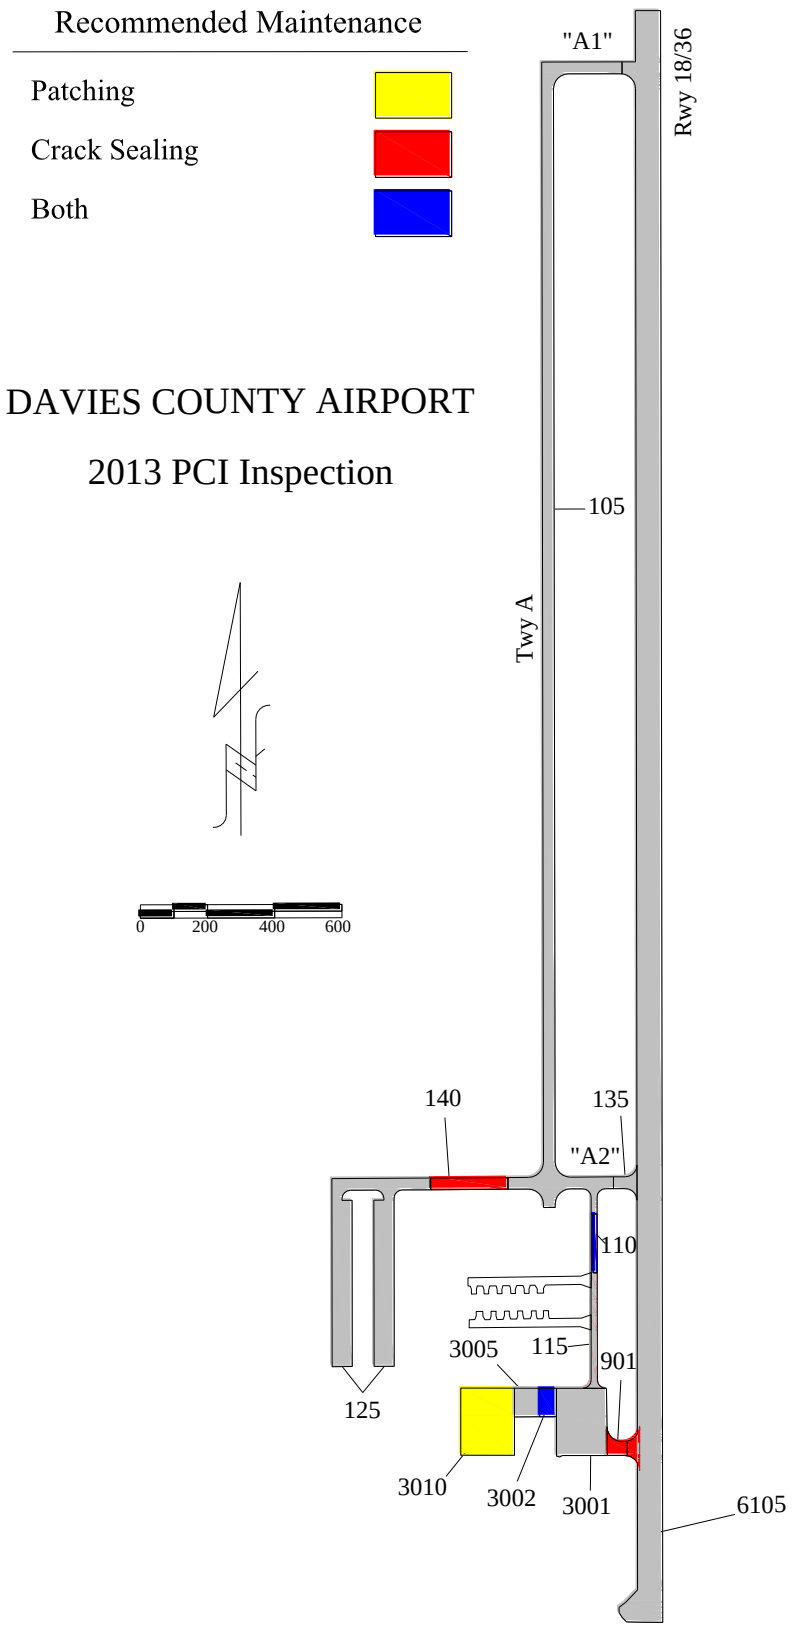
Recommended Maintenance
Patching
Crack Sealing
Both
DAVIES COUNTY AIRPORT
2013 PCI Inspection
0
200
400
600
"A1"
Rwy 18/36
105
Twy A
140
135
"A2"
110
3005
115
901
125
3010
3002
3001
6105

Analysis of potential maintenance projects identified approximately 610 square feet of patching needs and approximately 2,300 linear feet of crack sealing and crack repair needs, at an estimated total cost of approximately $9,300

Work Item	Quantity	Unit	Cost
AC PATCH	593	SF	5,148
AC RESTORATIVE CRACK REPAIR	1,002	LF	1,242
AC SUSTAINING CRACK REPAIR	228	LF	198
PCC RESTORATIVE CRACK REPAIR	1,085	LF	2,434
PCC PATCHING	18	SF	310
Total:			**$ 9,332**

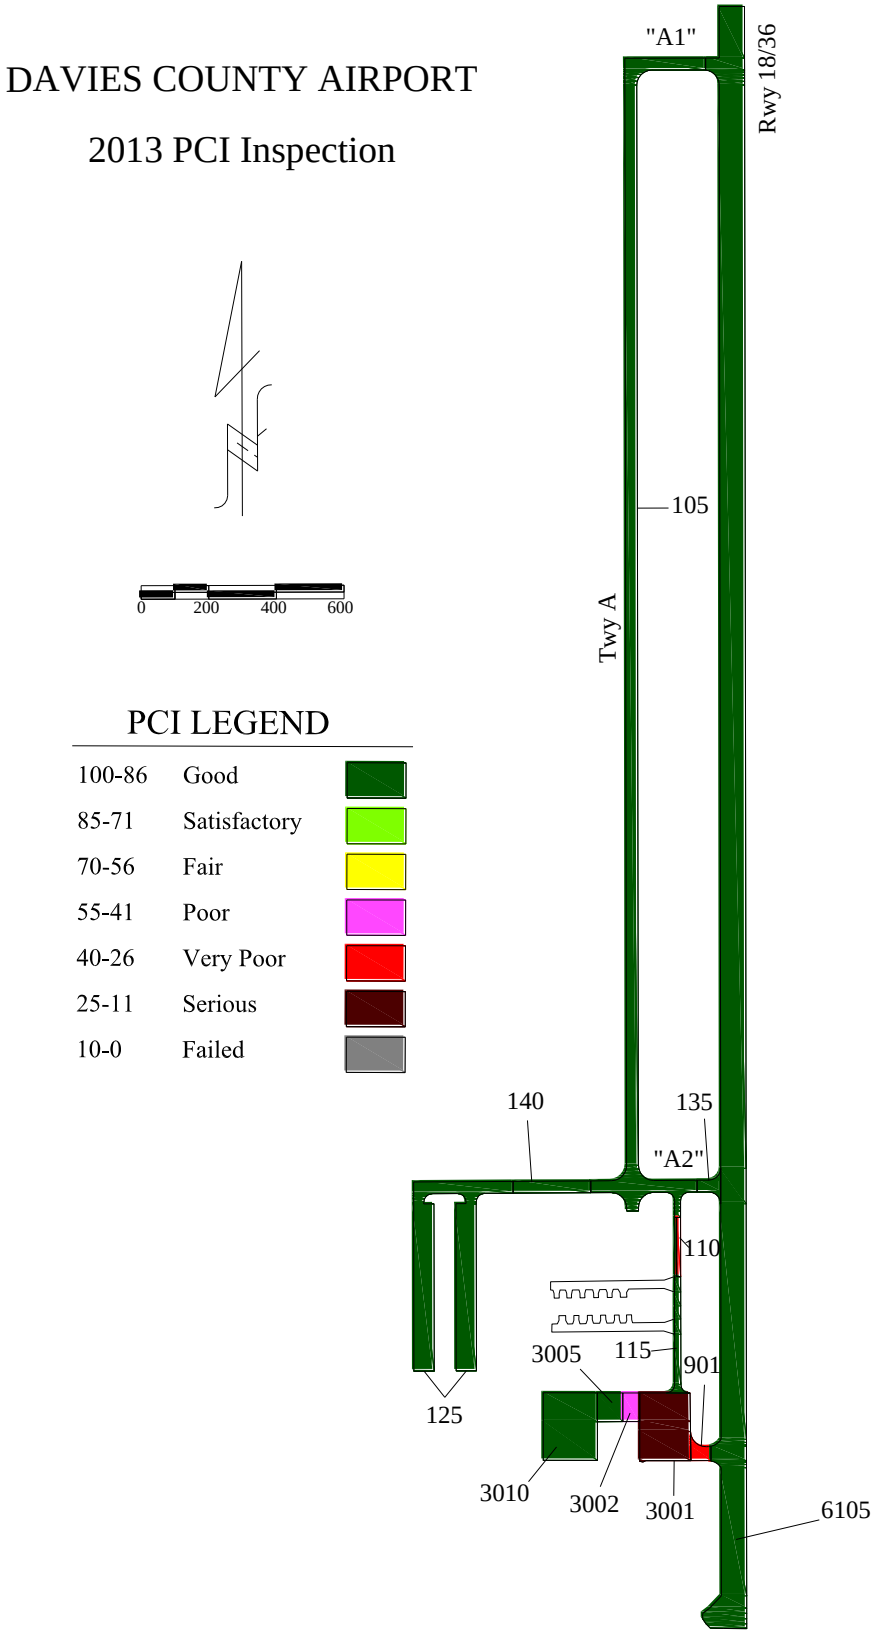
Figure 2-1. Inspected Pavement Condition

Four pavement sections representing approximately 5 percent of the total pavement area had a simplified PCI rating of Poor. Extensive maintenance may be required to maintain safety until rehabilitation can be programmed.

The pavement within each of the PCI condition categories is shown in Figure 2-1. The inspected PCI is summarized by branch use in Figure 2-2, and the photographs in Figure 2-3 through Figure 2-5 provide examples of the condition categories.

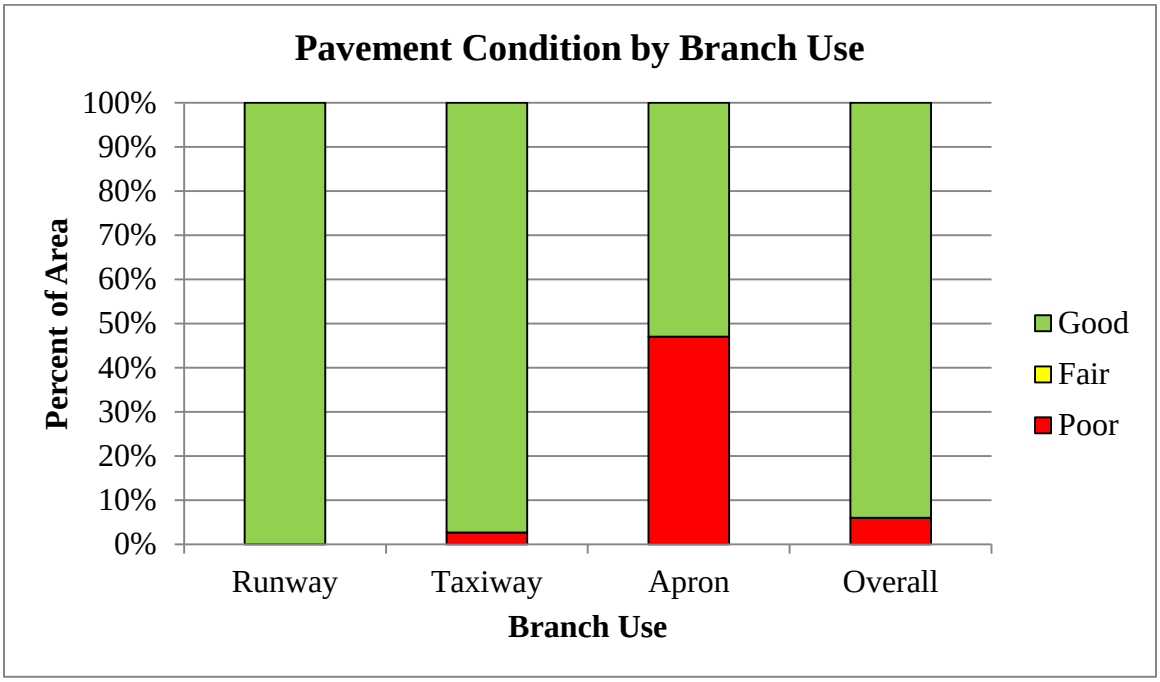
Figure 2-2. Pavement Condition by Branch Use

The overall Pavement Condition Index (PCI) for the airfield pavements was 95. Runways had an average inspected PCI of 100 and were above the desired MSL of 60. Taxiways had an average inspected PCI of 96, and ramps had an average inspected PCI of 63.

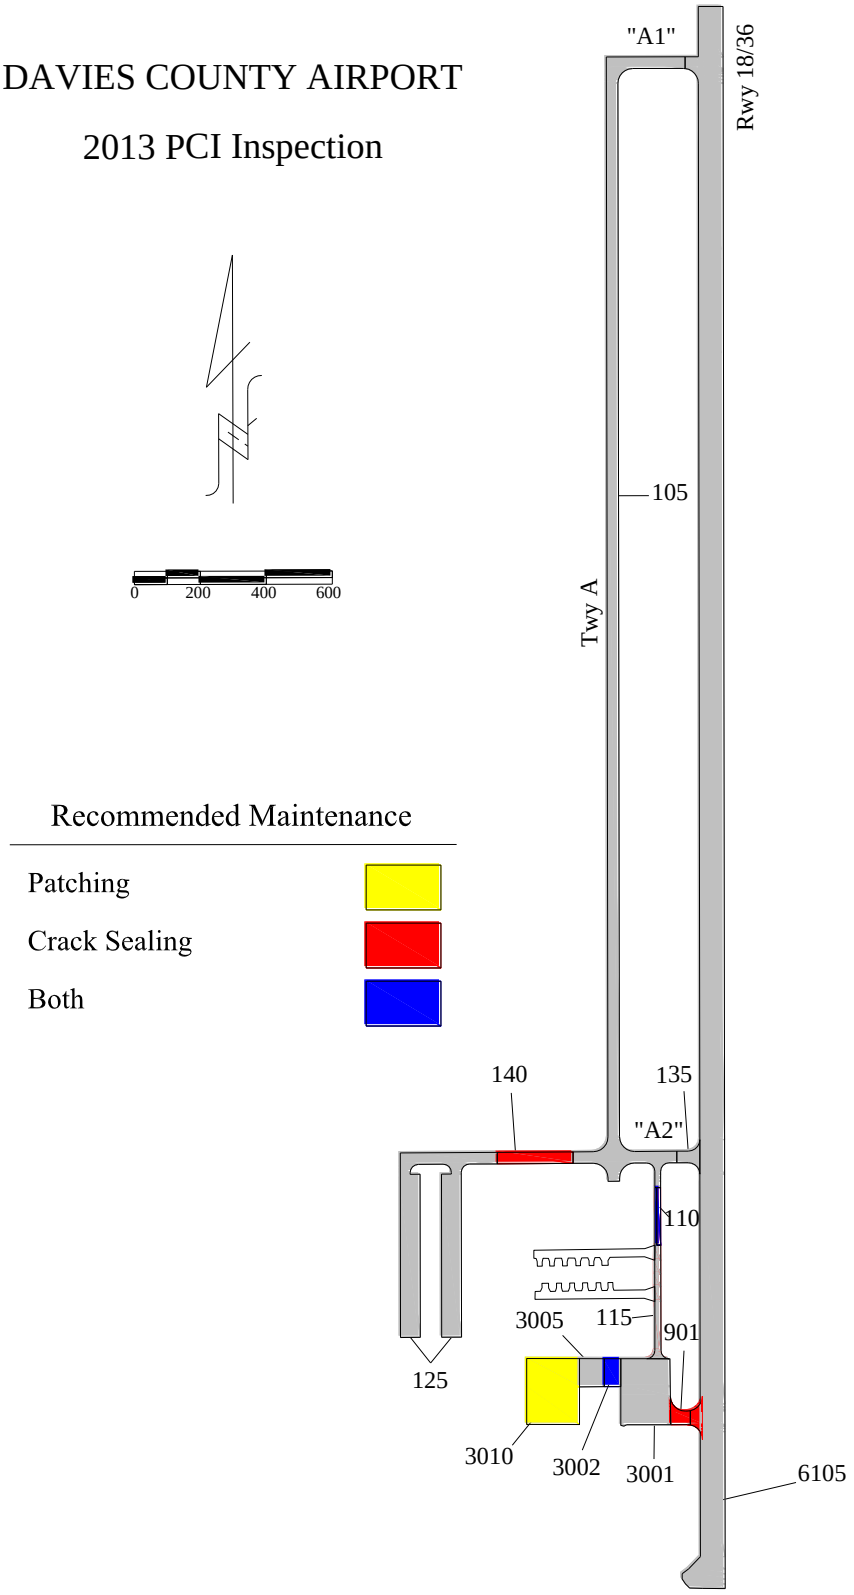
Figure 4-1. Recommended Maintenance

Feature	Work Item	Amount	Insp. PCI	Change	Est. PCI
140	PCC RESTORATIVE SEAL REPAIR	1,085 L.F.	90	5	95
EQUIPMENT: AIR COMPRESSOR, HEATING KETTLE, HAND TOOLS					
EST. MATERIALS: 217 POUNDS ASTM D3405 SEALANT OR EQUIVALENT					
EST. MATERIAL COST: $553					
EST. CREW HOURS: 9.0					
EST. CREW COST: $1,880					
EST. PROJECT COST: $2,434
