Pavement Condition Report

Paoli Municipal Airport

Project 13801869

January 2013

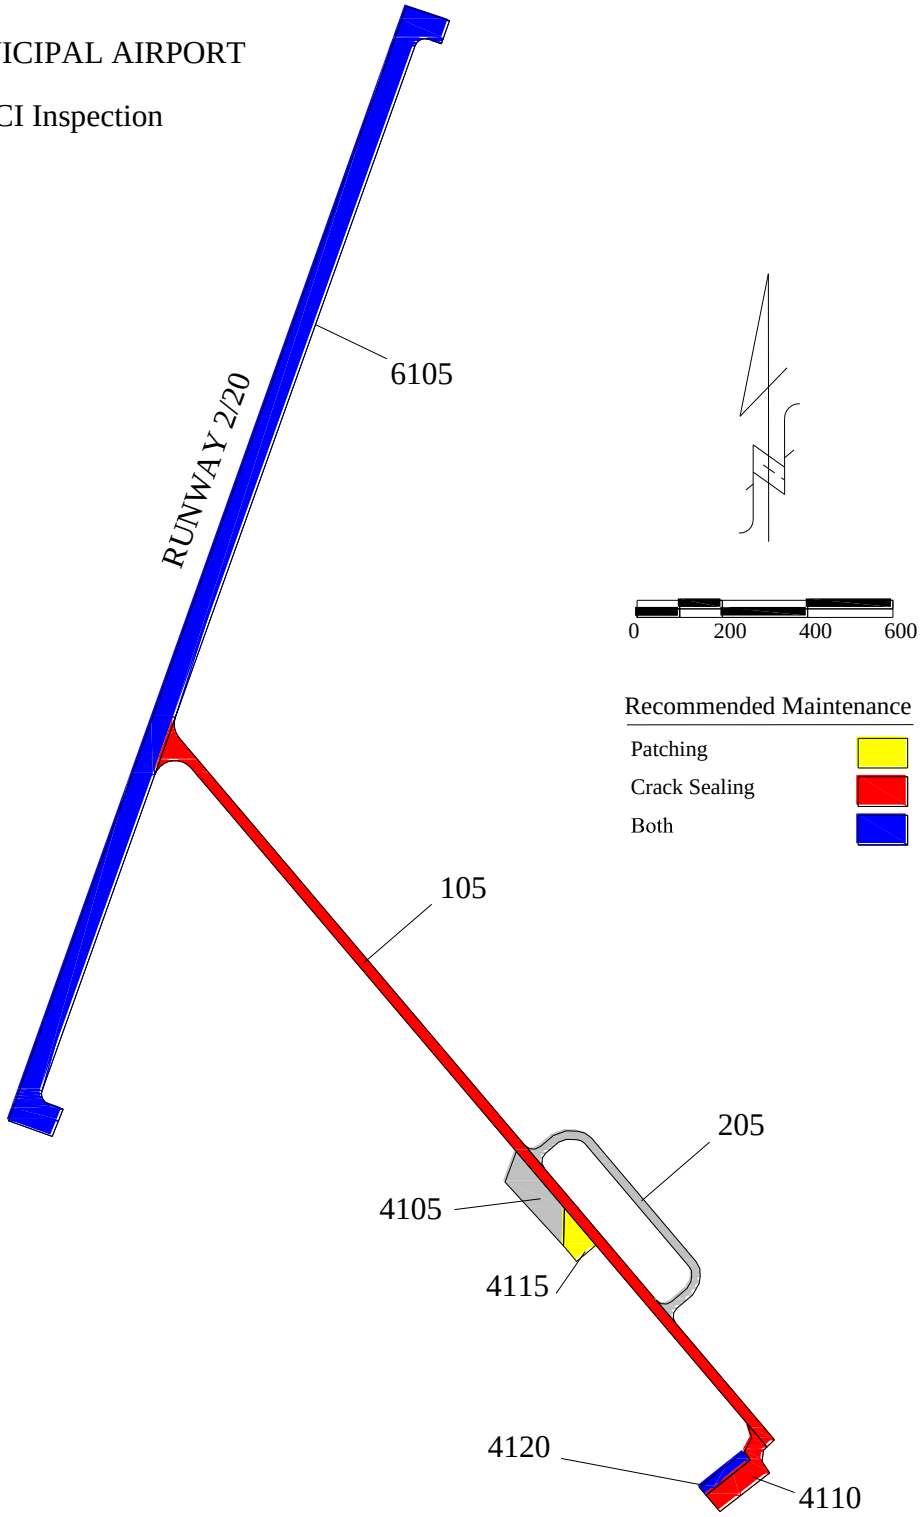
2012 PCI Inspection

The overall Pavement Condition Index (PCI) for the airfield pavements was 73. Runway 2-20 had an average inspected PCI of 64 and was above the desired MSL of 55. Taxiways had and average inspected PCI of 89, and ramps had an average inspected PCI of 80.

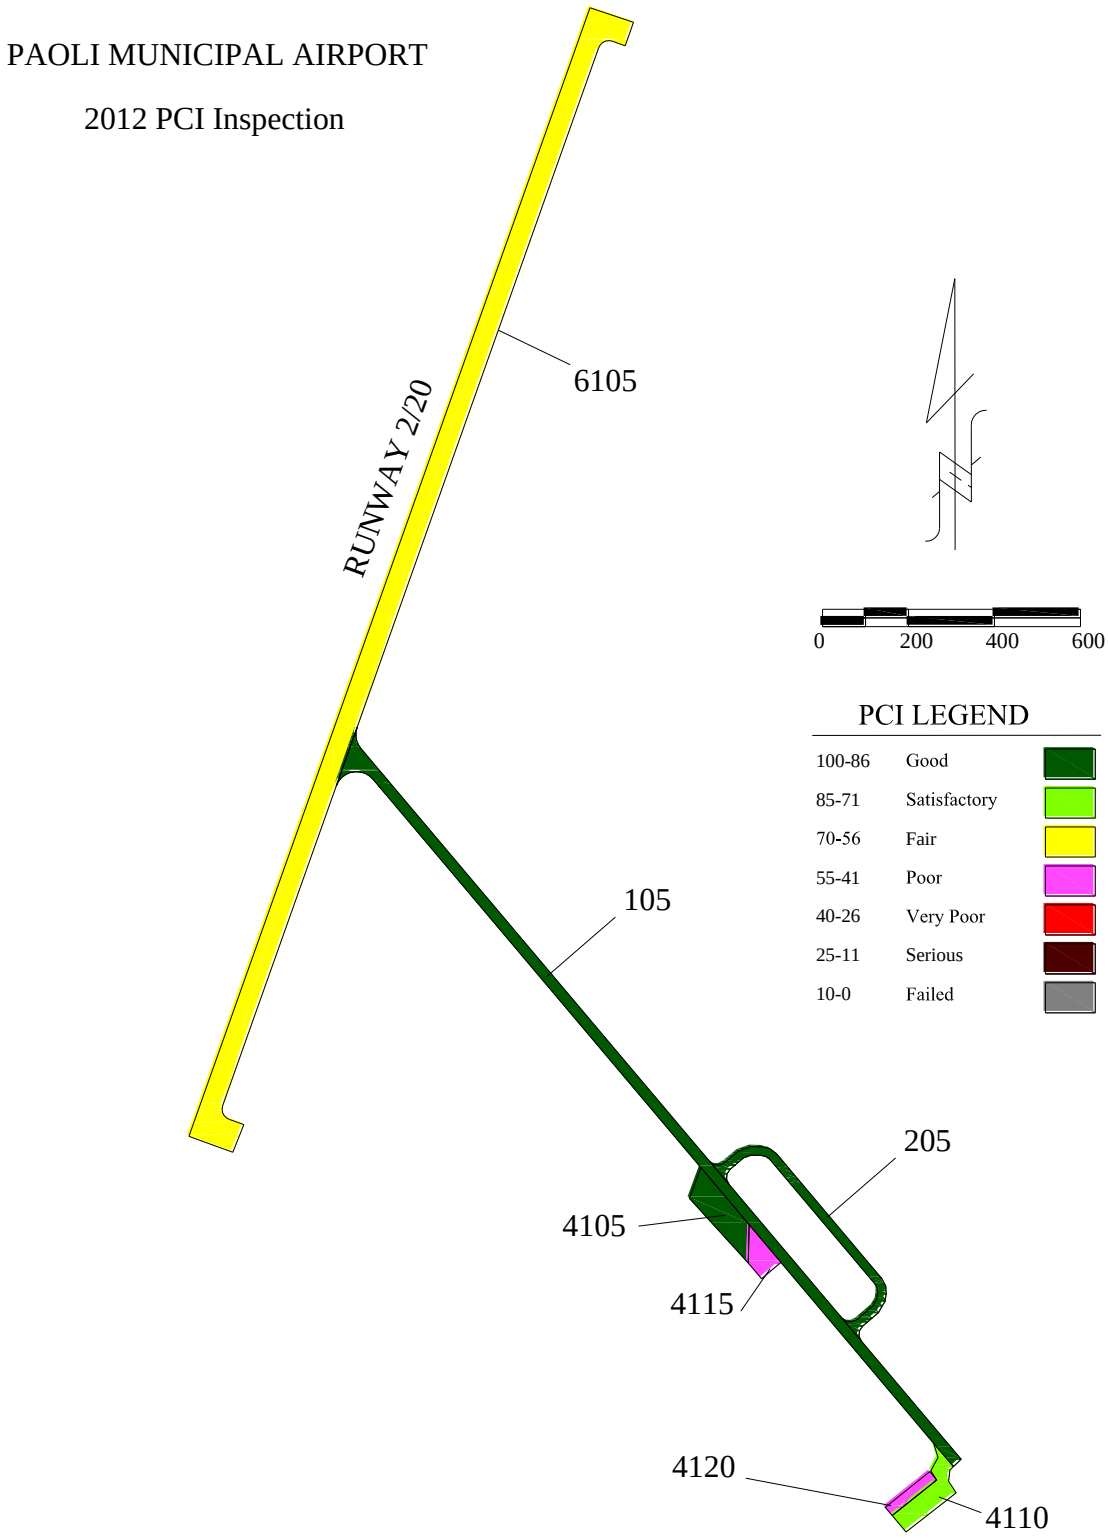
Figure 2-1. Inspected Pavement Condition

Apron pavement sections 4115 and 4120 had a simplified PCI rating of Poor, indicating that major M&R may be needed to maintain serviceability. The pavement within each of the PCI condition categories is shown in Figure 2-1. The inspected PCI is summarized by branch use in Figure 2-2, and the photographs that follow provide examples for each of the simplified condition categories.

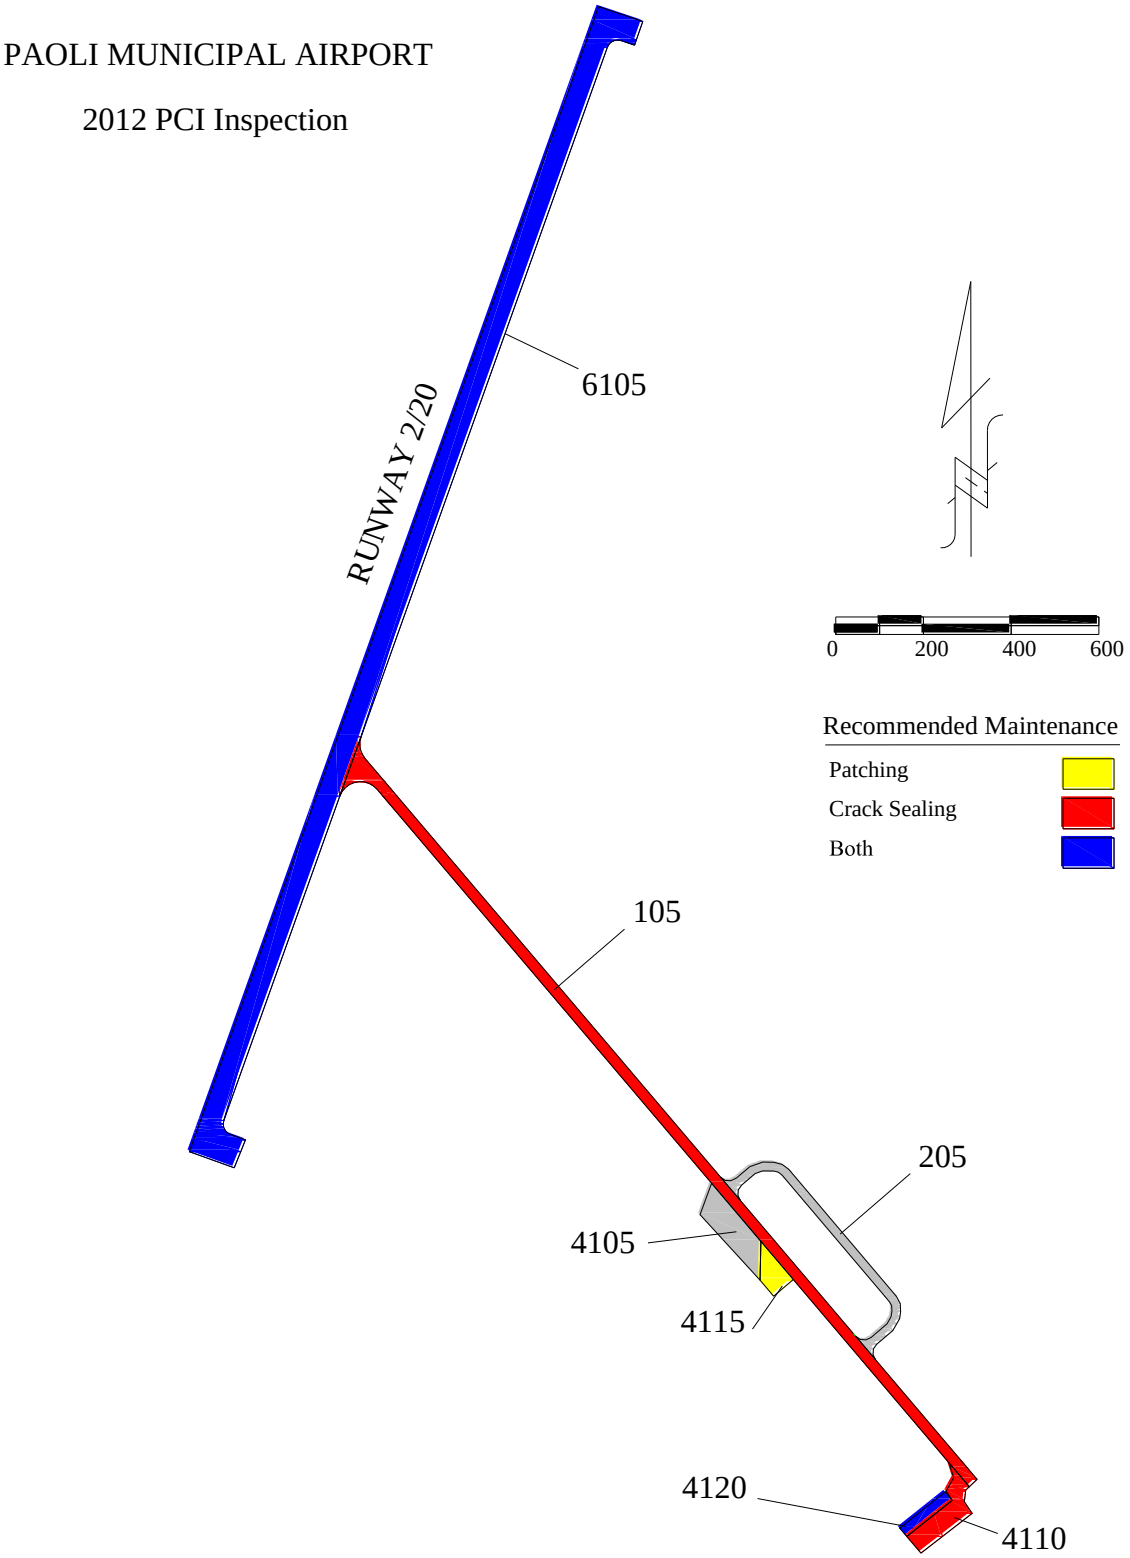
Figure 4-1. Recommended Maintenance

Analysis of potential maintenance projects identified less than 100 square feet of patching needs and approximately 3,800 linear feet of crack sealing and crack repair needs, at an estimated total cost of approximately $4,000.

Feature	Work Item	Amount	Insp. PCI	Change	Est. PCI
105	AC SUSTAINING CRACK REPAIR	298	87	-	87
6105	AC SUSTAINING CRACK REPAIR	2,802	64	-	64
	TOTAL:	3,100	L.F.		
EQUIPMENT: AIR COMPRESSOR, HEATING KETTLE, HAND TOOLS					
EST. MATERIALS: 620 POUNDS ASTM D3405 SEALANT OR EQUIVALENT					
EST. MATERIAL COST: $620					
EST. CREW HOURS: 13.5					
EST. CREW COST: $2,022					
EST. PROJECT COST: $2,642
