Pavement Condition Report

Shelbyville Municipal Airport

Project 1480370

January 2014

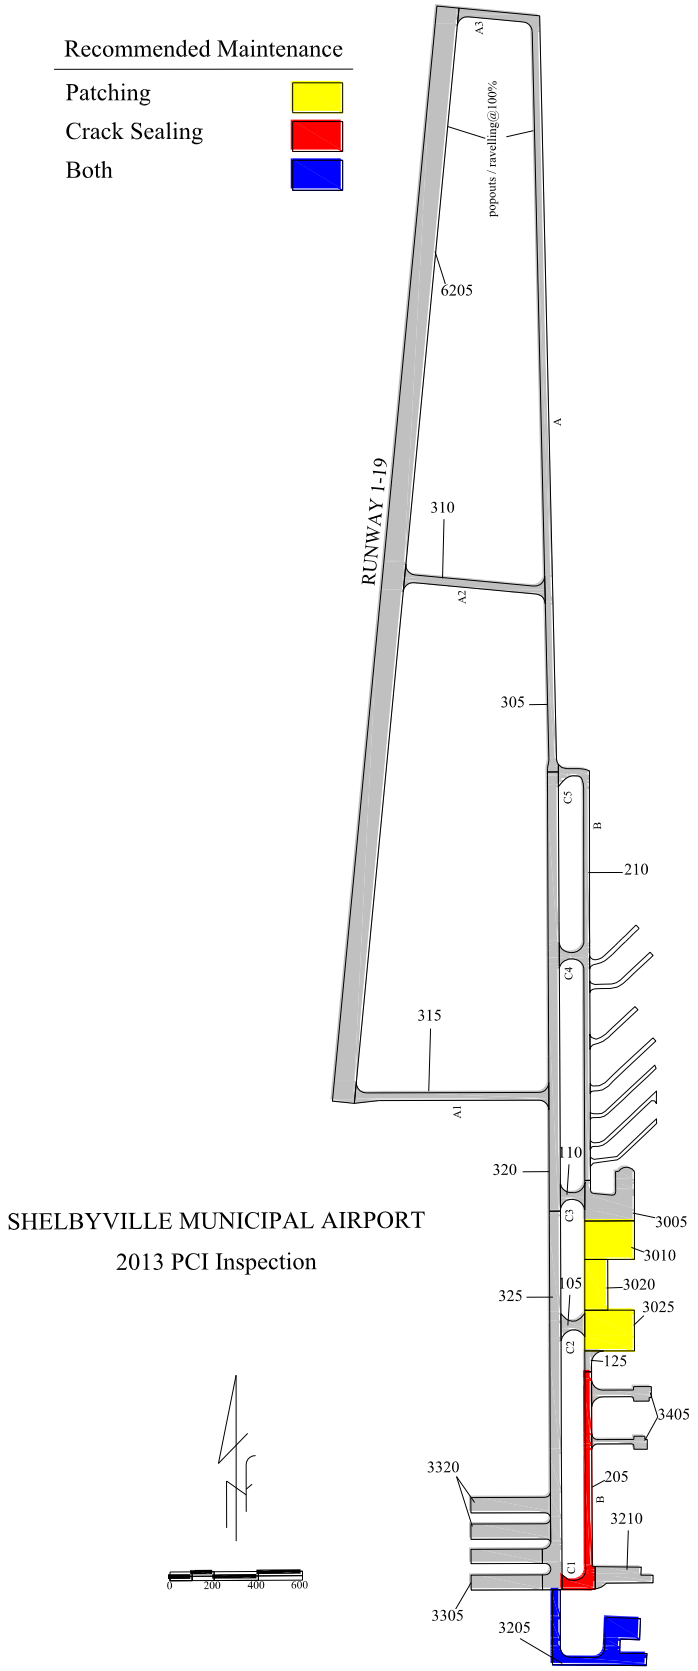
Recommended Maintenance
Patching
Crack Sealing
Both
SHELBYVILLE MUNICIPAL AIRPORT
2013 PCI Inspection
RUNWAY 1-19
popouts / ravelling@100%
A3
6205
A
310
A2
305
C5
B
210
C4
315
A1
110
320
C3
3005
3010
3020
105
325
3025
C2
125
3405
3320
205
B
3210
C1
3305
3205
0
200
400
600

Specific recommendations to help prioritize airfield maintenance are found in chapter 4 of this report. A summary of all identified maintenance needs is shown in the table below and in the figure on the following page.

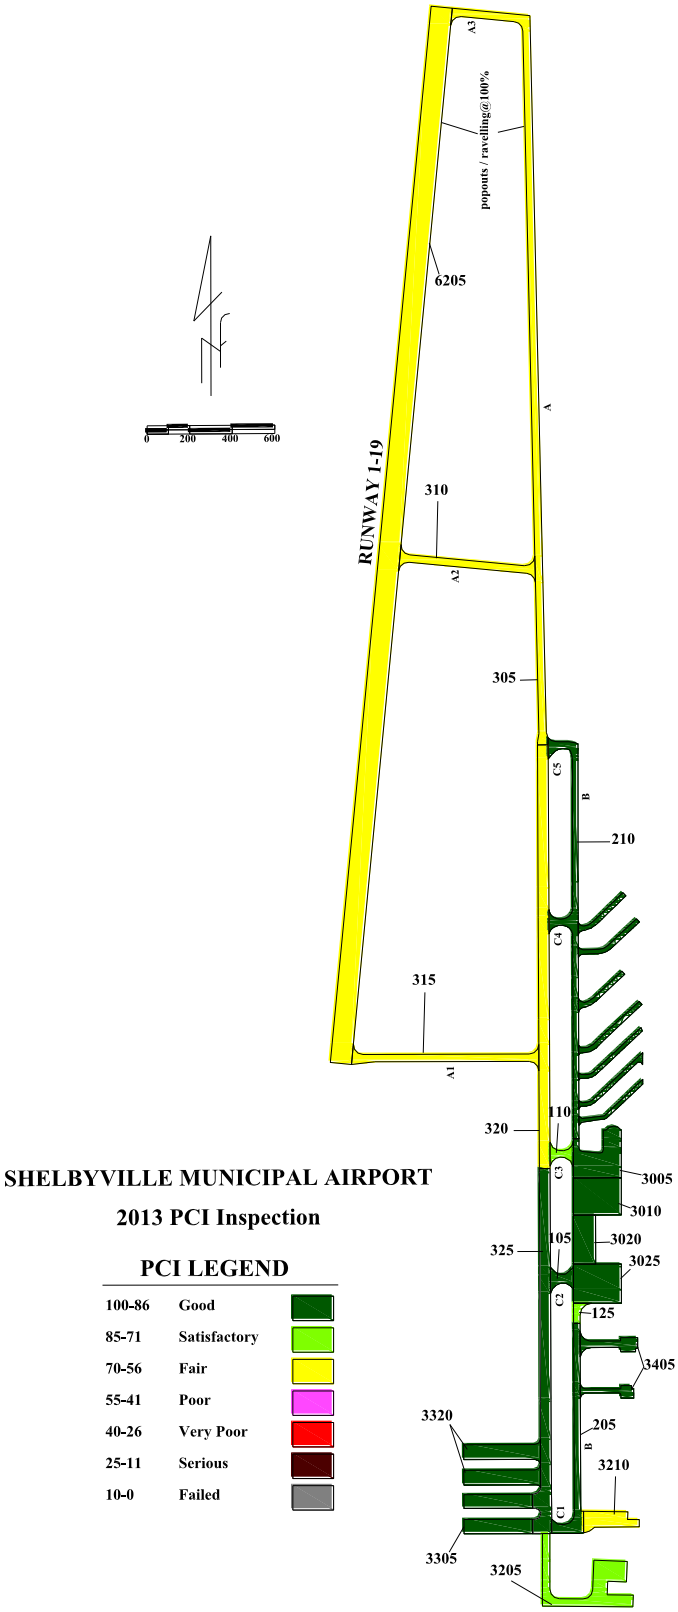
Figure 2-1. Inspected Pavement Condition

The pavement within each of the PCI condition categories is shown in Figure 2-1. The inspected PCI is summarized by branch use in Figure 2-2, and the photographs in Figure 2-3 through Figure 2-5 provide examples of the condition categories.

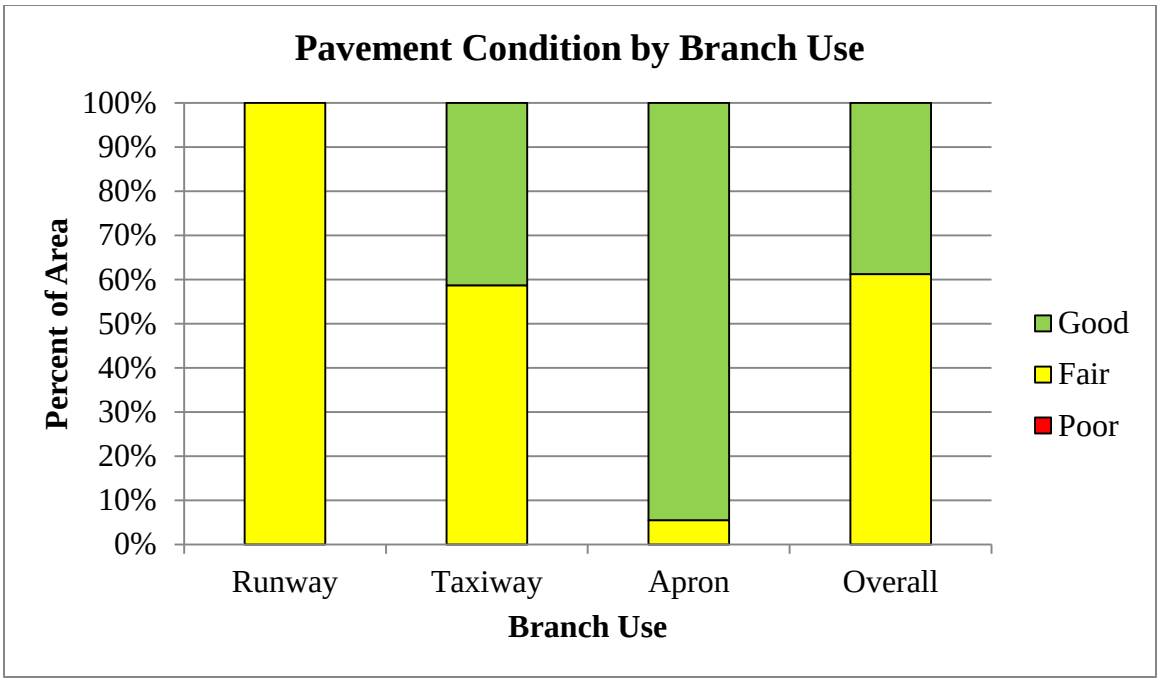
Figure 2-2. Pavement Condition by Branch Use

The overall Pavement Condition Index (PCI) for the airfield pavements was 78. Runways had an average inspected PCI of 68 and were above the desired MSL of 60. Taxiways had an average inspected PCI of 80, and ramps had an average inspected PCI of 92.

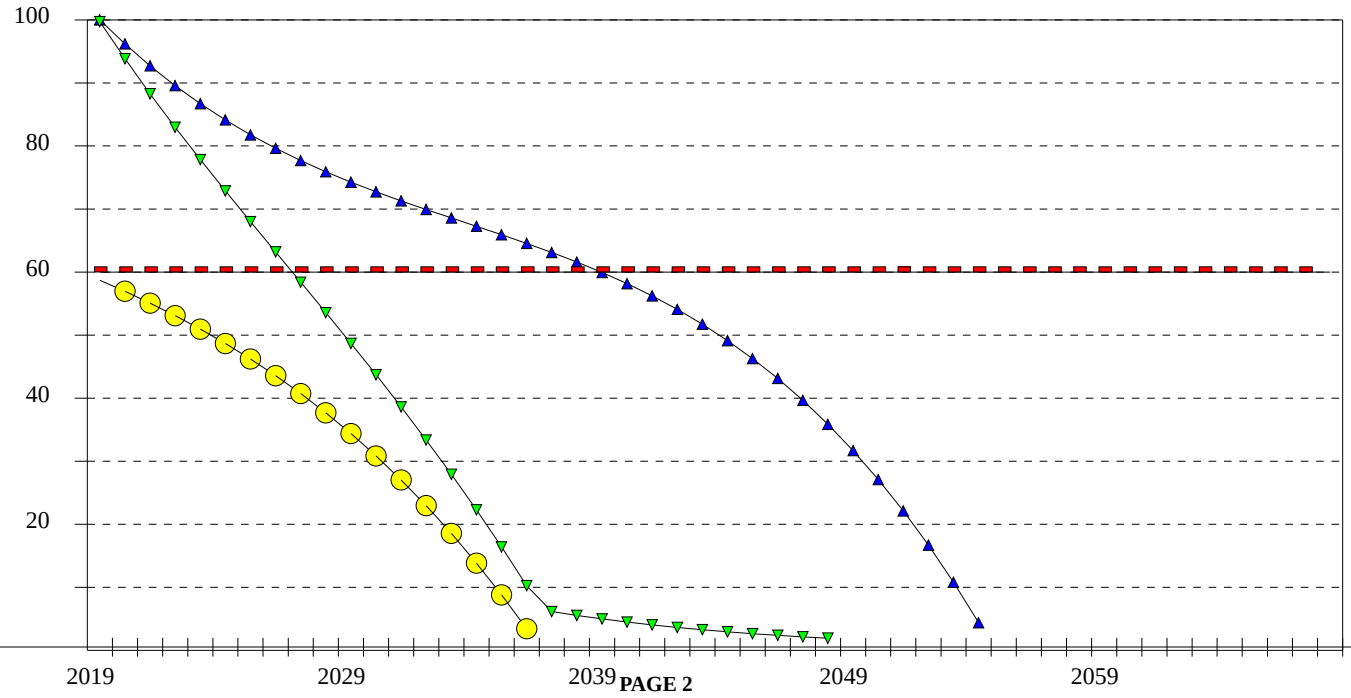
Runway 1-19 consisted of 1 section of AC pavement. The runway had a total area of 500,000 ft² with an area-weighted average PCI of 68 (Fair). The most common runway distresses were L&T cracking and raveling.

LEGEND	DESCRIPTION	COST	LIFE EXTENSION
▲	RESURFACING	$720,000	20 YEARS
▼	SURFACE TREATMENT	$194,999	8 YEARS
●	NO ACTION	N/A	N/A
-	MINIMUM SERVICE LEVEL, CURRENTLY 60

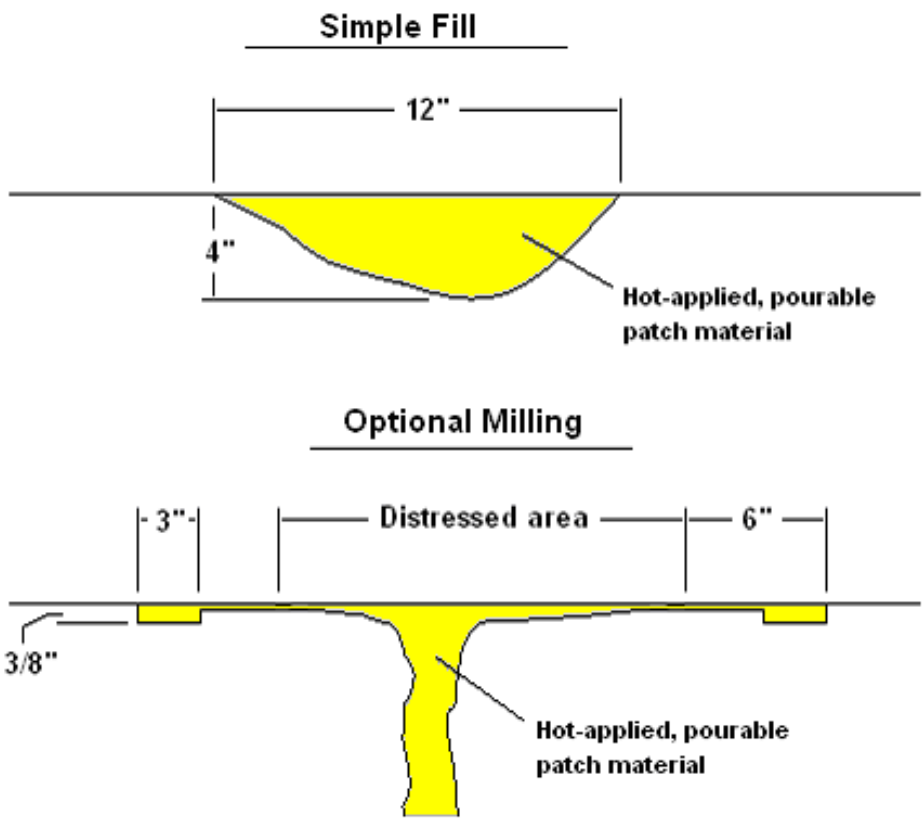
Patching (pourable materials)

Hot-applied, pourable materials generally are used to repair deficiencies larger than can be repaired by sealants, but smaller than those where traditional techniques would be required. Suggested uses for this type of repair include cracks over 2 inches wide, potholes less than 4 inches deep, as a leveling for small depressions, as a cap for settled utility cuts, and as a skin patch for areas of alligator cracking.

- Examine and mark the patch outline. Boundaries should extend to sound pavement.
- Apply patch material to clean, dry surfaces.
- A heating lance to preheat or dry existing pavement is recommended in cold or wet conditions.
- Patch material should be poured into the area to be repaired and leveled as appropriate.
- Patch edges should be sealed after application to assure good adhesion, preventing surface moisture from migrating under patch edges.
