Pavement Condition Report

Knox-Starke County Airport

Project 1480370

January 2014

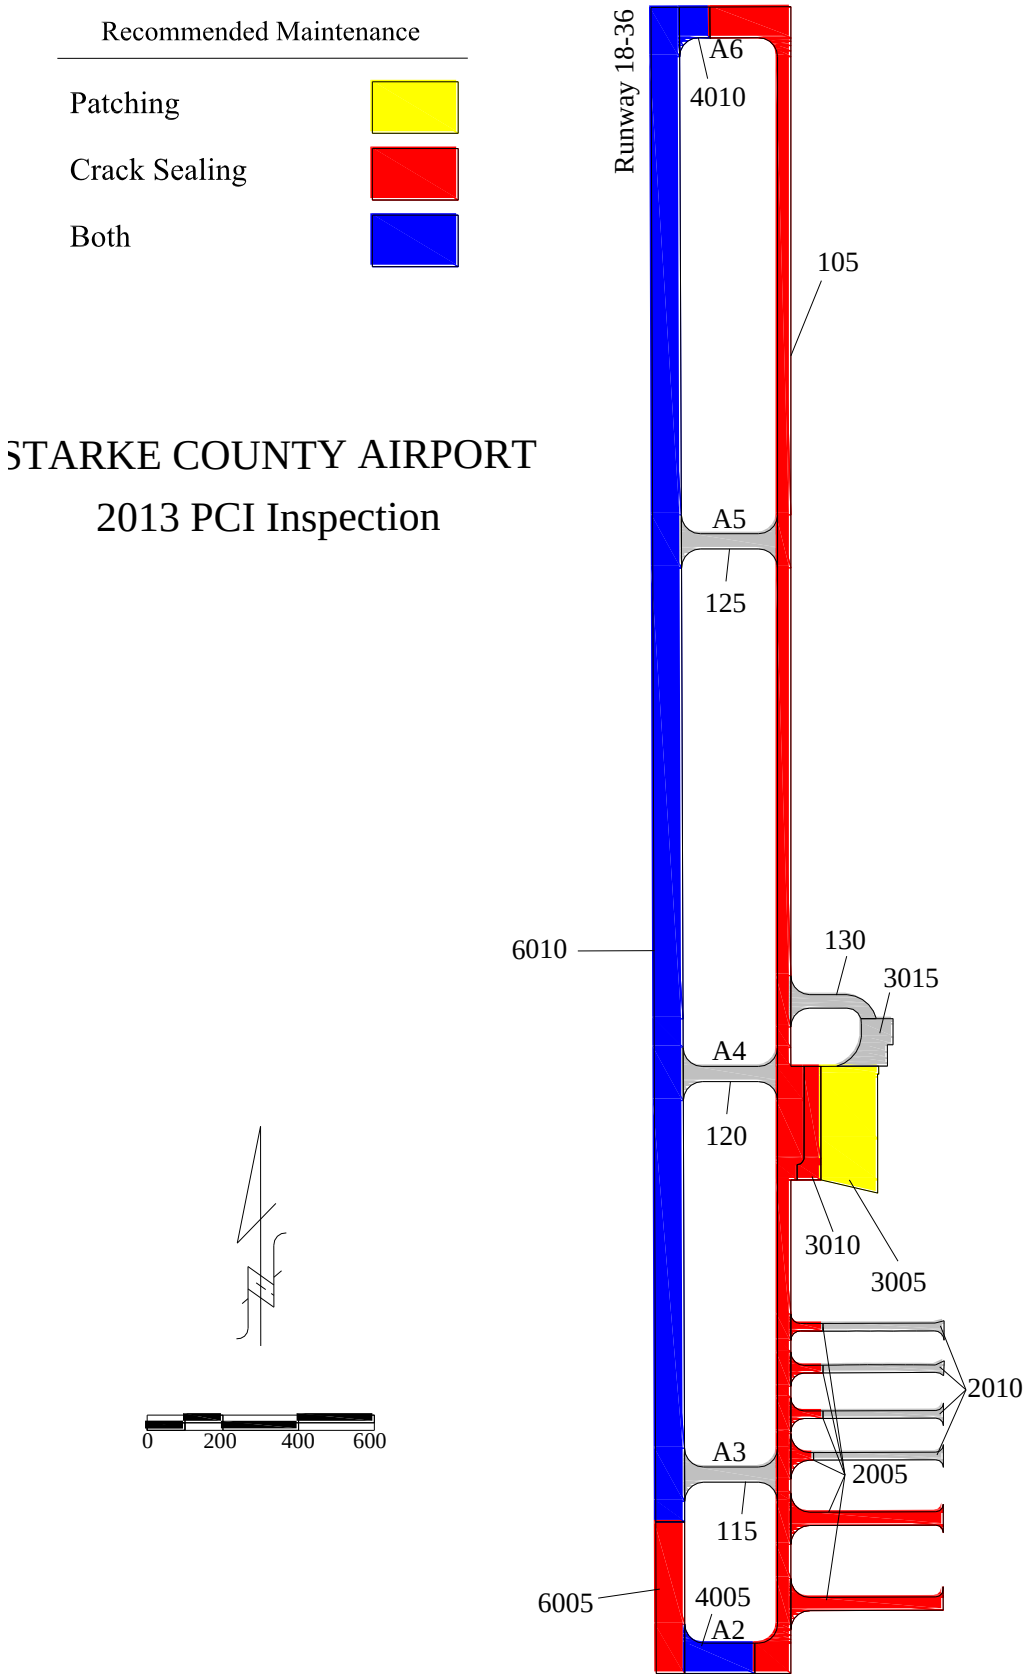
Recommended Maintenance
Patching
Crack Sealing
Both
STARKE COUNTY AIRPORT
2013 PCI Inspection
Runway 18-36
A6
4010
105
A5
125
6010
130
3015
A4
120
3010
3005
2010
A3
2005
115
6005
4005
A2
0
200
400
600

Analysis of potential maintenance projects identified approximately 760 square feet of patching needs and approximately 24,000 linear feet of crack sealing and crack repair needs, at an estimated total cost of approximately $36,000.

Work Item	Quantity	Unit	Cost
AC PATCH	735	SF	$6,376
AC RESTORATIVE CRACK REPAIR	22,838	LF	$28,319
AC SUSTAINING CRACK REPAIR	1,535	LF	$1,328
PCC PATCHING	22	SF	$380
Total:			**$ 36,403**

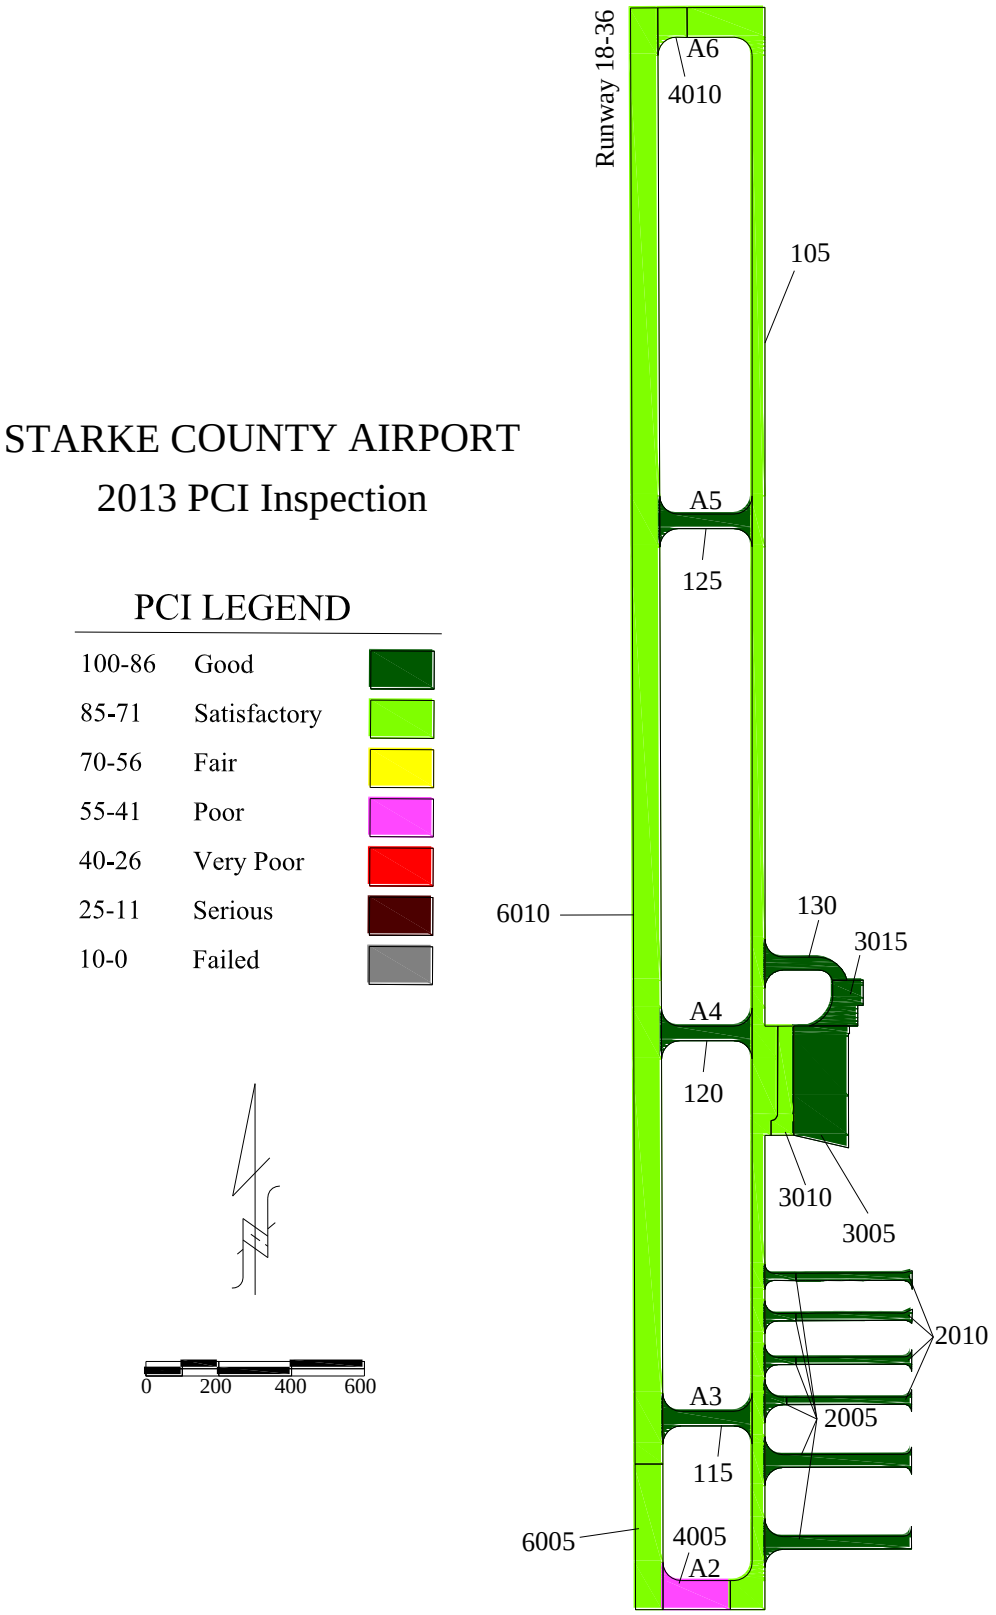
Figure 2-1. Inspected Pavement Condition

One pavement section, representing approximately 2 percent of the total area, had a simplified PCI rating of Poor. This section has deteriorated below the point where routine maintenance will be cost effective and should be viewed as a candidate for more extensive rehabilitation.

The pavement within each of the PCI condition categories is shown in Figure 2-1. The inspected PCI is summarized by branch use in Figure 2-2, and the photographs in Figure 2-3 through Figure 2-5 provide examples of the condition categories.

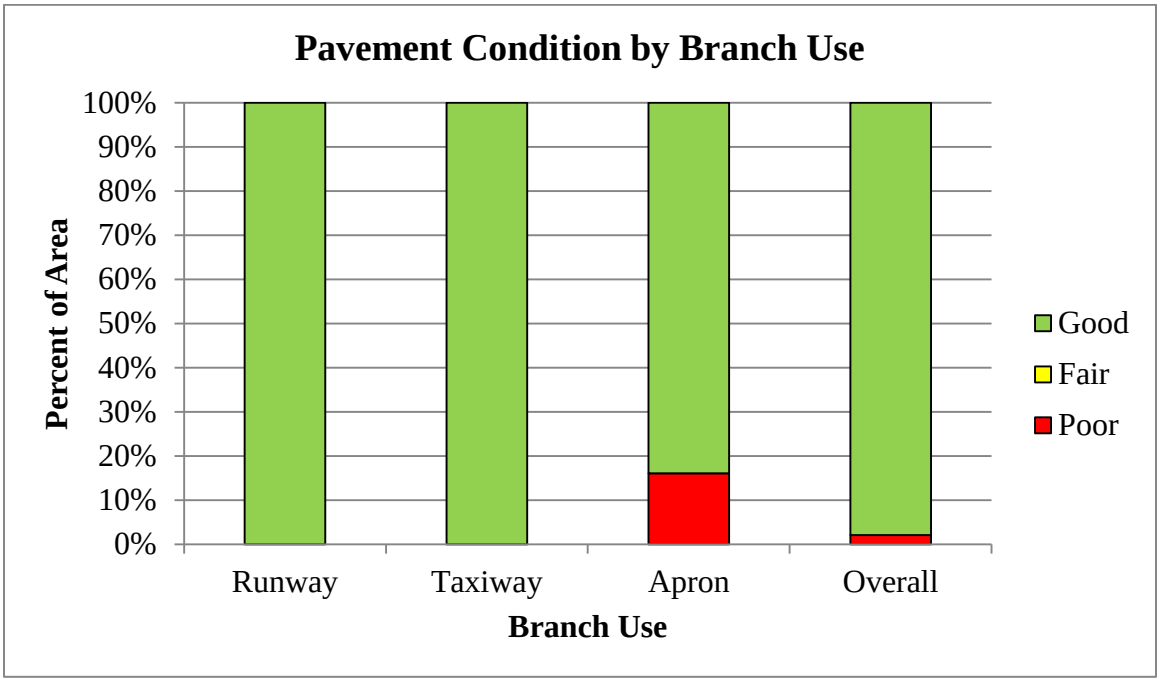
Figure 2-2. Pavement Condition by Branch Use

The overall Pavement Condition Index (PCI) for the airfield pavements was 81. Runways had an average inspected PCI of 73 and were above the desired MSL of 60. Taxiways had an average inspected PCI of 88, and ramps had an average inspected PCI of 84.

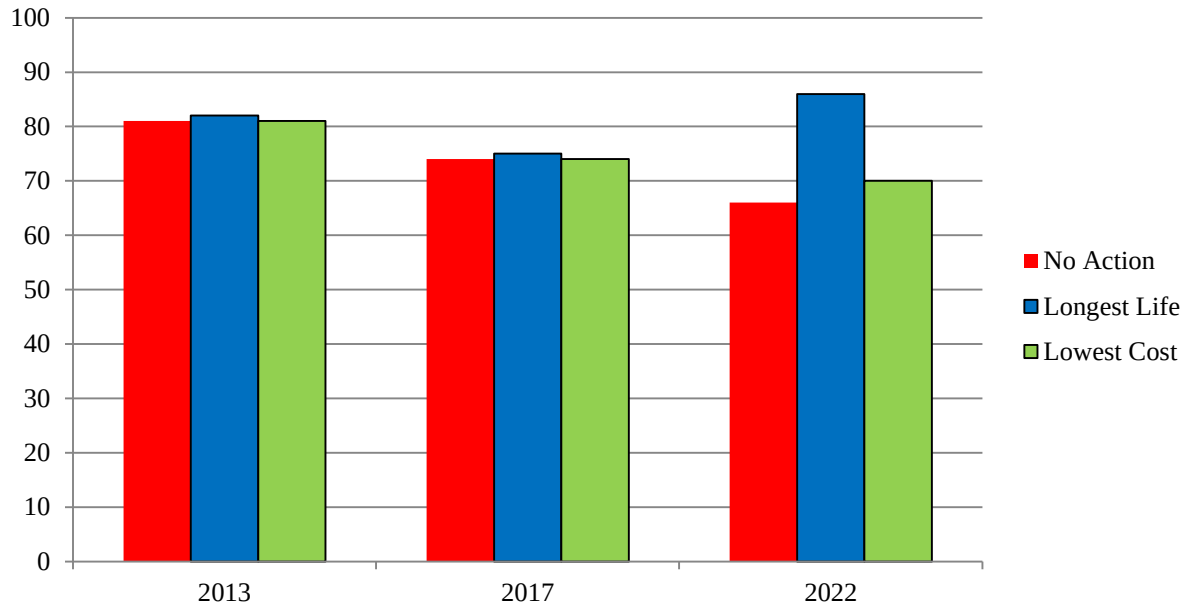
Figure 3-1. Programmed CIP

Figure 3-1 shows a projection of the overall airport pavement condition for the next 10 years based on implementing one of three capital improvement strategies:

The longest life CIP scenario is projected to cost approximately **$510,000** over the next 10 years. The lowest annual cost scenario is projected to cost approximately **$60,000** over the next 10 years. Examples of each capital improvement strategy and a complete listing of all viable capital projects are presented in Table 3-2 through Table 3-4.
