Pavement Condition Report

Warsaw Municipal Airport

Project 1480370

January 2014

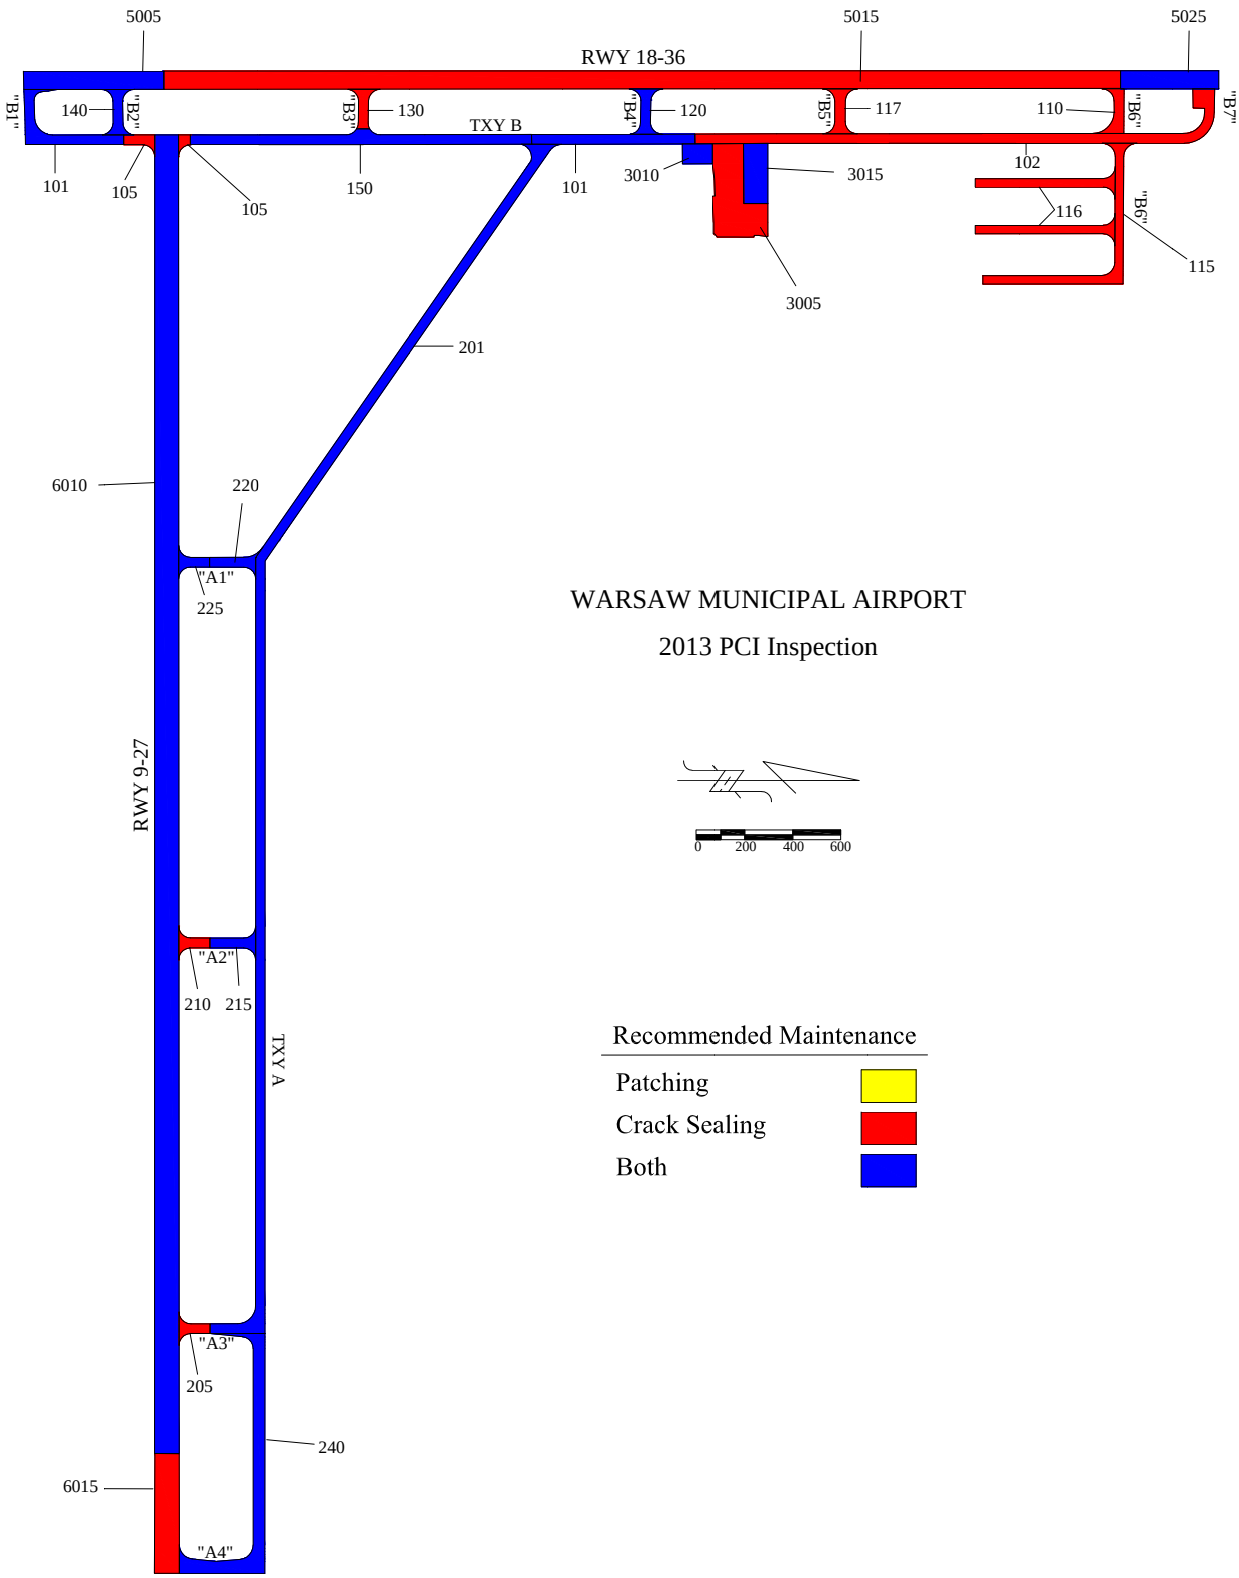
5005
5015
5025
RWY 18-36
"B1"
140
"B2"
"B3"
130
TXY B
"B4"
120
"B5"
117
110
"B6"
"B7"
101
105
105
150
101
3010
3015
102
116
"B9"
115
3005
201
6010
220
"A1"
225
WARSAW MUNICIPAL AIRPORT
2013 PCI Inspection
RWY 9-27
0
200
400
600
"A2"
210
215
TXY A
Recommended Maintenance
Patching
Crack Sealing
Both
"A3"
205
240
6015
"A4"

Specific recommendations to help prioritize airfield maintenance are found in chapter 4 of this report. A summary of all identified maintenance needs is shown in the table below and in the figure on the following page.

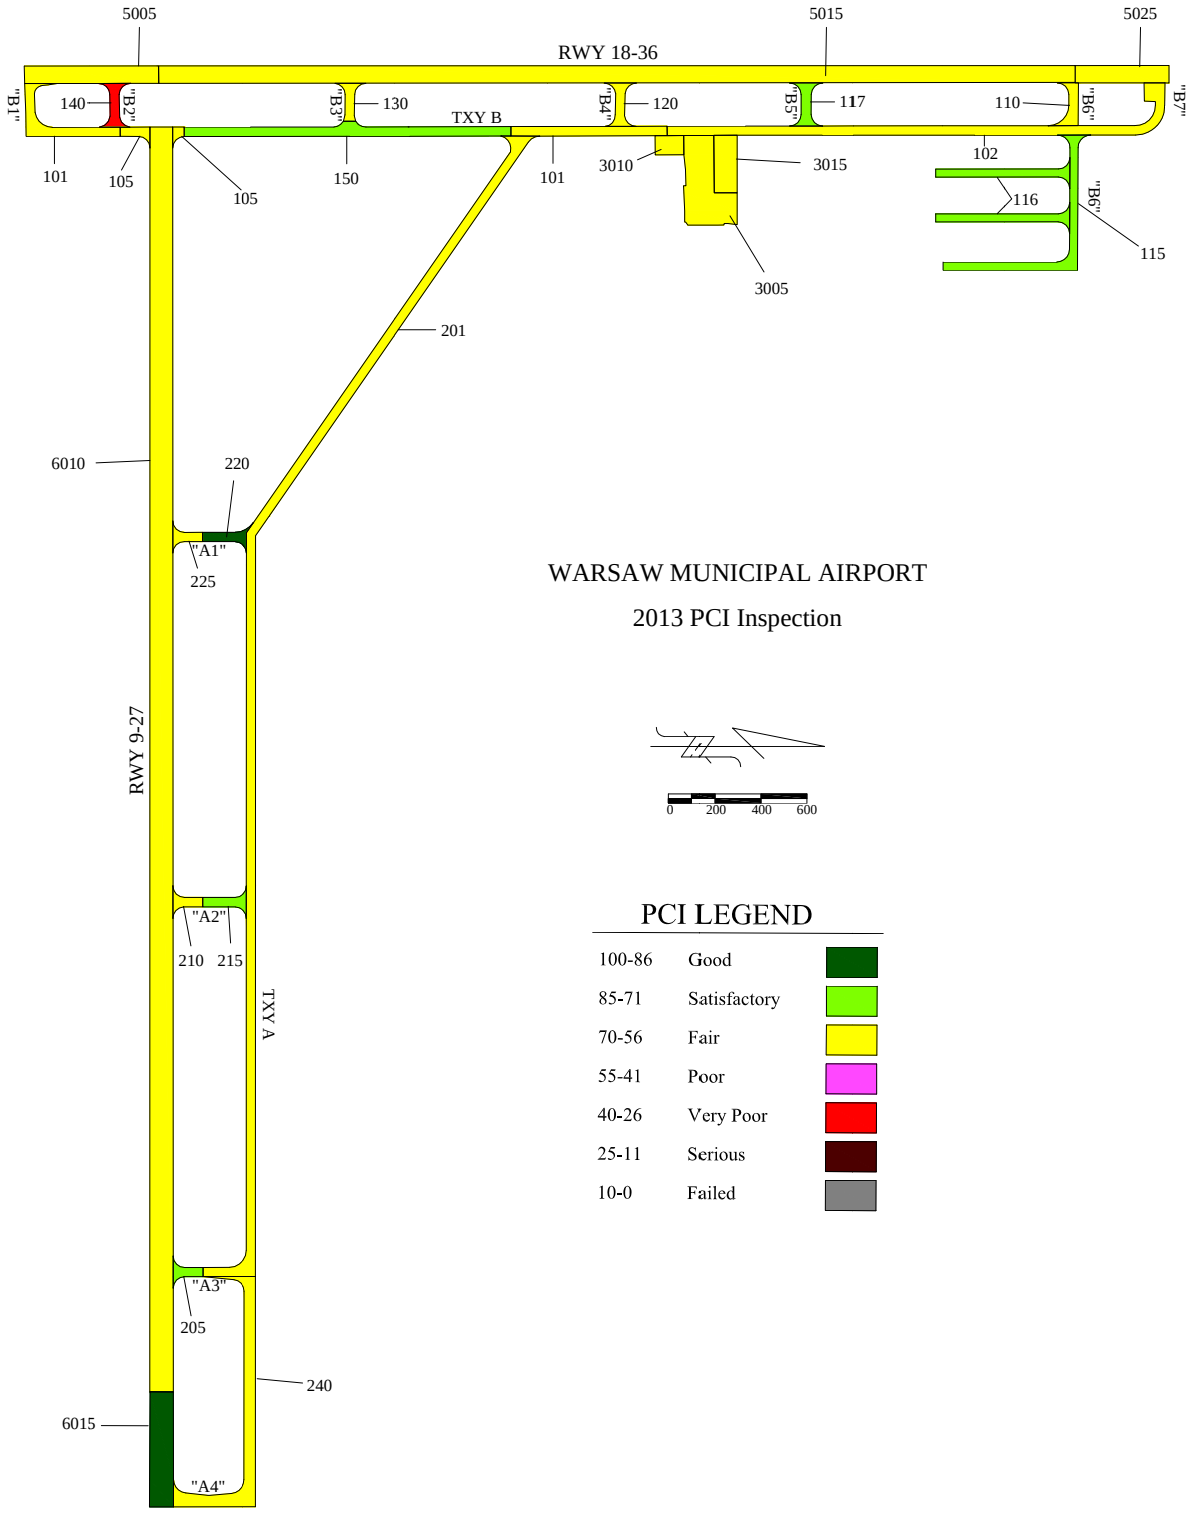
Figure 2-1. Inspected Pavement Condition

The pavement within each of the PCI condition categories is shown in Figure 2-1. The inspected PCI is summarized by branch use in Figure 2-2, and the photographs in Figure 2-3 through Figure 2-5 provide examples of the condition categories.

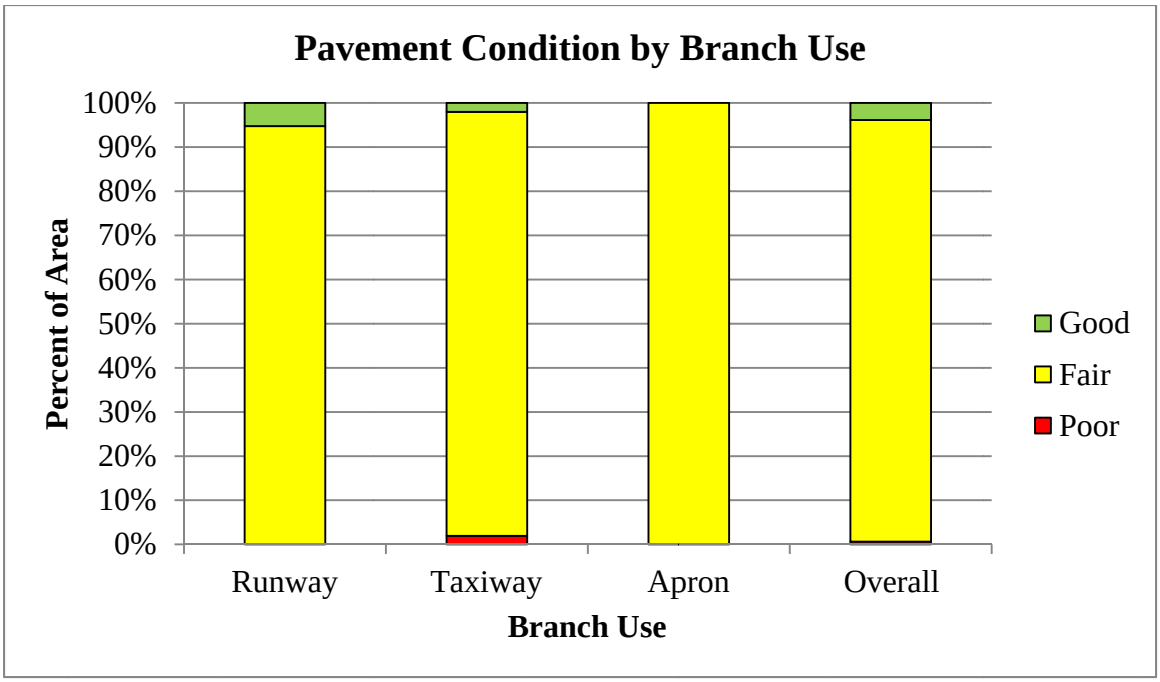
Figure 2-2. Pavement Condition by Branch Use

The overall Pavement Condition Index (PCI) for the airfield pavements was 69. Runways had an average inspected PCI of 70 and were above the desired MSL of 60. Taxiways had an average inspected PCI of 69, and ramps had an average inspected PCI of 62.

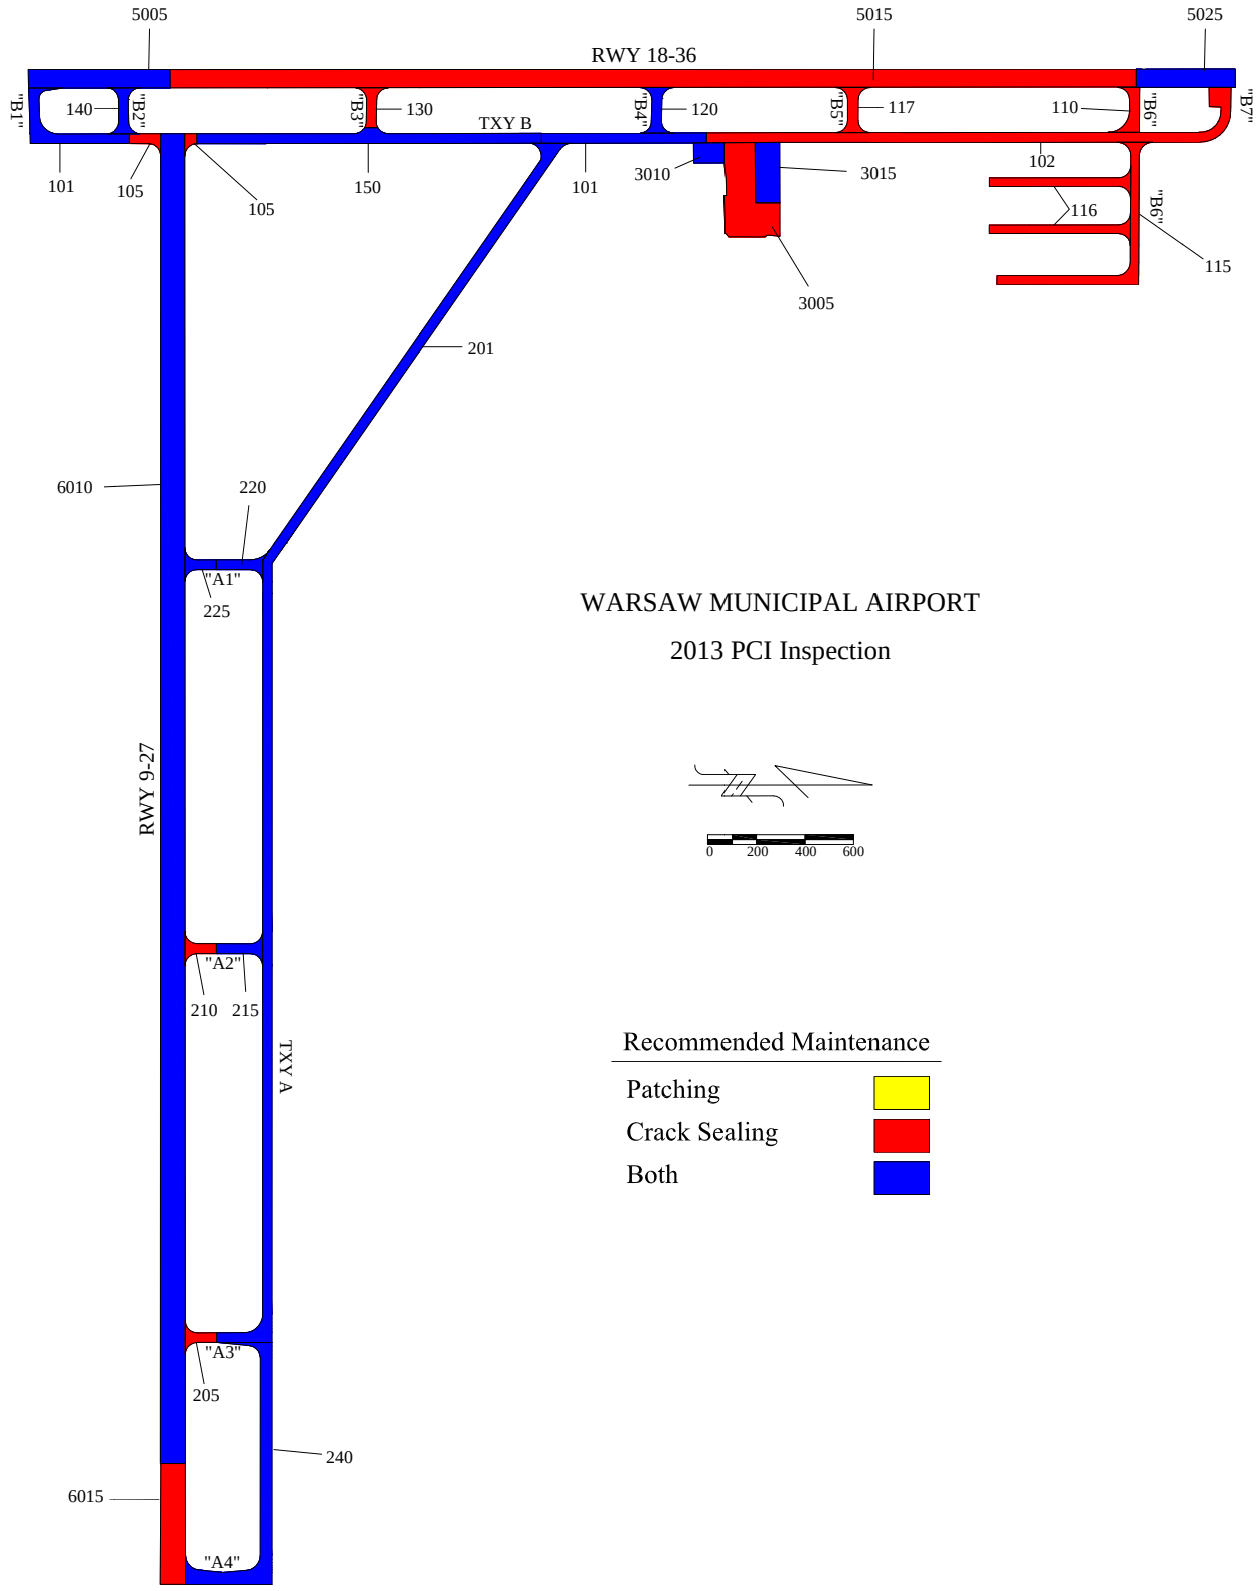
Figure 4-1. Recommended Maintenance

Analysis of potential maintenance projects identified approximately 2,600 square feet of patching needs and approximately 85,000 linear feet of crack sealing and crack repair needs, at an estimated total cost of approximately $130,000.

Work Item	Quantity	Unit	Cost
AC PATCH	2,587	SF	$22,448
AC RESTORATIVE CRACK REPAIR	81,978	LF	$101,652
AC SUSTAINING CRACK REPAIR	2,936	LF	$2,540
Total:			**$ 126,640**

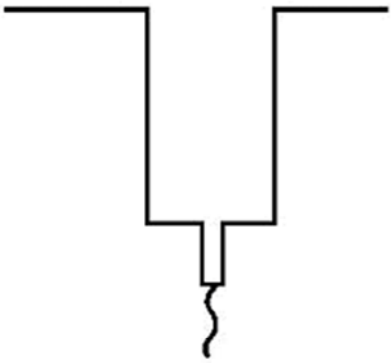
Typical failed joint sealant, w/ debris and incompressibles.
