PRELIMINARY HISTORIC BRIDGE ALTERNATIVE ANALYSIS REPORT

BUSINESS 37 NORTH OVER BEANBLOSSOM CREEK

Location: 0.1 Miles South of I-69, Monroe County, Indiana BRIDGE FILE #: MONROE NO. 913; NBI #: 5300130

DATE: NOVEMBER 2023

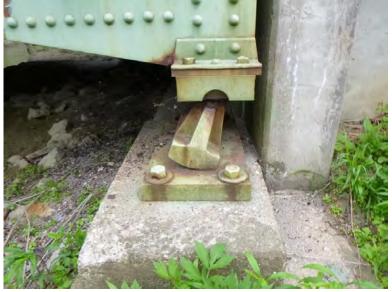
Deficiencies: Heavy debris had accumulated on the lower chord and at low chord connections. There are areas of heavy pitting and minor section loss on inside of flanges, top of web, and rivet heads of lower chords. Low chord gusset plates have areas of moderate section loss near the center. Some vertical members have moderate to heavy section loss on the inside flange connection to the low chord. Lateral bracing connections with moderate to heavy section loss. Areas of surface rust and minor expansion rust on stringers and floor beams. Expansion bearings are severely rotated to the south and may have seized.

PHOTO 30: MODERATE SECTION LOSS IN WEB AT NELO

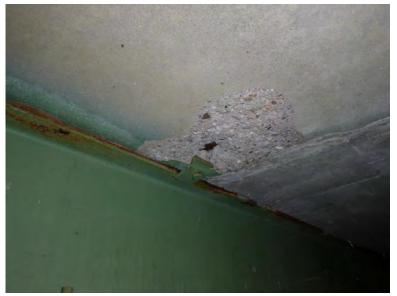
PHOTO 33: EXPANSION RUST AND SECTION LOSS AT NELO

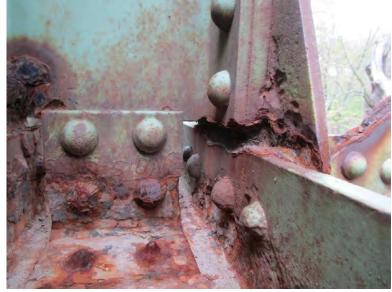
PHOTO 36: SEL2L1 INTERIOR GUSSET PLATE SECTION LOSS AT DIAGONAL END

Diagonal (L2U1)	D	6	Light surface rust and minor pitting. Areas of moderate pitting at gusset plate. 15% section loss on interior gusset plate on inside face and 10% section loss on exterior gusset plate on inside face at end of diagonal. 10% section loss on flanges at end of gusset plate. Less than 5% total section loss. No cracks evident.
Diagonal (L2U3)	D	6	Light surface rust and minor pitting. Inside face of gusset plates have heavy pitting and 10% section loss. Minor section loss in connection plate. Less than 5% total section loss. No cracks evident.
Floor Beam	D	6	Surface rust and minor pitting. Areas of heavy expansion rust and section loss at top and bottom flanges. Heavy section loss on some rivets. Expansion rust and minor section loss at web and angle connection. Lower lateral bracing has heavy section loss and expansion rust. South lateral bracing is severed. Less than 5% total section loss. No cracks evident.

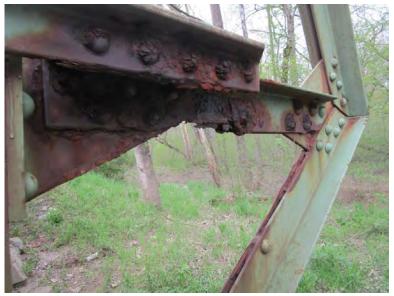
PHOTO 42: TYPICAL FLOOR BEAM DETERIORATION AT TOP FLANGE
