# Pavement Condition Report

## Angola-Steuben County Airport

Project 15805741

**February 2015**

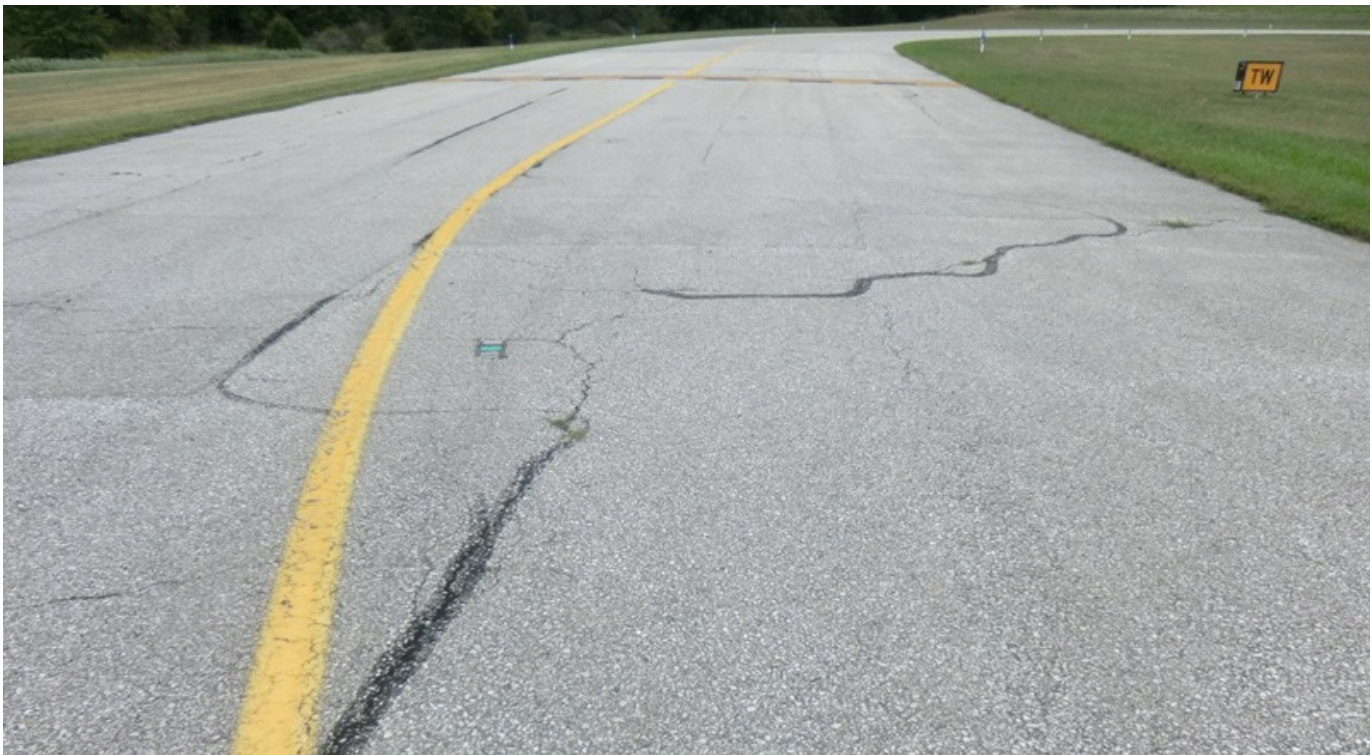
DISTRESS TYPE	SEVERITY	MEASURED QUANTITY	ESTIMATED TOTAL QUANTITY	UNITS	PERCENTAGE OF All DISTRESS
LONG.& TRANS. CRACK	HIGH	13	19	L.F.	13.9
LONG.& TRANS. CRACK	MED	91	136	L.F.	27.4
LONG.& TRANS. CRACK	LOW	568	849	L.F.	58.5

APPROXIMATE AMOUNT OF DISTRESS RELATED TO LOAD ON THE PAVEMENT IS:	0 %
APPROXIMATE AMOUNT OF DISTRESS RELATED TO MATERIALS PROBLEMS IN THE FEATURE IS:	67 %
APPROXIMATE AMOUNT OF DISTRESS RELATED TO AGE OF PAVEMENT AND TRAFFIC REPETITIONS IS:	33 %

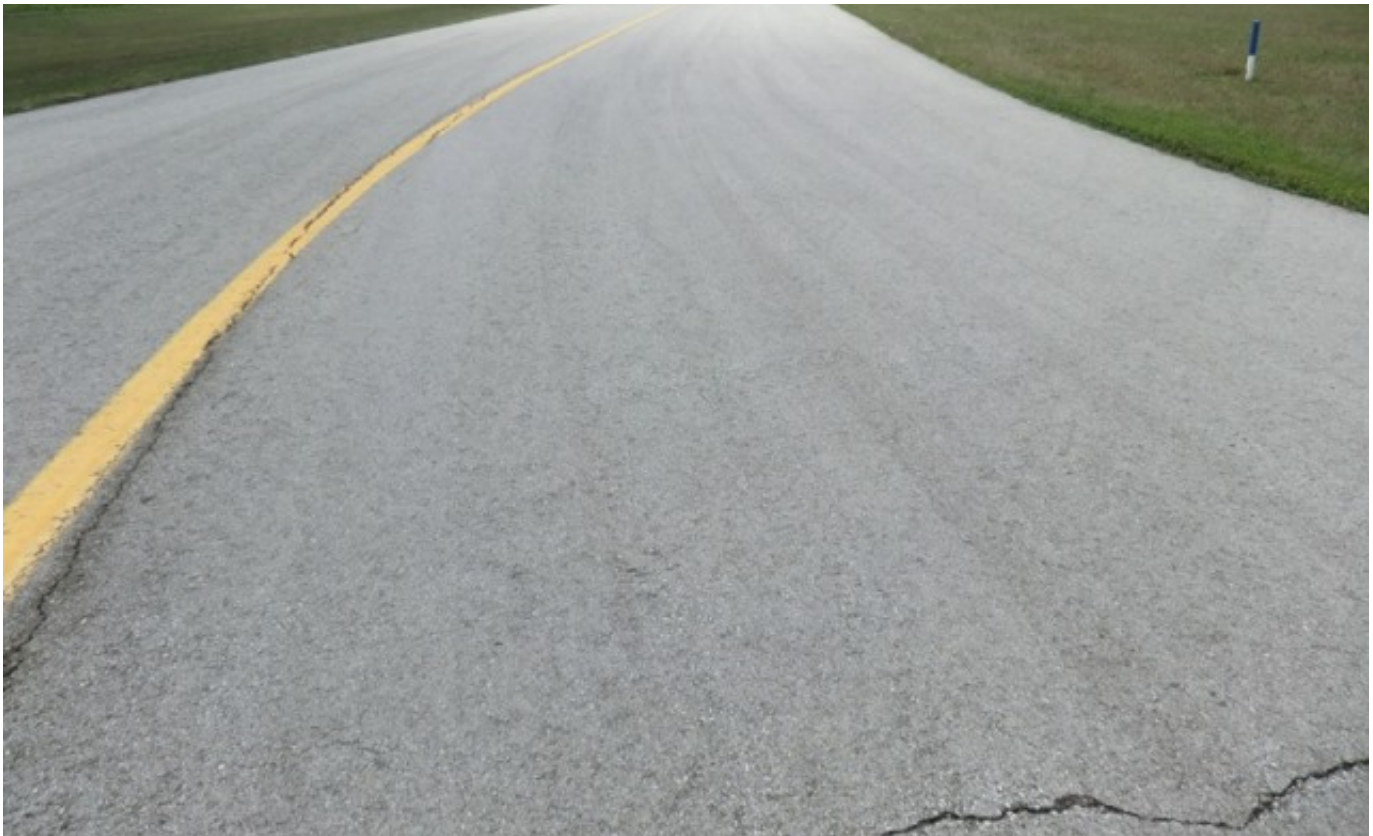
DISTRESS TYPE	SEVERITY	MEASURED QUANTITY	ESTIMATED TOTAL QUANTITY	UNITS	PERCENTAGE OF ALL DISTRESS
LONG.& TRANS. CRACK	LOW	1,022	5,069	L.F.	100

APPROXIMATE AMOUNT OF DISTRESS RELATED TO LOAD ON THE PAVEMENT IS:	0 %
APPROXIMATE AMOUNT OF DISTRESS RELATED TO MATERIALS PROBLEMS IN THE FEATURE IS:	67 %
APPROXIMATE AMOUNT OF DISTRESS RELATED TO AGE OF PAVEMENT AND TRAFFIC REPETITIONS IS:	33 %

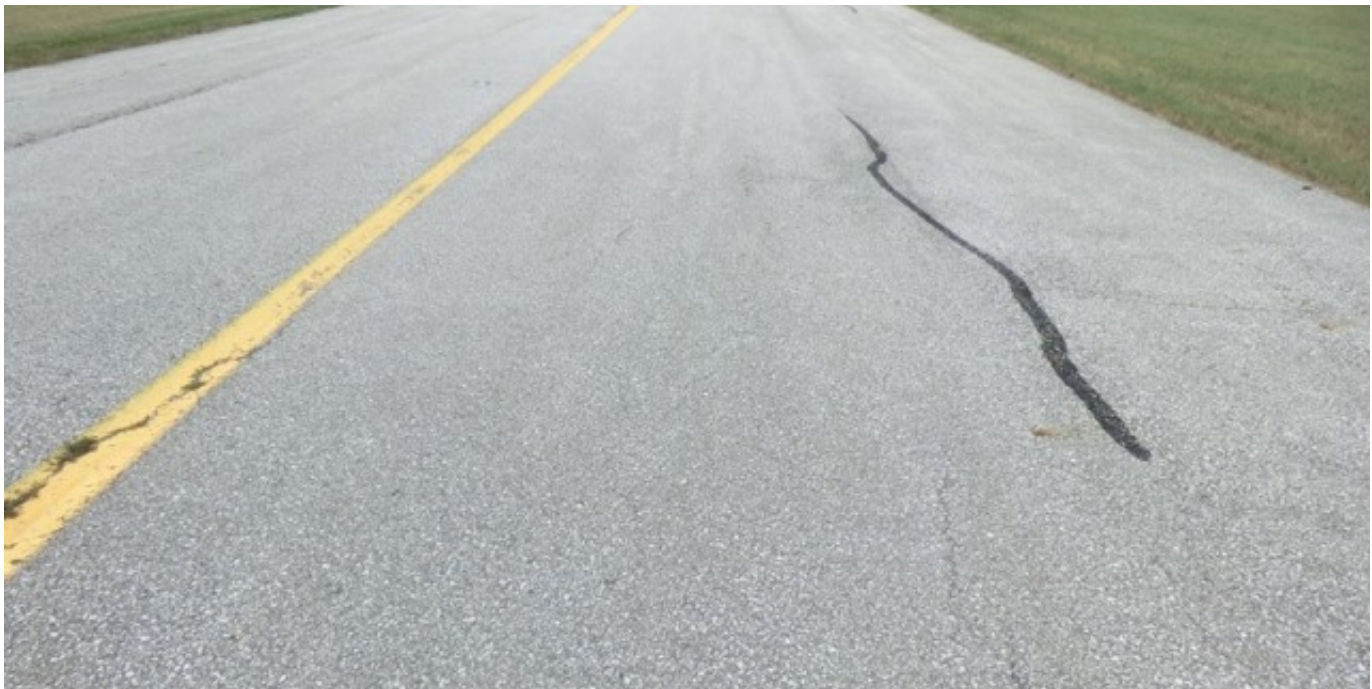
DISTRESS TYPE	SEVERITY	MEASURED QUANTITY	ESTIMATED TOTAL QUANTITY	UNITS	PERCENTAGE OF All DISTRESS
ALLIGATOR CRACKING	LOW	27	30	S.F.	16.7
LONG.& TRANS. CRACK	HIGH	9	10	L.F.	8.8
LONG.& TRANS. CRACK	MED	133	151	L.F.	22.5
LONG.& TRANS. CRACK	LOW	437	497	L.F.	27
RAVELING	LOW	50	56	S.F.	3.2
WEATHERING	HIGH	91	103	S.F.	15.9
WEATHERING	MED	400	455	S.F.	5.6

APPROXIMATE AMOUNT OF DISTRESS RELATED TO LOAD ON THE PAVEMENT IS:	17 %
APPROXIMATE AMOUNT OF DISTRESS RELATED TO MATERIALS PROBLEMS IN THE FEATURE IS:	47 %
APPROXIMATE AMOUNT OF DISTRESS RELATED TO AGE OF PAVEMENT AND TRAFFIC REPETITIONS IS:	36 %

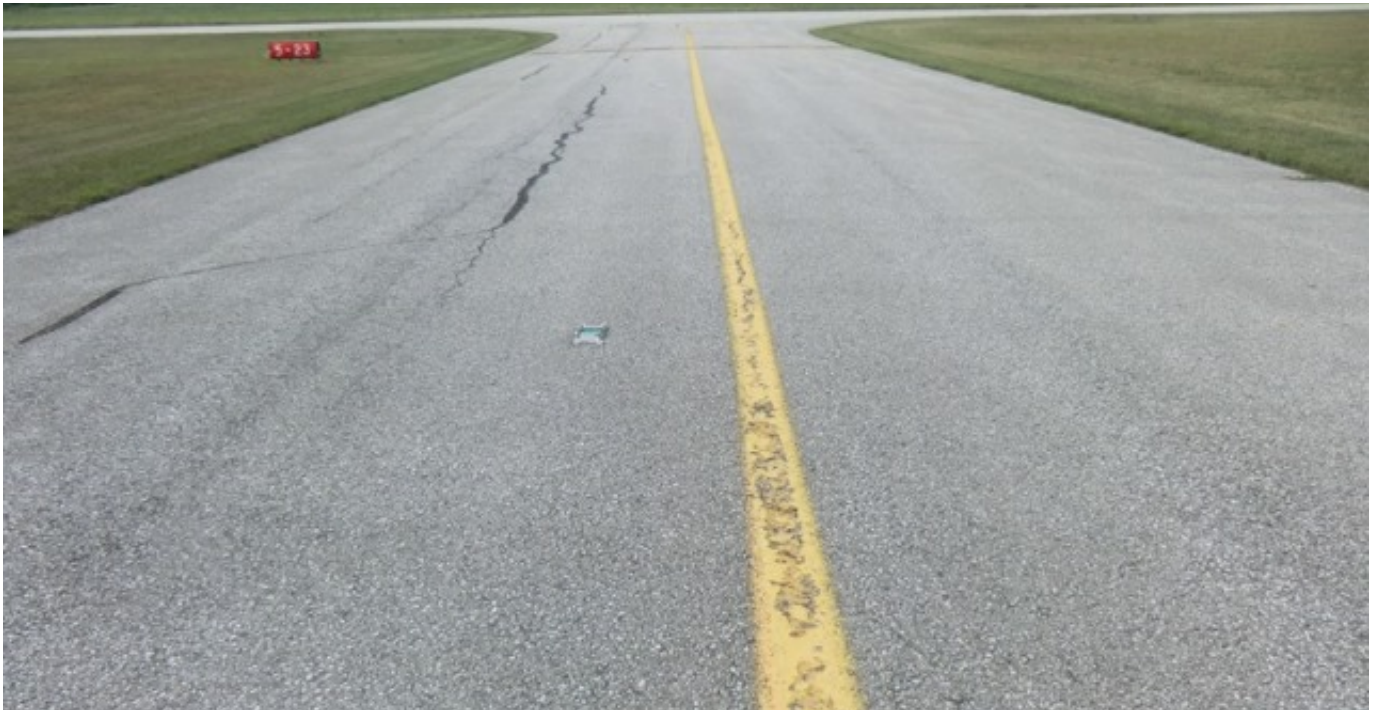
DISTRESS TYPE	SEVERITY	MEASURED QUANTITY	ESTIMATED TOTAL QUANTITY	UNITS	PERCENTAGE OF All DISTRESS
LONG.& TRANS. CRACK	HIGH	8	10	L.F.	8.7
LONG.& TRANS. CRACK	MED	191	250	L.F.	31.8
LONG.& TRANS. CRACK	LOW	586	767	L.F.	37.6
RAVELING	MED	50	65	S.F.	8.5
RAVELING	LOW	100	131	S.F.	5.1
WEATHERING	MED	500	655	S.F.	8

APPROXIMATE AMOUNT OF DISTRESS RELATED TO LOAD ON THE PAVEMENT IS:	0 %
APPROXIMATE AMOUNT OF DISTRESS RELATED TO MATERIALS PROBLEMS IN THE FEATURE IS:	59 %
APPROXIMATE AMOUNT OF DISTRESS RELATED TO AGE OF PAVEMENT AND TRAFFIC REPETITIONS IS:	41 %

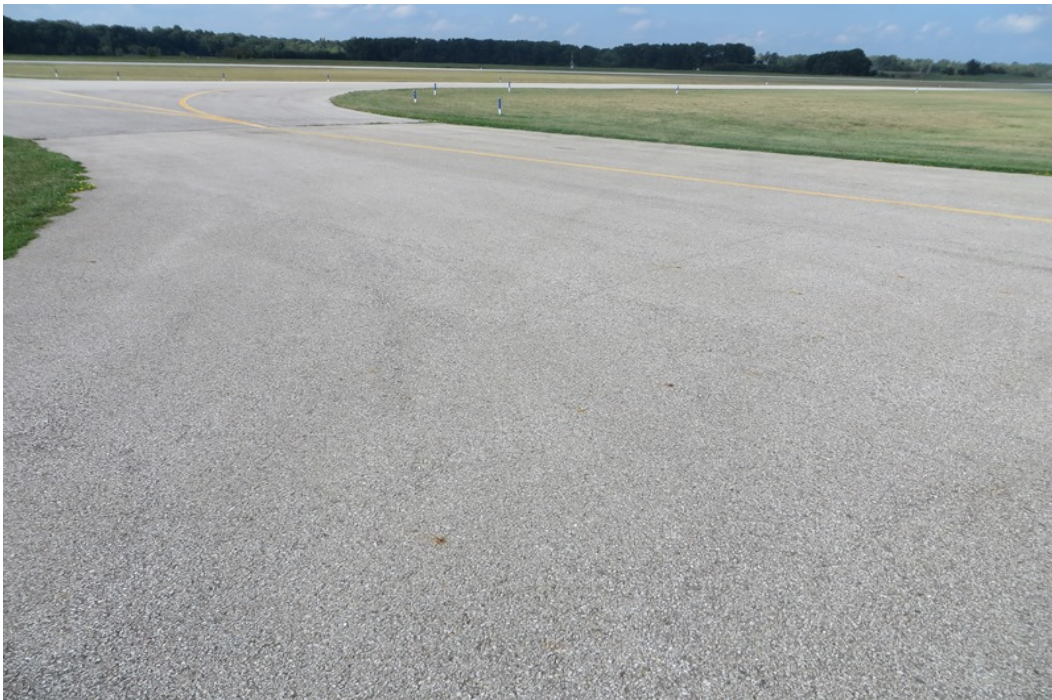
DISTRESS TYPE	SEVERITY	MEASURED QUANTITY	ESTIMATED TOTAL QUANTITY	UNITS	PERCENTAGE OF All DISTRESS
LONG.& TRANS. CRACK	LOW	19	24	L.F.	100

APPROXIMATE AMOUNT OF DISTRESS RELATED TO LOAD ON THE PAVEMENT IS:	0 %
APPROXIMATE AMOUNT OF DISTRESS RELATED TO MATERIALS PROBLEMS IN THE FEATURE IS:	67 %
APPROXIMATE AMOUNT OF DISTRESS RELATED TO AGE OF PAVEMENT AND TRAFFIC REPETITIONS IS:	33 %

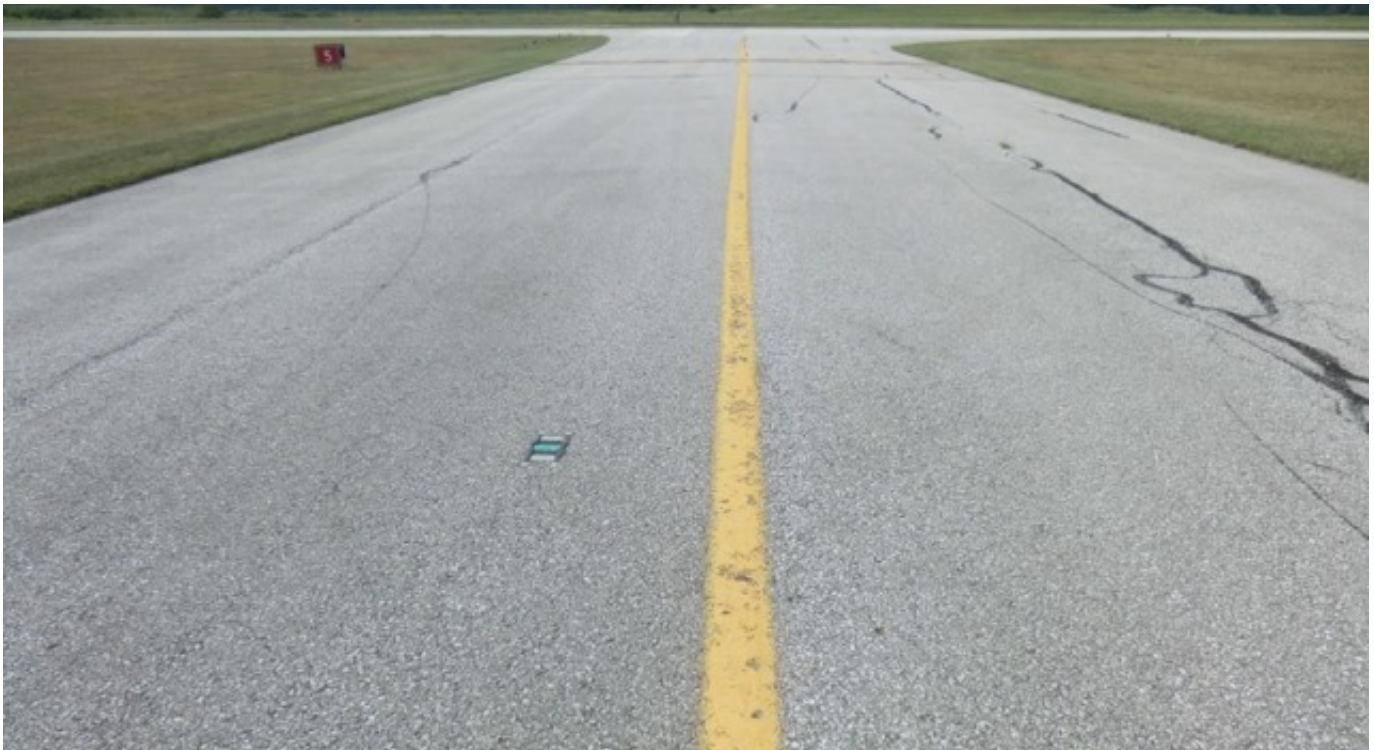
DISTRESS TYPE	SEVERITY	MEASURED QUANTITY	ESTIMATED TOTAL QUANTITY	UNITS	PERCENTAGE OF ALL DISTRESS
LONG.& TRANS. CRACK	HIGH	53	53	L.F.	36.1
LONG.& TRANS. CRACK	MED	142	142	L.F.	29.3
LONG.& TRANS. CRACK	LOW	395	395	L.F.	28.2
WEATHERING	MED	370	370	S.F.	6.2

APPROXIMATE AMOUNT OF DISTRESS RELATED TO LOAD ON THE PAVEMENT IS:	0 %
APPROXIMATE AMOUNT OF DISTRESS RELATED TO MATERIALS PROBLEMS IN THE FEATURE IS:	65 %
APPROXIMATE AMOUNT OF DISTRESS RELATED TO AGE OF PAVEMENT AND TRAFFIC REPETITIONS IS:	35 %

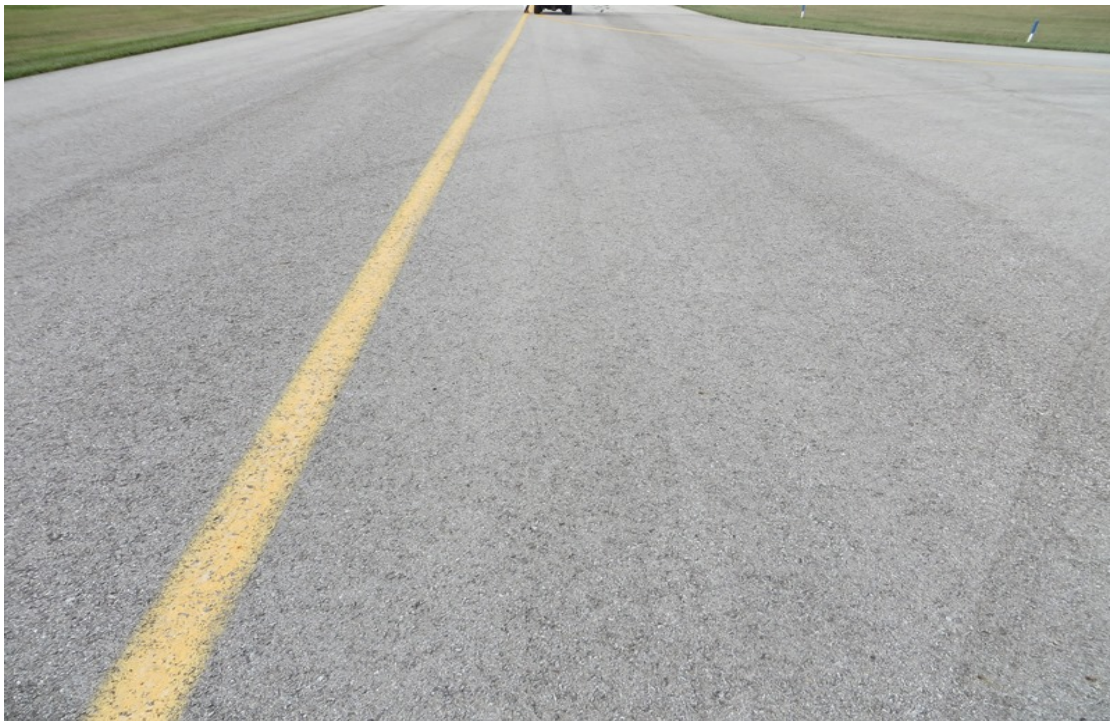
DISTRESS TYPE	SEVERITY	MEASURED QUANTITY	ESTIMATED TOTAL QUANTITY	UNITS	PERCENTAGE OF All DISTRESS
LONG.& TRANS. CRACK	LOW	12	17	L.F.	100

APPROXIMATE AMOUNT OF DISTRESS RELATED TO LOAD ON THE PAVEMENT IS:	0 %
APPROXIMATE AMOUNT OF DISTRESS RELATED TO MATERIALS PROBLEMS IN THE FEATURE IS:	67 %
APPROXIMATE AMOUNT OF DISTRESS RELATED TO AGE OF PAVEMENT AND TRAFFIC REPETITIONS IS:	33 %

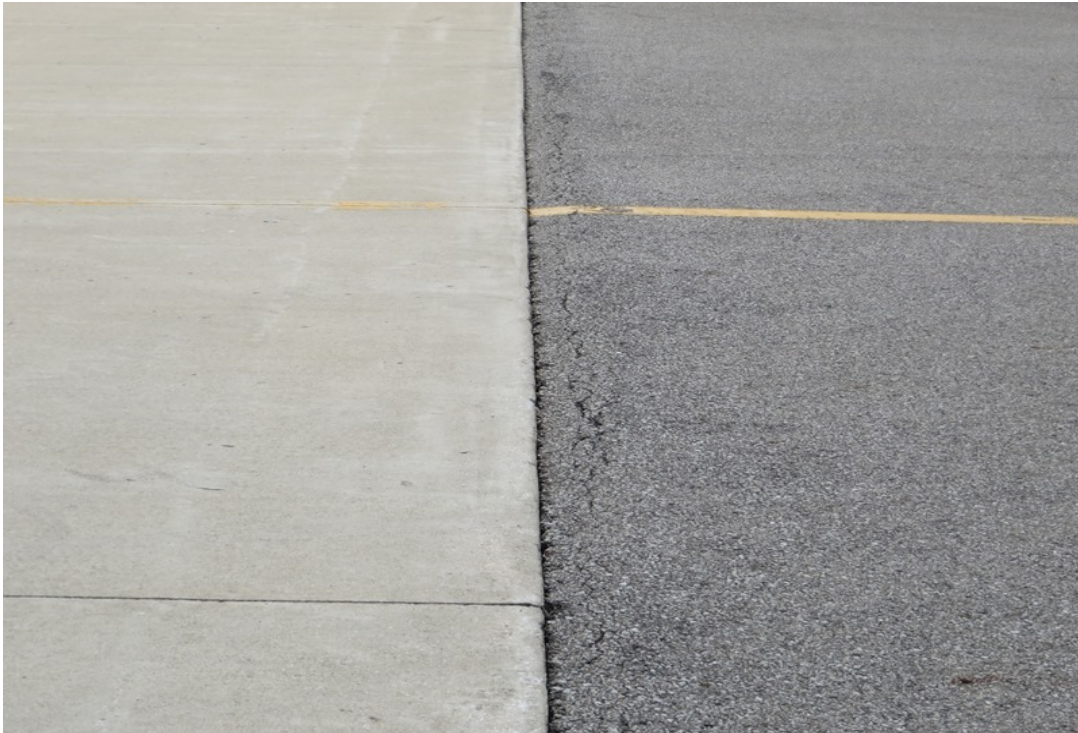
DISTRESS TYPE	SEVERITY	MEASURED QUANTITY	ESTIMATED TOTAL QUANTITY	UNITS	PERCENTAGE OF All DISTRESS
LONG.& TRANS. CRACK	LOW	4	4	L.F.	16.5
SHOVING BY PCC SLAB	LOW	69	69	S.F.	83.4

APPROXIMATE AMOUNT OF DISTRESS RELATED TO LOAD ON THE PAVEMENT IS:	0 %
APPROXIMATE AMOUNT OF DISTRESS RELATED TO MATERIALS PROBLEMS IN THE FEATURE IS:	94 %
APPROXIMATE AMOUNT OF DISTRESS RELATED TO AGE OF PAVEMENT AND TRAFFIC REPETITIONS IS:	6 %

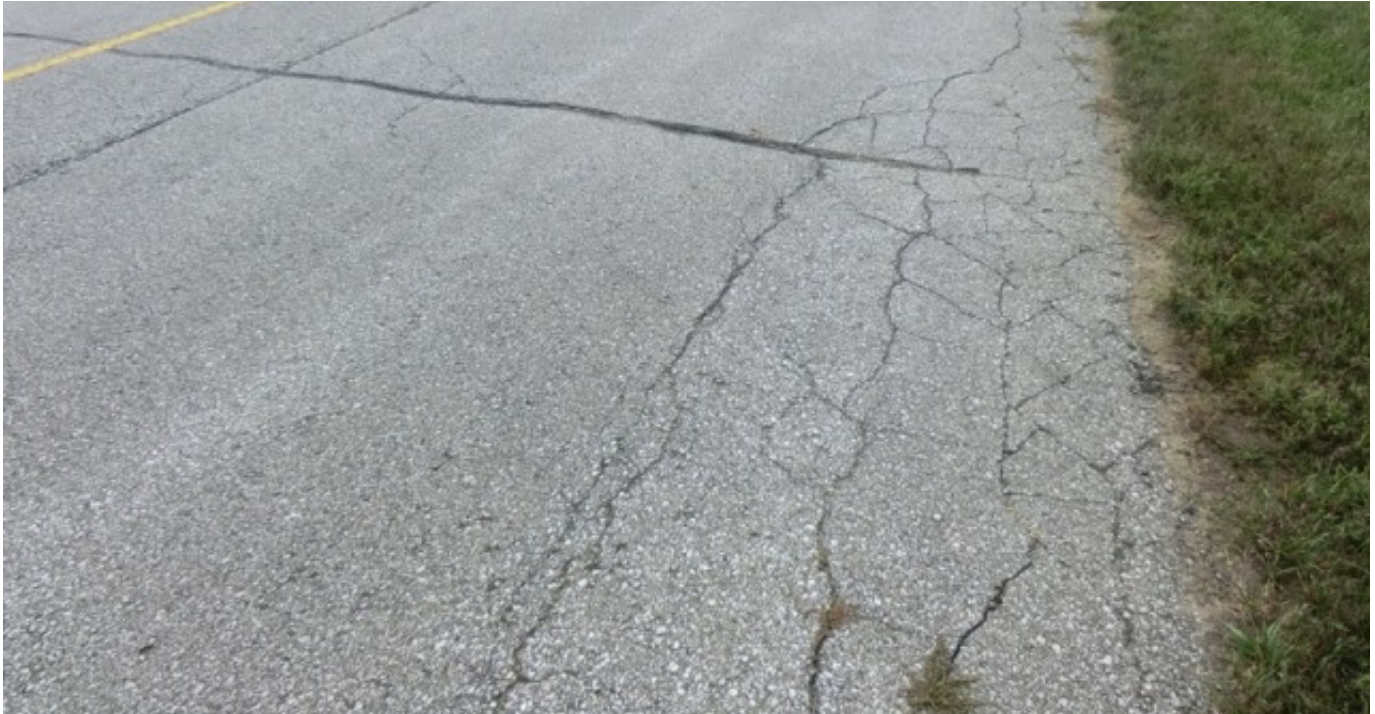
DISTRESS TYPE	SEVERITY	MEASURED QUANTITY	ESTIMATED TOTAL QUANTITY	UNITS	PERCENTAGE OF ALL DISTRESS
ALLIGATOR CRACKING	MED	66	107	S.F.	17.1
LONG.& TRANS. CRACK	HIGH	39	63	L.F.	14.5
LONG.& TRANS. CRACK	MED	702	1,140	L.F.	42.2
LONG.& TRANS. CRACK	LOW	499	810	L.F.	19.7
RAVELING	MED	81	131	S.F.	5.3
WEATHERING	MED	160	259	S.F.	1

APPROXIMATE AMOUNT OF DISTRESS RELATED TO LOAD ON THE PAVEMENT IS:	17 %
APPROXIMATE AMOUNT OF DISTRESS RELATED TO MATERIALS PROBLEMS IN THE FEATURE IS:	53 %
APPROXIMATE AMOUNT OF DISTRESS RELATED TO AGE OF PAVEMENT AND TRAFFIC REPETITIONS IS:	30 %

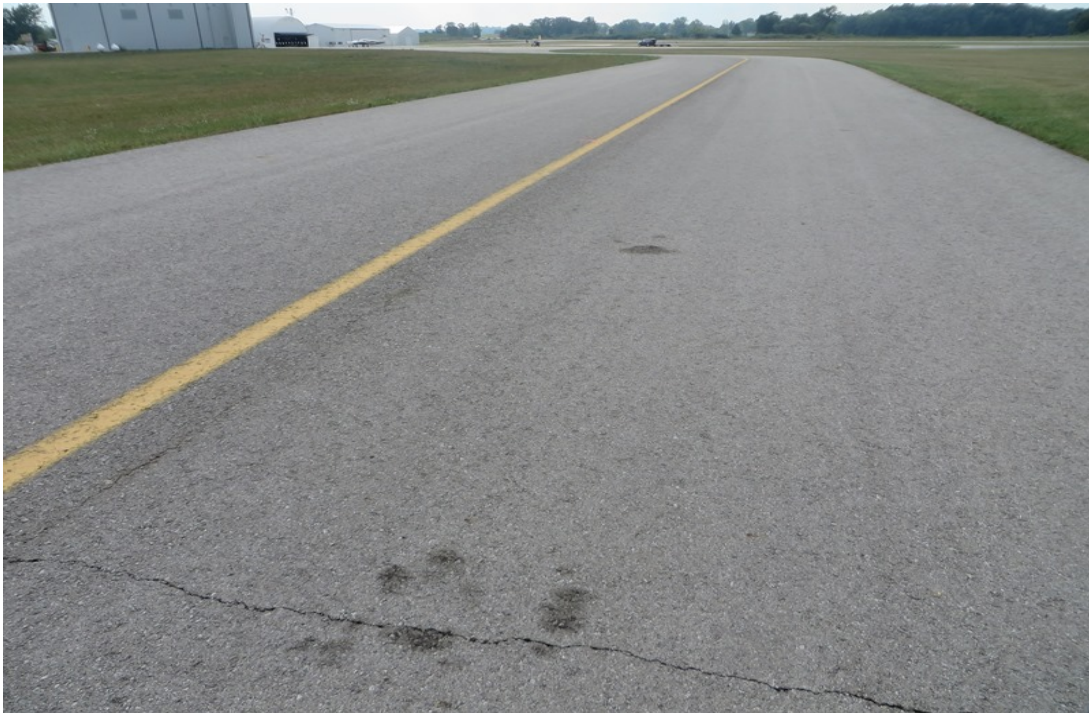
DISTRESS TYPE	SEVERITY	MEASURED QUANTITY	ESTIMATED TOTAL QUANTITY	UNITS	PERCENTAGE OF All DISTRESS
LONG.& TRANS. CRACK	LOW	189	435	L.F.	100

APPROXIMATE AMOUNT OF DISTRESS RELATED TO LOAD ON THE PAVEMENT IS:	0 %
APPROXIMATE AMOUNT OF DISTRESS RELATED TO MATERIALS PROBLEMS IN THE FEATURE IS:	67 %
APPROXIMATE AMOUNT OF DISTRESS RELATED TO AGE OF PAVEMENT AND TRAFFIC REPETITIONS IS:	33 %

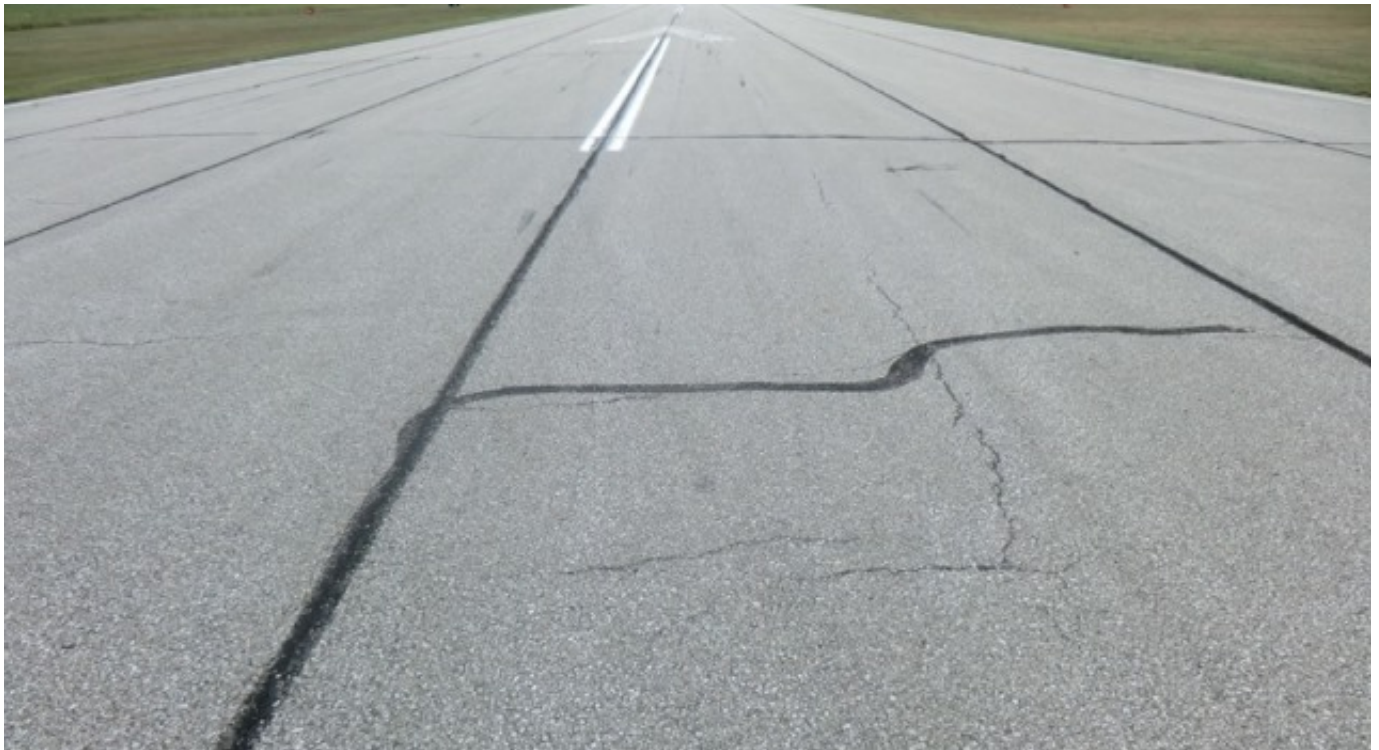
DISTRESS TYPE	SEVERITY	MEASURED QUANTITY	ESTIMATED TOTAL QUANTITY	UNITS	PERCENTAGE OF All DISTRESS
ALLIGATOR CRACKING	LOW	82	181	S.F.	17.2
LONG.& TRANS. CRACK	MED	695	1,539	L.F.	40.9
LONG.& TRANS. CRACK	LOW	1,591	3,523	L.F.	41.2
WEATHERING	MED	100	221	S.F.	.5

APPROXIMATE AMOUNT OF DISTRESS RELATED TO LOAD ON THE PAVEMENT IS:	17 %
APPROXIMATE AMOUNT OF DISTRESS RELATED TO MATERIALS PROBLEMS IN THE FEATURE IS:	55 %
APPROXIMATE AMOUNT OF DISTRESS RELATED TO AGE OF PAVEMENT AND TRAFFIC REPETITIONS IS:	28 %

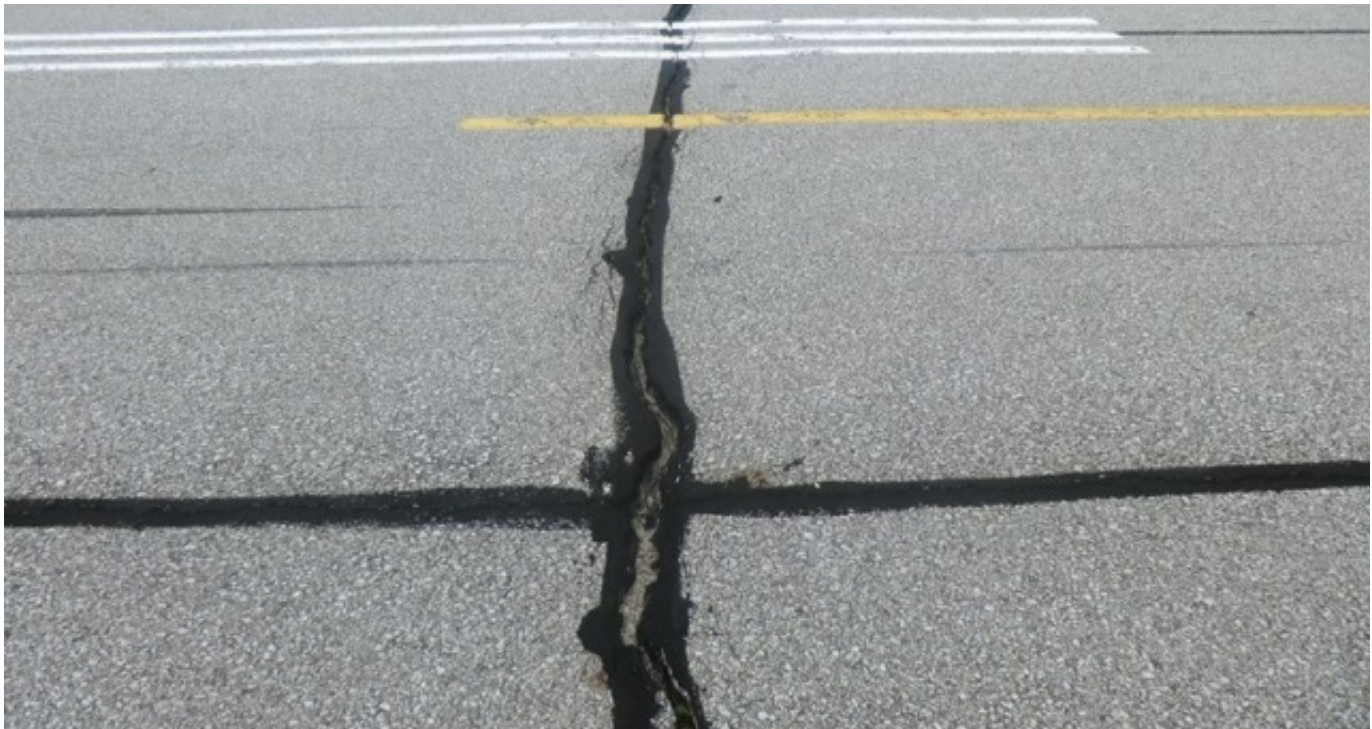
DISTRESS TYPE	SEVERITY	MEASURED QUANTITY	ESTIMATED TOTAL QUANTITY	UNITS	PERCENTAGE OF ALL DISTRESS
LONG.& TRANS. CRACK	HIGH	85	460	L.F.	6.1
LONG.& TRANS. CRACK	MED	2,037	11,043	L.F.	41.8
LONG.& TRANS. CRACK	LOW	6,451	34,973	L.F.	50.7
RAVELING	LOW	10	54	S.F.	.2
WEATHERING	MED	525	2,846	S.F.	1

APPROXIMATE AMOUNT OF DISTRESS RELATED TO LOAD ON THE PAVEMENT IS:	0 %
APPROXIMATE AMOUNT OF DISTRESS RELATED TO MATERIALS PROBLEMS IN THE FEATURE IS:	66 %
APPROXIMATE AMOUNT OF DISTRESS RELATED TO AGE OF PAVEMENT AND TRAFFIC REPETITIONS IS:	34 %
