Pavement Condition Report

Jeffersonville-Clark Regional Airport

Project 1480370

January 2014

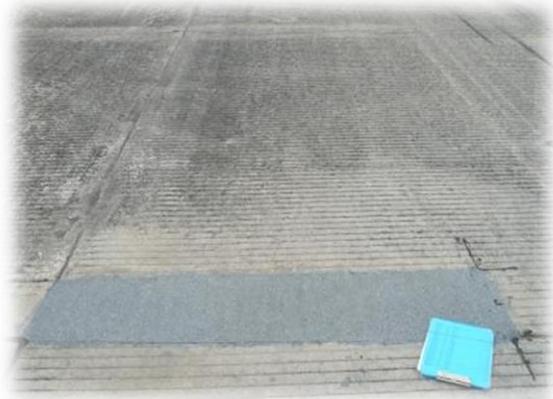
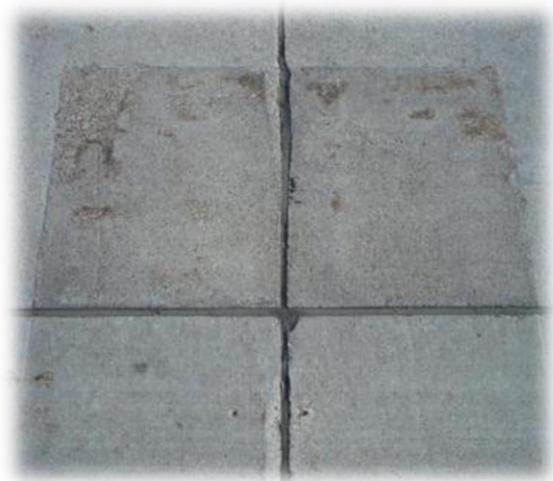
Patches, Large and Small

Large and small patches, by PCI inspection criteria, are distress conditions. Patches indicate deterioration and aging of pavement that contributes to shortened service life. However, patching also indicates that pavement is being maintained.

A patch that is performing well and shows no outward distress is recorded at low severity, and no corrective action is required. Medium-severity patches are serviceable but are beginning to deteriorate. Maintenance or replacement is indicated. At high severity, replacement is indicated.

By definition, small patches are smaller than 5 square feet in surface area, and they usually result from spall repair at slab joints and corners.

Large patches also may be the result of spall repair, but they often indicate more serious deficiencies, such as corner breaks or other full-depth failure smaller than panel size.

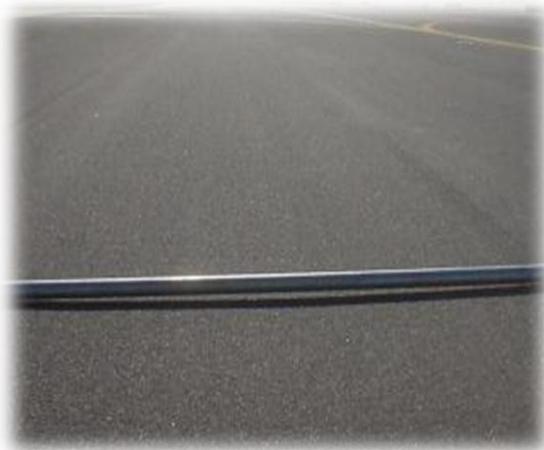
Ruts are localized areas of pavement having elevations lower than the surrounding sections.

Rutting is due to base and subgrade consolidation caused by excessive wheel loads or poor compaction. Ruts indicate structural failure and can cause hydroplaning.

At low severity, ruts have an average depth of ¼ to ½ inches. At medium severity, ruts have an average depth of ½ to 1 inch. At high severity, ruts have an average depth greater than 1 inch. Patching is the appropriate repair for ruts.
