Pavement Condition Report

Clinton Airport

Project 15805741

February 2015

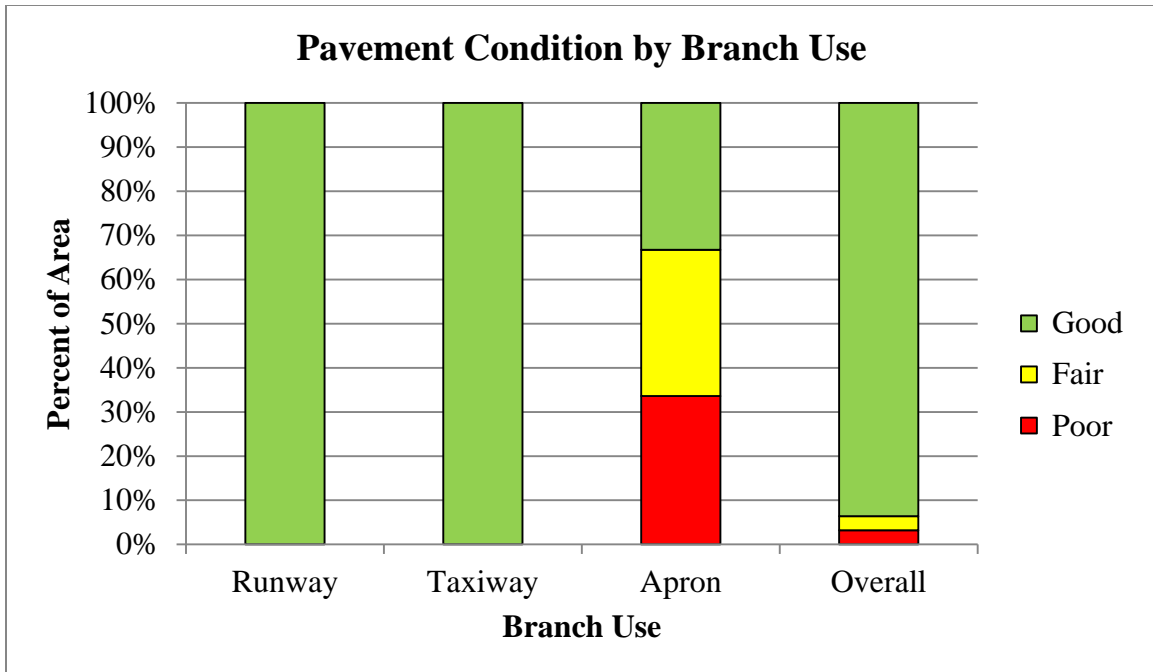
Figure 2-2. Pavement Condition by Branch Use

The average inspected Pavement Condition Index (PCI) for all the airfield pavements was 75. Runways had an average inspected PCI of 77 and were above the desired MSL of 60. Taxiways had an average inspected PCI of 78, and ramps had an average inspected PCI of 51.

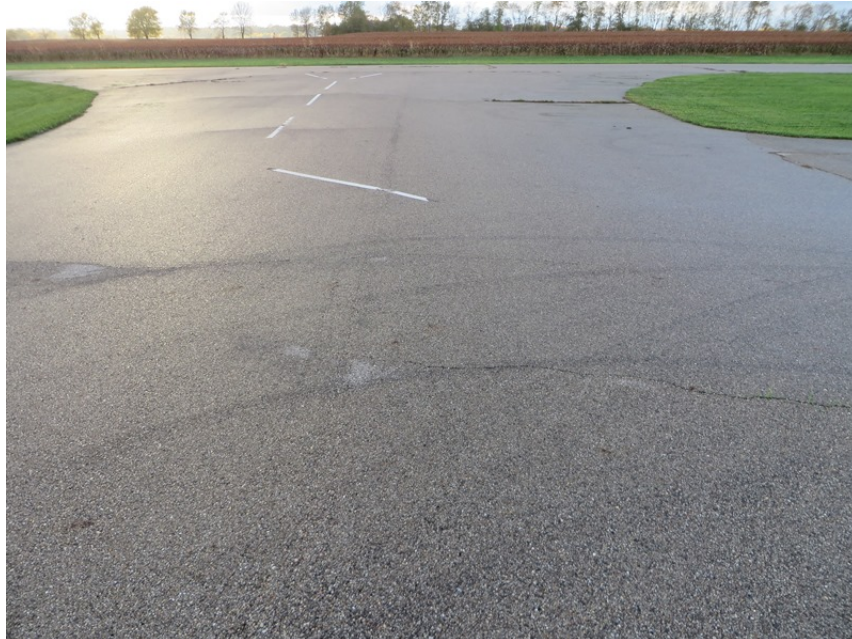
DISTRESS TYPE	SEVERITY	MEASURED QUANTITY	ESTIMATED TOTAL QUANTITY	UNITS	PERCENTAGE OF All DISTRESS
ALLIGATOR CRACKING	MED	1	1	S.F.	33.1
LONG.& TRANS. CRACK	MED	66	89	L.F.	38.6
LONG.& TRANS. CRACK	LOW	135	182	L.F.	28.2

APPROXIMATE AMOUNT OF DISTRESS RELATED TO LOAD ON THE PAVEMENT IS:	33 %
APPROXIMATE AMOUNT OF DISTRESS RELATED TO MATERIALS PROBLEMS IN THE FEATURE IS:	45 %
APPROXIMATE AMOUNT OF DISTRESS RELATED TO AGE OF PAVEMENT AND TRAFFIC REPETITIONS IS:	22 %

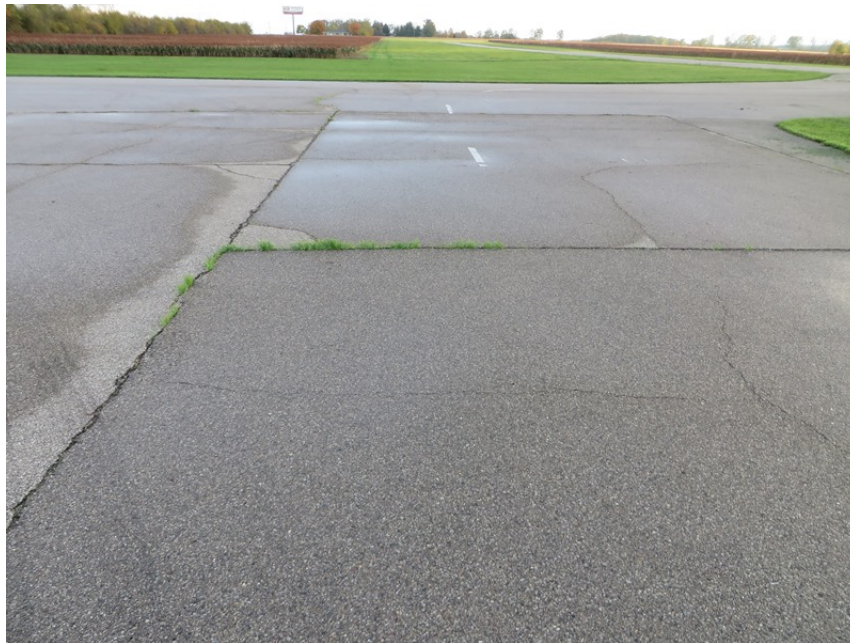
DISTRESS TYPE	SEVERITY	MEASURED QUANTITY	ESTIMATED TOTAL QUANTITY	UNITS	PERCENTAGE OF All DISTRESS
LONG.& TRANS. CRACK	MED	444	444	L.F.	65.8
LONG.& TRANS. CRACK	LOW	350	350	L.F.	34.1

APPROXIMATE AMOUNT OF DISTRESS RELATED TO LOAD ON THE PAVEMENT IS:	0 %
APPROXIMATE AMOUNT OF DISTRESS RELATED TO MATERIALS PROBLEMS IN THE FEATURE IS:	67 %
APPROXIMATE AMOUNT OF DISTRESS RELATED TO AGE OF PAVEMENT AND TRAFFIC REPETITIONS IS:	33 %

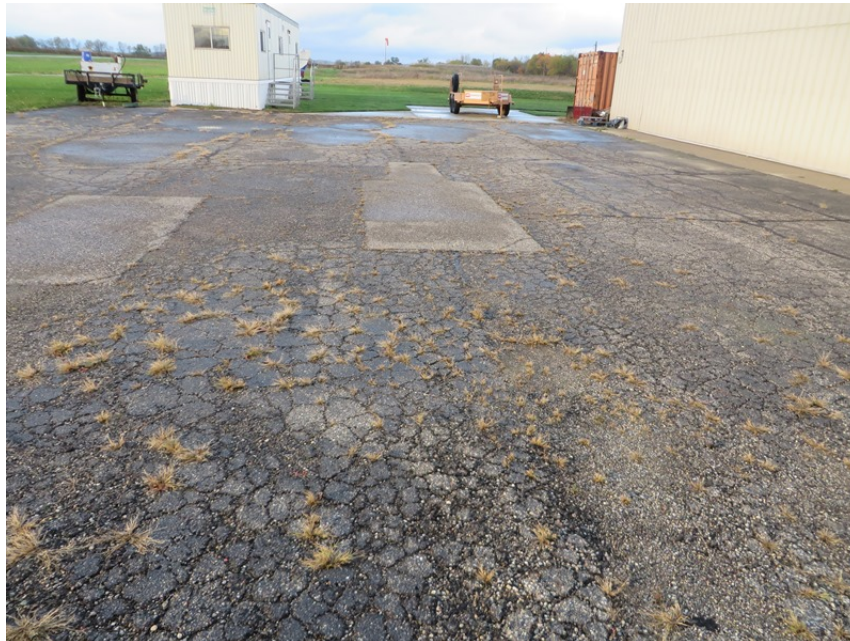
DISTRESS TYPE	SEVERITY	MEASURED QUANTITY	ESTIMATED TOTAL QUANTITY	UNITS	PERCENTAGE OF All DISTRESS
ALLIGATOR CRACKING	HIGH	150	203	S.F.	37.4
ALLIGATOR CRACKING	MED	1,800	2,442	S.F.	54.2
PATCH & UTILITY CUT	LOW	260	352	S.F.	8.3

APPROXIMATE AMOUNT OF DISTRESS RELATED TO LOAD ON THE PAVEMENT IS:	97 %
APPROXIMATE AMOUNT OF DISTRESS RELATED TO MATERIALS PROBLEMS IN THE FEATURE IS:	3 %
APPROXIMATE AMOUNT OF DISTRESS RELATED TO AGE OF PAVEMENT AND TRAFFIC REPETITIONS IS:	0 %

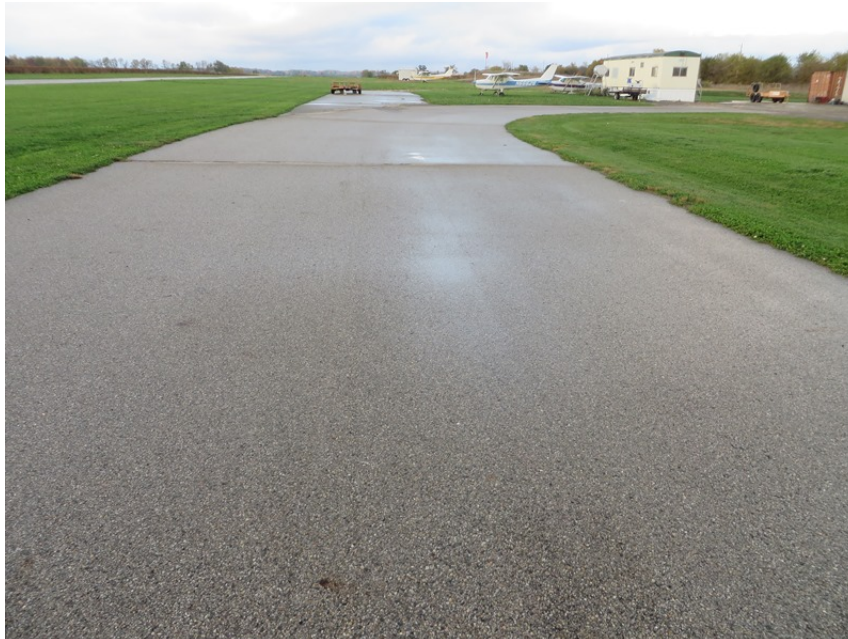
DISTRESS TYPE	SEVERITY	MEASURED QUANTITY	ESTIMATED TOTAL QUANTITY	UNITS	PERCENTAGE OF All DISTRESS
ALLIGATOR CRACKING	MED	14	15	S.F.	47.8
LONG.& TRANS. CRACK	MED	24	26	L.F.	30.4
LONG.& TRANS. CRACK	LOW	74	81	L.F.	21.7

APPROXIMATE AMOUNT OF DISTRESS RELATED TO LOAD ON THE PAVEMENT IS:	48 %
APPROXIMATE AMOUNT OF DISTRESS RELATED TO MATERIALS PROBLEMS IN THE FEATURE IS:	35 %
APPROXIMATE AMOUNT OF DISTRESS RELATED TO AGE OF PAVEMENT AND TRAFFIC REPETITIONS IS:	17 %

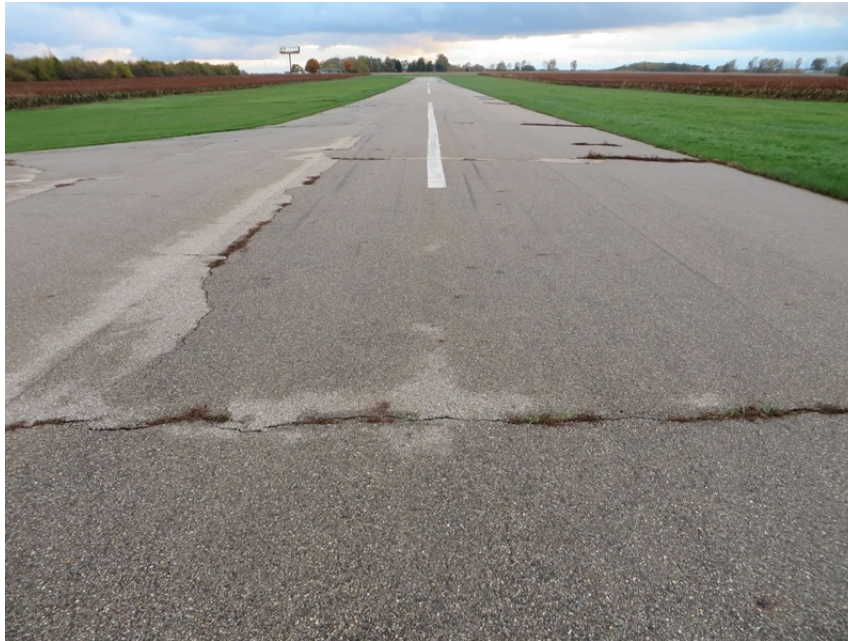
DISTRESS TYPE	SEVERITY	MEASURED QUANTITY	ESTIMATED TOTAL QUANTITY	UNITS	PERCENTAGE OF All DISTRESS
LONG.& TRANS. CRACK	HIGH	50	183	L.F.	17.7
LONG.& TRANS. CRACK	MED	970	3,561	L.F.	52.3
LONG.& TRANS. CRACK	LOW	1,190	4,369	L.F.	29.8

APPROXIMATE AMOUNT OF DISTRESS RELATED TO LOAD ON THE PAVEMENT IS:	0 %
APPROXIMATE AMOUNT OF DISTRESS RELATED TO MATERIALS PROBLEMS IN THE FEATURE IS:	67 %
APPROXIMATE AMOUNT OF DISTRESS RELATED TO AGE OF PAVEMENT AND TRAFFIC REPETITIONS IS:	33 %
