# Pavement Condition Report

## Indianapolis - Eagle Creek Airpark

Project 1480370

**January 2014**

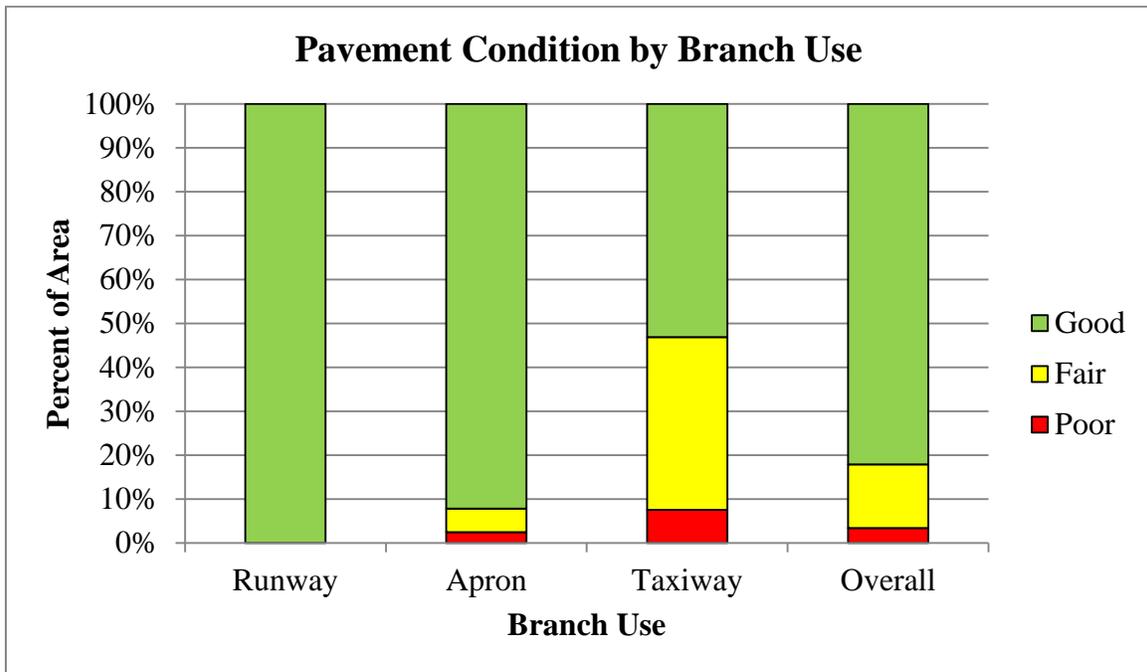
Figure 2-2. Pavement Condition by Branch Use

The pavement within each of the PCI condition categories is shown in Figure 2-1. The inspected PCI is summarized by branch use in Figure 2-2, and the photographs in Figure 2-3 through Figure 2-7 provide examples of the condition categories.

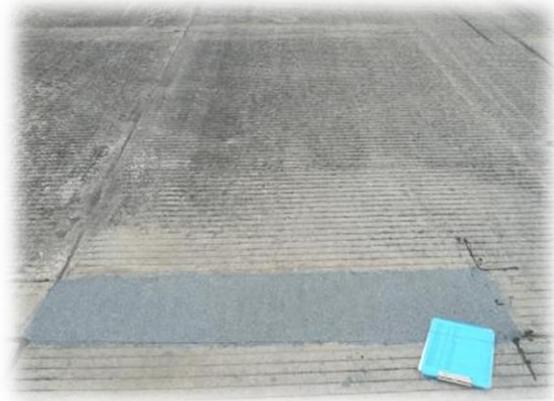
### *Patches, Large and Small*

Large and small patches, by PCI inspection criteria, are distress conditions. Patches indicate deterioration and aging of pavement that contributes to shortened service life. However, patching also indicates that pavement is being maintained.

A patch that is performing well and shows no outward distress is recorded at low severity, and no corrective action is required. Medium-severity patches are serviceable but are beginning to deteriorate. Maintenance or replacement is indicated. At high severity, replacement is indicated.

By definition, small patches are smaller than 5 square feet in surface area, and they usually result from spall repair at slab joints and corners.

Large patches also may be the result of spall repair, but they often indicate more serious deficiencies, such as corner breaks or other full-depth failure smaller than panel size.

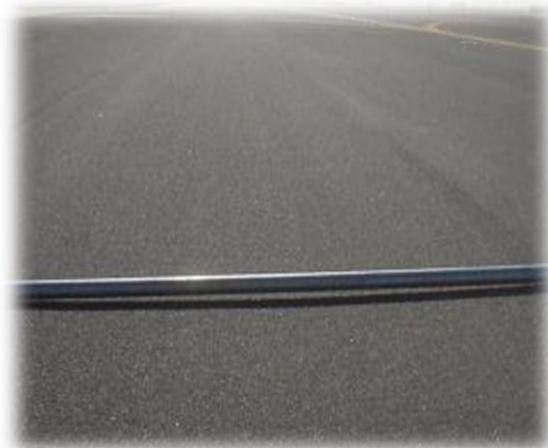
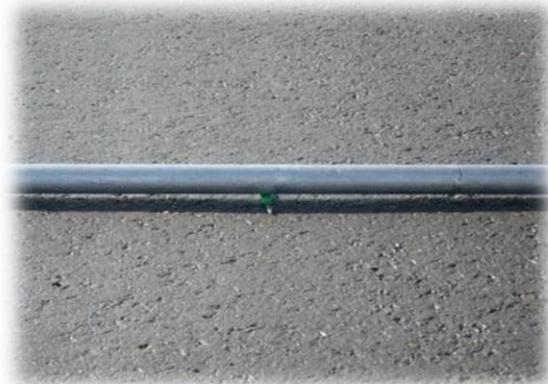
### Rutting

Ruts are localized areas of pavement having elevations lower than the surrounding sections.

Rutting is due to base and subgrade consolidation caused by excessive wheel loads or poor compaction. Ruts indicate structural failure and can cause hydroplaning.

At low severity, ruts have an average depth of ¼ to ½ inches. At medium severity, ruts have an average depth of ½ to 1 inch. At high severity, ruts have an average depth greater than 1 inch. Patching is the appropriate repair for ruts.
