Pavement Condition Report

Goshen Municipal Airport

Project 15805741

February 2015

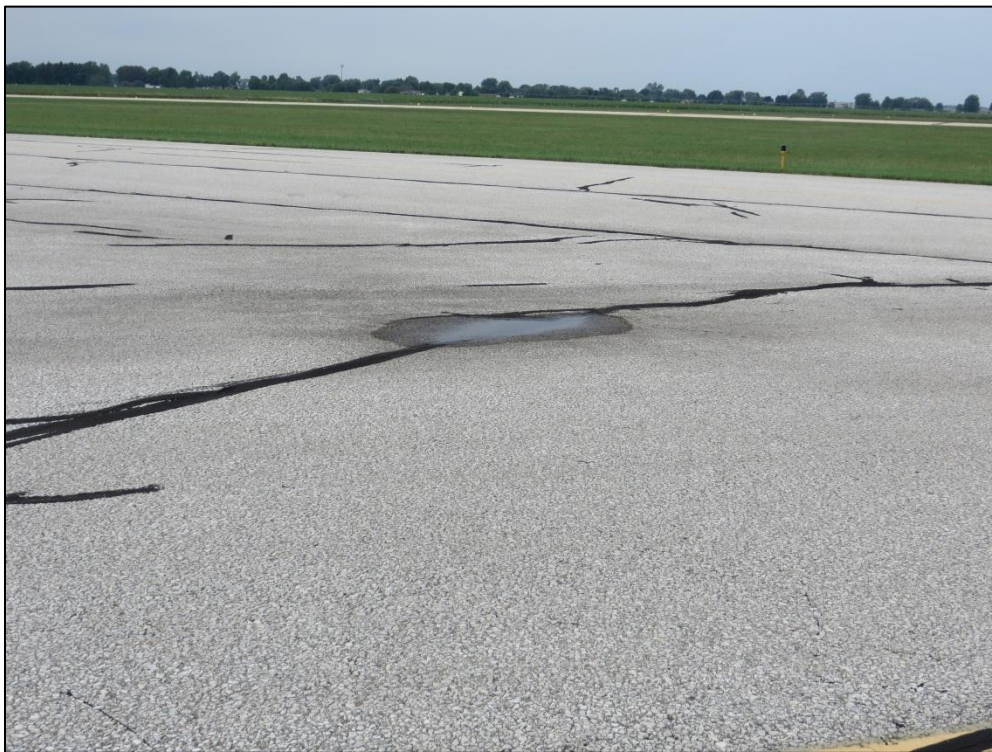
Figure 2-7. Typical Very Poor AC Pavement (Feature 120)

The PCI for feature 120 increased by 13 points. Upon further review, it was determined that the 2011 average PCI value of 25 was incorrect due to a data entry error. This error did not have any impact on the CIP recommendations.

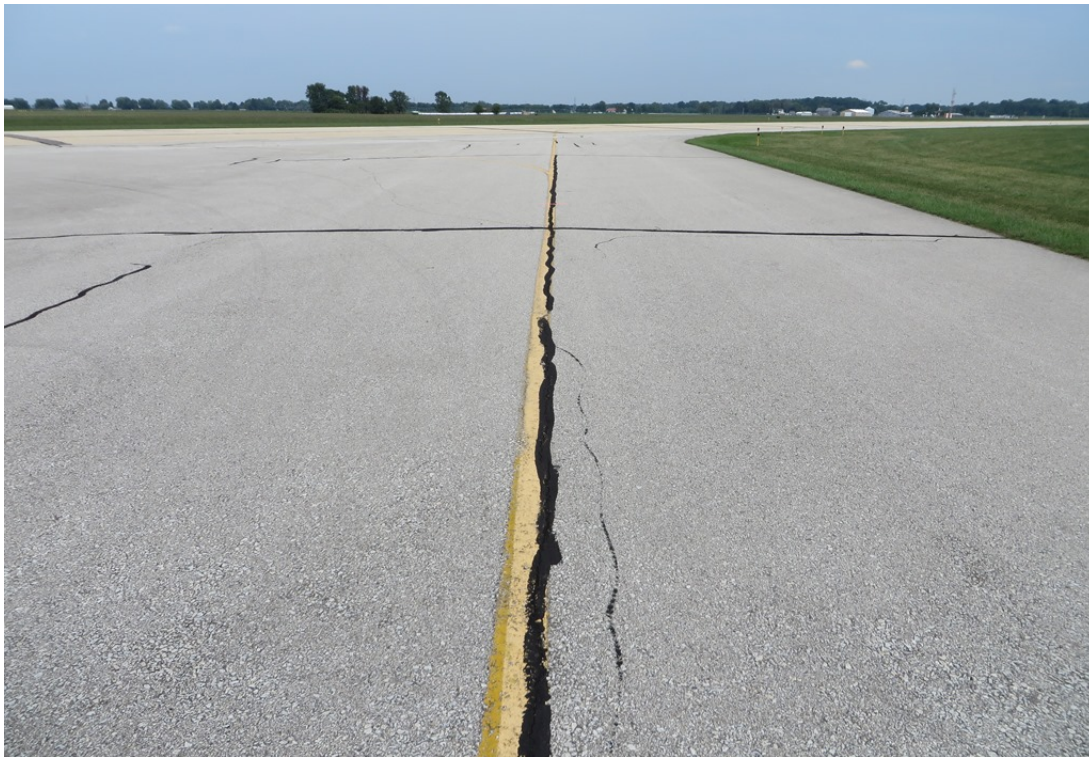
APPROXIMATE AMOUNT OF DISTRESS RELATED TO LOAD ON THE PAVEMENT IS:	0 %
APPROXIMATE AMOUNT OF DISTRESS RELATED TO MATERIALS PROBLEMS IN THE FEATURE IS:	67 %
APPROXIMATE AMOUNT OF DISTRESS RELATED TO AGE OF PAVEMENT AND TRAFFIC REPETITIONS IS:	33 %

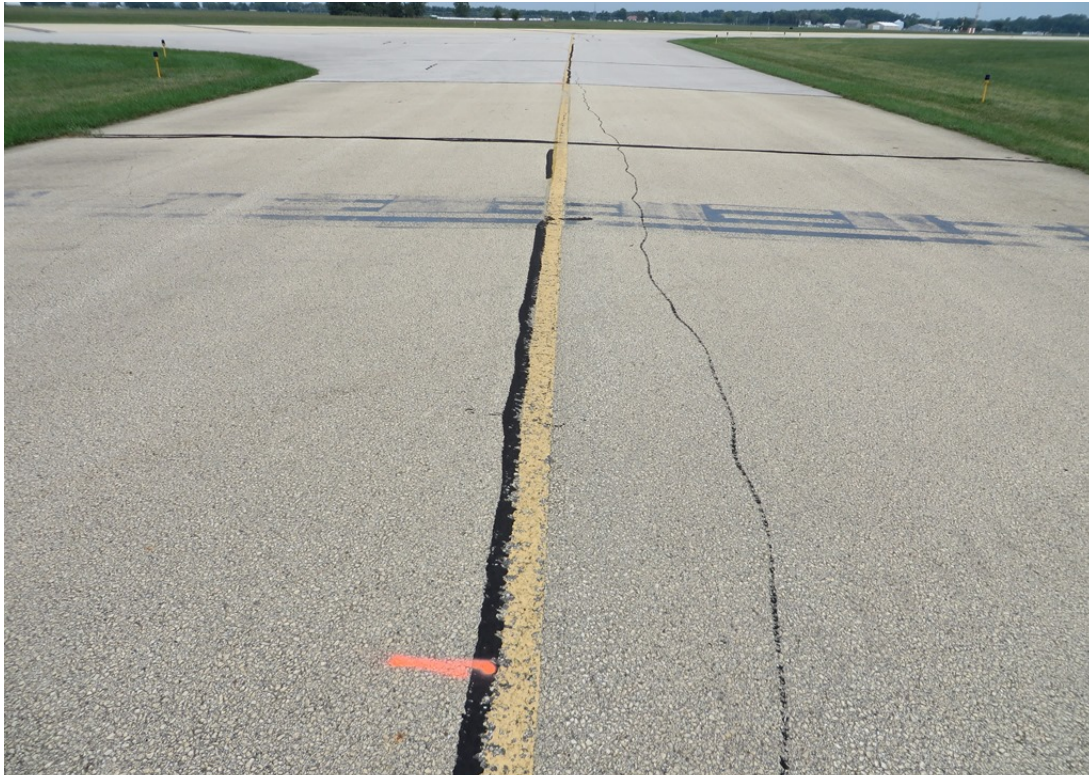
APPROXIMATE AMOUNT OF DISTRESS RELATED TO LOAD ON THE PAVEMENT IS:	0 %
APPROXIMATE AMOUNT OF DISTRESS RELATED TO MATERIALS PROBLEMS IN THE FEATURE IS:	67 %
APPROXIMATE AMOUNT OF DISTRESS RELATED TO AGE OF PAVEMENT AND TRAFFIC REPETITIONS IS:	33 %

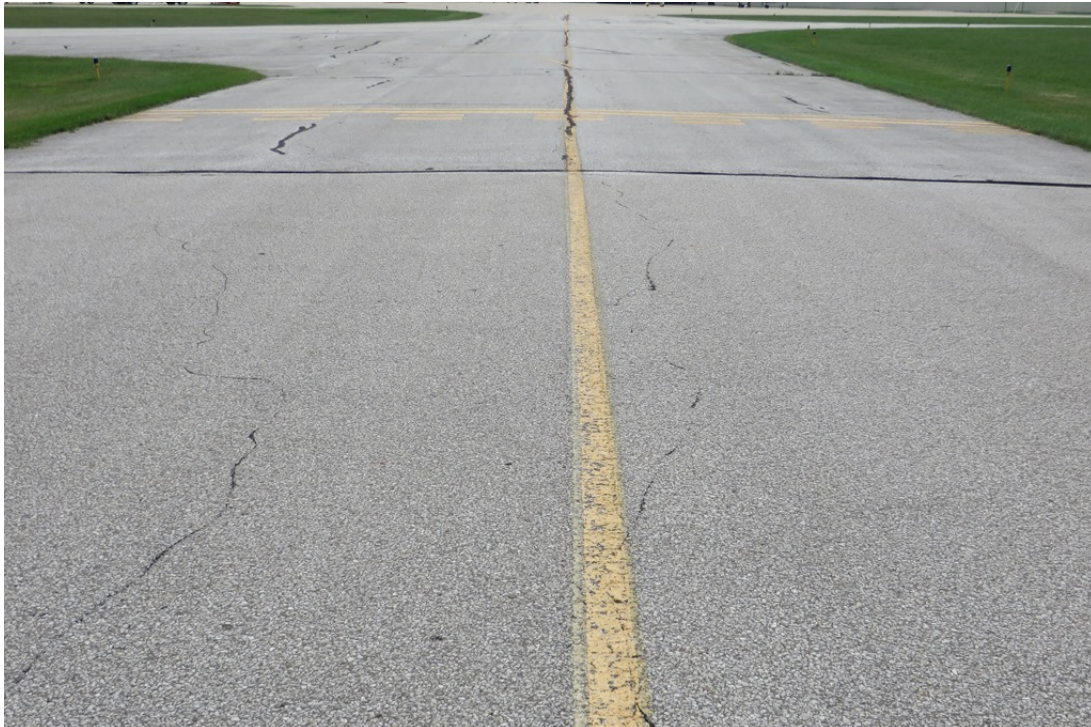
APPROXIMATE AMOUNT OF DISTRESS RELATED TO LOAD ON THE PAVEMENT IS:	0 %
APPROXIMATE AMOUNT OF DISTRESS RELATED TO MATERIALS PROBLEMS IN THE FEATURE IS:	60 %
APPROXIMATE AMOUNT OF DISTRESS RELATED TO AGE OF PAVEMENT AND TRAFFIC REPETITIONS IS:	40 %

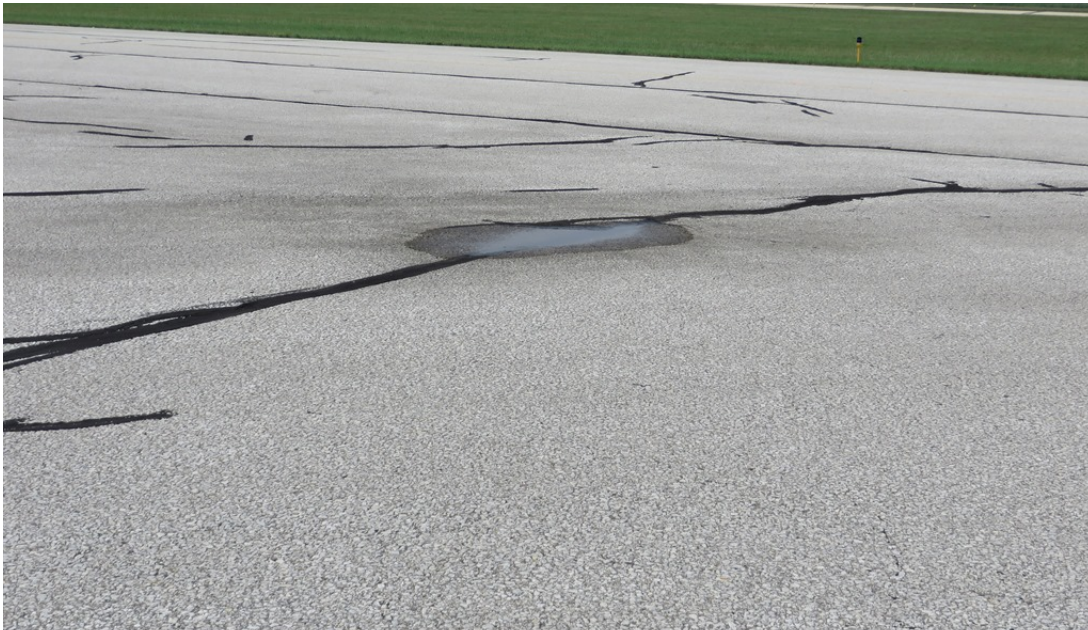
APPROXIMATE AMOUNT OF DISTRESS RELATED TO LOAD ON THE PAVEMENT IS:	56 %
APPROXIMATE AMOUNT OF DISTRESS RELATED TO MATERIALS PROBLEMS IN THE FEATURE IS:	33 %
APPROXIMATE AMOUNT OF DISTRESS RELATED TO AGE OF PAVEMENT AND TRAFFIC REPETITIONS IS:	11 %

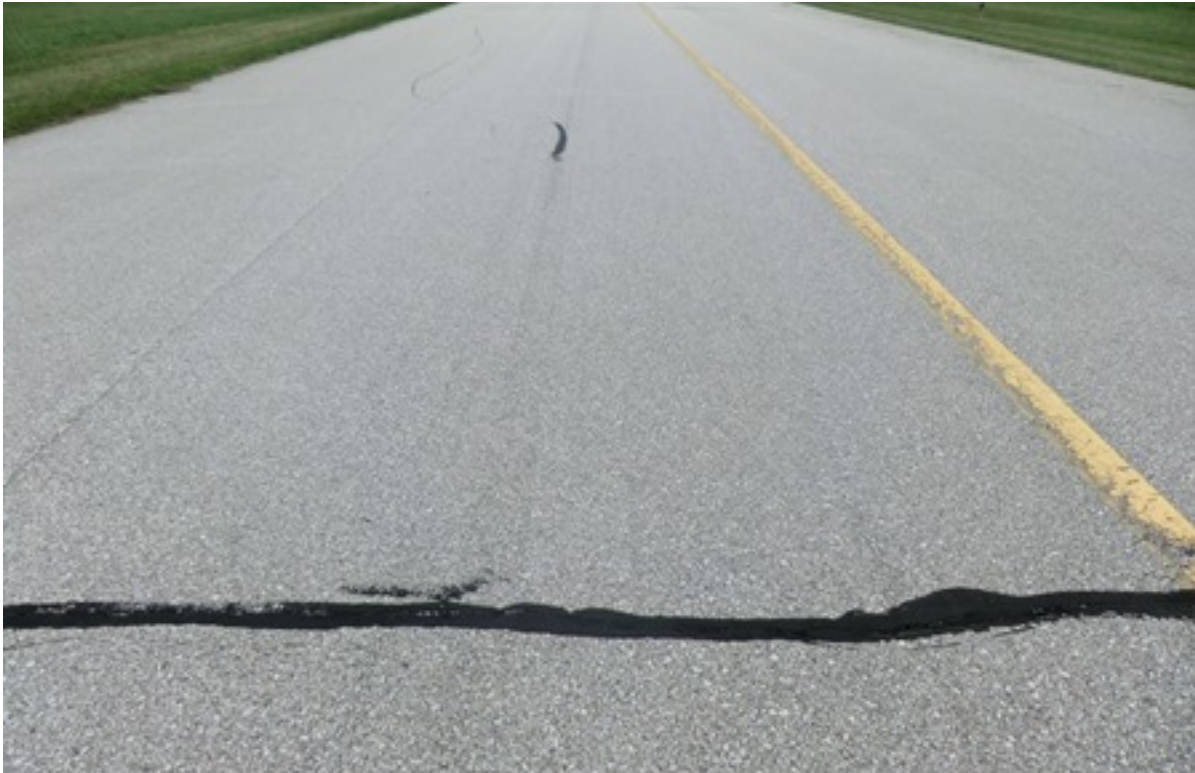
APPROXIMATE AMOUNT OF DISTRESS RELATED TO LOAD ON THE PAVEMENT IS: 0 %
 APPROXIMATE AMOUNT OF DISTRESS RELATED TO MATERIALS PROBLEMS IN THE FEATURE IS: 64 %
 APPROXIMATE AMOUNT OF DISTRESS RELATED TO AGE OF PAVEMENT AND TRAFFIC REPETITIONS IS: 36 %

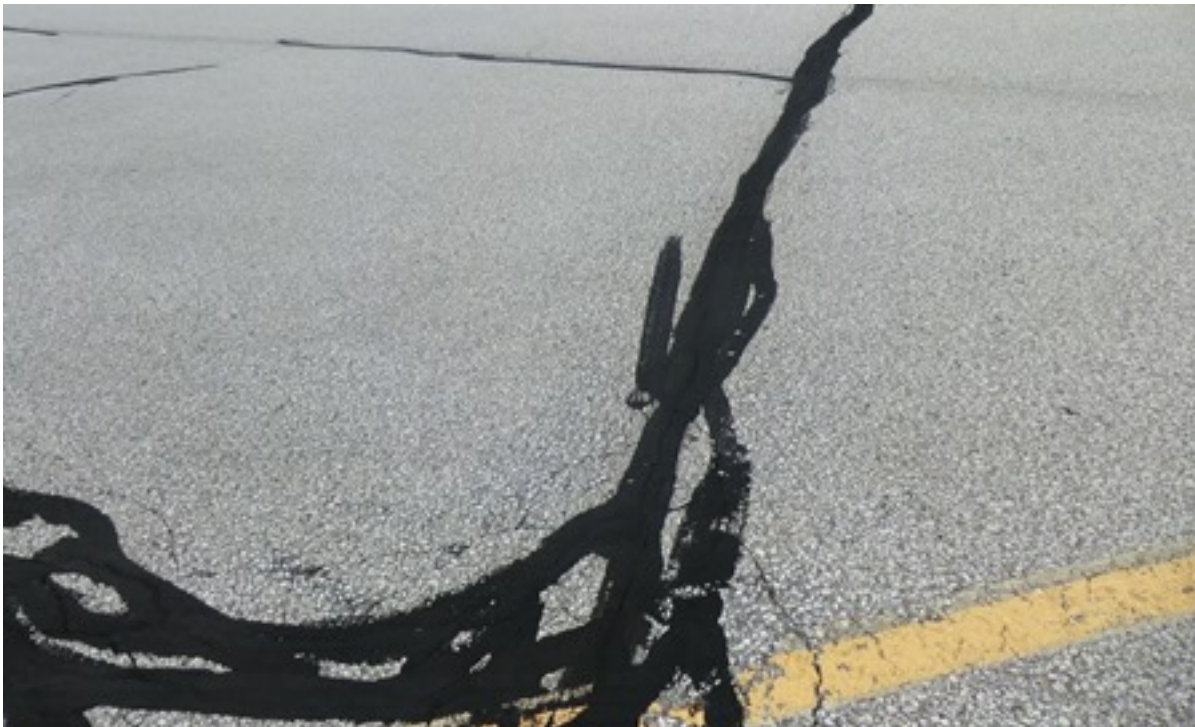
APPROXIMATE AMOUNT OF DISTRESS RELATED TO LOAD ON THE PAVEMENT IS:	39 %
APPROXIMATE AMOUNT OF DISTRESS RELATED TO MATERIALS PROBLEMS IN THE FEATURE IS:	39 %
APPROXIMATE AMOUNT OF DISTRESS RELATED TO AGE OF PAVEMENT AND TRAFFIC REPETITIONS IS:	22 %

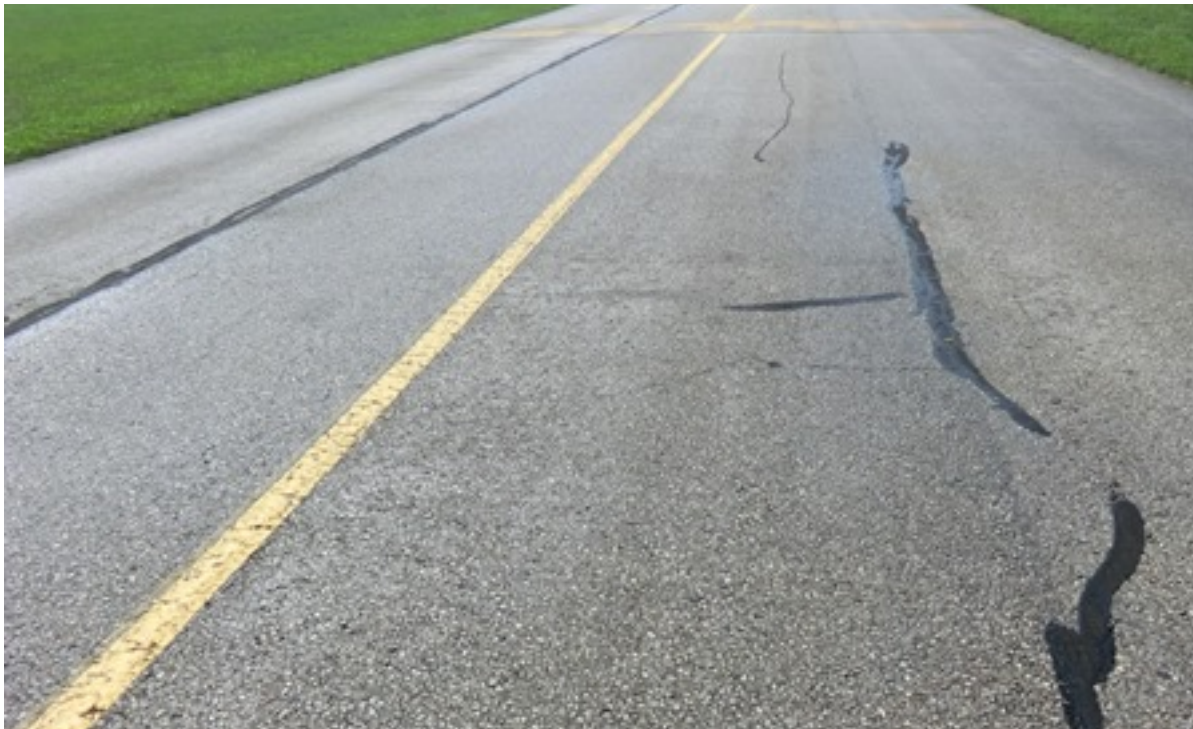
APPROXIMATE AMOUNT OF DISTRESS RELATED TO LOAD ON THE PAVEMENT IS:	18 %
APPROXIMATE AMOUNT OF DISTRESS RELATED TO MATERIALS PROBLEMS IN THE FEATURE IS:	54 %
APPROXIMATE AMOUNT OF DISTRESS RELATED TO AGE OF PAVEMENT AND TRAFFIC REPETITIONS IS:	29 %

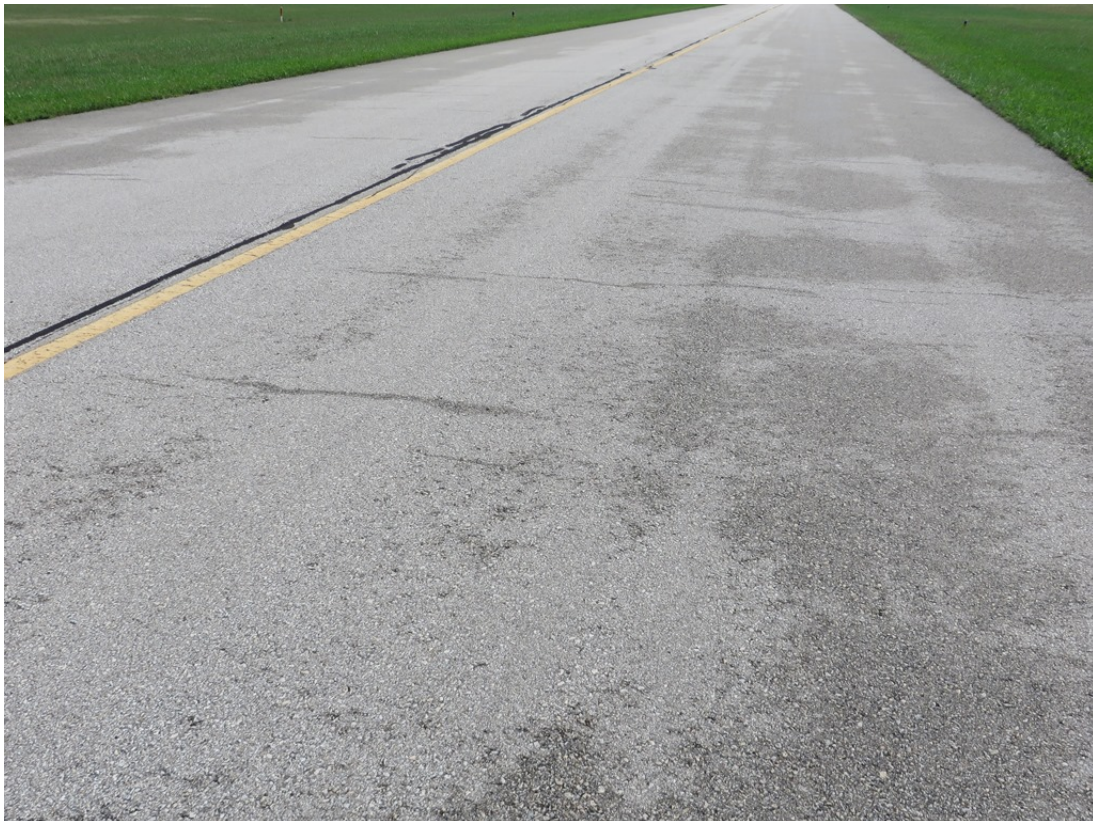
APPROXIMATE AMOUNT OF DISTRESS RELATED TO LOAD ON THE PAVEMENT IS:	0 %
APPROXIMATE AMOUNT OF DISTRESS RELATED TO MATERIALS PROBLEMS IN THE FEATURE IS:	67 %
APPROXIMATE AMOUNT OF DISTRESS RELATED TO AGE OF PAVEMENT AND TRAFFIC REPETITIONS IS:	33 %

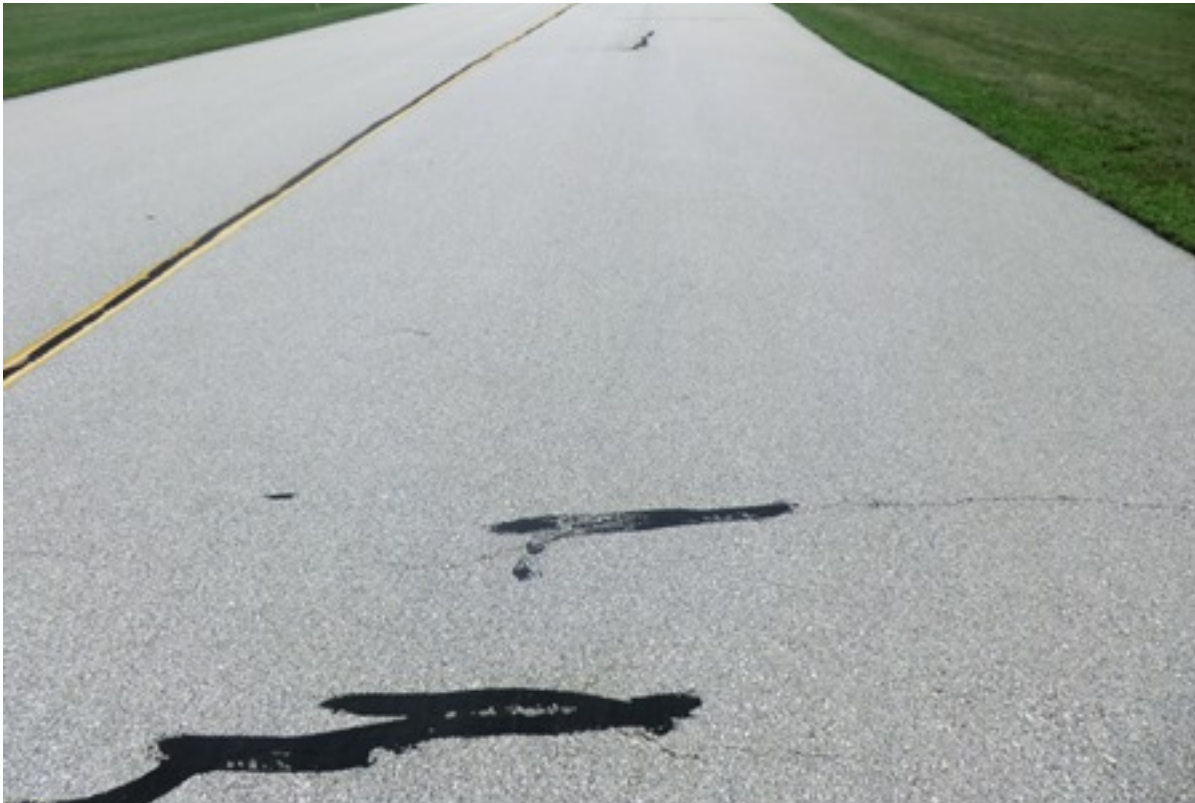
APPROXIMATE AMOUNT OF DISTRESS RELATED TO LOAD ON THE PAVEMENT IS:	0 %
APPROXIMATE AMOUNT OF DISTRESS RELATED TO MATERIALS PROBLEMS IN THE FEATURE IS:	66 %
APPROXIMATE AMOUNT OF DISTRESS RELATED TO AGE OF PAVEMENT AND TRAFFIC REPETITIONS IS:	34 %

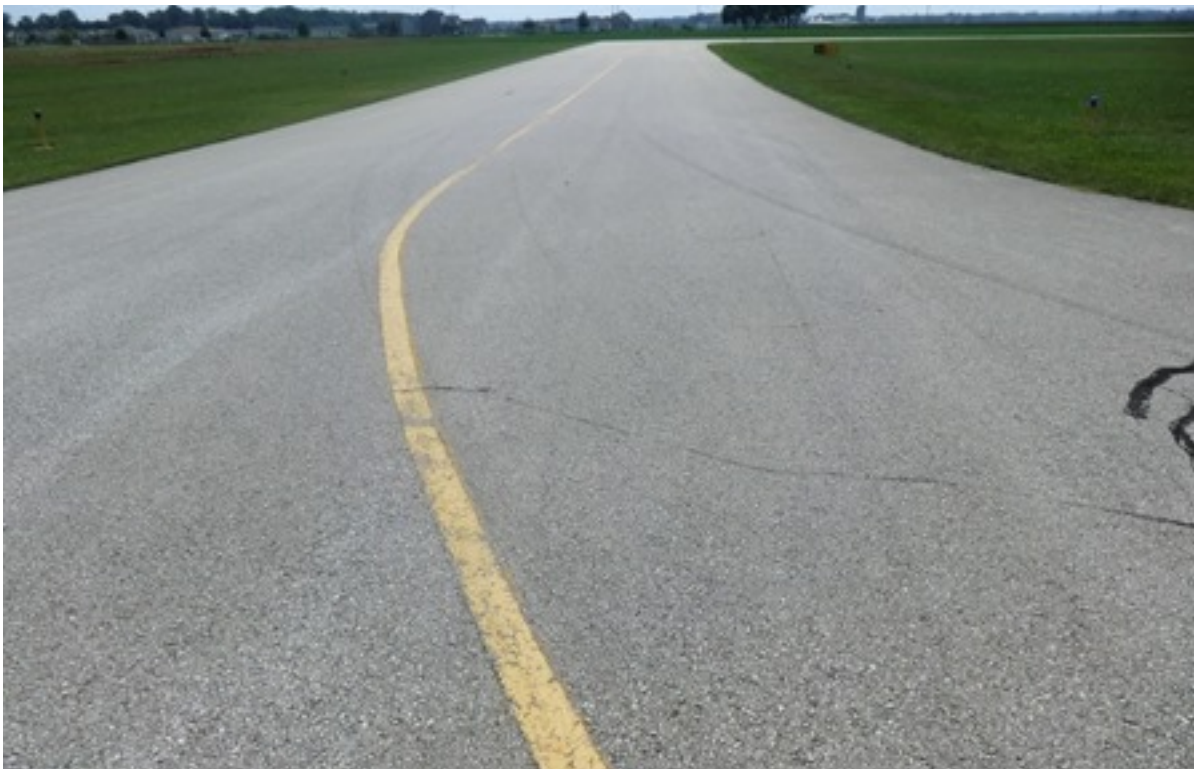
APPROXIMATE AMOUNT OF DISTRESS RELATED TO LOAD ON THE PAVEMENT IS:	0 %
APPROXIMATE AMOUNT OF DISTRESS RELATED TO MATERIALS PROBLEMS IN THE FEATURE IS:	65 %
APPROXIMATE AMOUNT OF DISTRESS RELATED TO AGE OF PAVEMENT AND TRAFFIC REPETITIONS IS:	35 %

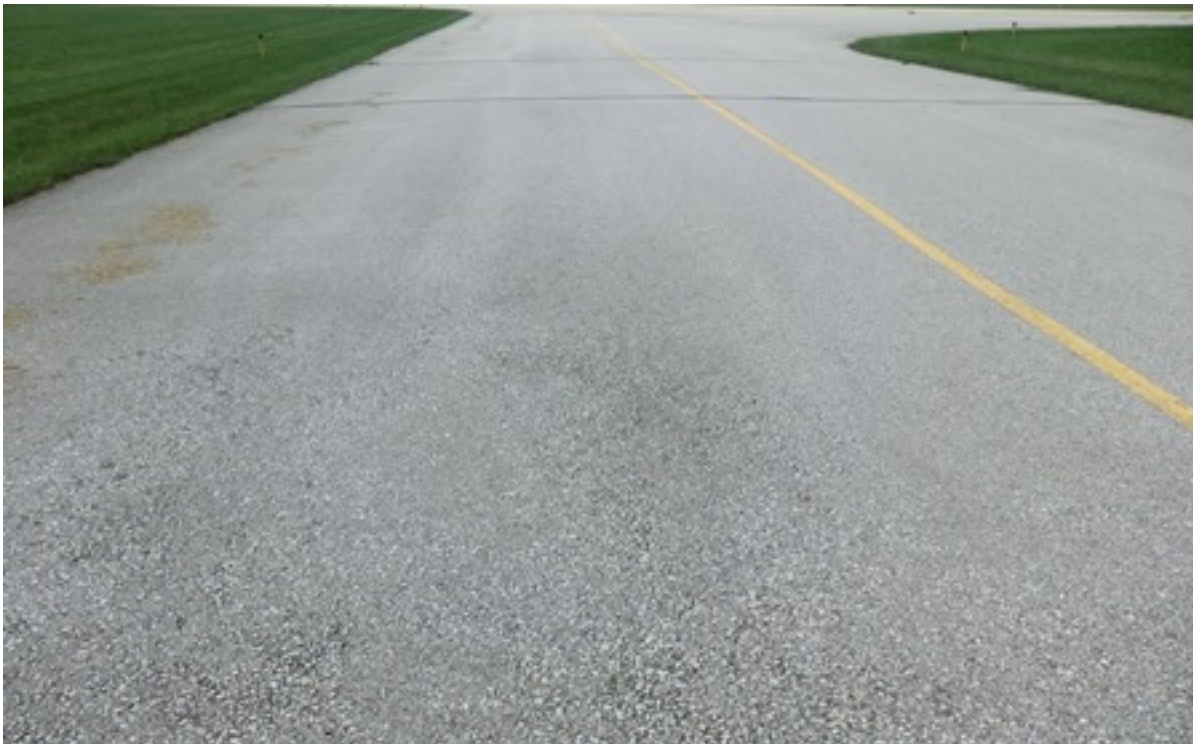
APPROXIMATE AMOUNT OF DISTRESS RELATED TO LOAD ON THE PAVEMENT IS:	0 %
APPROXIMATE AMOUNT OF DISTRESS RELATED TO MATERIALS PROBLEMS IN THE FEATURE IS:	57 %
APPROXIMATE AMOUNT OF DISTRESS RELATED TO AGE OF PAVEMENT AND TRAFFIC REPETITIONS IS:	43 %

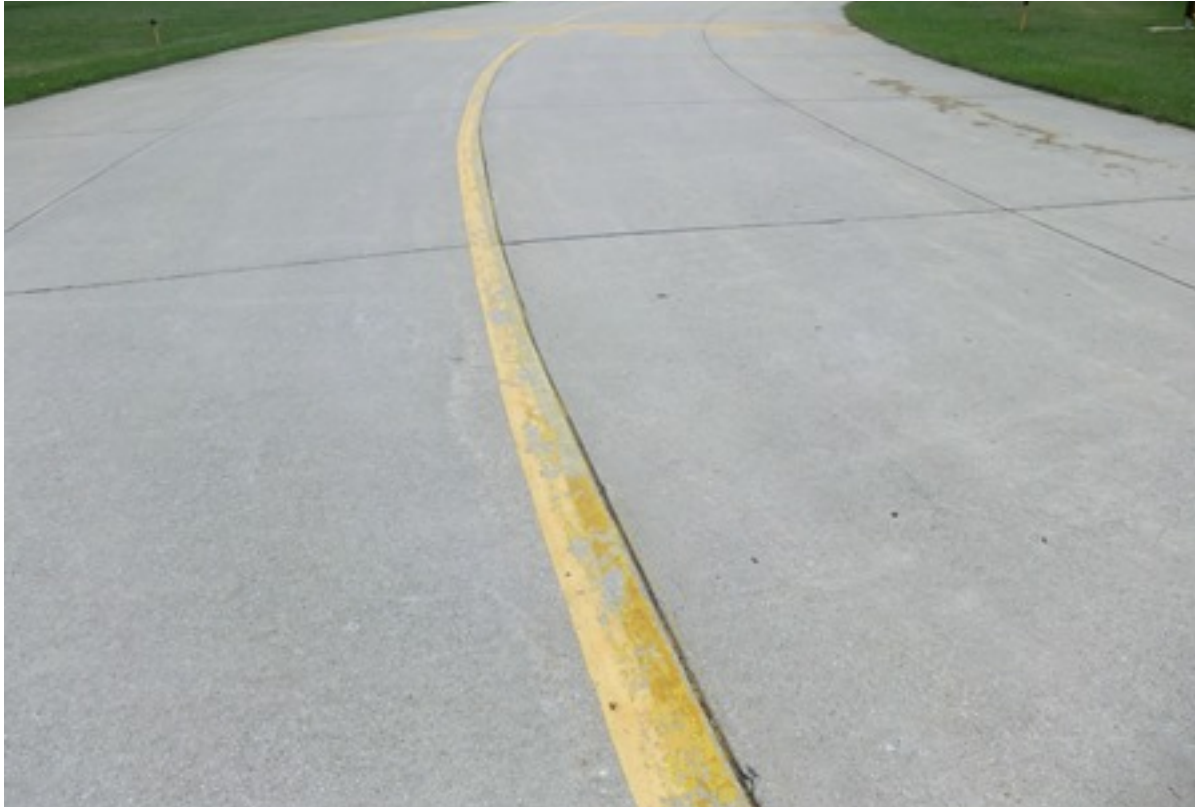
APPROXIMATE AMOUNT OF DISTRESS RELATED TO LOAD ON THE PAVEMENT IS:	67 %
APPROXIMATE AMOUNT OF DISTRESS RELATED TO MATERIALS PROBLEMS IN THE FEATURE IS:	0 %
APPROXIMATE AMOUNT OF DISTRESS RELATED TO AGE OF PAVEMENT AND TRAFFIC REPETITIONS IS:	33 %
