# Pavement Condition Report

## Griffith-Merrillville Airport

Project 15805741

**February 2015**

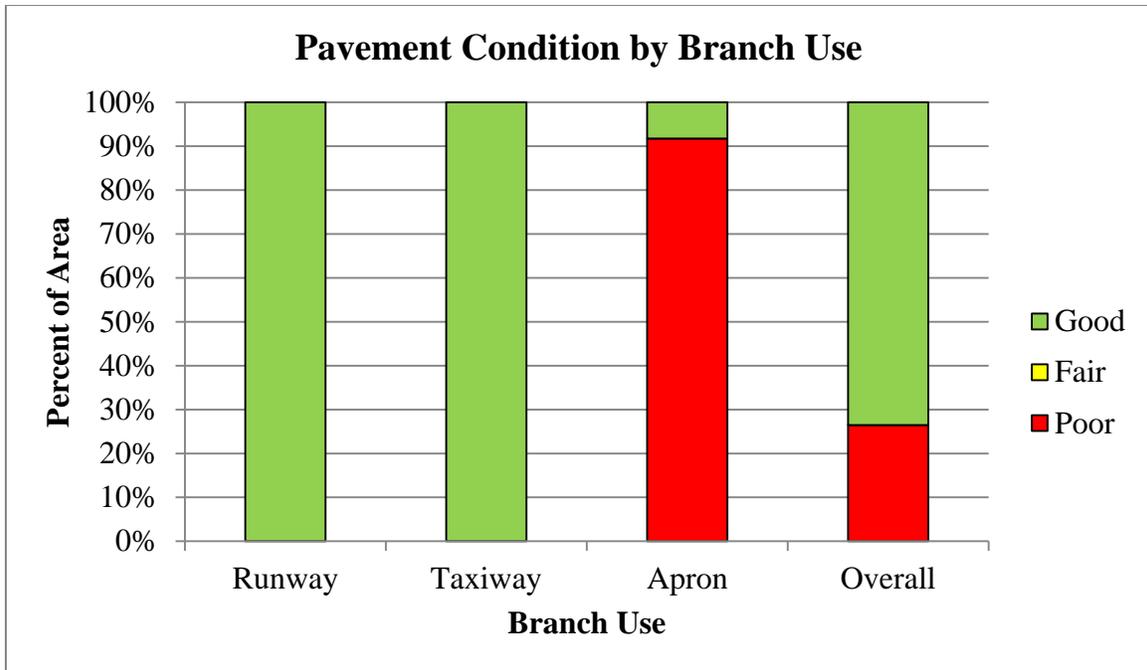
Figure 2-2. Pavement Condition by Branch Use

The average inspected Pavement Condition Index (PCI) for all the airfield pavements was 69. Runways had an average inspected PCI of 77 and were above the desired MSL of 60. Taxiways had an average inspected PCI of 94, and ramps had an average inspected PCI of 36.

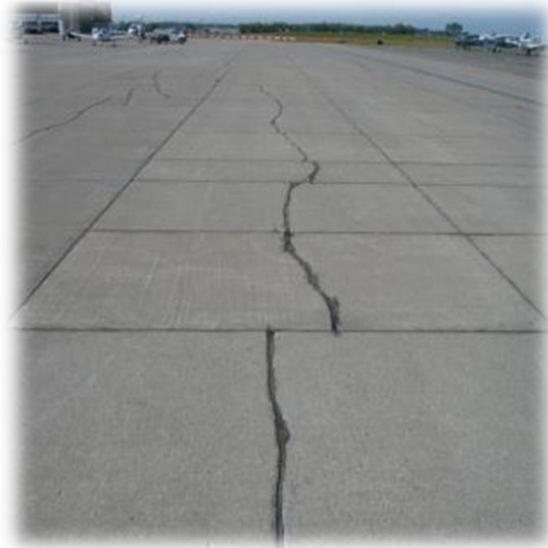
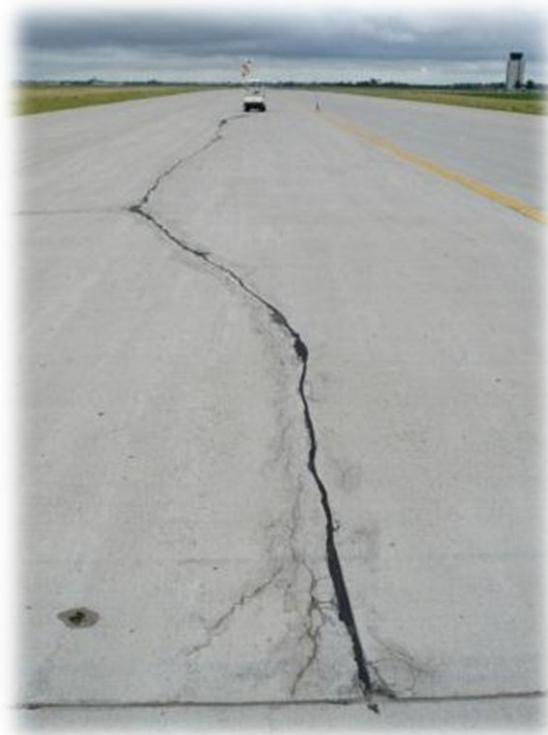
#### *Longitudinal, Transverse & Diagonal Cracking*

LTD cracking is often a result of load or temperature deformations. External loads cause flexure. Temperature changes can cause curling. When any of these stresses exceed the slab strength, cracking occurs.

LTD cracking is recorded at low, medium, or high severity, depending on the width of crack opening and degree of deterioration.

At low severity, a crack is less than 1/8 inch wide with little spalling, and no corrective action is indicated. At medium severity, LTD cracks can be up to 1 inch wide with moderate spalling and should be repaired using procedures similar to joint sealing. At high severity, cracks exceed 1 inch in width and may be severely spalled. High-severity LTD cracking is evidence of serious load failure, and correction may require patching or slab replacement. If distress occurs in several adjacent slabs at medium or high severity, major rehabilitation of that area is indicated.

A slab divided into four or more pieces is said to be “divided” or “shattered.” Shattered slab is a separate distress category and indicates a significant structural failure. A shattered slab has lost its ability to distribute loads. Shattered slabs are rated in three severities, but the recommended action in any case is slab replacement.

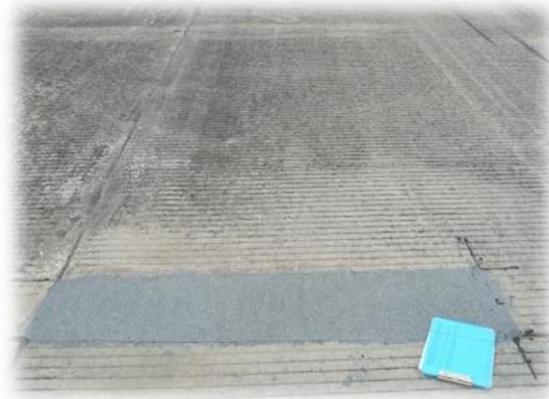
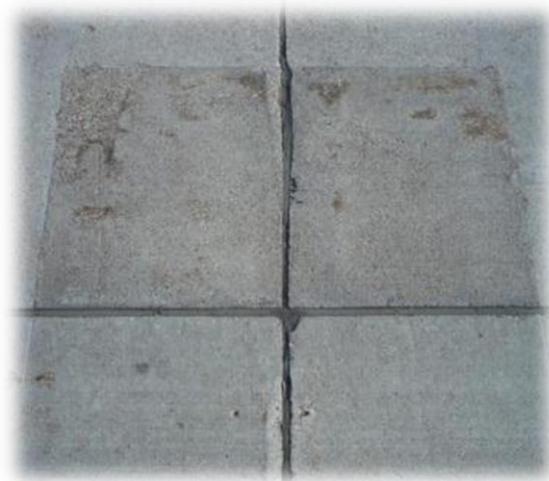
Large and small patches, by PCI inspection criteria, are distress conditions. Patches indicate deterioration and aging of pavement that contributes to shortened service life. However, patching also indicates that pavement is being maintained.

A patch that is performing well and shows no outward distress is recorded at low severity, and no corrective action is required. Medium-severity patches are serviceable but are beginning to deteriorate. Maintenance or replacement is indicated. At high severity, replacement is indicated.

By definition, small patches are smaller than 5 square feet in surface area, and they usually result from spall repair at slab joints and corners.

Large patches also may be the result of spall repair, but they often indicate more serious deficiencies, such as corner breaks or other full-depth failure smaller than panel size.

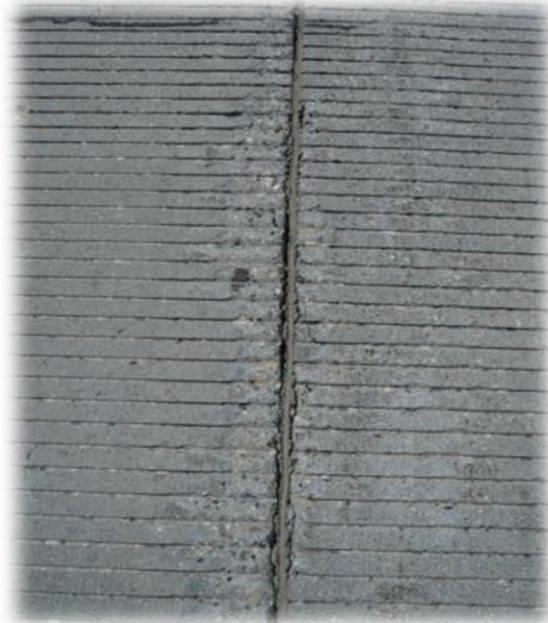
## Joint Seal Damage

When joint sealant is in perfect condition (no damage), there is no distress.

At low severity, at least 10 percent of the sealant is debonded but still in contact with the joint edges. Medium-severity joint seal damage is recorded when at least 10 percent of the sealant has visible gaps smaller than 1/8 inch and is an indicator that replacement should be programmed as soon as is practical. In the meantime, aggressive inspection and sustaining maintenance is recommended to minimize subsurface damage from moisture penetration. At high severity, visible gaps exceed 1/8 inch, and the amount and degree of joint seal damage typically requires complete removal and replacement of the existing sealant.

On serviceable pavement, deteriorated joint sealant should be repaired or replaced to preserve pavement and subgrade integrity and prolong service life. The issue is not so clear-cut with unserviceable pavement. Pavement that can be restored to serviceable condition by maintenance activities such as patching and joint seal repair, or by slab replacement, should be so maintained as long as the process is cost-effective. However, when age and condition preclude economical return to serviceable condition by such means, joint seal repair would no longer be cost-effective and should be suspended except for an interim maintenance program to control FOD potential.

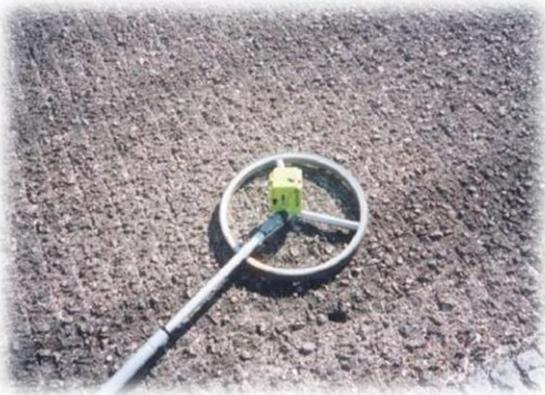
### Raveling/Weathering

Raveling and weathering are the wearing away of the pavement surface. Failure can be caused by the dislodging of aggregate particles or the loss of asphalt binder. These distresses are usually evident over large areas and may indicate that the asphalt binder has hardened significantly.

Raveling: At low severity, 5 to 20 coarse aggregate particles are missing per square yard. Medium severity is defined by 20 to 40 missing coarse aggregate particles per square yard. At high severity, more than 40 coarse aggregate particles are missing per square yard, and the top layer of aggregate has eroded away.

Weathering: At low severity, edges of coarse aggregate are exposed less than 1 mm. At medium severity, loss of fine aggregate is noticeable and edges of coarse aggregate are exposed up to 6 mm (1/4 inch). High severity weathering has edges of coarse aggregate exposed > 6 mm, with considerable loss of fine aggregate matrix and potential for loss of coarse aggregate.

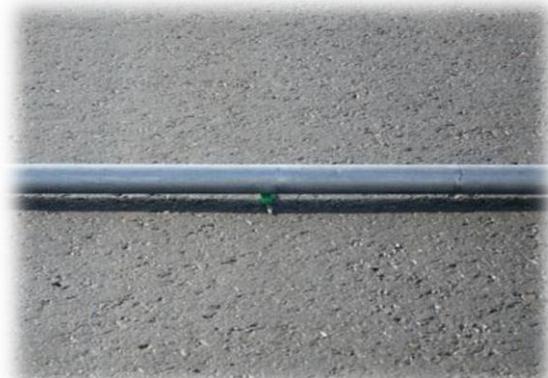
### Rutting

Ruts are localized areas of pavement having elevations lower than the surrounding sections.

Rutting is due to base and subgrade consolidation caused by excessive wheel loads or poor compaction. Ruts indicate structural failure and can cause hydroplaning.

At low severity, ruts have an average depth of ¼ to ½ inches. At medium severity, ruts have an average depth of ½ to 1 inch. At high severity, ruts have an average depth greater than 1 inch. Patching is the appropriate repair for ruts.
