Pavement Condition Report

Huntingburg Airport

Project 15805741

February 2015

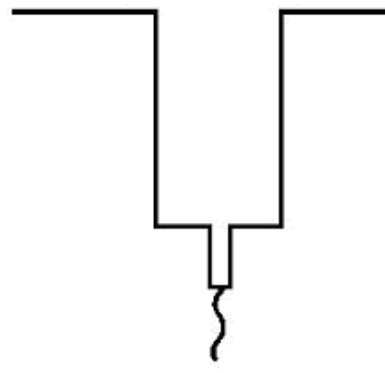
Clean joints exposing fresh, clean concrete and stone. Retain existing reservoir shape.

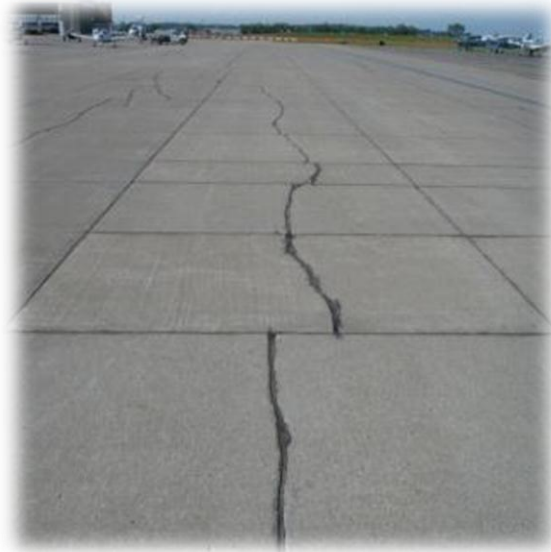
Longitudinal, Transverse & Diagonal Cracking

LTD cracking is often a result of load or temperature deformations. External loads cause flexure. Temperature changes can cause curling. When any of these stresses exceed the slab strength, cracking occurs.

LTD cracking is recorded at low, medium, or high severity, depending on the width of crack opening and degree of deterioration.

At low severity, a crack is less than 1/8 inch wide with little spalling, and no corrective action is indicated. At medium severity, LTD cracks can be up to 1 inch wide with moderate spalling and should be repaired using procedures similar to joint sealing. At high severity, cracks exceed 1 inch in width and may be severely spalled. High-severity LTD cracking is evidence of serious load failure, and correction may require patching or slab replacement. If distress occurs in several adjacent slabs at medium or high severity, major rehabilitation of that area is indicated.

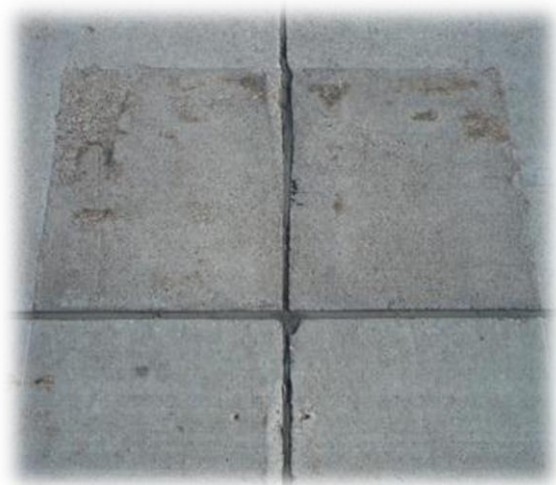
Large and small patches, by PCI inspection criteria, are distress conditions. Patches indicate deterioration and aging of pavement that contributes to shortened service life. However, patching also indicates that pavement is being maintained.

A patch that is performing well and shows no outward distress is recorded at low severity, and no corrective action is required. Medium-severity patches are serviceable but are beginning to deteriorate. Maintenance or replacement is indicated. At high severity, replacement is indicated.

By definition, small patches are smaller than 5 square feet in surface area, and they usually result from spall repair at slab joints and corners.

Large patches also may be the result of spall repair, but they often indicate more serious deficiencies, such as corner breaks or other full-depth failure smaller than panel size.

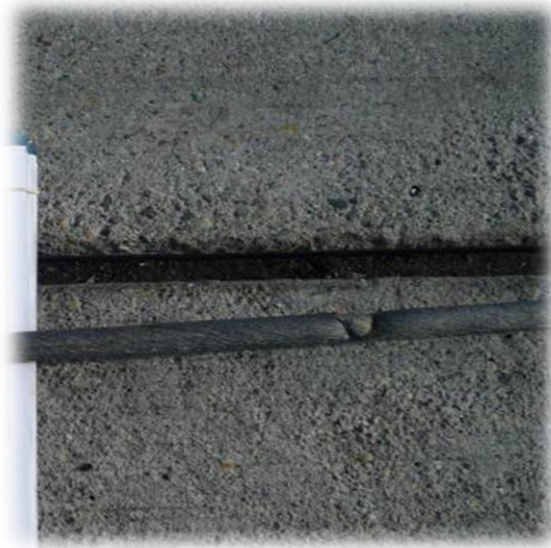
Joint Seal Damage

When joint sealant is in perfect condition (no damage), there is no distress.

At low severity, at least 10 percent of the sealant is debonded but still in contact with the joint edges. Medium-severity joint seal damage is recorded when at least 10 percent of the sealant has visible gaps smaller than 1/8 inch and is an indicator that replacement should be programmed as soon as is practical. In the meantime, aggressive inspection and sustaining maintenance is recommended to minimize subsurface damage from moisture penetration. At high severity, visible gaps exceed 1/8 inch, and the amount and degree of joint seal damage typically requires complete removal and replacement of the existing sealant.

On serviceable pavement, deteriorated joint sealant should be repaired or replaced to preserve pavement and subgrade integrity and prolong service life. The issue is not so clear-cut with unserviceable pavement. Pavement that can be restored to serviceable condition by maintenance activities such as patching and joint seal repair, or by slab replacement, should be so maintained as long as the process is cost-effective. However, when age and condition preclude economical return to serviceable condition by such means, joint seal repair would no longer be cost-effective and should be suspended except for an interim maintenance program to control FOD potential.

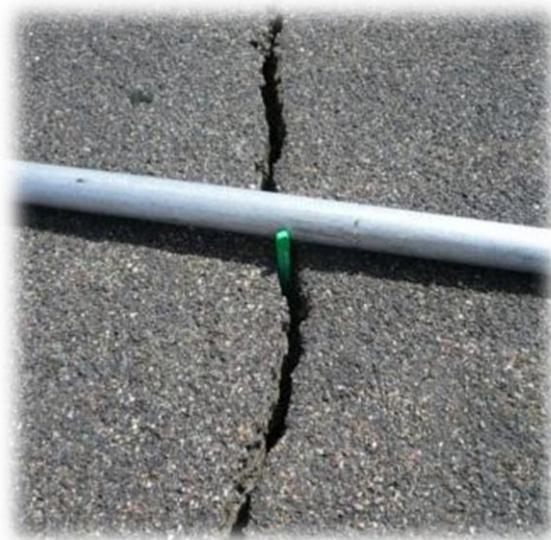
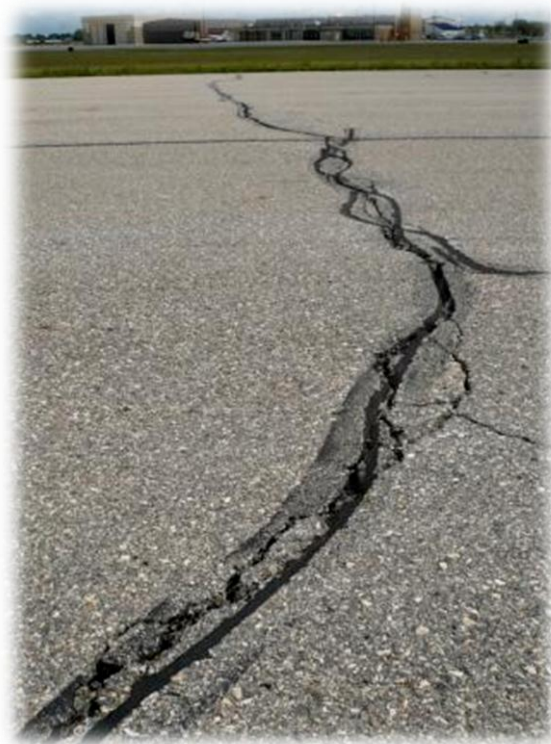
Longitudinal & Trans. Cracking

L&T cracks are caused by age, construction, and subsurface conditions. Age-related cracking occurs as oxidizing pavement loses components to the atmosphere and becomes more brittle. Consistent application of seal coats can help to prevent age-related cracks.

Seasonal movement caused by changes in subsurface moisture or temperature differences also can cause pavement cracking. Asphalt pavement placed over a PCC pavement or cement stabilized base course may evidence reflective cracking from the underlying material. Wheel loads do not cause L&T cracks, although traffic may worsen their condition.

Low-severity L&T cracks are less than $\frac{1}{4}$ inch wide, or if sealed with suitable filler material in satisfactory condition can be any width less than 3 inches, if they are not spalled. Maintenance usually is not indicated for low-severity cracking. Moderately spalled cracks and cracks wider than $\frac{1}{4}$ inch which are not satisfactorily sealed are at medium severity. Medium-severity cracks should be sealed with a high-quality crack filling material. Severely spalled cracks and cracks wider than 3 inches are at high severity. High-severity L&T cracks normally require patching.

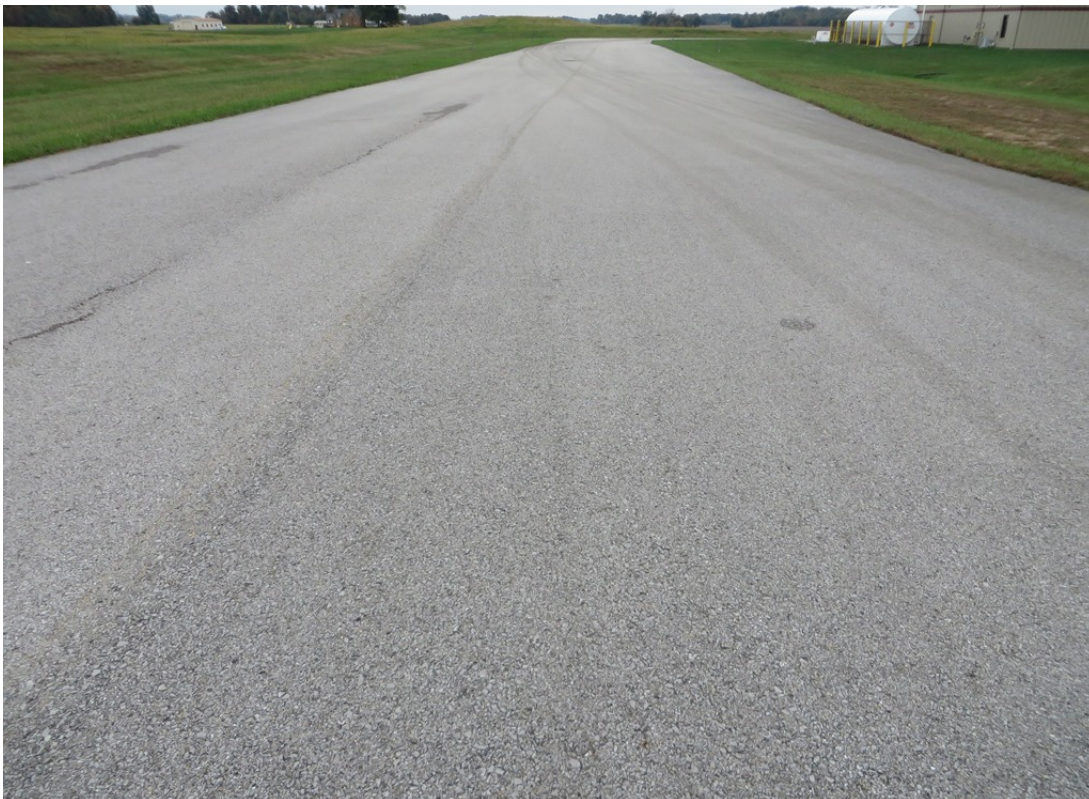
DISTRESS TYPE	SEVERITY	MEASURED QUANTITY	ESTIMATED TOTAL QUANTITY	UNITS	PERCENTAGE OF All DISTRESS
LONG.& TRANS. CRACK	LOW	140	341	L.F.	95.2
WEATHERING	MED	50	122	S.F.	4.7

APPROXIMATE AMOUNT OF DISTRESS RELATED TO LOAD ON THE PAVEMENT IS:	0 %
APPROXIMATE AMOUNT OF DISTRESS RELATED TO MATERIALS PROBLEMS IN THE FEATURE IS:	65 %
APPROXIMATE AMOUNT OF DISTRESS RELATED TO AGE OF PAVEMENT AND TRAFFIC REPETITIONS IS:	35 %

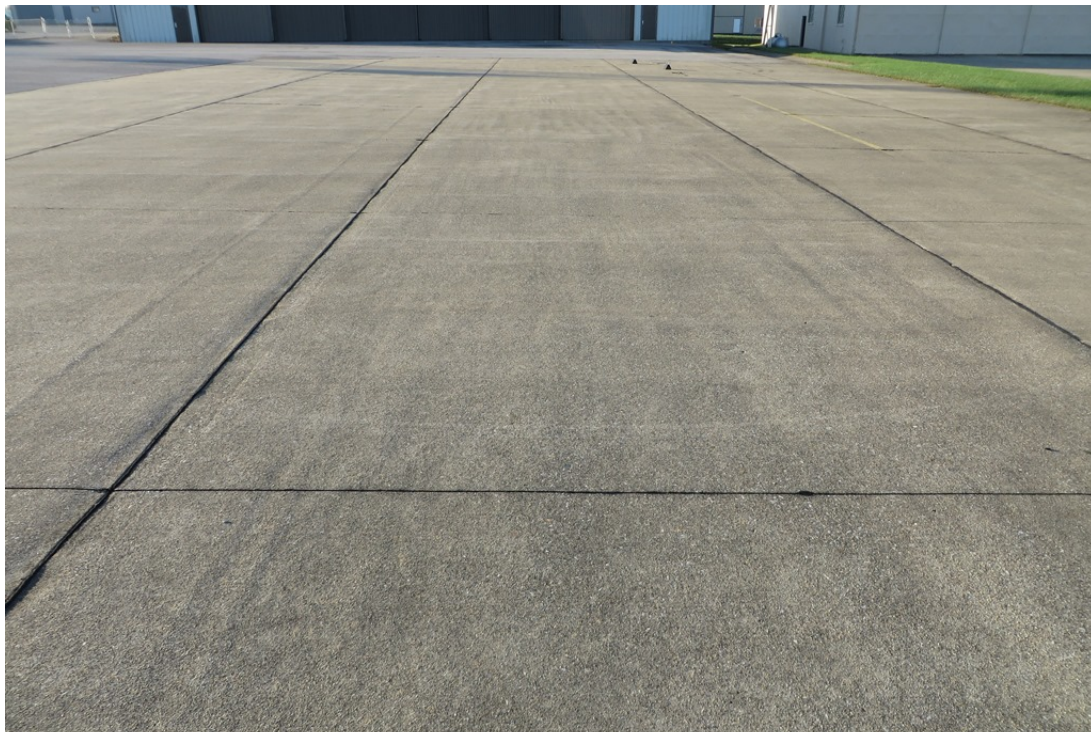
DISTRESS TYPE	SEVERITY	MEASURED QUANTITY	ESTIMATED TOTAL QUANTITY	UNITS	PERCENTAGE OF All DISTRESS
JOINT SEAL DAMAGE	MED	49	49	SLABS	51.5
SETTLEMENT/FAULT	LOW	3	3	SLABS	36.5
SPALLING-JOINTS	LOW	1	1	SLABS	5
SPALLING-CORNERS	LOW	1	1	SLABS	6.8

APPROXIMATE AMOUNT OF DISTRESS RELATED TO LOAD ON THE PAVEMENT IS:	30 %
APPROXIMATE AMOUNT OF DISTRESS RELATED TO MATERIALS PROBLEMS IN THE FEATURE IS:	32 %
APPROXIMATE AMOUNT OF DISTRESS RELATED TO AGE OF PAVEMENT AND TRAFFIC REPETITIONS IS:	38 %

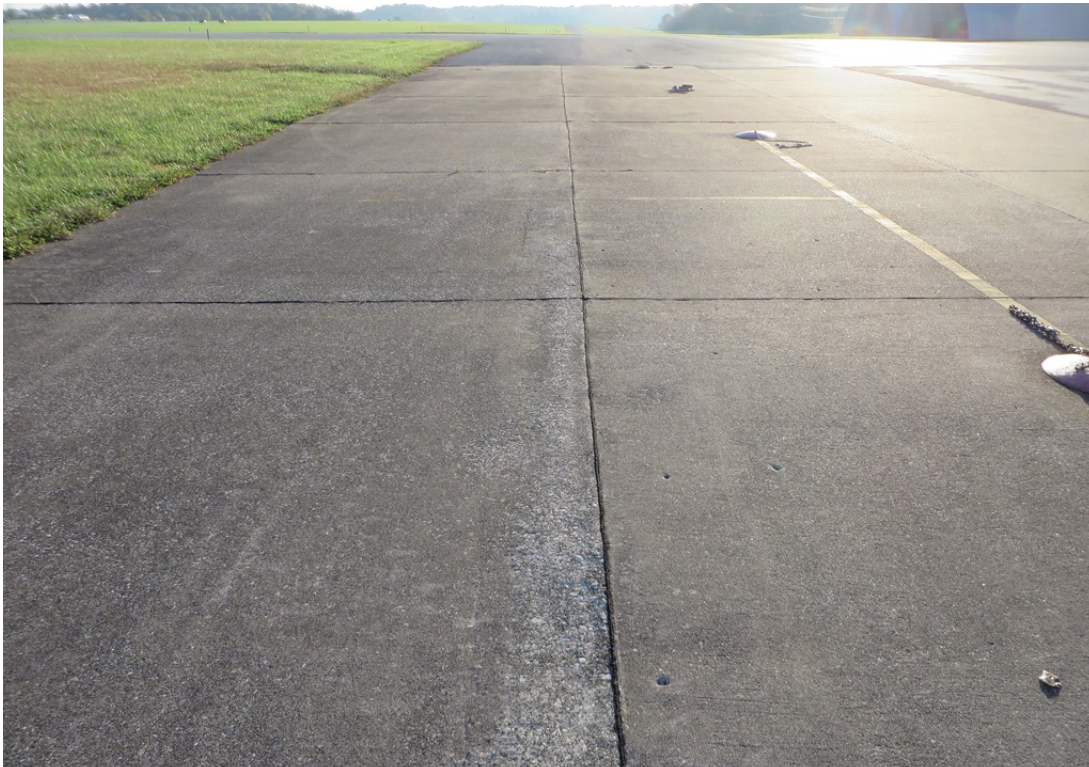
DISTRESS TYPE	SEVERITY	MEASURED QUANTITY	ESTIMATED TOTAL QUANTITY	UNITS	PERCENTAGE OF All DISTRESS
'D' CRACKING	LOW	6	6	SLABS	36.5
JOINT SEAL DAMAGE	MED	50	50	SLABS	56.7
SPALLING-CORNERS	LOW	1	1	SLABS	6.7

APPROXIMATE AMOUNT OF DISTRESS RELATED TO LOAD ON THE PAVEMENT IS:	2 %
APPROXIMATE AMOUNT OF DISTRESS RELATED TO MATERIALS PROBLEMS IN THE FEATURE IS:	46 %
APPROXIMATE AMOUNT OF DISTRESS RELATED TO AGE OF PAVEMENT AND TRAFFIC REPETITIONS IS:	52 %

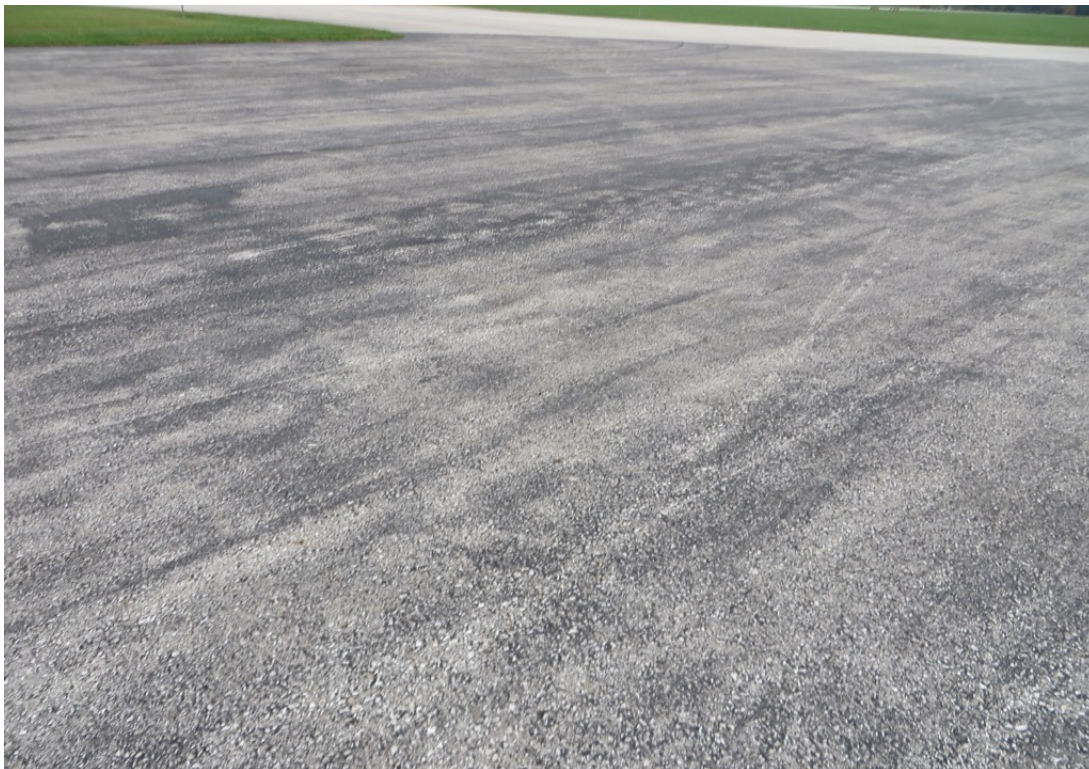
DISTRESS TYPE	SEVERITY	MEASURED QUANTITY	ESTIMATED TOTAL QUANTITY	UNITS	PERCENTAGE OF All DISTRESS
BLEEDING	N/A	30	44	S.F.	9.2
LONG.& TRANS. CRACK	MED	29	42	L.F.	32.1
LONG.& TRANS. CRACK	LOW	372	549	L.F.	58.5

APPROXIMATE AMOUNT OF DISTRESS RELATED TO LOAD ON THE PAVEMENT IS:	0 %
APPROXIMATE AMOUNT OF DISTRESS RELATED TO MATERIALS PROBLEMS IN THE FEATURE IS:	70 %
APPROXIMATE AMOUNT OF DISTRESS RELATED TO AGE OF PAVEMENT AND TRAFFIC REPETITIONS IS:	30 %

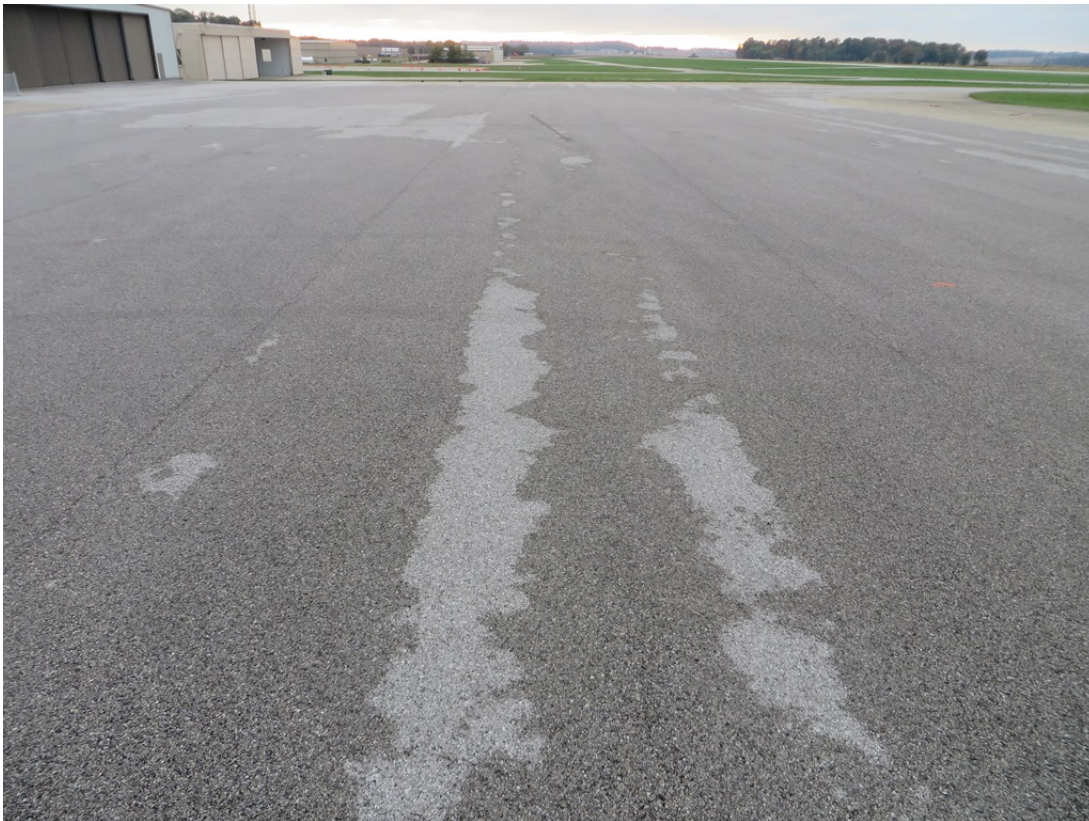
DISTRESS TYPE	SEVERITY	MEASURED QUANTITY	ESTIMATED TOTAL QUANTITY	UNITS	PERCENTAGE OF ALL DISTRESS
LONG.& TRANS. CRACK	LOW	373	873	L.F.	100

APPROXIMATE AMOUNT OF DISTRESS RELATED TO LOAD ON THE PAVEMENT IS:	0 %
APPROXIMATE AMOUNT OF DISTRESS RELATED TO MATERIALS PROBLEMS IN THE FEATURE IS:	67 %
APPROXIMATE AMOUNT OF DISTRESS RELATED TO AGE OF PAVEMENT AND TRAFFIC REPETITIONS IS:	33 %

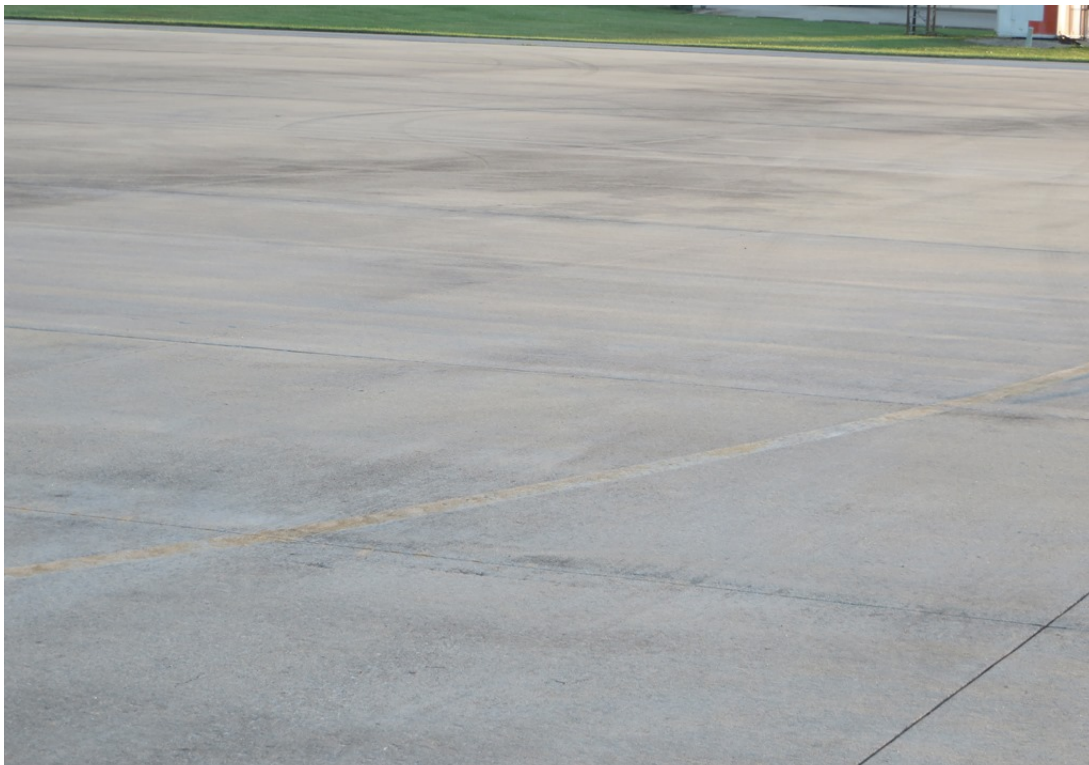
DISTRESS TYPE	SEVERITY	MEASURED QUANTITY	ESTIMATED TOTAL QUANTITY	UNITS	PERCENTAGE OF All DISTRESS
LONG/TRAN/DIAG CRK.	LOW	1	2	SLABS	38.8
SHRINKAGE CRACKS	N/A	4	9	SLABS	29.9
SPALLING-CORNERS	LOW	1	2	SLABS	31.1

APPROXIMATE AMOUNT OF DISTRESS RELATED TO LOAD ON THE PAVEMENT IS:	23 %
APPROXIMATE AMOUNT OF DISTRESS RELATED TO MATERIALS PROBLEMS IN THE FEATURE IS:	25 %
APPROXIMATE AMOUNT OF DISTRESS RELATED TO AGE OF PAVEMENT AND TRAFFIC REPETITIONS IS:	51 %

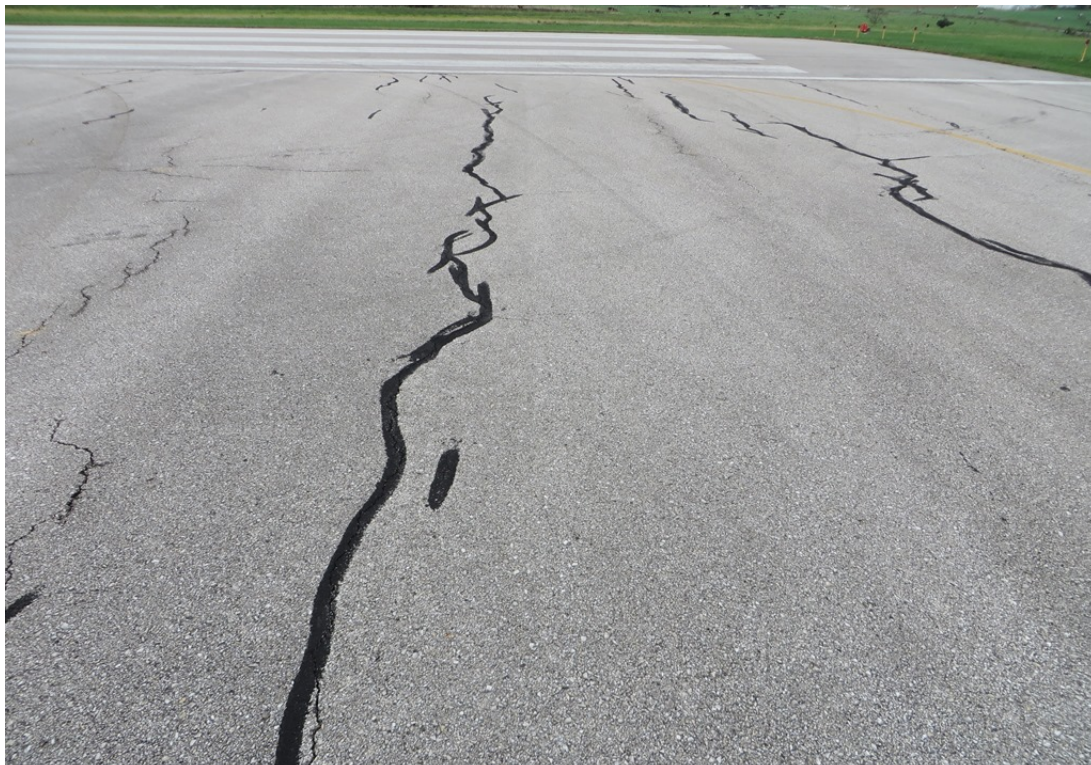
DISTRESS TYPE	SEVERITY	MEASURED QUANTITY	ESTIMATED TOTAL QUANTITY	UNITS	PERCENTAGE OF All DISTRESS
ALLIGATOR CRACKING	LOW	12	22	S.F.	16.3
LONG.& TRANS. CRACK	MED	87	159	L.F.	26.7
LONG.& TRANS. CRACK	LOW	782	1,434	L.F.	56.8

APPROXIMATE AMOUNT OF DISTRESS RELATED TO LOAD ON THE PAVEMENT IS:	16 %
APPROXIMATE AMOUNT OF DISTRESS RELATED TO MATERIALS PROBLEMS IN THE FEATURE IS:	56 %
APPROXIMATE AMOUNT OF DISTRESS RELATED TO AGE OF PAVEMENT AND TRAFFIC REPETITIONS IS:	28 %

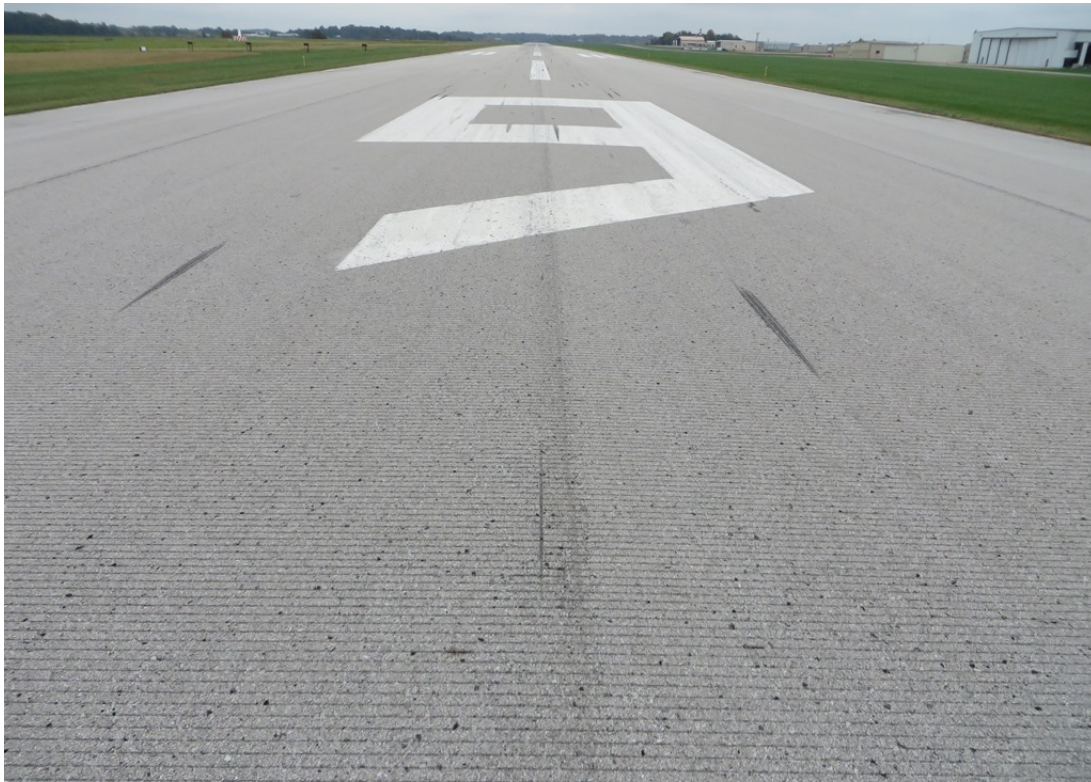
DISTRESS TYPE	SEVERITY	MEASURED QUANTITY	ESTIMATED TOTAL QUANTITY	UNITS	PERCENTAGE OF All DISTRESS
LONG.& TRANS. CRACK	MED	625	3,720	L.F.	56
LONG.& TRANS. CRACK	LOW	1,357	8,078	L.F.	43.9

APPROXIMATE AMOUNT OF DISTRESS RELATED TO LOAD ON THE PAVEMENT IS:	0 %
APPROXIMATE AMOUNT OF DISTRESS RELATED TO MATERIALS PROBLEMS IN THE FEATURE IS:	67 %
APPROXIMATE AMOUNT OF DISTRESS RELATED TO AGE OF PAVEMENT AND TRAFFIC REPETITIONS IS:	33 %

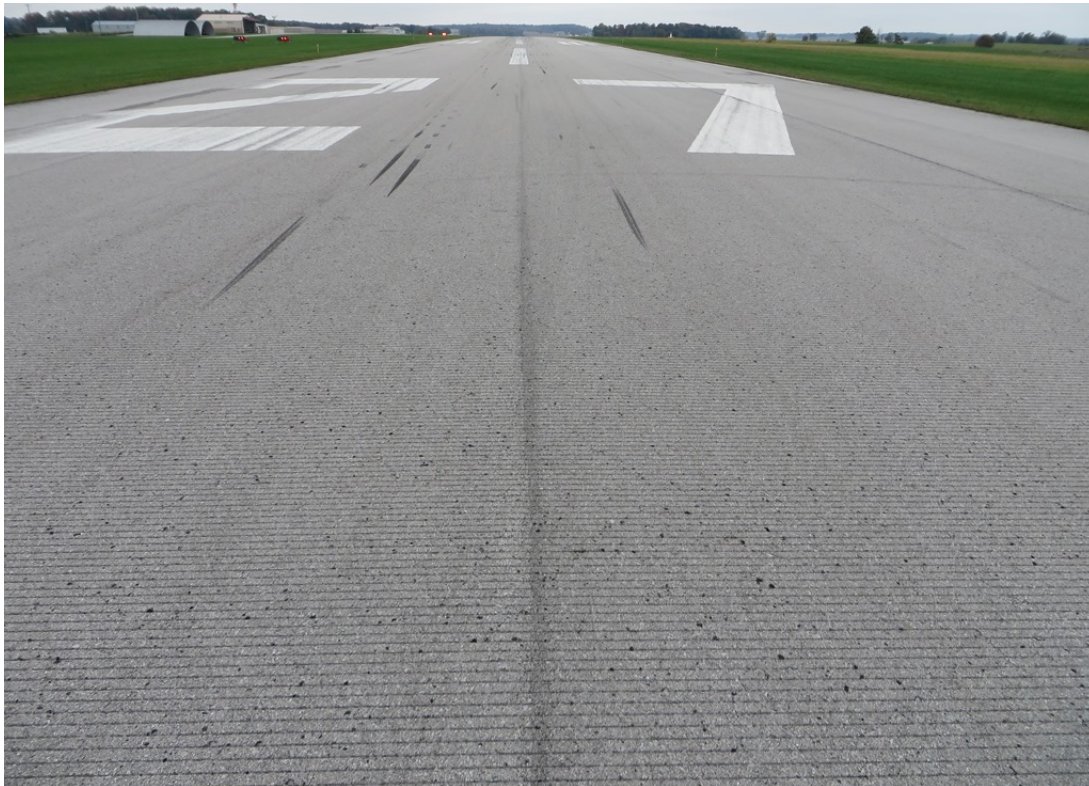
DISTRESS TYPE	SEVERITY	MEASURED QUANTITY	ESTIMATED TOTAL QUANTITY	UNITS	PERCENTAGE OF All DISTRESS
LONG.& TRANS. CRACK	MED	147	334	L.F.	53.3
LONG.& TRANS. CRACK	LOW	386	877	L.F.	46.6

APPROXIMATE AMOUNT OF DISTRESS RELATED TO LOAD ON THE PAVEMENT IS:	0 %
APPROXIMATE AMOUNT OF DISTRESS RELATED TO MATERIALS PROBLEMS IN THE FEATURE IS:	67 %
APPROXIMATE AMOUNT OF DISTRESS RELATED TO AGE OF PAVEMENT AND TRAFFIC REPETITIONS IS:	33 %
