Pavement Condition Report

Indianapolis Executive Airport

Project 13801869

January 2013

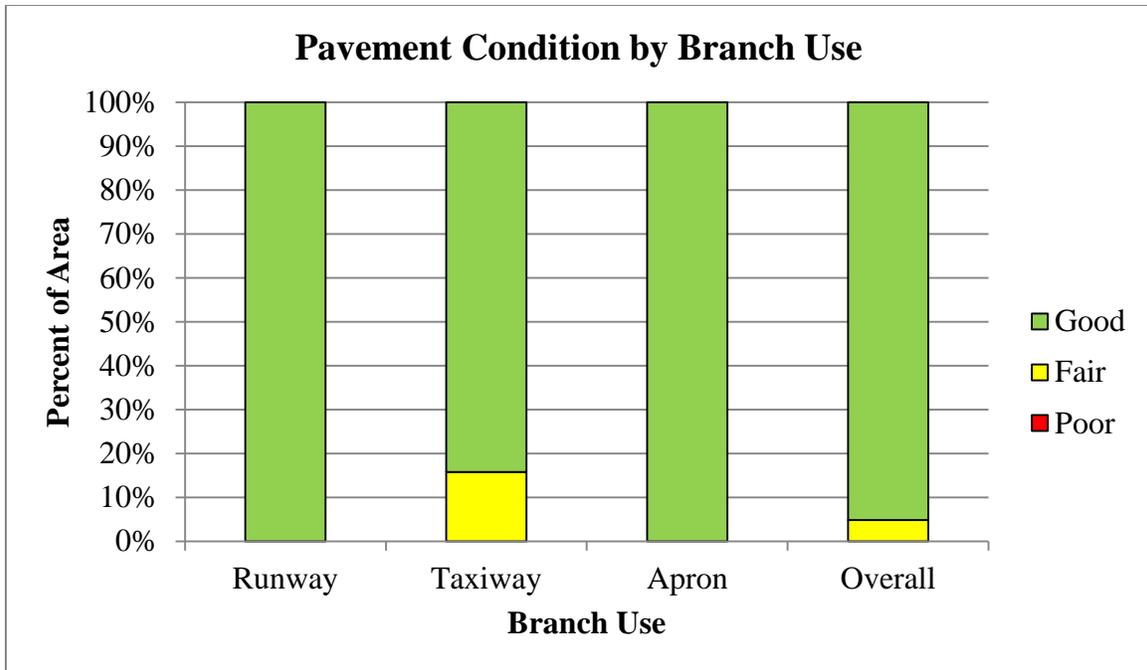
Figure 2-2. Pavement Condition by Branch Use

The overall Pavement Condition Index (PCI) for the airfield pavements was 95. Runway 18-36 had an average inspected PCI of 100 and was above the desired MSL of 60. Taxiways had an average inspected PCI of 85, and ramps had an average inspected PCI of 97.
