Pavement Condition Report

Indianapolis-Hendricks County Airport

Project 15805741

February 2015

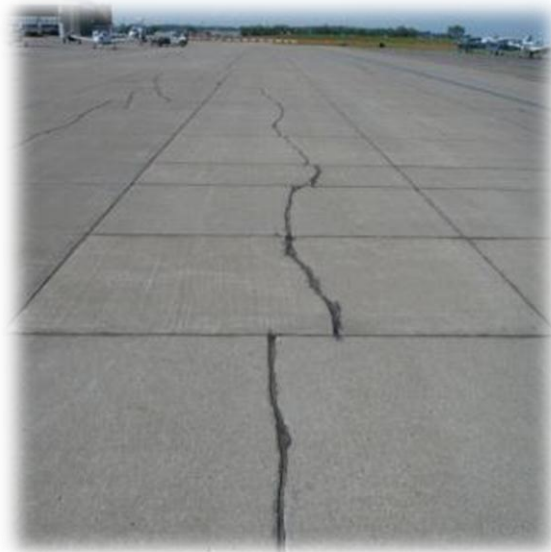
Longitudinal, Transverse & Diagonal Cracking

LTD cracking is often a result of load or temperature deformations. External loads cause flexure. Temperature changes can cause curling. When any of these stresses exceed the slab strength, cracking occurs.

LTD cracking is recorded at low, medium, or high severity, depending on the width of crack opening and degree of deterioration.

At low severity, a crack is less than 1/8 inch wide with little spalling, and no corrective action is indicated. At medium severity, LTD cracks can be up to 1 inch wide with moderate spalling and should be repaired using procedures similar to joint sealing. At high severity, cracks exceed 1 inch in width and may be severely spalled. High-severity LTD cracking is evidence of serious load failure, and correction may require patching or slab replacement. If distress occurs in several adjacent slabs at medium or high severity, major rehabilitation of that area is indicated.

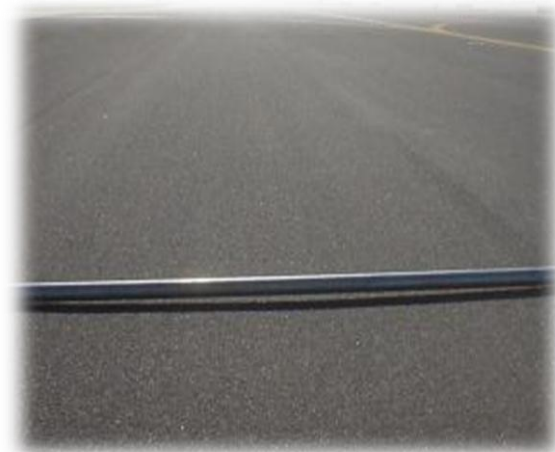
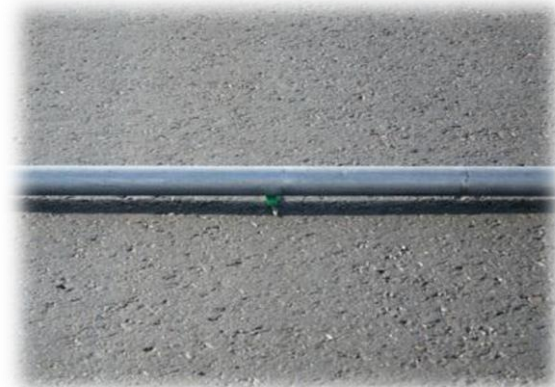
Ruts are localized areas of pavement having elevations lower than the surrounding sections.

Rutting is due to base and subgrade consolidation caused by excessive wheel loads or poor compaction. Ruts indicate structural failure and can cause hydroplaning.

At low severity, ruts have an average depth of ¼ to ½ inches. At medium severity, ruts have an average depth of ½ to 1 inch. At high severity, ruts have an average depth greater than 1 inch. Patching is the appropriate repair for ruts.
