Pavement Condition Report

Indianapolis Regional Airport

Project 15805741

February 2015

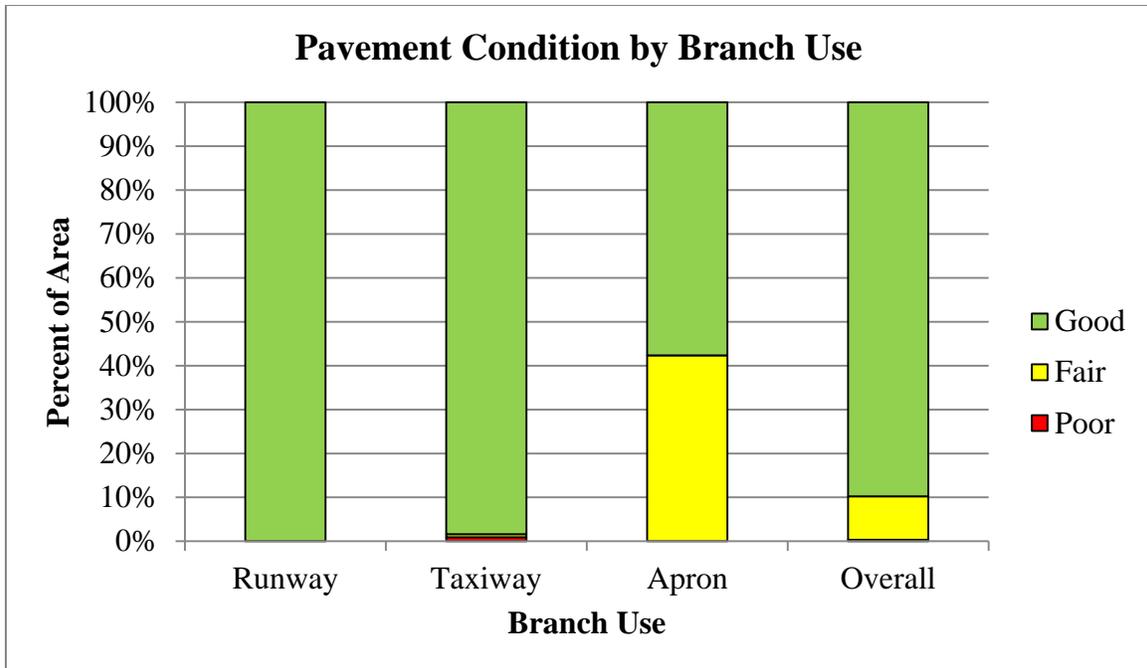
Figure 2-2. Pavement Condition by Branch Use

The average inspected Pavement Condition Index (PCI) for all the airfield pavements was 85. Runways had an average inspected PCI of 83 and were above the desired MSL of 60. Taxiways had an average inspected PCI of 95, and ramps had an average inspected PCI of 74.

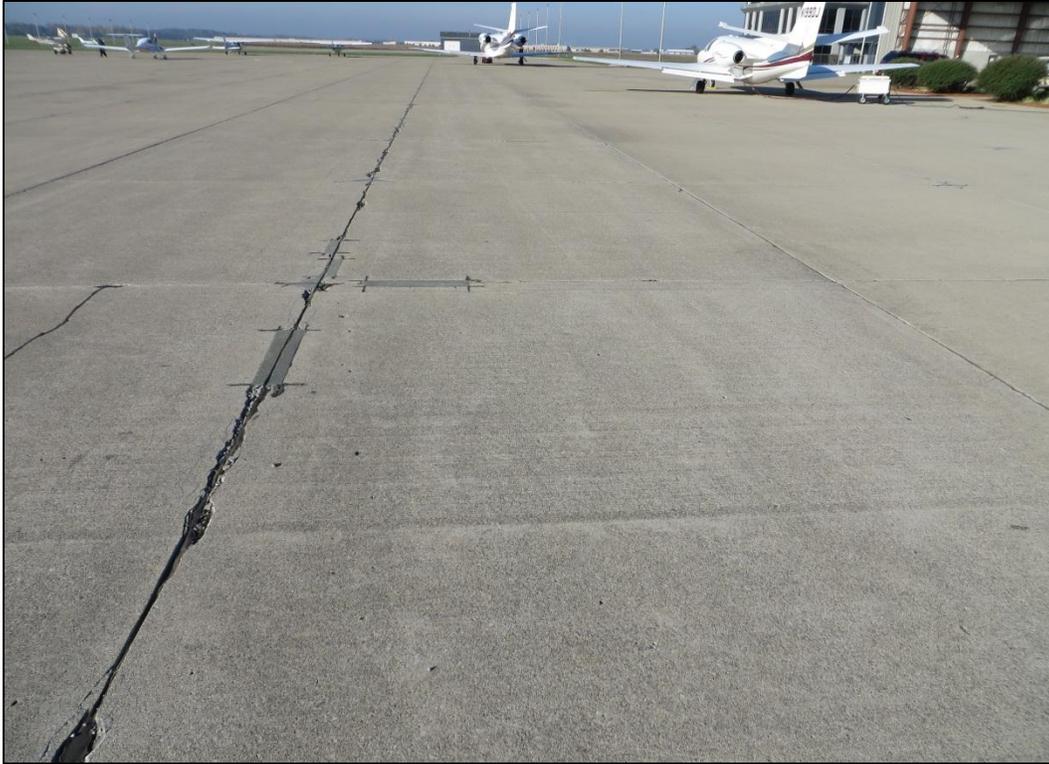
Figure 2-4. Typical Satisfactory PCC Pavement (Feature 3001)

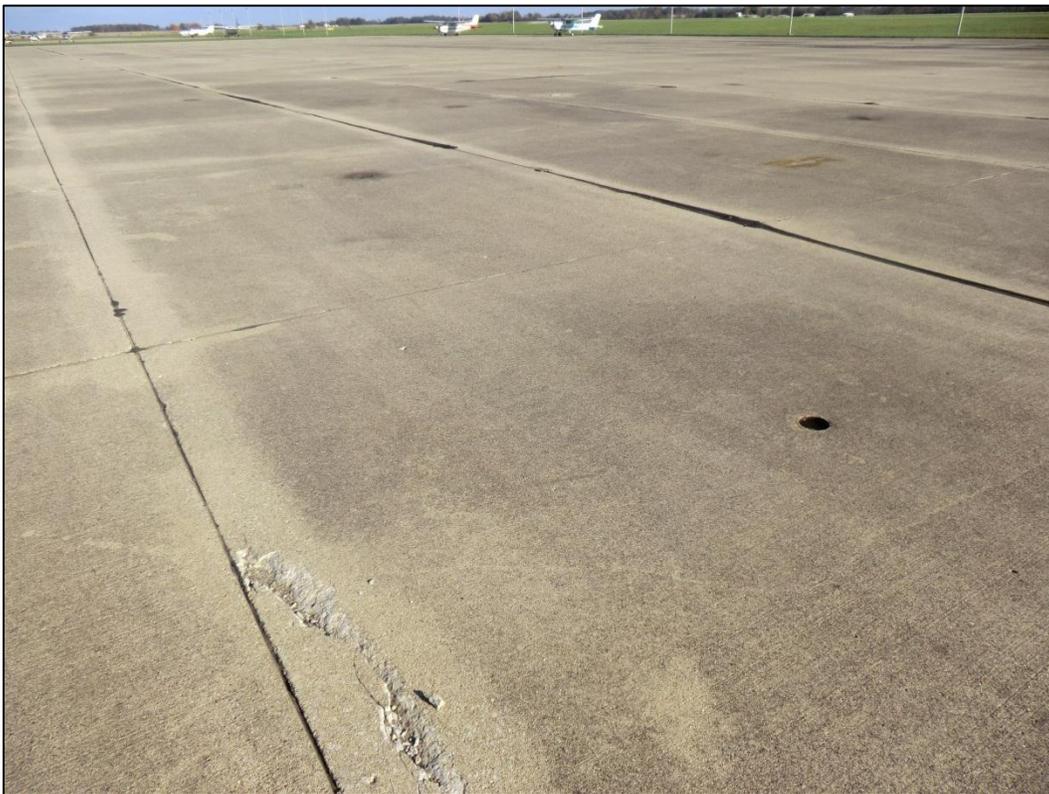
Figure 2-5. Typical Fair PCC Pavement (Feature 3005)

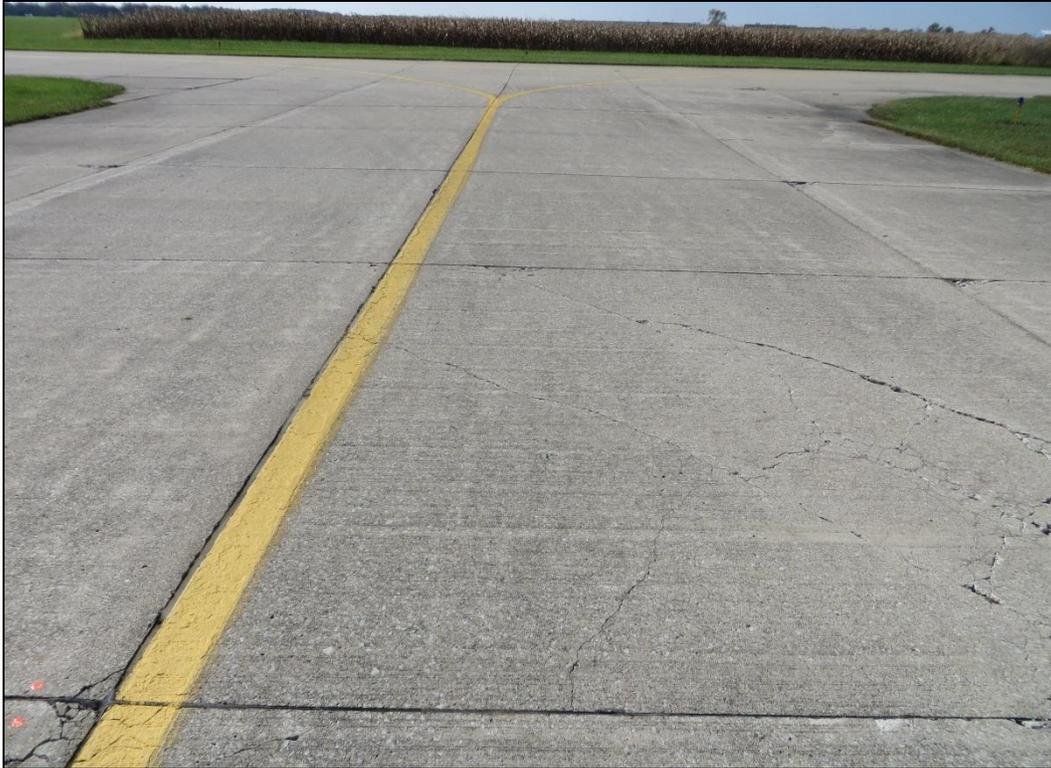
Figure 2-6. Typical Poor PCC Pavement (Feature 120)

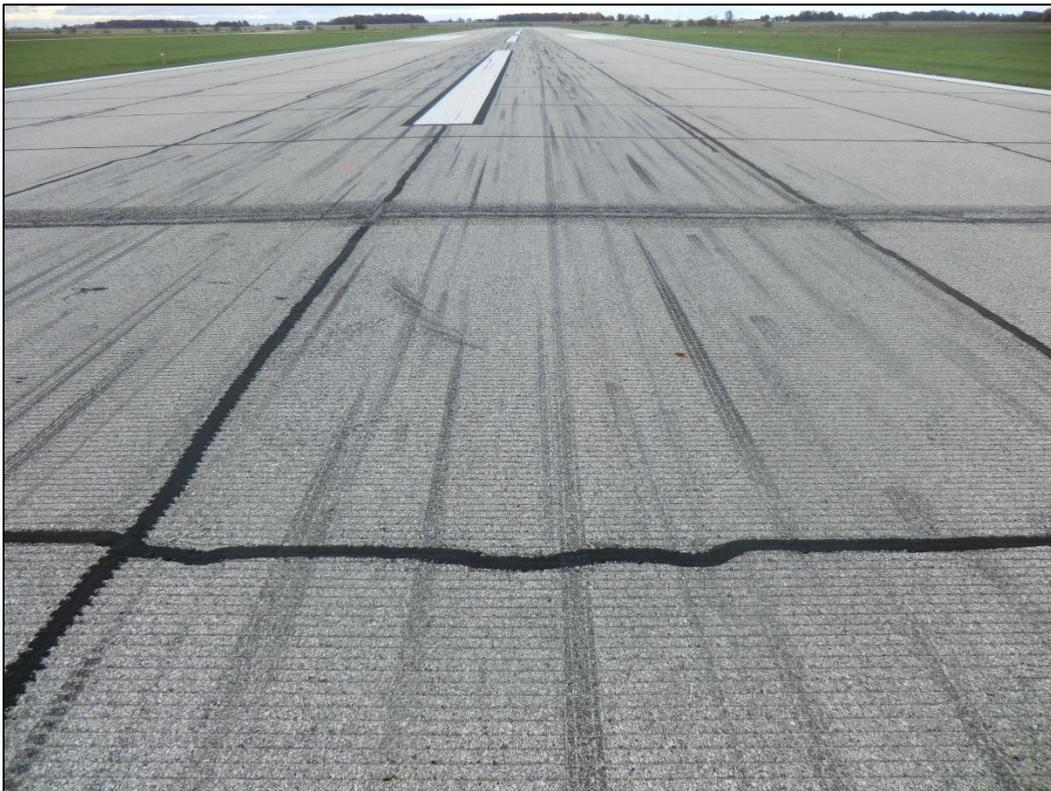
Figure 2-7. Typical Satisfactory AC Pavement (Feature 6105)

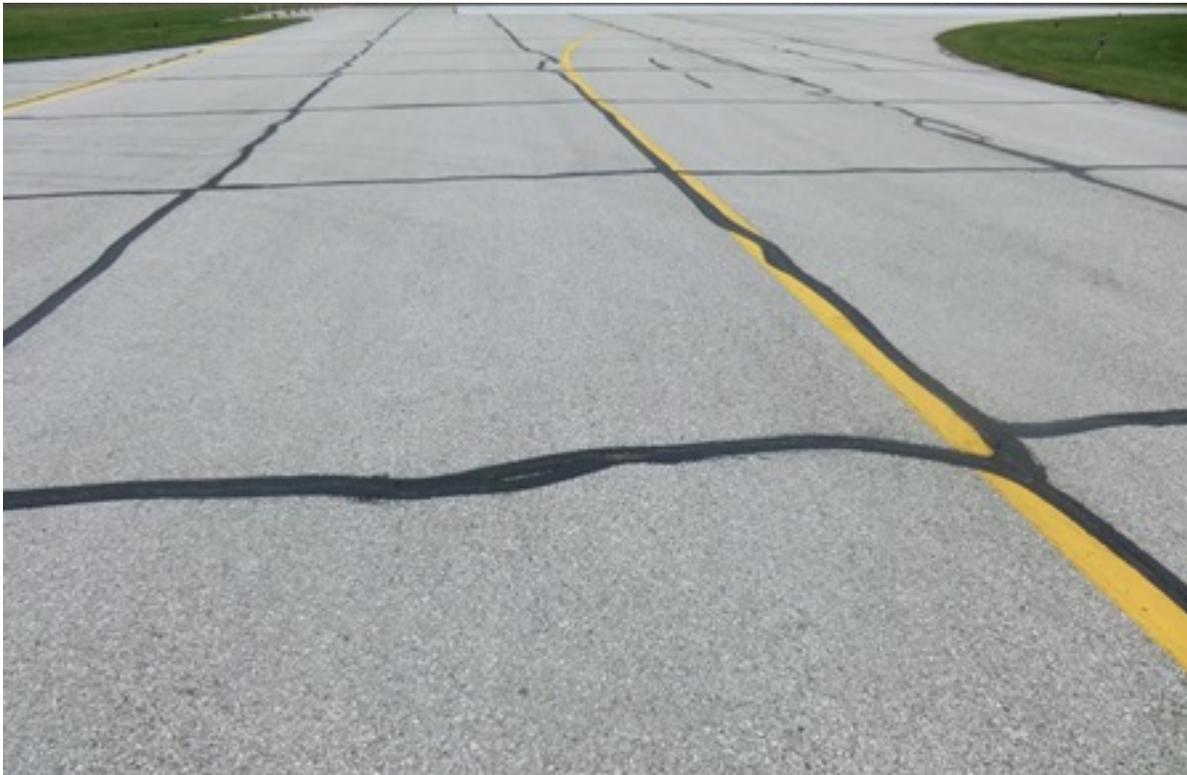
DISTRESS TYPE	SEVERITY	MEASURED QUANTITY	ESTIMATED TOTAL QUANTITY	UNITS	PERCENTAGE OF All DISTRESS
JOINT REF. CRACKING	LOW	1,922	2,900	L.F.	69.8
LONG. & TRANS. CRACK	LOW	202	304	L.F.	22.3
WEATHERING	MED	400	603	S.F.	7.7

APPROXIMATE AMOUNT OF DISTRESS RELATED TO LOAD ON THE PAVEMENT IS:	0 %
APPROXIMATE AMOUNT OF DISTRESS RELATED TO MATERIALS PROBLEMS IN THE FEATURE IS:	87 %
APPROXIMATE AMOUNT OF DISTRESS RELATED TO AGE OF PAVEMENT AND TRAFFIC REPETITIONS IS:	13 %

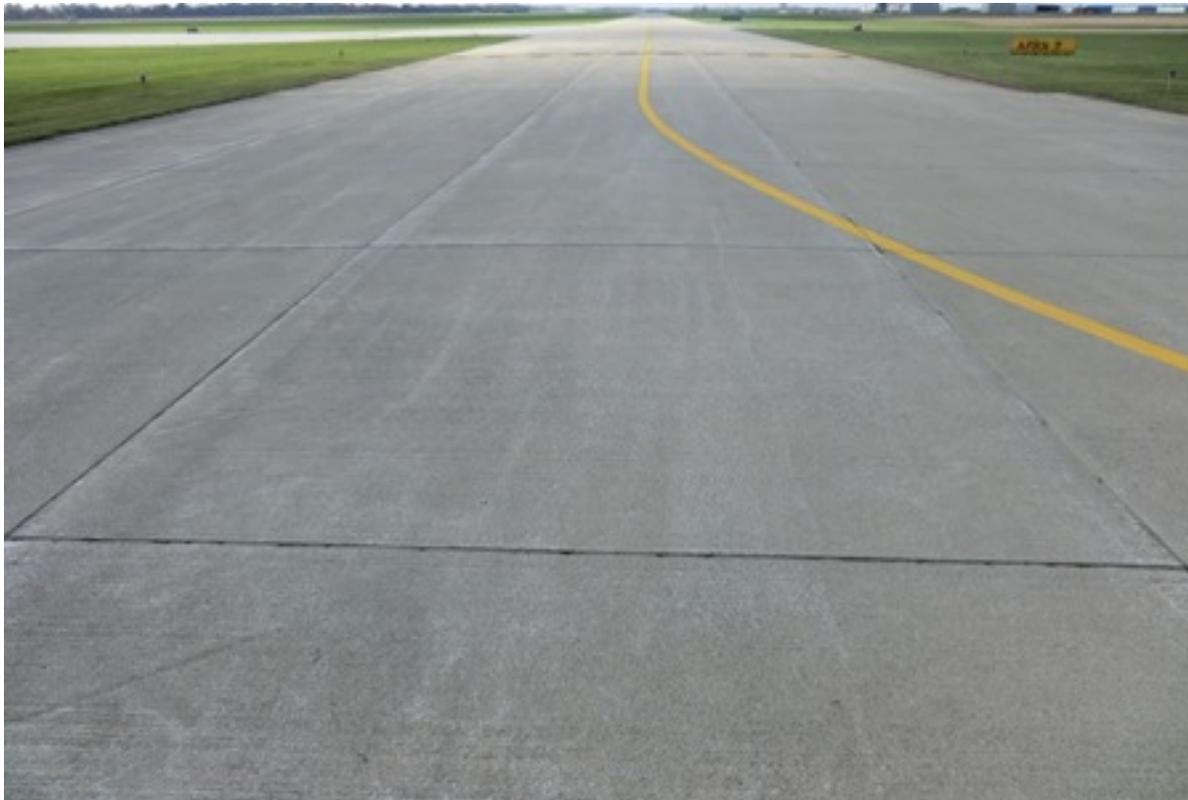
DISTRESS TYPE	SEVERITY	MEASURED QUANTITY	ESTIMATED TOTAL QUANTITY	UNITS	PERCENTAGE OF All DISTRESS
JOINT SEAL DAMAGE	MED	40	91	SLABS	63.2
SETTLEMENT/FAULT	LOW	2	4	SLABS	36.7

APPROXIMATE AMOUNT OF DISTRESS RELATED TO LOAD ON THE PAVEMENT IS:	25 %
APPROXIMATE AMOUNT OF DISTRESS RELATED TO MATERIALS PROBLEMS IN THE FEATURE IS:	33 %
APPROXIMATE AMOUNT OF DISTRESS RELATED TO AGE OF PAVEMENT AND TRAFFIC REPETITIONS IS:	42 %

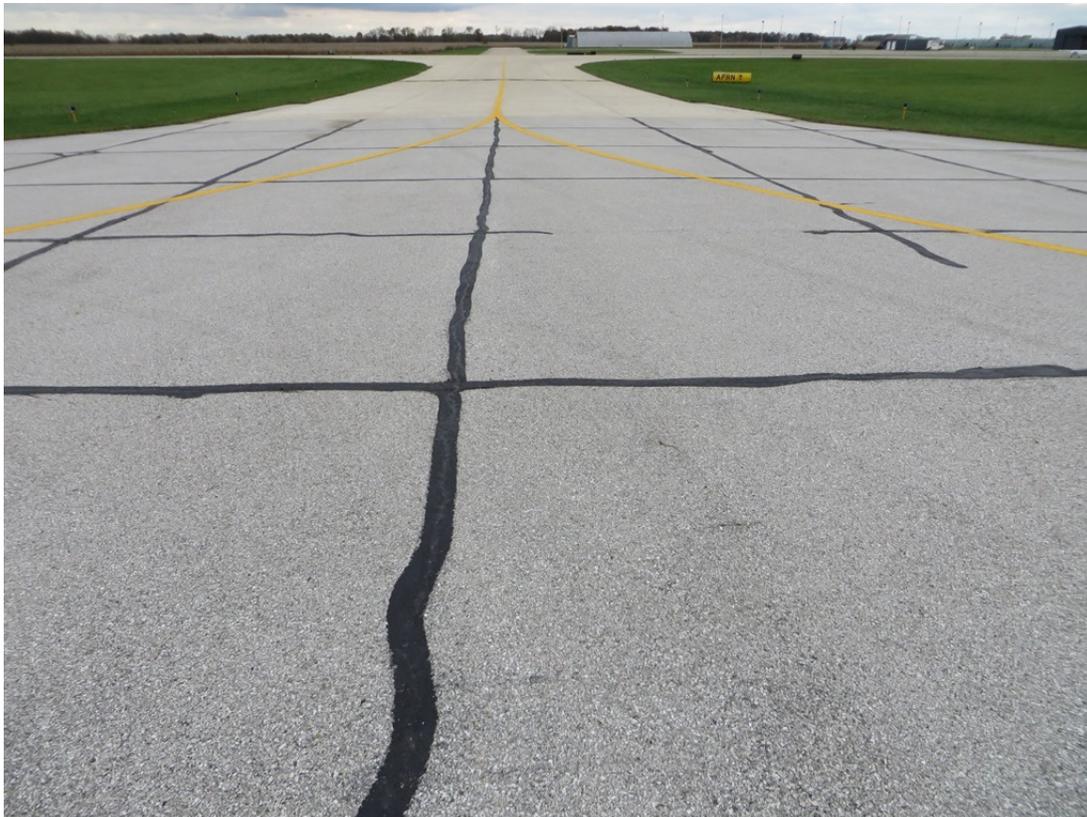
DISTRESS TYPE	SEVERITY	MEASURED QUANTITY	ESTIMATED TOTAL QUANTITY	UNITS	PERCENTAGE OF All DISTRESS
JOINT REF. CRACKING	LOW	1,061	1,733	L.F.	100

APPROXIMATE AMOUNT OF DISTRESS RELATED TO LOAD ON THE PAVEMENT IS:	0 %
APPROXIMATE AMOUNT OF DISTRESS RELATED TO MATERIALS PROBLEMS IN THE FEATURE IS:	100 %
APPROXIMATE AMOUNT OF DISTRESS RELATED TO AGE OF PAVEMENT AND TRAFFIC REPETITIONS IS:	0 %

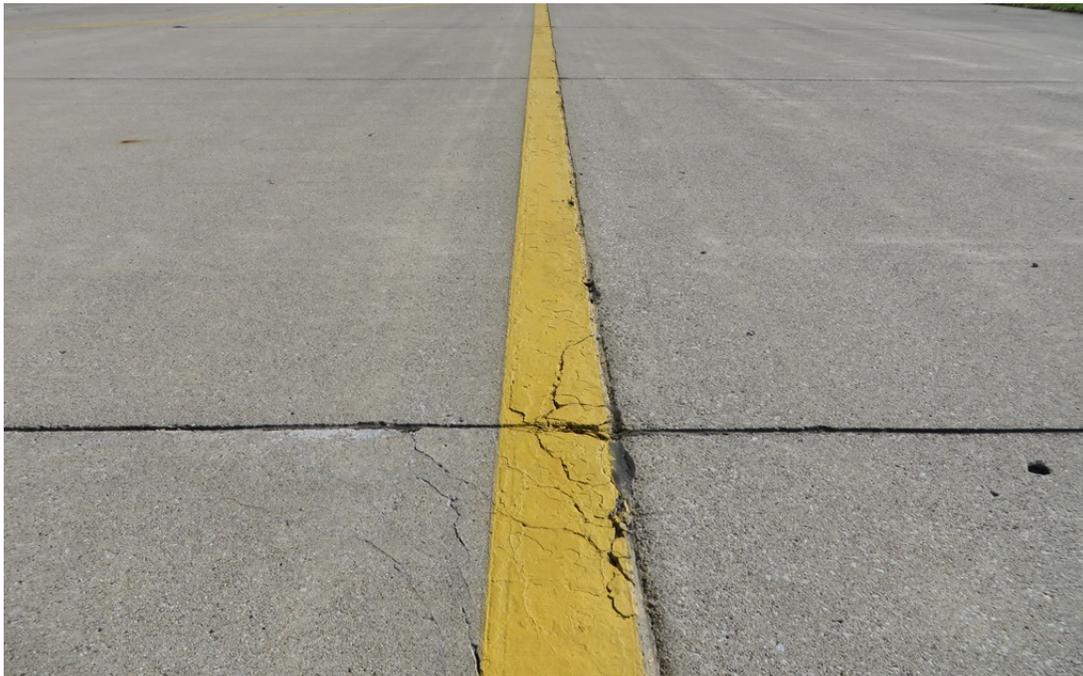
DISTRESS TYPE	SEVERITY	MEASURED QUANTITY	ESTIMATED TOTAL QUANTITY	UNITS	PERCENTAGE OF All DISTRESS
'D' CRACKING	HIGH	1	3	SLABS	6.5
'D' CRACKING	MED	15	47	SLABS	41.5
'D' CRACKING	LOW	17	54	SLABS	24.9
JOINT SEAL DAMAGE	LOW	20	63	SLABS	1.8
PATCH<5 SF	HIGH	1	3	SLABS	4.7
PATCH>5 SF/UTIL.CUT	MED	1	3	SLABS	9.9
SETTLEMENT/FAULT	LOW	3	9	SLABS	10.4

APPROXIMATE AMOUNT OF DISTRESS RELATED TO LOAD ON THE PAVEMENT IS:	10 %
APPROXIMATE AMOUNT OF DISTRESS RELATED TO MATERIALS PROBLEMS IN THE FEATURE IS:	59 %
APPROXIMATE AMOUNT OF DISTRESS RELATED TO AGE OF PAVEMENT AND TRAFFIC REPETITIONS IS:	30 %
