# Pavement Condition Report

## Rensselaer-Jasper County Airport

Project 15805741

**February 2015**

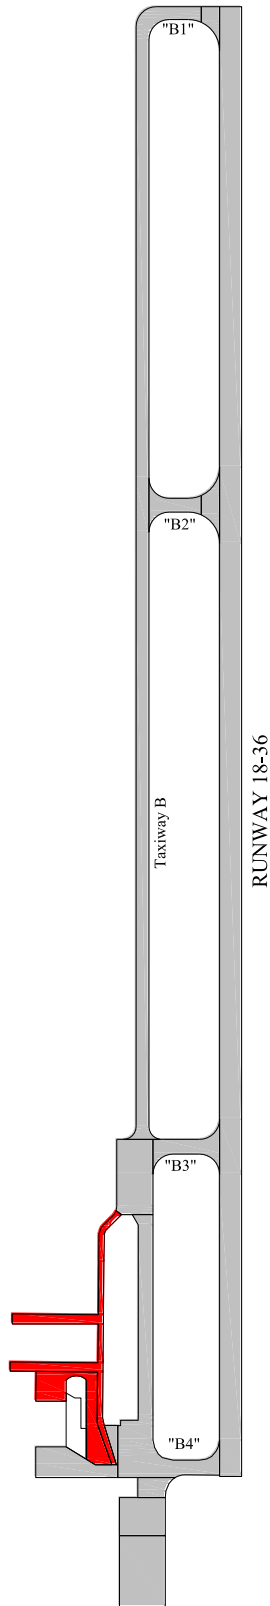
RECOMMENDED MAINTENANCE

Analysis of potential maintenance projects identified approximately 1,300 square feet of patching needs and approximately 300 linear feet of crack sealing and crack repair needs, at an estimated total cost of approximately \$12,000.

Work Item	Quantity	Unit	Cost
AC PATCH	1,334	S.F.	11,572
AC SUSTAINING CRACK REPAIR	311	L.F.	269
<b>Total:</b>			<b>\$11,841</b>

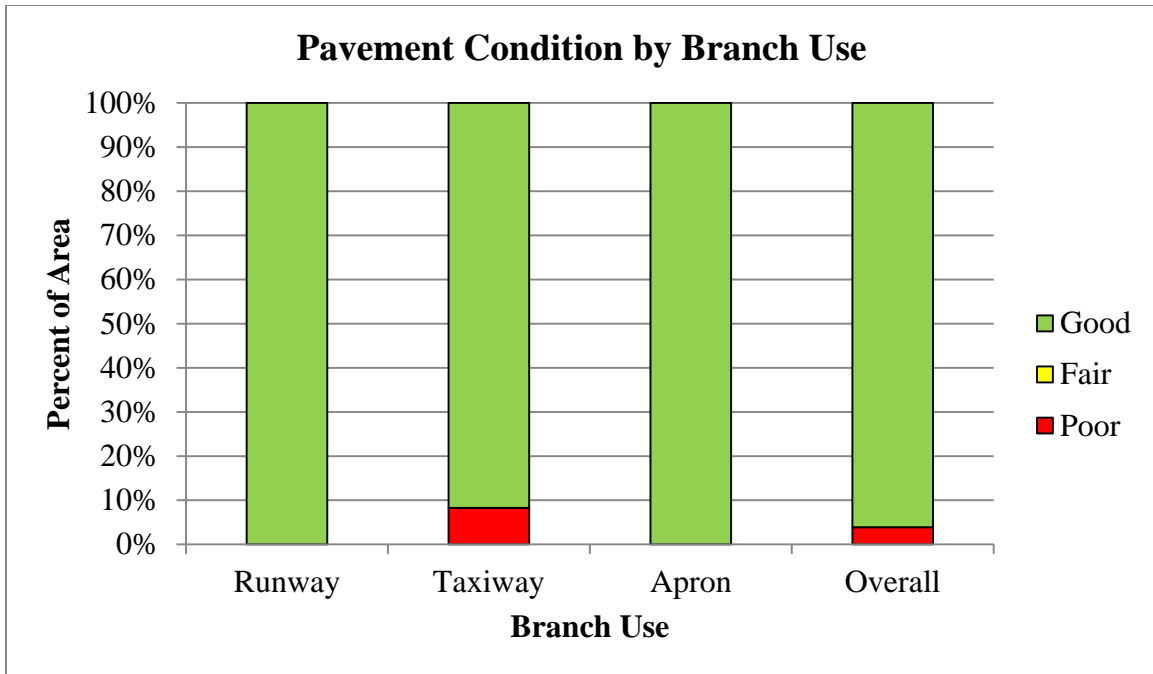
Figure 2-2. Pavement Condition by Branch Use

The average inspected Pavement Condition Index (PCI) for all the airfield pavements was 90. Runways had an average inspected PCI of 100 and were above the desired MSL of 60. Taxiways had an average inspected PCI of 82, and ramps had an average inspected PCI of 88.

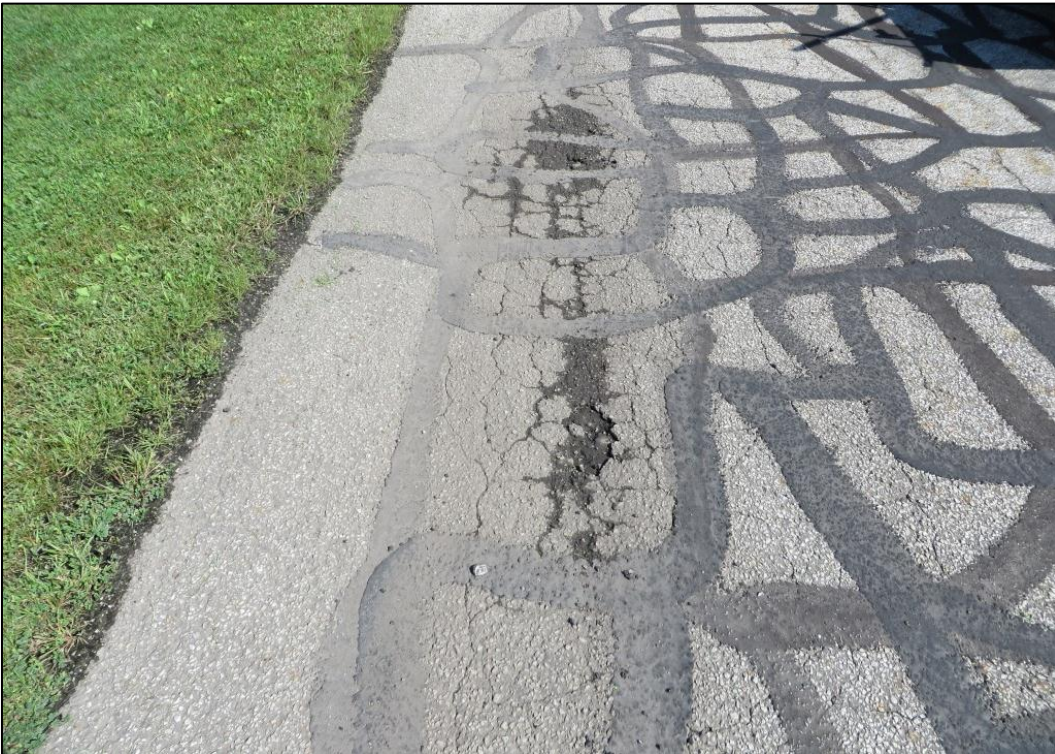
Figure 2-5. Typical Poor AC Pavement (Feature 210)

Section 140 had maintenance performed between inspections and stayed at a PCI 88. Section 205 had both an area change and new crack seal since the last inspection and had a two point PCI increase.

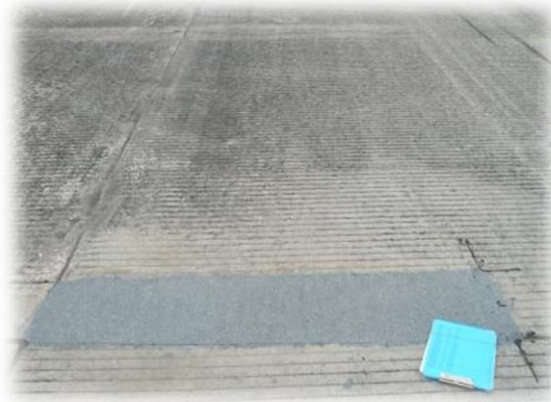
Large and small patches, by PCI inspection criteria, are distress conditions. Patches indicate deterioration and aging of pavement that contributes to shortened service life. However, patching also indicates that pavement is being maintained.

A patch that is performing well and shows no outward distress is recorded at low severity, and no corrective action is required. Medium-severity patches are serviceable but are beginning to deteriorate. Maintenance or replacement is indicated. At high severity, replacement is indicated.

By definition, small patches are smaller than 5 square feet in surface area, and they usually result from spall repair at slab joints and corners.

Large patches also may be the result of spall repair, but they often indicate more serious deficiencies, such as corner breaks or other full-depth failure smaller than panel size.

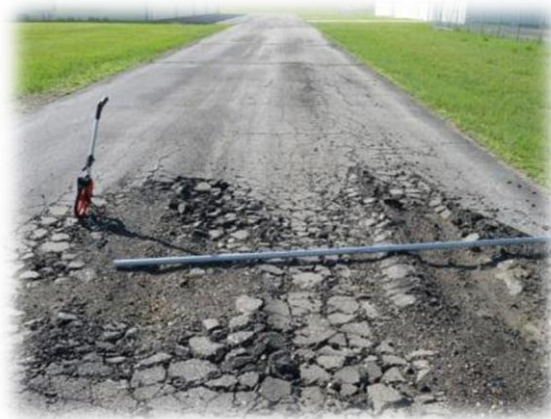
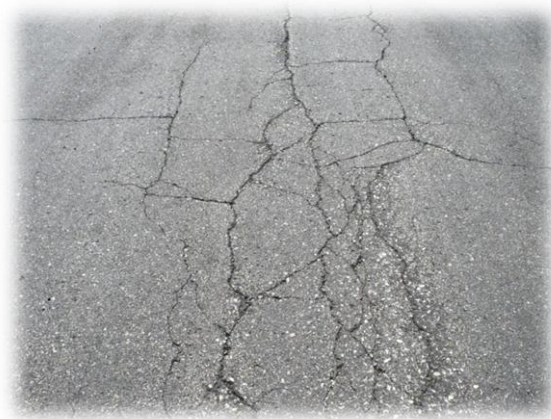
## Alligator Cracking

Alligator cracks are a series of interconnected load-related cracks caused by fatigue of the asphalt surface. Alligator cracking is a significant structural distress and develops only in places subject to traffic loads. These cracks typically initiate at the bottom of the asphalt layer and propagate upward. Once a fatigue crack is visible at the surface, significant damage has already occurred.

At low severity, alligator cracks are evidenced by a series of parallel hairline cracks (usually in a wheel path). Medium-severity alligator cracking is a well-defined pattern of interconnected cracks, and some spalling may be present. High-severity alligator cracks have lost aggregate interlock between adjacent pieces, and the cracks may be severely spalled with FOD potential. Most likely, the pieces will move freely under traffic.

Alligator cracking is a serious structural failure that cannot be repaired with sealant. The proper repair is patching.

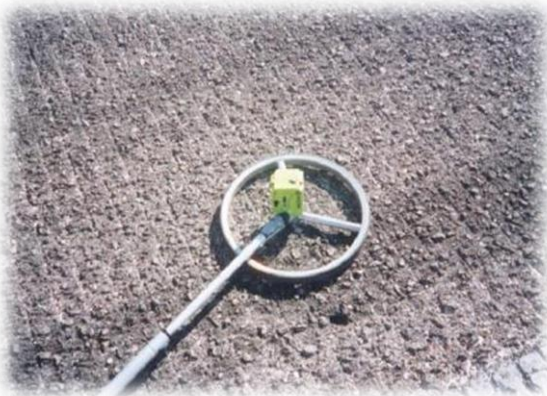
### Raveling/Weathering

Raveling and weathering are the wearing away of the pavement surface. Failure can be caused by the dislodging of aggregate particles or the loss of asphalt binder. These distresses are usually evident over large areas and may indicate that the asphalt binder has hardened significantly.

Raveling: At low severity, 5 to 20 coarse aggregate particles are missing per square yard. Medium severity is defined by 20 to 40 missing coarse aggregate particles per square yard. At high severity, more than 40 coarse aggregate particles are missing per square yard, and the top layer of aggregate has eroded away.

Weathering: At low severity, edges of coarse aggregate are exposed less than 1 mm. At medium severity, loss of fine aggregate is noticeable and edges of coarse aggregate are exposed up to 6 mm (1/4 inch). High severity weathering has edges of coarse aggregate exposed > 6 mm, with considerable loss of fine aggregate matrix and potential for loss of coarse aggregate.

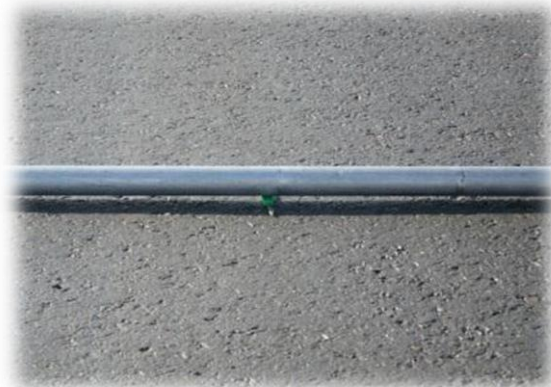
### Rutting

Ruts are localized areas of pavement having elevations lower than the surrounding sections.

Rutting is due to base and subgrade consolidation caused by excessive wheel loads or poor compaction. Ruts indicate structural failure and can cause hydroplaning.

At low severity, ruts have an average depth of ¼ to ½ inches. At medium severity, ruts have an average depth of ½ to 1 inch. At high severity, ruts have an average depth greater than 1 inch. Patching is the appropriate repair for ruts.

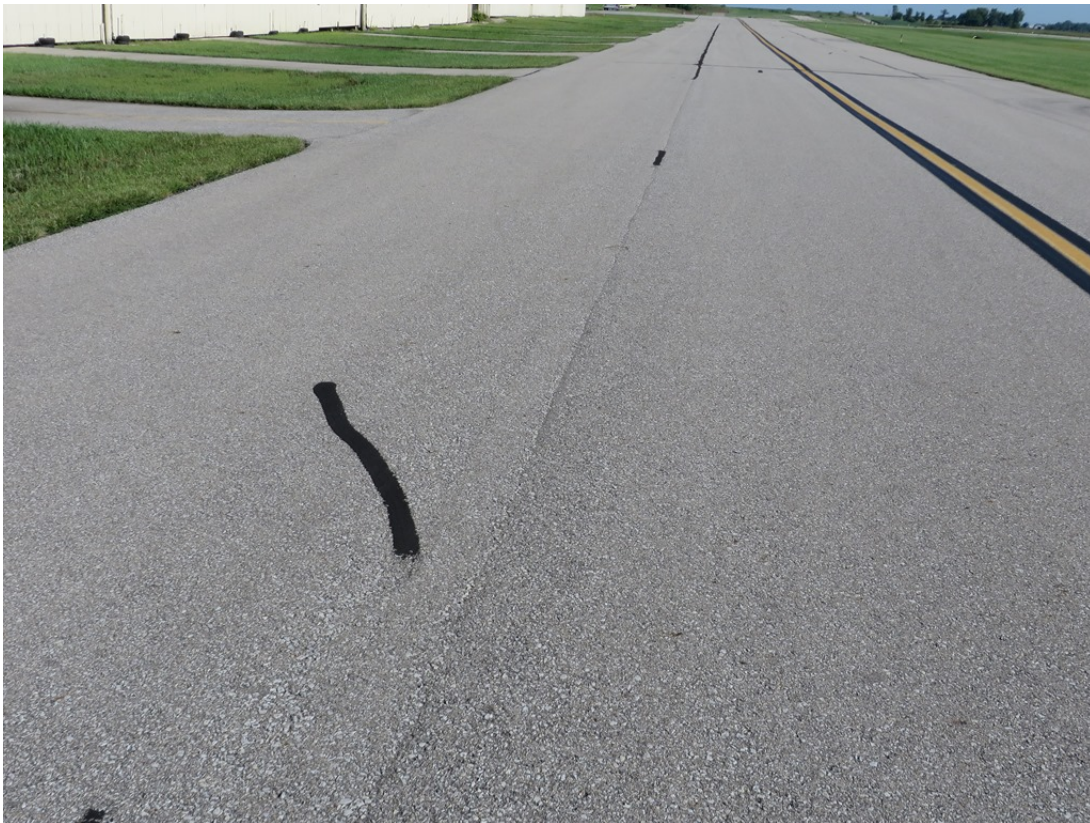
DISTRESS TYPE	SEVERITY	MEASURED QUANTITY	ESTIMATED TOTAL QUANTITY	UNITS	PERCENTAGE OF All DISTRESS
LONG.& TRANS. CRACK	LOW	497	1,452	L.F.	100

APPROXIMATE AMOUNT OF DISTRESS RELATED TO LOAD ON THE PAVEMENT IS: 0 %  
 APPROXIMATE AMOUNT OF DISTRESS RELATED TO MATERIALS PROBLEMS IN THE FEATURE IS: 67 %  
 APPROXIMATE AMOUNT OF DISTRESS RELATED TO AGE OF PAVEMENT AND TRAFFIC REPETITIONS IS: 33 %

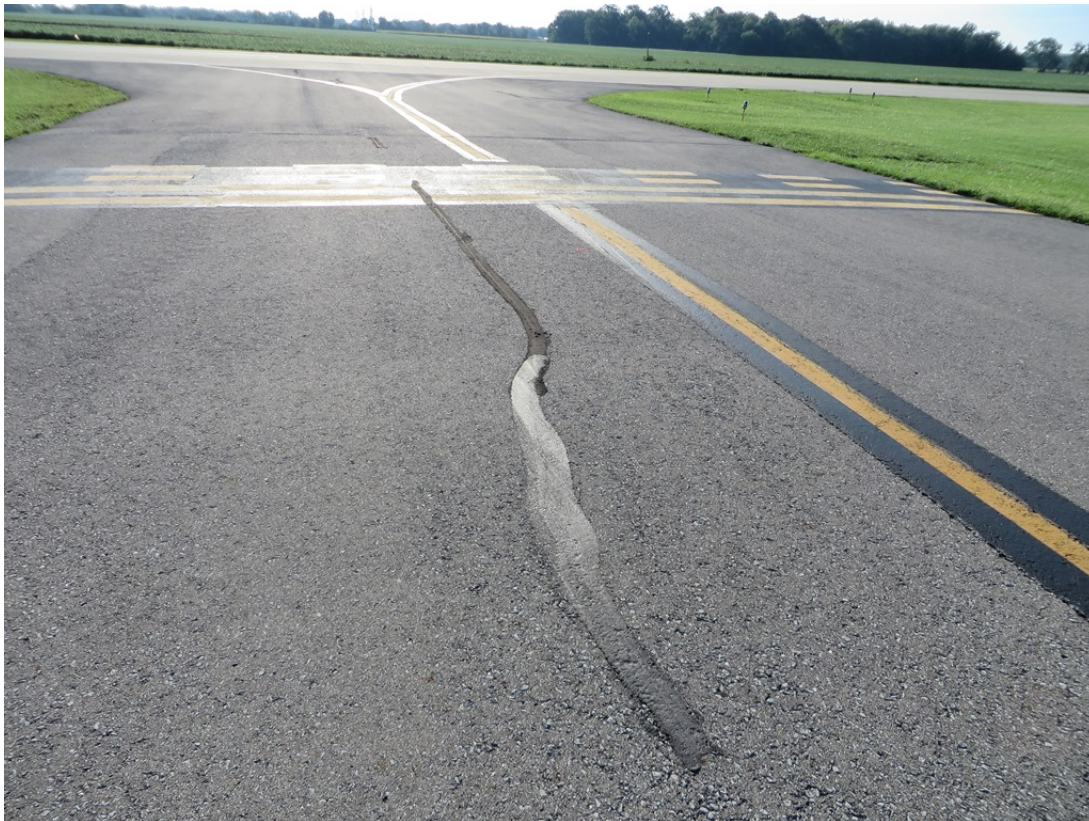
DISTRESS TYPE	SEVERITY	MEASURED QUANTITY	ESTIMATED TOTAL QUANTITY	UNITS	PERCENTAGE OF All DISTRESS
LONG.& TRANS. CRACK	LOW	127	143	L.F.	100

APPROXIMATE AMOUNT OF DISTRESS RELATED TO LOAD ON THE PAVEMENT IS:	0 %
APPROXIMATE AMOUNT OF DISTRESS RELATED TO MATERIALS PROBLEMS IN THE FEATURE IS:	67 %
APPROXIMATE AMOUNT OF DISTRESS RELATED TO AGE OF PAVEMENT AND TRAFFIC REPETITIONS IS:	33 %

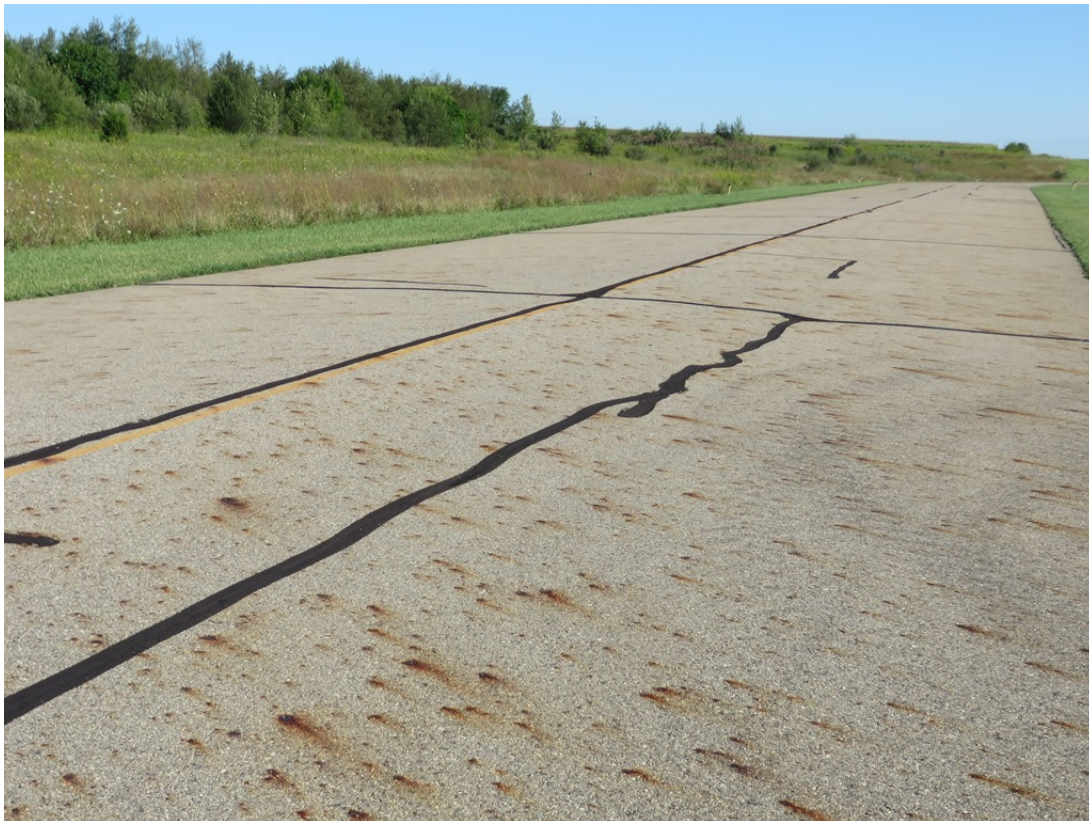
DISTRESS TYPE	SEVERITY	MEASURED QUANTITY	ESTIMATED TOTAL QUANTITY	UNITS	PERCENTAGE OF ALL DISTRESS
LONG.& TRANS. CRACK	LOW	2,114	7,633	L.F.	100

APPROXIMATE AMOUNT OF DISTRESS RELATED TO LOAD ON THE PAVEMENT IS:	0 %
APPROXIMATE AMOUNT OF DISTRESS RELATED TO MATERIALS PROBLEMS IN THE FEATURE IS:	67 %
APPROXIMATE AMOUNT OF DISTRESS RELATED TO AGE OF PAVEMENT AND TRAFFIC REPETITIONS IS:	33 %

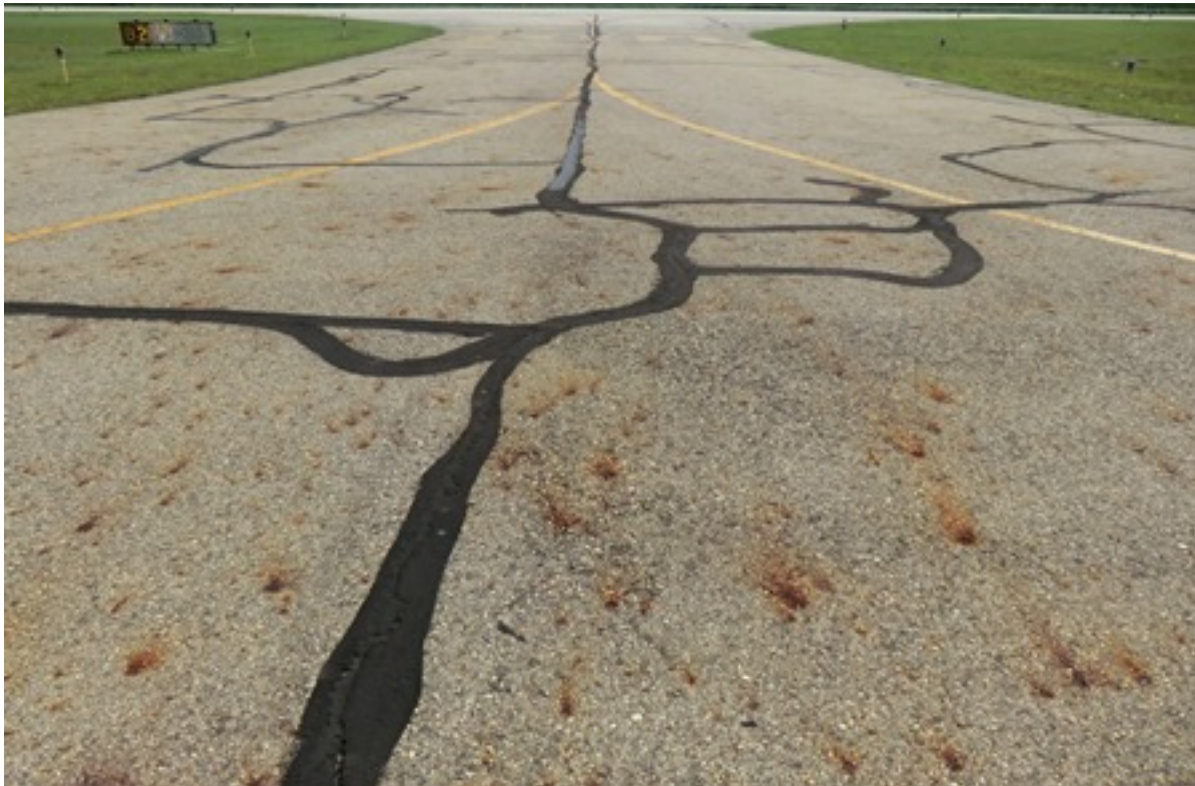
DISTRESS TYPE	SEVERITY	MEASURED QUANTITY	ESTIMATED TOTAL QUANTITY	UNITS	PERCENTAGE OF ALL DISTRESS
LONG.& TRANS. CRACK	LOW	531	558	L.F.	97.6
WEATHERING	MED	55	57	S.F.	2.3

APPROXIMATE AMOUNT OF DISTRESS RELATED TO LOAD ON THE PAVEMENT IS:	0 %
APPROXIMATE AMOUNT OF DISTRESS RELATED TO MATERIALS PROBLEMS IN THE FEATURE IS:	66 %
APPROXIMATE AMOUNT OF DISTRESS RELATED TO AGE OF PAVEMENT AND TRAFFIC REPETITIONS IS:	34 %

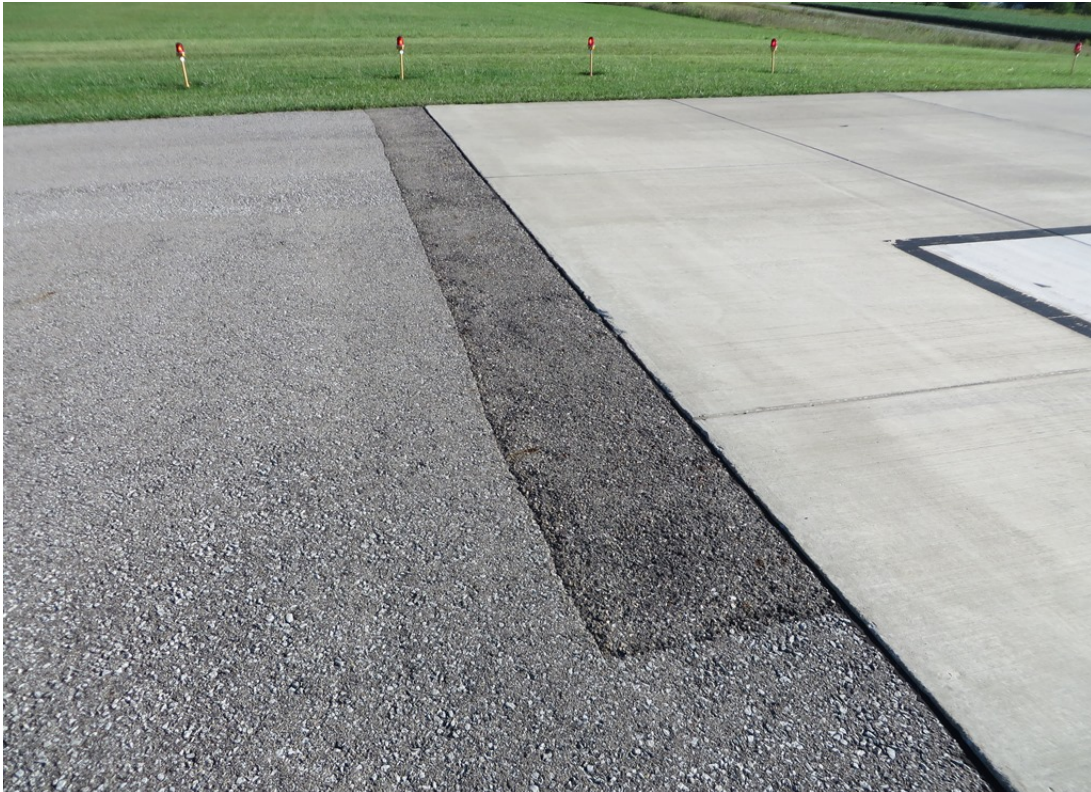
DISTRESS TYPE	SEVERITY	MEASURED QUANTITY	ESTIMATED TOTAL QUANTITY	UNITS	PERCENTAGE OF All DISTRESS
LONG.& TRANS. CRACK	LOW	50	621	L.F.	47.6
PATCH & UTILITY CUT	LOW	60	746	S.F.	52.3

APPROXIMATE AMOUNT OF DISTRESS RELATED TO LOAD ON THE PAVEMENT IS:	35 %
APPROXIMATE AMOUNT OF DISTRESS RELATED TO MATERIALS PROBLEMS IN THE FEATURE IS:	49 %
APPROXIMATE AMOUNT OF DISTRESS RELATED TO AGE OF PAVEMENT AND TRAFFIC REPETITIONS IS:	16 %

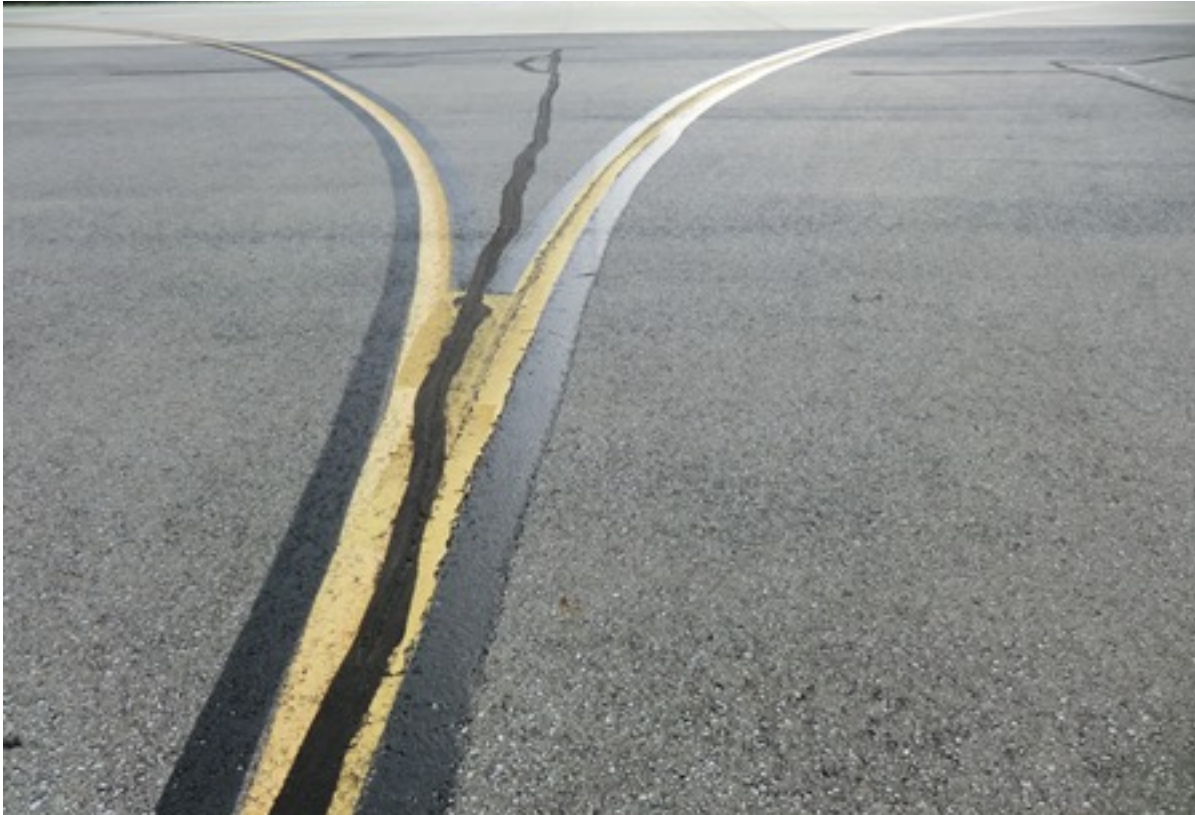
DISTRESS TYPE	SEVERITY	MEASURED QUANTITY	ESTIMATED TOTAL QUANTITY	UNITS	PERCENTAGE OF All DISTRESS
LONG.& TRANS. CRACK	LOW	233	414	L.F.	100

APPROXIMATE AMOUNT OF DISTRESS RELATED TO LOAD ON THE PAVEMENT IS:	0 %
APPROXIMATE AMOUNT OF DISTRESS RELATED TO MATERIALS PROBLEMS IN THE FEATURE IS:	67 %
APPROXIMATE AMOUNT OF DISTRESS RELATED TO AGE OF PAVEMENT AND TRAFFIC REPETITIONS IS:	33 %

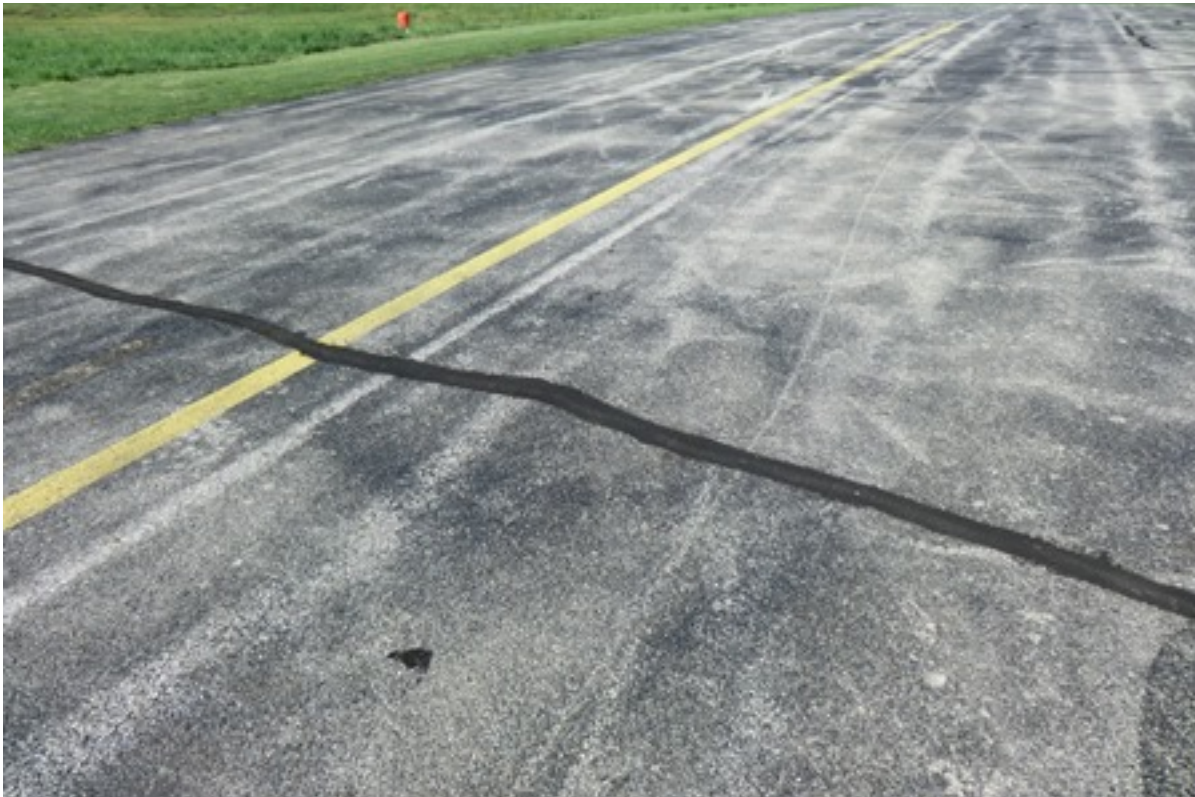
DISTRESS TYPE	SEVERITY	MEASURED QUANTITY	ESTIMATED TOTAL QUANTITY	UNITS	PERCENTAGE OF All DISTRESS
LONG.& TRANS. CRACK	MED	3	6	L.F.	15.2
LONG.& TRANS. CRACK	LOW	231	530	L.F.	84.7

APPROXIMATE AMOUNT OF DISTRESS RELATED TO LOAD ON THE PAVEMENT IS:	0 %
APPROXIMATE AMOUNT OF DISTRESS RELATED TO MATERIALS PROBLEMS IN THE FEATURE IS:	67 %
APPROXIMATE AMOUNT OF DISTRESS RELATED TO AGE OF PAVEMENT AND TRAFFIC REPETITIONS IS:	33 %

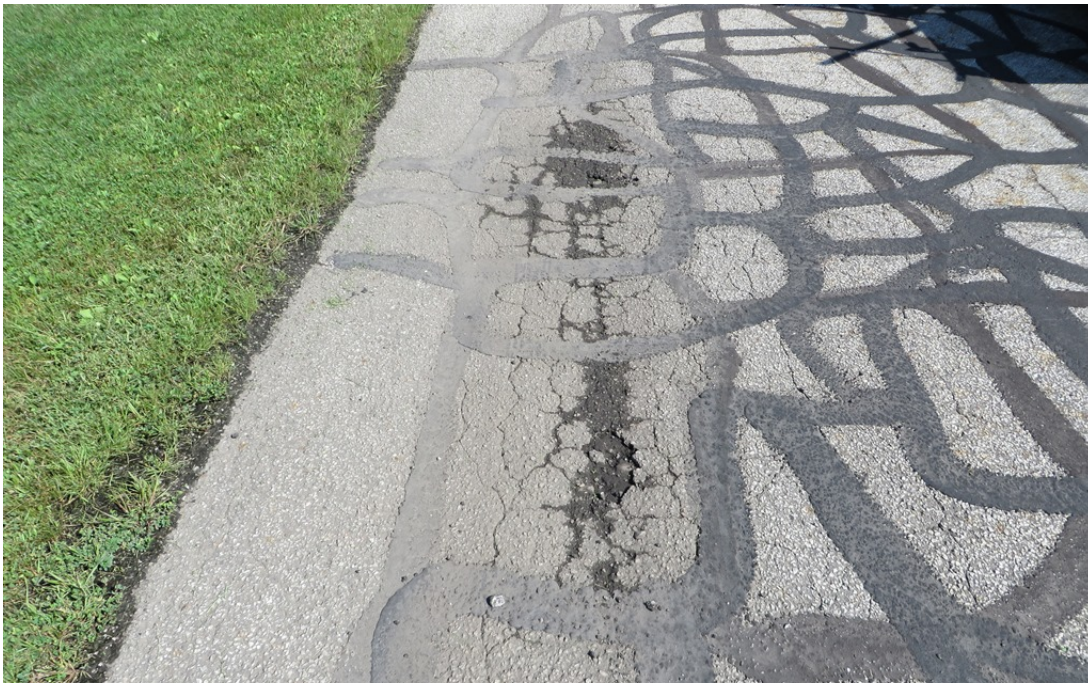
DISTRESS TYPE	SEVERITY	MEASURED QUANTITY	ESTIMATED TOTAL QUANTITY	UNITS	PERCENTAGE OF All DISTRESS
ALLIGATOR CRACKING	MED	87	203	S.F.	19.6
ALLIGATOR CRACKING	LOW	20	46	S.F.	6
LONG.& TRANS. CRACK	MED	86	201	L.F.	8.3
LONG.& TRANS. CRACK	LOW	801	1,876	L.F.	26.9
RAVELING	LOW	150	351	S.F.	3.6
RUTTING	MED	252	590	S.F.	22
RUTTING	LOW	210	492	S.F.	13.2

APPROXIMATE AMOUNT OF DISTRESS RELATED TO LOAD ON THE PAVEMENT IS:	49 %
APPROXIMATE AMOUNT OF DISTRESS RELATED TO MATERIALS PROBLEMS IN THE FEATURE IS:	37 %
APPROXIMATE AMOUNT OF DISTRESS RELATED TO AGE OF PAVEMENT AND TRAFFIC REPETITIONS IS:	14 %

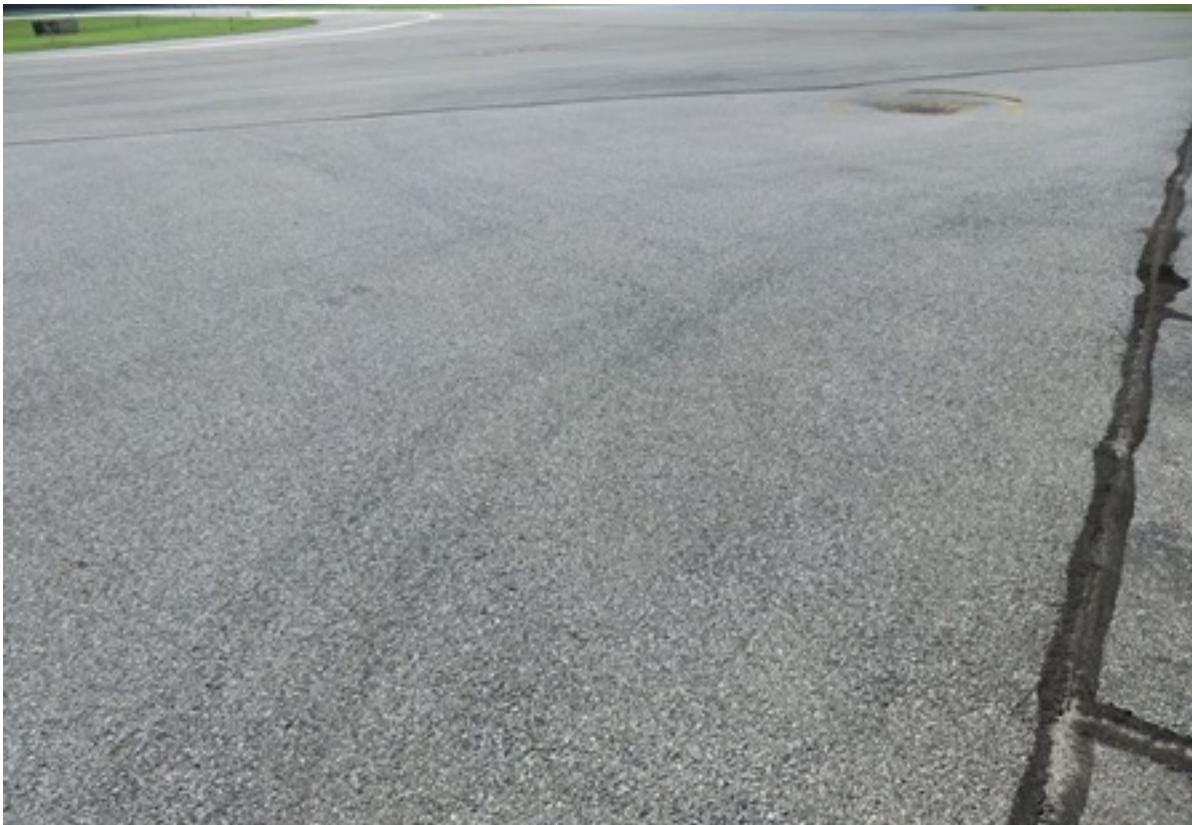
DISTRESS TYPE	SEVERITY	MEASURED QUANTITY	ESTIMATED TOTAL QUANTITY	UNITS	PERCENTAGE OF All DISTRESS
LONG.& TRANS. CRACK	LOW	92	106	L.F.	100

APPROXIMATE AMOUNT OF DISTRESS RELATED TO LOAD ON THE PAVEMENT IS:	0 %
APPROXIMATE AMOUNT OF DISTRESS RELATED TO MATERIALS PROBLEMS IN THE FEATURE IS:	67 %
APPROXIMATE AMOUNT OF DISTRESS RELATED TO AGE OF PAVEMENT AND TRAFFIC REPETITIONS IS:	33 %

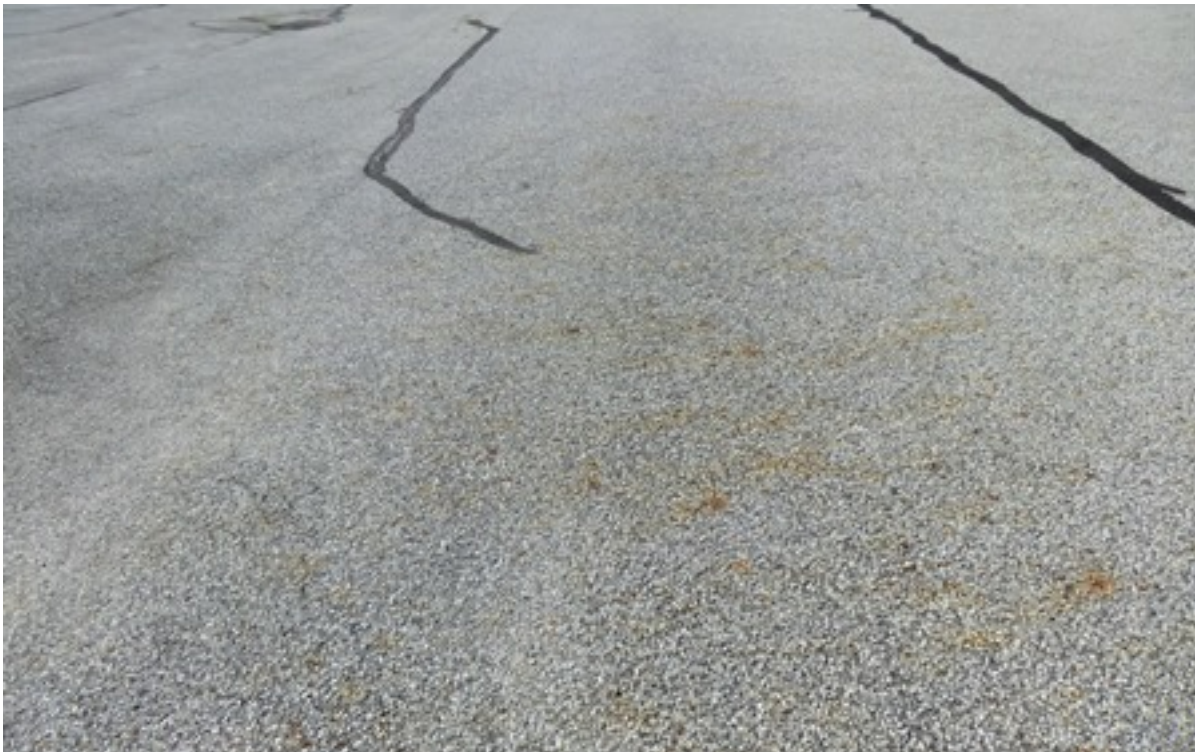
DISTRESS TYPE	SEVERITY	MEASURED QUANTITY	ESTIMATED TOTAL QUANTITY	UNITS	PERCENTAGE OF All DISTRESS
LONG.& TRANS. CRACK	LOW	218	399	L.F.	19.5
RUTTING	MED	90	164	S.F.	29.1
RUTTING	LOW	193	353	S.F.	36.1
WEATHERING	MED	1,000	1,831	S.F.	15.1

APPROXIMATE AMOUNT OF DISTRESS RELATED TO LOAD ON THE PAVEMENT IS:	44 %
APPROXIMATE AMOUNT OF DISTRESS RELATED TO MATERIALS PROBLEMS IN THE FEATURE IS:	40 %
APPROXIMATE AMOUNT OF DISTRESS RELATED TO AGE OF PAVEMENT AND TRAFFIC REPETITIONS IS:	17 %

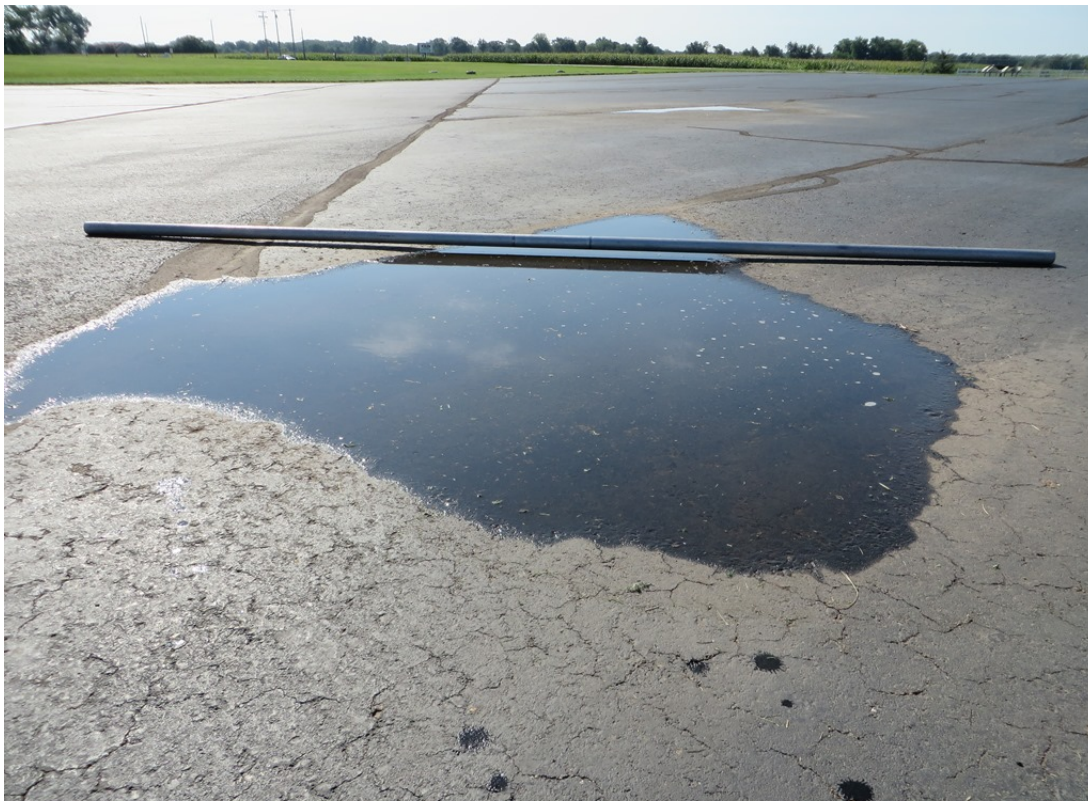
DISTRESS TYPE	SEVERITY	MEASURED QUANTITY	ESTIMATED TOTAL QUANTITY	UNITS	PERCENTAGE OF All DISTRESS
DEPRESSION	LOW	64	103	S.F.	19.9
LONG.& TRANS. CRACK	LOW	529	851	L.F.	80

APPROXIMATE AMOUNT OF DISTRESS RELATED TO LOAD ON THE PAVEMENT IS:	0 %
APPROXIMATE AMOUNT OF DISTRESS RELATED TO MATERIALS PROBLEMS IN THE FEATURE IS:	73 %
APPROXIMATE AMOUNT OF DISTRESS RELATED TO AGE OF PAVEMENT AND TRAFFIC REPETITIONS IS:	27 %

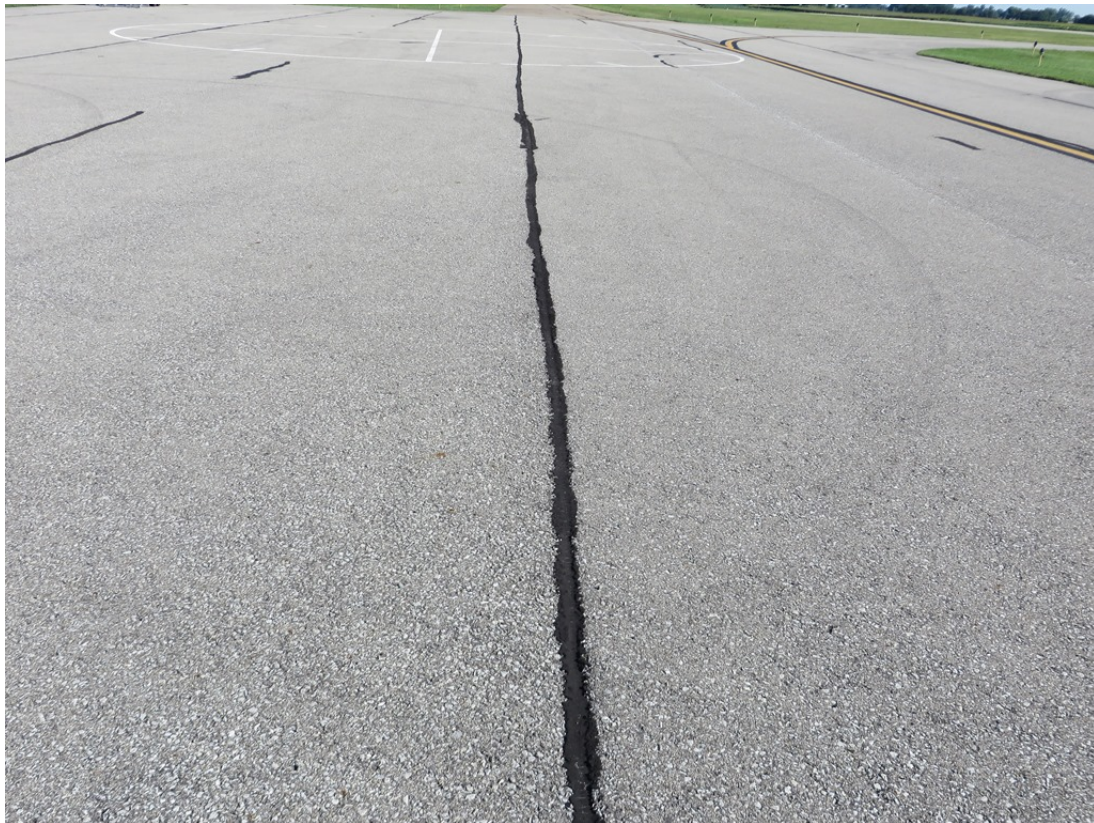
DISTRESS TYPE	SEVERITY	MEASURED QUANTITY	ESTIMATED TOTAL QUANTITY	UNITS	PERCENTAGE OF All DISTRESS
LONG.& TRANS. CRACK	LOW	428	864	L.F.	100

APPROXIMATE AMOUNT OF DISTRESS RELATED TO LOAD ON THE PAVEMENT IS:	0 %
APPROXIMATE AMOUNT OF DISTRESS RELATED TO MATERIALS PROBLEMS IN THE FEATURE IS:	67 %
APPROXIMATE AMOUNT OF DISTRESS RELATED TO AGE OF PAVEMENT AND TRAFFIC REPETITIONS IS:	33 %

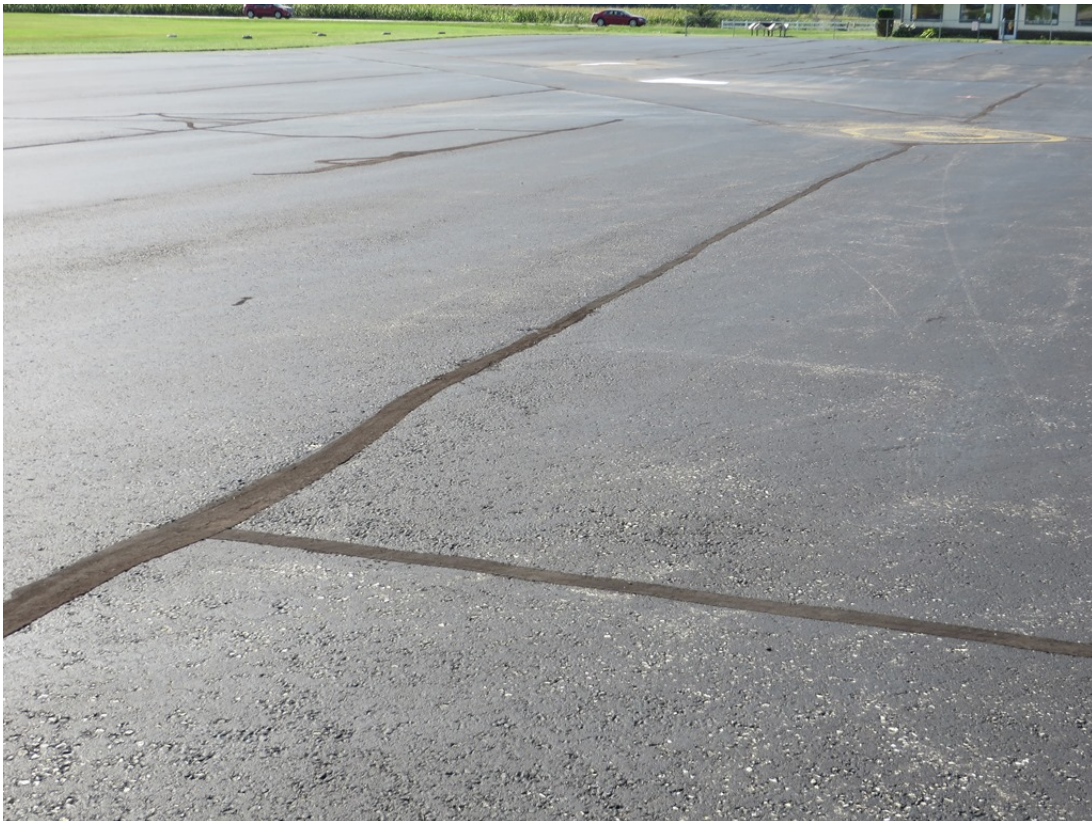
DISTRESS TYPE	SEVERITY	MEASURED QUANTITY	ESTIMATED TOTAL QUANTITY	UNITS	PERCENTAGE OF ALL DISTRESS
LONG.& TRANS. CRACK	LOW	420	546	L.F.	100

APPROXIMATE AMOUNT OF DISTRESS RELATED TO LOAD ON THE PAVEMENT IS:	0 %
APPROXIMATE AMOUNT OF DISTRESS RELATED TO MATERIALS PROBLEMS IN THE FEATURE IS:	67 %
APPROXIMATE AMOUNT OF DISTRESS RELATED TO AGE OF PAVEMENT AND TRAFFIC REPETITIONS IS:	33 %

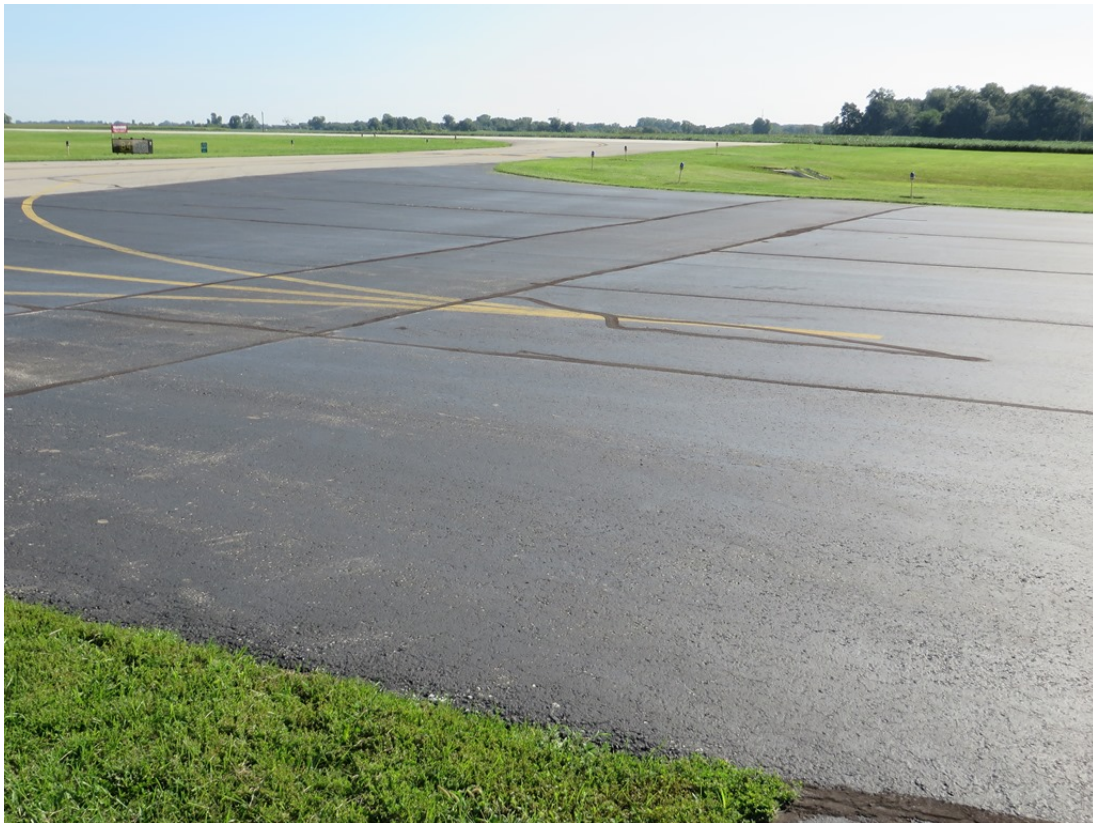
DISTRESS TYPE	SEVERITY	MEASURED QUANTITY	ESTIMATED TOTAL QUANTITY	UNITS	PERCENTAGE OF All DISTRESS
LONG.& TRANS. CRACK	LOW	214	214	L.F.	100

APPROXIMATE AMOUNT OF DISTRESS RELATED TO LOAD ON THE PAVEMENT IS:	0 %
APPROXIMATE AMOUNT OF DISTRESS RELATED TO MATERIALS PROBLEMS IN THE FEATURE IS:	67 %
APPROXIMATE AMOUNT OF DISTRESS RELATED TO AGE OF PAVEMENT AND TRAFFIC REPETITIONS IS:	33 %

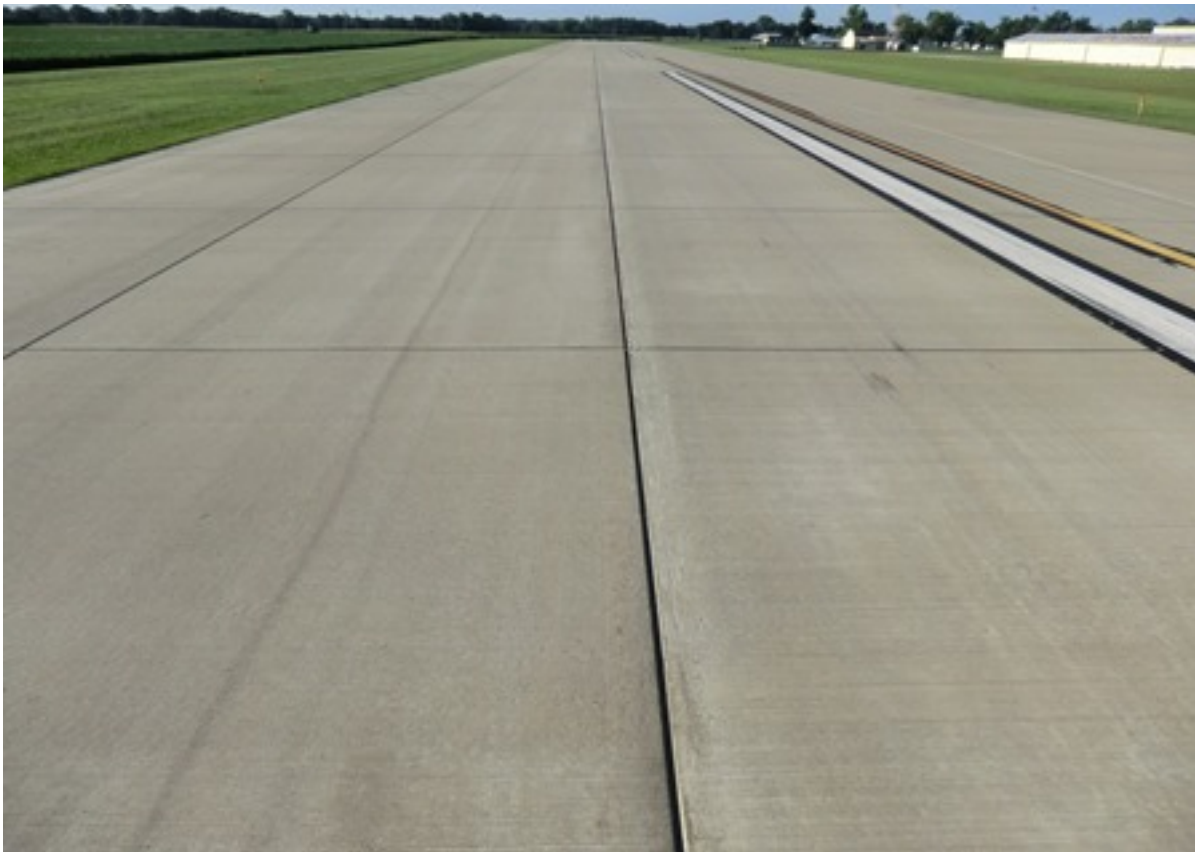
APPROXIMATE AMOUNT OF DISTRESS RELATED TO LOAD ON THE PAVEMENT IS:	0 %
APPROXIMATE AMOUNT OF DISTRESS RELATED TO MATERIALS PROBLEMS IN THE FEATURE IS:	0 %
APPROXIMATE AMOUNT OF DISTRESS RELATED TO AGE OF PAVEMENT AND TRAFFIC REPETITIONS IS:	0 %
