Pavement Condition Report

Michigan City Municipal Airport

Project 13801869

January 2013

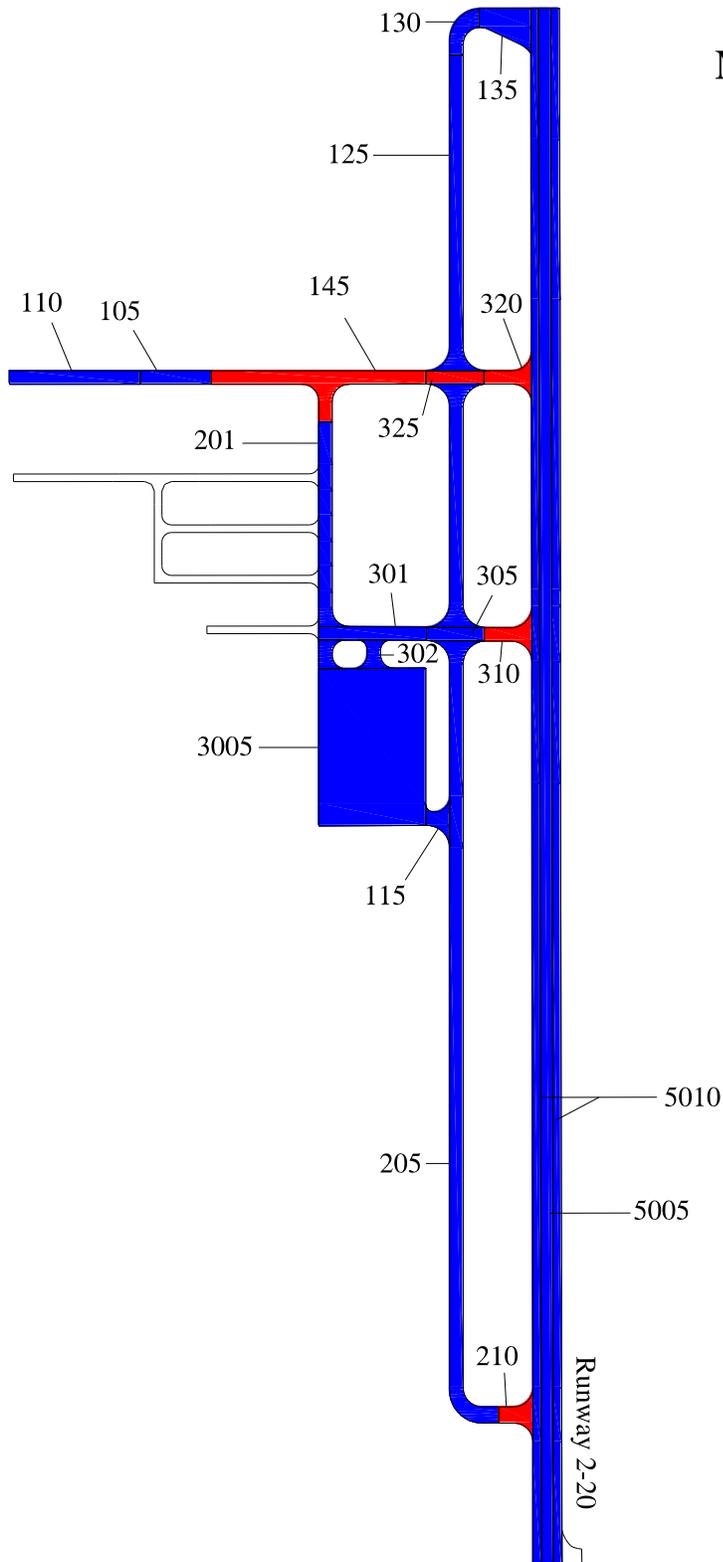
2012 PCI Inspection

Analysis of potential maintenance projects identified approximately 12,000 square feet of patching needs and approximately 34,000 linear feet of crack sealing and crack repair needs, at an estimated total cost of approximately \$180,000.

- Patching
- Crack Sealing
- Both

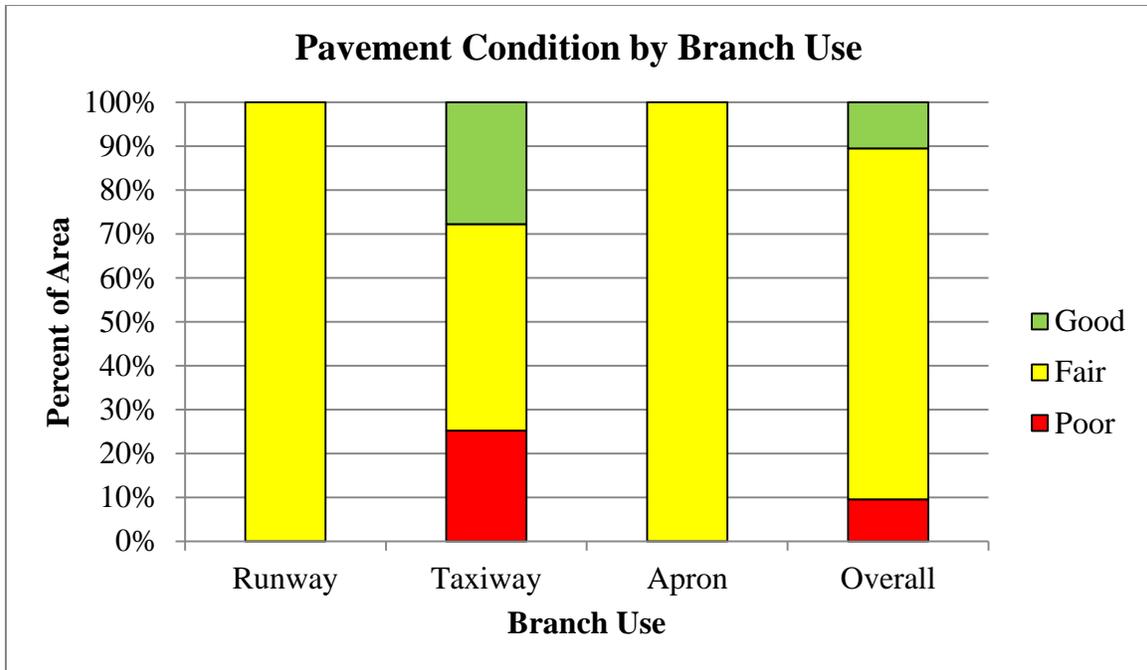
Figure 2-2. Pavement Condition by Branch Use

The overall Pavement Condition Index (PCI) for the airfield pavements was 64. Runways had an average inspected PCI of 69 and were above the desired MSL of 60. Taxiways had an average inspected PCI of 62, and ramps had an average inspected PCI of 59.

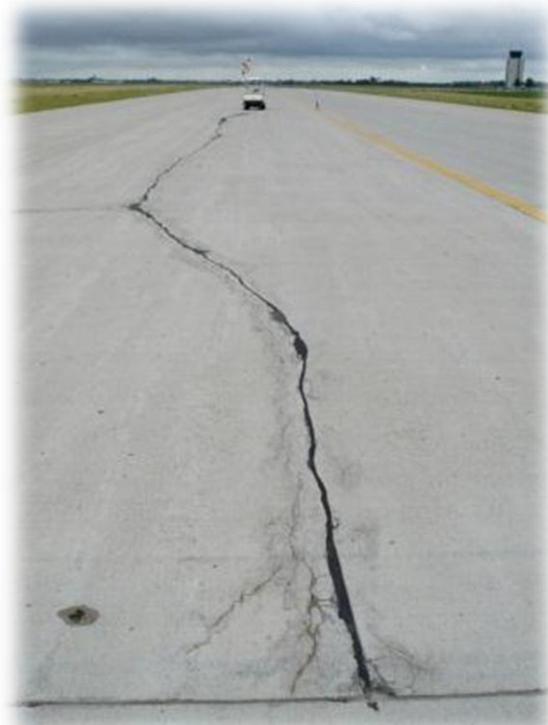
Longitudinal, Transverse & Diagonal Cracking

LTD cracking is often a result of load or temperature deformations. External loads cause flexure. Temperature changes can cause curling. When any of these stresses exceed the slab strength, cracking occurs.

LTD cracking is recorded at low, medium, or high severity, depending on the width of crack opening and degree of deterioration.

At low severity, a crack is less than 1/8 inch wide with little spalling, and no corrective action is indicated. At medium severity, LTD cracks can be up to 1 inch wide with moderate spalling and should be repaired using procedures similar to joint sealing. At high severity, cracks exceed 1 inch in width and may be severely spalled. High-severity LTD cracking is evidence of serious load failure, and correction may require patching or slab replacement. If distress occurs in several adjacent slabs at medium or high severity, major rehabilitation of that area is indicated.

A slab divided into four or more pieces is said to be “divided” or “shattered.” Shattered slab is a separate distress category and indicates a significant structural failure. A shattered slab has lost its ability to distribute loads. Shattered slabs are rated in three severities, but the recommended action in any case is slab replacement.
