Pavement Condition Report

Monticello-White County Airport

Project 15805741

February 2015

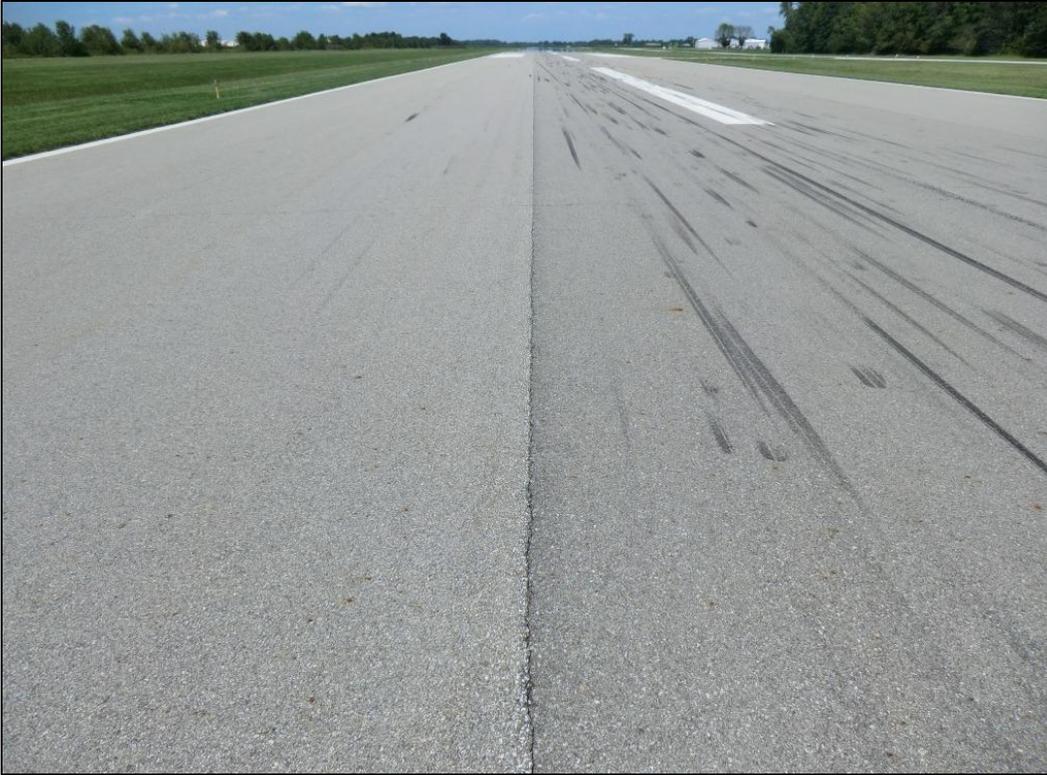
Figure 2-4. Typical Satisfactory AC Pavement (Feature 6110)

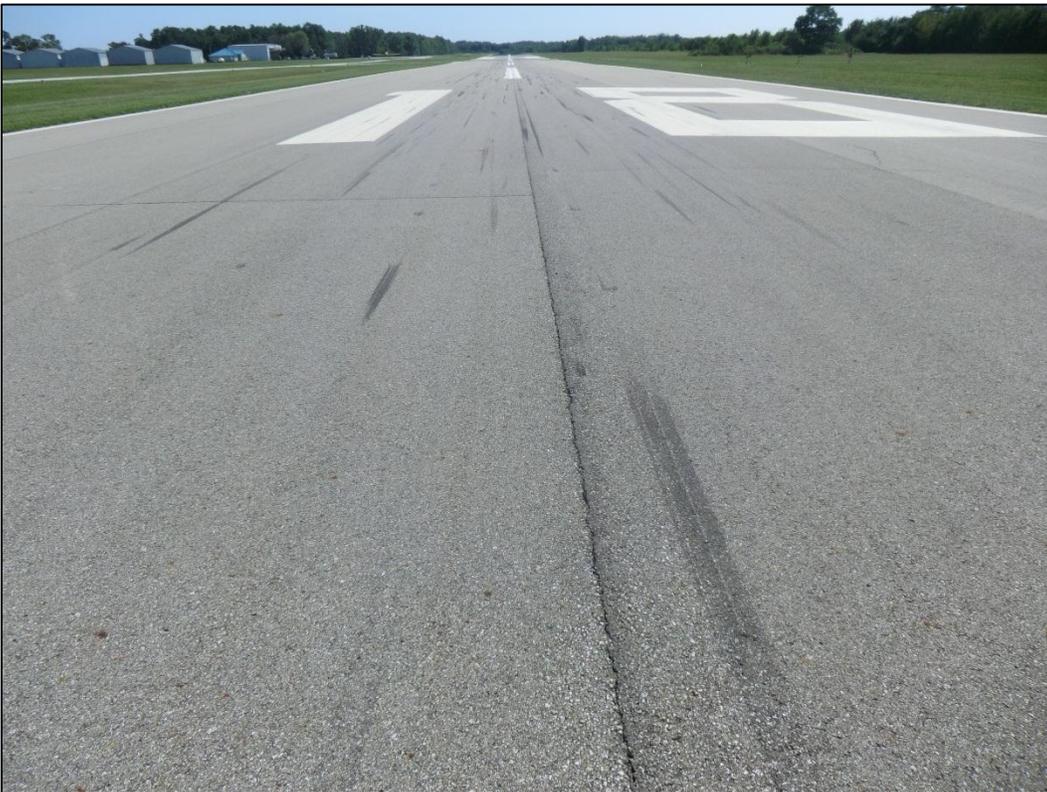
Figure 2-5. Typical Satisfactory AC Pavement (Feature 6115)

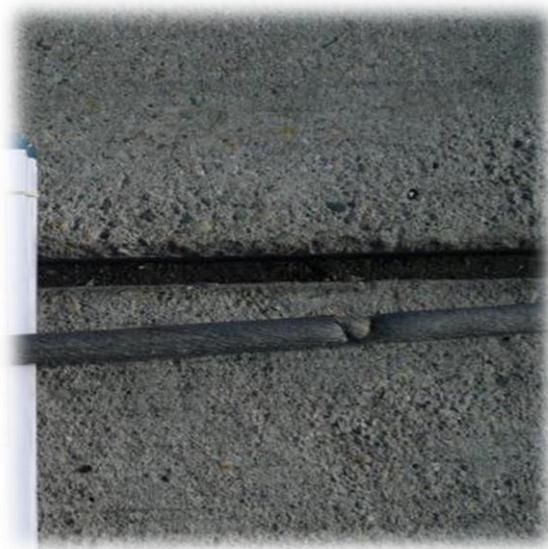
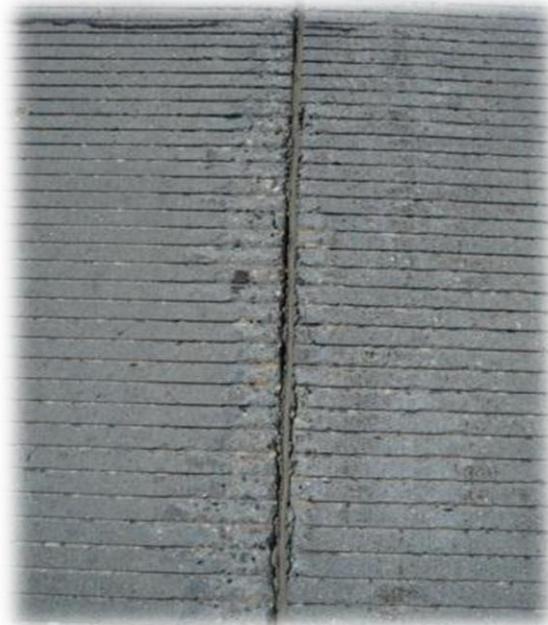
Joint Seal Damage

When joint sealant is in perfect condition (no damage), there is no distress.

At low severity, at least 10 percent of the sealant is debonded but still in contact with the joint edges. Medium-severity joint seal damage is recorded when at least 10 percent of the sealant has visible gaps smaller than 1/8 inch and is an indicator that replacement should be programmed as soon as is practical. In the meantime, aggressive inspection and sustaining maintenance is recommended to minimize subsurface damage from moisture penetration. At high severity, visible gaps exceed 1/8 inch, and the amount and degree of joint seal damage typically requires complete removal and replacement of the existing sealant.

On serviceable pavement, deteriorated joint sealant should be repaired or replaced to preserve pavement and subgrade integrity and prolong service life. The issue is not so clear-cut with unserviceable pavement. Pavement that can be restored to serviceable condition by maintenance activities such as patching and joint seal repair, or by slab replacement, should be so maintained as long as the process is cost-effective. However, when age and condition preclude economical return to serviceable condition by such means, joint seal repair would no longer be cost-effective and should be suspended except for an interim maintenance program to control FOD potential.

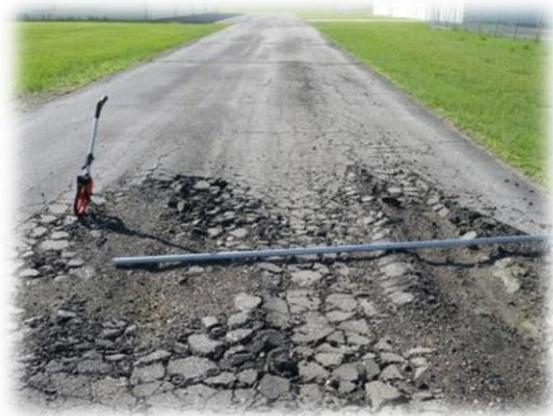
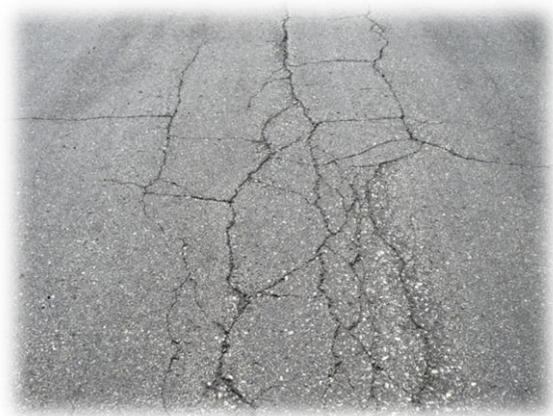
Alligator Cracking

Alligator cracks are a series of interconnected load-related cracks caused by fatigue of the asphalt surface. Alligator cracking is a significant structural distress and develops only in places subject to traffic loads. These cracks typically initiate at the bottom of the asphalt layer and propagate upward. Once a fatigue crack is visible at the surface, significant damage has already occurred.

At low severity, alligator cracks are evidenced by a series of parallel hairline cracks (usually in a wheel path). Medium-severity alligator cracking is a well-defined pattern of interconnected cracks, and some spalling may be present. High-severity alligator cracks have lost aggregate interlock between adjacent pieces, and the cracks may be severely spalled with FOD potential. Most likely, the pieces will move freely under traffic.

Alligator cracking is a serious structural failure that cannot be repaired with sealant. The proper repair is patching.

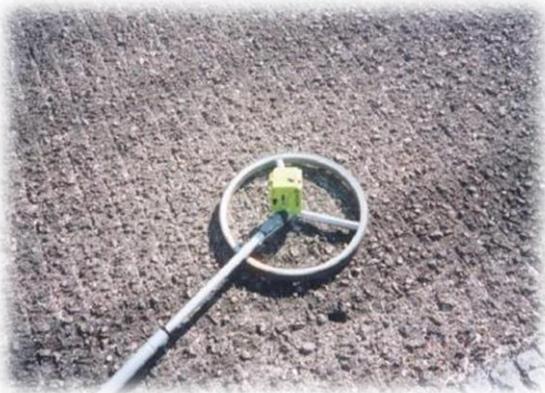
Raveling/Weathering

Raveling and weathering are the wearing away of the pavement surface. Failure can be caused by the dislodging of aggregate particles or the loss of asphalt binder. These distresses are usually evident over large areas and may indicate that the asphalt binder has hardened significantly.

Raveling: At low severity, 5 to 20 coarse aggregate particles are missing per square yard. Medium severity is defined by 20 to 40 missing coarse aggregate particles per square yard. At high severity, more than 40 coarse aggregate particles are missing per square yard, and the top layer of aggregate has eroded away.

Weathering: At low severity, edges of coarse aggregate are exposed less than 1 mm. At medium severity, loss of fine aggregate is noticeable and edges of coarse aggregate are exposed up to 6 mm (1/4 inch). High severity weathering has edges of coarse aggregate exposed > 6 mm, with considerable loss of fine aggregate matrix and potential for loss of coarse aggregate.

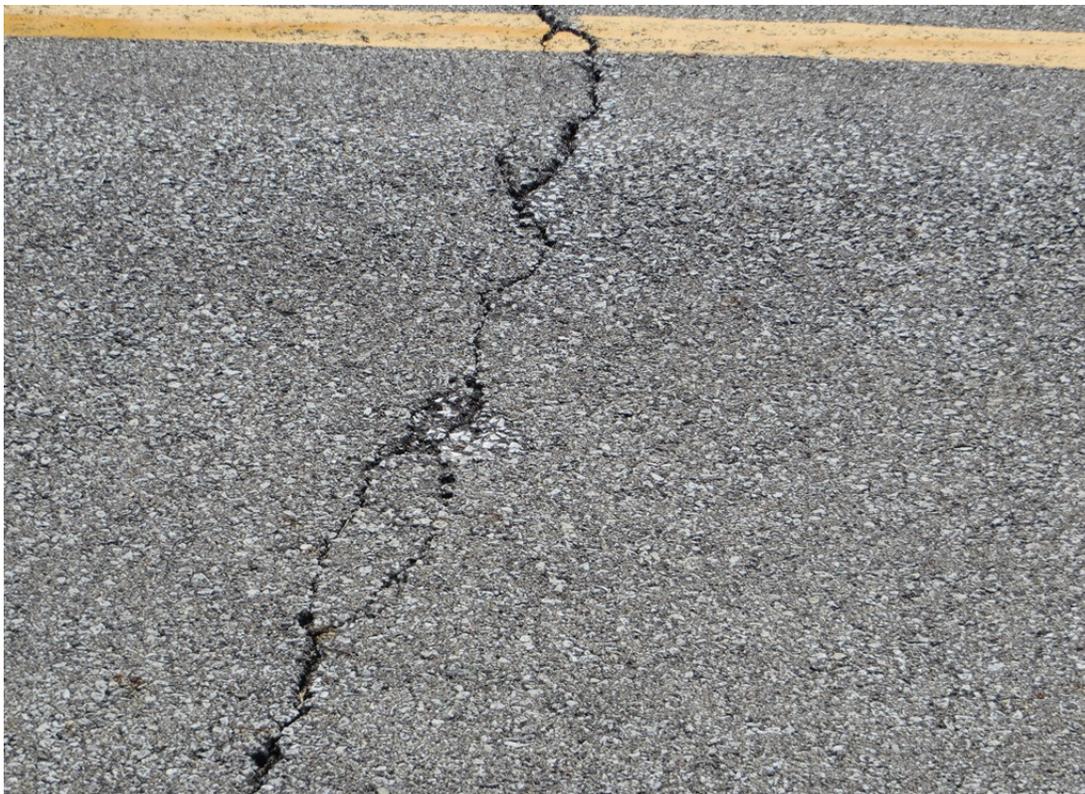
DISTRESS TYPE	SEVERITY	MEASURED QUANTITY	ESTIMATED TOTAL QUANTITY	UNITS	PERCENTAGE OF All DISTRESS
LONG.& TRANS. CRACK	MED	10	10	L.F.	61.5
LONG.& TRANS. CRACK	LOW	17	17	L.F.	38.4

APPROXIMATE AMOUNT OF DISTRESS RELATED TO LOAD ON THE PAVEMENT IS:	0 %
APPROXIMATE AMOUNT OF DISTRESS RELATED TO MATERIALS PROBLEMS IN THE FEATURE IS:	67 %
APPROXIMATE AMOUNT OF DISTRESS RELATED TO AGE OF PAVEMENT AND TRAFFIC REPETITIONS IS:	33 %

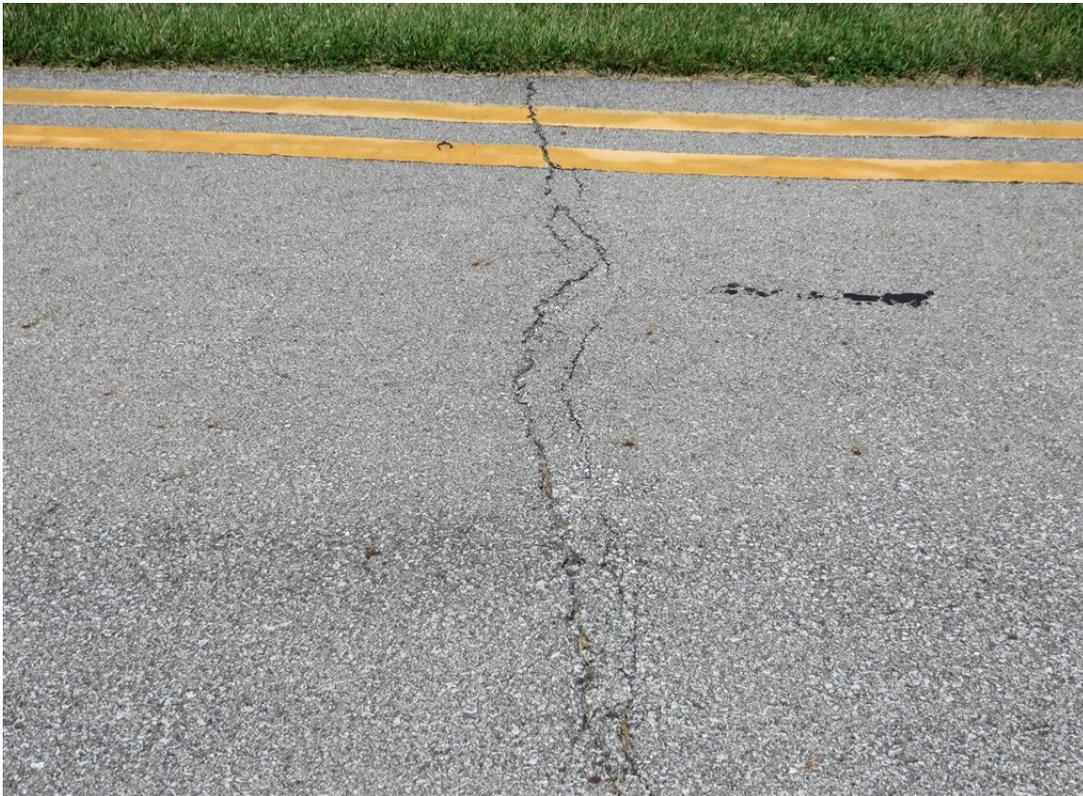
DISTRESS TYPE	SEVERITY	MEASURED QUANTITY	ESTIMATED TOTAL QUANTITY	UNITS	PERCENTAGE OF All DISTRESS
LONG.& TRANS. CRACK	MED	14	14	L.F.	66.2
LONG.& TRANS. CRACK	LOW	16	16	L.F.	33.7

APPROXIMATE AMOUNT OF DISTRESS RELATED TO LOAD ON THE PAVEMENT IS:	0 %
APPROXIMATE AMOUNT OF DISTRESS RELATED TO MATERIALS PROBLEMS IN THE FEATURE IS:	67 %
APPROXIMATE AMOUNT OF DISTRESS RELATED TO AGE OF PAVEMENT AND TRAFFIC REPETITIONS IS:	33 %

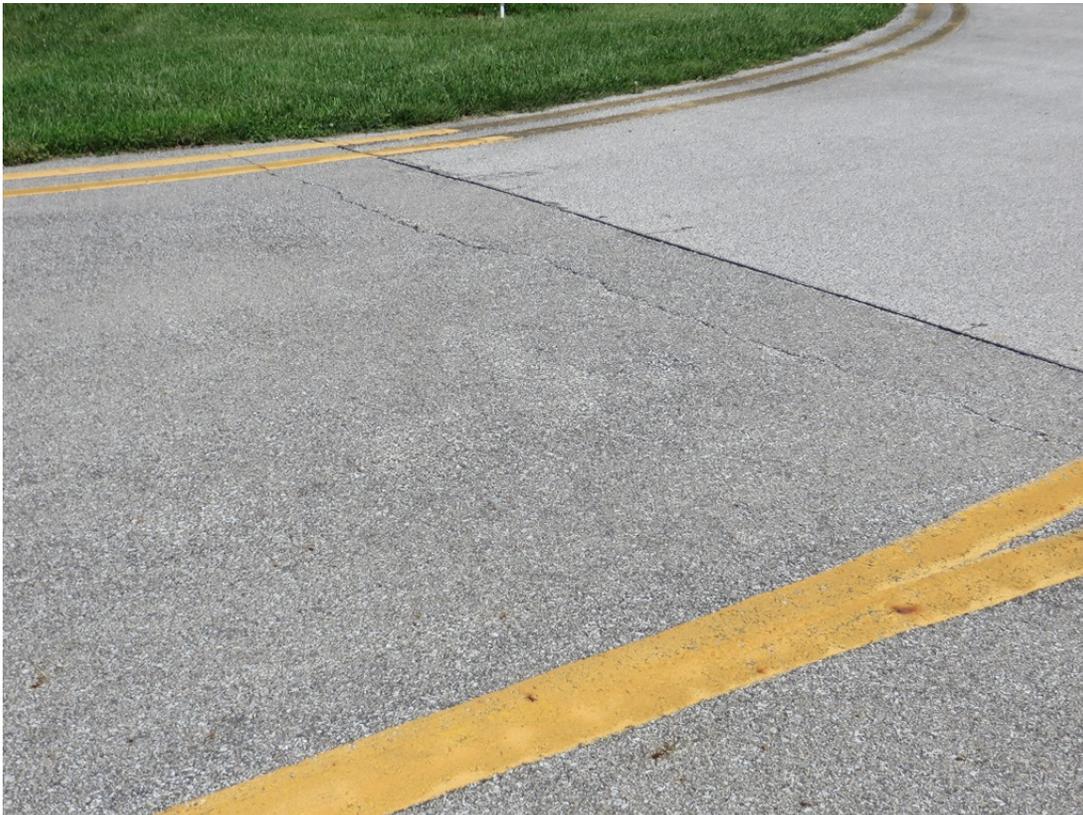
DISTRESS TYPE	SEVERITY	MEASURED QUANTITY	ESTIMATED TOTAL QUANTITY	UNITS	PERCENTAGE OF All DISTRESS
LONG.& TRANS. CRACK	LOW	55	55	L.F.	100

APPROXIMATE AMOUNT OF DISTRESS RELATED TO LOAD ON THE PAVEMENT IS:	0 %
APPROXIMATE AMOUNT OF DISTRESS RELATED TO MATERIALS PROBLEMS IN THE FEATURE IS:	67 %
APPROXIMATE AMOUNT OF DISTRESS RELATED TO AGE OF PAVEMENT AND TRAFFIC REPETITIONS IS:	33 %

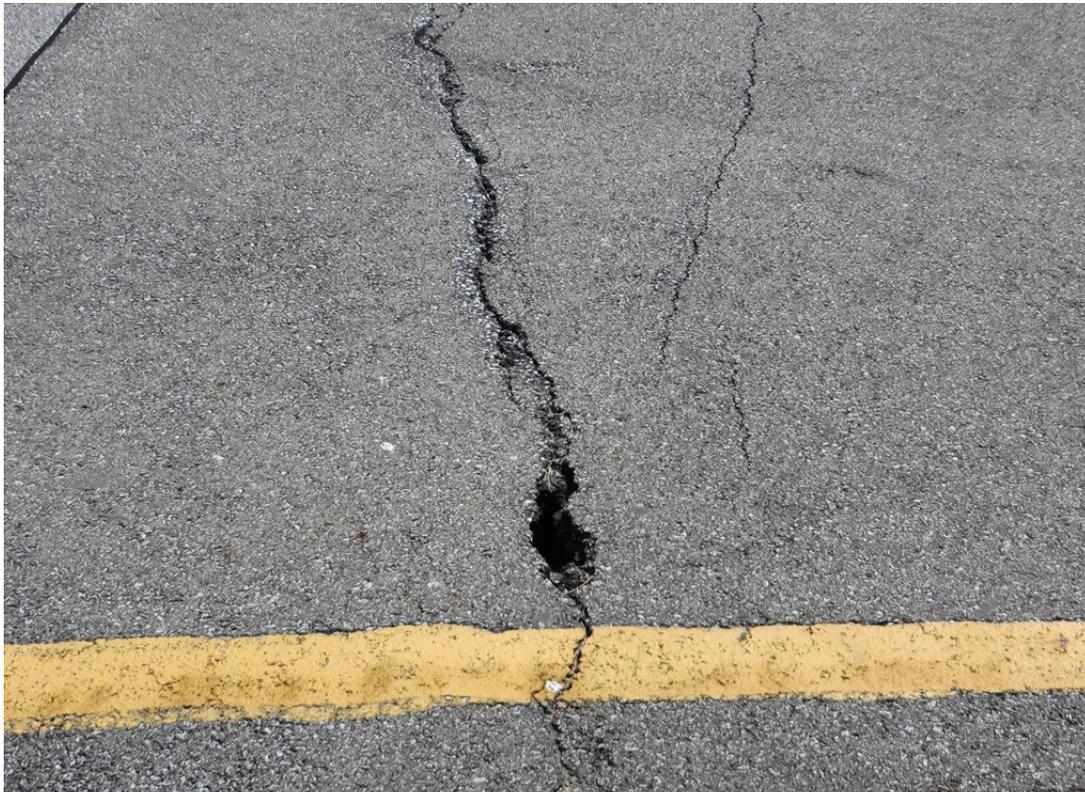
DISTRESS TYPE	SEVERITY	MEASURED QUANTITY	ESTIMATED TOTAL QUANTITY	UNITS	PERCENTAGE OF All DISTRESS
LONG.& TRANS. CRACK	HIGH	8	8	L.F.	67.1
LONG.& TRANS. CRACK	LOW	41	41	L.F.	32.8

APPROXIMATE AMOUNT OF DISTRESS RELATED TO LOAD ON THE PAVEMENT IS:	0 %
APPROXIMATE AMOUNT OF DISTRESS RELATED TO MATERIALS PROBLEMS IN THE FEATURE IS:	67 %
APPROXIMATE AMOUNT OF DISTRESS RELATED TO AGE OF PAVEMENT AND TRAFFIC REPETITIONS IS:	33 %

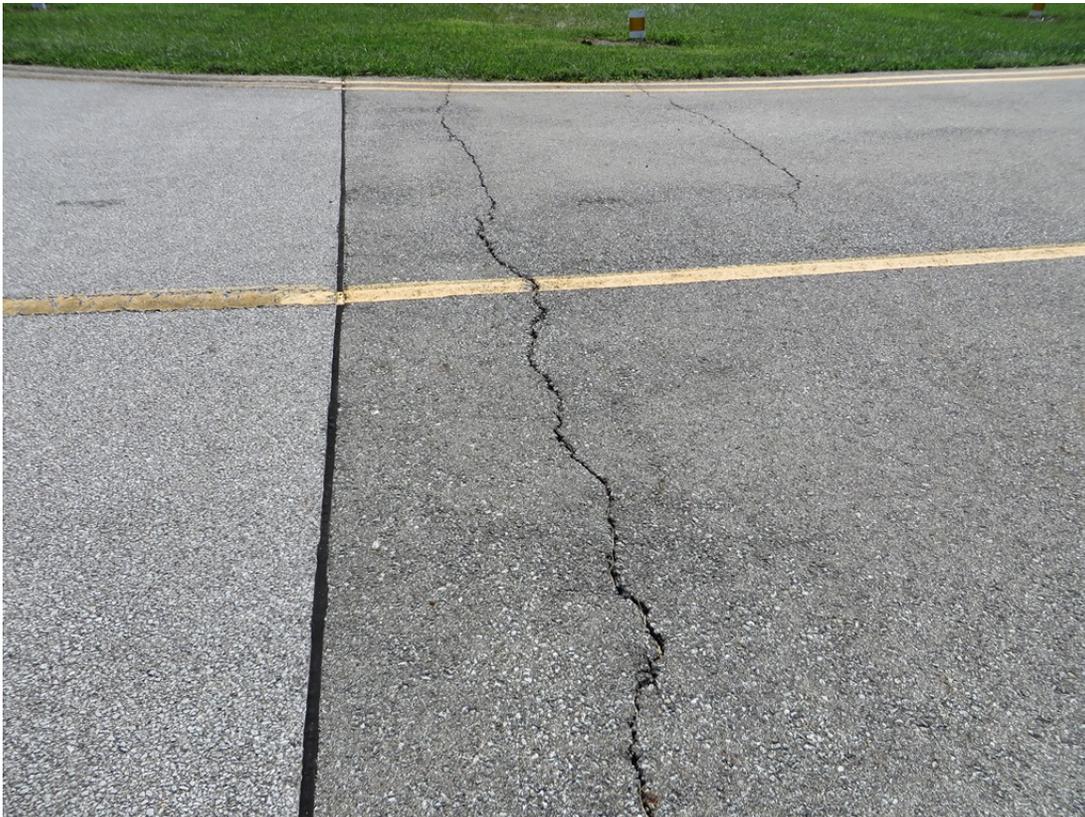
DISTRESS TYPE	SEVERITY	MEASURED QUANTITY	ESTIMATED TOTAL QUANTITY	UNITS	PERCENTAGE OF All DISTRESS
LONG.& TRANS. CRACK	LOW	53	67	L.F.	100

APPROXIMATE AMOUNT OF DISTRESS RELATED TO LOAD ON THE PAVEMENT IS:	0 %
APPROXIMATE AMOUNT OF DISTRESS RELATED TO MATERIALS PROBLEMS IN THE FEATURE IS:	67 %
APPROXIMATE AMOUNT OF DISTRESS RELATED TO AGE OF PAVEMENT AND TRAFFIC REPETITIONS IS:	33 %

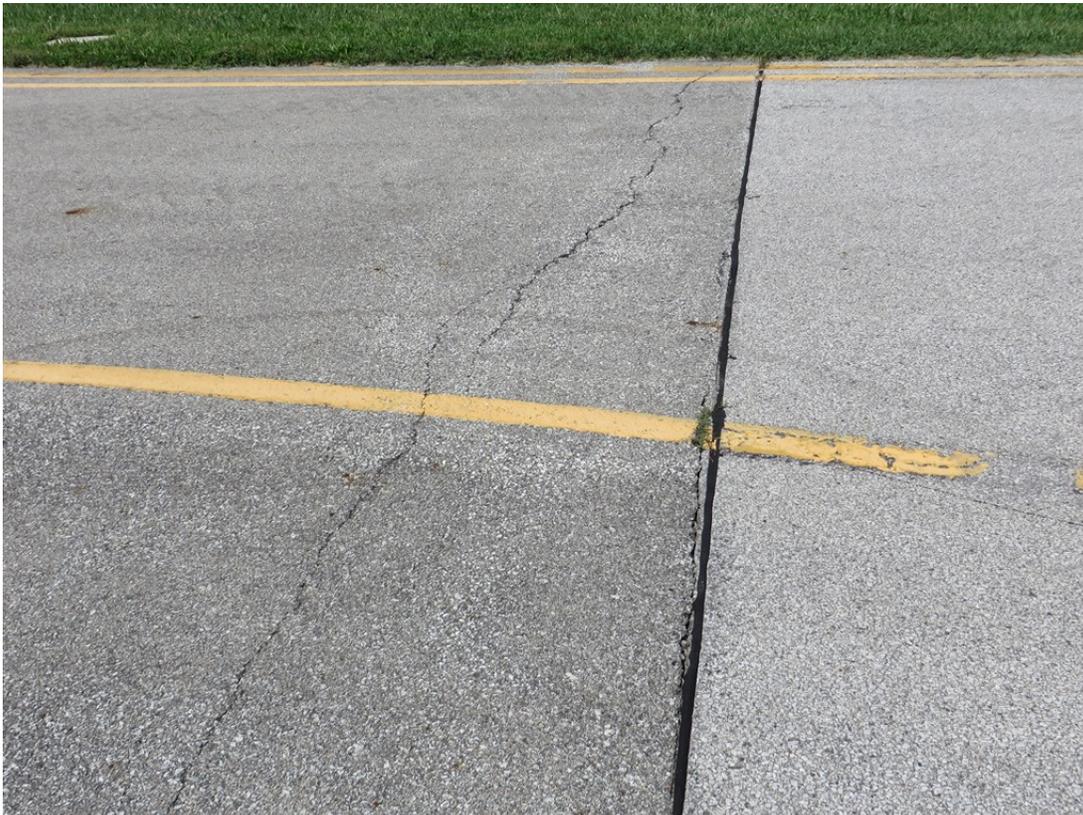
DISTRESS TYPE	SEVERITY	MEASURED QUANTITY	ESTIMATED TOTAL QUANTITY	UNITS	PERCENTAGE OF All DISTRESS
LONG.& TRANS. CRACK	LOW	39	42	L.F.	100

APPROXIMATE AMOUNT OF DISTRESS RELATED TO LOAD ON THE PAVEMENT IS:	0 %
APPROXIMATE AMOUNT OF DISTRESS RELATED TO MATERIALS PROBLEMS IN THE FEATURE IS:	67 %
APPROXIMATE AMOUNT OF DISTRESS RELATED TO AGE OF PAVEMENT AND TRAFFIC REPETITIONS IS:	33 %

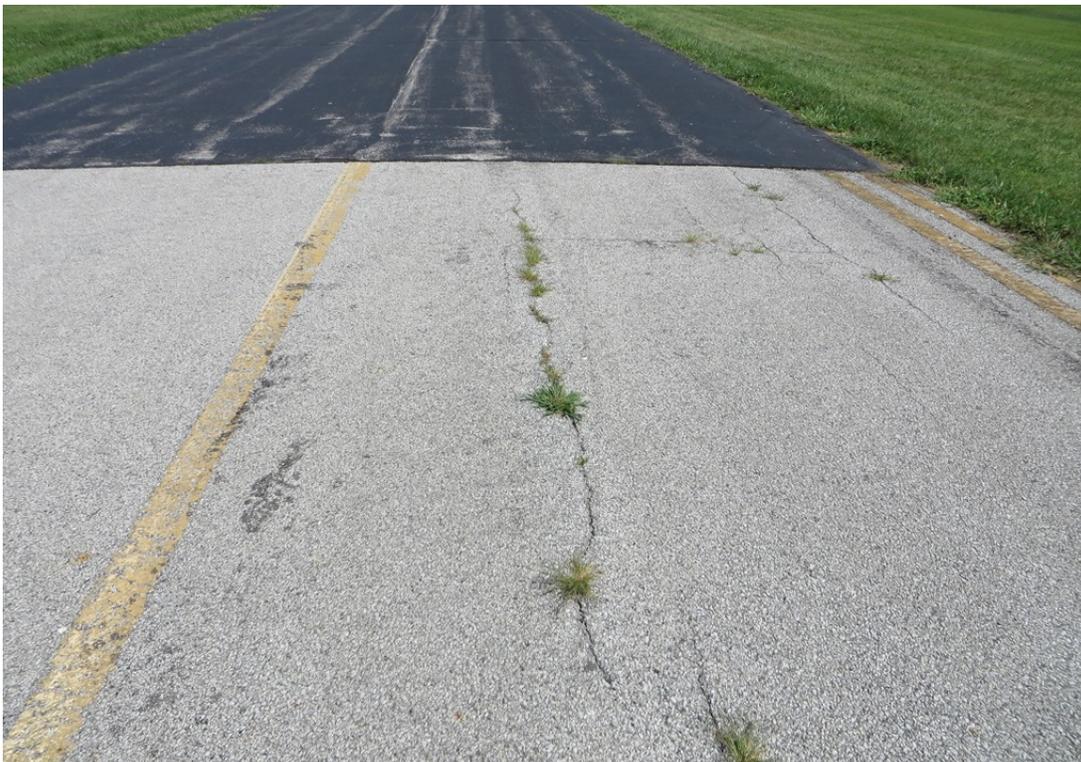
DISTRESS TYPE	SEVERITY	MEASURED QUANTITY	ESTIMATED TOTAL QUANTITY	UNITS	PERCENTAGE OF All DISTRESS
LONG.& TRANS. CRACK	MED	64	92	L.F.	53.2
LONG.& TRANS. CRACK	LOW	111	160	L.F.	39.3
WEATHERING	LOW	550	793	S.F.	7.4

APPROXIMATE AMOUNT OF DISTRESS RELATED TO LOAD ON THE PAVEMENT IS:	0 %
APPROXIMATE AMOUNT OF DISTRESS RELATED TO MATERIALS PROBLEMS IN THE FEATURE IS:	64 %
APPROXIMATE AMOUNT OF DISTRESS RELATED TO AGE OF PAVEMENT AND TRAFFIC REPETITIONS IS:	36 %

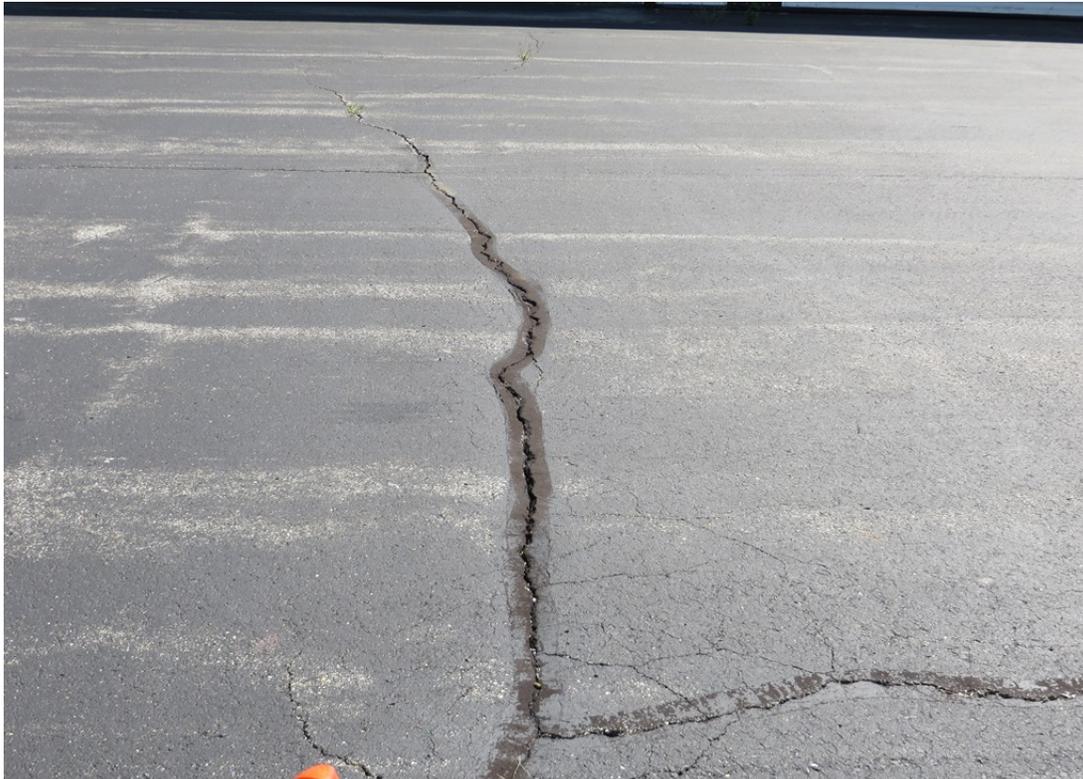
DISTRESS TYPE	SEVERITY	MEASURED QUANTITY	ESTIMATED TOTAL QUANTITY	UNITS	PERCENTAGE OF All DISTRESS
ALLIGATOR CRACKING	LOW	5	11	S.F.	12.9
LONG.& TRANS. CRACK	MED	83	185	L.F.	41.4
LONG.& TRANS. CRACK	LOW	398	887	L.F.	45.5

APPROXIMATE AMOUNT OF DISTRESS RELATED TO LOAD ON THE PAVEMENT IS:	13 %
APPROXIMATE AMOUNT OF DISTRESS RELATED TO MATERIALS PROBLEMS IN THE FEATURE IS:	58 %
APPROXIMATE AMOUNT OF DISTRESS RELATED TO AGE OF PAVEMENT AND TRAFFIC REPETITIONS IS:	29 %

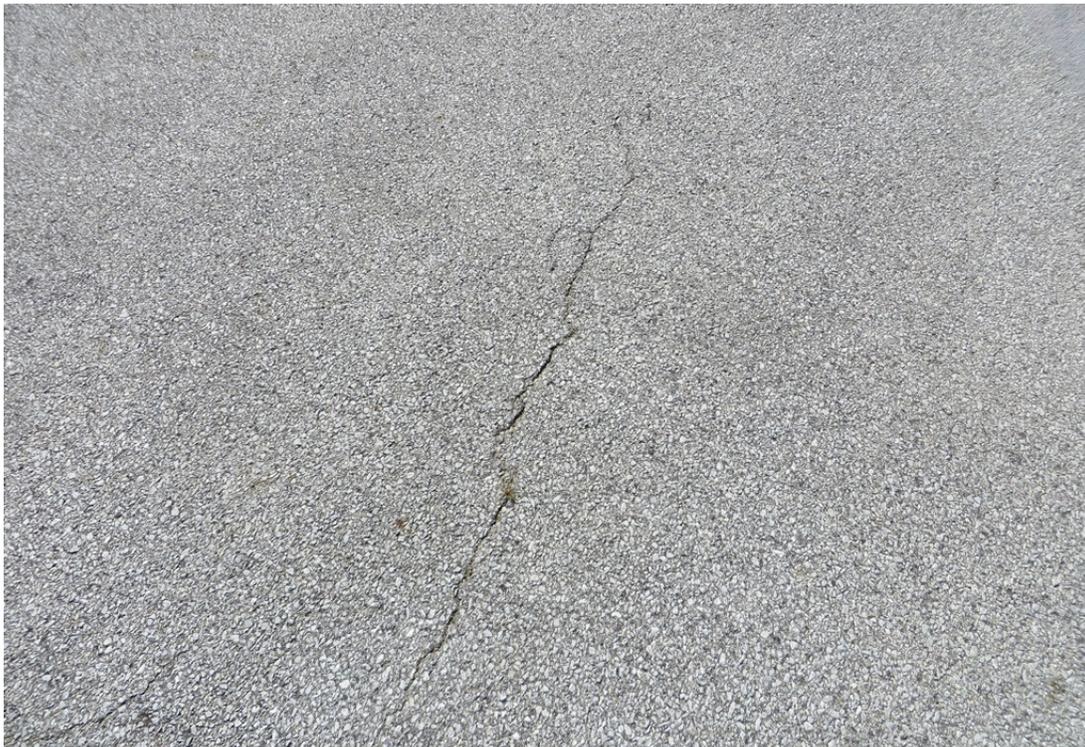
DISTRESS TYPE	SEVERITY	MEASURED QUANTITY	ESTIMATED TOTAL QUANTITY	UNITS	PERCENTAGE OF All DISTRESS
LONG.& TRANS. CRACK	HIGH	32	56	L.F.	10.1
LONG.& TRANS. CRACK	MED	703	1,248	L.F.	54.7
LONG.& TRANS. CRACK	LOW	843	1,496	L.F.	31.9
PATCH & UTILITY CUT	LOW	72	127	S.F.	3.1

APPROXIMATE AMOUNT OF DISTRESS RELATED TO LOAD ON THE PAVEMENT IS: 2 %
 APPROXIMATE AMOUNT OF DISTRESS RELATED TO MATERIALS PROBLEMS IN THE FEATURE IS: 66 %
 APPROXIMATE AMOUNT OF DISTRESS RELATED TO AGE OF PAVEMENT AND TRAFFIC REPETITIONS IS: 32 %

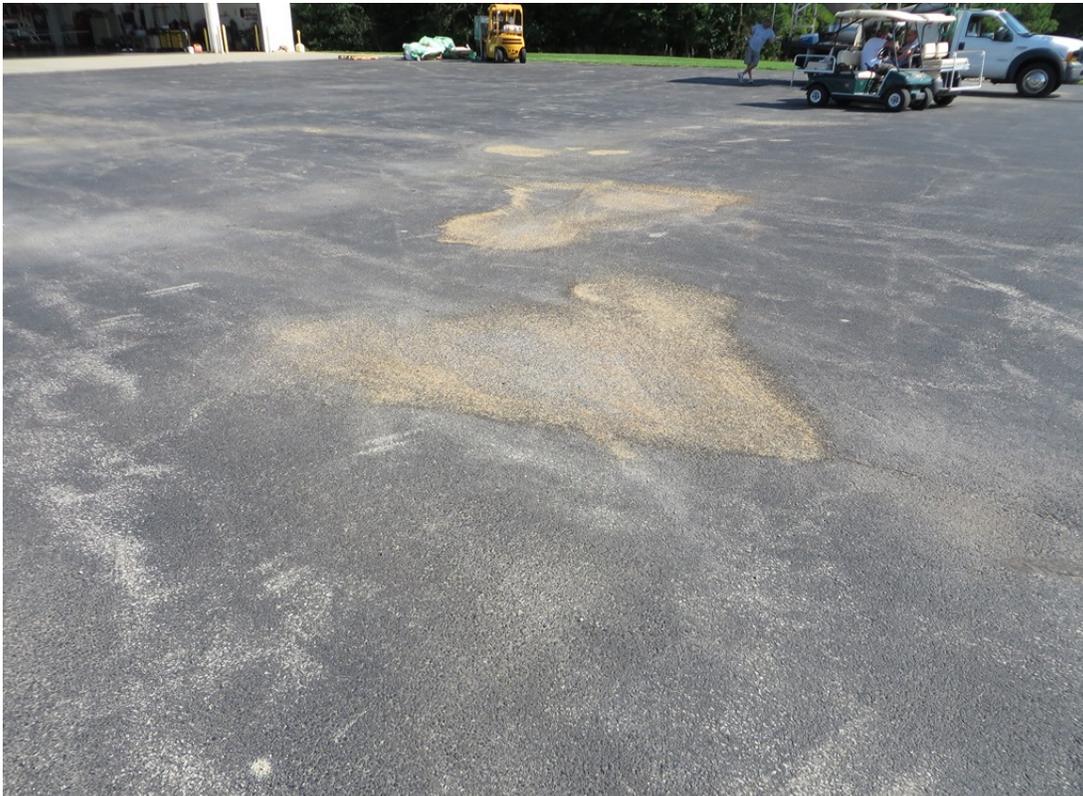
DISTRESS TYPE	SEVERITY	MEASURED QUANTITY	ESTIMATED TOTAL QUANTITY	UNITS	PERCENTAGE OF All DISTRESS
DEPRESSION	LOW	272	284	S.F.	61.7
LONG.& TRANS. CRACK	LOW	198	206	L.F.	38.2

APPROXIMATE AMOUNT OF DISTRESS RELATED TO LOAD ON THE PAVEMENT IS:	0 %
APPROXIMATE AMOUNT OF DISTRESS RELATED TO MATERIALS PROBLEMS IN THE FEATURE IS:	87 %
APPROXIMATE AMOUNT OF DISTRESS RELATED TO AGE OF PAVEMENT AND TRAFFIC REPETITIONS IS:	13 %

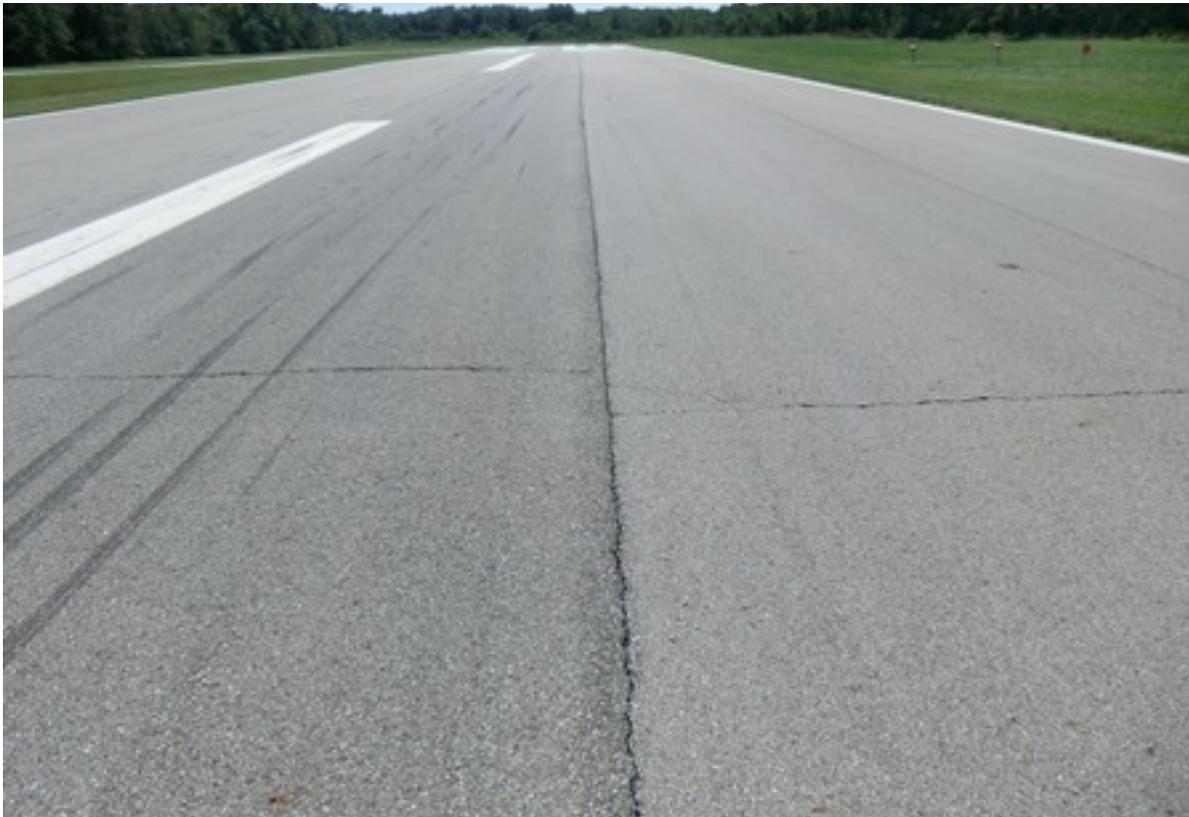
DISTRESS TYPE	SEVERITY	MEASURED QUANTITY	ESTIMATED TOTAL QUANTITY	UNITS	PERCENTAGE OF ALL DISTRESS
LONG.& TRANS. CRACK	LOW	876	1,752	L.F.	100

APPROXIMATE AMOUNT OF DISTRESS RELATED TO LOAD ON THE PAVEMENT IS:	0 %
APPROXIMATE AMOUNT OF DISTRESS RELATED TO MATERIALS PROBLEMS IN THE FEATURE IS:	67 %
APPROXIMATE AMOUNT OF DISTRESS RELATED TO AGE OF PAVEMENT AND TRAFFIC REPETITIONS IS:	33 %

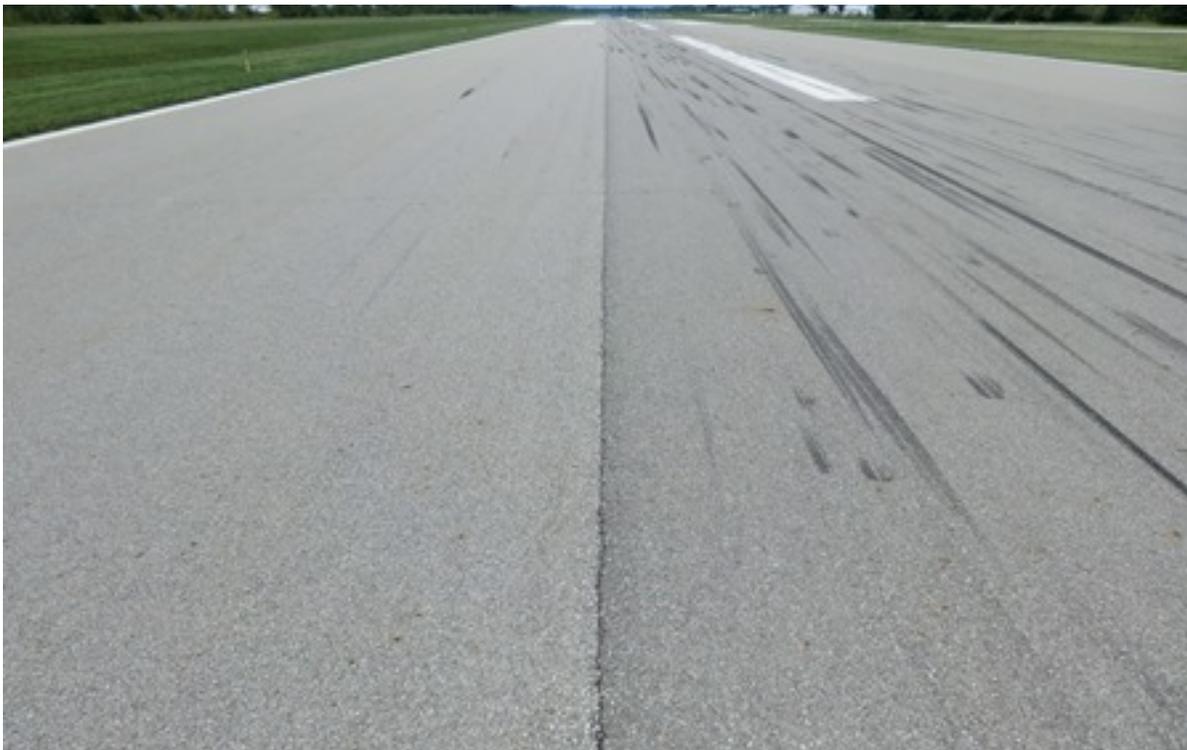
DISTRESS TYPE	SEVERITY	MEASURED QUANTITY	ESTIMATED TOTAL QUANTITY	UNITS	PERCENTAGE OF All DISTRESS
DEPRESSION	LOW	2	10	S.F.	0
LONG.& TRANS. CRACK	HIGH	1	5	L.F.	2.6
LONG.& TRANS. CRACK	MED	293	1,562	L.F.	26.4
LONG.& TRANS. CRACK	LOW	2,582	13,770	L.F.	70.8

APPROXIMATE AMOUNT OF DISTRESS RELATED TO LOAD ON THE PAVEMENT IS:	0 %
APPROXIMATE AMOUNT OF DISTRESS RELATED TO MATERIALS PROBLEMS IN THE FEATURE IS:	67 %
APPROXIMATE AMOUNT OF DISTRESS RELATED TO AGE OF PAVEMENT AND TRAFFIC REPETITIONS IS:	33 %

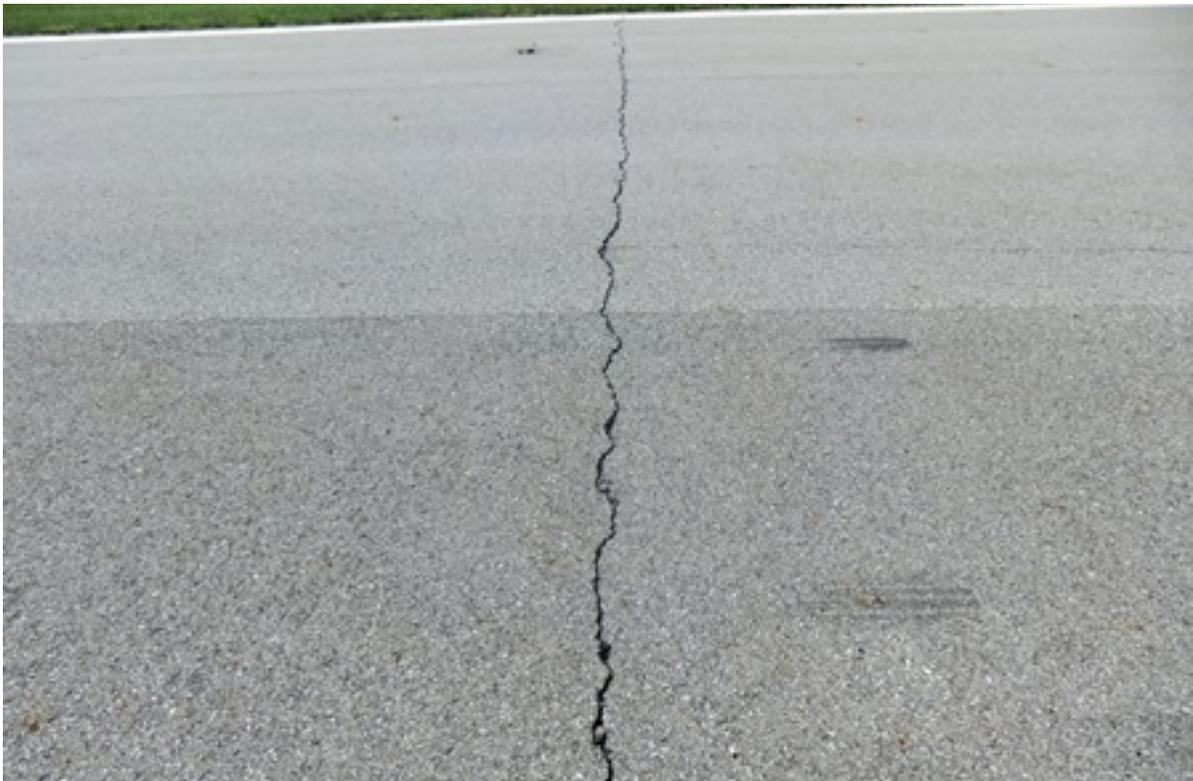
DISTRESS TYPE	SEVERITY	MEASURED QUANTITY	ESTIMATED TOTAL QUANTITY	UNITS	PERCENTAGE OF All DISTRESS
DEPRESSION	MED	1	2	S.F.	5
LONG.& TRANS. CRACK	MED	46	92	L.F.	24
LONG.& TRANS. CRACK	LOW	997	2,006	L.F.	70.9

APPROXIMATE AMOUNT OF DISTRESS RELATED TO LOAD ON THE PAVEMENT IS:	0 %
APPROXIMATE AMOUNT OF DISTRESS RELATED TO MATERIALS PROBLEMS IN THE FEATURE IS:	68 %
APPROXIMATE AMOUNT OF DISTRESS RELATED TO AGE OF PAVEMENT AND TRAFFIC REPETITIONS IS:	32 %
