Pavement Condition Report

Valparaiso-Porter County Regional Airport

Project 1480370

January 2014

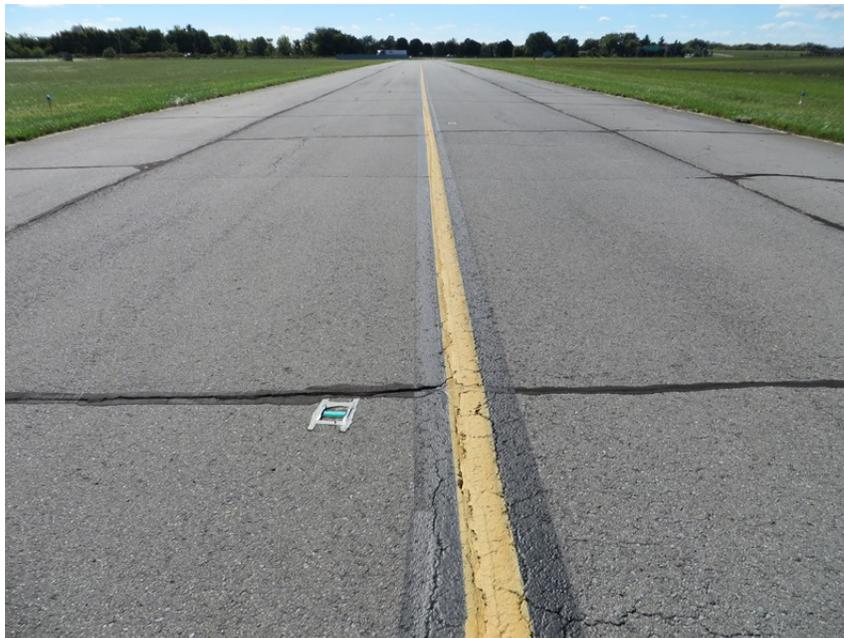
DISTRESS TYPE	SEVERITY	MEASURED QUANTITY	ESTIMATED TOTAL QUANTITY	UNITS	PERCENTAGE OF All DISTRESS
ALLIGATOR CRACKING	MED	133	412	S.F.	15.9
ALLIGATOR CRACKING	LOW	83	257	S.F.	10.7
BLOCK CRACKING	MED	1,250	3,877	S.F.	5.6
BLOCK CRACKING	LOW	2,708	8,399	S.F.	11
LONG.& TRANS. CRACK	HIGH	9	27	L.F.	2.7
LONG.& TRANS. CRACK	MED	1,926	5,974	L.F.	28.5
LONG.& TRANS. CRACK	LOW	3,502	10,862	L.F.	25.2

APPROXIMATE AMOUNT OF DISTRESS RELATED TO LOAD ON THE PAVEMENT IS:	27 %
APPROXIMATE AMOUNT OF DISTRESS RELATED TO MATERIALS PROBLEMS IN THE FEATURE IS:	38 %
APPROXIMATE AMOUNT OF DISTRESS RELATED TO AGE OF PAVEMENT AND TRAFFIC REPETITIONS IS:	36 %

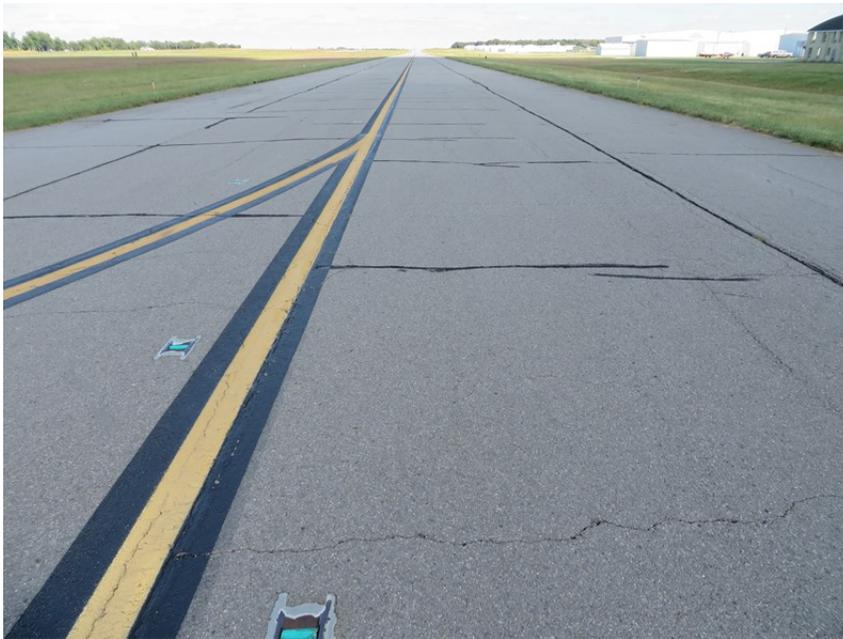
DISTRESS TYPE	SEVERITY	MEASURED QUANTITY	ESTIMATED TOTAL QUANTITY	UNITS	PERCENTAGE OF All DISTRESS
ALLIGATOR CRACKING	MED	45	161	S.F.	7.3
ALLIGATOR CRACKING	LOW	74	266	S.F.	9.1
BLOCK CRACKING	MED	7,774	27,941	S.F.	26.5
BLOCK CRACKING	LOW	4,516	16,231	S.F.	12.5
LONG.& TRANS. CRACK	MED	1,248	4,485	L.F.	21.7
LONG.& TRANS. CRACK	LOW	2,867	10,304	L.F.	21.6
PATCH & UTILITY CUT	LOW	66	237	S.F.	.7
SWELL	LOW	10	35	S.F.	.1
WEATHERING	MED	100	359	S.F.	.1

APPROXIMATE AMOUNT OF DISTRESS RELATED TO LOAD ON THE PAVEMENT IS:	17 %
APPROXIMATE AMOUNT OF DISTRESS RELATED TO MATERIALS PROBLEMS IN THE FEATURE IS:	29 %
APPROXIMATE AMOUNT OF DISTRESS RELATED TO AGE OF PAVEMENT AND TRAFFIC REPETITIONS IS:	54 %

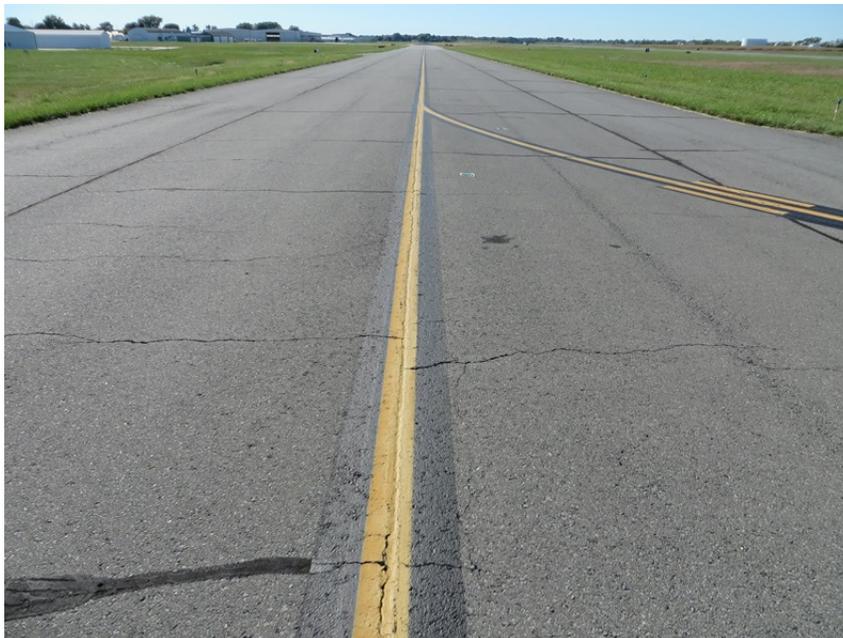
DISTRESS TYPE	SEVERITY	MEASURED QUANTITY	ESTIMATED TOTAL QUANTITY	UNITS	PERCENTAGE OF All DISTRESS
ALLIGATOR CRACKING	MED	56	211	S.F.	9.1
ALLIGATOR CRACKING	LOW	62	233	S.F.	5.7
BLOCK CRACKING	MED	910	3,429	S.F.	6.4
BLOCK CRACKING	LOW	2,550	9,610	S.F.	8.4
LONG.& TRANS. CRACK	MED	2,411	9,086	L.F.	32.7
LONG.& TRANS. CRACK	LOW	6,173	23,264	L.F.	34.7
PATCH & UTILITY CUT	LOW	1	3	S.F.	.2
RAVELING	MED	60	226	S.F.	2
SWELL	LOW	24	90	S.F.	.2

APPROXIMATE AMOUNT OF DISTRESS RELATED TO LOAD ON THE PAVEMENT IS:	15 %
APPROXIMATE AMOUNT OF DISTRESS RELATED TO MATERIALS PROBLEMS IN THE FEATURE IS:	46 %
APPROXIMATE AMOUNT OF DISTRESS RELATED TO AGE OF PAVEMENT AND TRAFFIC REPETITIONS IS:	39 %

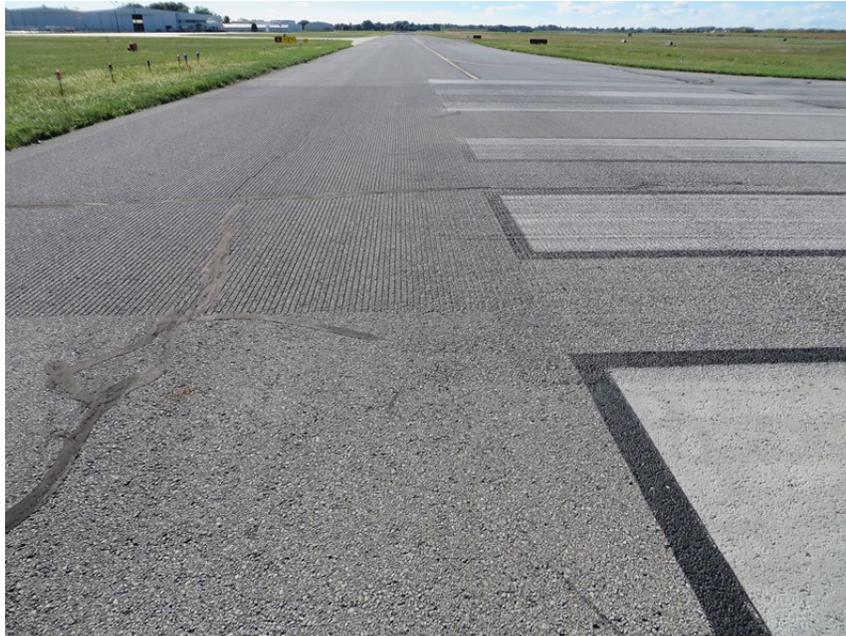
DISTRESS TYPE	SEVERITY	MEASURED QUANTITY	ESTIMATED TOTAL QUANTITY	UNITS	PERCENTAGE OF All DISTRESS
DEPRESSION	LOW	30	61	S.F.	2.2
LONG.& TRANS. CRACK	MED	195	401	L.F.	22
LONG.& TRANS. CRACK	LOW	828	1,706	L.F.	28.6
PATCH & UTILITY CUT	HIGH	1	2	S.F.	9.9
PATCH & UTILITY CUT	MED	2	4	S.F.	9.2
PATCH & UTILITY CUT	LOW	106	218	S.F.	4.1
RAVELING	LOW	110	226	S.F.	4.1
RUTTING	LOW	630	1,298	S.F.	19.5

APPROXIMATE AMOUNT OF DISTRESS RELATED TO LOAD ON THE PAVEMENT IS:	29 %
APPROXIMATE AMOUNT OF DISTRESS RELATED TO MATERIALS PROBLEMS IN THE FEATURE IS:	52 %
APPROXIMATE AMOUNT OF DISTRESS RELATED TO AGE OF PAVEMENT AND TRAFFIC REPETITIONS IS:	20 %

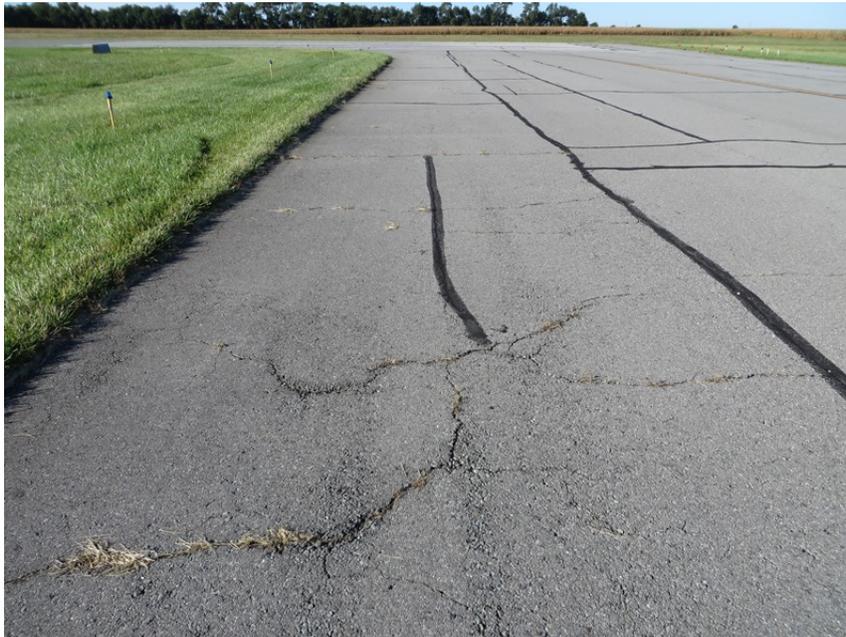
DISTRESS TYPE	SEVERITY	MEASURED QUANTITY	ESTIMATED TOTAL QUANTITY	UNITS	PERCENTAGE OF All DISTRESS
ALLIGATOR CRACKING	LOW	6	6	S.F.	5.1
BLOCK CRACKING	MED	160	160	S.F.	10.9
BLOCK CRACKING	LOW	160	160	S.F.	7.7
LONG.& TRANS. CRACK	MED	564	564	L.F.	36.2
LONG.& TRANS. CRACK	LOW	1,204	1,204	L.F.	34.3
RAVELING	MED	40	40	S.F.	5.5

APPROXIMATE AMOUNT OF DISTRESS RELATED TO LOAD ON THE PAVEMENT IS:	5 %
APPROXIMATE AMOUNT OF DISTRESS RELATED TO MATERIALS PROBLEMS IN THE FEATURE IS:	49 %
APPROXIMATE AMOUNT OF DISTRESS RELATED TO AGE OF PAVEMENT AND TRAFFIC REPETITIONS IS:	46 %

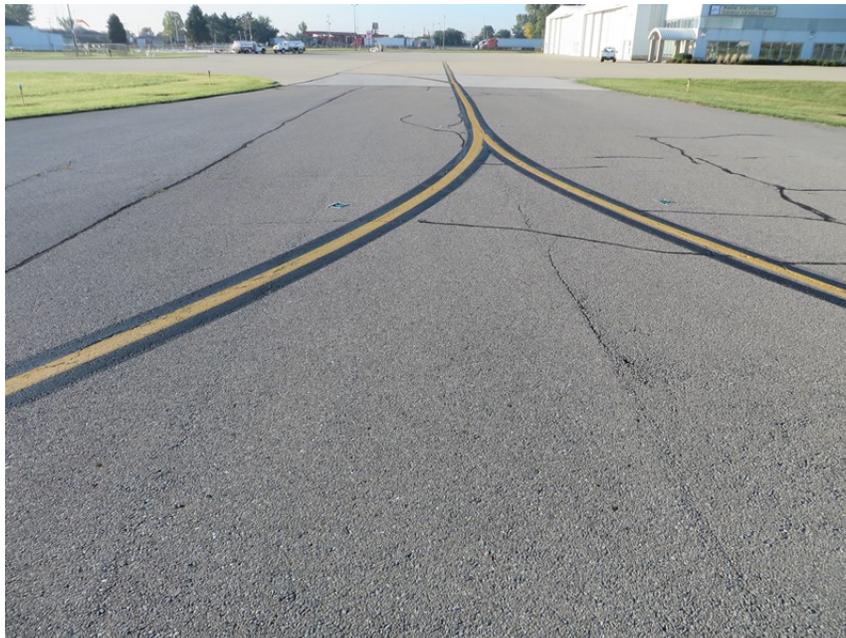
DISTRESS TYPE	SEVERITY	MEASURED QUANTITY	ESTIMATED TOTAL QUANTITY	UNITS	PERCENTAGE OF All DISTRESS
ALLIGATOR CRACKING	MED	15	18	S.F.	15.1
ALLIGATOR CRACKING	LOW	21	25	S.F.	12.6
BLOCK CRACKING	MED	180	221	S.F.	15.1
BLOCK CRACKING	LOW	455	559	S.F.	14.5
LONG.& TRANS. CRACK	MED	164	201	L.F.	15
LONG.& TRANS. CRACK	LOW	544	669	L.F.	19.2
RUTTING	LOW	1	1	S.F.	8.1

APPROXIMATE AMOUNT OF DISTRESS RELATED TO LOAD ON THE PAVEMENT IS:	33 %
APPROXIMATE AMOUNT OF DISTRESS RELATED TO MATERIALS PROBLEMS IN THE FEATURE IS:	26 %
APPROXIMATE AMOUNT OF DISTRESS RELATED TO AGE OF PAVEMENT AND TRAFFIC REPETITIONS IS:	41 %

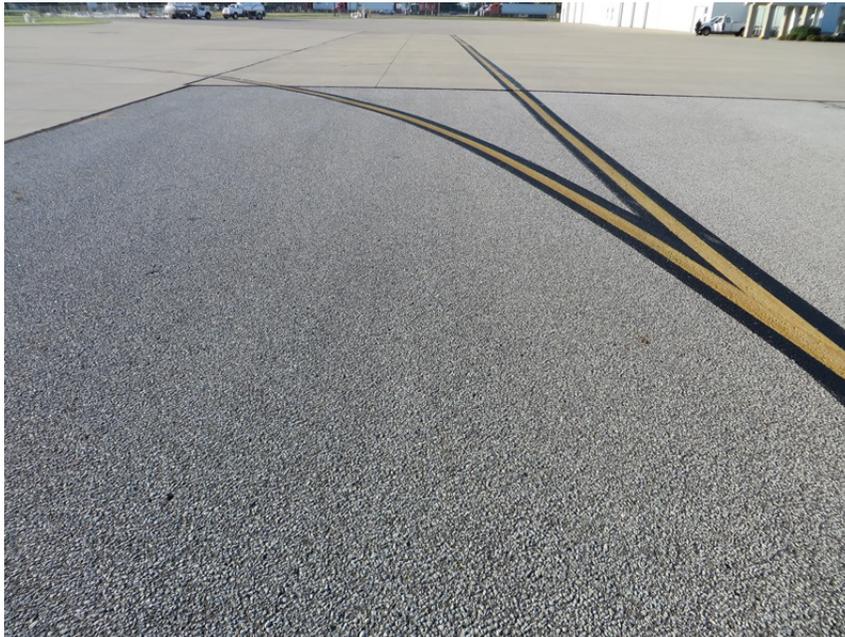
DISTRESS TYPE	SEVERITY	MEASURED QUANTITY	ESTIMATED TOTAL QUANTITY	UNITS	PERCENTAGE OF All DISTRESS
LONG.& TRANS. CRACK	MED	10	10	L.F.	14.7
LONG.& TRANS. CRACK	LOW	46	46	L.F.	12.2
RAVELING	MED	52	52	S.F.	23.3
WEATHERING	MED	2,900	2,900	S.F.	49.6

APPROXIMATE AMOUNT OF DISTRESS RELATED TO LOAD ON THE PAVEMENT IS:	0 %
APPROXIMATE AMOUNT OF DISTRESS RELATED TO MATERIALS PROBLEMS IN THE FEATURE IS:	42 %
APPROXIMATE AMOUNT OF DISTRESS RELATED TO AGE OF PAVEMENT AND TRAFFIC REPETITIONS IS:	58 %

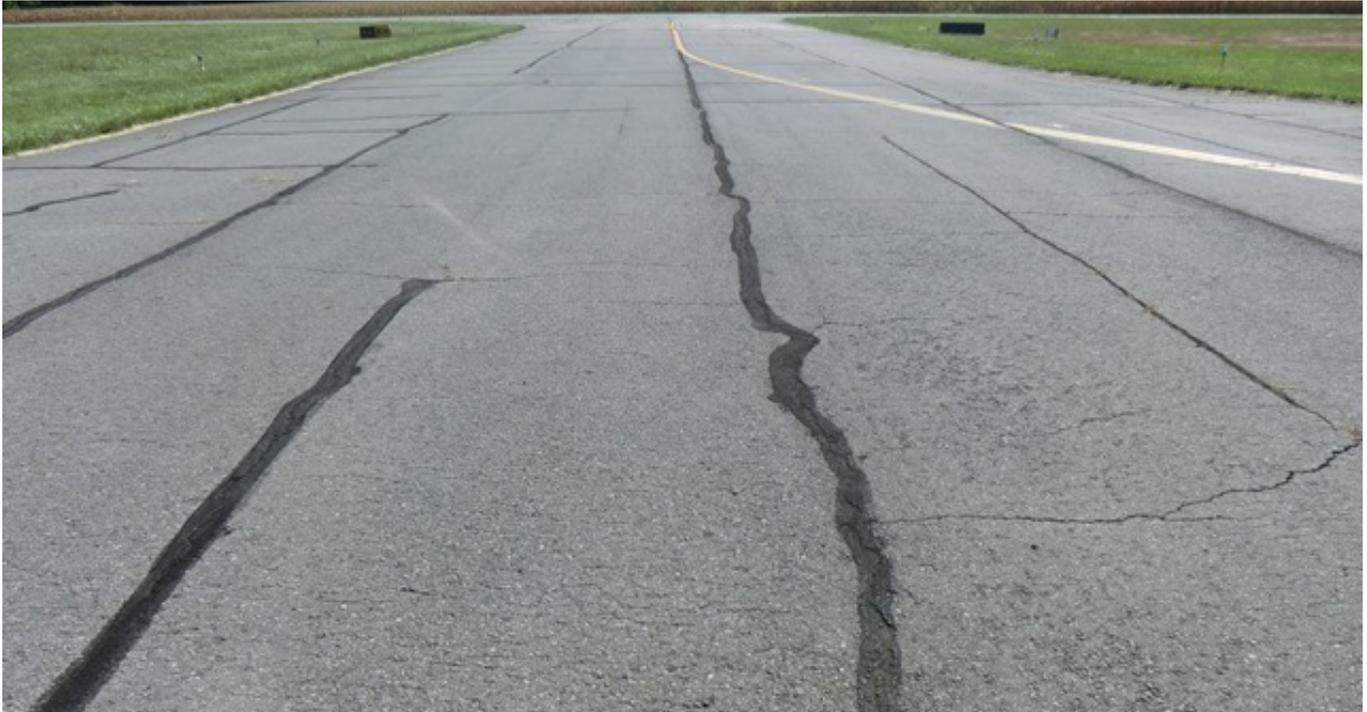
DISTRESS TYPE	SEVERITY	MEASURED QUANTITY	ESTIMATED TOTAL QUANTITY	UNITS	PERCENTAGE OF All DISTRESS
ALLIGATOR CRACKING	LOW	4	8	S.F.	4.2
BLOCK CRACKING	MED	380	842	S.F.	20.3
BLOCK CRACKING	LOW	1,465	3,246	S.F.	22.7
LONG.& TRANS. CRACK	MED	293	649	L.F.	21.2
LONG.& TRANS. CRACK	LOW	971	2,151	L.F.	27
RAVELING	MED	27	59	S.F.	4.2

APPROXIMATE AMOUNT OF DISTRESS RELATED TO LOAD ON THE PAVEMENT IS:	4 %
APPROXIMATE AMOUNT OF DISTRESS RELATED TO MATERIALS PROBLEMS IN THE FEATURE IS:	34 %
APPROXIMATE AMOUNT OF DISTRESS RELATED TO AGE OF PAVEMENT AND TRAFFIC REPETITIONS IS:	62 %

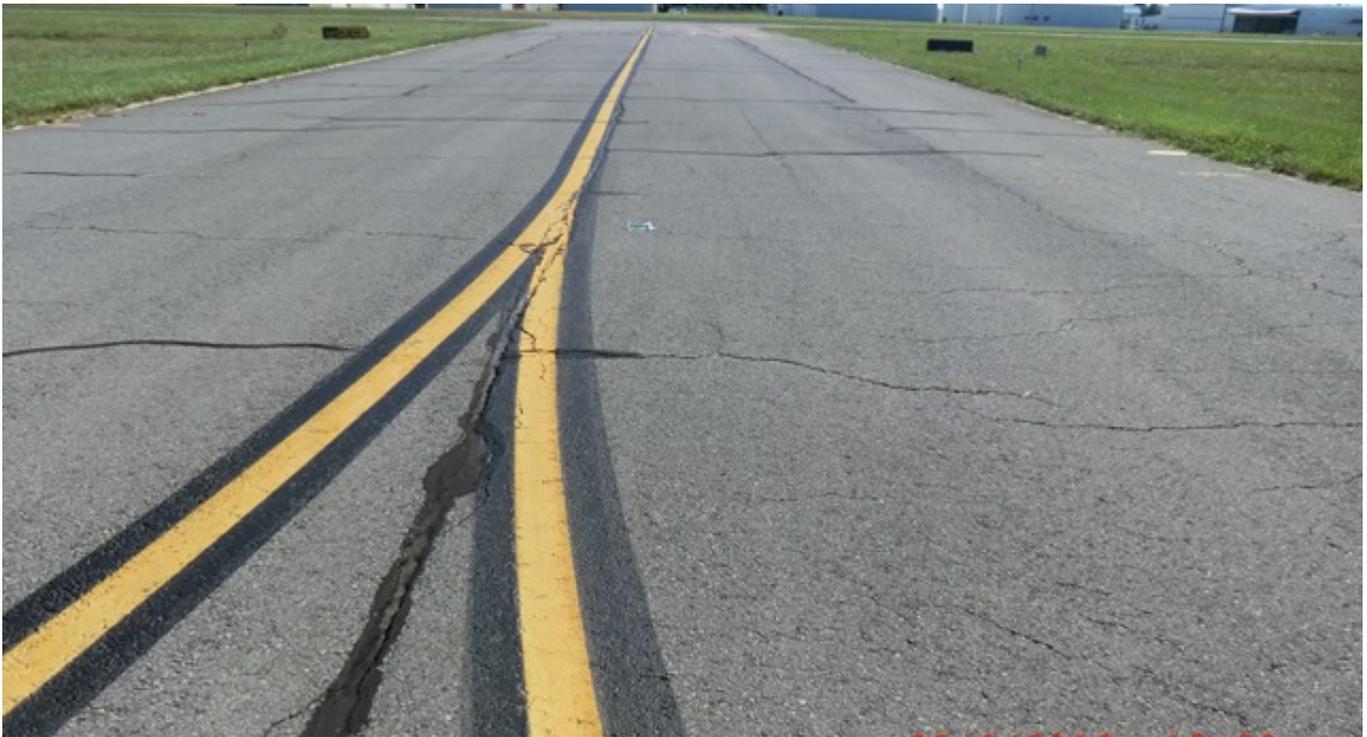
DISTRESS TYPE	SEVERITY	MEASURED QUANTITY	ESTIMATED TOTAL QUANTITY	UNITS	PERCENTAGE OF ALL DISTRESS
BLOCK CRACKING	MED	450	763	S.F.	15
BLOCK CRACKING	LOW	2,775	4,705	S.F.	30.3
LONG.& TRANS. CRACK	MED	263	446	L.F.	21.6
LONG.& TRANS. CRACK	LOW	1,173	1,989	L.F.	33

APPROXIMATE AMOUNT OF DISTRESS RELATED TO LOAD ON THE PAVEMENT IS:	0 %
APPROXIMATE AMOUNT OF DISTRESS RELATED TO MATERIALS PROBLEMS IN THE FEATURE IS:	36 %
APPROXIMATE AMOUNT OF DISTRESS RELATED TO AGE OF PAVEMENT AND TRAFFIC REPETITIONS IS:	64 %

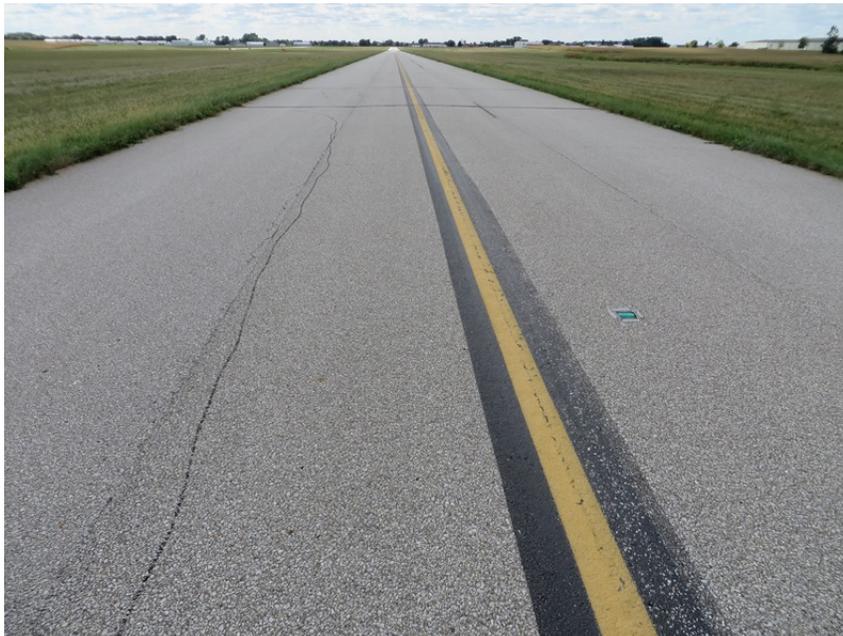
DISTRESS TYPE	SEVERITY	MEASURED QUANTITY	ESTIMATED TOTAL QUANTITY	UNITS	PERCENTAGE OF All DISTRESS
ALLIGATOR CRACKING	LOW	10	38	S.F.	3.5
DEPRESSION	LOW	15	57	S.F.	.5
LONG.& TRANS. CRACK	HIGH	122	463	L.F.	28.5
LONG.& TRANS. CRACK	MED	776	2,949	L.F.	42
LONG.& TRANS. CRACK	LOW	787	2,991	L.F.	21.1
PATCH & UTILITY CUT	HIGH	1	3	S.F.	4.2

APPROXIMATE AMOUNT OF DISTRESS RELATED TO LOAD ON THE PAVEMENT IS:	6 %
APPROXIMATE AMOUNT OF DISTRESS RELATED TO MATERIALS PROBLEMS IN THE FEATURE IS:	63 %
APPROXIMATE AMOUNT OF DISTRESS RELATED TO AGE OF PAVEMENT AND TRAFFIC REPETITIONS IS:	31 %

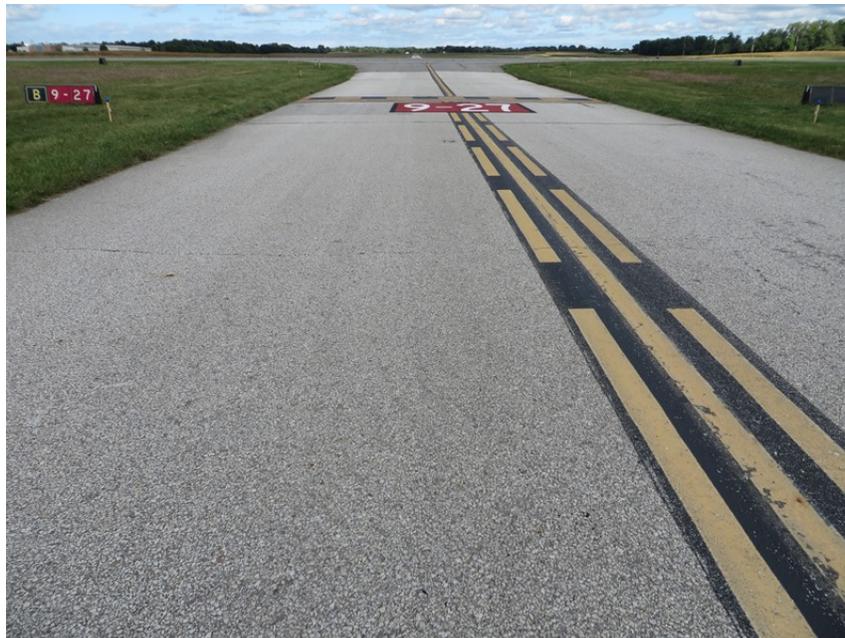
DISTRESS TYPE	SEVERITY	MEASURED QUANTITY	ESTIMATED TOTAL QUANTITY	UNITS	PERCENTAGE OF All DISTRESS
DEPRESSION	LOW	15	15	S.F.	2.2
LONG.& TRANS. CRACK	HIGH	23	23	L.F.	24.7
LONG.& TRANS. CRACK	MED	66	66	L.F.	21.6
LONG.& TRANS. CRACK	LOW	298	298	L.F.	27.1
PATCH & UTILITY CUT	LOW	4	4	S.F.	2.1
RAVELING	HIGH	1	1	S.F.	7.7
RAVELING	MED	20	20	S.F.	7.9
RAVELING	LOW	40	40	S.F.	3.5
WEATHERING	MED	140	140	S.F.	2.6

APPROXIMATE AMOUNT OF DISTRESS RELATED TO LOAD ON THE PAVEMENT IS: 1 %
 APPROXIMATE AMOUNT OF DISTRESS RELATED TO MATERIALS PROBLEMS IN THE FEATURE IS: 59 %
 APPROXIMATE AMOUNT OF DISTRESS RELATED TO AGE OF PAVEMENT AND TRAFFIC REPETITIONS IS: 39 %

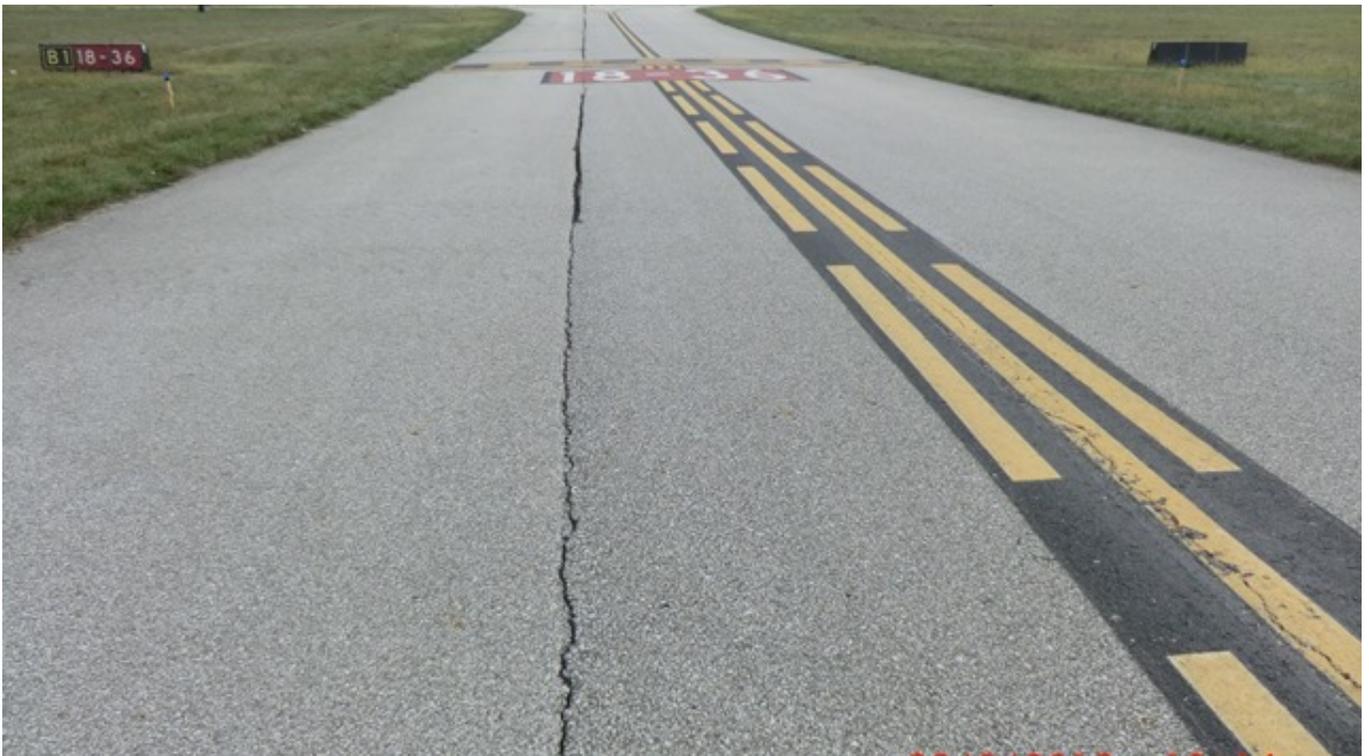
DISTRESS TYPE	SEVERITY	MEASURED QUANTITY	ESTIMATED TOTAL QUANTITY	UNITS	PERCENTAGE OF All DISTRESS
LONG.& TRANS. CRACK	HIGH	38	77	L.F.	26.8
LONG.& TRANS. CRACK	MED	213	432	L.F.	47.6
LONG.& TRANS. CRACK	LOW	129	261	L.F.	16.2
RAVELING	HIGH	1	2	S.F.	9.2

APPROXIMATE AMOUNT OF DISTRESS RELATED TO LOAD ON THE PAVEMENT IS:	0 %
APPROXIMATE AMOUNT OF DISTRESS RELATED TO MATERIALS PROBLEMS IN THE FEATURE IS:	64 %
APPROXIMATE AMOUNT OF DISTRESS RELATED TO AGE OF PAVEMENT AND TRAFFIC REPETITIONS IS:	36 %

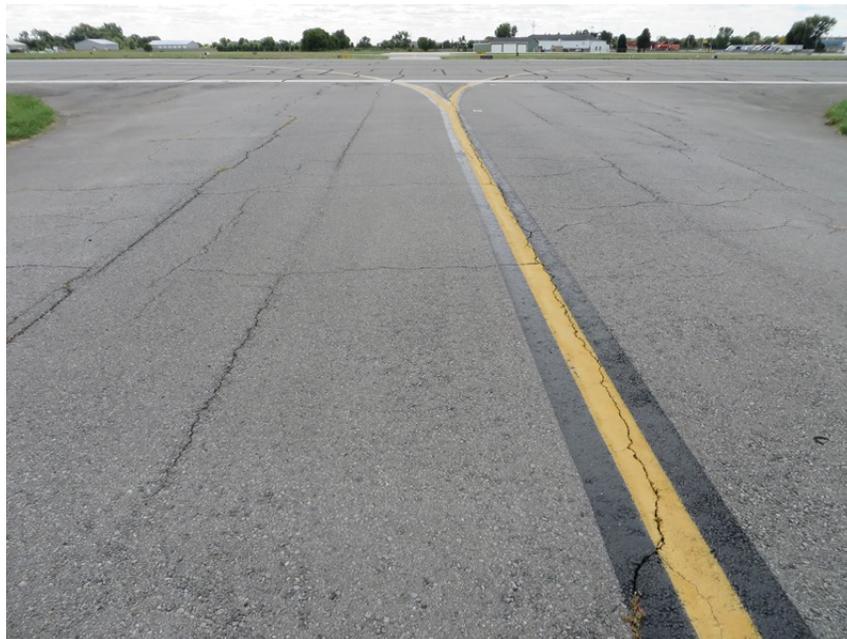
DISTRESS TYPE	SEVERITY	MEASURED QUANTITY	ESTIMATED TOTAL QUANTITY	UNITS	PERCENTAGE OF All DISTRESS
BLOCK CRACKING	MED	1,120	1,314	S.F.	44.5
BLOCK CRACKING	LOW	700	821	S.F.	25.8
LONG.& TRANS. CRACK	MED	28	32	L.F.	12.1
LONG.& TRANS. CRACK	LOW	109	127	L.F.	12.1
SWELL	LOW	24	28	S.F.	3.1
WEATHERING	MED	100	117	S.F.	2.1

APPROXIMATE AMOUNT OF DISTRESS RELATED TO LOAD ON THE PAVEMENT IS:	0 %
APPROXIMATE AMOUNT OF DISTRESS RELATED TO MATERIALS PROBLEMS IN THE FEATURE IS:	20 %
APPROXIMATE AMOUNT OF DISTRESS RELATED TO AGE OF PAVEMENT AND TRAFFIC REPETITIONS IS:	80 %

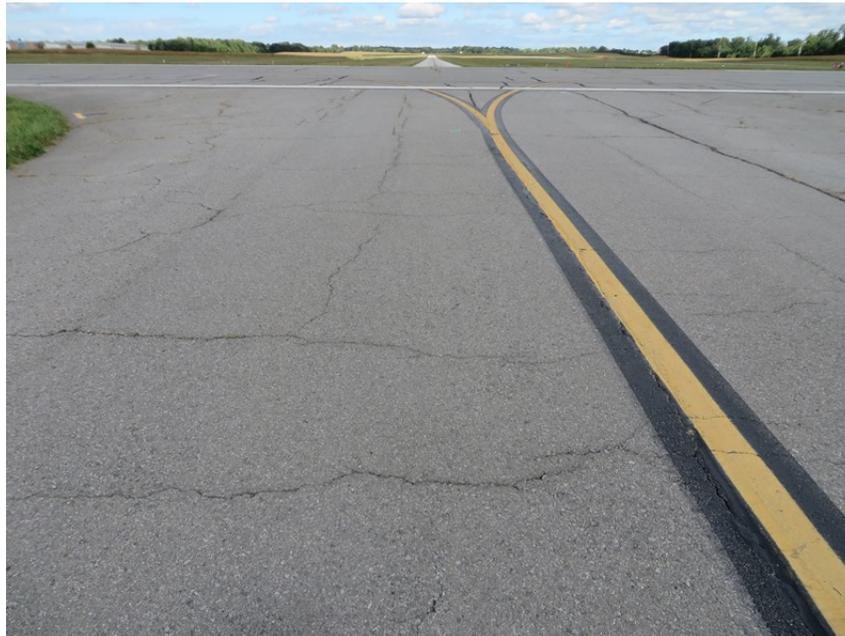
DISTRESS TYPE	SEVERITY	MEASURED QUANTITY	ESTIMATED TOTAL QUANTITY	UNITS	PERCENTAGE OF All DISTRESS
ALLIGATOR CRACKING	HIGH	2	2	S.F.	19.4
BLOCK CRACKING	MED	2,000	2,130	S.F.	51.6
BLOCK CRACKING	LOW	1,200	1,278	S.F.	28.8

APPROXIMATE AMOUNT OF DISTRESS RELATED TO LOAD ON THE PAVEMENT IS:	19 %
APPROXIMATE AMOUNT OF DISTRESS RELATED TO MATERIALS PROBLEMS IN THE FEATURE IS:	0 %
APPROXIMATE AMOUNT OF DISTRESS RELATED TO AGE OF PAVEMENT AND TRAFFIC REPETITIONS IS:	81 %

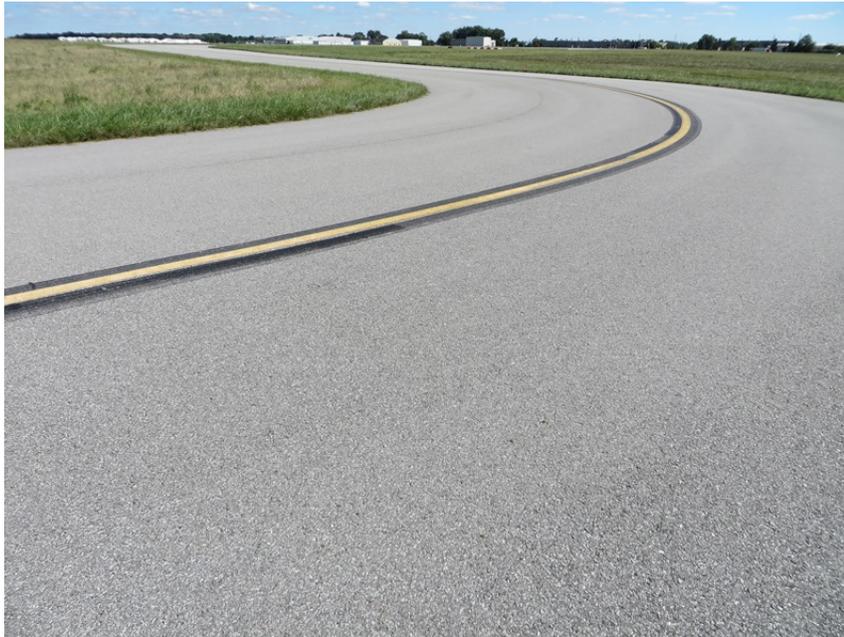
DISTRESS TYPE	SEVERITY	MEASURED QUANTITY	ESTIMATED TOTAL QUANTITY	UNITS	PERCENTAGE OF All DISTRESS
LONG.& TRANS. CRACK	LOW	3	9	L.F.	100

APPROXIMATE AMOUNT OF DISTRESS RELATED TO LOAD ON THE PAVEMENT IS:	0 %
APPROXIMATE AMOUNT OF DISTRESS RELATED TO MATERIALS PROBLEMS IN THE FEATURE IS:	67 %
APPROXIMATE AMOUNT OF DISTRESS RELATED TO AGE OF PAVEMENT AND TRAFFIC REPETITIONS IS:	33 %

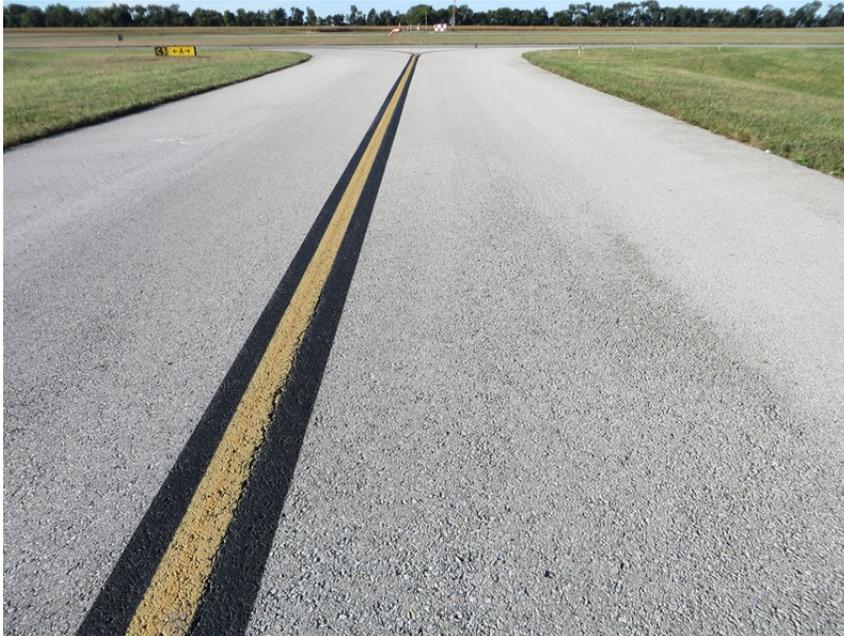
DISTRESS TYPE	SEVERITY	MEASURED QUANTITY	ESTIMATED TOTAL QUANTITY	UNITS	PERCENTAGE OF All DISTRESS
ALLIGATOR CRACKING	LOW	15	32	S.F.	28.9
DEPRESSION	LOW	40	87	S.F.	14.9
LONG.& TRANS. CRACK	LOW	174	379	L.F.	33.4
SWELL	LOW	120	261	S.F.	17.9
WEATHERING	MED	150	327	S.F.	4.6

APPROXIMATE AMOUNT OF DISTRESS RELATED TO LOAD ON THE PAVEMENT IS:	29 %
APPROXIMATE AMOUNT OF DISTRESS RELATED TO MATERIALS PROBLEMS IN THE FEATURE IS:	57 %
APPROXIMATE AMOUNT OF DISTRESS RELATED TO AGE OF PAVEMENT AND TRAFFIC REPETITIONS IS:	14 %

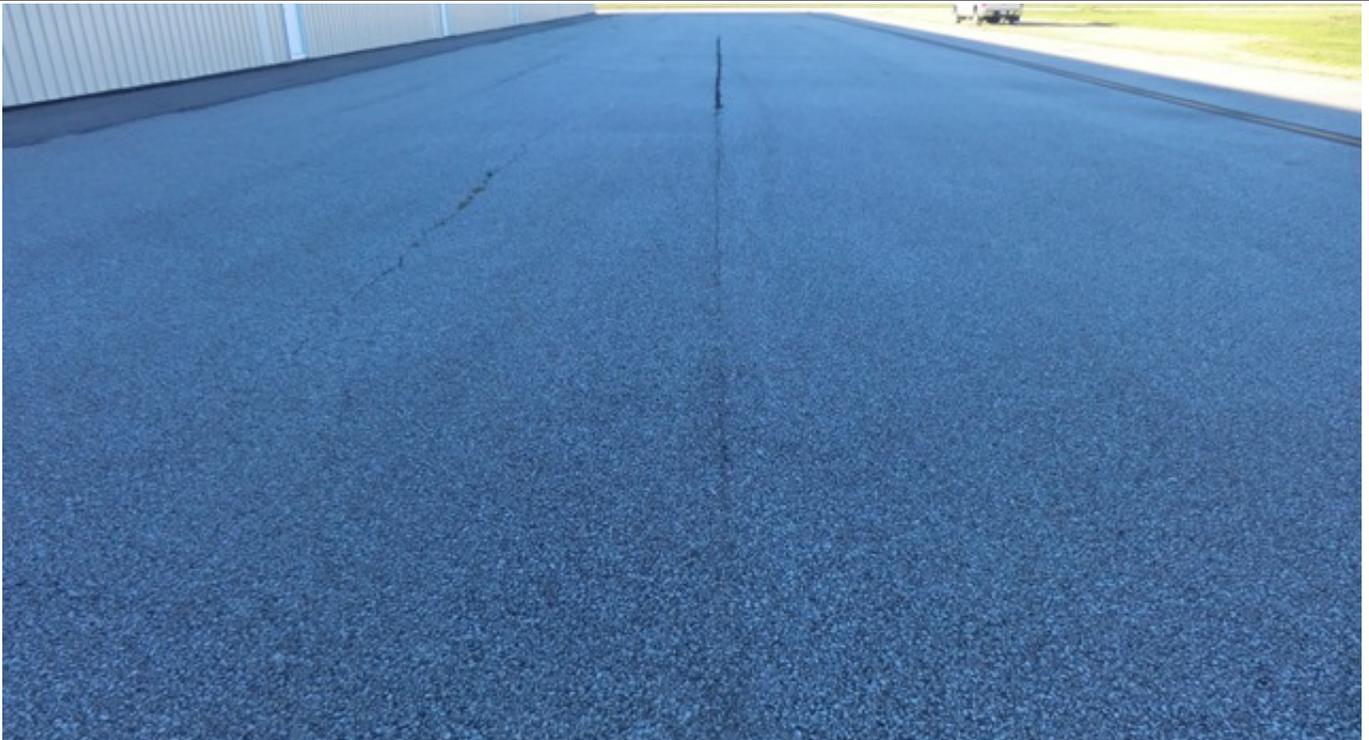
DISTRESS TYPE	SEVERITY	MEASURED QUANTITY	ESTIMATED TOTAL QUANTITY	UNITS	PERCENTAGE OF All DISTRESS
LONG.& TRANS. CRACK	MED	46	145	L.F.	8.6
LONG.& TRANS. CRACK	LOW	359	1,137	L.F.	40.1
RUTTING	LOW	159	503	S.F.	36.9
WEATHERING	MED	200	633	S.F.	3.4
WEATHERING	LOW	7,000	22,185	S.F.	10.8

APPROXIMATE AMOUNT OF DISTRESS RELATED TO LOAD ON THE PAVEMENT IS:	25 %
APPROXIMATE AMOUNT OF DISTRESS RELATED TO MATERIALS PROBLEMS IN THE FEATURE IS:	50 %
APPROXIMATE AMOUNT OF DISTRESS RELATED TO AGE OF PAVEMENT AND TRAFFIC REPETITIONS IS:	26 %

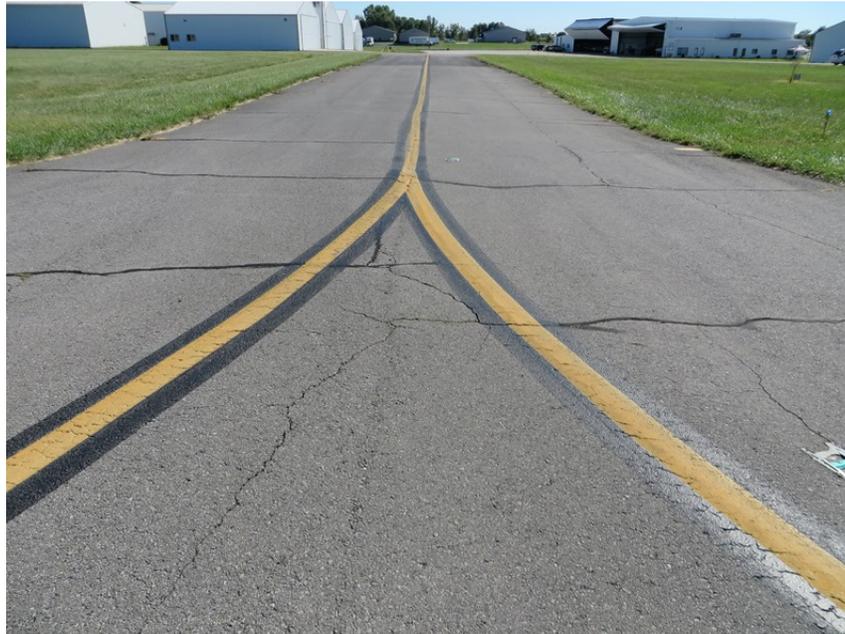
DISTRESS TYPE	SEVERITY	MEASURED QUANTITY	ESTIMATED TOTAL QUANTITY	UNITS	PERCENTAGE OF All DISTRESS
LONG.& TRANS. CRACK	MED	189	251	L.F.	42.2
LONG.& TRANS. CRACK	LOW	601	798	L.F.	51.6
RAVELING	LOW	50	66	S.F.	3.7
SWELL	LOW	20	26	S.F.	2.3

APPROXIMATE AMOUNT OF DISTRESS RELATED TO LOAD ON THE PAVEMENT IS:	0 %
APPROXIMATE AMOUNT OF DISTRESS RELATED TO MATERIALS PROBLEMS IN THE FEATURE IS:	66 %
APPROXIMATE AMOUNT OF DISTRESS RELATED TO AGE OF PAVEMENT AND TRAFFIC REPETITIONS IS:	34 %

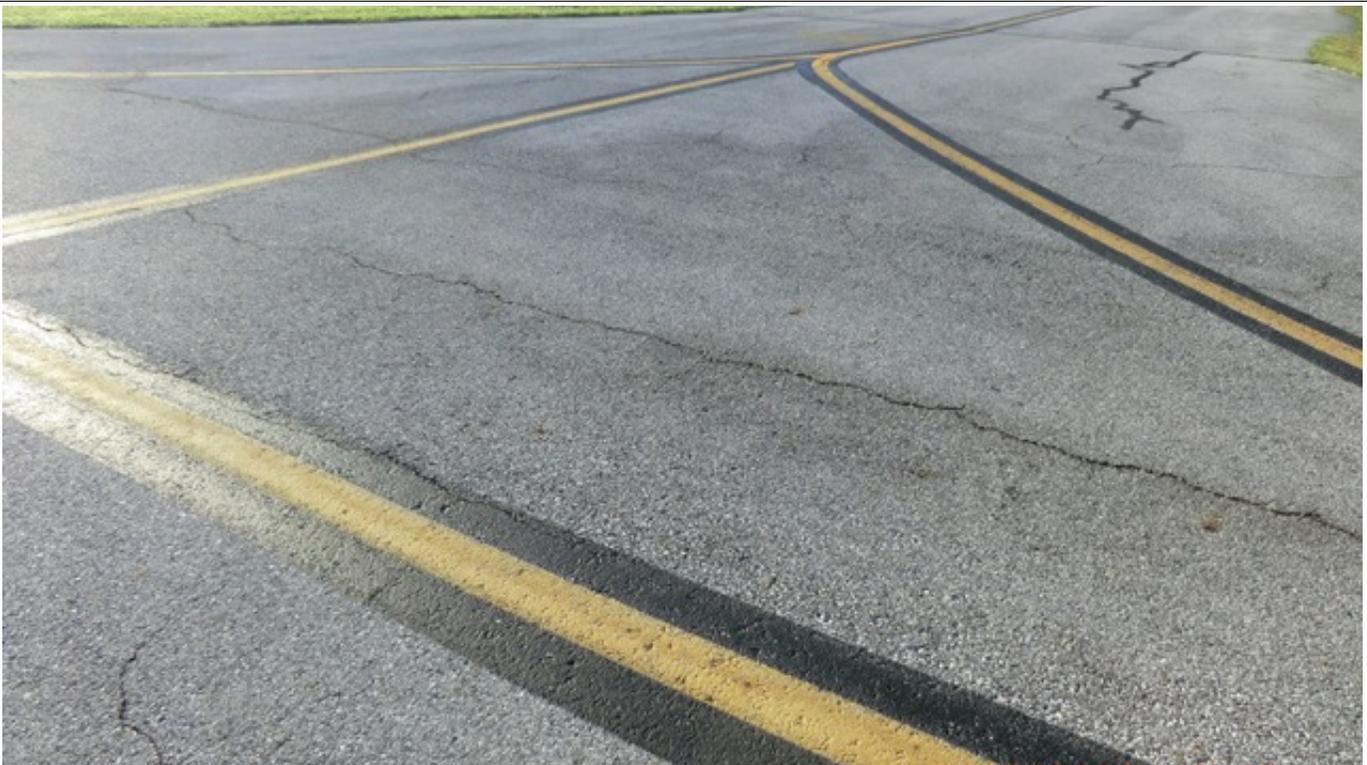
DISTRESS TYPE	SEVERITY	MEASURED QUANTITY	ESTIMATED TOTAL QUANTITY	UNITS	PERCENTAGE OF ALL DISTRESS
BLOCK CRACKING	MED	1,035	4,563	S.F.	18.7
BLOCK CRACKING	LOW	8,730	38,493	S.F.	48.8
LONG.& TRANS. CRACK	MED	116	511	L.F.	14.2
LONG.& TRANS. CRACK	LOW	418	1,843	L.F.	18.1

APPROXIMATE AMOUNT OF DISTRESS RELATED TO LOAD ON THE PAVEMENT IS:	0 %
APPROXIMATE AMOUNT OF DISTRESS RELATED TO MATERIALS PROBLEMS IN THE FEATURE IS:	22 %
APPROXIMATE AMOUNT OF DISTRESS RELATED TO AGE OF PAVEMENT AND TRAFFIC REPETITIONS IS:	78 %

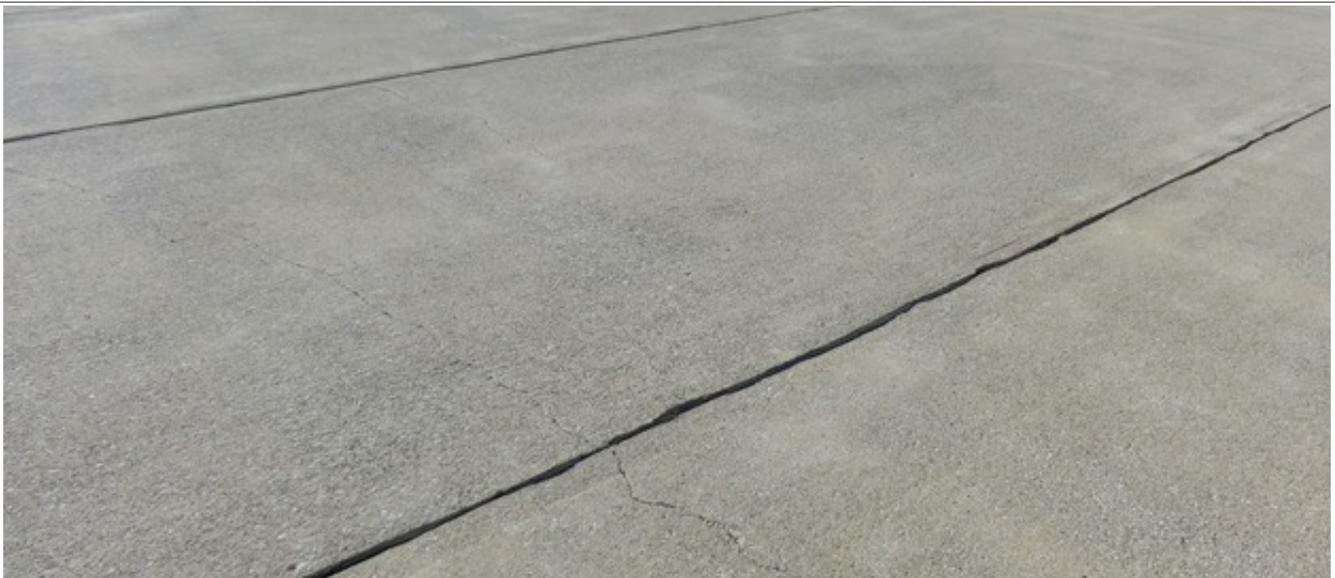
DISTRESS TYPE	SEVERITY	MEASURED QUANTITY	ESTIMATED TOTAL QUANTITY	UNITS	PERCENTAGE OF All DISTRESS
LONG/TRAN/DIAG CRK.	MED	5	11	SLABS	21.3
LONG/TRAN/DIAG CRK.	LOW	29	68	SLABS	31.1
JOINT SEAL DAMAGE	MED	32	75	SLABS	4.9
JOINT SEAL DAMAGE	LOW	16	37	SLABS	.7
PATCH<5 SF	MED	2	4	SLABS	2.3
PATCH<5 SF	LOW	6	14	SLABS	2.1
SHRINKAGE CRACKS	N/A	8	18	SLABS	3
SPALLING-JOINTS	HIGH	2	4	SLABS	8.4
SPALLING-JOINTS	MED	1	2	SLABS	2.1
SPALLING-CORNERS	HIGH	9	21	SLABS	17.2
SPALLING-CORNERS	MED	3	7	SLABS	4.5
SPALLING-CORNERS	LOW	2	4	SLABS	1.8

APPROXIMATE AMOUNT OF DISTRESS RELATED TO LOAD ON THE PAVEMENT IS:	32 %
APPROXIMATE AMOUNT OF DISTRESS RELATED TO MATERIALS PROBLEMS IN THE FEATURE IS:	14 %
APPROXIMATE AMOUNT OF DISTRESS RELATED TO AGE OF PAVEMENT AND TRAFFIC REPETITIONS IS:	53 %

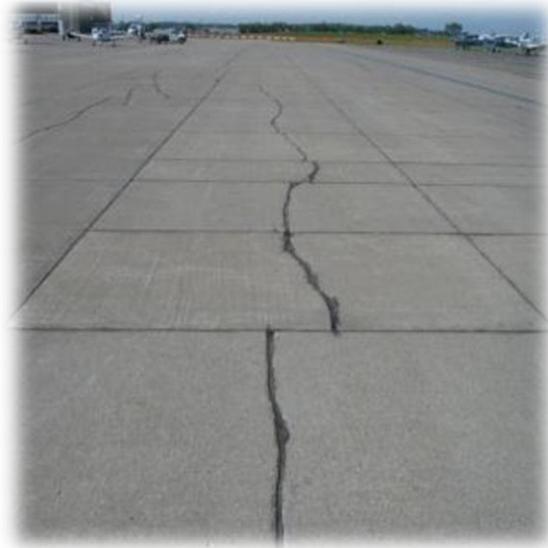
Longitudinal, Transverse & Diagonal Cracking

LTD cracking is often a result of load or temperature deformations. External loads cause flexure. Temperature changes can cause curling. When any of these stresses exceed the slab strength, cracking occurs.

LTD cracking is recorded at low, medium, or high severity, depending on the width of crack opening and degree of deterioration.

At low severity, a crack is less than 1/8 inch wide with little spalling, and no corrective action is indicated. At medium severity, LTD cracks can be up to 1 inch wide with moderate spalling and should be repaired using procedures similar to joint sealing. At high severity, cracks exceed 1 inch in width and may be severely spalled. High-severity LTD cracking is evidence of serious load failure, and correction may require patching or slab replacement. If distress occurs in several adjacent slabs at medium or high severity, major rehabilitation of that area is indicated.
