# Pavement Condition Report

## Portland Municipal Airport

Project 1480370

**January 2014**

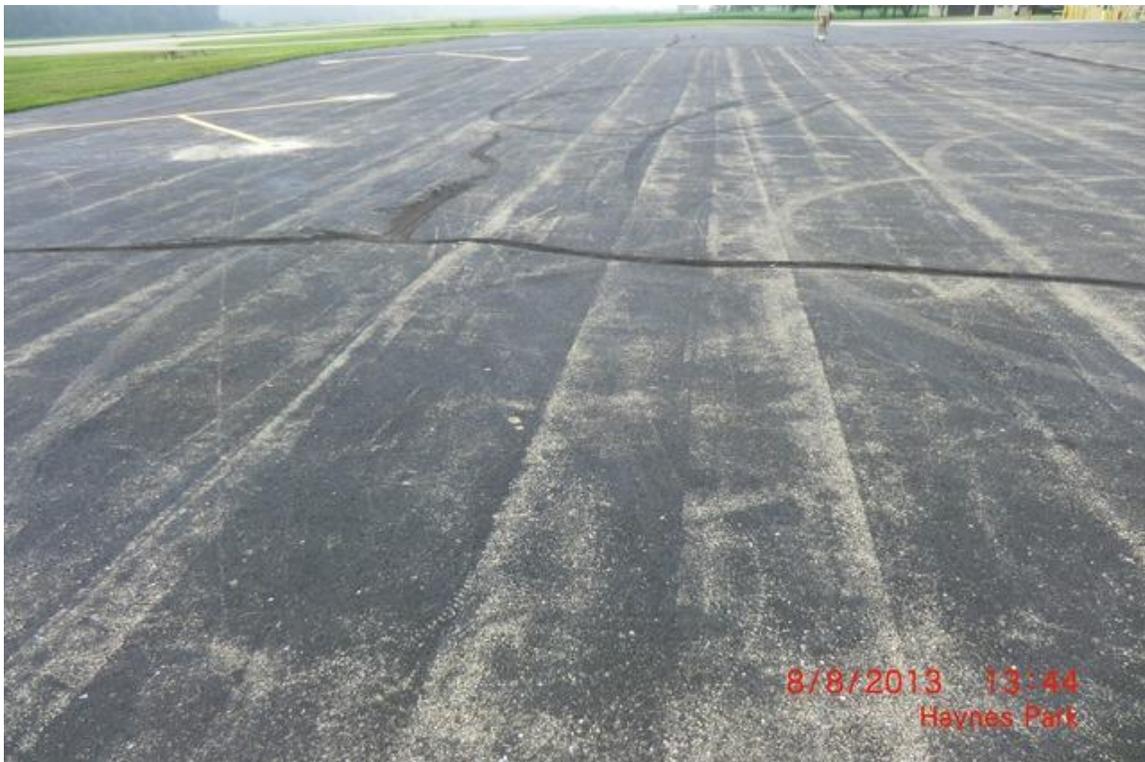
Figure 2-5. Typical Fair AC Pavement (Feature 4105)

The 4105 series ramp consisted 1 section of AAC pavement. The branch had a total area of 58,225 ft<sup>2</sup> with a PCI of 66 (Fair). The observed distresses were L&T cracking, depressions, patching, and alligator cracking.

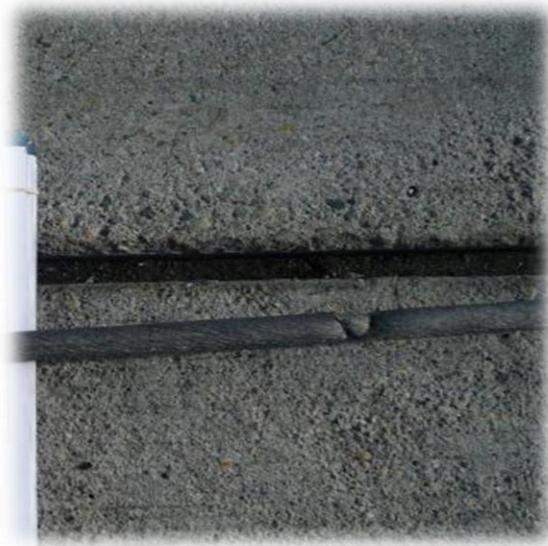
## Joint Seal Damage

When joint sealant is in perfect condition (no damage), there is no distress.

At low severity, at least 10 percent of the sealant is debonded but still in contact with the joint edges. Medium-severity joint seal damage is recorded when at least 10 percent of the sealant has visible gaps smaller than 1/8 inch and is an indicator that replacement should be programmed as soon as is practical. In the meantime, aggressive inspection and sustaining maintenance is recommended to minimize subsurface damage from moisture penetration. At high severity, visible gaps exceed 1/8 inch, and the amount and degree of joint seal damage typically requires complete removal and replacement of the existing sealant.

On serviceable pavement, deteriorated joint sealant should be repaired or replaced to preserve pavement and subgrade integrity and prolong service life. The issue is not so clear-cut with unserviceable pavement. Pavement that can be restored to serviceable condition by maintenance activities such as patching and joint seal repair, or by slab replacement, should be so maintained as long as the process is cost-effective. However, when age and condition preclude economical return to serviceable condition by such means, joint seal repair would no longer be cost-effective and should be suspended except for an interim maintenance program to control FOD potential.
