Pavement Condition Report

Richmond Municipal Airport

Project 15805741

February 2015

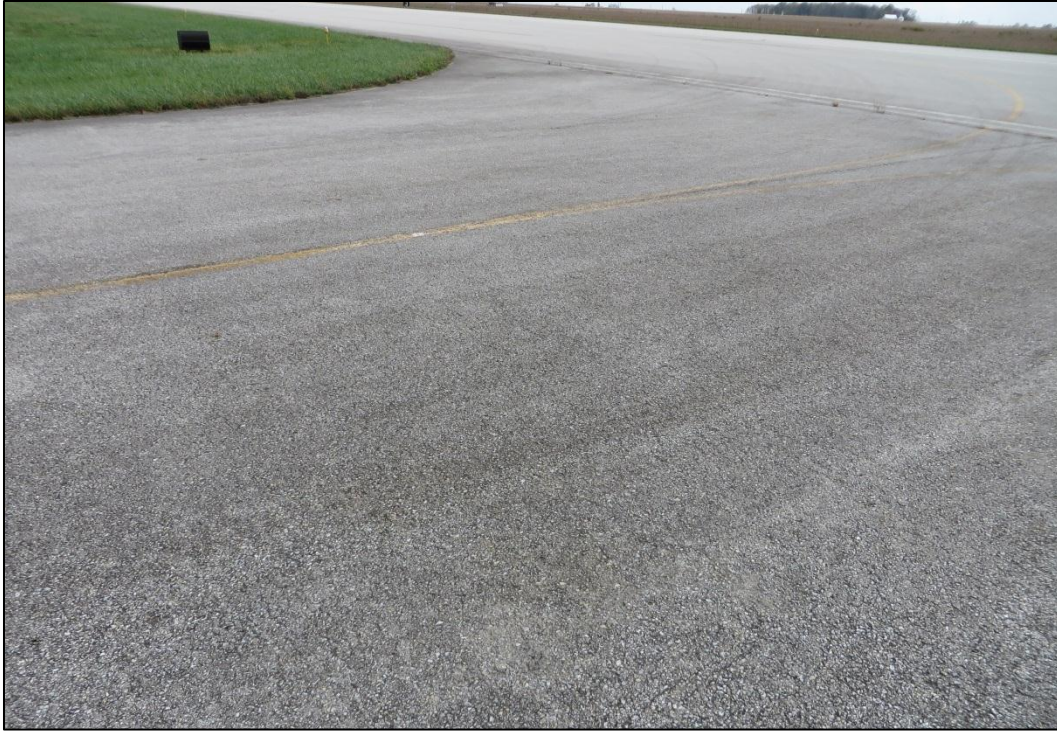
Figure 2-4. Typical Good AC Pavement (Feature 215)

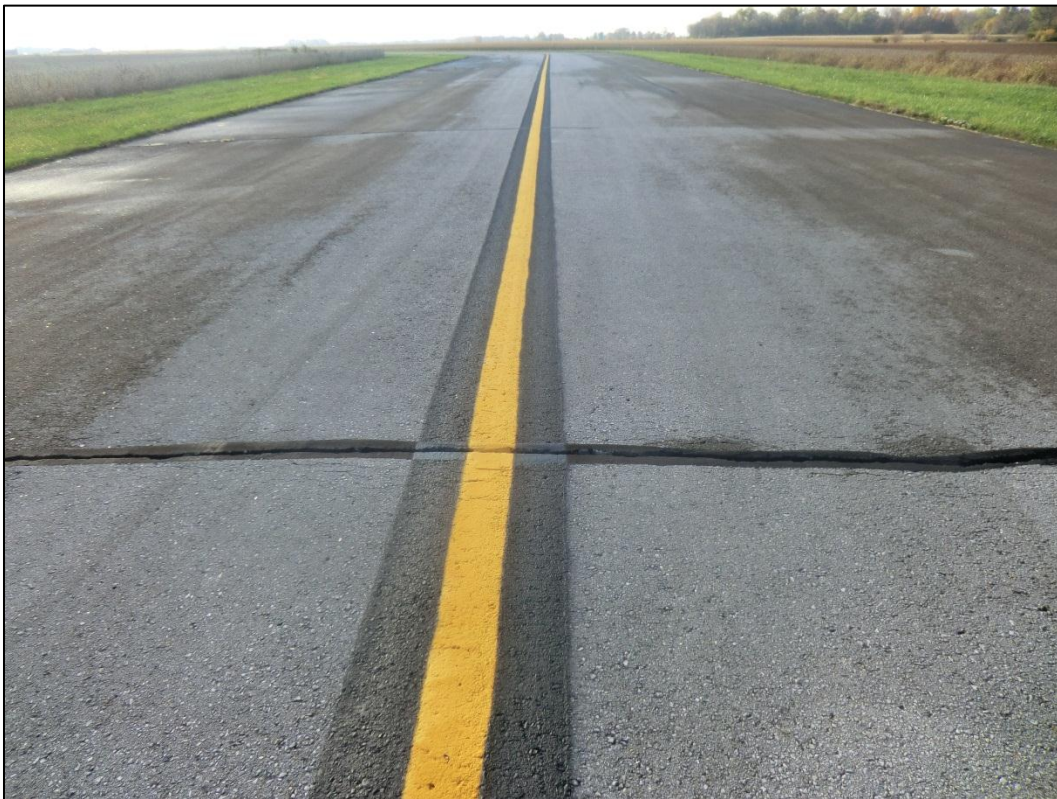
Figure 2-5. Typical Satisfactory AC Pavement (Feature 110)

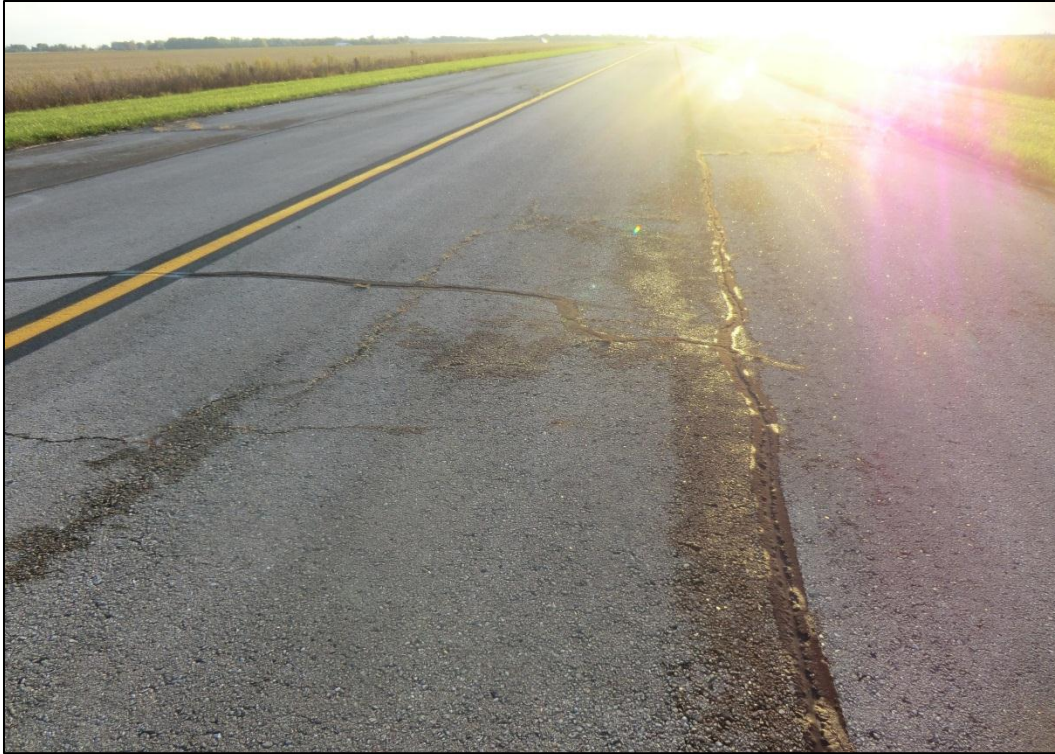
Figure 2-6. Typical Fair AC Pavement (Feature 120)

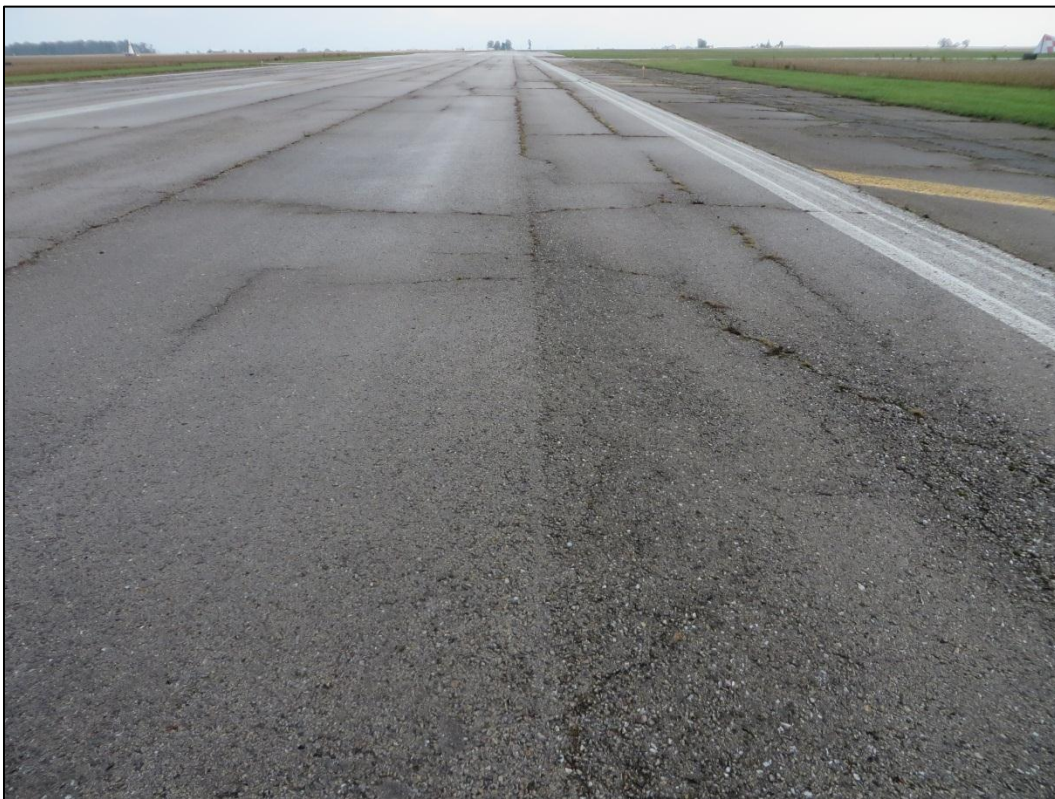
Figure 2-7. Typical Poor AC Pavement (Feature 6005)
