# Pavement Condition Report

## Sheridan Airport

Project 15805741

**February 2015**

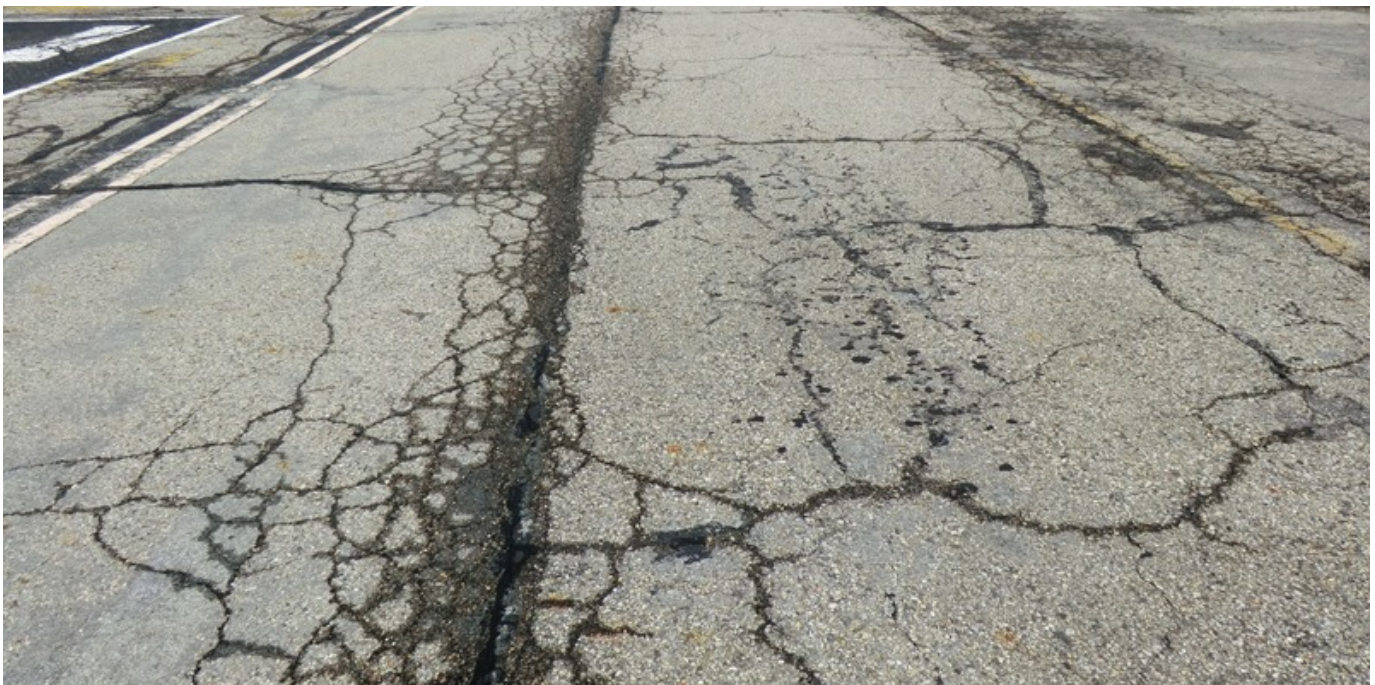
FEATURE: 110

<b>FEATURE:</b> 110	<b>DESCRIPTION:</b> TAXIWAY TO RAMP
<b>ANALYSIS YEAR:</b> 2015	<b>INSPECTION DATE:</b> 9-2-14
<b>PAVEMENT TYPE:</b> AC	<b>FEATURE'S HIGH PCI:</b> 5
<b>FEATURE AREA:</b> 6,885	<b>FEATURE'S LOW PCI:</b> 4
<b>INSPECTED AREA:</b> 6,125	<b>AVERAGE PCI:</b> 4 FAILED
<b>MINIMUM SERVICE LEVEL:</b> 55	<b>ESTIMATED PCI IS:</b> 0 in 2015

DISTRESS TYPE	SEVERITY	MEASURED QUANTITY	ESTIMATED TOTAL QUANTITY	UNITS	PERCENTAGE OF All DISTRESS
ALLIGATOR CRACKING	HIGH	825	927	S.F.	34.1
ALLIGATOR CRACKING	MED	1,310	1,472	S.F.	30.2
ALLIGATOR CRACKING	LOW	190	213	S.F.	8.4
RAVELING	HIGH	50	56	S.F.	7.3
RAVELING	LOW	1,000	1,124	S.F.	3.7
RUTTING	MED	70	78	S.F.	6.6
RUTTING	LOW	175	196	S.F.	9.3

APPROXIMATE AMOUNT OF DISTRESS RELATED TO LOAD ON THE PAVEMENT IS:	84 %
APPROXIMATE AMOUNT OF DISTRESS RELATED TO MATERIALS PROBLEMS IN THE FEATURE IS:	9 %
APPROXIMATE AMOUNT OF DISTRESS RELATED TO AGE OF PAVEMENT AND TRAFFIC REPETITIONS IS:	7 %

AVERAGE PCI AT INSPECTION: 4 FAILED

LEGEND	DESCRIPTION	COST	LIFE EXTENSION
▲	RECONSTRUCTION	\$36,903	24 YEARS
▼	STRUCTURAL OVERLAY	\$12,737	23 YEARS
●	NO ACTION	N/A	N/A
-	MINIMUM SERVICE LEVEL, CURRENTLY 55
