# Pavement Condition Report

## Wabash Municipal Airport

Project 13801869

**January 2013**

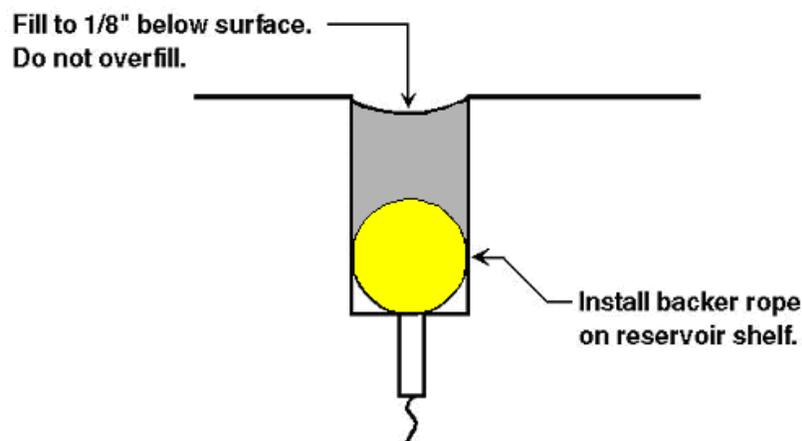
Typical failed joint sealant, w/ debris and incompressibles.

Clean joints exposing fresh, clean concrete and stone. Retain existing reservoir shape.

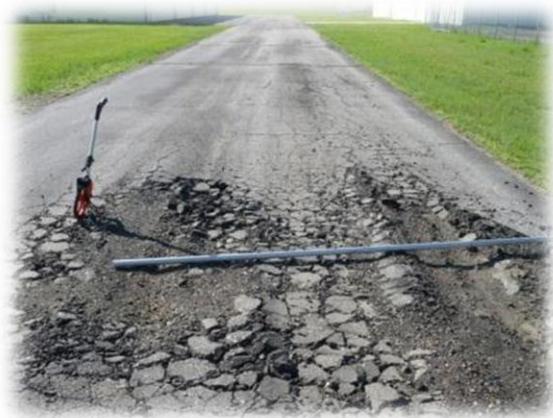
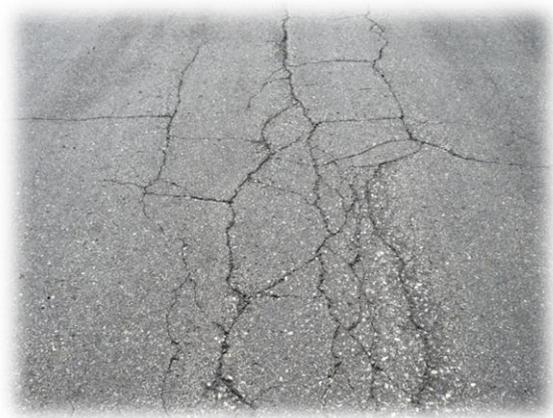
### *Alligator Cracking*

Alligator cracks are a series of interconnected load-related cracks caused by fatigue of the asphalt surface. Alligator cracking is a significant structural distress and develops only in places subject to traffic loads. These cracks typically initiate at the bottom of the asphalt layer and propagate upward. Once a fatigue crack is visible at the surface, significant damage has already occurred.

At low severity, alligator cracks are evidenced by a series of parallel hairline cracks (usually in a wheel path). Medium-severity alligator cracking is a well-defined pattern of interconnected cracks, and some spalling may be present. High-severity alligator cracks have lost aggregate interlock between adjacent pieces, and the cracks may be severely spalled with FOD potential. Most likely, the pieces will move freely under traffic.

Alligator cracking is a serious structural failure that cannot be repaired with sealant. The proper repair is patching.

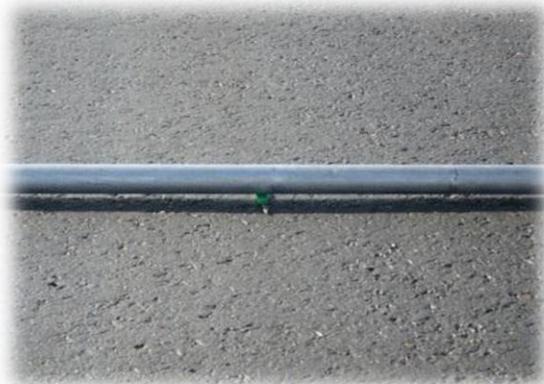
Rutting is due to base and subgrade consolidation caused by excessive wheel loads or poor compaction. Ruts indicate structural failure and can cause hydroplaning.

At low severity, ruts have an average depth of ¼ to ½ inches. At medium severity, ruts have an average depth of ½ to 1 inch. At high severity, ruts have an average depth greater than 1 inch. Patching is the appropriate repair for ruts.
