Pavement Condition Report

Winchester-Randolph County Airport

Project 15805741

February 2015

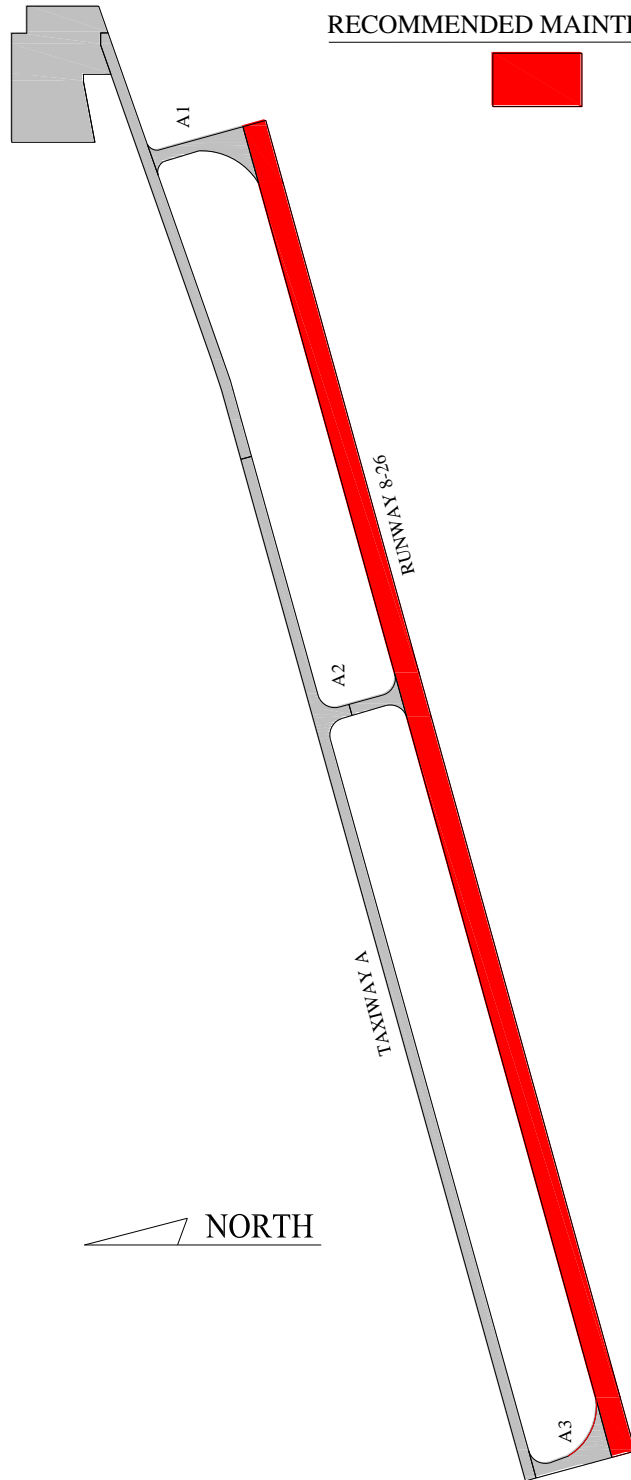
RECOMMENDED MAINTENANCE

Analysis of potential maintenance projects identified approximately 2,000 linear feet of crack sealing and crack repair needs, at an estimated total cost of approximately \$1,700.

| Work Item | Quantity | Unit | Cost |
|---|---|---|---|
| AC SUSTAINING CRACK REPAIR | 1,969 | L.F. | 1,703 |

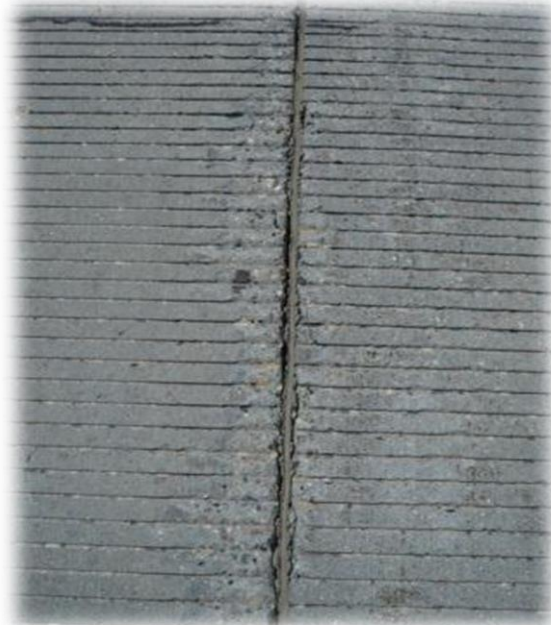
Joint Seal Damage

When joint sealant is in perfect condition (no damage), there is no distress.

At low severity, at least 10 percent of the sealant is debonded but still in contact with the joint edges. Medium-severity joint seal damage is recorded when at least 10 percent of the sealant has visible gaps smaller than 1/8 inch and is an indicator that replacement should be programmed as soon as is practical. In the meantime, aggressive inspection and sustaining maintenance is recommended to minimize subsurface damage from moisture penetration. At high severity, visible gaps exceed 1/8 inch, and the amount and degree of joint seal damage typically requires complete removal and replacement of the existing sealant.

On serviceable pavement, deteriorated joint sealant should be repaired or replaced to preserve pavement and subgrade integrity and prolong service life. The issue is not so clear-cut with unserviceable pavement. Pavement that can be restored to serviceable condition by maintenance activities such as patching and joint seal repair, or by slab replacement, should be so maintained as long as the process is cost-effective. However, when age and condition preclude economical return to serviceable condition by such means, joint seal repair would no longer be cost-effective and should be suspended except for an interim maintenance program to control FOD potential.

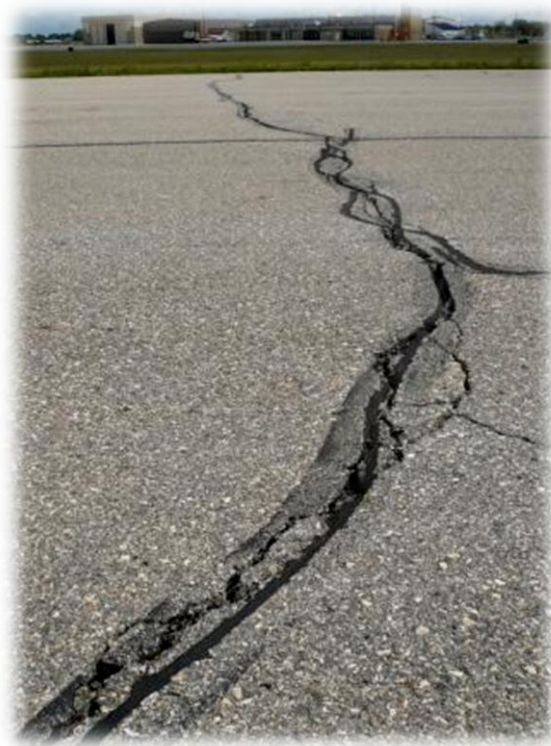
Longitudinal & Trans. Cracking

L&T cracks are caused by age, construction, and subsurface conditions. Age-related cracking occurs as oxidizing pavement loses components to the atmosphere and becomes more brittle. Consistent application of seal coats can help to prevent age-related cracks.

Construction-related cracking often develops along paving joints. Ensuring that joints are made when both sides are still hot, and near the same temperature, is one of the best ways to mitigate this potential problem.

Seasonal movement caused by changes in subsurface moisture or temperature differences also can cause pavement cracking. Asphalt pavement placed over a PCC pavement or cement stabilized base course may evidence reflective cracking from the underlying material. Wheel loads do not cause L&T cracks, although traffic may worsen their condition.

Low-severity L&T cracks are less than ¼ inch wide, or if sealed with suitable filler material in satisfactory condition can be any width less than 3 inches, if they are not spalled. Maintenance usually is not indicated for low-severity cracking. Moderately spalled cracks and cracks wider than ¼ inch which are not satisfactorily sealed are at medium severity. Medium-severity cracks should be sealed with a high-quality crack filling material. Severely spalled cracks and cracks wider than 3 inches are at high severity. High-severity L&T cracks normally require patching.

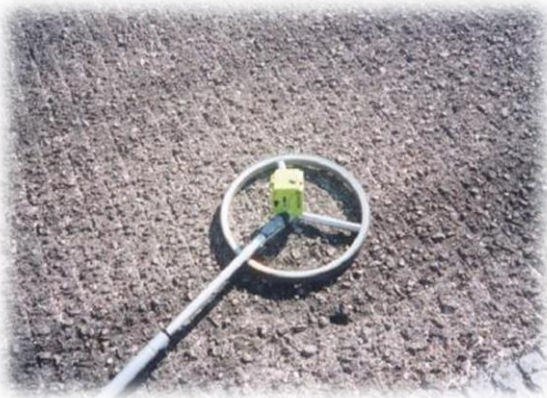
Raveling/Weathering

Raveling and weathering are the wearing away of the pavement surface. Failure can be caused by the dislodging of aggregate particles or the loss of asphalt binder. These distresses are usually evident over large areas and may indicate that the asphalt binder has hardened significantly.

Raveling: At low severity, 5 to 20 coarse aggregate particles are missing per square yard. Medium severity is defined by 20 to 40 missing coarse aggregate particles per square yard. At high severity, more than 40 coarse aggregate particles are missing per square yard, and the top layer of aggregate has eroded away.

Weathering: At low severity, edges of coarse aggregate are exposed less than 1 mm. At medium severity, loss of fine aggregate is noticeable and edges of coarse aggregate are exposed up to 6 mm (1/4 inch). High severity weathering has edges of coarse aggregate exposed > 6 mm, with considerable loss of fine aggregate matrix and potential for loss of coarse aggregate.

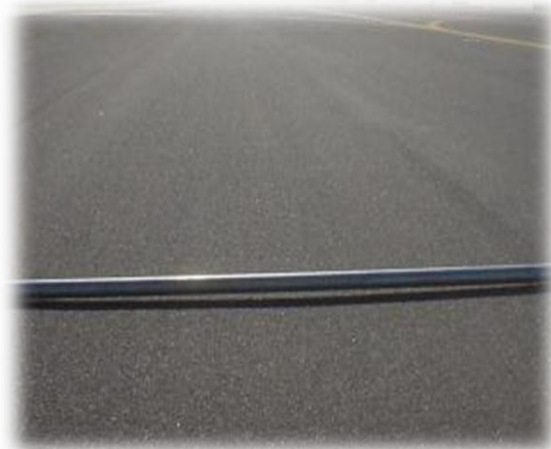
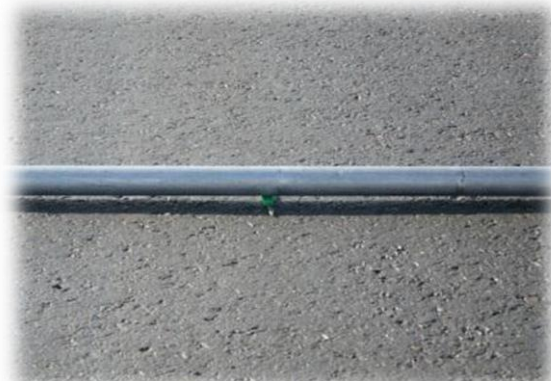
Ruts are localized areas of pavement having elevations lower than the surrounding sections.

Rutting is due to base and subgrade consolidation caused by excessive wheel loads or poor compaction. Ruts indicate structural failure and can cause hydroplaning.

At low severity, ruts have an average depth of ¼ to ½ inches. At medium severity, ruts have an average depth of ½ to 1 inch. At high severity, ruts have an average depth greater than 1 inch. Patching is the appropriate repair for ruts.
